# Laboratory Investigation of Concrete Beam-End Treatments

**Final Report  
May 2015**

**IOWA STATE UNIVERSITY**  
**Institute for Transportation**

**Sponsored by**  
Federal Highway Administration  
Iowa Department of Transportation  
(InTrans Project 12-442)

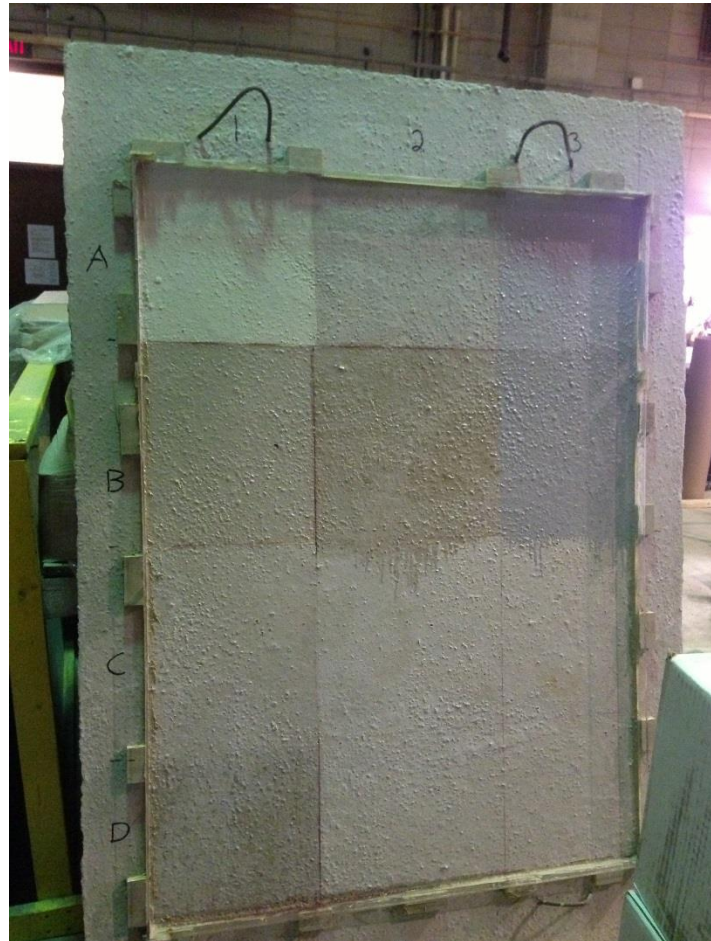
**Figure 2. Typical ponding slab with coating alternatives applied**

The application of two coats of Sikagard 62 to D3 was at the request of Iowa DOT staff to evaluate any potential benefit to using two coats versus the typical one-coat application specified by the manufacturer, and both coats were applied after the photo was taken but prior to ponding.

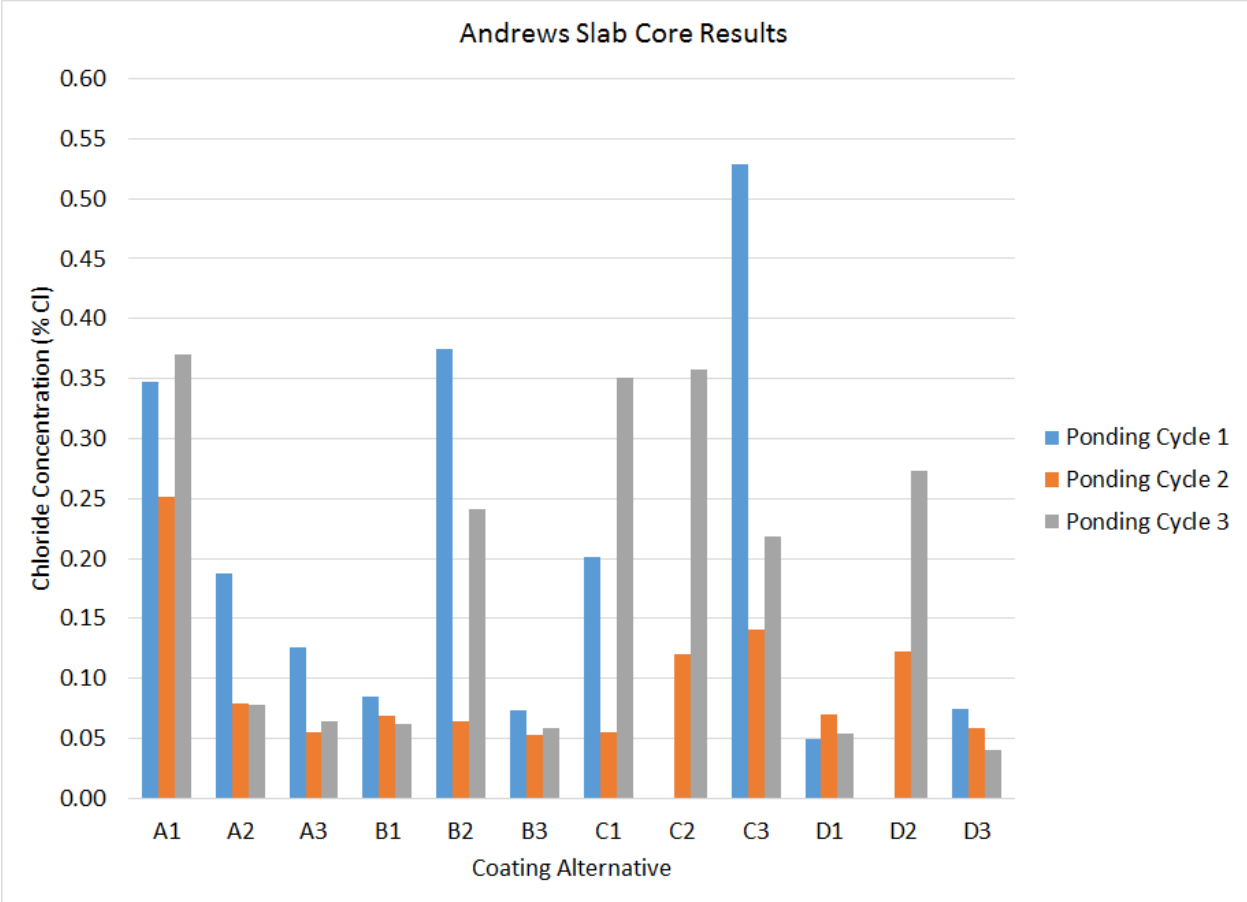
**Figure 4. Chloride test results for the Andrews Slab**

Table 2 and Figures 4 through 6 provide several useful pieces of information. (Recall that Andrews is no longer a precast supplier, so the presented data is for informational purposes only.) First, in general, all three slabs performed relatively the same, indicating that differences between the suppliers do not have a notable effect on the performance of the concrete coating alternatives. Additionally, visual inspection throughout the project found there to be no issues with adhesion of any of the alternatives to the concrete surfaces provided by all three manufacturers throughout the three ponding cycles. Second, if we compare the performance of the control squares (C3 and D2) with all the squares that had an applied coating, there is a general improvement of the chloride resistance where a coating is used, as expected. The one exception to this is the TEX•COTE XL 70 product; based on the results from the laboratory ponding tests, this was the only alternative to not perform better than the control. Third, although the chloride contents varied up and down slightly from one ponding cycle to the next, the variances were relatively small and showed no notable increase in the chloride content of the concrete over the course of the three ponding cycles. Lastly, using the numbers in Table 2 or Figures 4 through 6 as a guide, the alternatives may be rated as follows in terms of decreasing performance to resist chloride penetration into the concrete: (1) tie: BASF Sonoguard, BASF Hydrozo 100, Sikagard 62 – two coats, (2) Viking Aqua Guard, (3) Sikagard 62 – one coat, (4) TEX•COTE RAINSTOPPER 140, (5) PAULCO TE-3008-1, (6) Evercrete, (7) TEX•COTE XL 70.

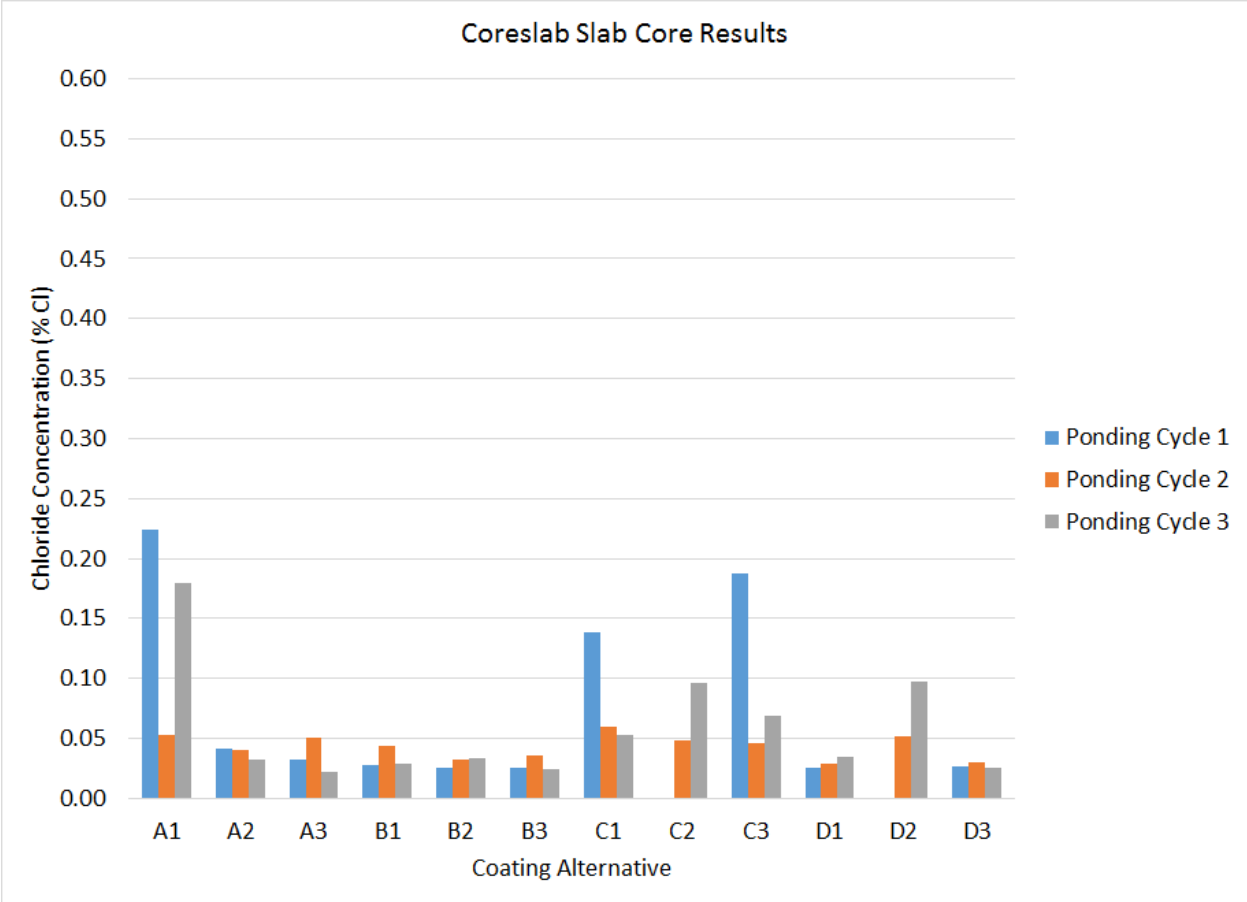
**Figure 5. Chloride test results for the Coreslab Slab**

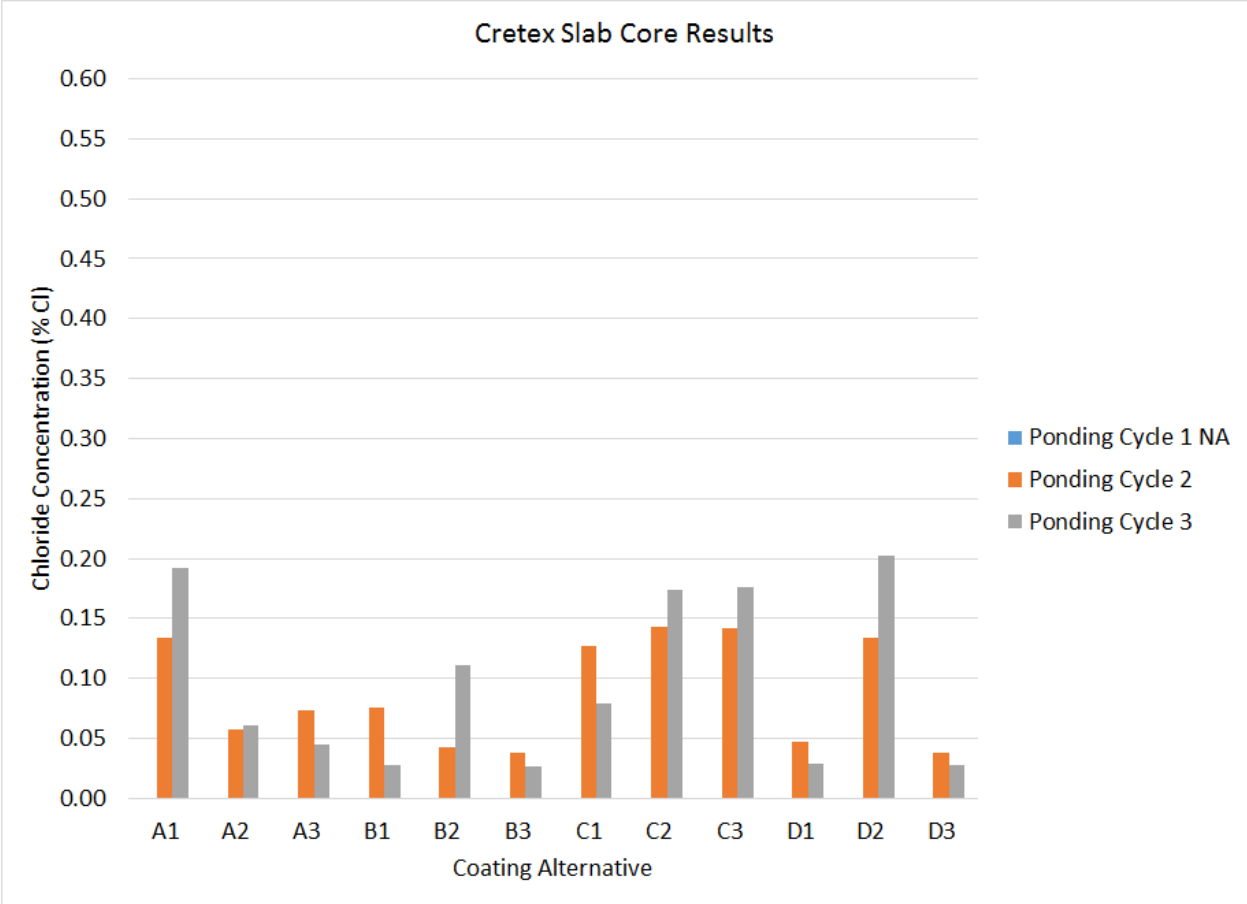
**Figure 6. Chloride test results for the Cretex Slab**

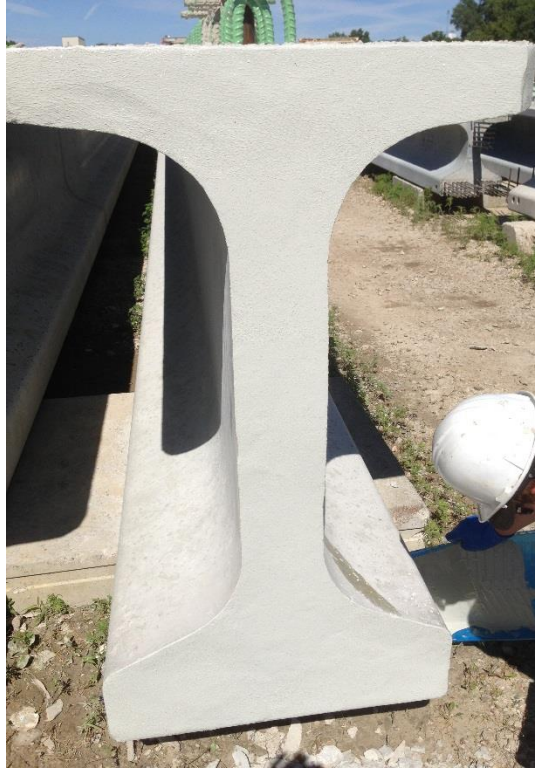
**Figure 7. BD08501E – TEX•COTE XL 70**

Figures 7 through 13 show a representative prestressed concrete beam end after application of each of the seven coating alternatives at the precast plant. As noted previously, all of the girders were prepared for coating application by the precaster as per their own specifications. In addition, immediately prior to application of the coatings, at the recommendation of the Iowa DOT, the research team removed any visible surface rust from the prestressing strand ends using an angle grinder and removed any dust and visible surface debris.

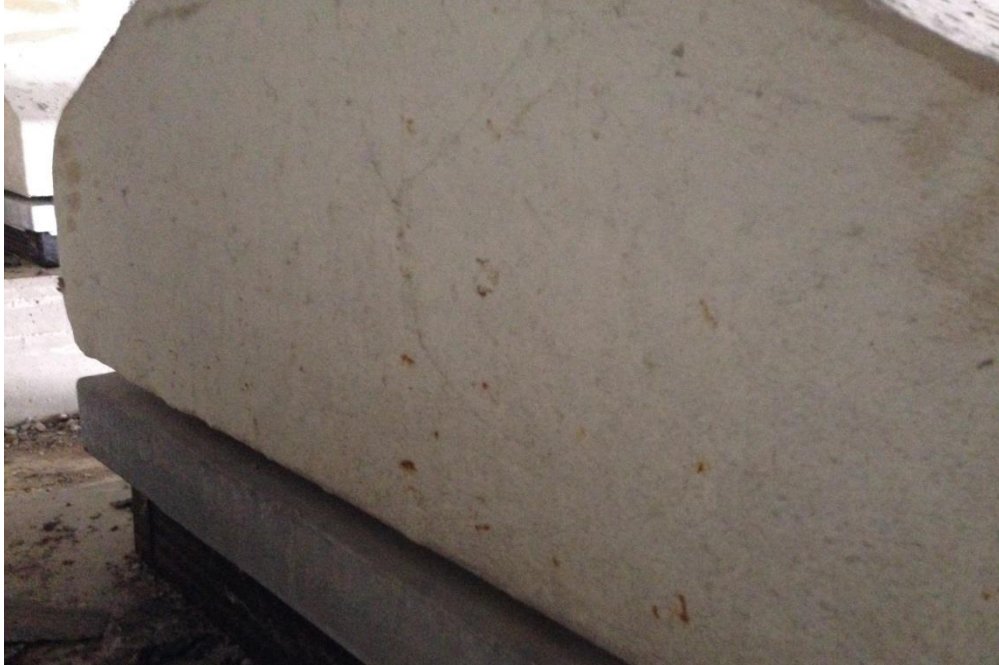
**Figure 15. TEX•COTE XL 70 field condition on BD13526**

Field inspection of beams BD13526 and BD8501E revealed several strand ends where the coating has peeled off completely, exposing the rusty end of the strand. Beam BD8501E had four or five strand ends exposed and showing significant signs of rusting (see Figure 18). On beam BC11527, the precaster noted that within a couple weeks of application several of the strand ends were showing signs of rust. The rusty areas were removed with an angle grinder by the research team and the entire end of the beam recoated with TEX•COTE XL 70. Upon inspection after nearly a year and a half in service, beam BC11527 showed signs of rust appearing through the coating at several strand end locations similar to what was found after the first application, but no chipping or peeling of the coating was evident (see Figure 21).

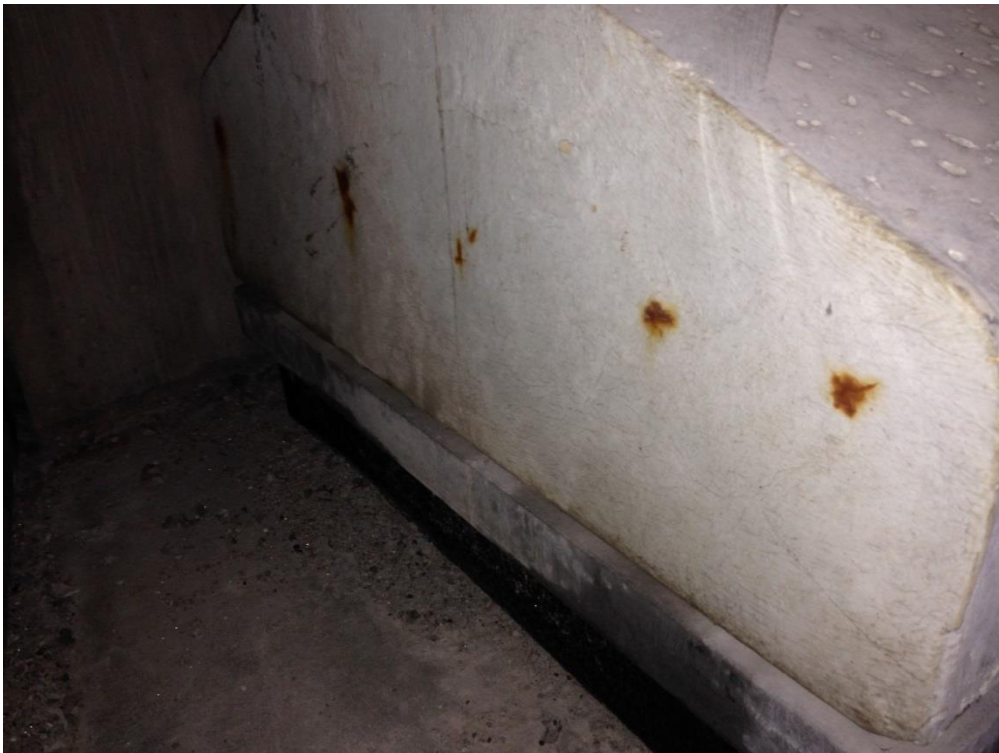
**Figure 18. TEX•COTE XL 70 field performance on BD08501E**

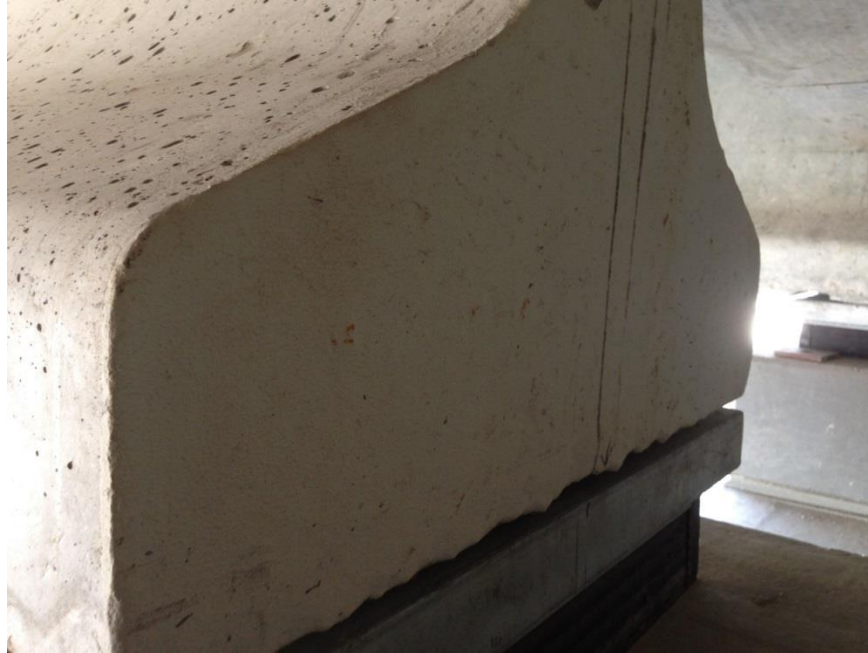
**Figure 21. TEX•COTE XL 70 field performance on BC11527**

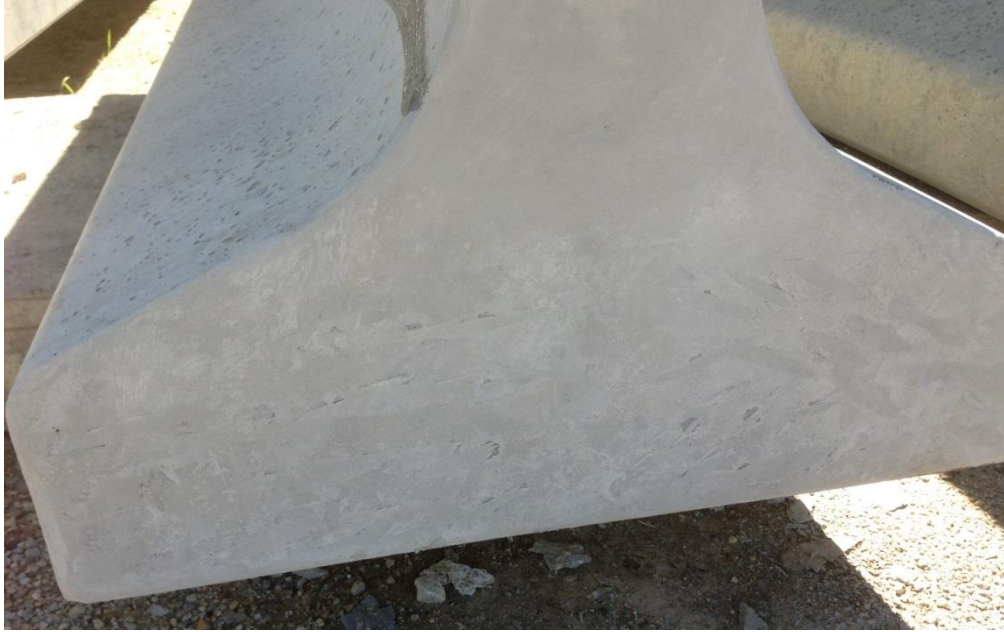
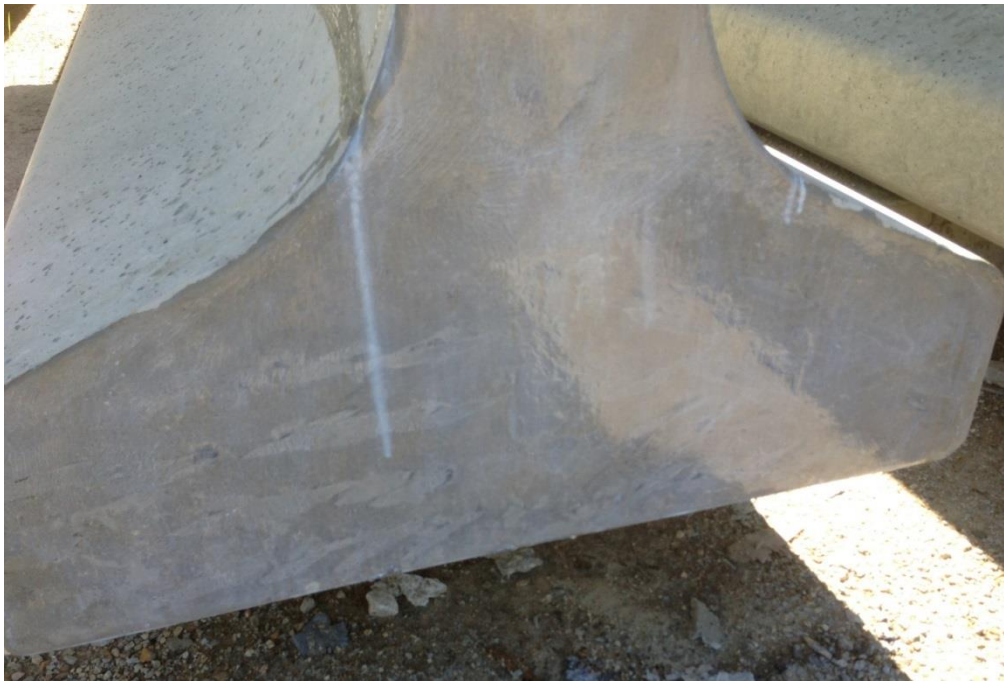
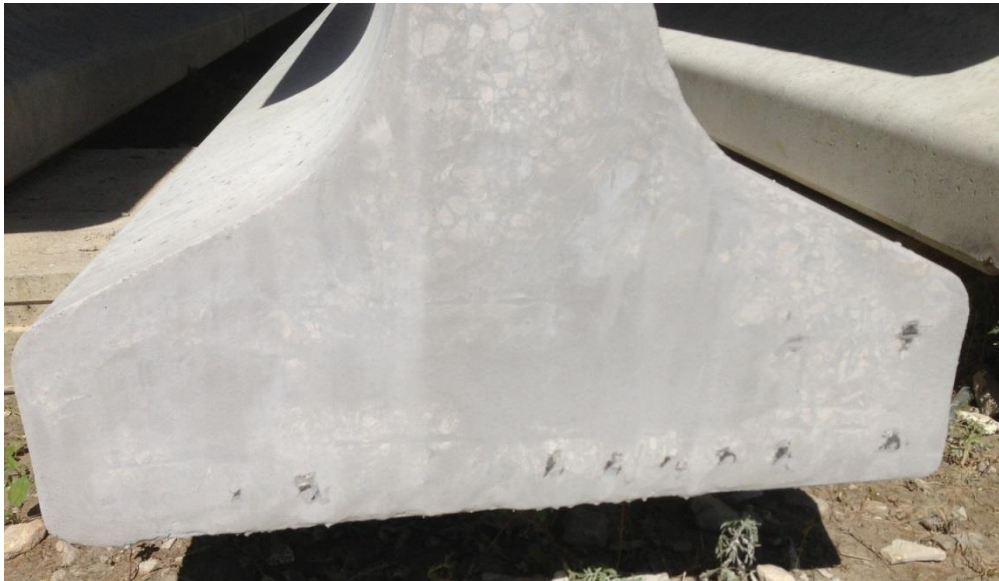
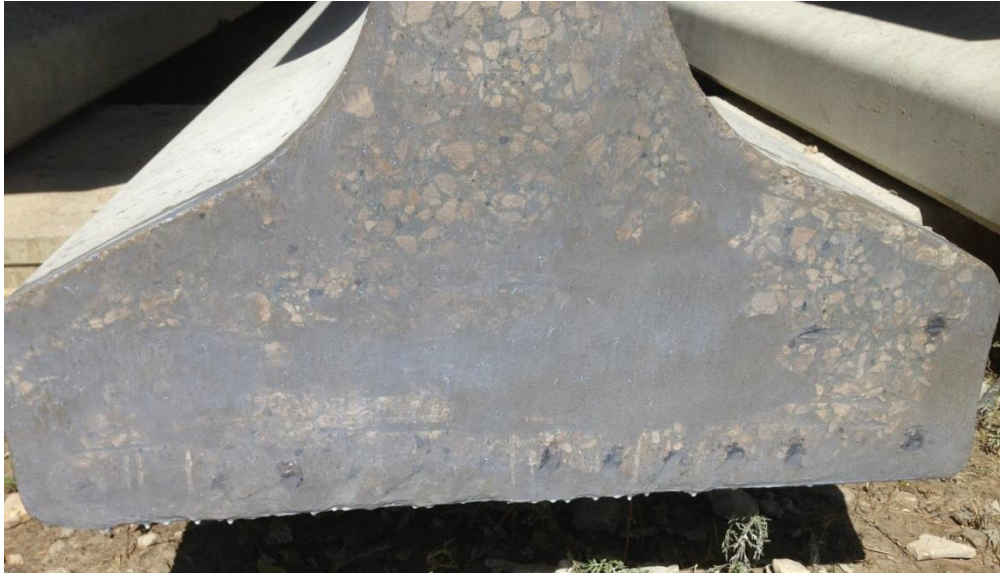
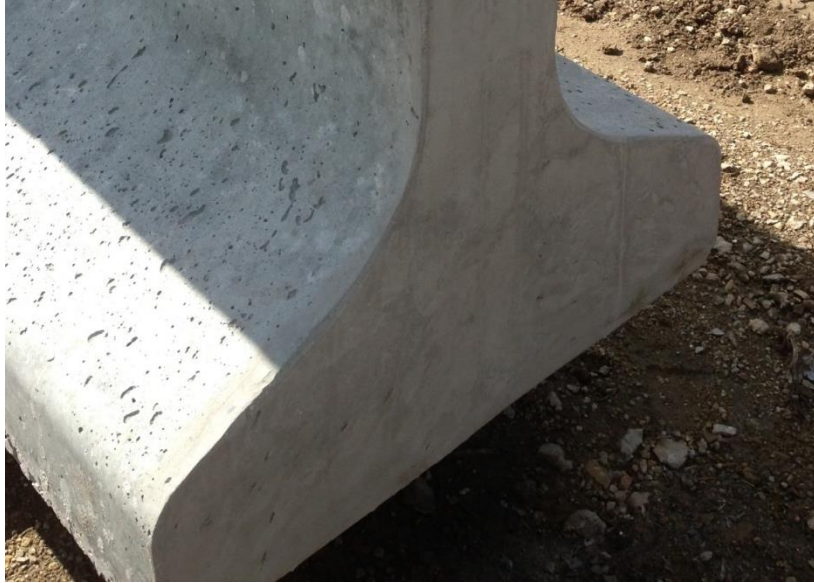
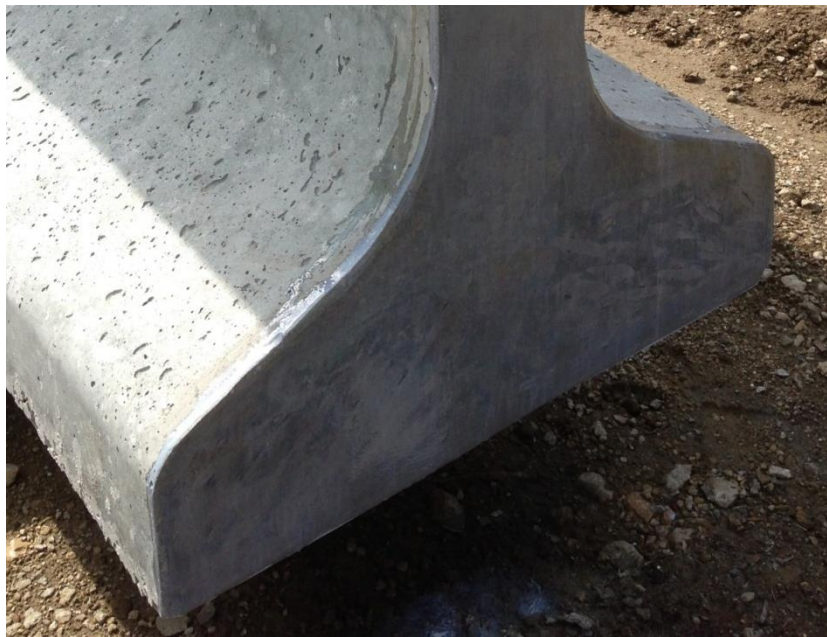
All three beams (BD13528, BD08502, and BC11526E) coated with this product showed similar levels of performance. There were numerous strand ends exposed and covered with rust (see Figures 22 through 30).

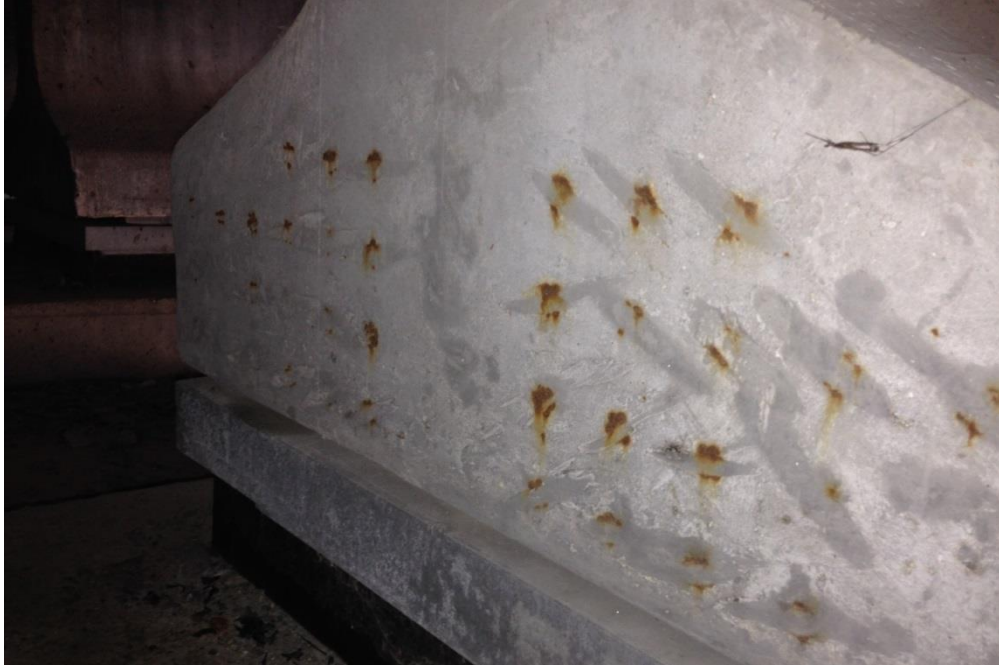
**Figure 24. TEX•COTE RAINSTOPPER 140 field performance on BD13528**

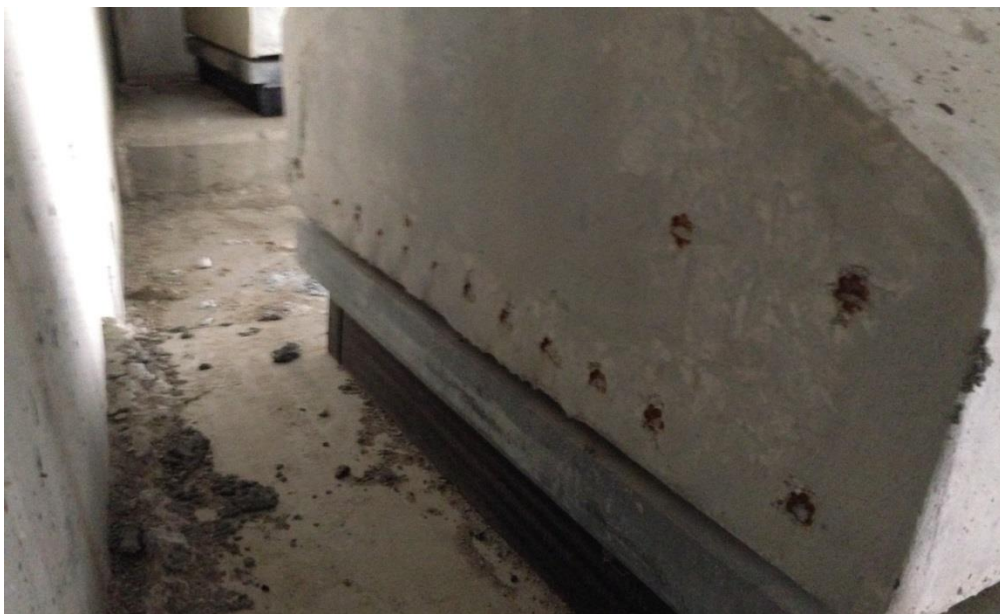
**Figure 27. TEX•COTE RAINSTOPPER 140 field performance on BD08502**

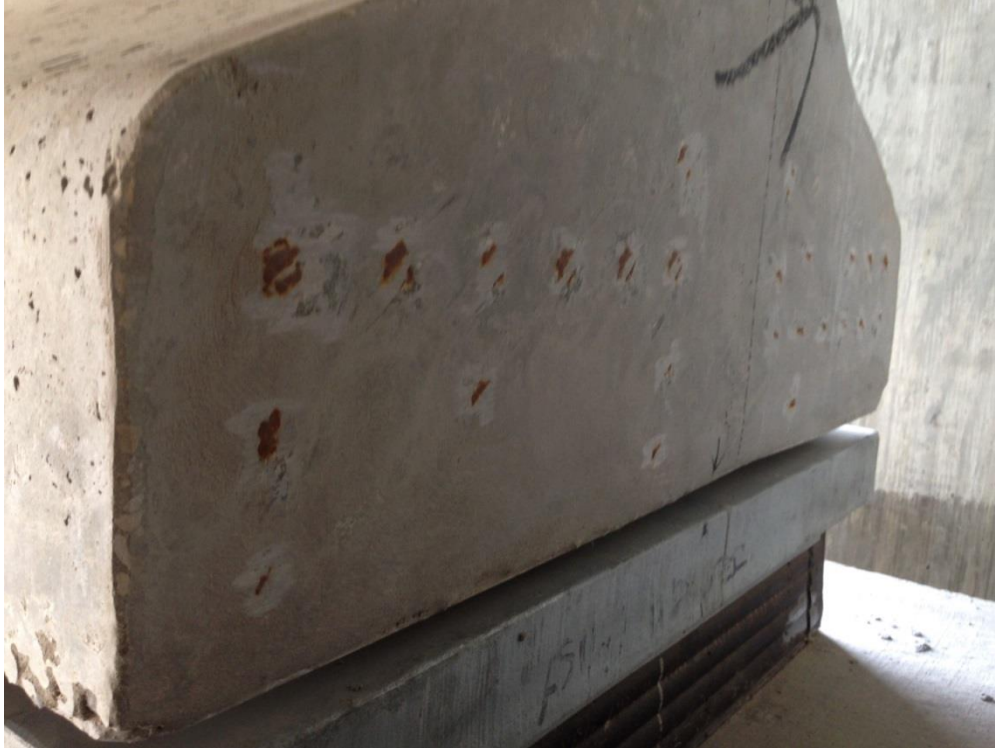
**Figure 30. TEX•COTE RAINSTOPPER 140 field performance on BC11526E**

Recall that beam BC11526E had a second coating applied at the plant. Visual inspection by both the plant foreman and the research team revealed that the rust had not penetrated the coating yet, but rust was visible through the coating. The rusty areas were then removed using an angle grinder and the entire surface of the beam retreated with the TEX•COTE RAINSTOPPER 140. Eighteen months after being in service, the most recent field inspection of BC11526E found the strand ends again to be visible and rusty, and in some locations the rust was piercing the coating.

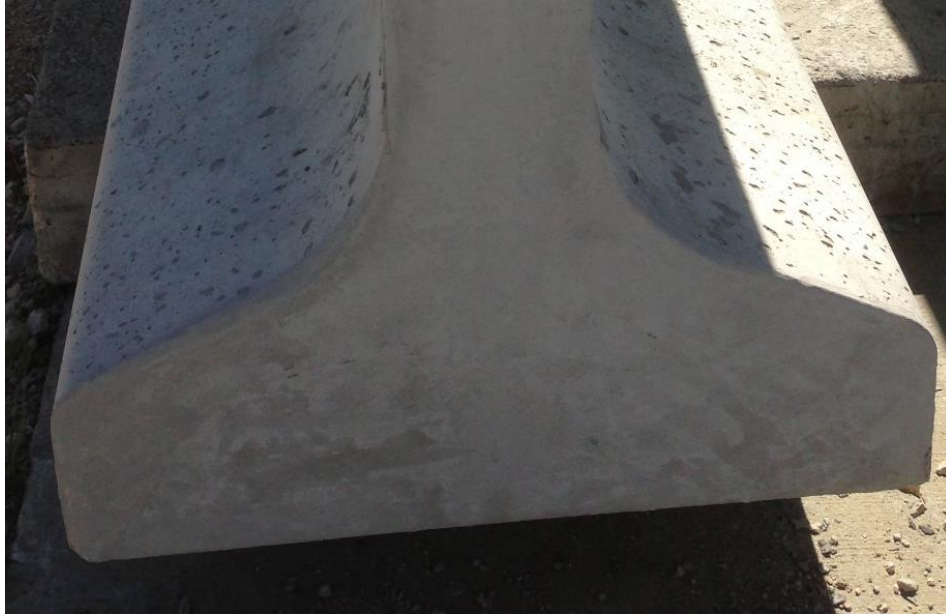
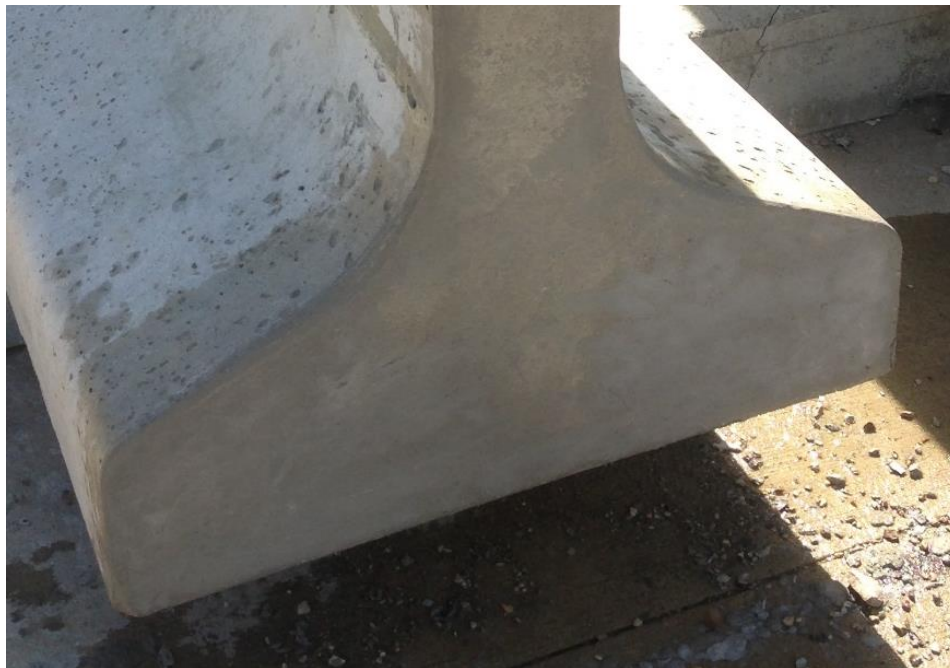
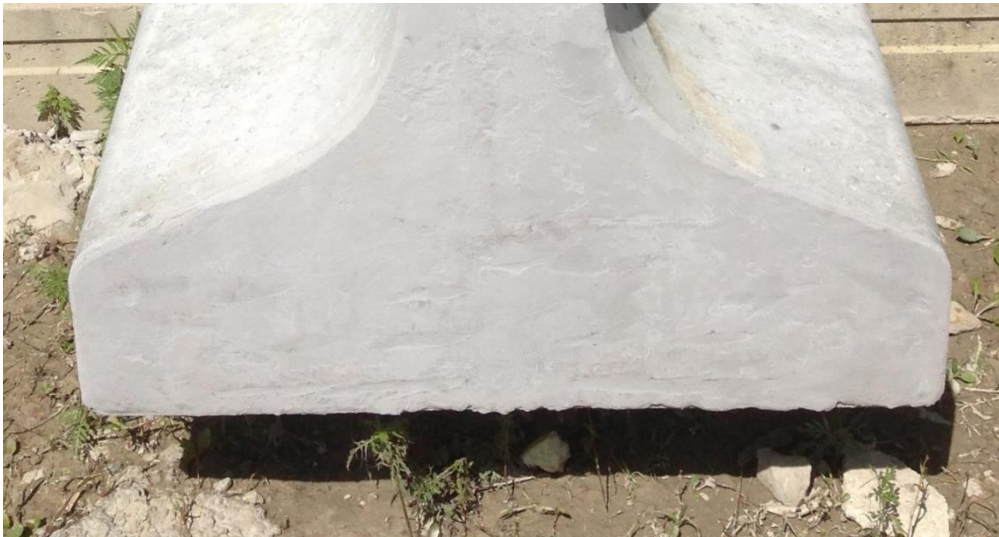
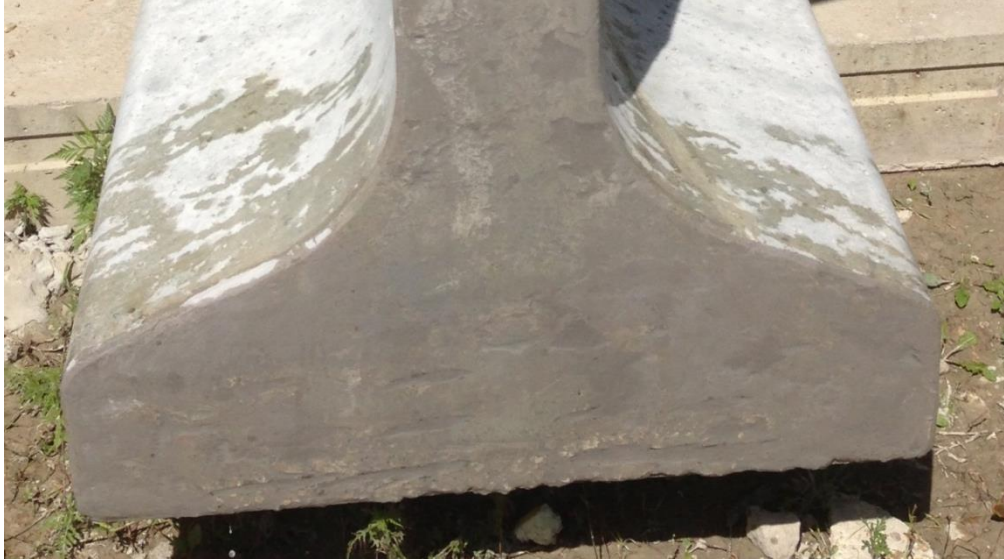
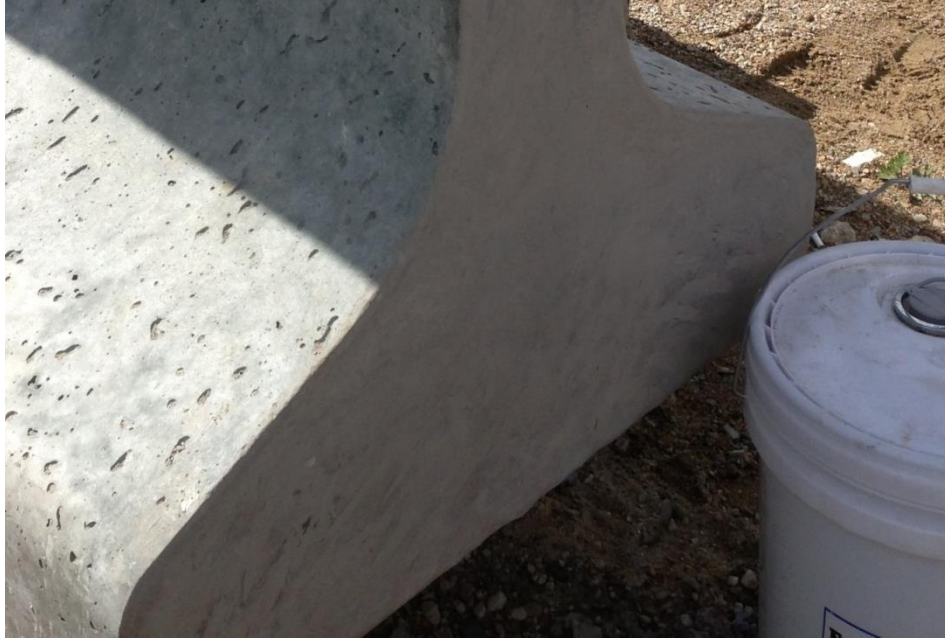
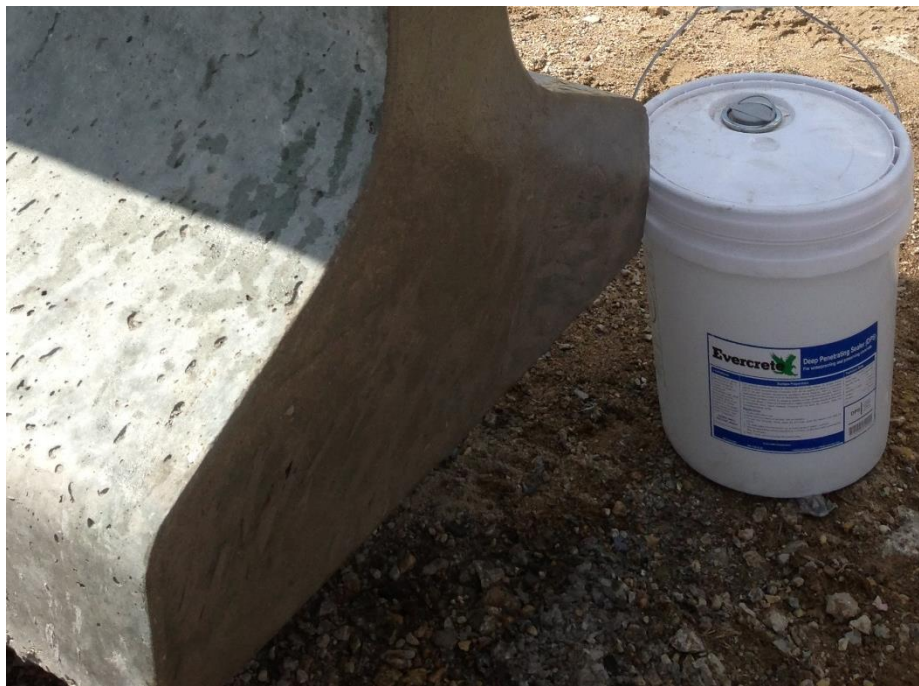
All three beams (BD13527, BD08507, and BC11529) coated with this product showed similar levels of performance and performed similarly to the RAINSTOPPER product. There were numerous strand ends exposed and covered with rust (see Figures 31 through 39).

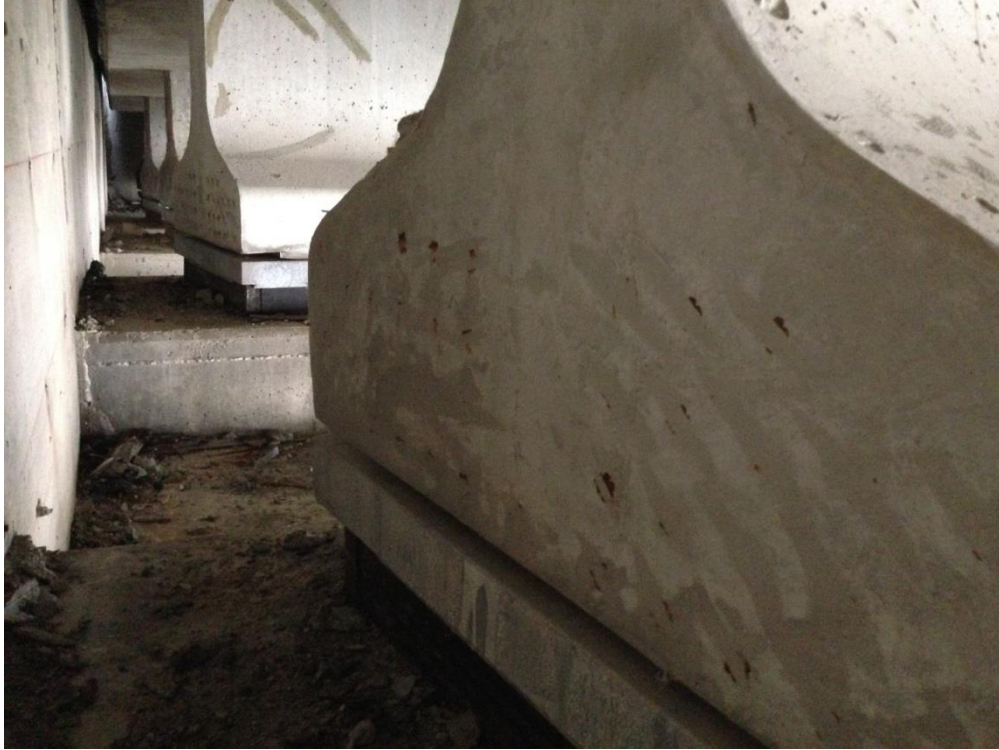
**Figure 33. Evercrete DPS field performance on BD13527**

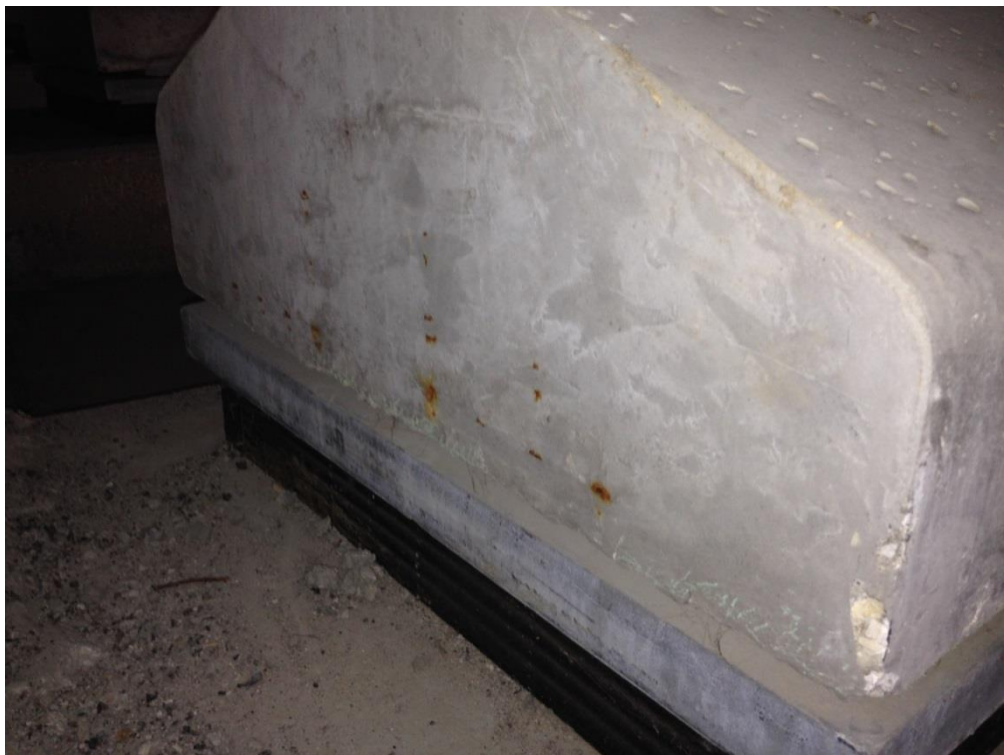
**Figure 36. Evercrete DPS field performance on BD08507**

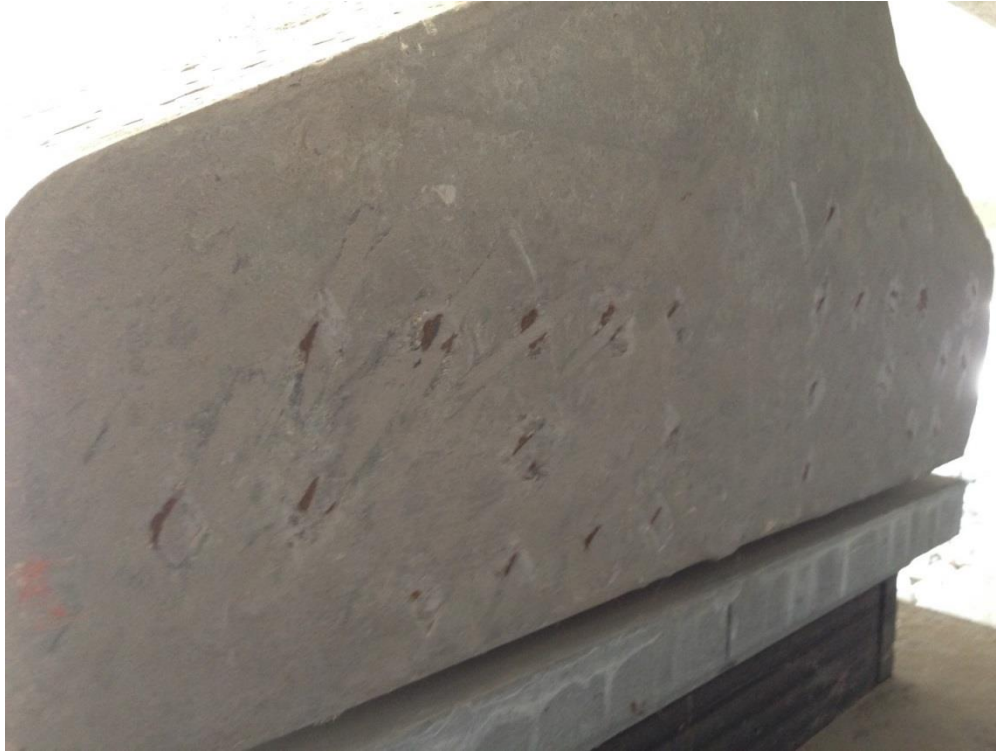
**Figure 39. Evercrete DPS field performance on BC11529**

Recall that beam BC11529 had a second coating applied at the plant. Visual inspection by both the plant foreman and research team revealed that the rust had not penetrated the coating yet, but rust was visible through the coating. The rusty areas were then removed using an angle grinder and the entire surface of the beam retreated with Evercrete DPS. During the most recent field inspection of BC11529, several strand ends were again found to be visible and rusty, and in some locations the rust was piercing the coating.

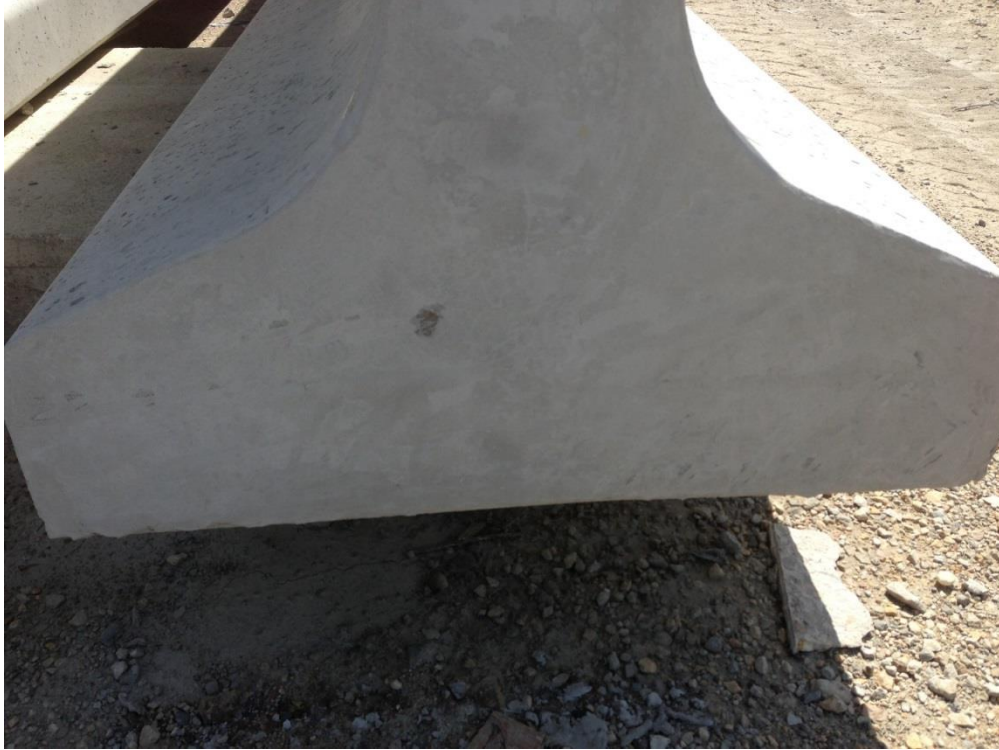
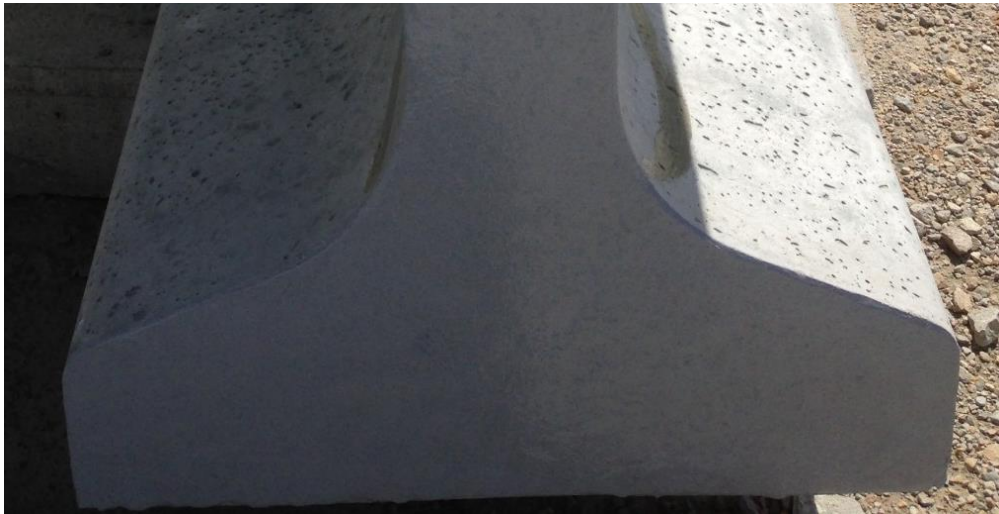
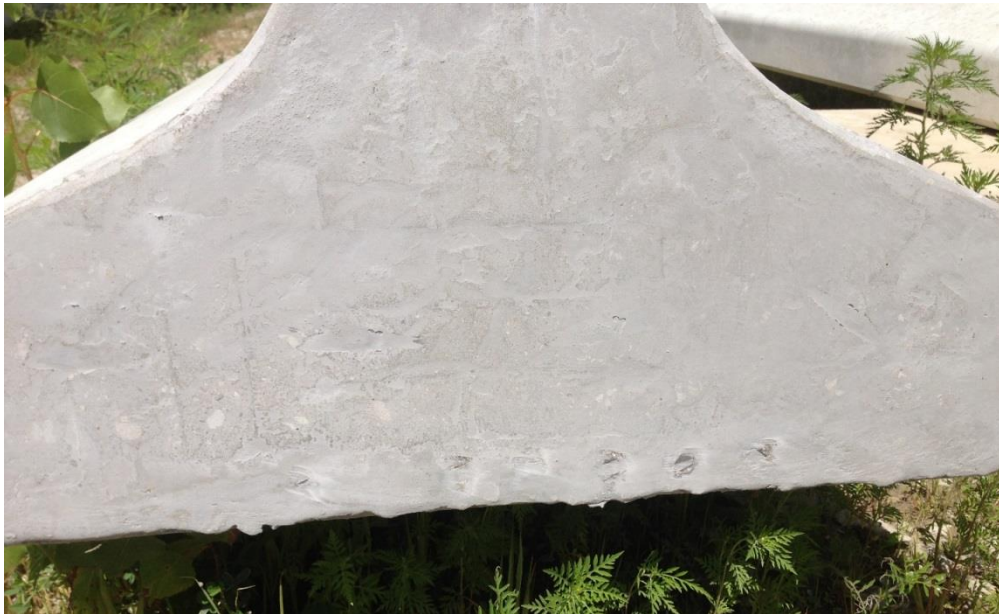
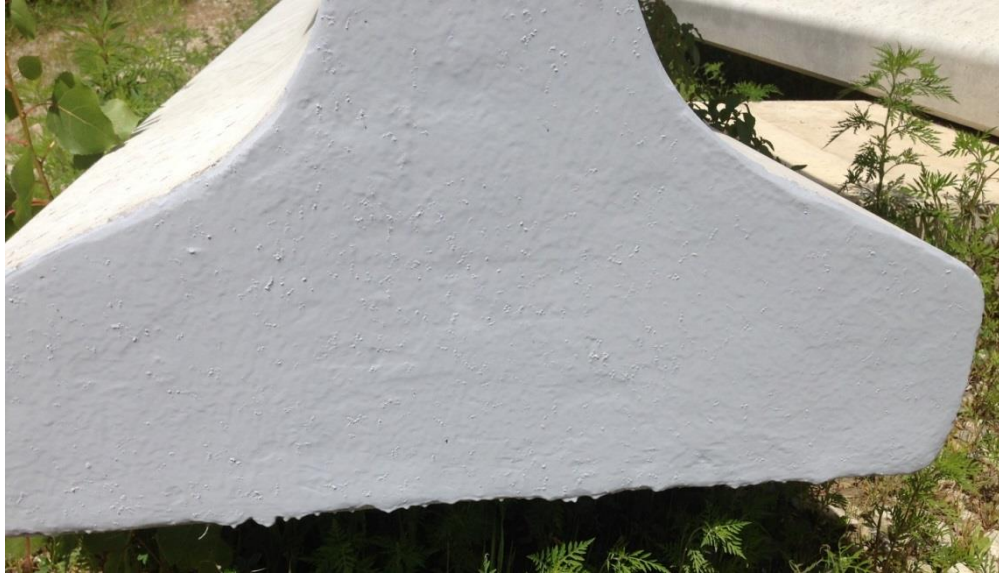
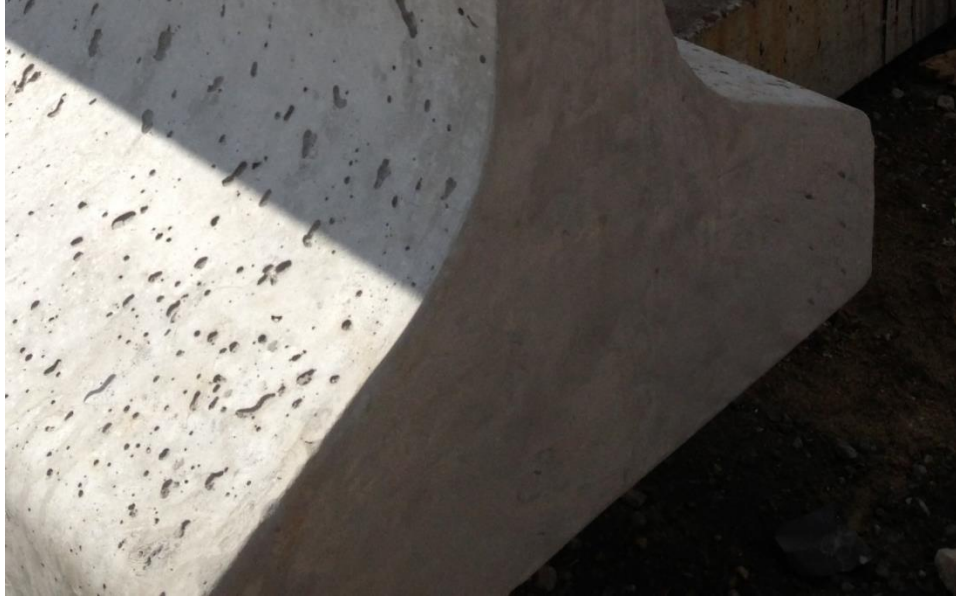
Figures 40 through 48 illustrate the condition of the beams (BD13524, BD08503, BC11530E) coated with BASF Sonoguard. In all cases, except one localized spot on BD13524 that appeared to have one strand end with the coating peeling off, the coating appeared to be performing effectively. The one strand end where the coating was peeling off is likely a result of pre-existing rust within the strand prior to application of the beam-end treatment and coating. Progression of the rust likely resulted in the puncturing of the coating. All other areas on BD13524 and the other two beams exhibited no signs of deterioration of the Sonoguard coating.
