# Laboratory Investigation of Concrete Beam-End Treatments

**Final Report  
May 2015**

**IOWA STATE UNIVERSITY**  
**Institute for Transportation**

**Sponsored by**  
Federal Highway Administration  
Iowa Department of Transportation  
(InTrans Project 12-442)

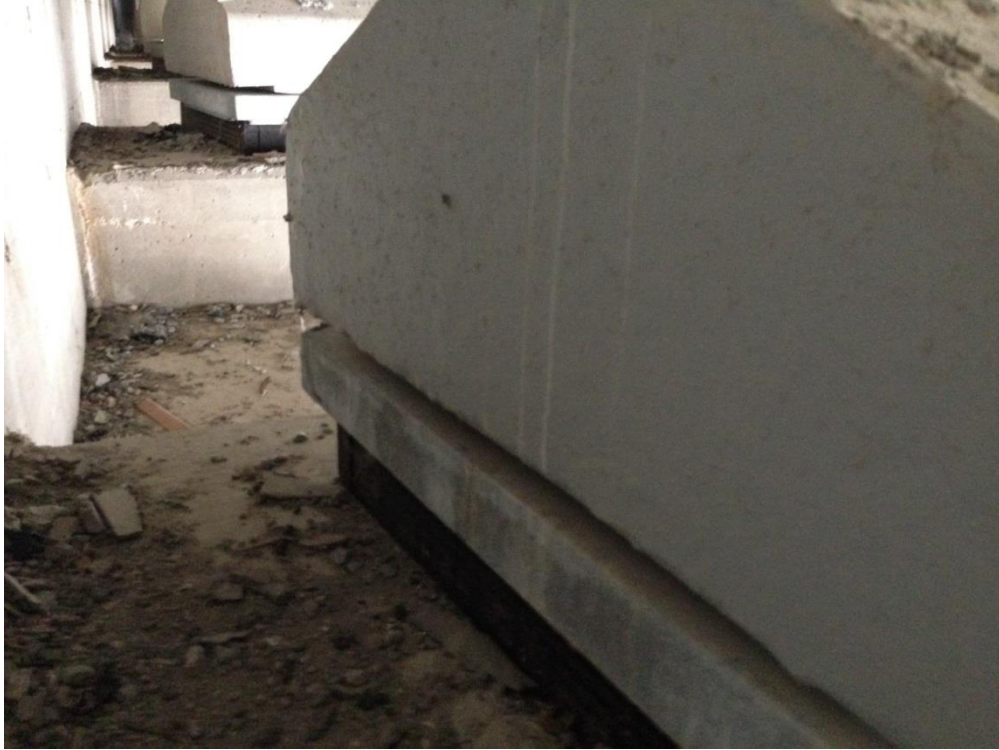
**Figure 42. BASF Sonoguard field performance on BD13524**

Figures 40 through 48 illustrate the condition of the beams (BD13524, BD08503, BC11530E) coated with BASF Sonoguard. In all cases, except one localized spot on BD13524 that appeared to have one strand end with the coating peeling off, the coating appeared to be performing effectively. The one strand end where the coating was peeling off is likely a result of pre-existing rust within the strand prior to application of the beam-end treatment and coating. Progression of the rust likely resulted in the puncturing of the coating. All other areas on BD13524 and the other two beams exhibited no signs of deterioration of the Sonoguard coating.

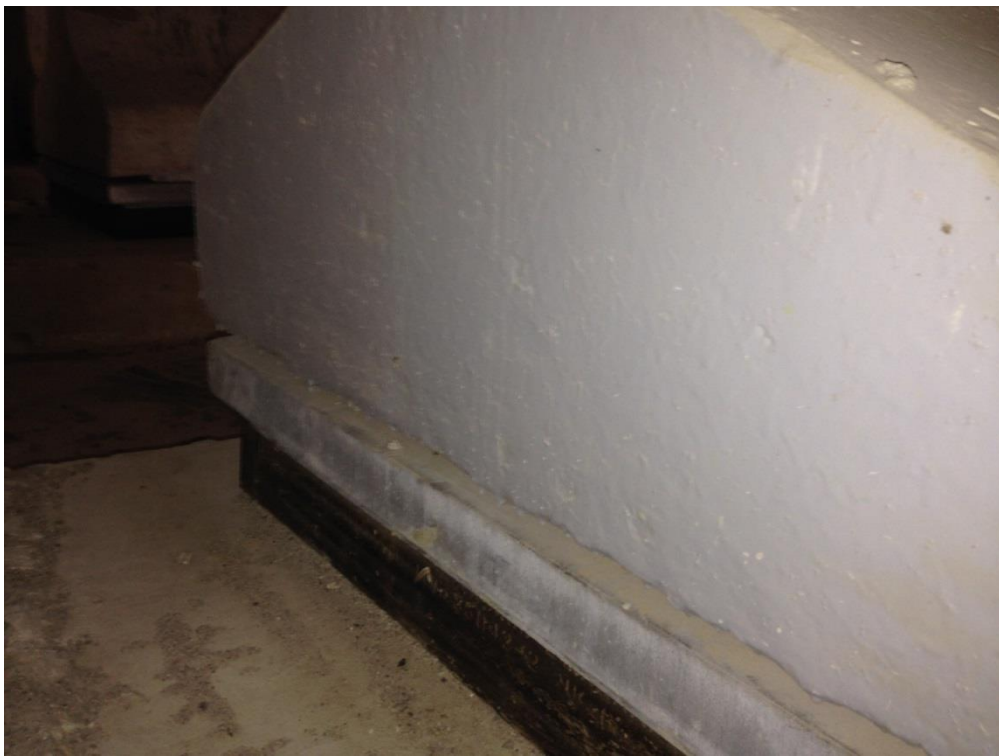
**Figure 45. BASF Sonoguard field performance on BD08503**

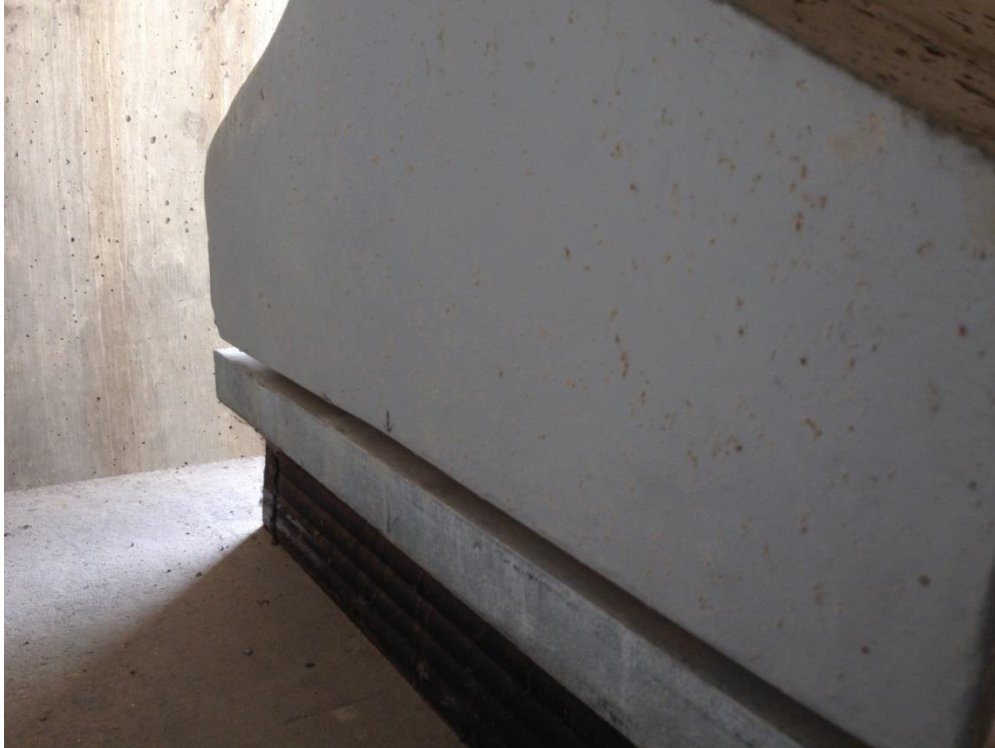
**Figure 48. BASF Sonoguard field performance on BC11530E**

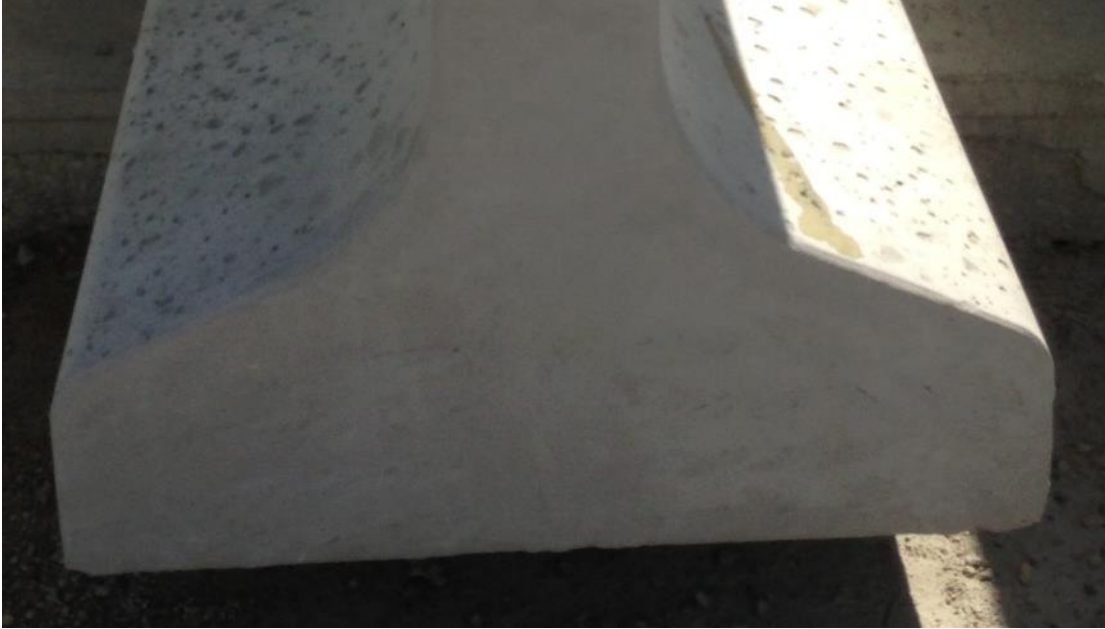
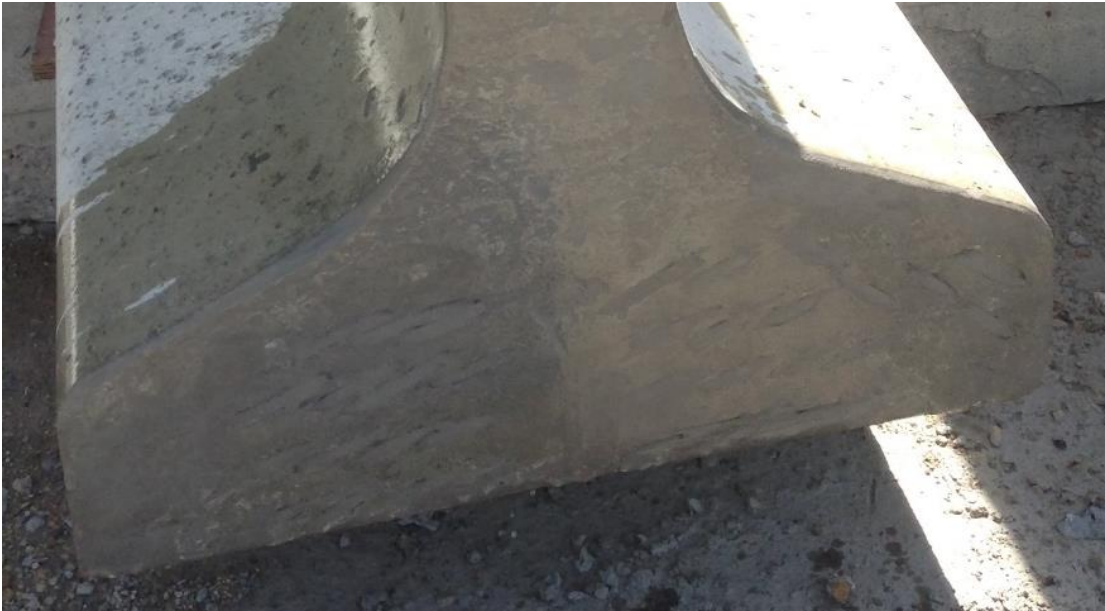
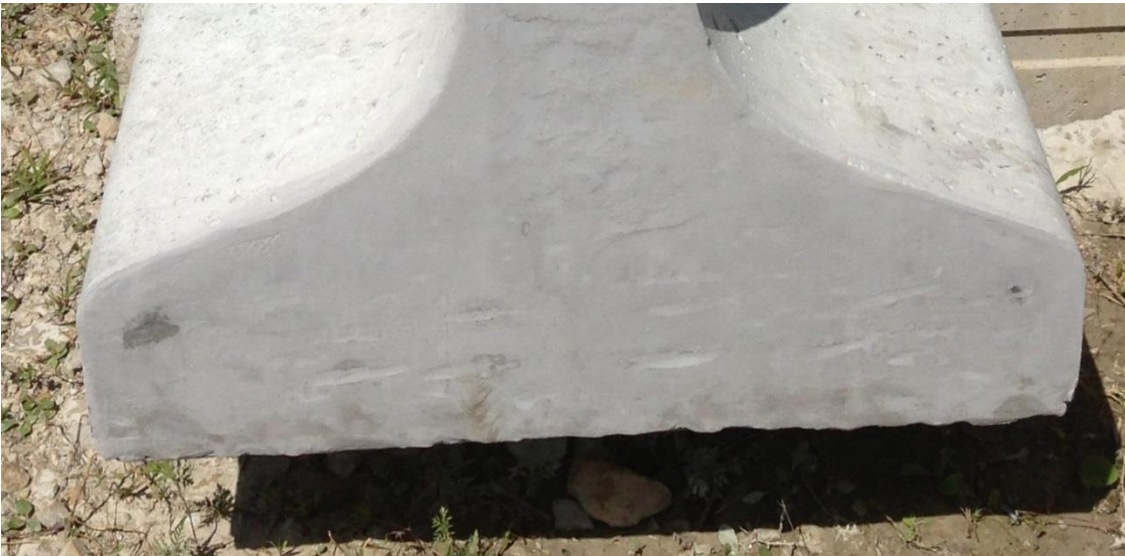
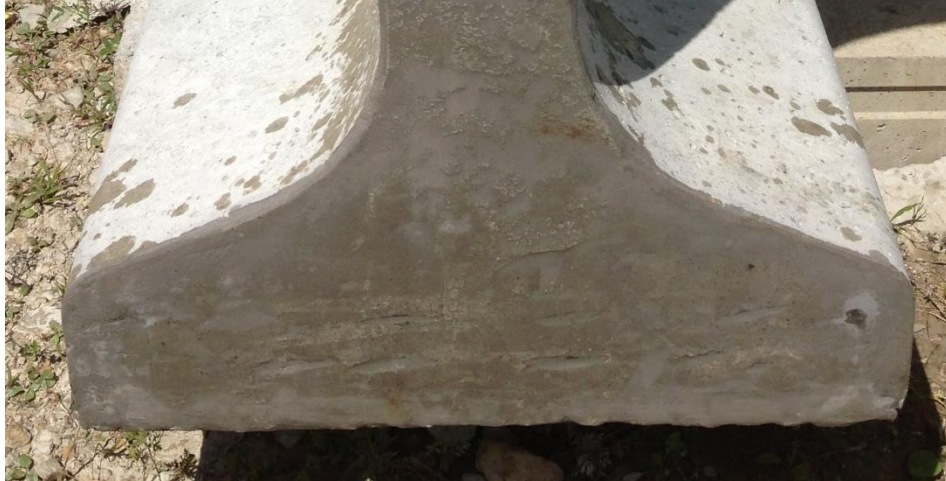
There were two beams coated with the BASF Hydrozo 100 product, beams BD13525 and BD08506. As can be seen in Figures 49 through 54, both beams have numerous strand ends that are visible with significant rust penetrating the coating.

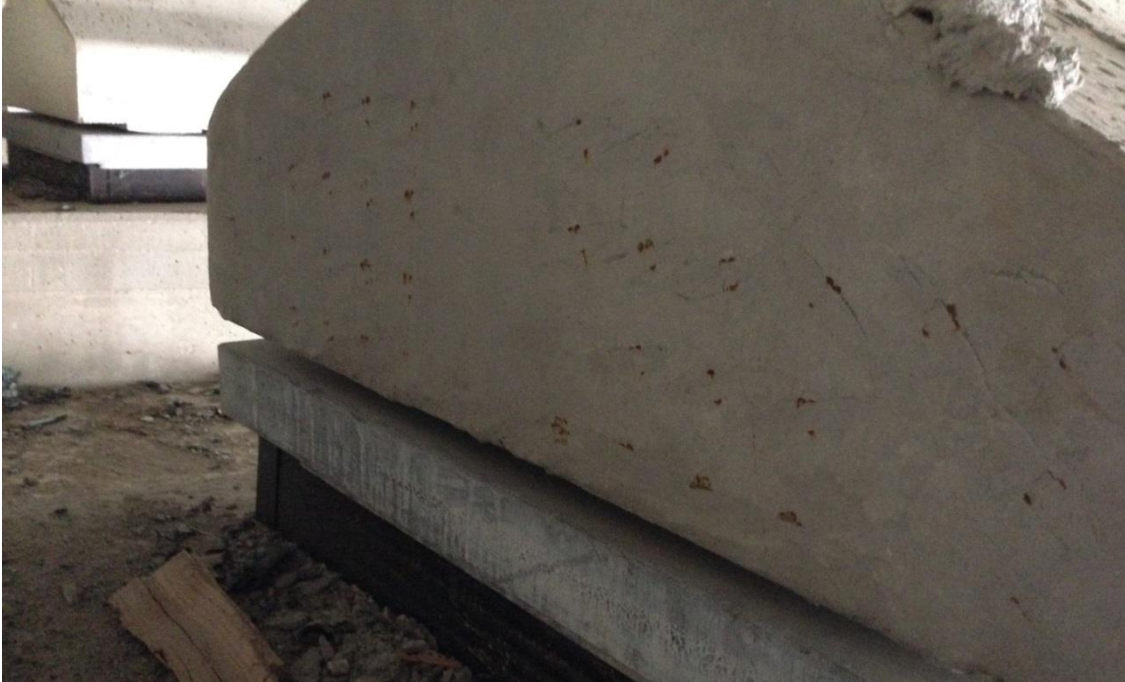
**Figure 51. BASF Hydrozo 100 field performance on BD13525**

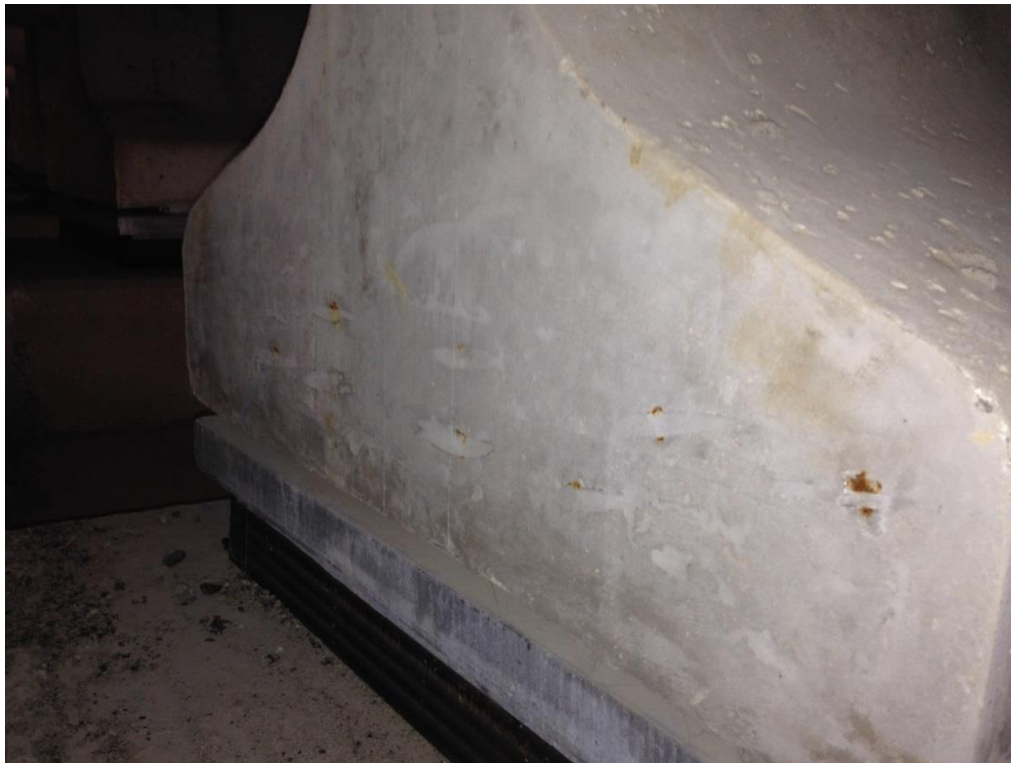
**Figure 54. BASF Hydrozo 100 field performance on BD08525**

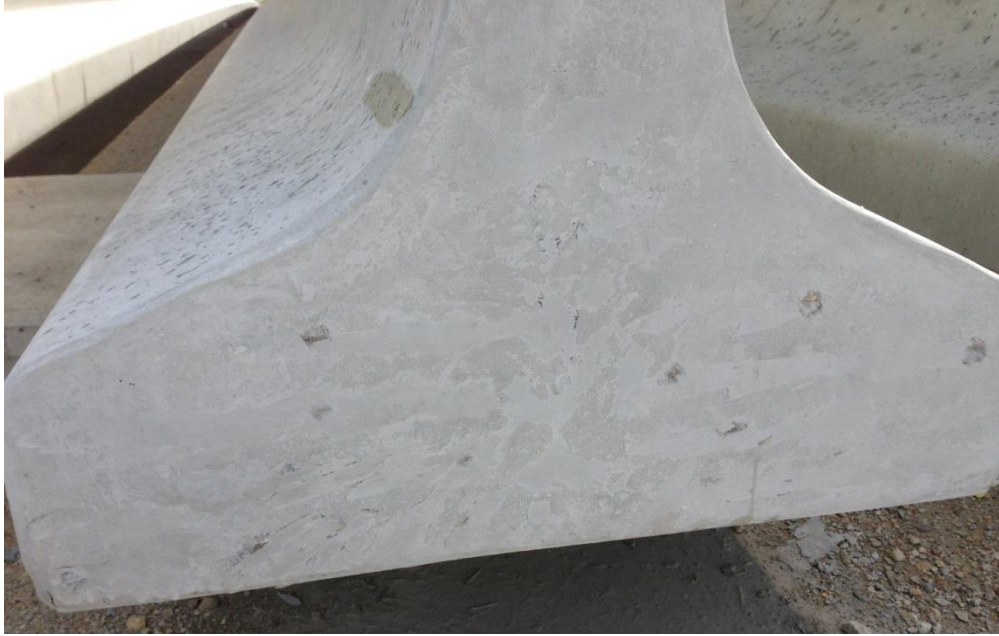
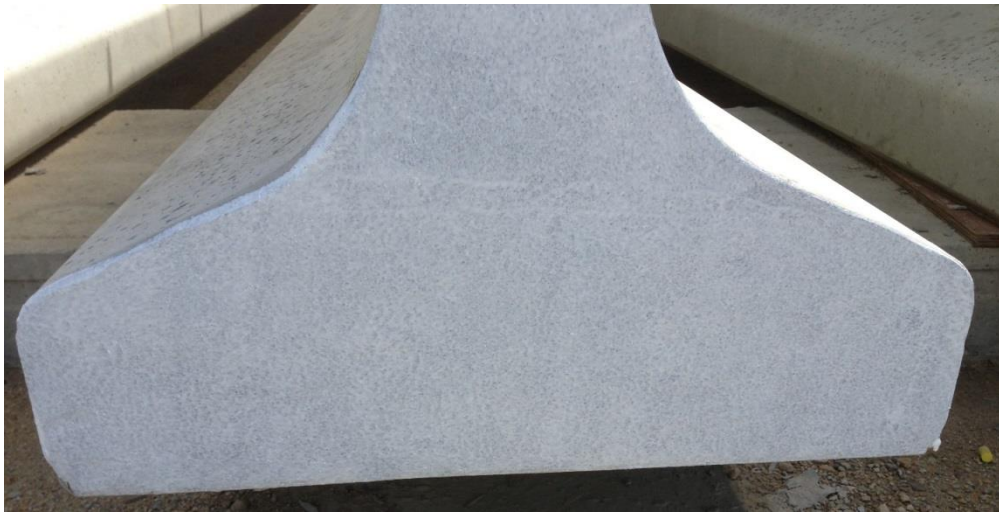
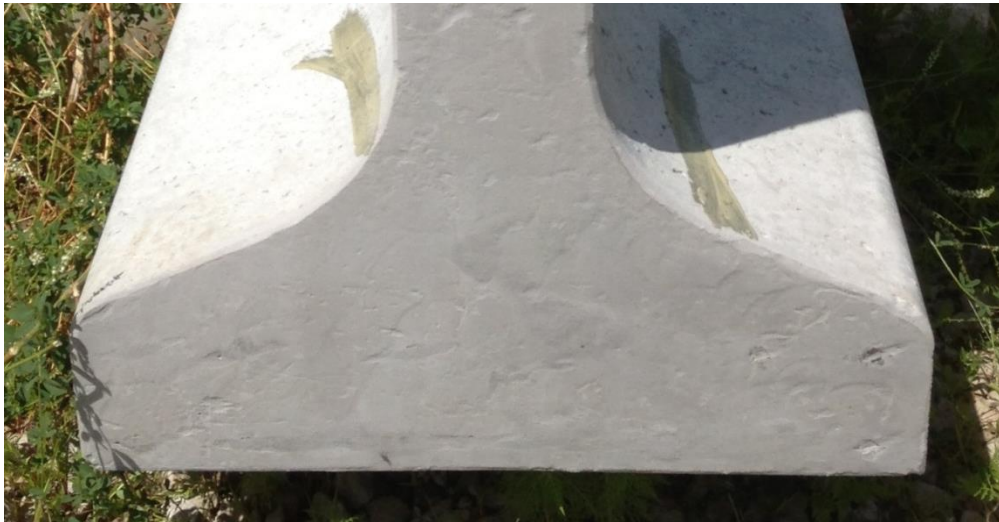
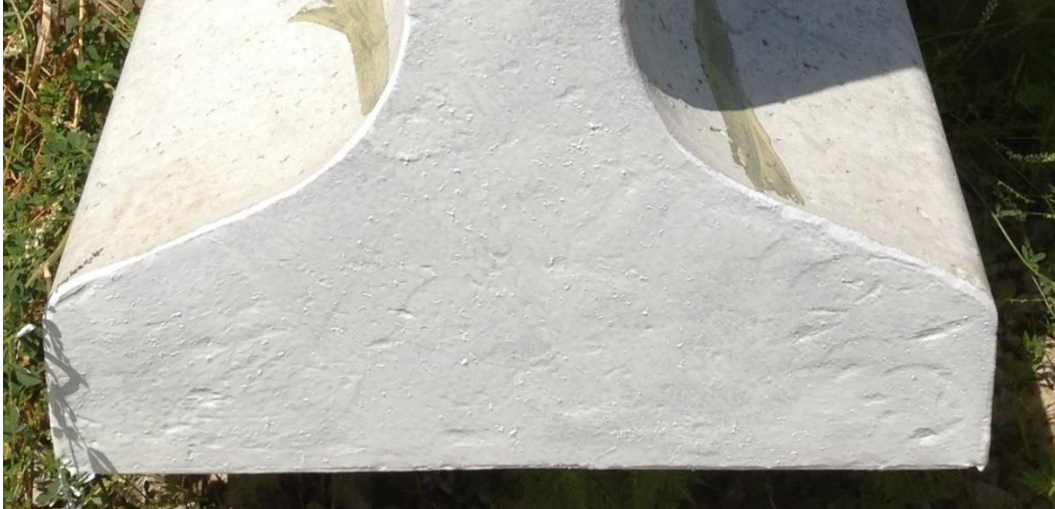
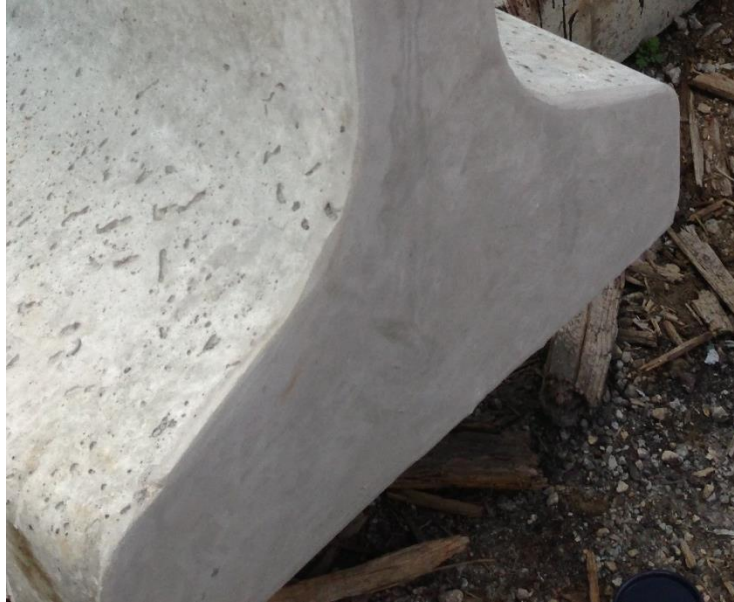
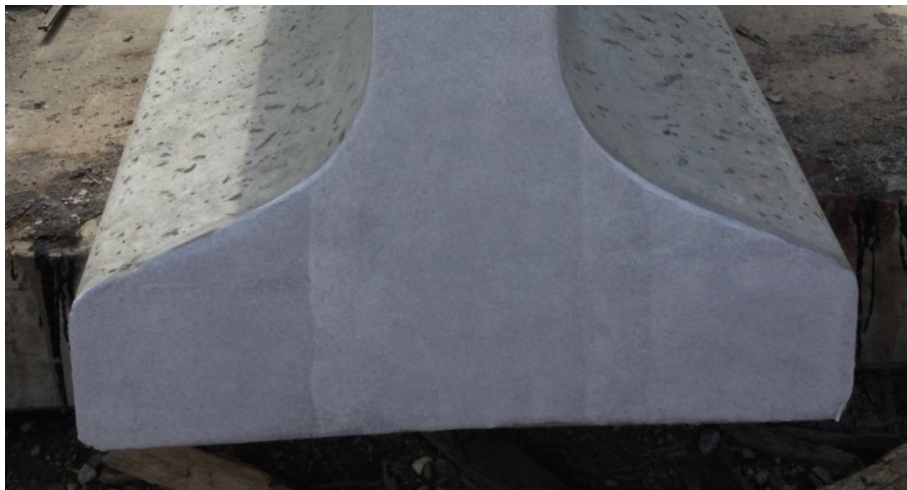
All three beams coated with Viking Aqua Guard (BD13522E, BD08505, and BC11528) performed similarly upon field inspection, and the coating on all accounts is holding up adequately (see Figures 55 through 63). The only notable element on all three beam ends was the evidence of some visible rust on a few of the strand ends, although no rust was found to have penetrated the coating to date.

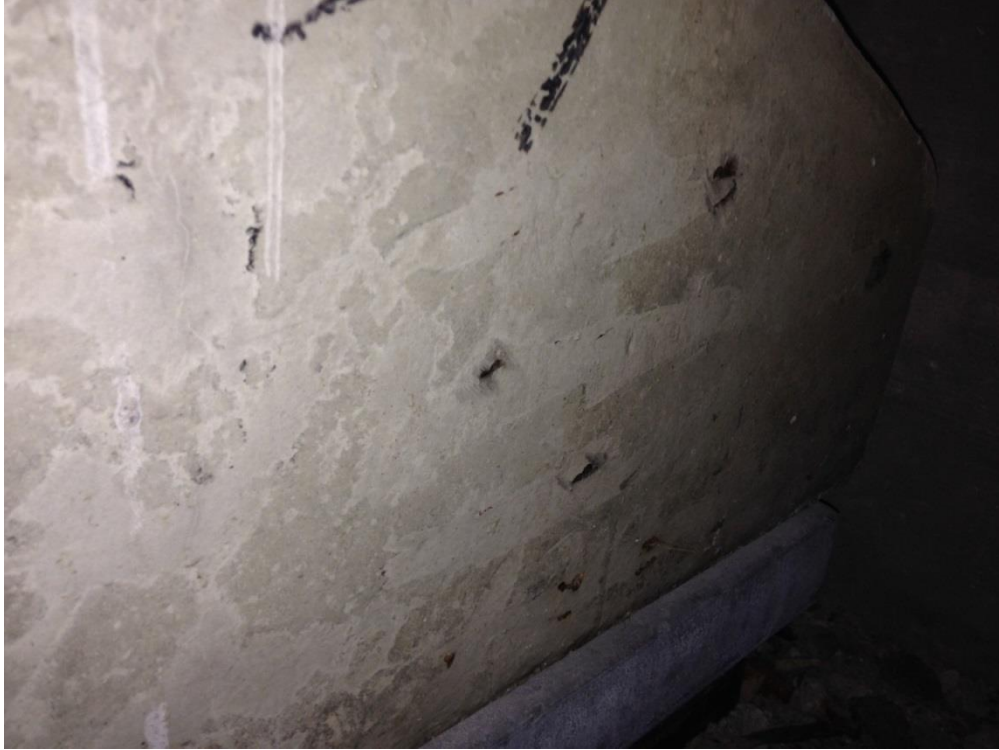
**Figure 57. Viking Aqua Guard field performance on BD13522E**

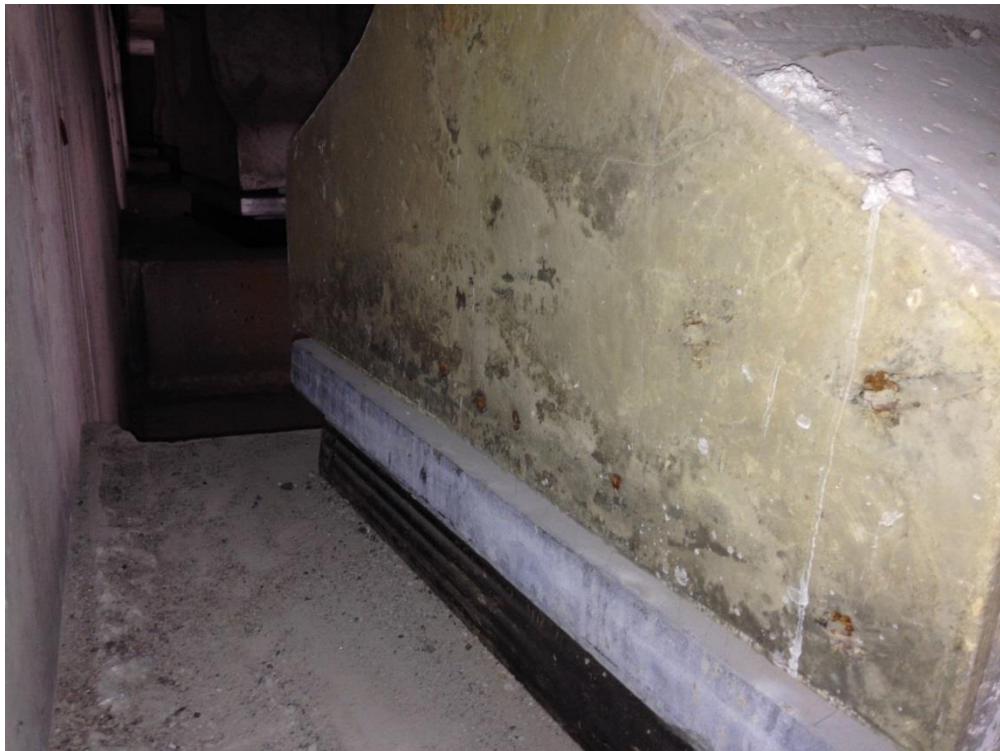
**Figure 60. Viking Aqua Guard field performance on BD08505**

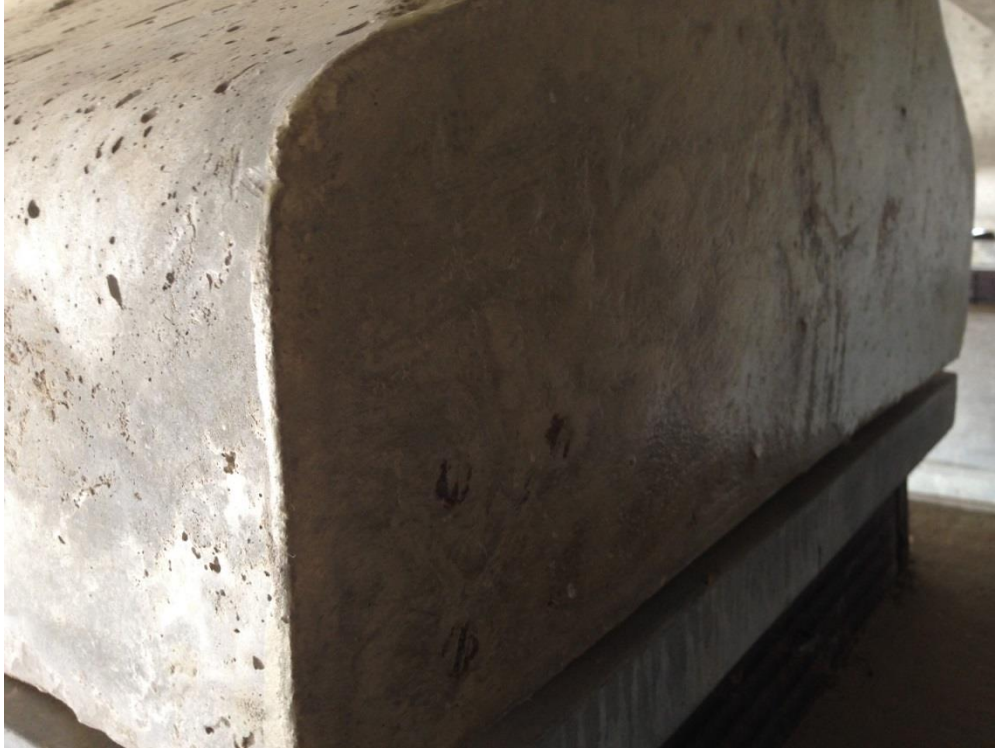
**Figure 63. Viking Aqua Guard field performance on BC11528**

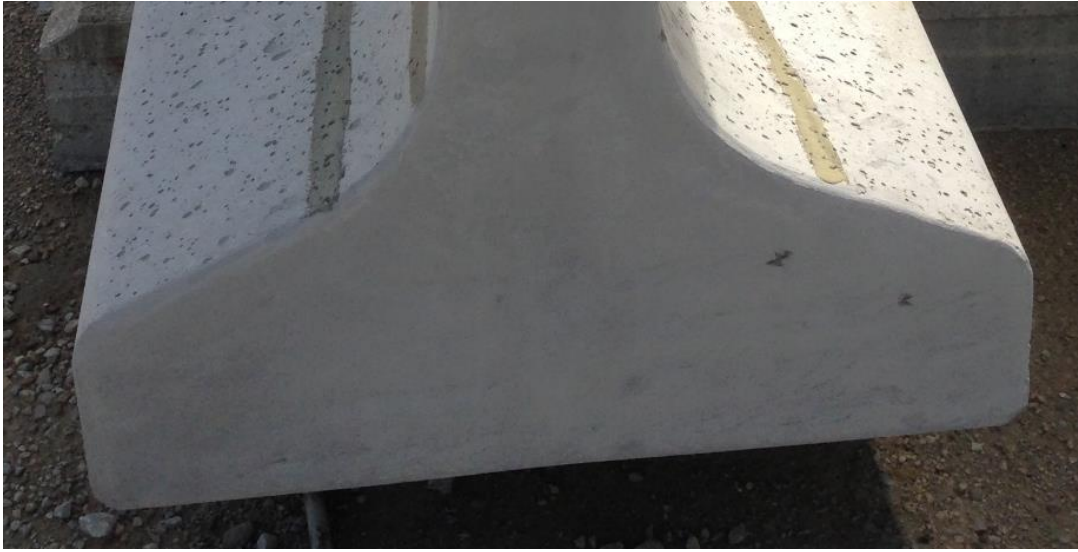
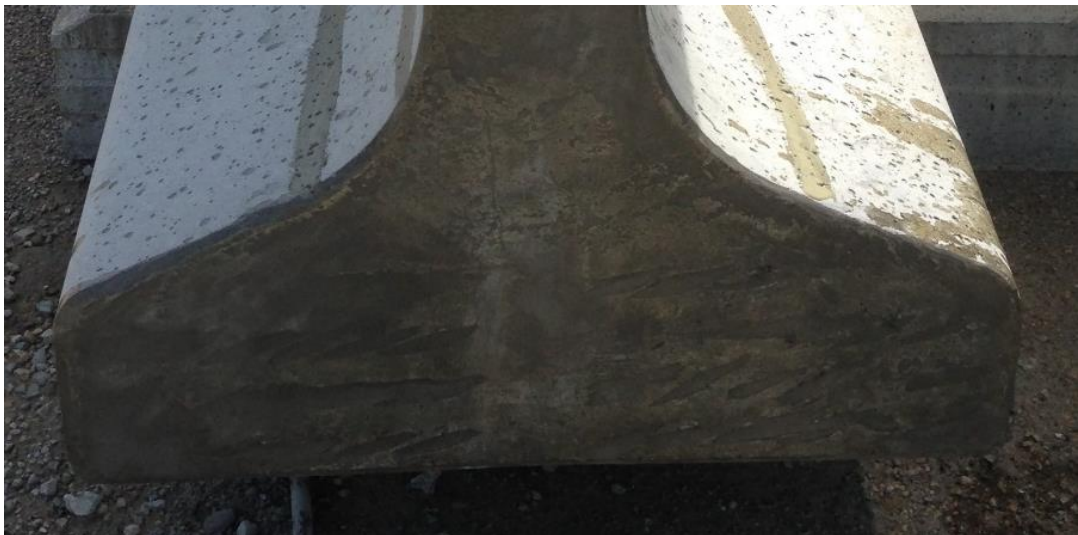
During field inspection, this coating alternative showed no signs of deterioration or problematic areas on either of the two beams (BD13523 and BD08504) to which it was applied (see Figures 64 through 69). For both beams, all areas of concrete and the few exposed strand ends appeared to be still well protected, with very little to no rust evident on the strands and no rust penetrating the coating.

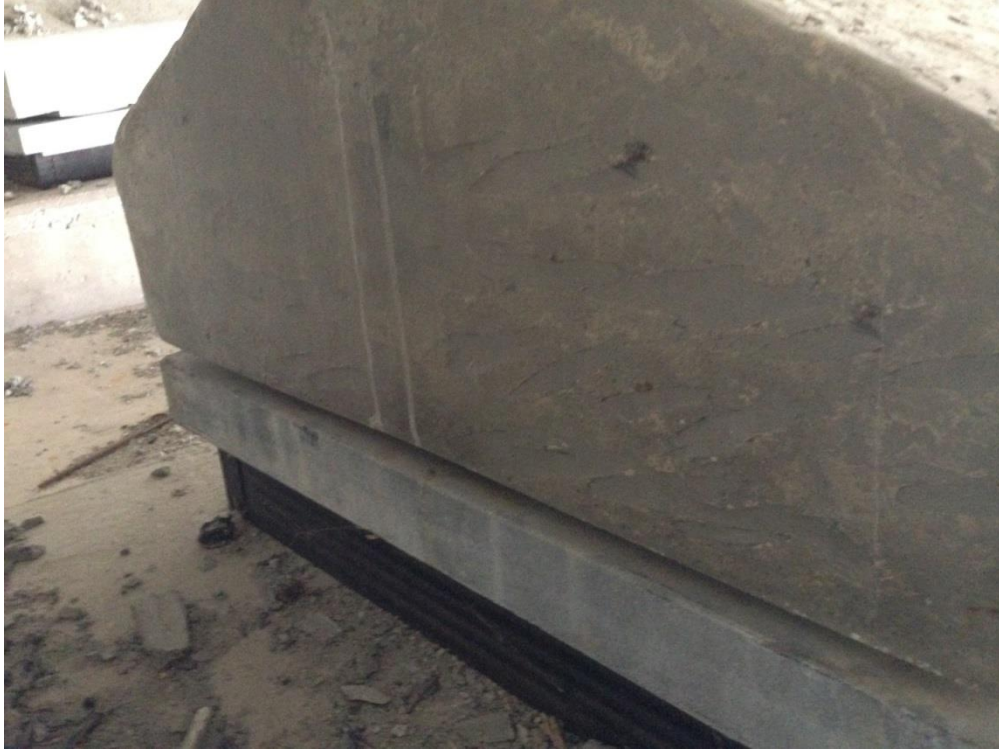
**Figure 66. PAULCO TE-3008-1 field performance on BD13523**

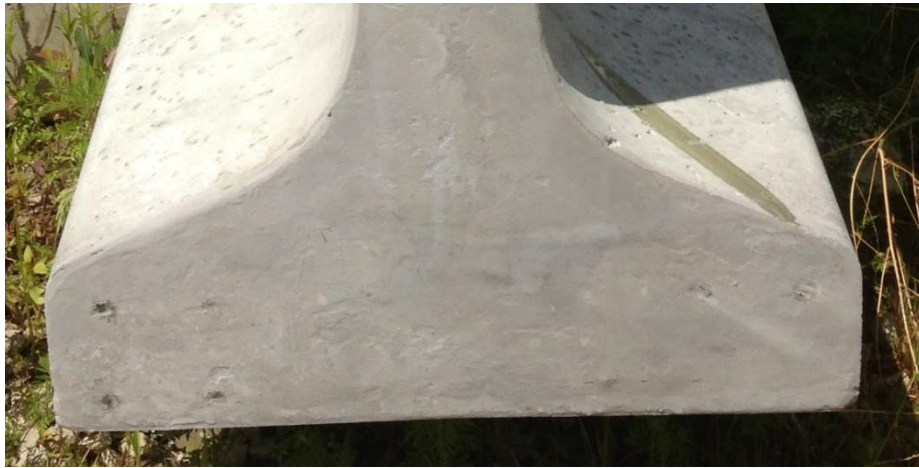
**Figure 67. BD08504 before application of PAULCO TE-3008-1**

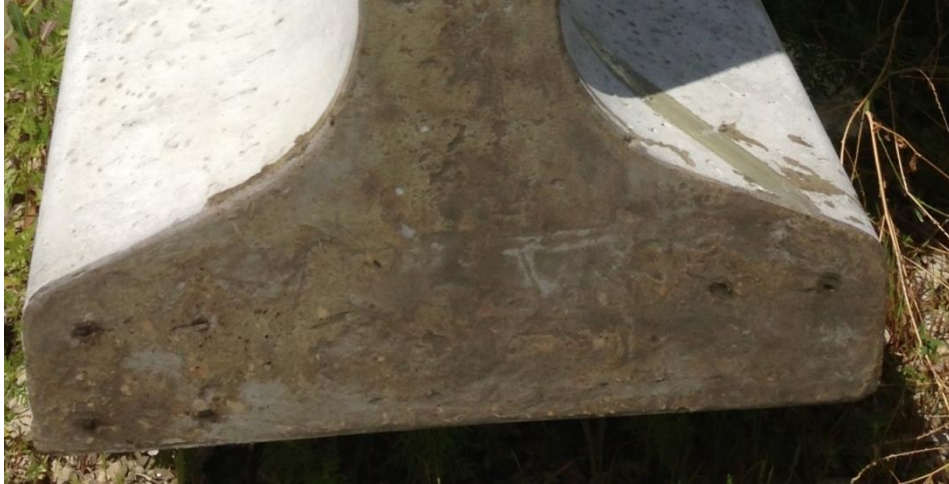
**Figure 68. PAULCO TE-3008-1 applied to BD08504**

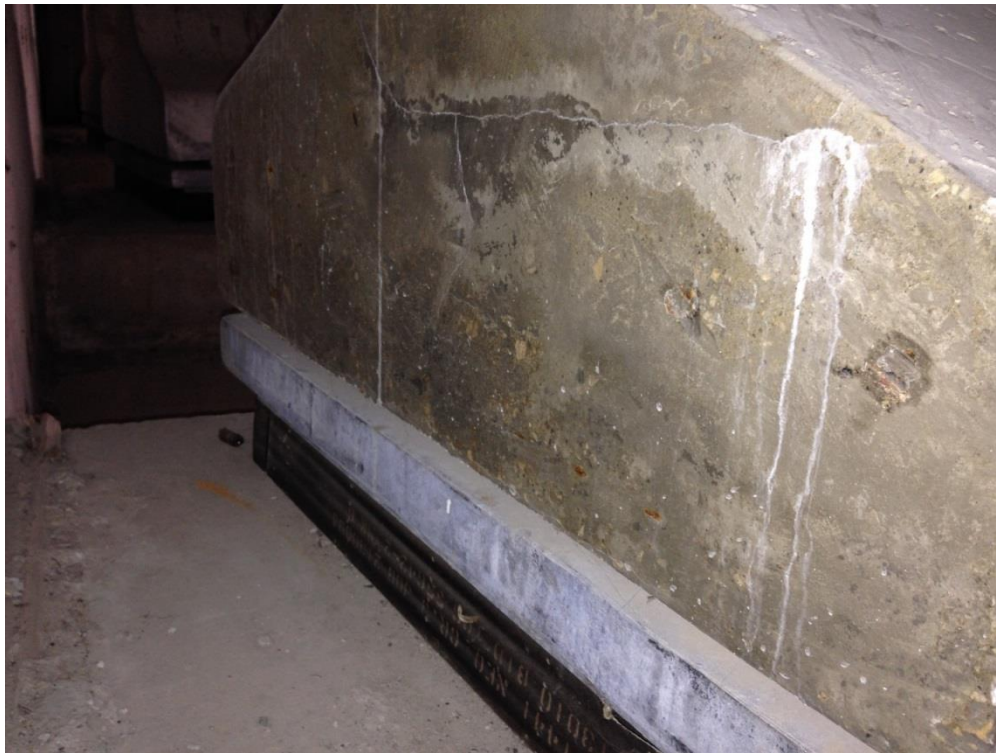
**Figure 69. PAULCO TE-3008-1 field performance on BD08504**

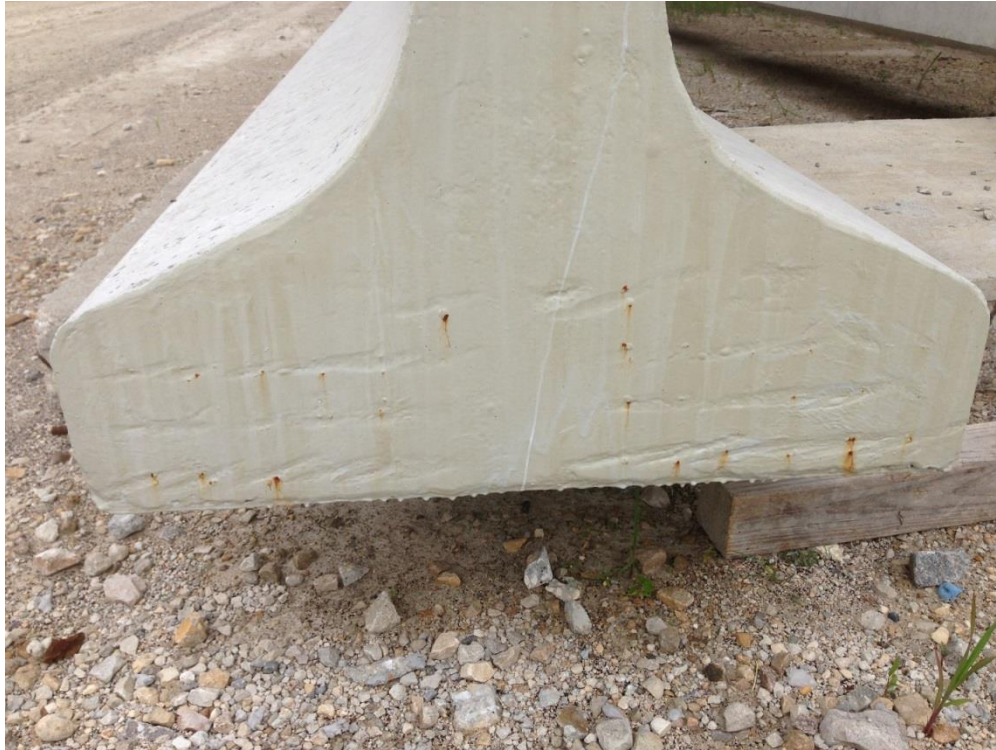
**Figure 70. Beam end coated with Sikagard 62 at precast plant**

Note that Figure 70 was taken at the precast plant, not in the field, and the beam was already showing signs of rust penetrating through the coating. In addition, during the field inspection of the other beams detailed above, there were other beams on Bridge BD found to be coated with Sikagard 62. A cursory inspection of several of those beams was also conducted, some showing no signs of distress of the coating, as shown in Figure 71; others were found to have the coating beginning to peel off the strand ends and exposing the rusted strands, as shown in Figure 72.

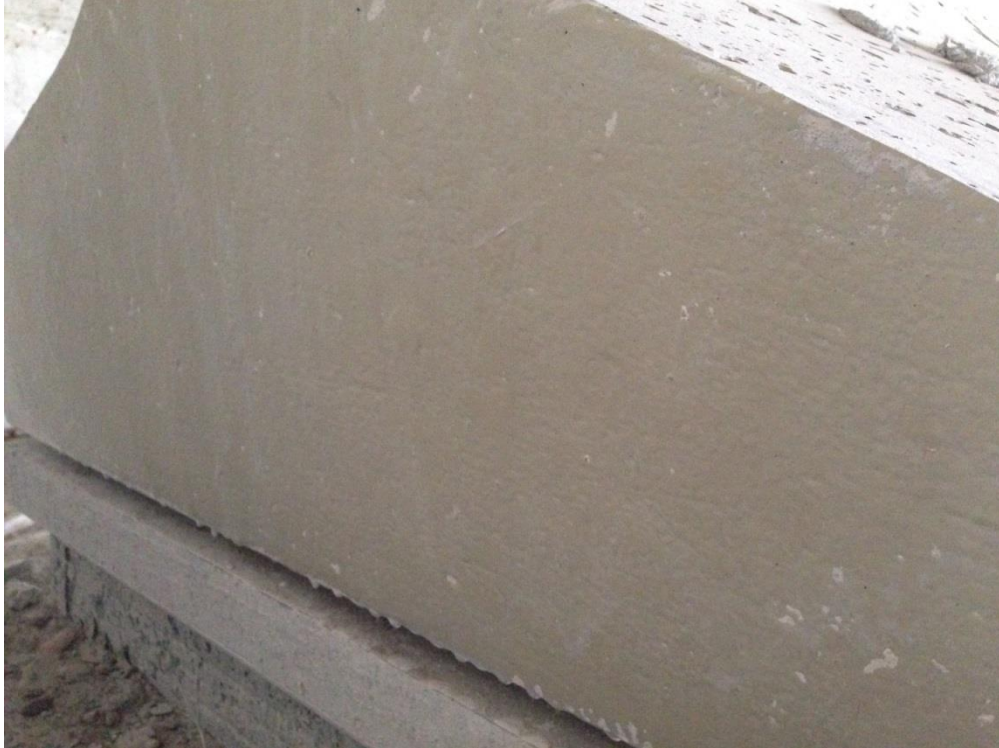
**Figure 71. Good field performance of Sikagard 62 on bridge beams**

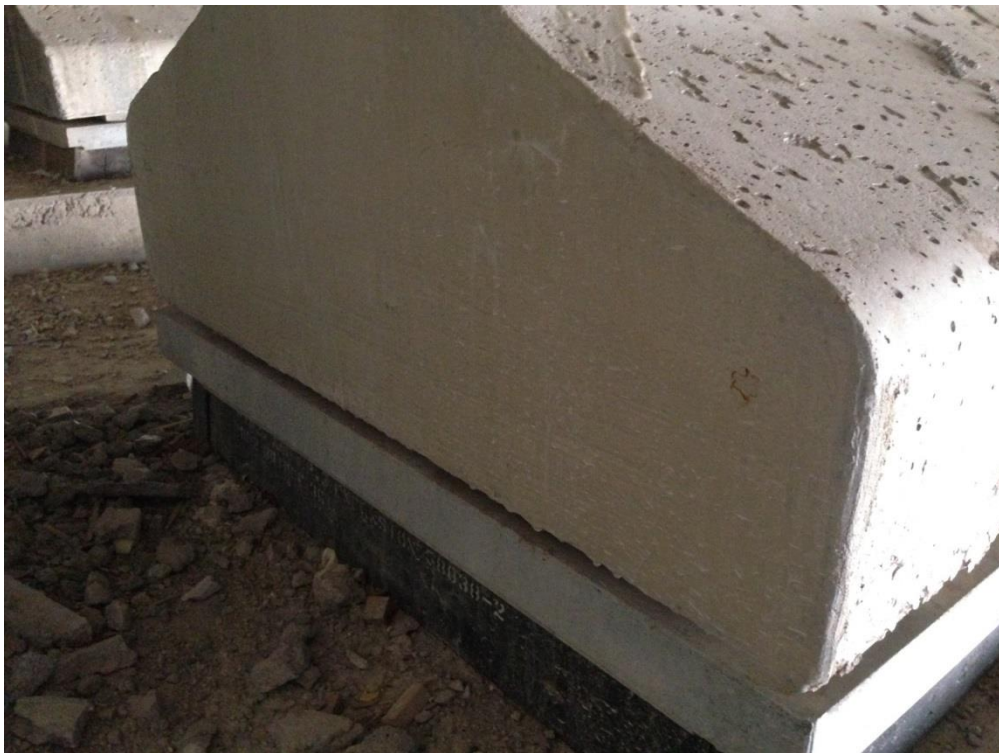
**Figure 72. Poor field performance of Sikagard 62 on bridge beams**

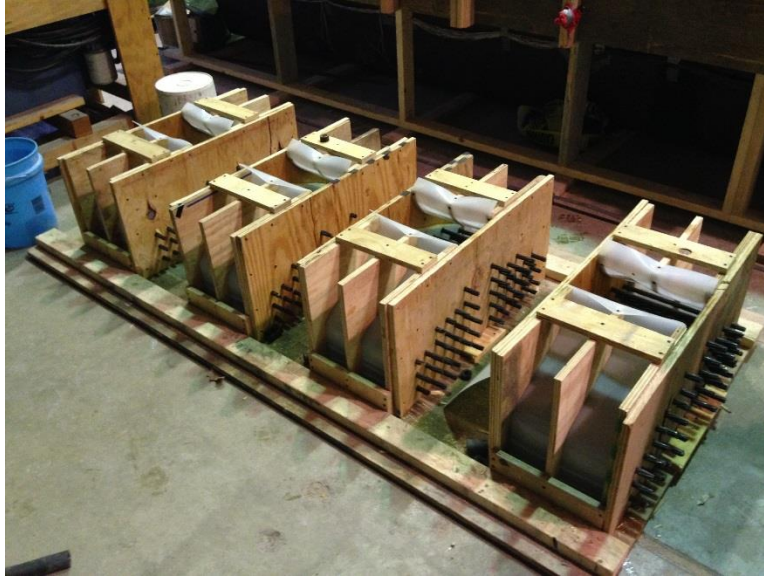
**Figure 73. Formwork for laboratory beam-end specimens**

All of these alternatives were only evaluated on the bottom flange of a standard Iowa DOT prestressed concrete T-section to reduce the size of the laboratory specimens and improve handling during testing. Figure 73 illustrates the lab specimen formwork prior to the concrete pour. For the termination of the strand ends on these specimens, most were flush cut with a cut-off wheel on the specimens with the larger blockouts; for the Bar Knockout specimen, the strands were first flush cut with a cut-off wheel and then burned back into the recess using a torch.

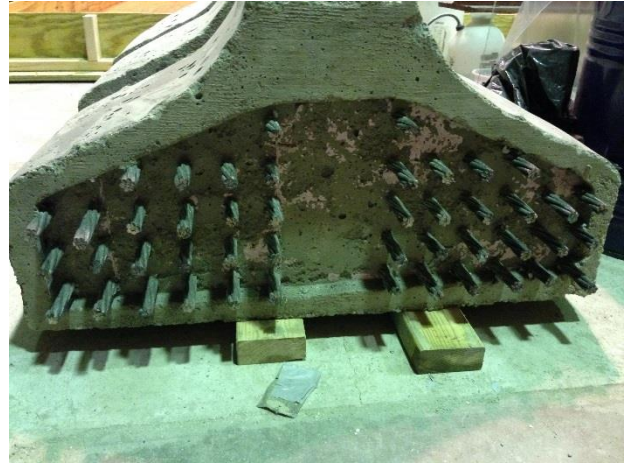
**Figure 74. Single Blockout formed with 1 in. foam**

This beam-end forming alternative involves creating a blockout in the area surrounding the cluster of prestressing strands such that when the forms and blockout material are removed the area around the strands is recessed from the face of the girder a predetermined distance. This recess allows for the strands to be cut off back from the face of the girder and covered for protection. Three different blockout options were evaluated for the Single Blockout alternative: (1) 1 in. thick foam blockout, (2) 2 in. thick foam blockout, and (3)  $\frac{3}{4}$  in. plywood blockout with chamfered edges. Figures 74 through 76 illustrate the three Single Blockout alternative specimens, both prior to and after concrete placement.

The foam blockout was very simple to fabricate and did not result in any complications when passing the prestressing strands through the ends of the formwork. Two methods were investigated for creating the holes in the foam for passage of the strands: drilling out the foam through the form end with a drill bit and marking the location of each strand on the inside of the foam and simply pushing the strand through the foam and formwork. Both methods worked adequately, although the first option was slightly more construction friendly because the strands slid through much easier with the hole already in place in the foam. On these specimens, the foam was attached to the formwork using a basic spray-on adhesive and presented no issues.

As can be seen in Figures 74 through 76, none of the blockouts created using foam had chamfered edges.

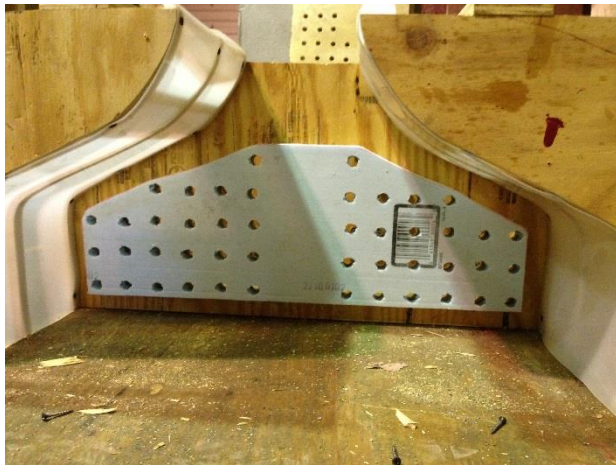
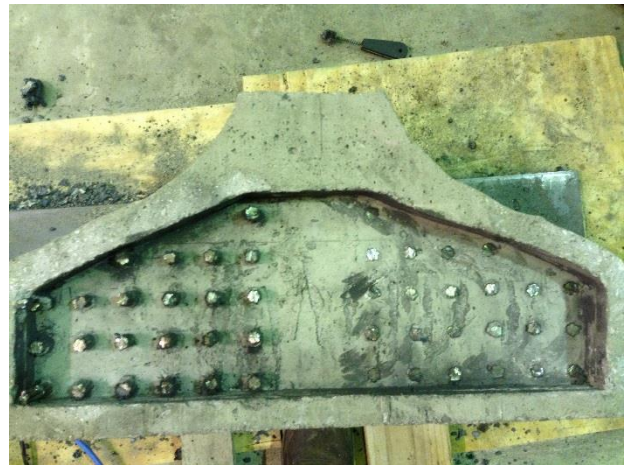
**Figure 75. Single Blockout formed with 2 in. foam**

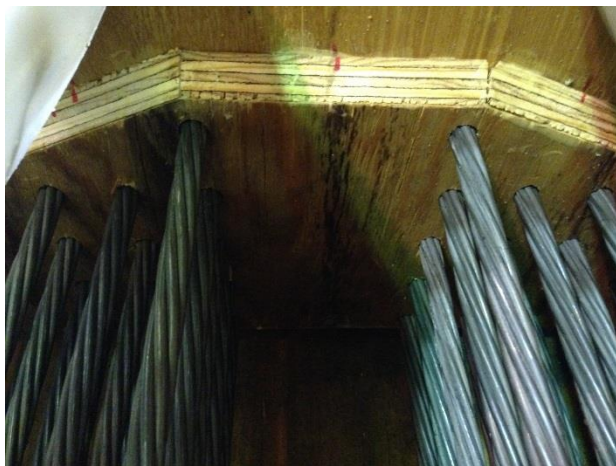
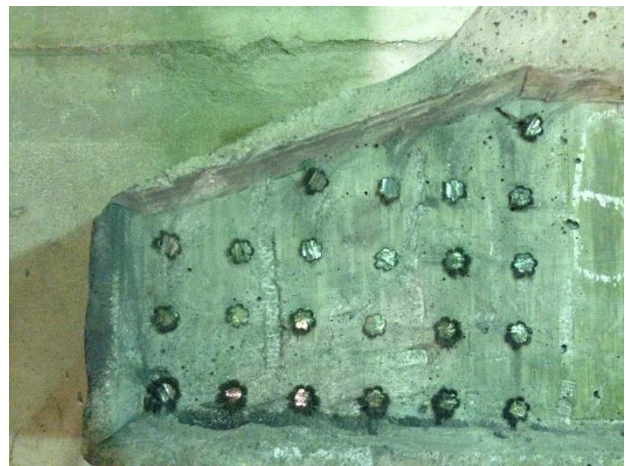
**Figure 76. Single Blockout formed with  $\frac{3}{4}$  in. plywood with chamfered edges**

When the blockout was created using plywood or another stiff forming material (i.e., steel), removal of the end formwork became extremely difficult, if not impossible, with some form of damage being done to the formwork, without the chamfers around the edges of the blockout. Even with the chamfer, removal of the formwork was problematic and cumbersome because both the end form and the blockout must be slid over the numerous protruding strands simultaneously. Lastly, it is worth noting that the chamfer in the blockout did facilitate easier cutting/removal of the prestressing strands in the corners of the blockouts. However, further investigation may be necessary to see what long-term effects the chamfer may have on the bond of the grout because any cracking at the interface between the grout and the existing concrete could subsequently funnel moisture (possibly containing chlorides) into the blockout and to the strand ends.

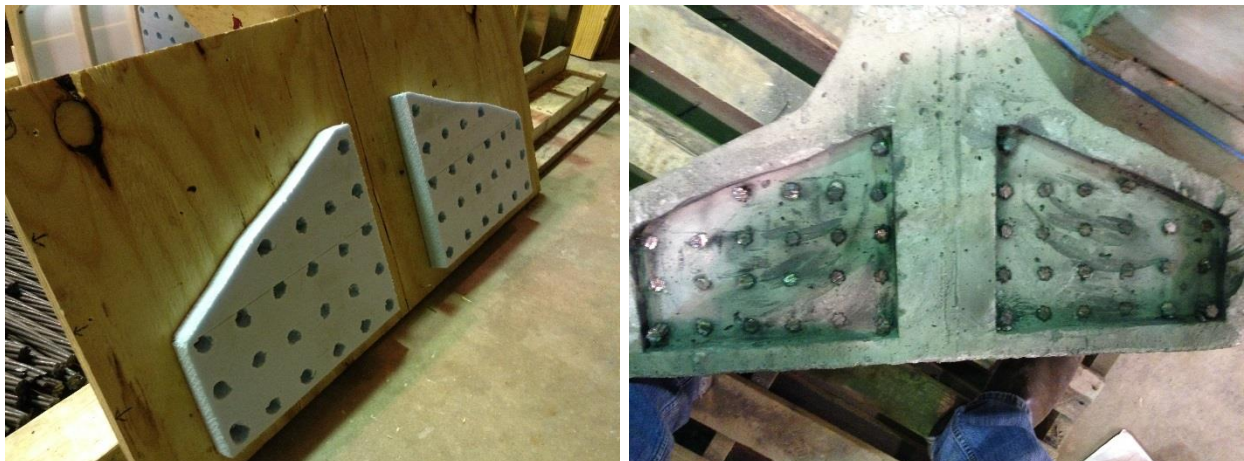
**Figure 77. Double Blockout formed with 1 in. foam**

This blockout alternative is a derivative of the Single Blockout alternative, in that two individual blockouts are created around the main clusters of strands and separated along the vertical centerline of the beam (see Figure 77).
