# Laboratory Investigation of Concrete Beam-End Treatments

**Final Report  
May 2015**

**IOWA STATE UNIVERSITY**  
**Institute for Transportation**

**Sponsored by**  
Federal Highway Administration  
Iowa Department of Transportation  
(InTrans Project 12-442)

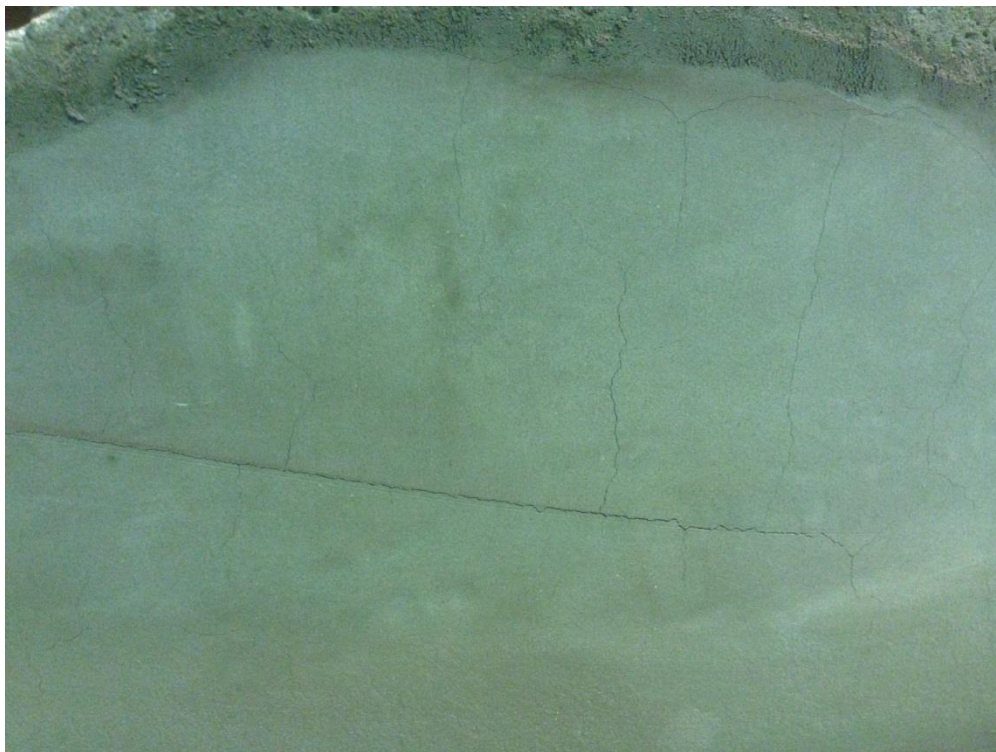
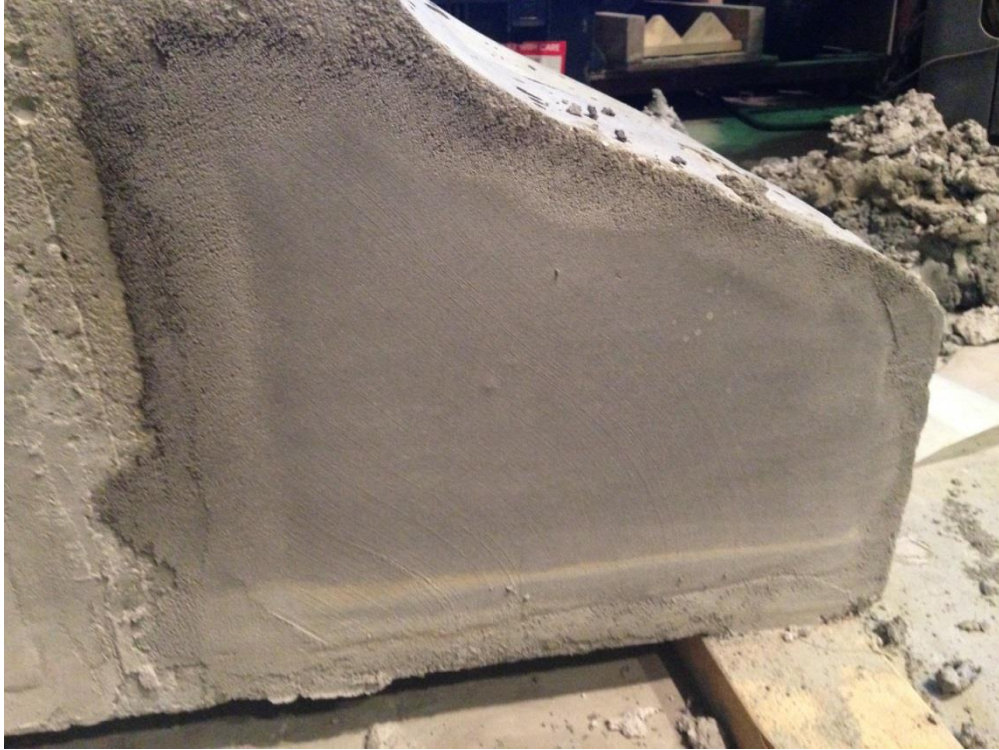
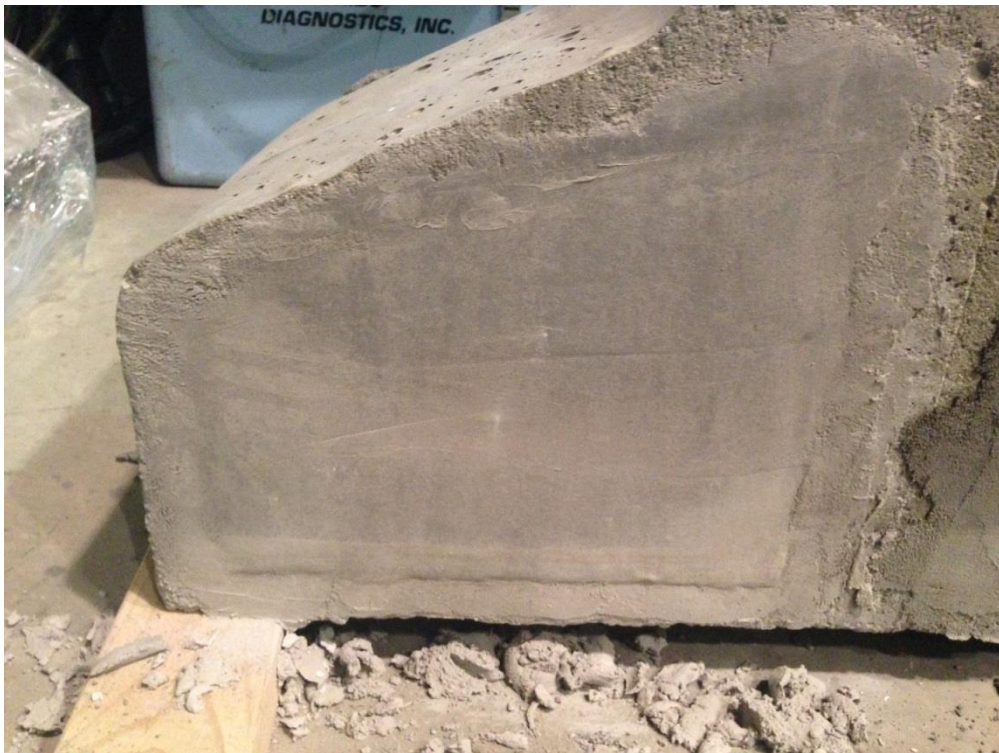
**Figure 79. UNIQUE Overhead and Vertical Repair**

**Figure 80. Sikacrete 211 SCC Plus**

**Figure 81. Garon TIGERCRETE SP**

From a constructability standpoint, all the grout products were easy to mix and were easily placed into the vertical voids using a basic hand trowel, as previously mentioned. Given the relatively short set time of these types of products, it seems unlikely that a batch much bigger than that required for two to three beam ends, which ideally would be seated adjacent to each other in the precast yard, could be managed without several skilled laborers on hand to quickly place the grout. As for short-term performance (i.e., days and weeks), performance of the three grout products was pretty even across the board, with all of them developing some level of cracking within and/or around the patch area (see Figures 79 through 81).

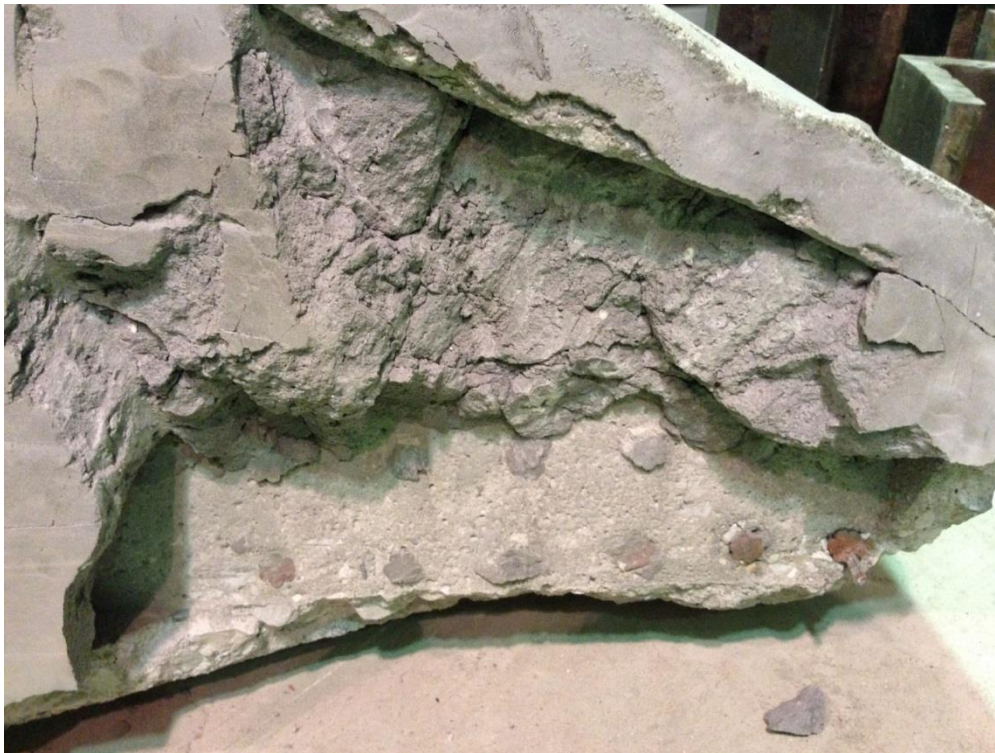
**Figure 82. UNIQUE Overhead and Vertical Repair – Batch 1 bond performance**

For the UNIQUE product's bond performance, recall that in the application of the first batch of the UNIQUE Overhead and Vertical Repair the slurry coat step was mistakenly skipped. Removal of this patch was subsequently found to be quite simple because little to no bond between the existing concrete and the grout existed (see Figure 82).

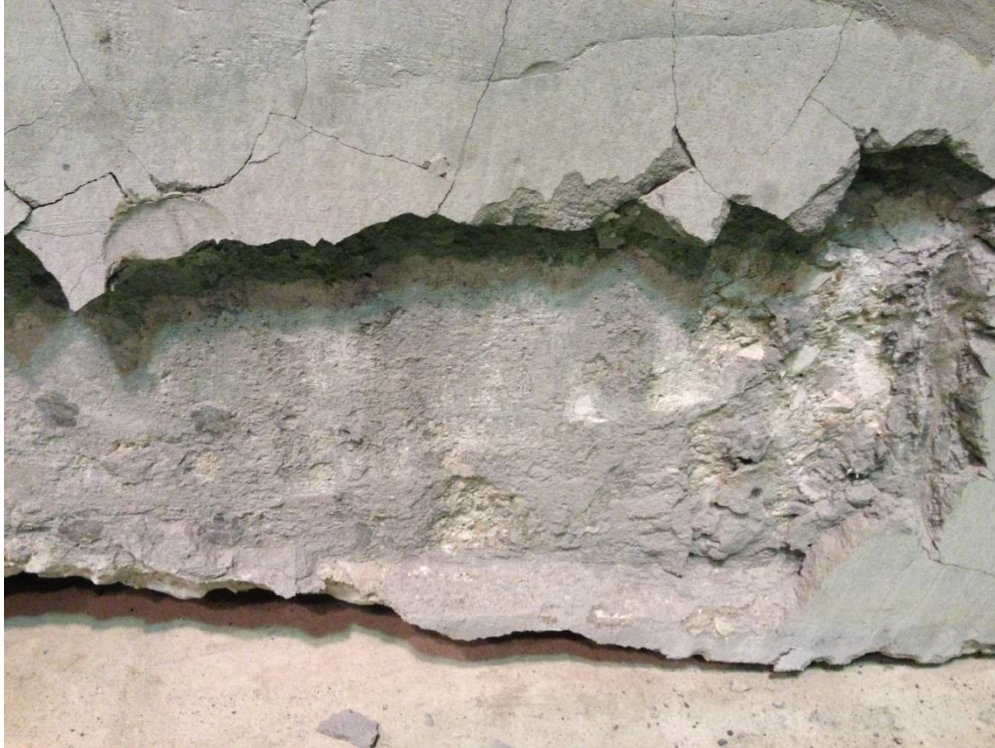
**Figure 83. UNIQUE Overhead and Vertical Repair – Batch 2 bond performance**

The bond performance of the UNIQUE Overhead and Vertical Repair then began to improve slightly throughout the mix progression. The second batch was found to have a good bond between the slurry coat and the existing concrete but very little bond between the grout and the slurry coat (Figure 83).

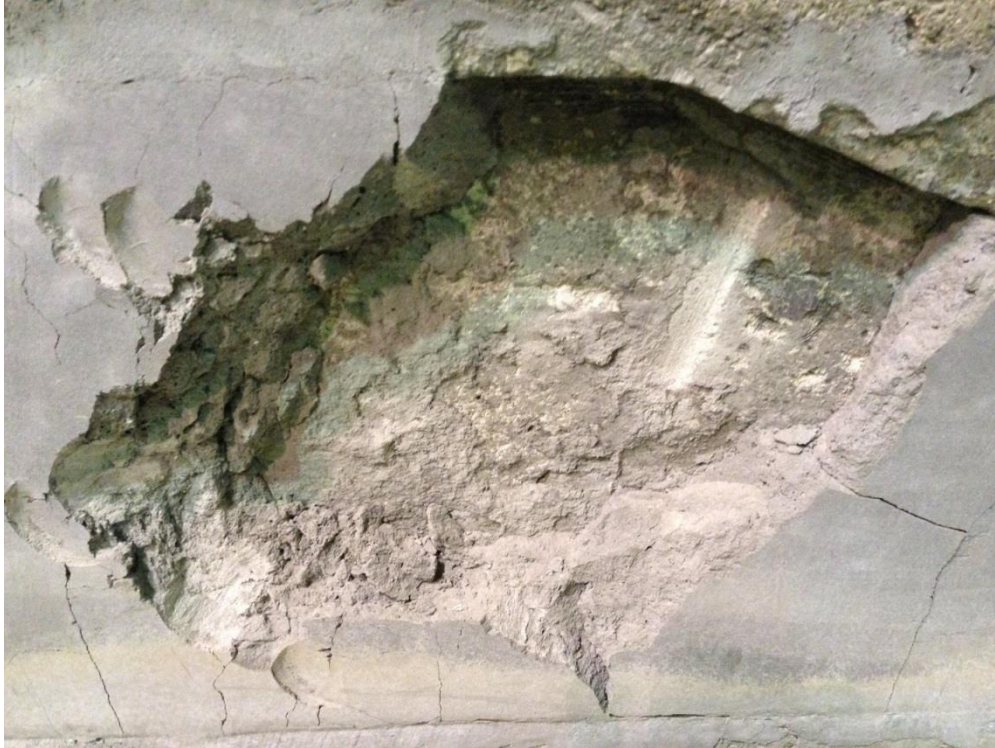
**Figure 84. UNIQUE Overhead and Vertical Repair – Batch 3 bond performance**

The third batch also had a good bond between the slurry coat and existing concrete, as well as a better bond between the slurry and grout than the second batch (Figure 84).

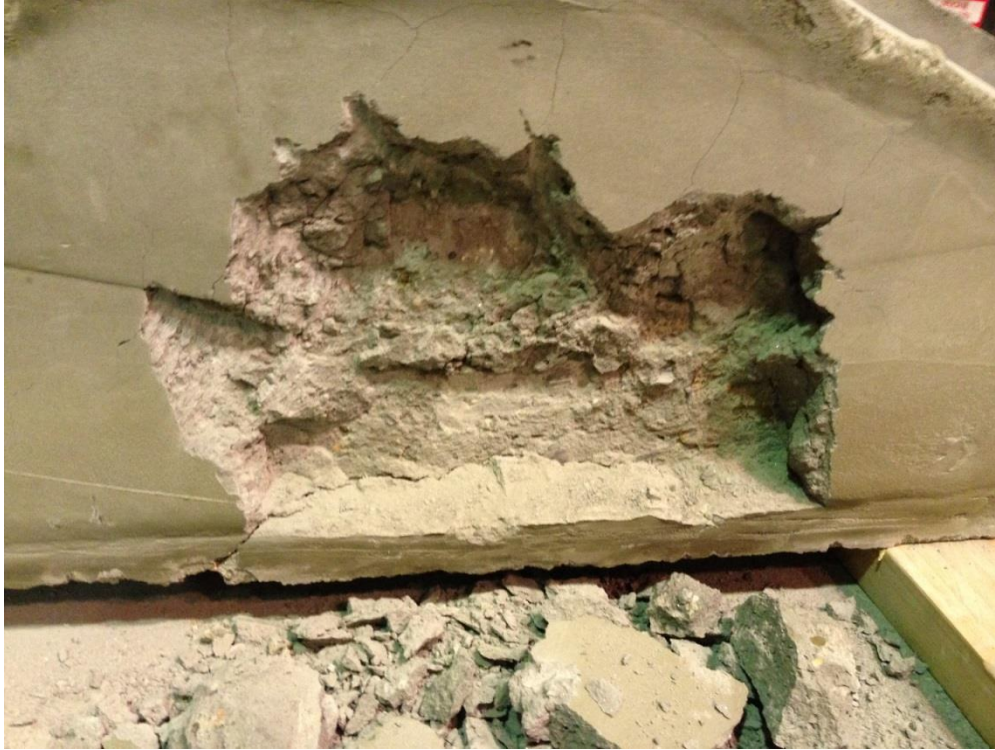
**Figure 85. UNIQUE Overhead and Vertical Repair – Batch 4 bond performance**

The final batch of the UNIQUE Overhead and Vertical Repair had the best performance in terms of bond, with good bond performance all around (Figure 85).

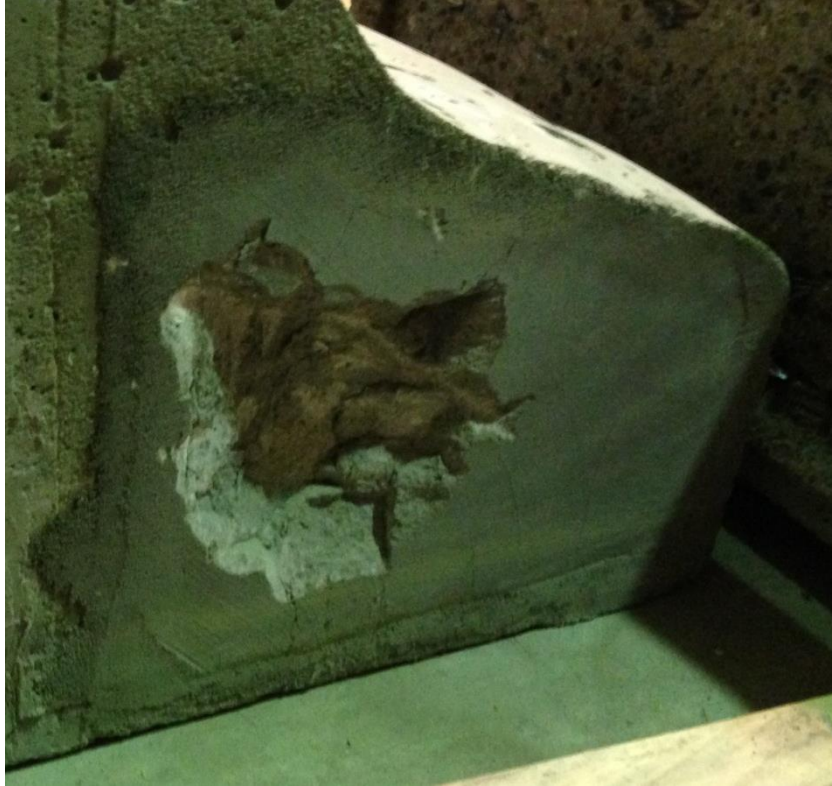
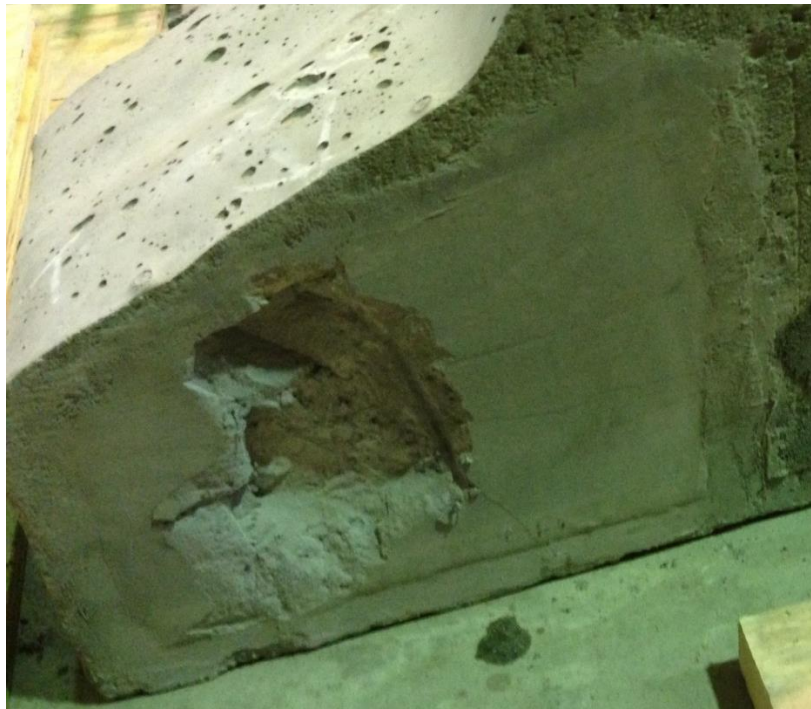
**Figure 86. Sikacrete SCC 211 Plus bond performance**

**Figure 87. Garon TIGERCRETE SP bond performance**

The bond performance of both the Sikacrete 211 SCC Plus and Garon TIGERCRETE SP products, shown in Figures 86 and 87, respectively, was much like that of the last batch of the UNIQUE Overhead and Vertical Repair. Slurry coats on both applications bonded well to the existing concrete, and the grout exhibited good bond performance to the slurry coats.
