## **Landslides Shut Down Highway 87 Between Payson and Phoenix**

A series of landslides occurred along State Route 87 at about mile marker 224 (between the Bush Highway and Route 188) last Friday, March 21, 2008, buckling the southbound lanes and causing the highway to be shut down in both directions over the holiday weekend. The slides occurred on a slope that had been mitigated with various combinations of vertical concrete walls (shotcrete), horizontal bolts, straw wattles, and drainages lined with boulders. No trigger for the slides was immediately apparent, although it is suspected that a combination of groundwater buildup in conjunction with vibrations from passing vehicles may have contributed. AZGS geologists are continuing to assess the landslides.

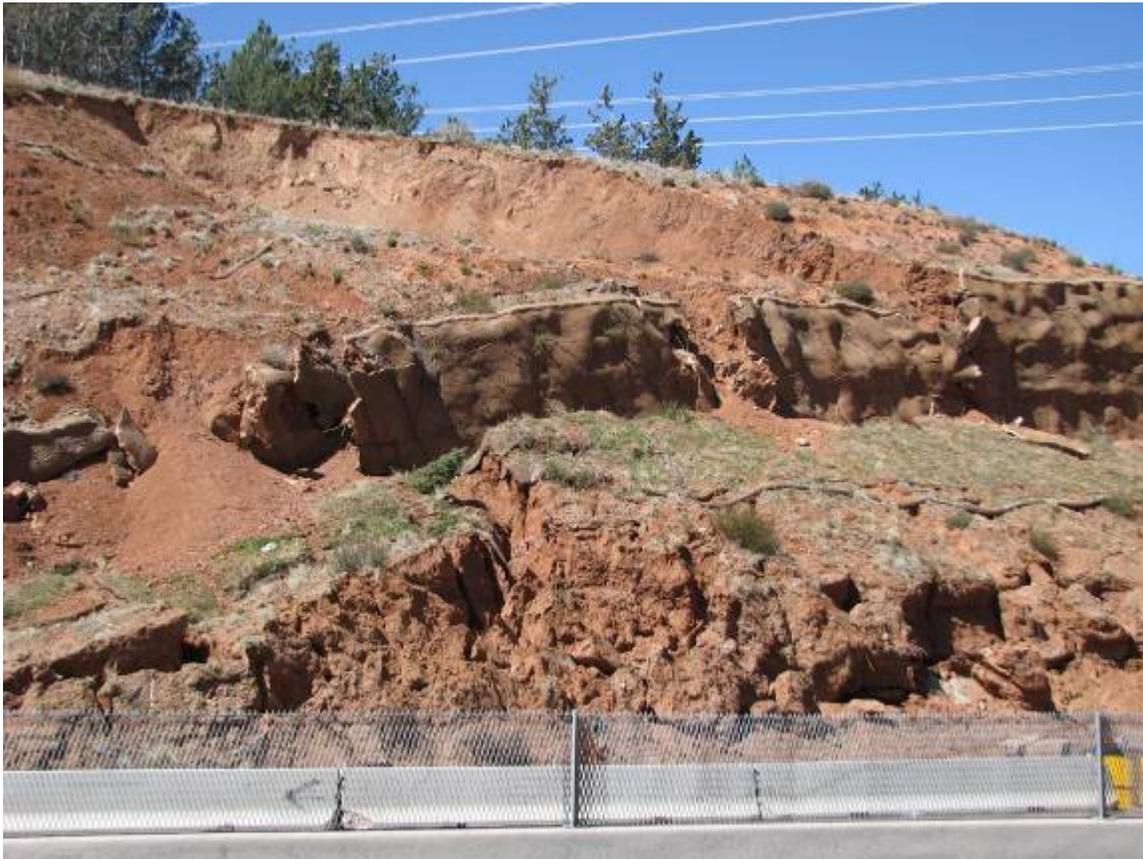
One of several landslides on the west side of the road. Note the broken shotcrete and straw wattles. The metal fence in the foreground is the median of the highway; the Jersey barriers behind the fence are actually on the shoulder of the southbound lane, and are serving as a buffer against further downslope movement of the landslide material.

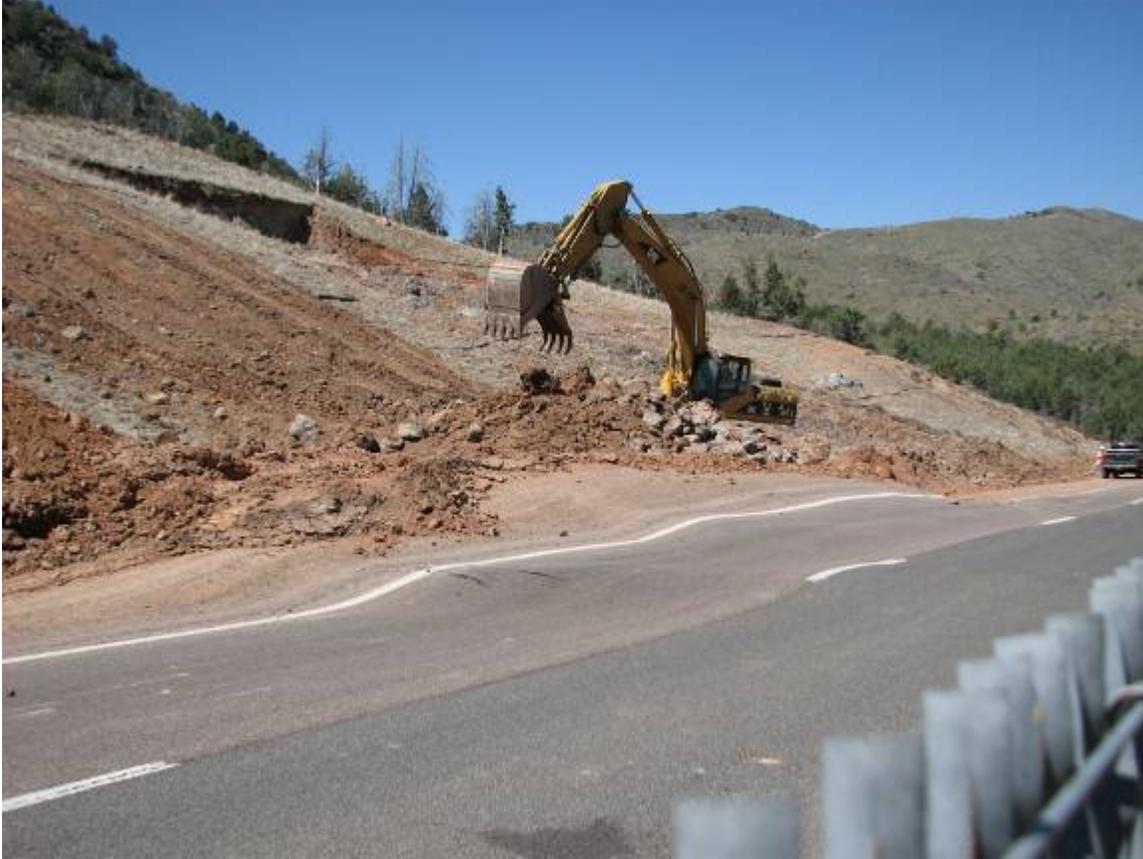
The toe of the rotational landslide came up underneath the highway, buckling the southbound lanes to approximately 1 meter in height for a stretch of about 15 meters.

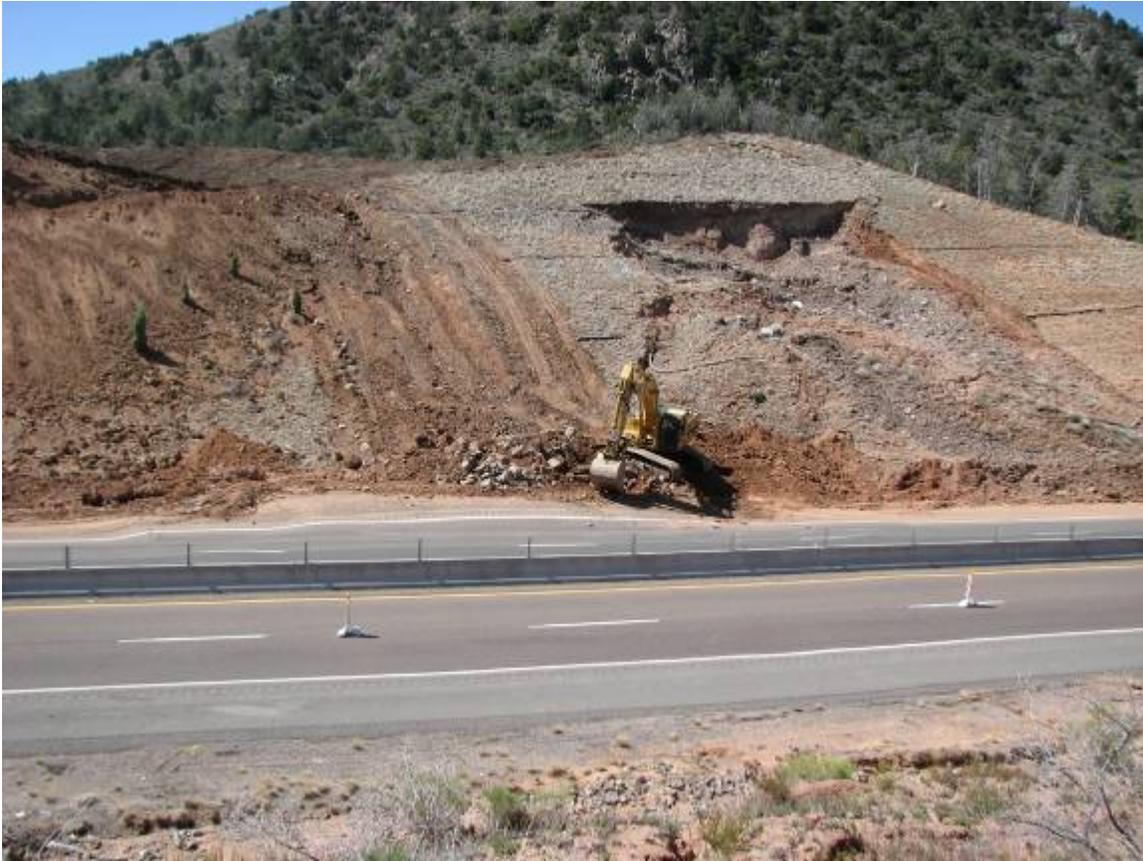
The shovel bucket is sitting on top of the buckled area. Headscarps of landslides are visible on either side of the one that buckled the road. Bulldozers have already obliterated the scarps at the head of the slides on the left.

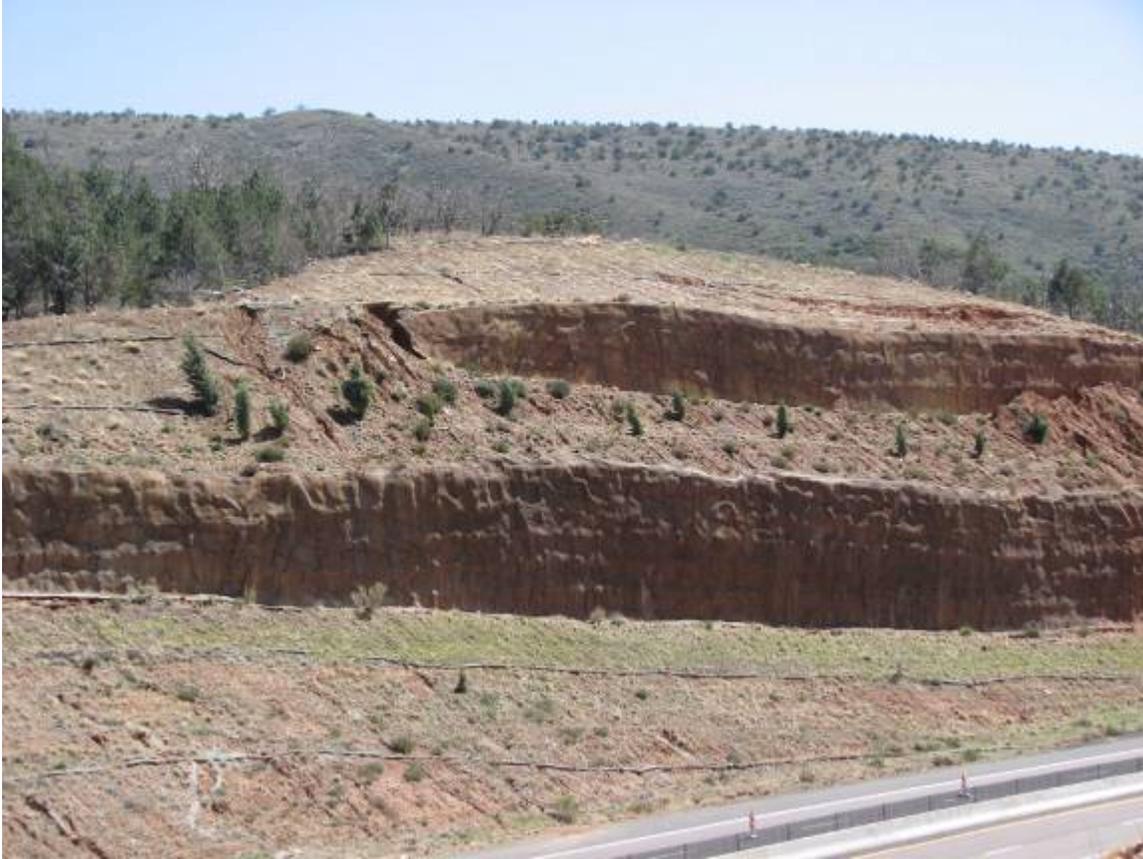
Slump block headscarps on east side of highway immediately across from the preceding photos.

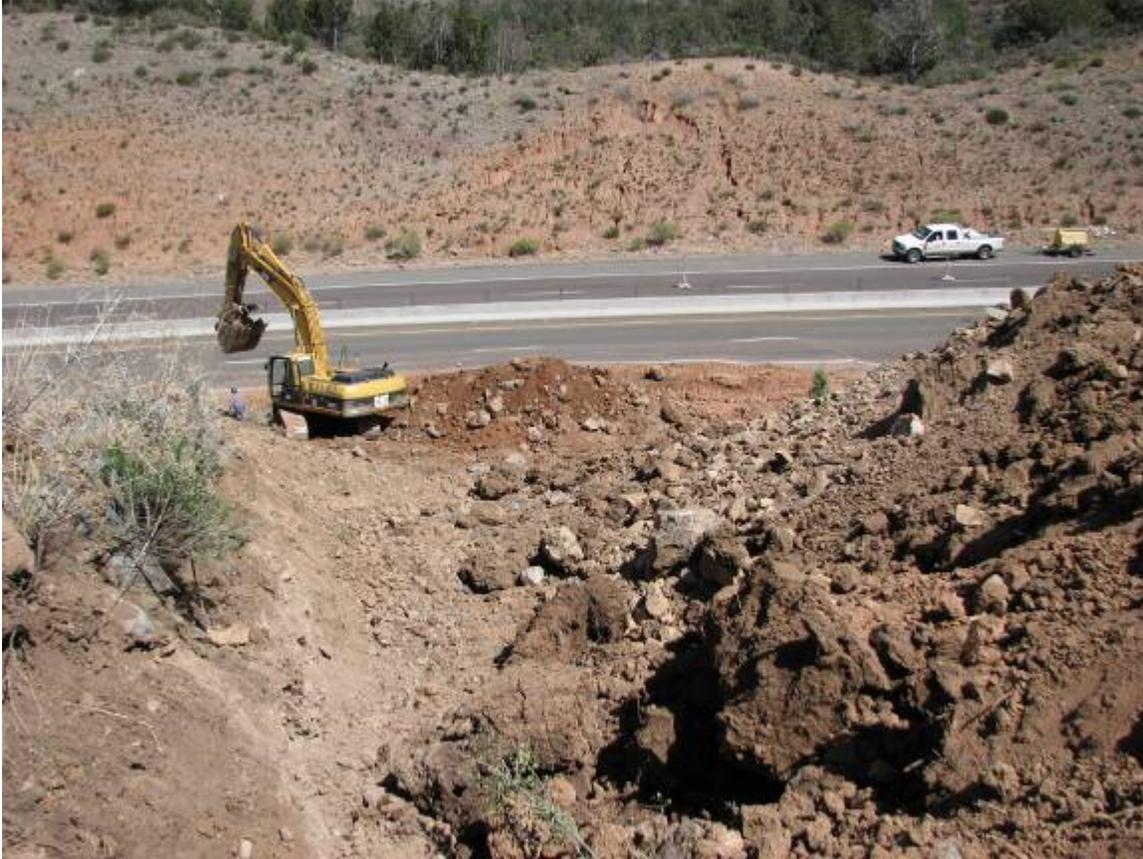
View down a possible drainage underlying the landslide where the toe caused the road to buckle. Note arcuate headscarp directly across the highway.

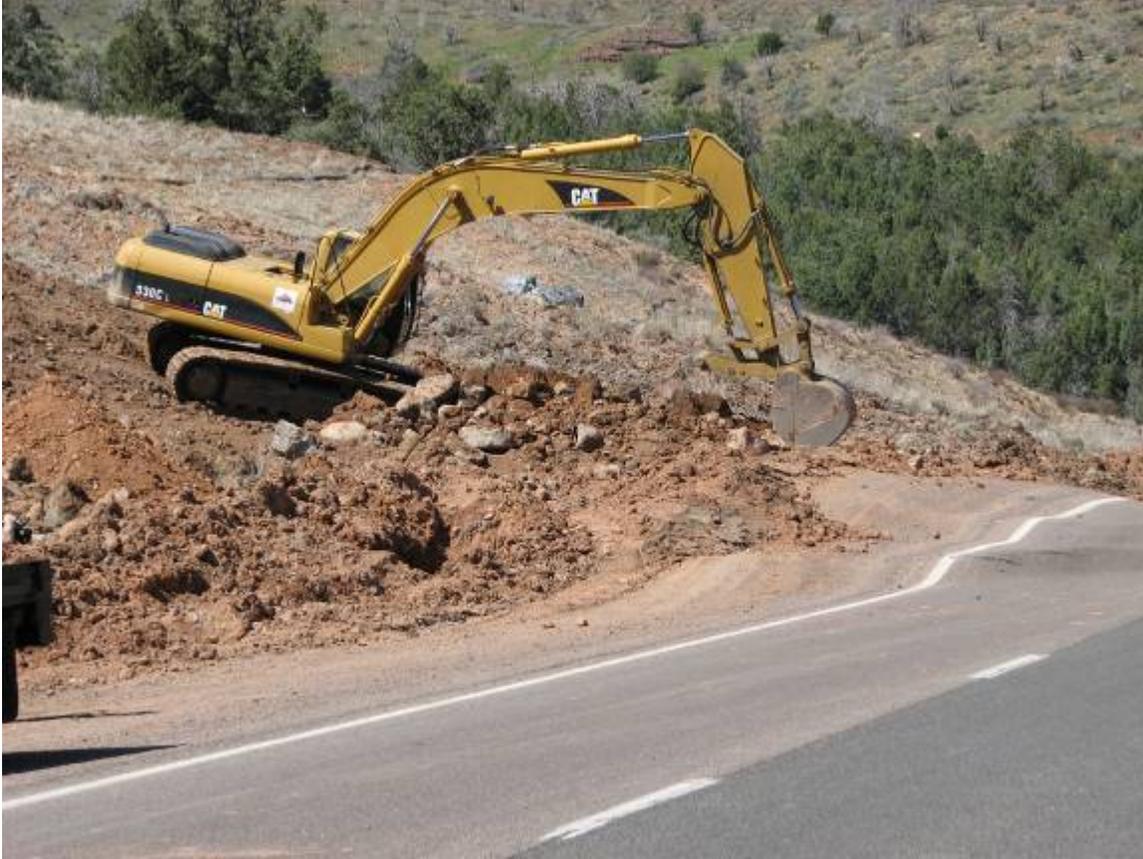
Truckloads of debris have been steadily removed since late Friday, and much repair work remains to be done.

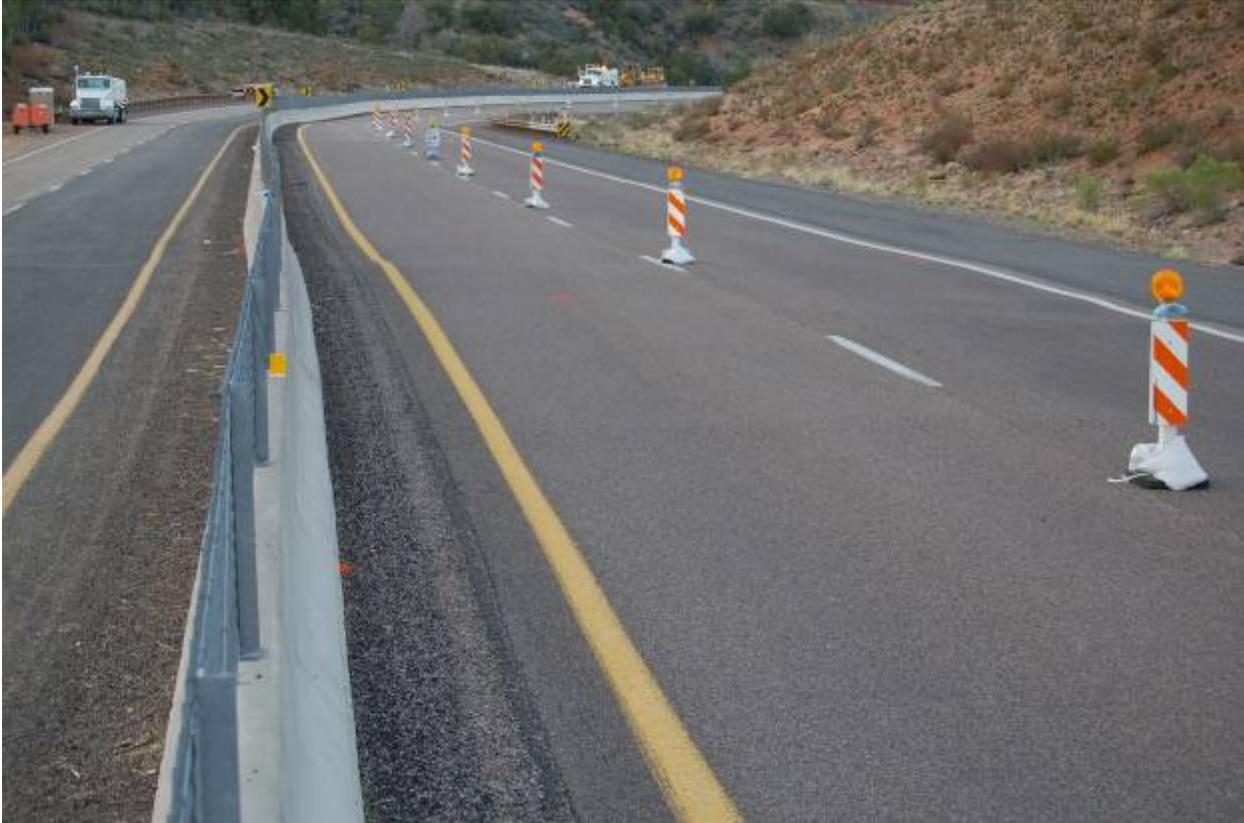
Highway State Route 87 with the northbound lanes on the right and landslide on the left (southbound). The base of the landslide appears to be below the freeway here and has moved the road and divider horizontally approximately 0.3 meters to the right.

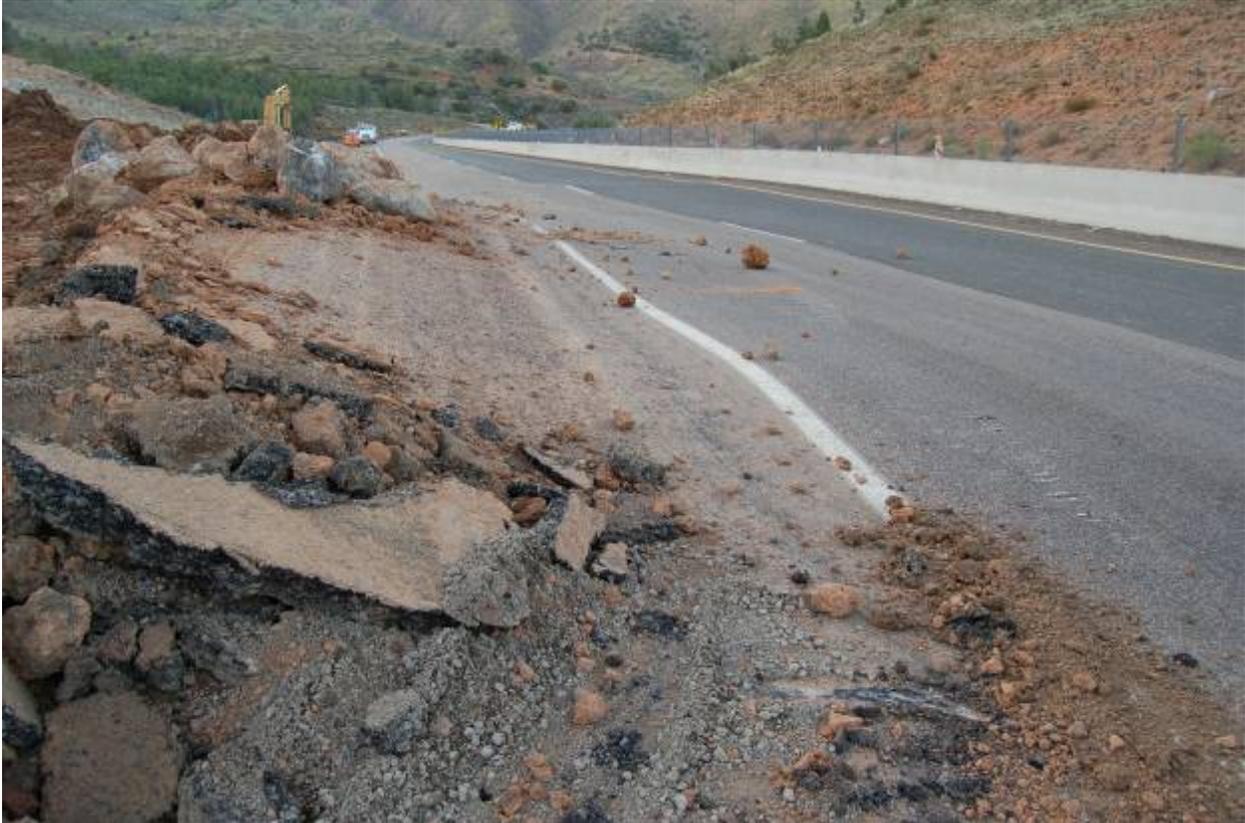
The landslide that meets southbound SR-87 has buckled the highway and appears to have continually crept over the weekend, pushing the highway up over one meter high and shifting the highway horizontally several tens of centimeters.

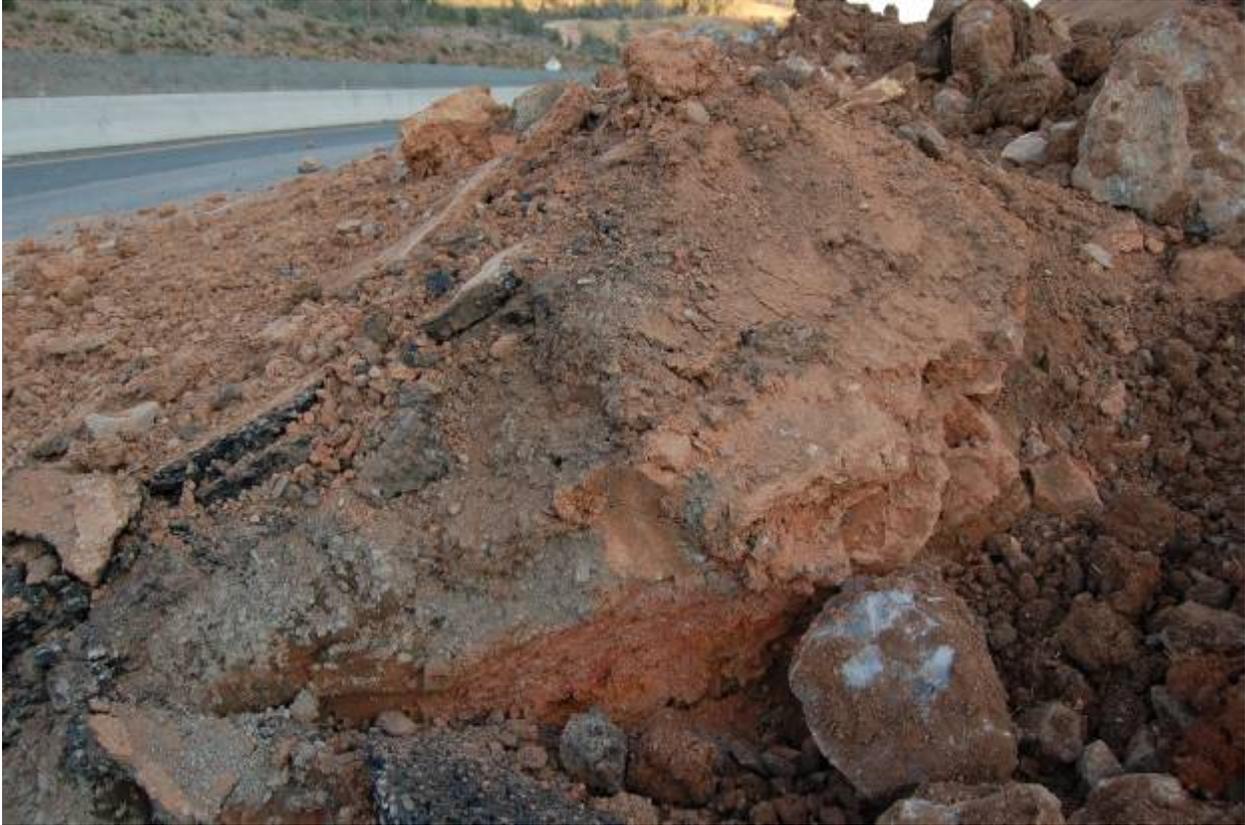
The toe of the landslide feature up against the highway pavement. Notice the pavement, gray artificial fill underneath the pavement, and the red clay-rich and moistened sediment underneath the highway fill. The landslide appears to be moving along this clay-rich zone.

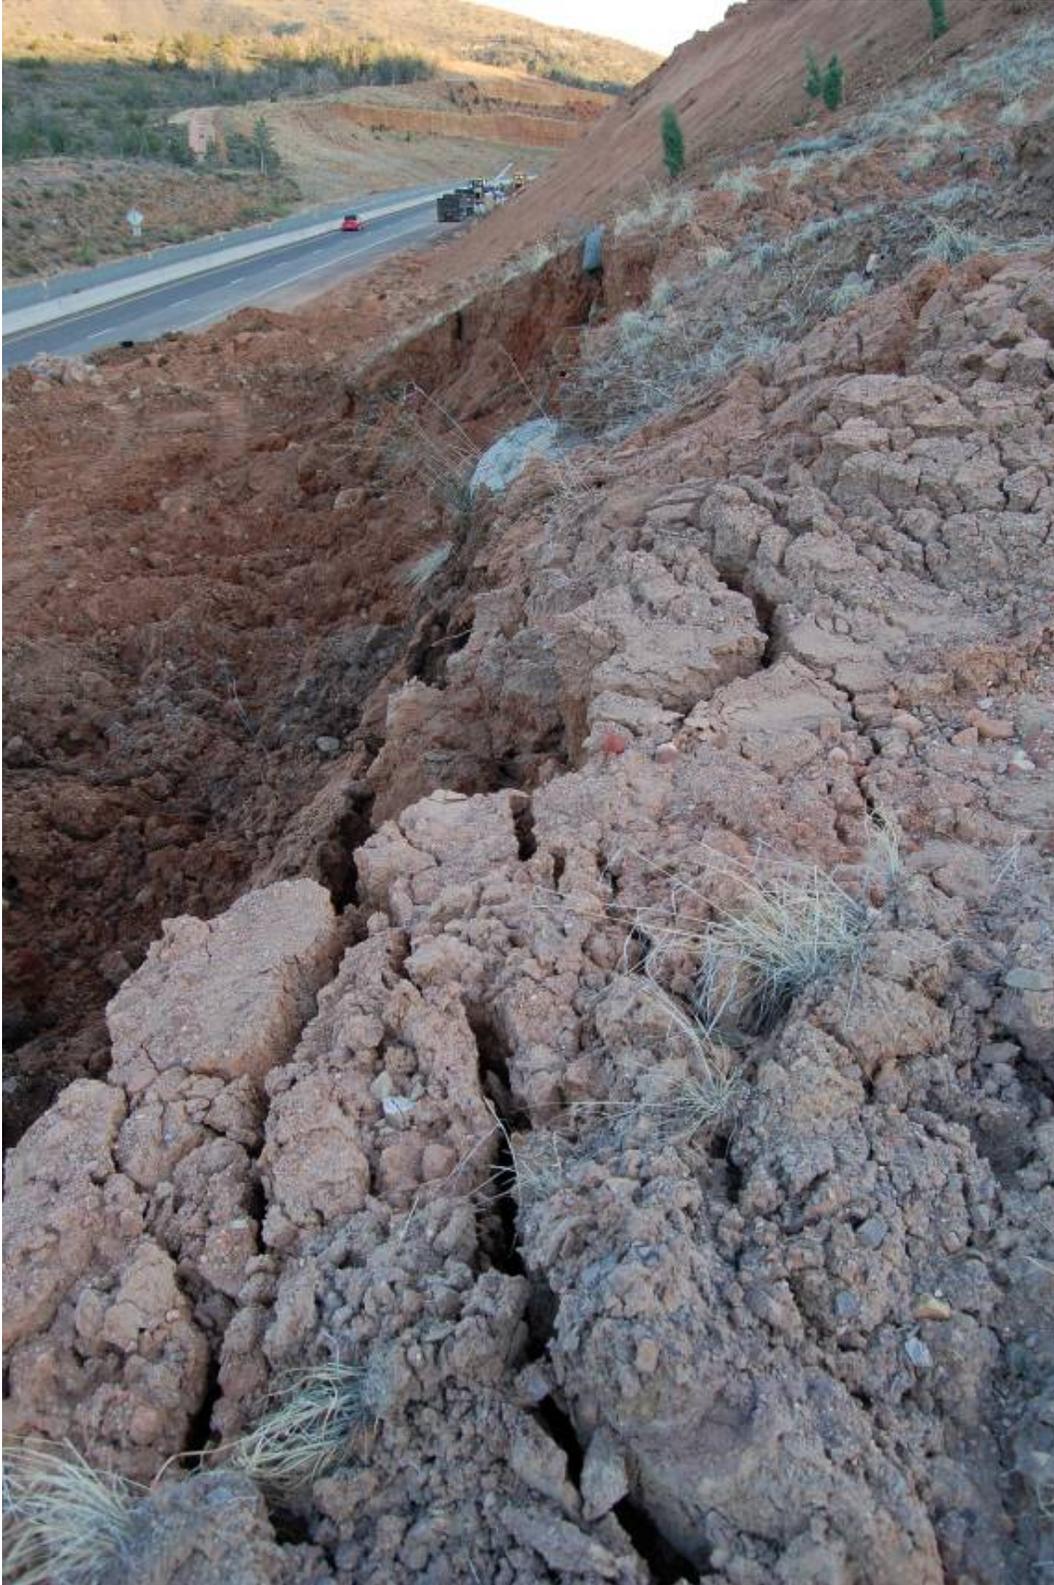
Earth movers have removed some of the toe of the landslide on the left. The unmoved sediment continues to move to the left, creating several zones of cracks.

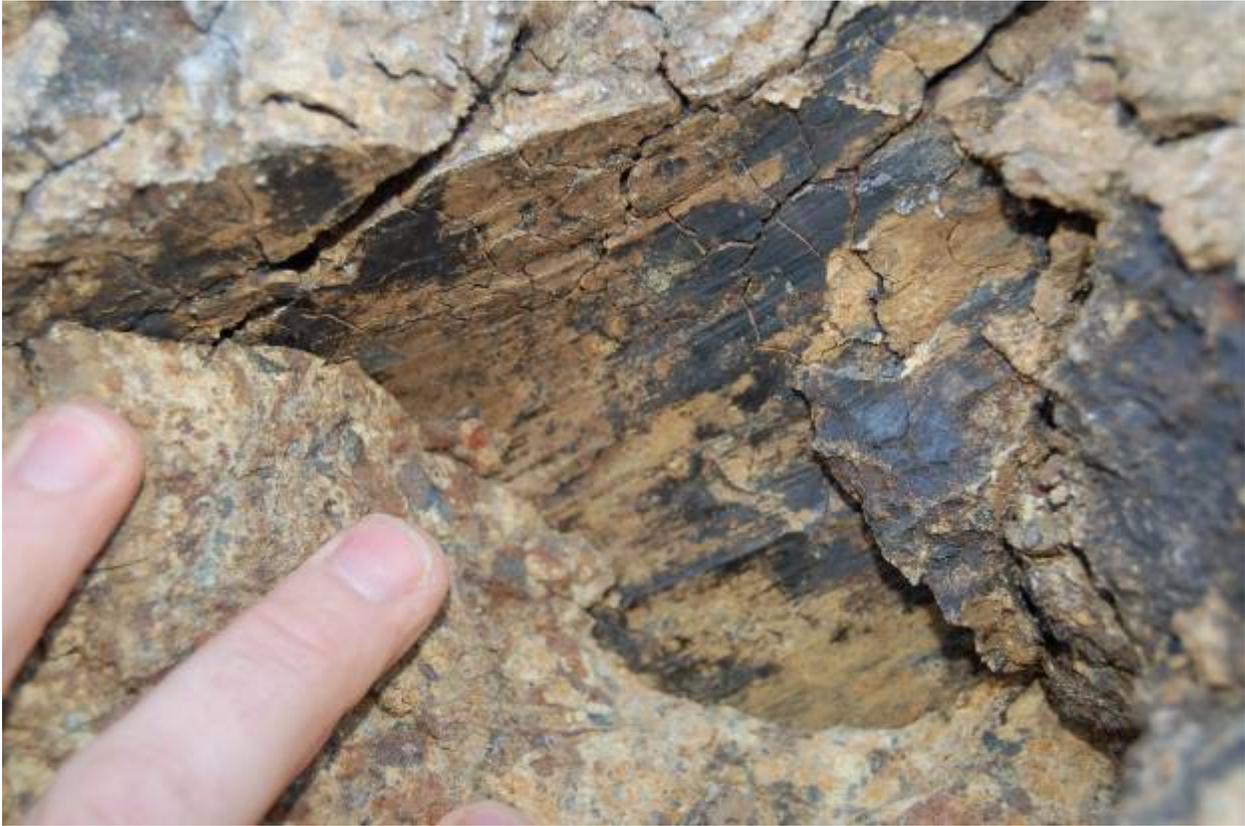
The interior of the landslide shows evidence of shearing in a clayey gravel sediment.

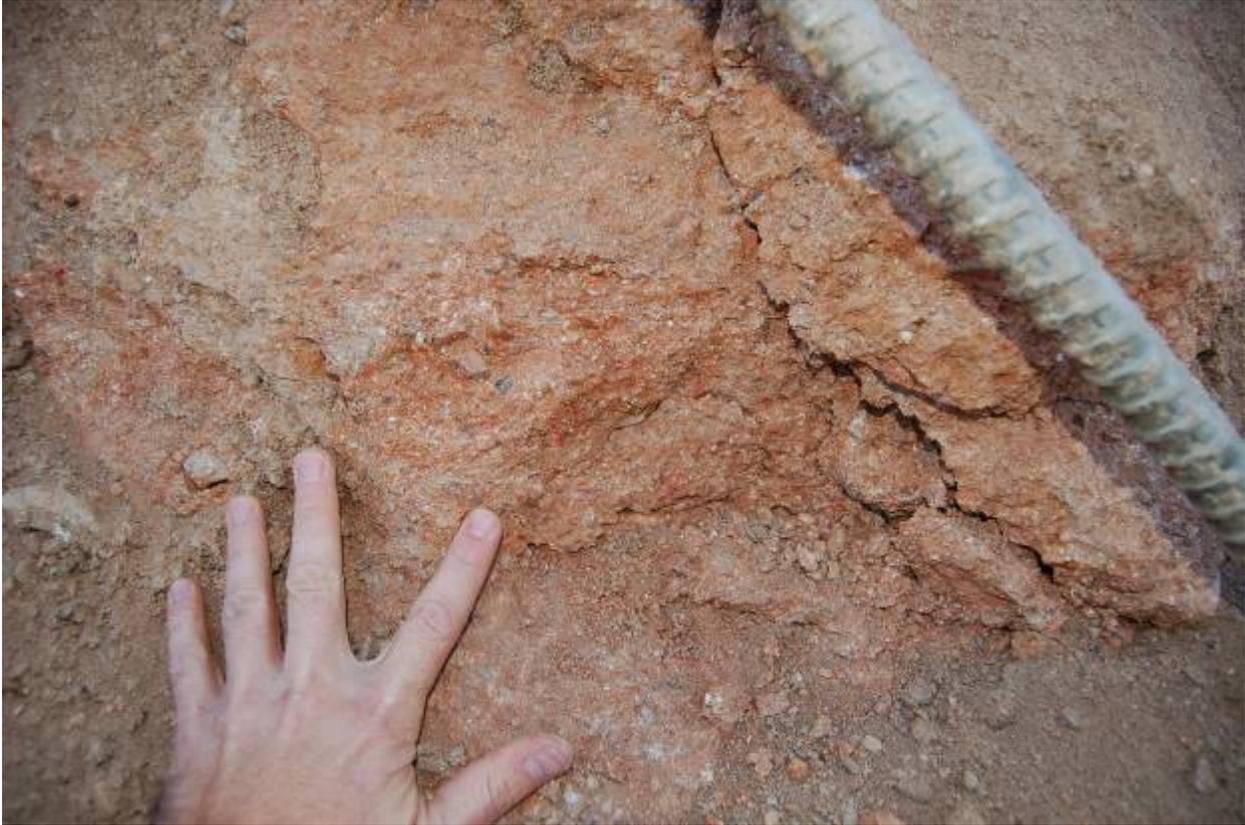
Some of the interior of the landslide is composed of a coarse sand and gravel sediment with minor amounts of red clay.

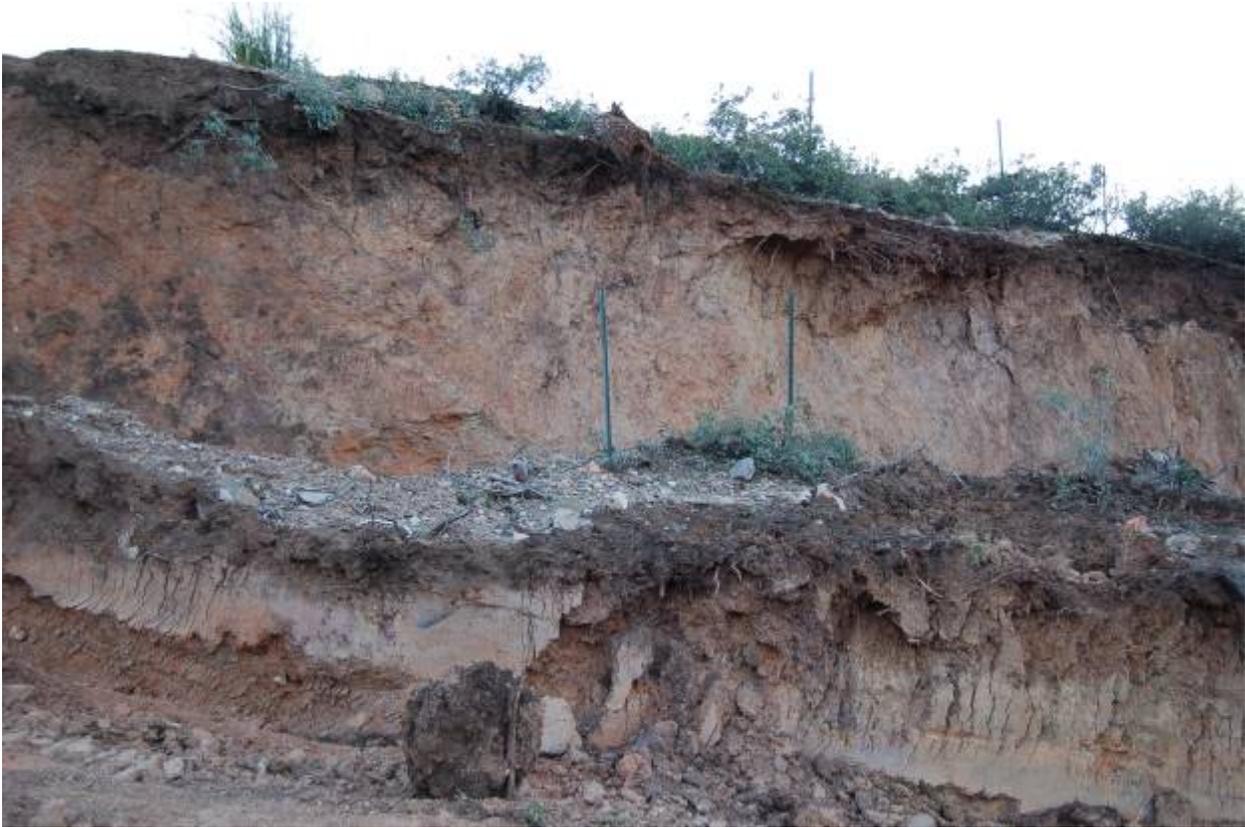
One of the scarps present near the top of the landslide. Approximately two meters of offset is visible here, as indicated by the matching soil cap on top of the two blocks.

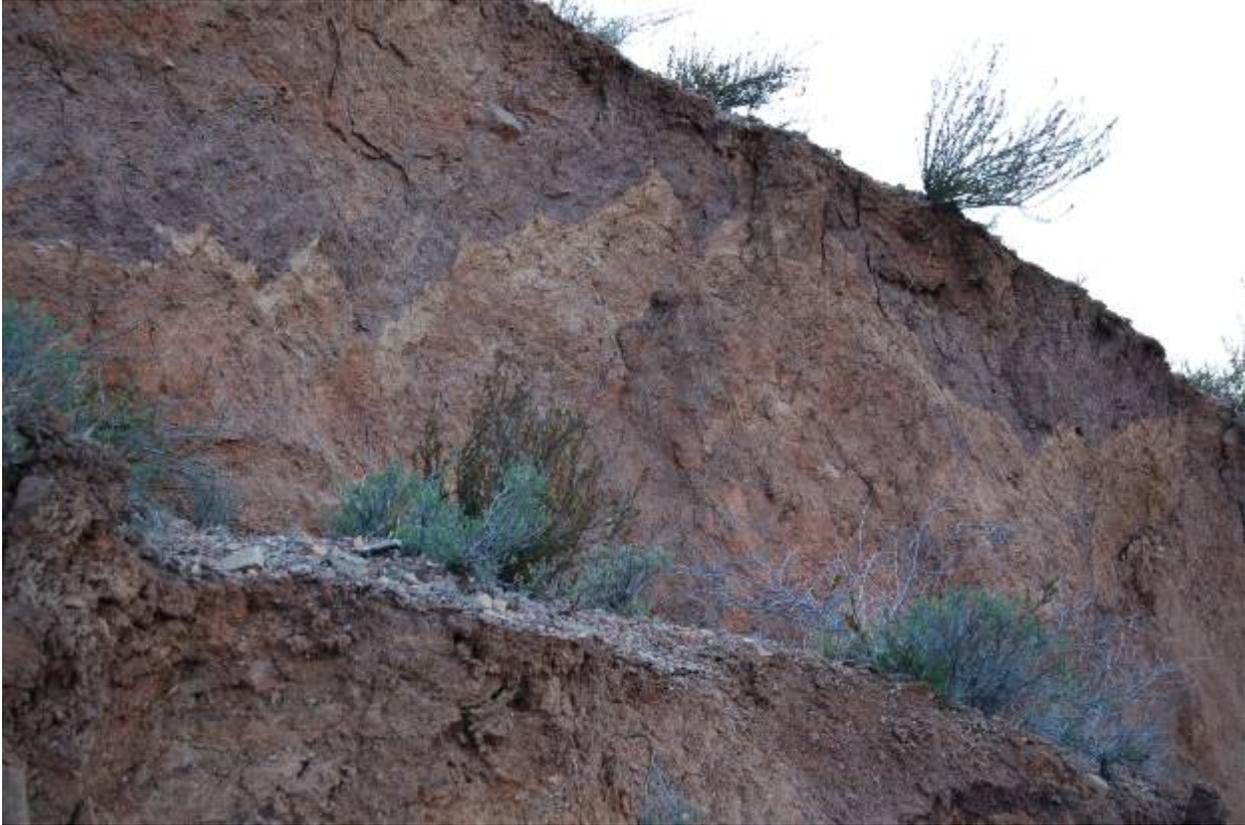
Looking up at two vertical walls of the landslide between two scarps. Note the vegetation on the top of each block separated vertically almost two meters. Also note the purple zone at the top; a clay-rich layer that appears to be strongly deformed, possibly from a previous landslide event.

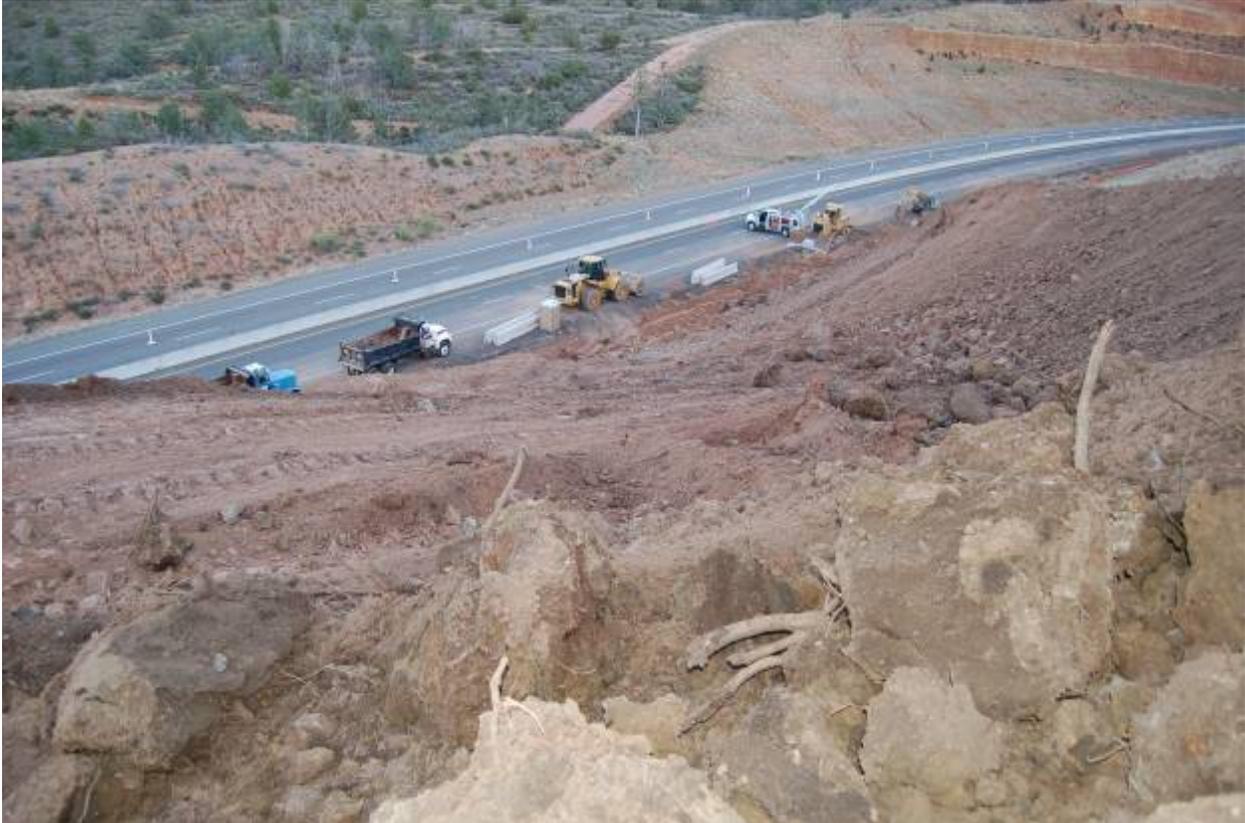
Looking down from halfway up the road cut where headscarps are present. Much of the slope has been removed and shored up. The blocks of sediment in the foreground are remnants of a soil cap.

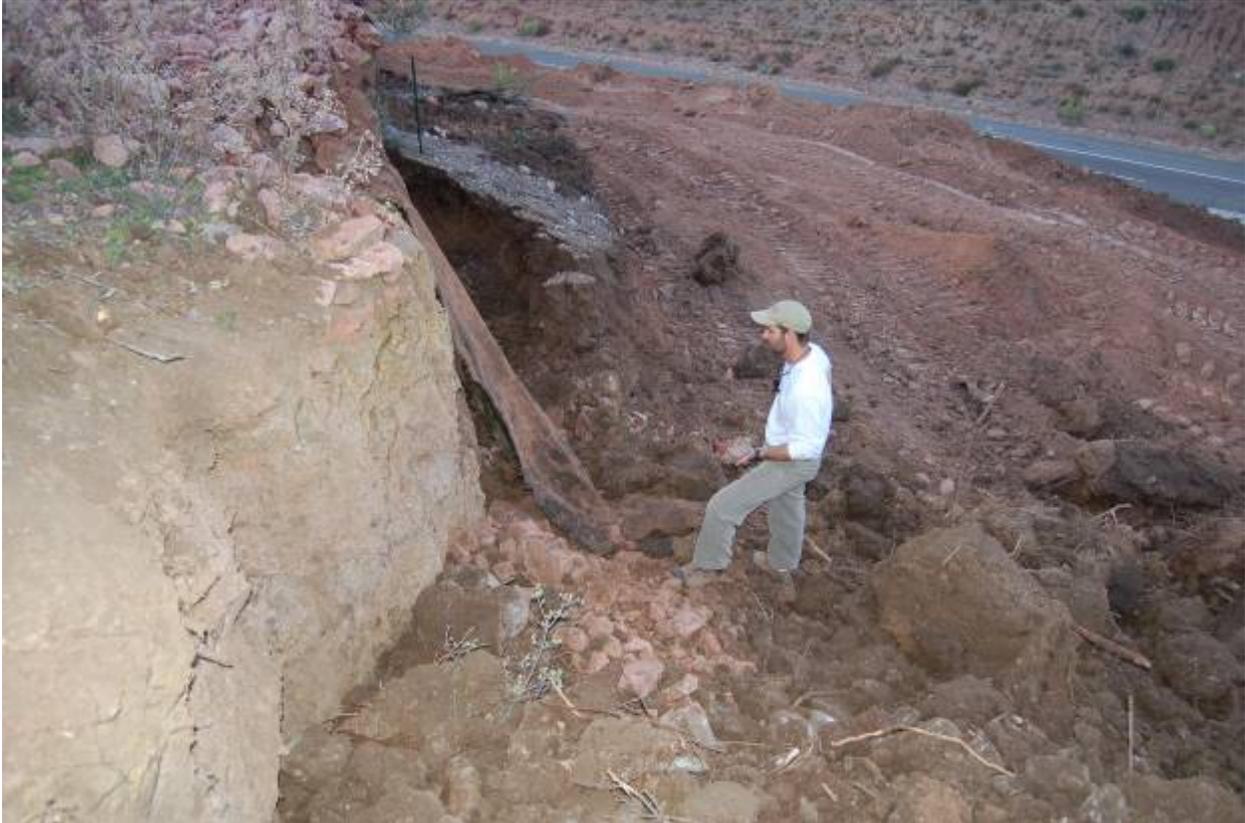
Halfway up the roadcut and landslide is the boulder-lined canal, where one scarp has approximately 2 meters of vertical offset, and 1 meter horizontal offset.
