NAVSEA REPORT NO. S555-79  
JUNE 1981

# LASER TRANSFORMATION HARDENING OF FIRING ZONE CUTOUT CAMS

FINAL REPORT

by  
ROBERT W. LOWRY

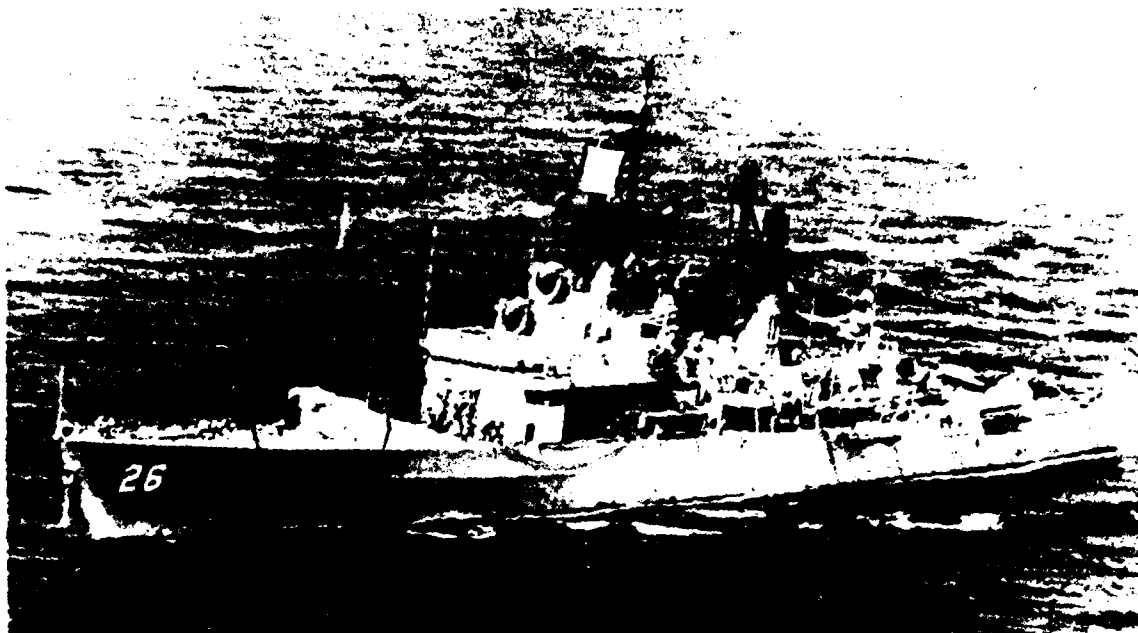
Figure 2. Photograph of USS BELKNAP (CG 26)  
Showing Mk 10 Terrier Launcher (Encircled)

The Naval Surface Weapons Center (NSWC) is currently the design agent for the Mk 10 GMLS firing zone cutout cam (see Figure 1). These items are used aboard ship to confine launcher azimuth and elevation angles in order to prevent firing the missile toward ship structures. Figures 2-5 help illustrate the cam function. Figure 2 is a photograph of the USS BELKNAP (CG 26), which has a Terrier missile launcher (encircled) that uses the Mk 10 firing zone cutout cam. Figure 3, a schematic of a DDG 37 class ship, shows a missile being launched to avoid the ship's superstructure. Figure 4 provides an example of cam contour, while Figure 5 provides a schematic of a typical firing cutout zone. The contour of the cam corresponds to the nonfiring zone profile that is configured to the layout of the ship superstructure. A cam follower (contact pin), when in contact with the cam, tells the launcher not to fire.

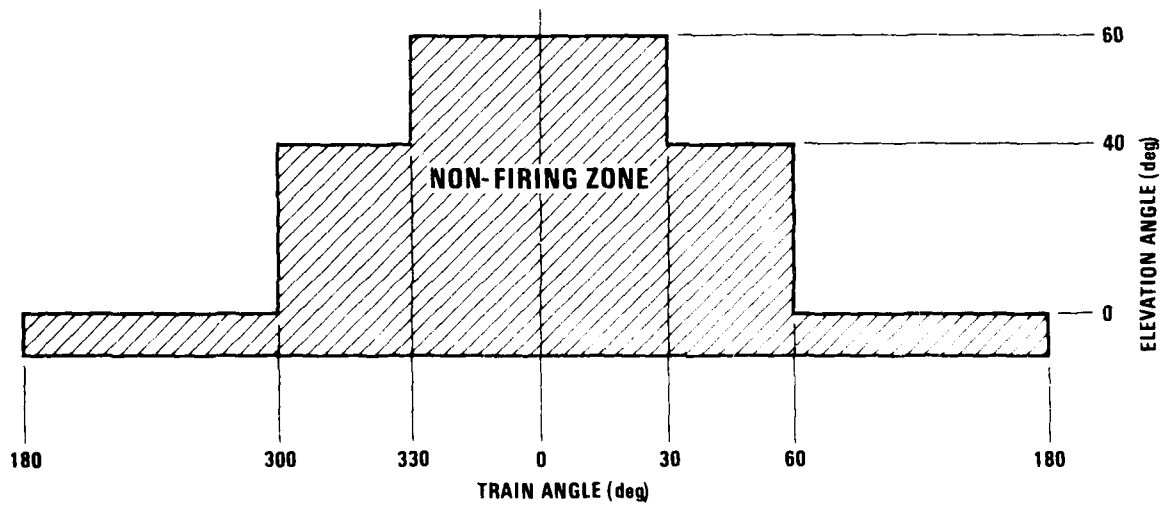
Figure 5. Schematic Illustration of Typical Firing Cutout Zone

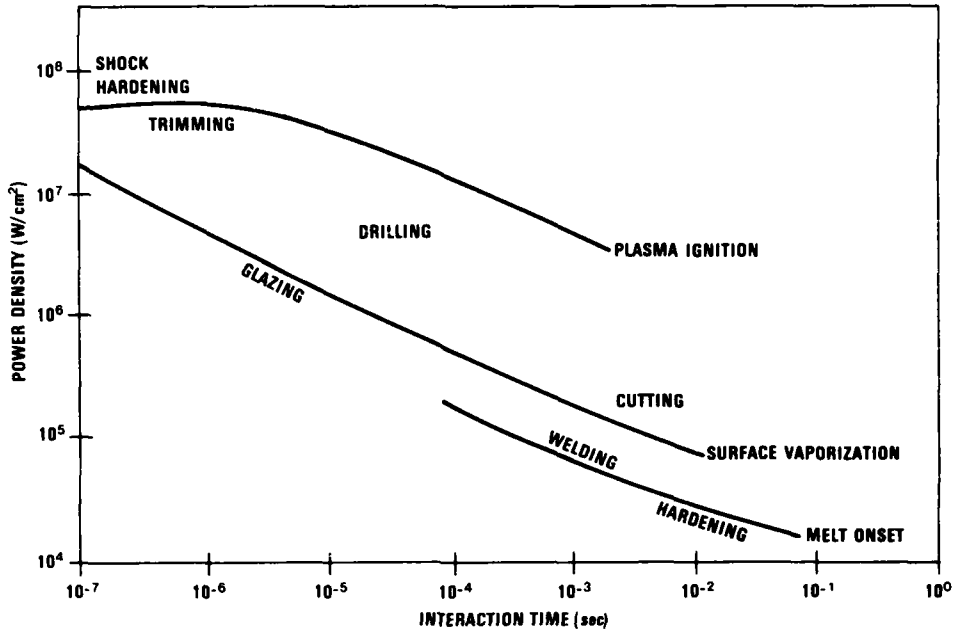
Figure 6. Regions of Laser Power Density and Interaction Time\*

Regions of laser operations with regard to power density and interaction time is illustrated in Figure 6. The power required for laser hardening (heat treating) is in the region of  $10^3 - 10^5$  W/cm<sup>2</sup>. An interaction time on the order of  $10^{-1} - 10^{-2}$  sec is necessary.

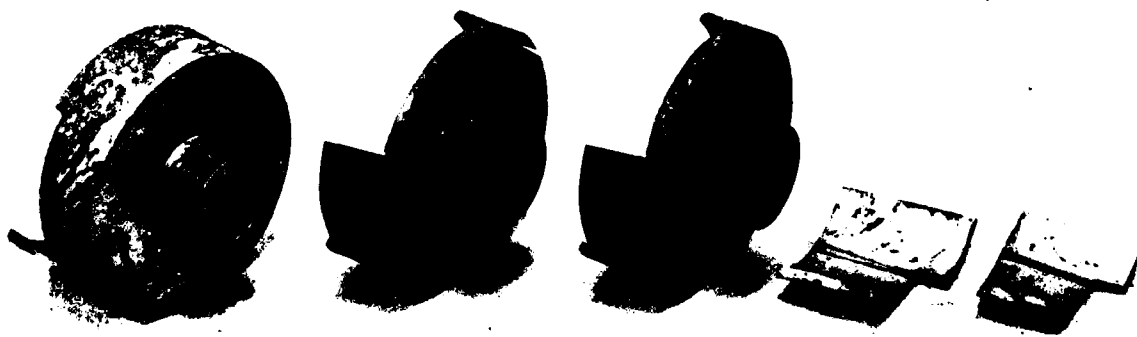
Figure 23. Cam Sections After 48-Hour Salt-Spray Test  
(Reverse of Figure 22)

A 48-hour accelerated corrosion salt-spray test was conducted on both nitrided and laser-treated cams and cam sections. Photographs of these sections after salt-spray testing are provided in Figures 22 and 23. Figure 23 simply shows the reverse side of Figure 22. The general result of the accelerated corrosion test was that there was no apparent difference in the corrosion resistance of the five sections shown in Figures 22 and 23. The five sections shown in these figures are nitrided nitralloy steel, parcoluberized-laser-treated 1045 and 4340 steels, and bare-laser-treated 1045 and 4340 steels.

One problem interpreting these results lies in the fact that much of the corrosion was caused by salt-spray runoff or spillage from an area where salt water collected. The corrosion appears worse than it normally would and interferes with proper interpretation. It was expected that the nitrided corrosion resistance would be better than untreated steel (non-nitrided). However, it is obvious that the nitrided cam corrodes.
