NASA/TM-2011-217047

Lightning Pin Injection Test: MOSFETS in “ON” State

*Jay J. Ely, Truong X. Nguyen, George N. Szatkowski, and Sandra V. Koppen
Langley Research Center, Hampton, Virginia*

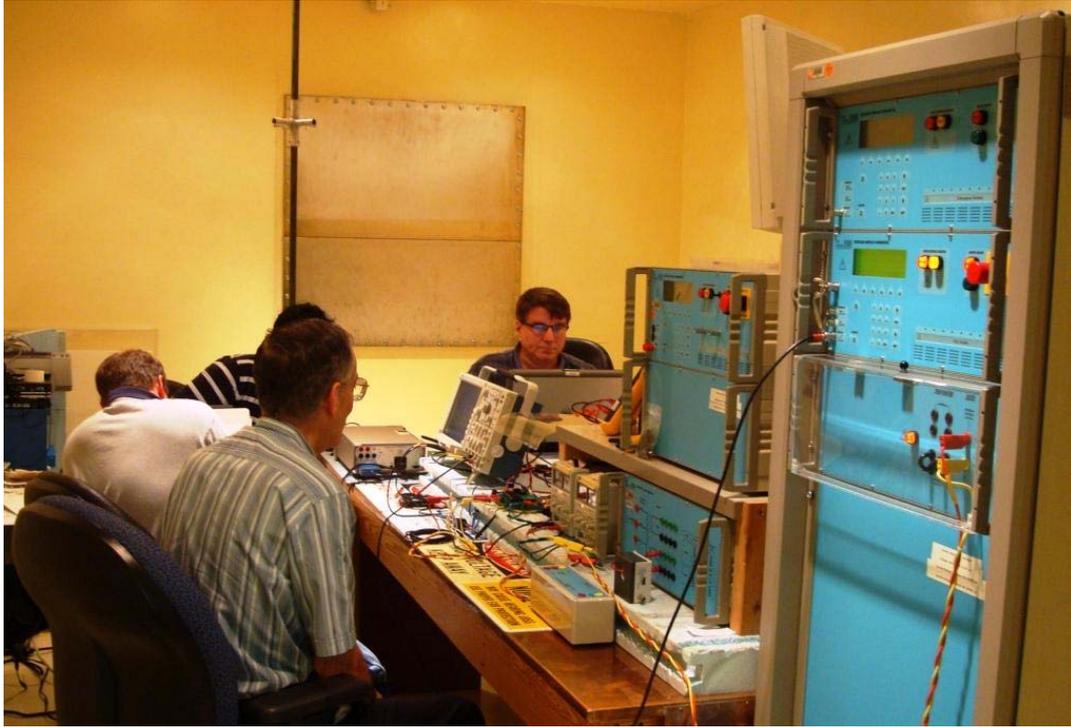
Figure 3: Lightning-generating equipment was used for pin-injection tests. (EMC Partner MIG0600MS shown on right.)

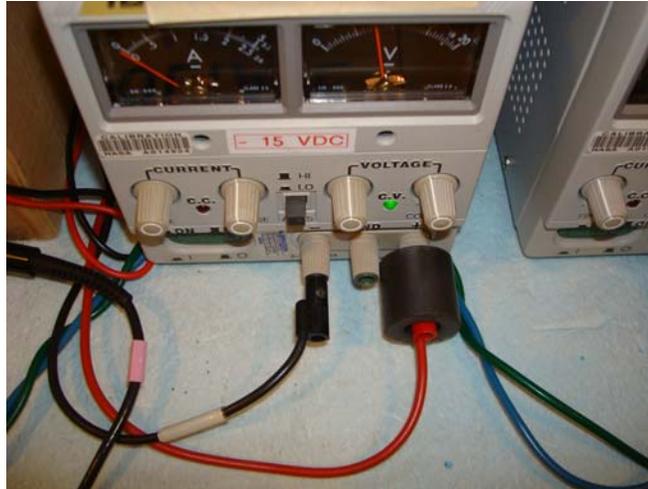
Figure 20: Installation of ferrite core on V_{GS+} Power supply terminal.

Subsequent D-S injection testing with $V_{GS-bias} = 8VDC$ and WF4+ again caused ringing, randomly, for about half the injection tests. It was observed that placing a ferrite core around either the positive or negative terminal of the $V_{GS-bias}$ power supply eliminated the ringing. Placing the ferrite core over either $V_{DS-bias}$ power supply terminal had no effect. The Test Matrix was completed using the ferrite core installed on the $V_{GS-bias}$ power supply positive terminal. A photograph of the ferrite core, installed, is provided as Figure 20.
