LONG-TERM TESTING OF HIGH PERFORMANCE CORROSION INHIBITING SPRAYABLE THERMOPLASTICS (CIST)

ABSTRACT

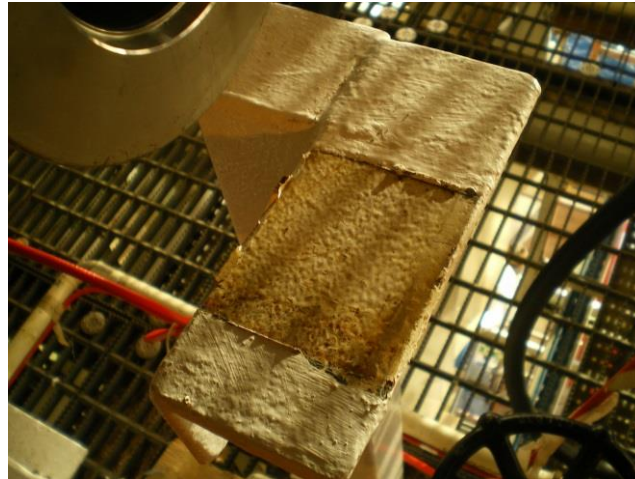
Without complete disassembly, some corrosion will remain between bolts, washers and substrate and, in the case of flanges, between the flange faces. No amount of blasting and cleaning will remove corrosion from these areas. So, painting will always be over-coating some rust, which will soon reappear.

Fig 2 - Over-painting covering rust

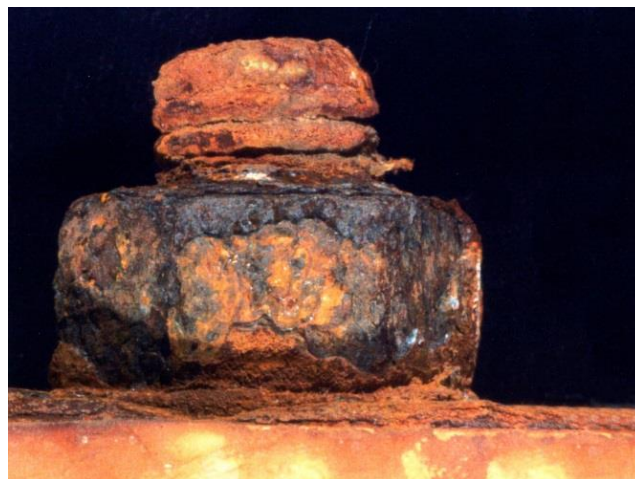
Other factors also have an impact on corrosion in bolted assemblies, particularly galvanic effects where, for example, a carbon-steel bolt in a stainless steel flange will become a sacrificial anode and may completely fail within 18 months - even if protected with zinc and PTFE.

Fig 3 - PTFE/zinc coated bolt failure after 18 months in the splash zone

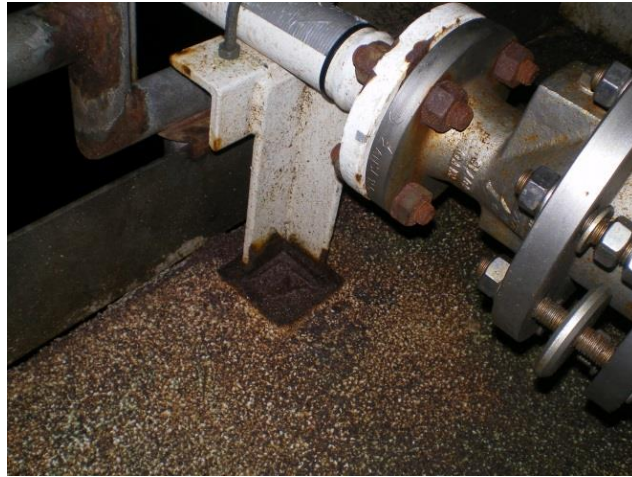
Fig 4 - rusting carbon bolts in stainless substrate

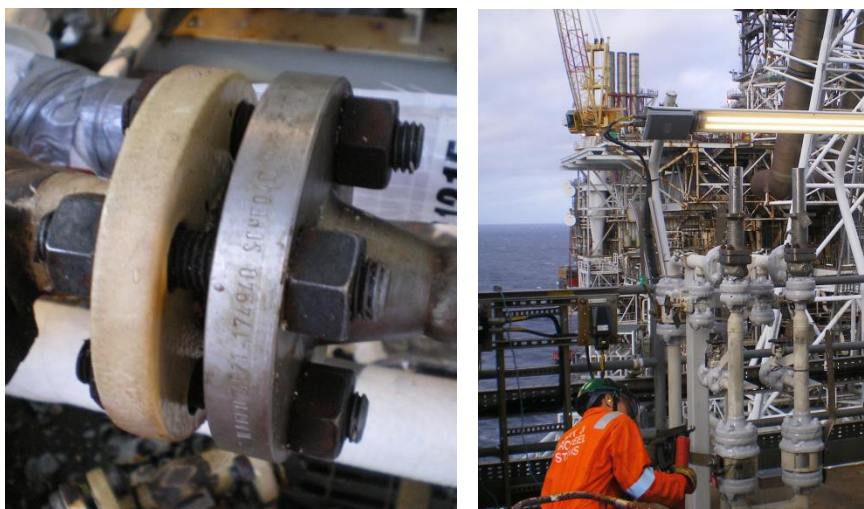
Fig 6 - Offshore platform and mixed metal substrate after 7 years

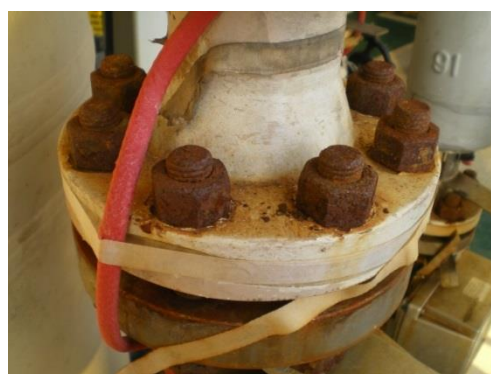
Fig 12 - Bolt corrosion after 18 months offshore North Sea

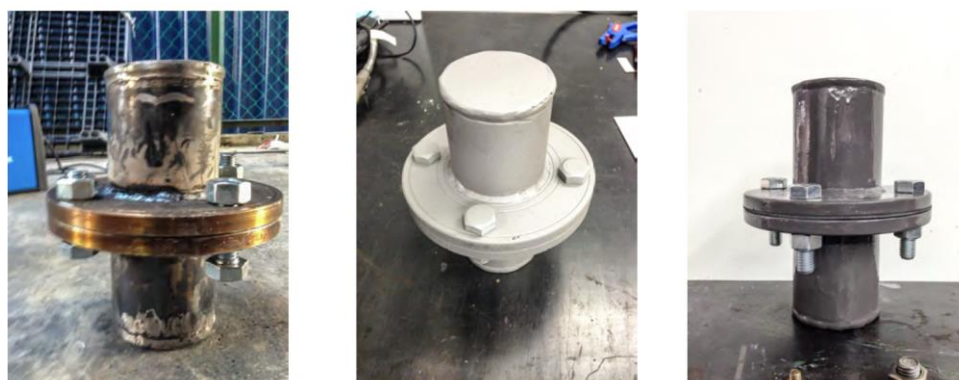
The samples were prepared using carbon steel test pieces, blasted and coated with a single coat of epoxy and fastened using standard nickel-plated B7 bolts. They were then coated with CIST using 2 coats at 2mm per coat, with edges sealed using standard cable ties and the pipe ends left unprotected.

Fig 15 - sample preparation

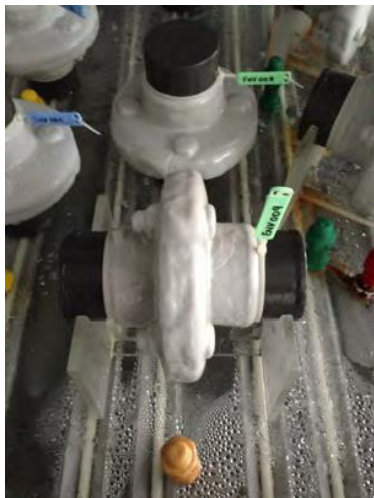
Fig 17 - Samples at 336 hours in hot salt fog cabinet Fig 18 - Sample at 2016 hours in UV cabinet

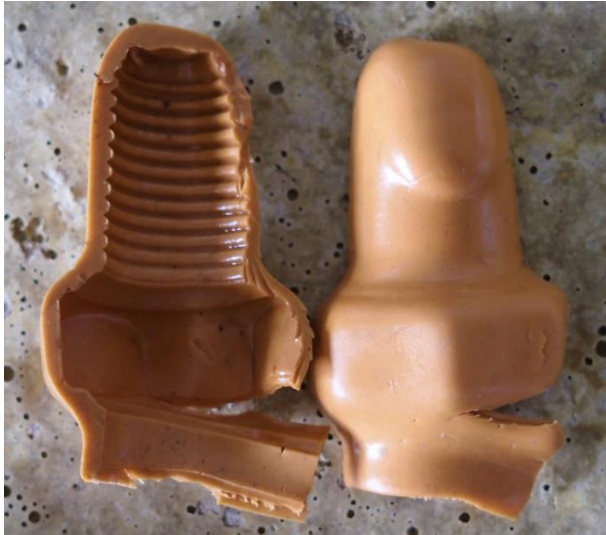
The bolt itself displayed no signs of deterioration, and although the exterior of the CIST coating was found to be relatively free of inhibiting oil, inside the encapsulation inhibitors were evident on all surfaces.

Fig 21 - part of the removed coating showing the inside and outside of the sample after 4500 hours exposure

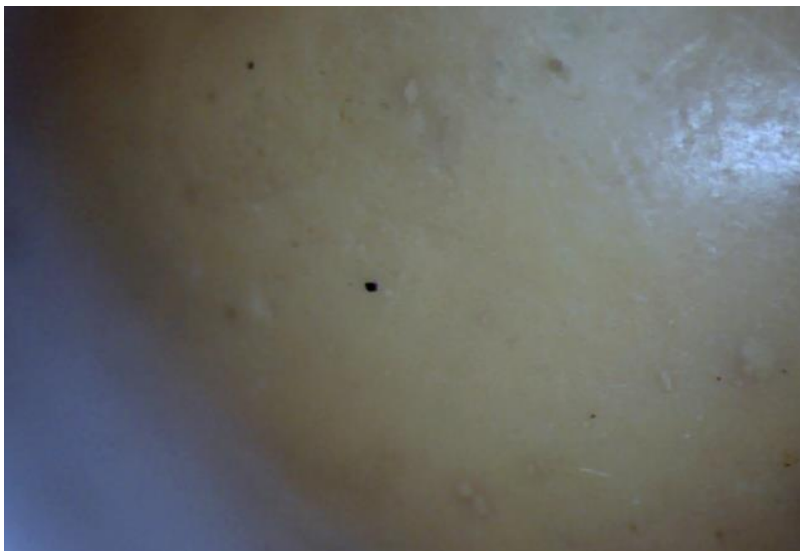
Fig 23 - close examination showed no crazing or cracking of the surface

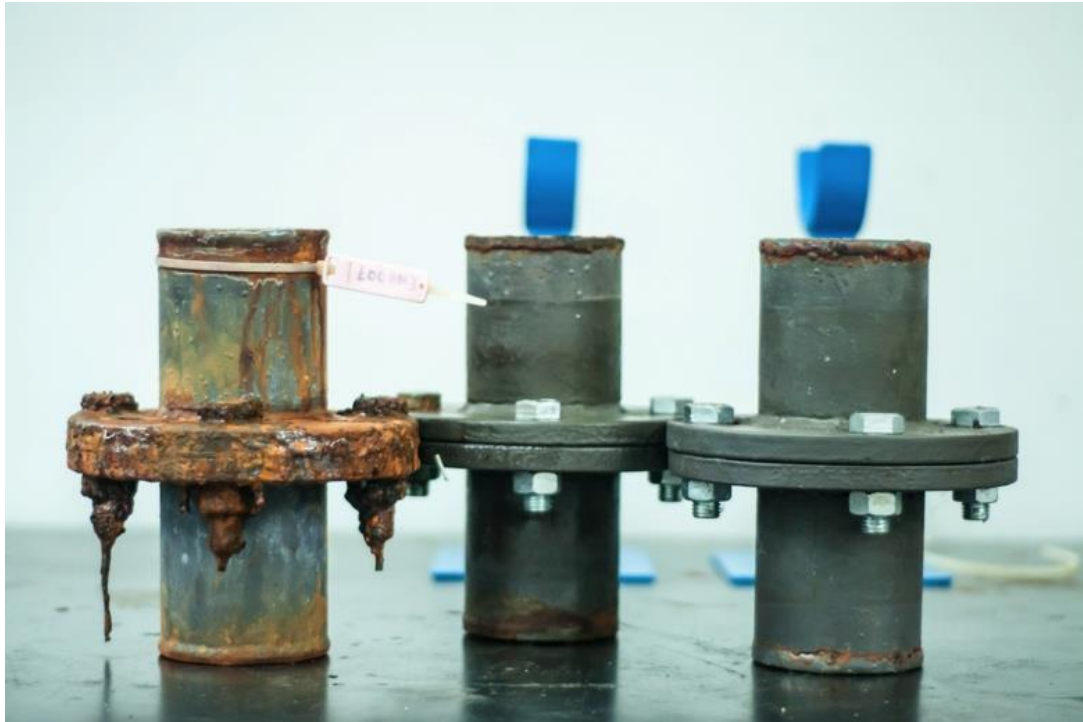
outcome will be achieved in the real world. So it was decided that an unprecedented 9000 hours (over 12 months) of continuous HFS testing would go a long way to showing what CIST could achieve. The most recent milestone in this test was the removal after 7500 hours of a second test piece after the successful examination of a sample removed at 4500 hours. In both cases, while the uncoated control piece displayed increasing levels of deterioration, the CIST samples were in excellent condition. No corrosion or deterioration of any kind could be detected within the CIST encapsulation, bolts, nuts and flange were in perfect condition.

Fig 26 - Side-by-side comparison of control (left) with 4500-hour sample (middle) and 7500-hour sample (right). The corrosion at the top and base of the samples is on areas outside the CIST encapsulation

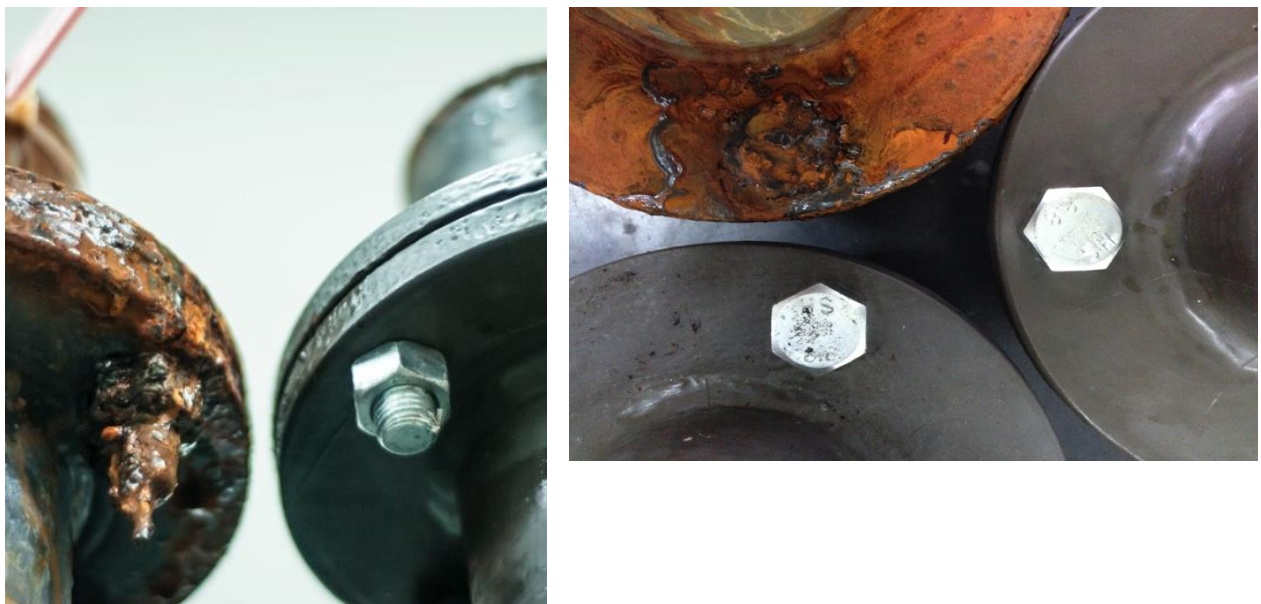
Figure 27 - Comparison of bolts from below and above

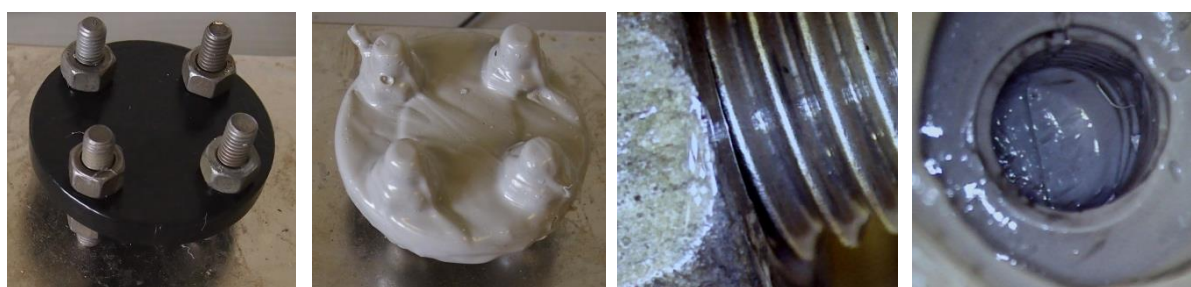
Over the six-month period there was no significant change in weight nor any escape of oil on to the tray. Initially weekly measurements were taken but, with no changes found, the interval was increased to monthly. At the end of six months, the material was removed and examined. Good oil deposits were found within the encapsulation, on bolt threads, metal and CIST interior surfaces. Other than some soiling from handling, no surface effects were found on the CIST exterior.

Fig 28 - Test piece before & after coating, close up of bolt thread and removed CIST after test completion

For this test, an encapsulated substrate was subjected to a continuous cycle of temperature variations from 45°C to 4°C on a 24-hour cycle for six months. The weight of the substrate and the applied CIST material was recorded before and after encapsulation. The sample was suspended over a tray to collect any potentially escaping liquids.

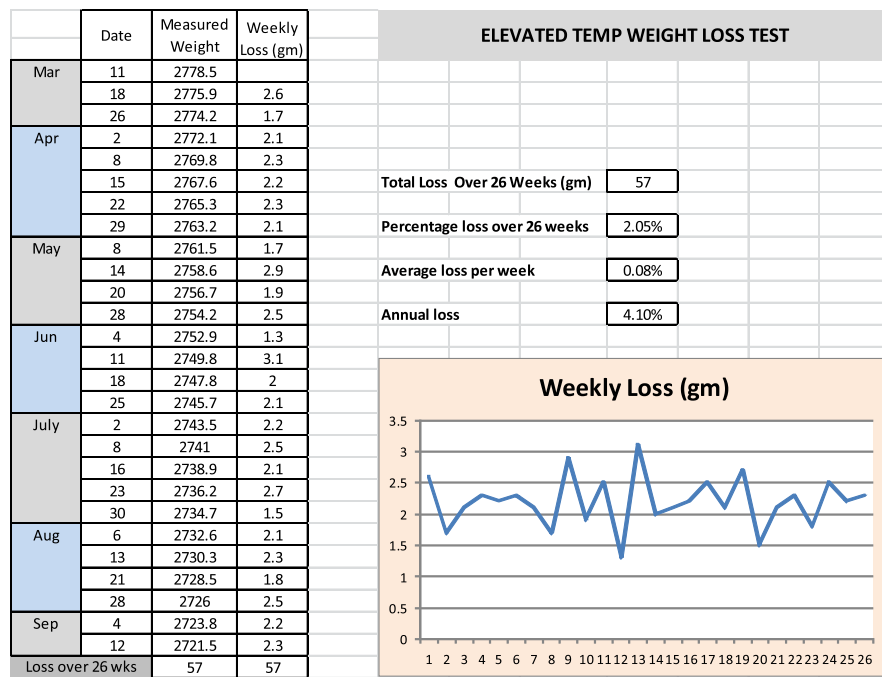
A measured and weighed sample of CIST material was placed in a laboratory oven for 3 months at 80°C in order to establish the rate of inhibitor loss at elevated temperatures. At the end of each week the material was removed from the oven, measured, weighed and immediately returned to the oven to maintain its temperature. Weight loss was consistent over the period with an average loss of 0.08% per week. Weekly measurements showed no measurable shrinkage over the period.

Fig 30 - Data from High Temperature Test

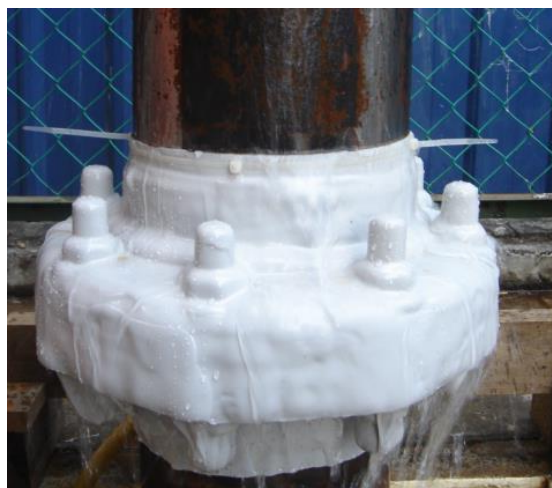
A 20% saline solution was cycled at approximately 400 litres an hour for 11 hours a day, 5 days out of 7 for 6 weeks. Ambient temperatures were between 24°C and 38°C. The steel pipe substrate and flange were new and uncoated low-carbon steel, a section along the length of the pipe was abraded prior to coating with CIST to provide the best potential conditions for corrosion. The CIST encapsulation was sealed using a standard tie-wrap technique.

Fig 31 - Test substrate at commencement of test

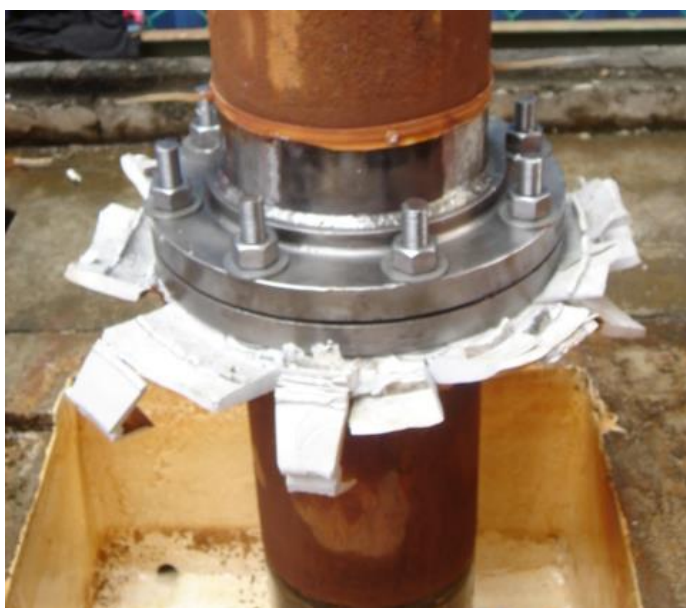
Fig 34 - Complete removal of the material shows no corrosion on substrate
