Low-Cost Highway-Rail Intersection Active Warning System Field Operational Test

Evaluation Report

**Minnesota Department of Transportation
Office of Traffic, Security and Operations**

**URS Corporation
and
TranSmart Technologies, Inc.**

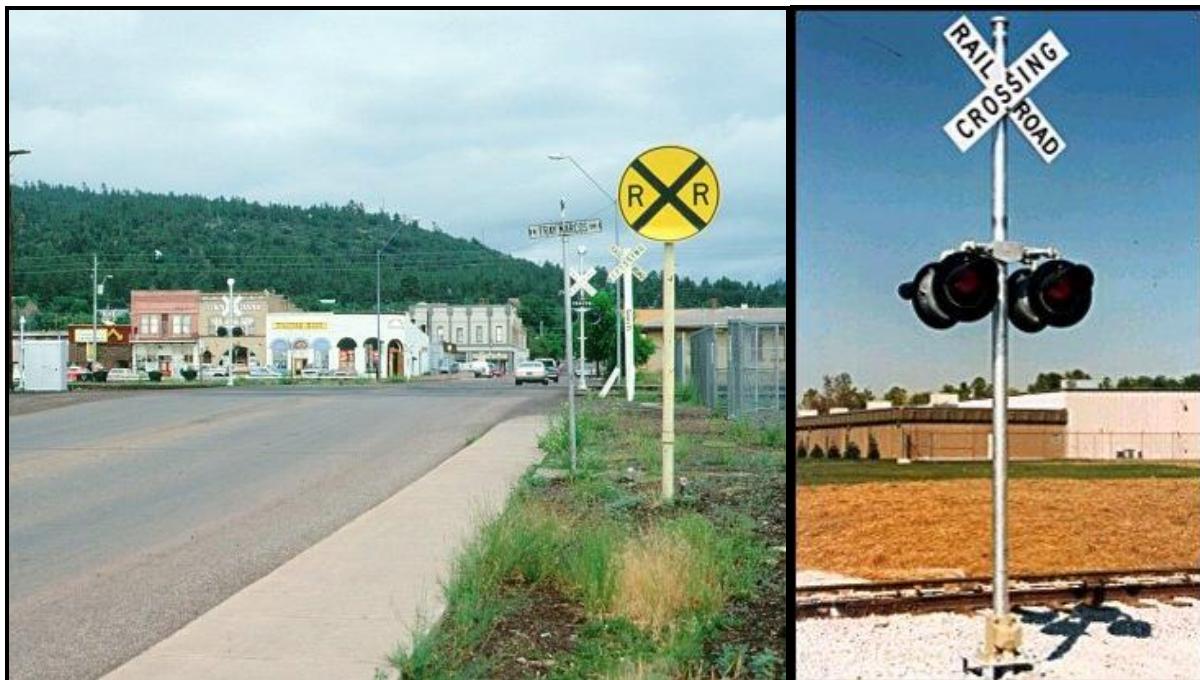
Figure 1-1. Types of Traffic Control at Highway-Rail Grade Crossings: Passive Control (Left) and Active Control (Right)

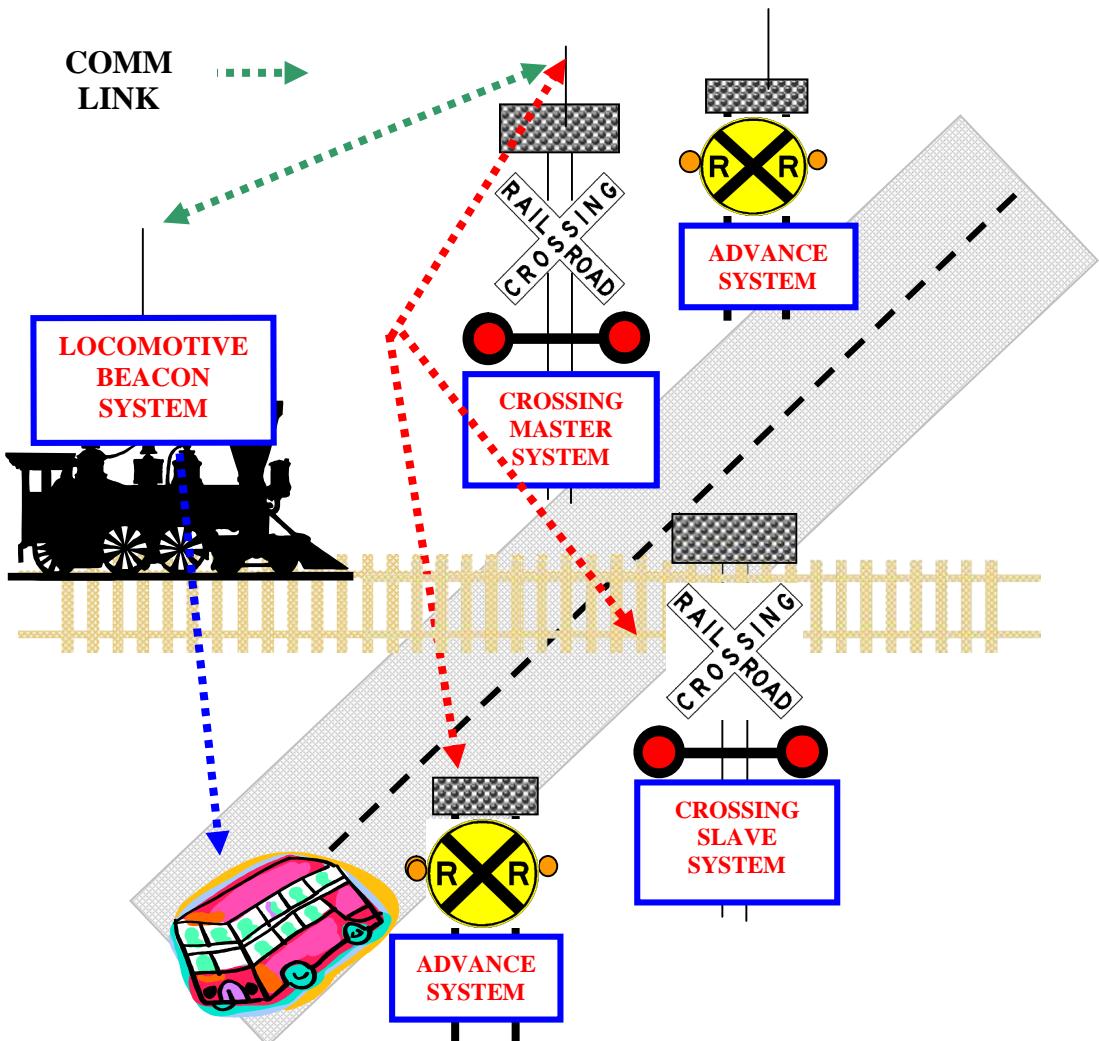
Figure 4-1. HRI-2000 System Diagram

The system was designed to provide “constant warning” by activating the crossing with preset warning time regardless of train speed. Advance train detection is accomplished by the sub-systems on board the locomotive knowing its location and sending out a beacon at regular intervals. Any crossing within radio range (up to 5 km) will pick up this beacon and initiate a data exchange session with the approaching locomotive. Crossings however do not respond to locomotives if the distance between them is greater than 2 km. Based on the location, travel direction, and speed of the locomotive, the crossing will be activated at the preset warning time and will remain activated until the train has cleared the crossing.

The island circuit detection in the HRI System is considered to be a “stay on” device whose main function is to keep the system active while the train is in the crossing. The island is bounded by two post-mounted sensors. Each sensor consists of a magnetometer and an ultrasonic sensor that are integrated together using proprietary processing algorithms. The magnetometer is a primary detection device, and is operating constantly. The ultrasonic sensor is a secondary detection device that is activated only after the magnetometer detects a vehicle at the crossing. The ultrasonic sensor is used to confirm the presence of a rail vehicle at the crossing. The auxiliary function of the island circuit is to activate the crossing if a roll-away stock is fully or partially blocking the crossing. The island detection circuit operates independently of the radio/GPS activation scheme, and is not considered to be a primary crossing activation device.

The system is based on a shared radio network model and supports multiple crossings and locomotives operating in an area. It utilizes a new 220 MHz frequency that is dedicated to ITS in the U.S. The HRI System permits the locomotive system to expect a crossing ahead and if it fails to communicate with the crossing on approach, it can issue the alarm to the crew indicating a non-responsive crossing ahead. In the event of a system failure, the locomotive's on-board system will provide alarm feedback to the train crew. There is a display for the crew in the locomotive (Figure 4-2). This display indicates health status of the on-board systems and the health status of the crossings within radio range. If there is a system error the crew will be notified via a display and audible warning. The train would then stop on the approach to the crossing and the crew would manually flag the crossing before entering. No current system deployed in the U.S. offers this feature except high-speed rail corridors.

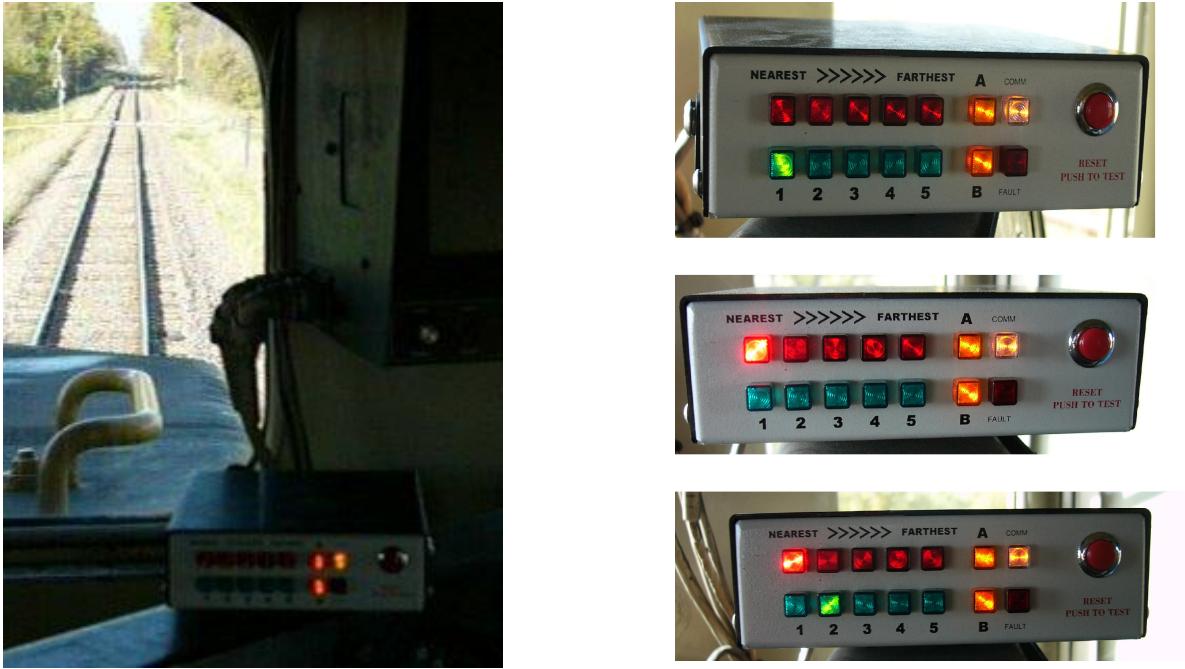
Figure 4-2. In Cab Crew Indicator Panel

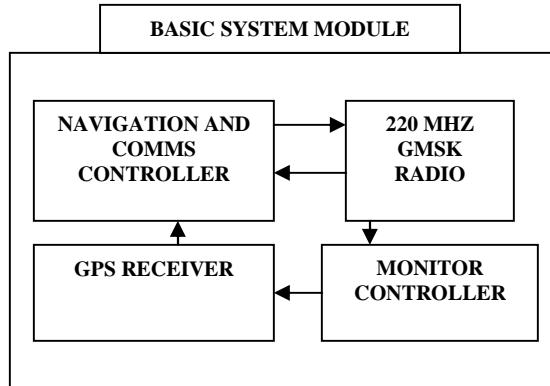
Figure 4-3. Basic Building Block Module

The following figures illustrate the system configuration used in the FOT. Figure 4-3 is the basic building block upon which all system devices are built. It contains the navigation and communications controller (nav/comm), which is a 16-bit microcomputer. It performs the distance and activation time calculations. The 220 MHz radio is a Gaussian minimum shift keying (GMSK) FM system controlled by the nav/comm, which sends and receives all communications between devices over the air. A GPS receiver is connected to the nav/comm to provide accurate position data and system timing information. A monitor controller oversees proper system operation and can shut the system down in the event of a malfunction.

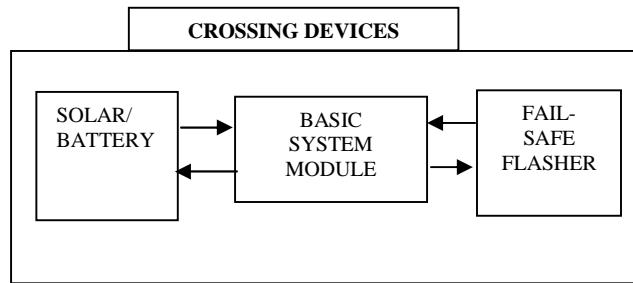
Figure 4-4. Crossing Devices (Master, Slave and 2 Advance Warning)

The crossing devices are shown in Figure 4-4. Crossing devices have island sensors connected via the monitor controller when installed as a crossing master or slave controller. Advance warning devices do not use island sensors. All crossing devices have a separate independent fail-safe flasher controller, which listens for status from the nav/comm and activates the flashing lights. Figure 4-5 illustrates typical crossing and advanced warning device installations.

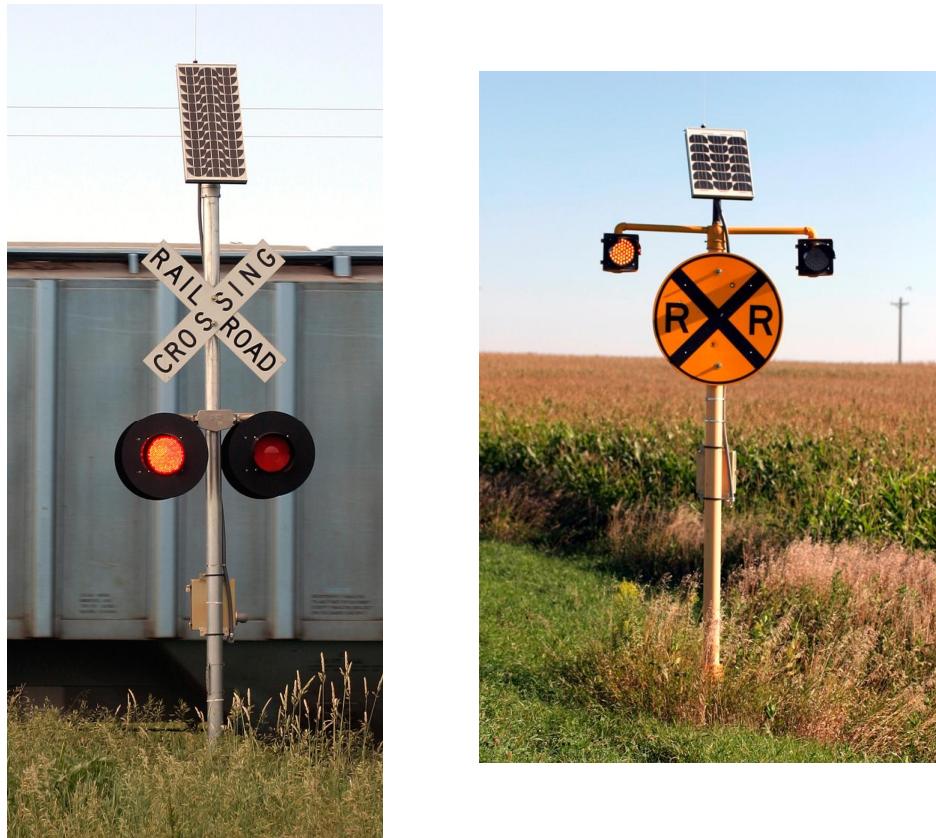
Figure 4-5. Typical Crossing and Advanced Warning Installations

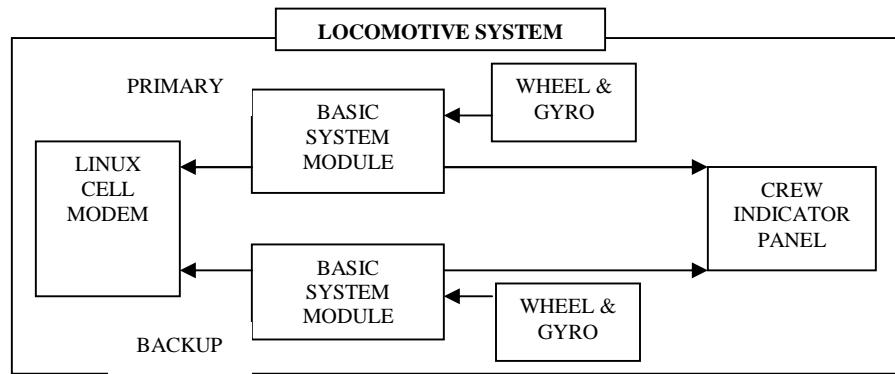
Figure 4-6. Locomotive System

The locomotive system consists of dual cross-linked systems that provide enhanced availability in case of radio failure, as shown in Figure 4-6. The basic building block module is similar to the crossing devices, except the GPS receiver supports dead reckoning for use when the GPS cannot communicate with satellites. The gyro and wheel inputs are used in the dead reckoning solution. Either system can drive the crew indicator panel and Linux data collection system. The Linux system also manages the cell modem for use in relaying data collected and fault reporting.

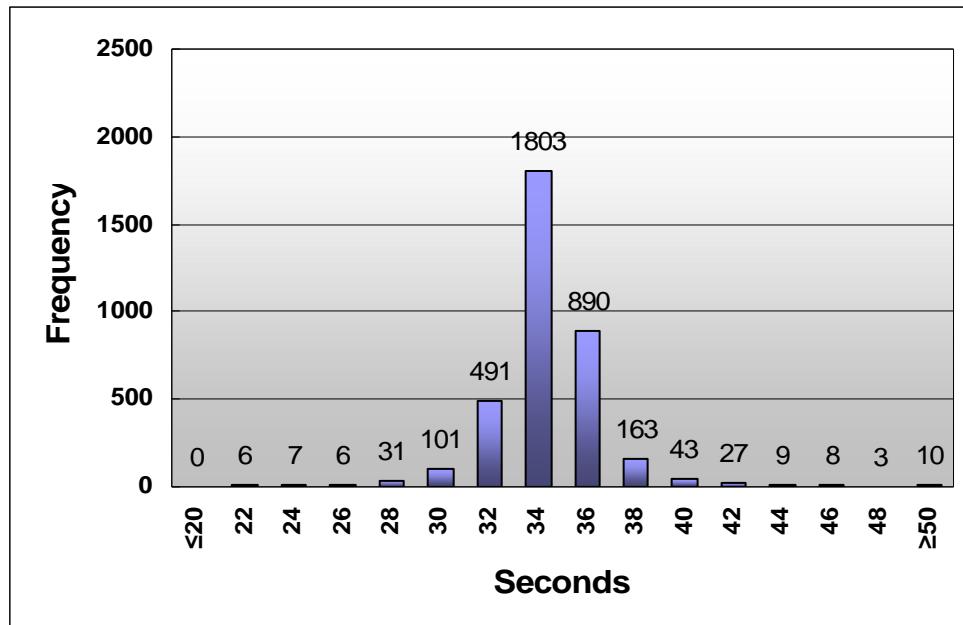
Figure 6-1. Activation Times Histogram

Figures 6-1 and 6-2 present the frequency distributions of the crossing activation times and the advanced warning activation times. The analysis indicated that 98.4% of the encounters had activation times between 20 and 40 seconds, and 98.5% of the encounters had advanced warning time between 40 and 60 seconds. It was found that the 240th Street and CSAH 6 crossings had a higher variety of warning times than other locations. These two locations are known to have numerous switching maneuvers taking place near the crossings. Detailed activation and advanced warning times for each crossing can be found in Appendix B: *Activation Times and Advanced Warning Times by Crossings*.

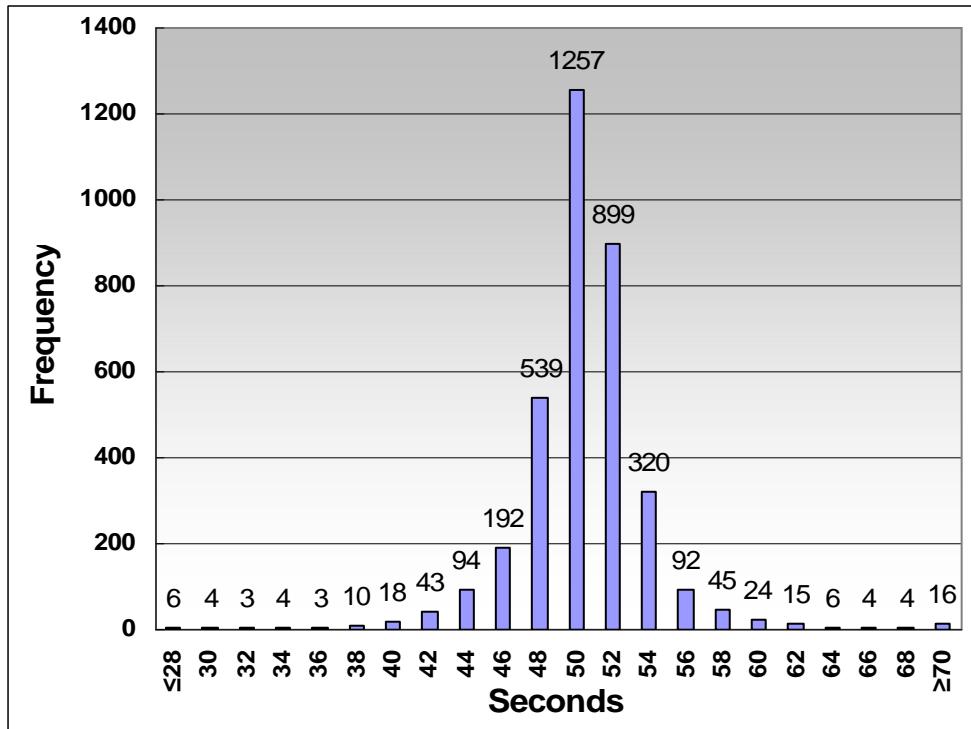
Figure 6-2. Advanced Warning Activation Times Histogram

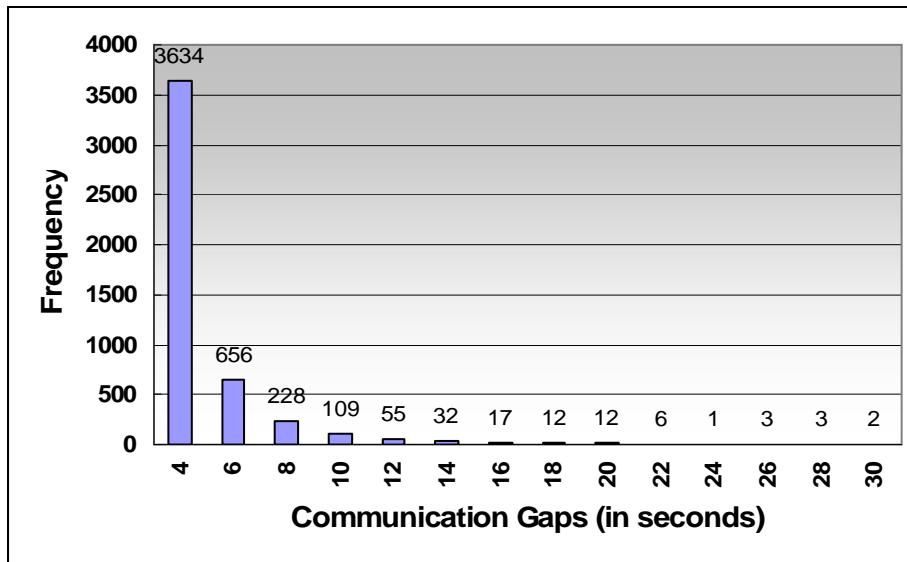
Figure 6-3. Communication Gaps and Frequency Distribution

Figure 6-3 illustrates the length of time gap with a corresponding frequency of occurrence. As illustrated, 90% of communication time lapse was less than 6 seconds.
