# LOW-VOLTAGE ARC SUSTAINABILITY

**Abstract** – Arc Flash in low voltage equipment (480 volts and below) is a safety issue that can impact work practices for electrical workers. When estimating incident energy for low voltage equipment, the duration of the arc is typically the driving factor. This paper summarizes previous testing results that establish arc sustainability for various equipment configurations, when trip devices do not operate. In some cases, arc duration is limited by the physical conditions of the enclosure and by the driving voltage and current available. Using the maximum duration for arc sustainability can provide more realistic estimated incident energies than using the two-second self-extraction time cited in IEEE 1584-2002. Consequently, required levels of personal protective equipment can be reduced while still providing adequate protection to the worker.

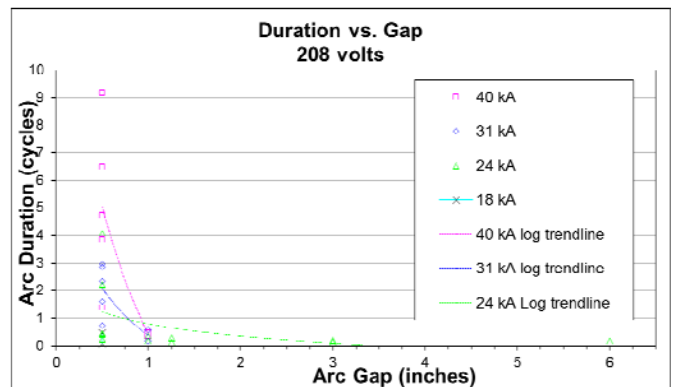
Fig. 2 Duration vs arc gap

A major utility performed a series of arc duration tests for the configuration shown in Figure 1. See Figure 2 for test results at 208 V [12]. At 208 V, arcs did not sustain for more than one half cycle above an arc gap of 0.5 in (1.3 cm) for this configuration. At a one-half-inch arc gap, faults cleared within 10 cycles. Because the bus bars are arranged so that the three phases are pointing at each other, it is a severe test. Arcs are more likely to self-sustain because the magnetic fields force the arcs towards the center of this arrangement. In parallel bus arrangements (as found in real equipment), the magnetic forces propel the arcs and hot gases away from the source, making it more likely that arcs will self-extinguish.

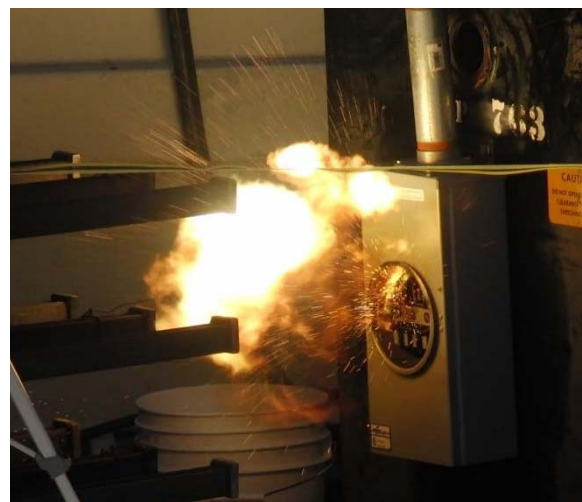
Fig. 3 Example fault on 120/208-V meter socket

Arc flash in self-contained meter sockets was tested with a 120/208-V supply. Faults were initiated in the self-contained meter base by jumpering between all three phases with a #12 copper wire (worst case initiation). See Figure 3 for an example test.

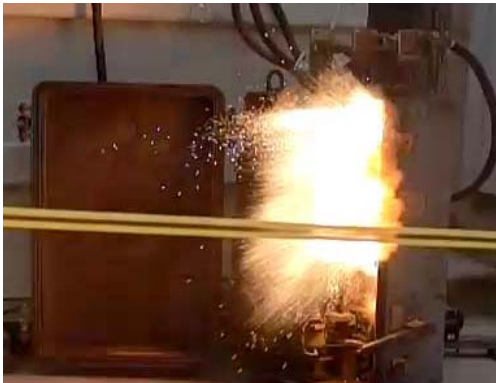
Fig. 4 Example fault on a 208-V network protector

Tests were performed on two different network protectors with a 120/208-V supply at two bolted fault currents, 30.7 kA and 40.4 kA [12]. Unit #1 was physically smaller and had been previously tested for smoldering faults. Consequently, Unit #1 had the internal components significantly covered by soot and represents worst case. Testing was conducted primarily to determine arc sustainability; however for Unit #2, incident energy measurements were also made. Figure 4 shows a typical event.

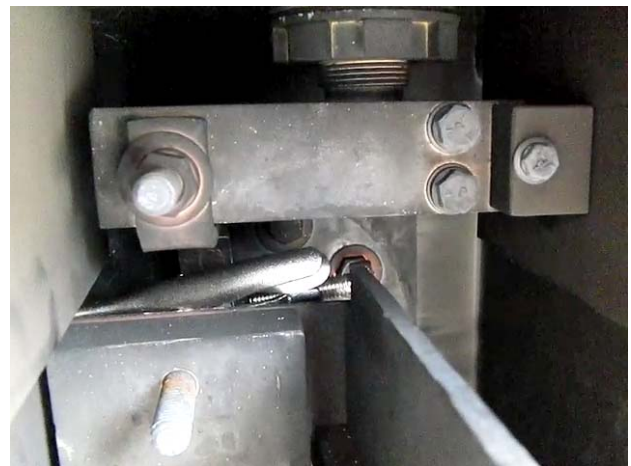
Fig. 5 Vice grip wedged AΦ – BΦ in back of the protector

Table 2 shows a summary of the 14 tests on the two network protectors. All measured incident energies were very low. The most extreme case had approximately 12 cycles of arcing current. Even though the incident energy was not measured on this particular event. It is estimated that this event would not have exceeded 4 cal/cm<sup>2</sup> by extrapolating similar events initiated in similar locations i.e. 3.79-cycle event. Additionally, this event was created by wedging a vice grip inside the back of the protector in such a way that the magnetic forces could not dislodge the tool. This initiation does not represent any possible real condition that workers could duplicate in the field. Figure 5 shows the vice grip for this event.

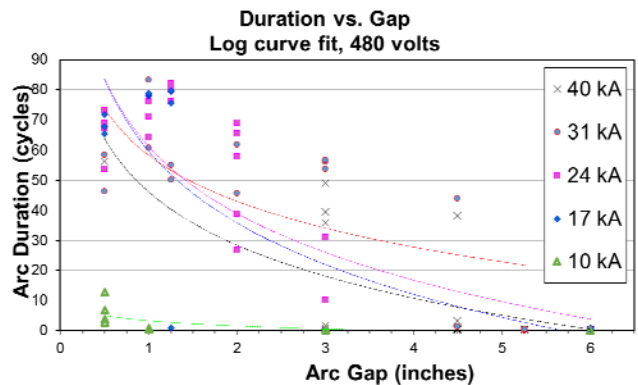
Fig. 6 Duration vs arc gap for staged tests

Arc duration tests were conducted similar to those reported in Section III but this time a 480-V source was used. See Figure 6 for test results at 480 V. At 480 V, arcs did not sustain when

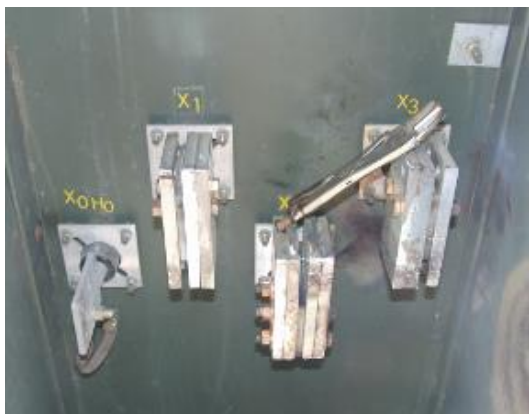
Fig. 7 Padmounted transformer secondary compartment

Padmounted transformer secondary compartments self-extinguished in two cycles or less with incident energies measured at much less than  $4 \text{ cal/cm}^2$ . This is primarily due to the electrode spacing being very large and the compartment being fairly large and open. Even artificially reducing the arc gap to under 2 in (5 cm) between phases failed to produce a sustainable arc. See Fig 7.

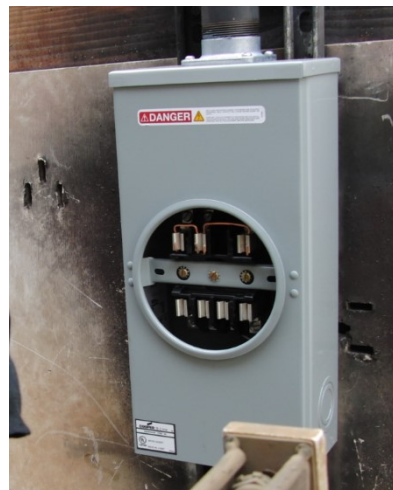
Fig. 8 Ringed self-contained meter socket

Ringed self-contained meter sockets, style 16S, were able to sustain arcs. See Fig. 8. The tight confinement of the enclosure, close electrode spacing, and three-phase arcing combined to allow the arc to sustain until the metal jaws were vaporized and incoming 1/0 conductors melted beyond the attachment point allowing them to swing away from each other. Higher currents were found to reach this point quicker than lower currents, making 12-kA bolted faults capable of delivering more incident energy than 44 kA ( $20 \text{ cal/cm}^2$  vs  $6 \text{ cal/cm}^2$  respectively). 12-kA faults took up to 60 cycles to self-extinguish while 44-kA faults took less than 10 cycles. Additionally, larger current more consistently deliver incident energy while currents 12 kA only delivered significant energy 50% of the time. Even lower currents of 6 kA delivered measurable incident energy 20% of the time.

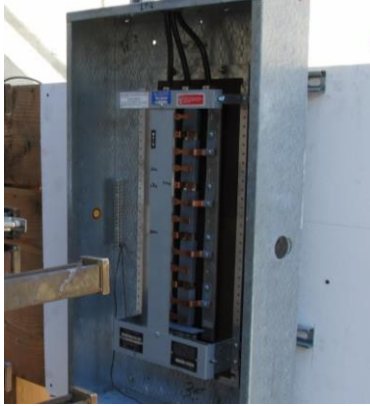
Fig. 11 Small panelboard, 50A-100A

Conversely, small panelboards with 50-A and 100-A ratings, as shown in Fig 11, had arcing faults that self-extinguished. Primarily, the arc ended when the mechanical forces to the bus bars pushed the bus bars apart. On these, the bracing is not sufficient to hold together the bus bars for longer-duration faults. These bus bars were not facing, another factor reducing the likelihood of sustained arcing. Average incident energy measurements were under  $8 \text{ cal/cm}^2$ .

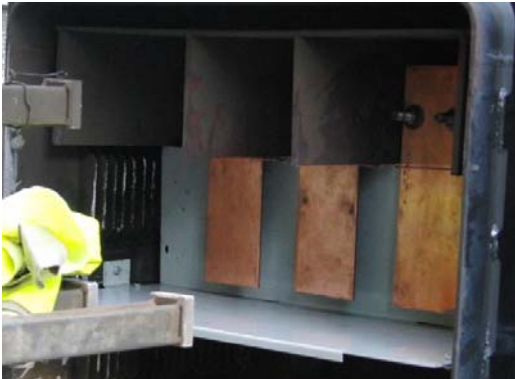
Fig. 12 Network protector testing-simulated back bus bar

Simulated arcing the back bus bar of a network protector was created by gutting a network protector and installing a conductive back plate one inch (2.5 cm) away. In addition a conductive bottom plate was installed to mimic the conditions of the bottom back of the network protector. See Fig 12.

Because the bus bars are flat rather than facing, arcs tend to separate. Arcing sustains because the back and bottom plates provide confinement and conductive arc paths. Equipment with these conditions can have arcs that will sustain for as long as it takes to vaporize the entire length of bus bar i.e. many seconds. Incident energies are best estimated with IEEE 1584 formulas and actual circuit clearing times or the two-second assumed self-extraction time of the worker, if appropriate. In the test case, measured heat flux rates exceeded 60 cal/cm<sup>2</sup>.

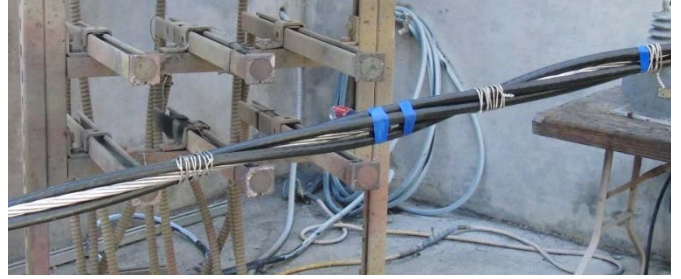
Fig. 13 Overhead quadraplex cable

Outdoor overhead secondary quadraplex cable was tested. See Fig. 13. Although these have tight spacing, there is no arc confinement. In addition, faults were started either as phase to neutral or phase to phase. In both cases, there is just a single arc with no propagation to adjacent phases. Arcs generally self-extinguish on the first zero crossing and have minimal measured incident energy.

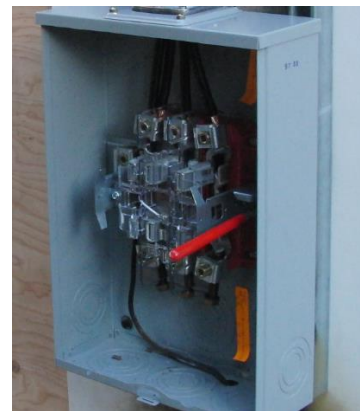
Fig. 14 Ring-less meter socket with cover removed

Meter sockets and CT cabinets were tested of different types and configurations. Results were highly variant. Ring-less meter sockets, see Fig. 14, were not able to sustain arcing as long as the ringed meter sockets. The ring-less design has less confinement, but even with fairly tight electrode spacing, arcs self-extinguished fairly quickly with generally low incident energies when arcs were initiated inside the meter socket. Arc initiated at the incoming terminations or on the load side terminations with the meter bypass switch engaged did last longer and have incident energies measured as high as 14 cal/cm<sup>2</sup>. The other main difference between ringed meter sockets and ring-less meter sockets is focusing of the incident energy. The enclosure geometry is the main reason for the peak incident energy to be higher for the ringed design. With the cover off on the ring-less design, the arc energy is much less directed. In addition, the ring-less design is a larger enclosure and since the cover will be off, the fireball expands in many directions. Fig. A-1 in Appendix A shows the pattern of incident energy between these two types of meters.

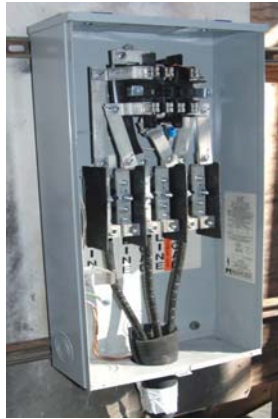
Fig. 15 200-A meter socket with bottom entry and exit

Because there is wide variability in the design of meter socket enclosures, additional testing was performed with meters that had more internal bus bar. Meter sockets that have bypass switches or meter sockets with bottom entry and exit are much more likely to have this additional internal bus bar. Fig. 15 and Fig. 16 shows two additional single meter base enclosures that were tested. While the meter socket in Fig. 15 had a maximum measured incident energy less than 8 cal/cm<sup>2</sup>, the meter socket shown in Fig. 16 experienced one test that continued to re-ignite many times until finally the lab circuit protection de-energized the test specimen at two seconds. In this event, peak incident energy was measured 87 cal/cm<sup>2</sup>. Fig A2 in Appendix A compares the damage post arc-event between these two test specimens.

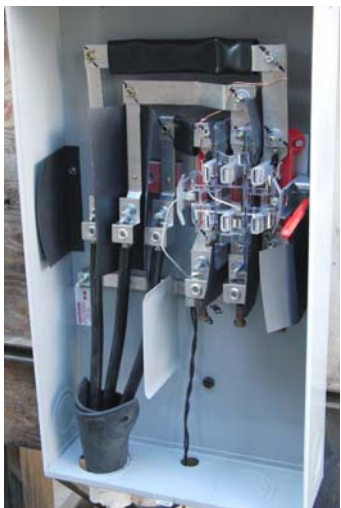
Fig. 16 320-A meter socket with bypass switch

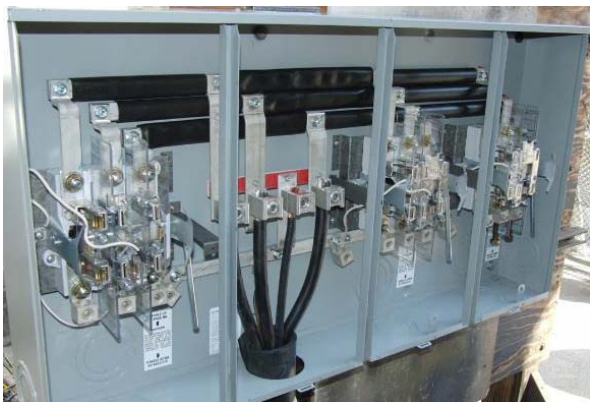
Fig. 17 Multi-bank meter sockets

Multi-bank meter sockets have much more robust electrodes than the single-meter sockets above. With the robust electrodes, tight spacing, and enclosure confinement, and close proximity to the conductive back plate, faults can arc for long durations. See Fig. 17. Tests on these indicate that arcs will not self-extinguish. Incident energies will be dependent on circuit protective devices or worker self-extraction. Post-test photos can be seen in Fig. A-3 in Appendix A.

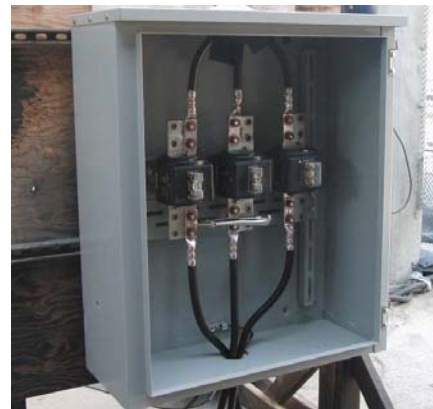
Fig. 18 CT enclosure

A CT cabinet was also tested. See Fig. 18. As with meter socket enclosures, CT enclosures can be widely variant in internal configuration. However, limited resources were available for this destructive testing. For the CT enclosure configuration shown, testing with initiating points reasonable replicable by field personnel self-extinguished quickly (under five cycles). However, CT cabinets with tighter spacings, smaller cabinets, and/or larger cable or bus bar could reproduce arcs that would not self-extinguish.

Table 3 does not cover all low-voltage equipment presented. For example, CT cabinets are not listed because only one sample configuration was tested. The CT cabinet in Fig. 18 is in the low-sustainability category, but CT cabinets with tighter electrode or box spacings may be high sustainability. When considering arc sustainability, the electrode size, electrode spacings, and the box spacings are critical parameters. The spacings at the ends of electrodes are particularly important. If these create a barrier effect, arcs are more likely to sustain.

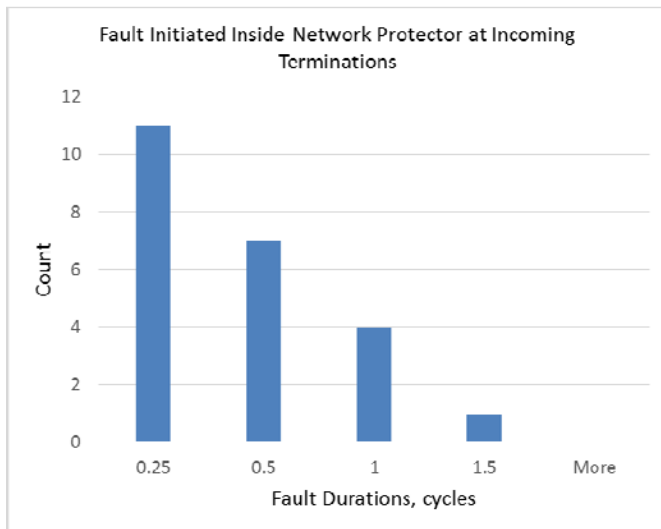
Fig. 20 Network protector- inside arc durations

Keeping in mind the requirements for sustained arcing identified in the previous section, arc initiations near the top of the NP have robust electrodes and tight spacing that would permit arc sustainability. However, there is large gaps to sides of the equipment, flat electrodes not facing each other, and not enough confinement to keep the ionized gases dense enough to allow arc re-ignition at this location inside the NP.

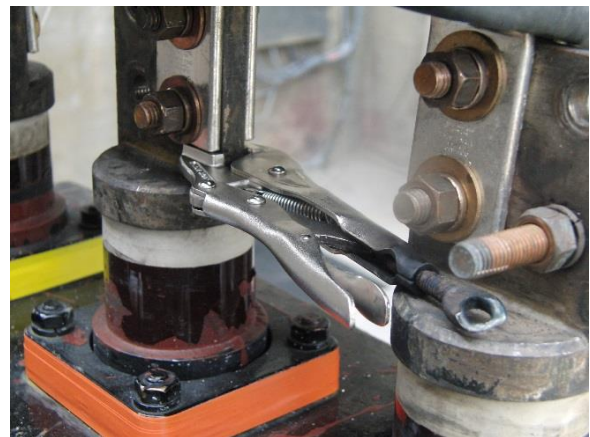
Fig. 22 NP Tool placed phase to phase- 2.65 cycles

To simulate removal of a termination from the top of an NP further tests were performed. Simulations for tool contact between the phase and the case or adjacent phases along with loose terminations coming into contact with adjacent phases. See Fig. 22 and Fig. 23. In all cases the arc self-extinguished in under four cycles with almost negligible measured incident energy.

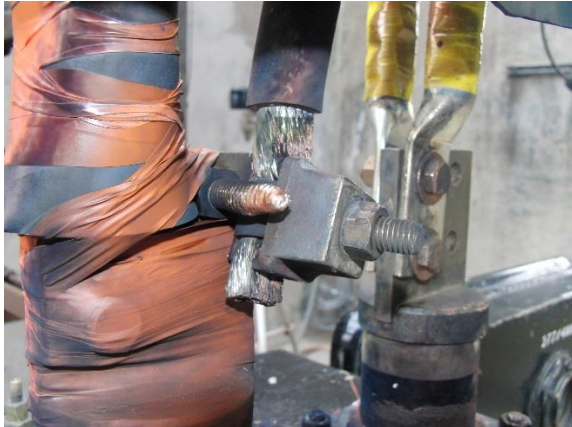
Fig. 23 Loose termination phase to phase- 1.09 cycles

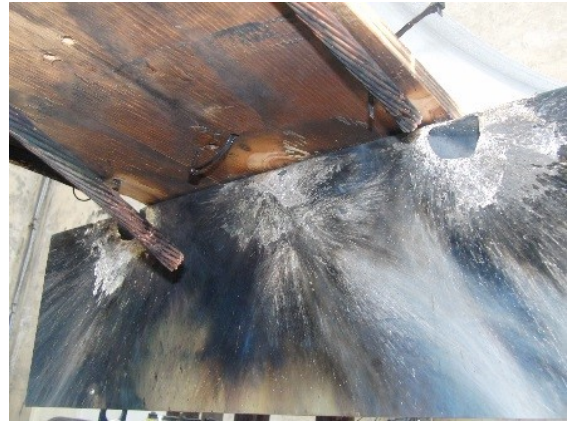
Fig. 26 Simulated ceiling bus bar- 1.92 cycles

Ceiling mounted bus bar, was simulated by attaching bare conductors to the bottom of a non-conductive surface (in this case wood), supporting them as rigidly as possible and ending them at a barrier. Arcs were initiated at the barrier end (which would be worst case, and changing the barrier from conductive to non-conductive material. See Fig. 26. In these cases, all the arcs self-extinguished in under two cycles.

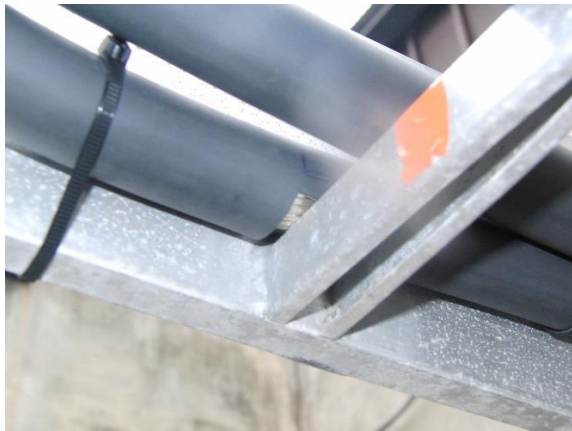
Fig. 24 Phase to ground in cable tray- 3.52 cycles

Additional tests were done to simulate arc in the areas around the common bus, both in cable trays and in simulated ceiling mounted bus bar. The insulation was removed in windows on the conductors and the expose conductors were tie-wrapped to force contact with the grounded tray or with adjacent exposed conductors. This physical constraint represents severe conditions. In real world scenarios, the cable would be free to move and the arc would not last as long. See Fig. 24 and Fig. 25. For the cable tray, all the arcs self-extinguished again in under four cycles.

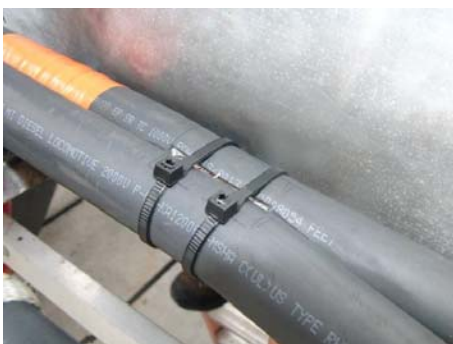
Fig. 25 Phase to phase in cable tray- 1.54 cycles

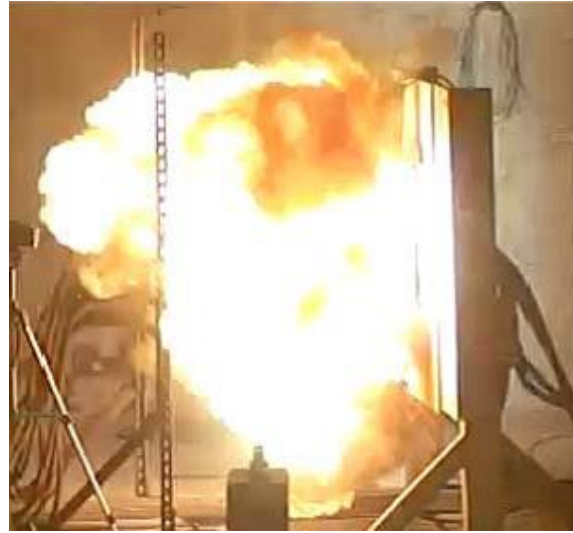
Ringed Meter Socket

Ring-less Meter Socket

Fig. A-1 Comparison of Energy Pattern Between Ringed and Ring-less Meter Sockets

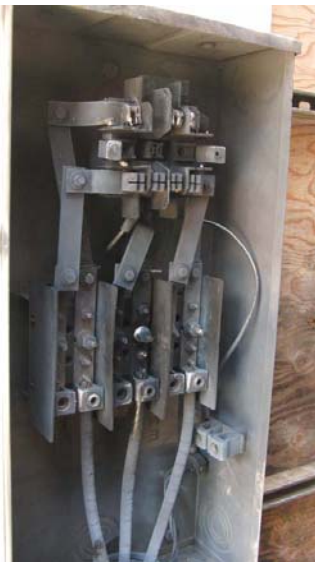
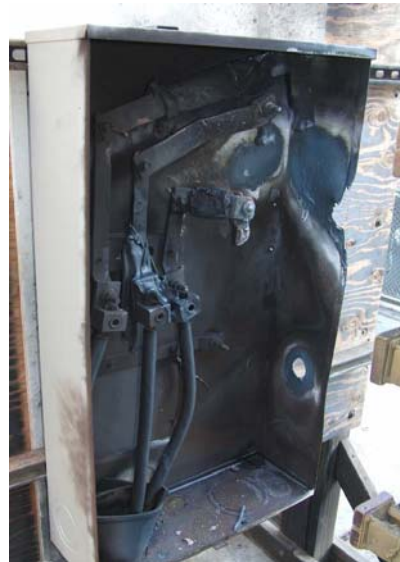
Test Specimen from Fig 15 Post-Test

Test Specimen from Fig. 16 Post-Test

Fig. A-2 Post-Test Damage of Meter Sockets Shown Fig. 15 and Fig. 16

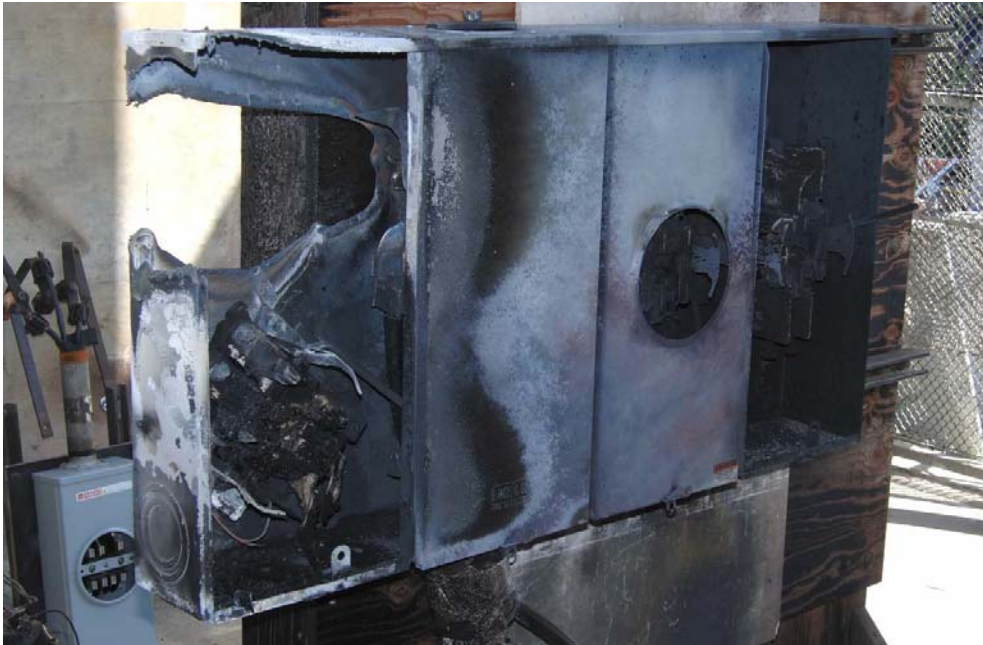
Multi-Meter Sockets Post-Test

Multi-Meter Sockets Post-Test (Covers Removed)

Fig. A-3 Multi-Meter Socket Panel Post Test with and without covers

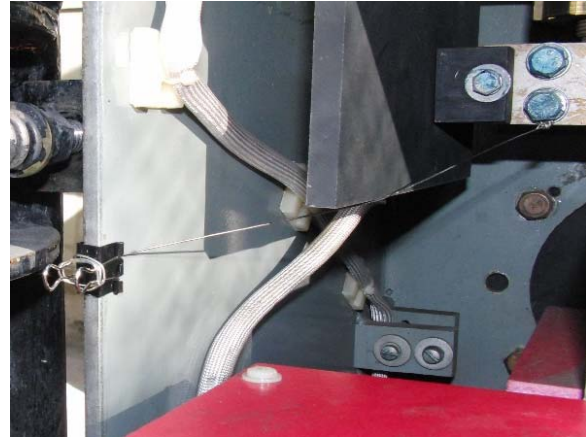
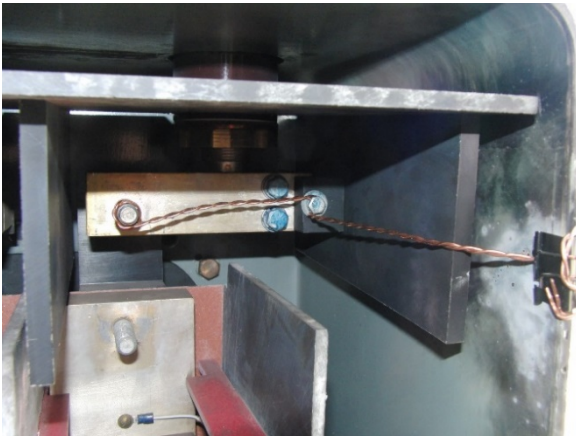
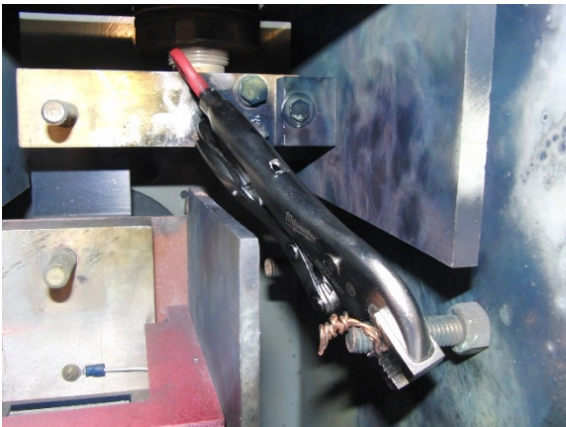
Test 13: AΦ to Case - 20 AWG - 0.14 cycles

Test 33: CΦ to Case - 20 AWG - 0.17 cycles

Test 15: AΦ to Case - 2-#14 - 0.35 cycles

Test 16: AΦ to Front Bolt - #14 - 0.41 cycles

Test ID 18: AΦ to Front Bolt- Vise Grip - 1.5 cycles

Test ID 23: AΦ to Back Bolt- 2-14 AWG - 0.55 cycles

Fig. A-4 Six Example Network Protector Arc Initiation Points

Extensive testing at the internal fuse terminations shown in Fig. 19 discovered that arcs will self-extinguish in under two cycles [14]. The majority of events self-extinguished in under one cycle, see Fig. 20. Testing was done with two 250kVA transformers in parallel feeding the tested NP which resulted in over 5 kA of available bolted fault current. Specific examples of initiation points is shown in Appendix A.
