MAINTAINING ASSET INTEGRITY IN THE OIL AND GAS INDUSTRY – UPSTREAM

Belzona Protective Coatings and Repair Composites

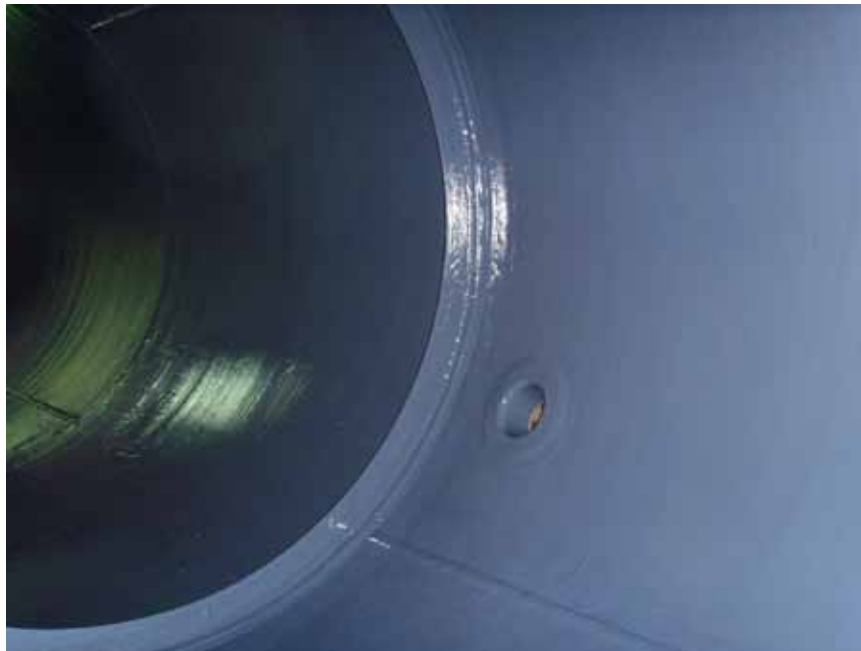
Belzona lining applied to a newly fabricated separator

Belzona liquid applied vessel linings were first specified in 1987 for separator corrosion repair and protection at a UK North Sea platform. Outstanding erosion resistance prevented wear during the sand jetting system operation and has prompted the use of Belzona linings on hundreds of other vessels. We now offer a complete solution for pressure vessels handling liquid hydrocarbons, gas and process chemicals including separators, slug catchers, knock-out drums and many more. Based on the experience of corrosion repair and prevention, spanning two decades, in the early 2000s asset owners and operators began to specify Belzona linings at the design stage to protect newbuild vessels.

Our linings can be spray or hand applied and, once cured in service, form a barrier between the substrate and corrosive media, enabling the operator to implement a corrosion management plan. As well as resisting erosion-corrosion, Belzona linings are designed to withstand vast pressure and temperature fluctuations, including steam-out and explosive decompression.

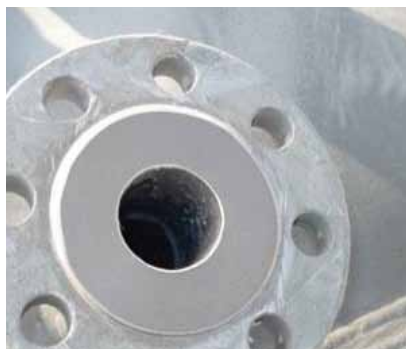
Cold forming isolates flange faces from corrosive media

Crevice and galvanic corrosion can be prevented or repaired with a unique Belzona composite forming technology. Prefabricated formers are used to shape the specified Belzona material that bonds strongly to the flange face. The sealing face is then effectively isolated from corrosive media whilst maintaining its shape and profile.

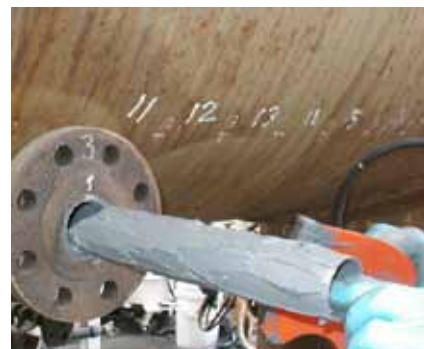
Prefabricated Belzona insert bonded into small bore nozzle

Narrow nozzles no longer need to be considered "the Achilles' heel" of process vessels. Tailor made Belzona inserts can be bonded into the nozzle using a fluid grade material, eliminating the risk of pinholes or holidays. Excellent chemical and erosion resistance ensures long-term protection of the nozzle, thus extending maintenance-free periods.

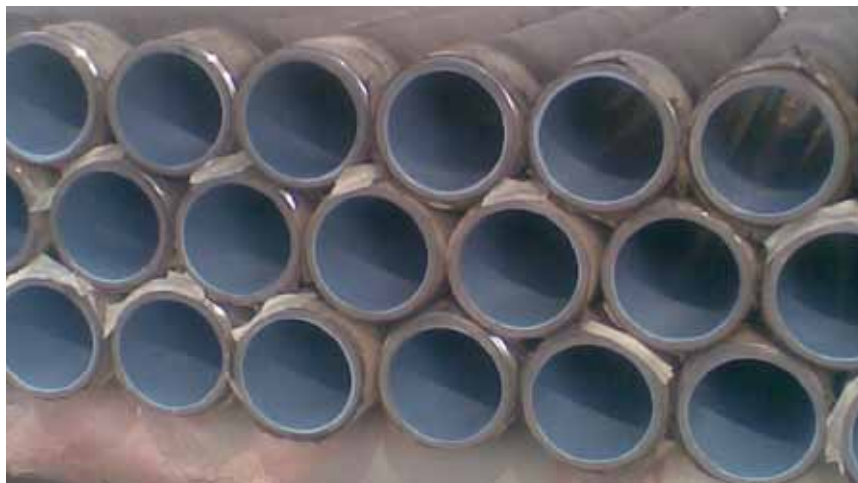
Internal pipe lining

Sand entrainment and high flow rates coupled with large quantities of CO₂, H₂S and brine can lead to pipe corrosion rates of several hundred mils per year. In 2012, Belzona pioneered a spray-friendly pipe lining system that offers erosion-corrosion protection. The substitution of hard-ceramic fillers for a thermoplastic filler blend ensures there is very little wear to the spray equipment.

Sprayable erosion-corrosion protective linings allow for the material to be spin spray applied in situ at wet film thickness up to 2000 microns without sagging, effectively covering girth welds and joints in a single coat. The thermoplastic filler blend is formulated to achieve excellent impact and sliding abrasion resistance, a high degree of toughness and chemical resistance.

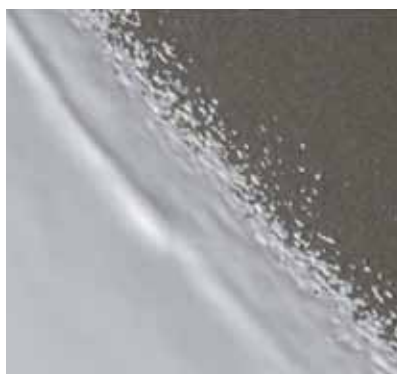
Girth weld covered in a single coat

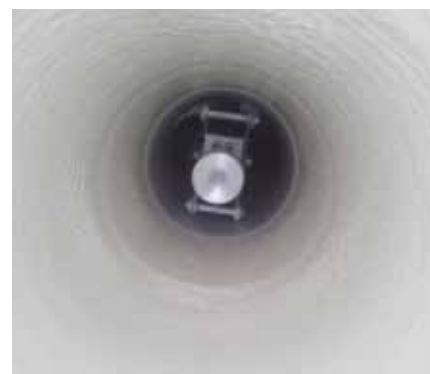
Spin spray application

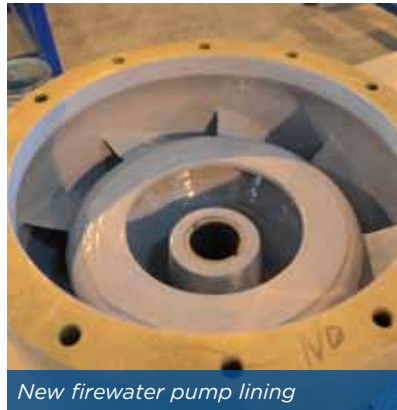
New firewater pump lining

Due to over 30 years' experience in repairing and restoring upstream pumps, Belzona linings are now specified to protect new pumps, thus significantly extending the lifetime of the assets and subsequent maintenance-free periods. Belzona linings have become a first choice in protecting firewater pumps in particular, offering long-term corrosion protection and seizure prevention.

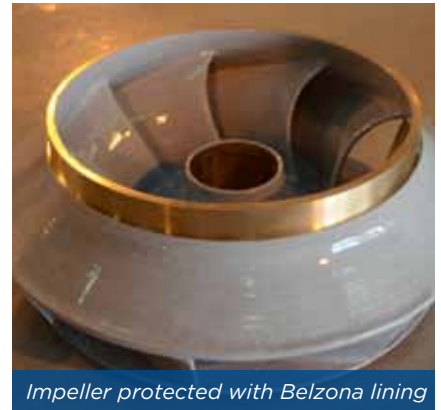
Impeller protected with Belzona lining

Pump deterioration leads to decreased pumping efficiency and eventually costly part replacement. Pitting, worn wear ring clearances as well as casing thin and through wall defects can be rebuilt using composites specifically designed for pumping applications. Pumping efficiency is restored and enhanced with the use of a hydrophobic smooth lining, which also protects from erosion-corrosion and cavitation. Once the pump has been protected with Belzona, it can remain maintenance-free for many years.

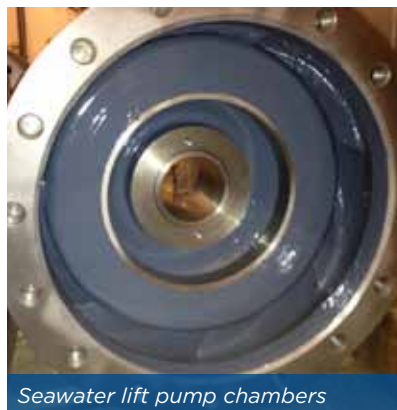
Seawater lift pump chambers

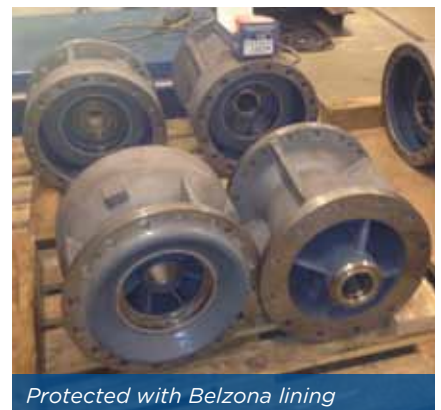
Protected with Belzona lining

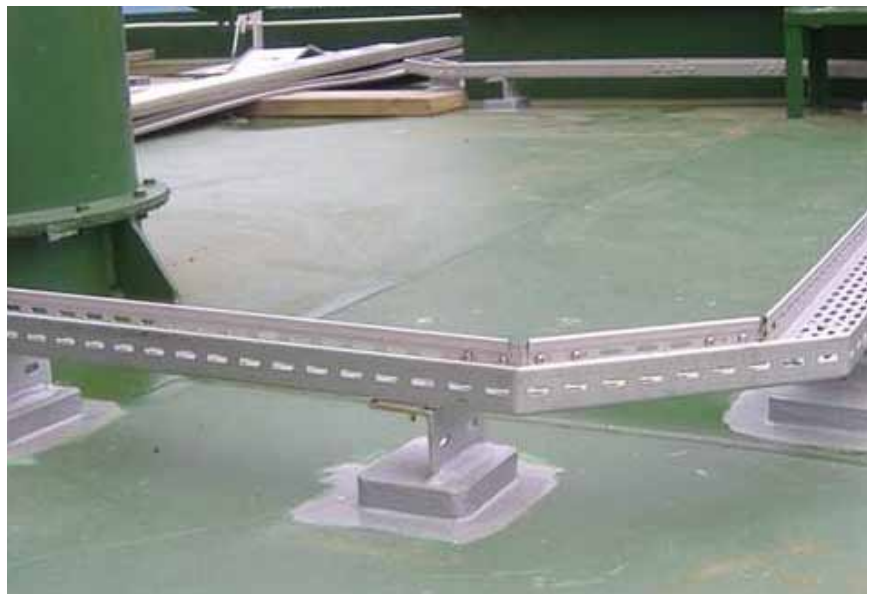
Cable tray bonded on FPSO

Cold bonding deck equipment eliminates the need for hot work and facilitates rapid installation. With tensile shear adhesion of up to 2,960 psi (20.4MPa), pull off adhesion of up to 3,240 psi (22.3MPa) and flexural strength of up to 14,300 psi (98.6MPa) deck equipment, framework and supports can be bonded permanently and safely. Belzona cold bonding is equally effective at a fabrication stage, during turnarounds or whilst the platform is in operation. Belzona cold bonding materials are also recommended to fill gaps arising in tack welded elements, such as pipe saddles supports.

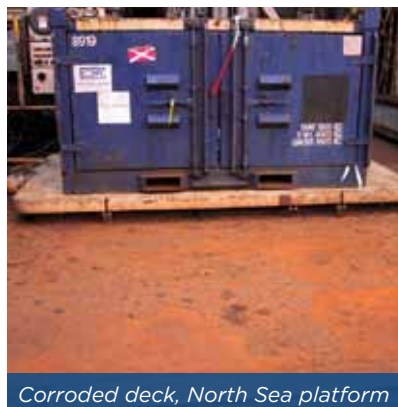
Corroded deck, North Sea platform

Corroded equipment and structures can be repaired in situ with Belzona's pioneering injection bonding technology. This technique has been successfully utilised for deck renovation and other structural integrity repairs. Over a decade of successful applications, which are still in service today, attest to this method's effectiveness and have prompted engineering houses to specify injection bonding for greenfield applications.

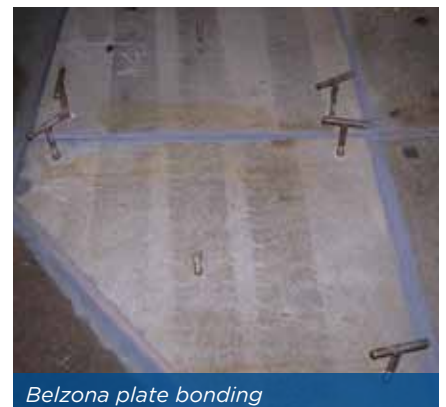
Belzona plate bonding

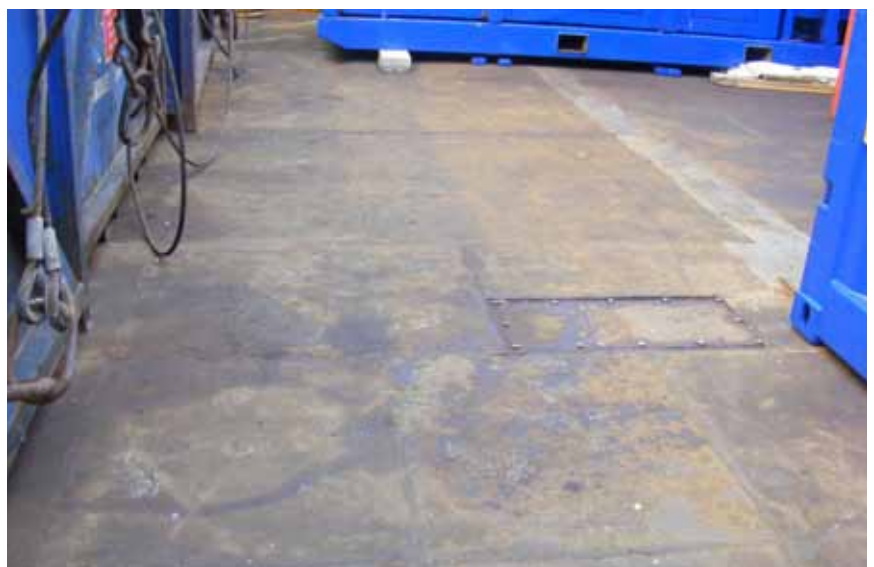
8 years later, Belzona plate bonding solution in excellent condition

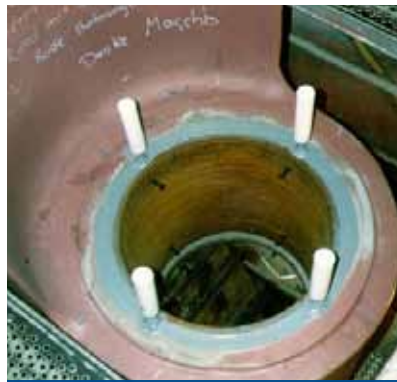
Rudder bearing bonding – top view

Bearing bonding is carried out by injecting the Belzona material between the bearing and the housing. The Belzona shim takes up any ovality or housing wear, thus creating a durable barrier with 100% surface contact, electrically isolating the bearing. This method has been applied to multiple situations including riser bearings and bushes amongst others.

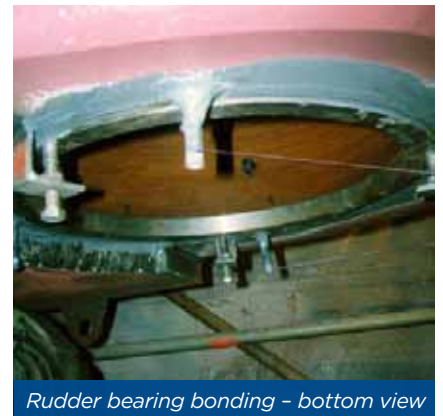
Rudder bearing bonding – bottom view

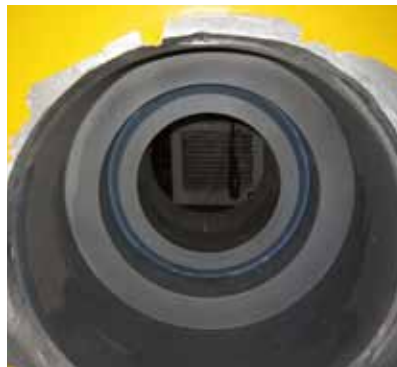
Bush installation, North Sea

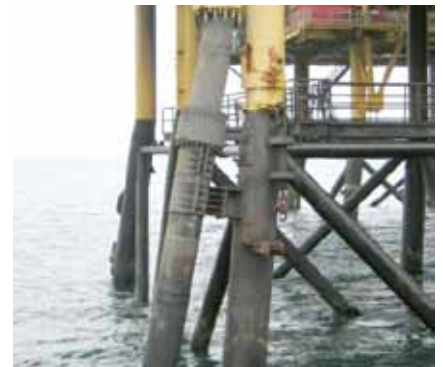
Riser bearing bonding

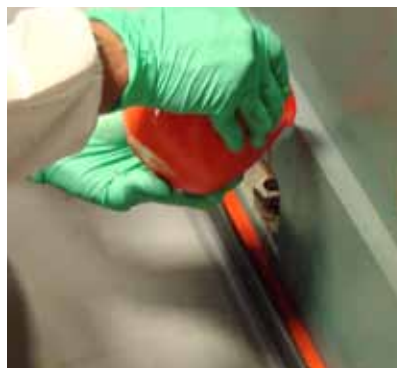
Pourable shimming in action

Following over five decades of bonding and shimming applications, in 2014 Belzona developed a novel pourable chocking compound. The system is ideal for pouring foundations for heavy equipment and to maintain precise alignment under machinery ensuring effective bearing underneath.

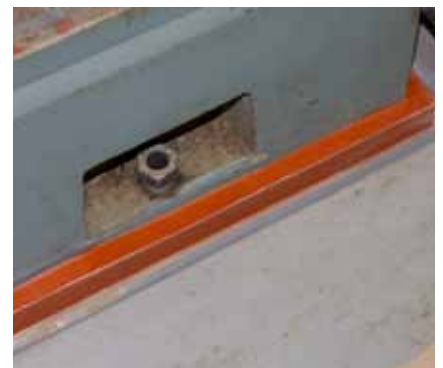
Bespoke chocking solution

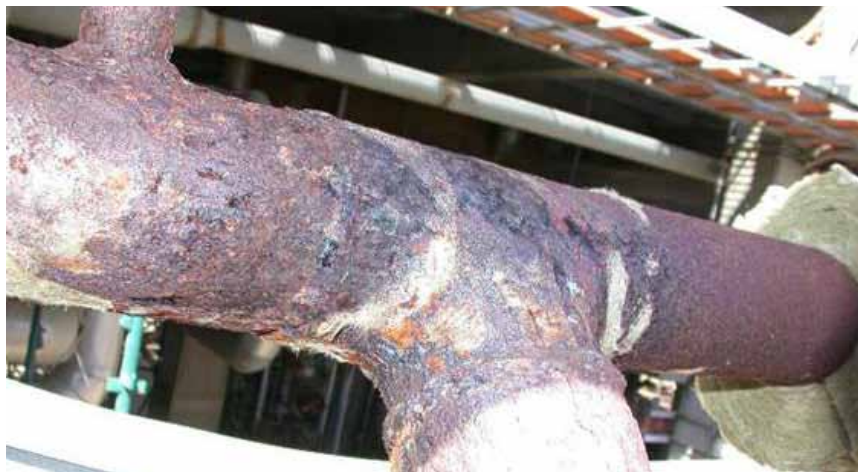
Corrosion under insulation

Corrosion under insulation occurs at an accelerated rate and can remain undetected for some time. Taking affected parts of the pipework out of service for repairs or replacement can in turn lead to high costs and lengthy downtime. To address this problem, in the late 1990s, Belzona formulated heat activated composites and coatings that facilitate on-line repairs. These materials adhere exceptionally well to hot contaminated surfaces and penetrate deep into the substrate eliminating the need for an angular blast profile prior to application.

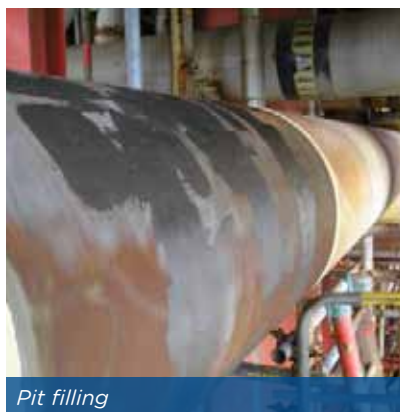
Pit filling

Simple manual surface preparation and on-line brush application have inspired the use of Belzona heat activated materials to combat CUI globally, from the Gulf of Mexico to the North Sea. Typical applications in the range of -10°C to 150°C (50°F - 302°F) will resist salt spray and commonly found inorganic acids and alkalis at concentrations up to 20%.

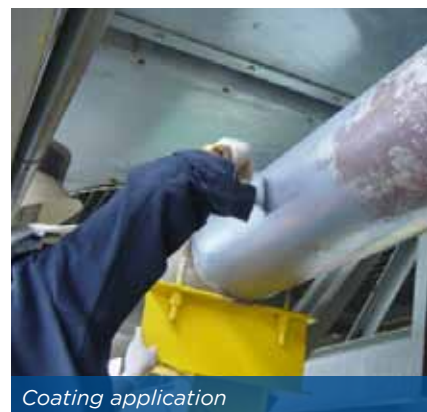
Coating application

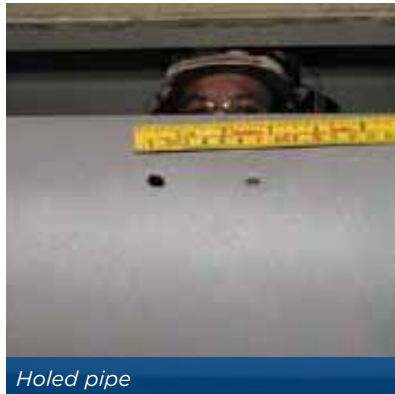
Holed pipe

Thin and through wall defects caused by external and internal corrosion can be repaired using composite wrap systems. A wrap system is composed of a reinforcement sheet and a Belzona material, tailored to the asset's performance criteria, such as presence of contaminants, operating temperatures and pressures amongst others. A wrap system can also be applied in conjunction with a bonded plate where additional reinforcement is required.

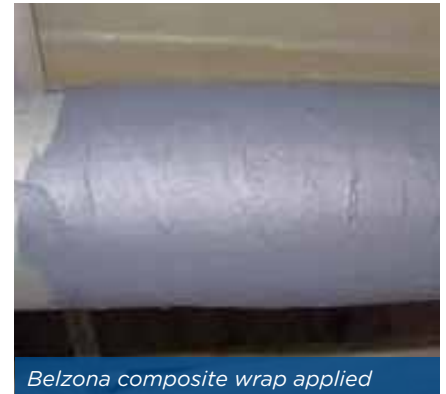
Belzona composite wrap applied

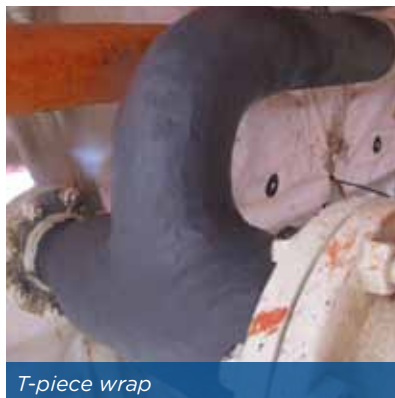
T-piece wrap

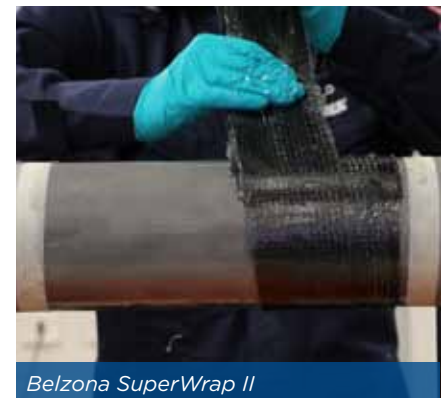
Belzona SuperWrap II

Following almost five decades of pipe wrap installations, in 2007 we added Belzona SuperWrap to the range, which is compliant with ASME PCC2 Article 4.1 and ISO/TS 24817. Every Belzona SuperWrap system is individually designed and applied by validated specialists. Repairs can be carried out to a variety of defects to restore pressurised pipeline and pipework integrity. In 2014, Belzona SuperWrap II was released, which exhibits greater strength and allows for a much more efficient application procedure, therefore reducing overall costs and downtime.

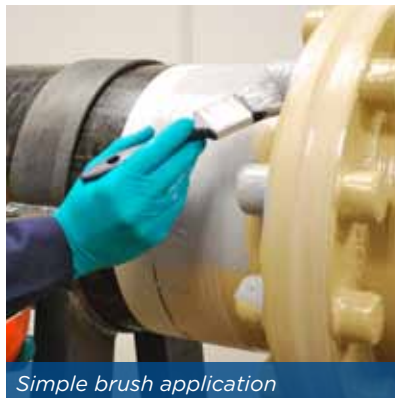
Simple brush application

Repairing flange crevice corrosion can be a very costly exercise, whereas common preventative measures in most cases are not 'inspection friendly'. The Belzona encapsulating membrane system introduced in 2014 seals bolted flange connections preventing corrosion. The liquid applied system includes a corrosion inhibitor and was designed to allow for periodic inspection, where flexible protection can be cut, peeled back and then easily resealed. To maintain Health and Safety standards, the system is hand applied, cures at ambient temperatures and can resist common corrosive media.

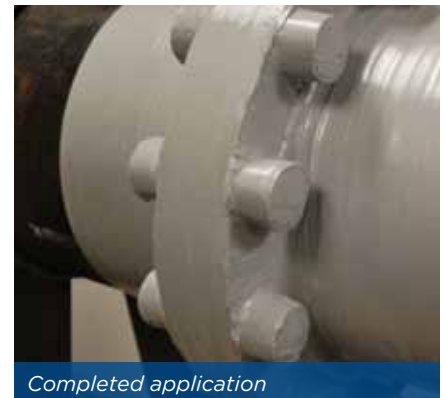
Completed application

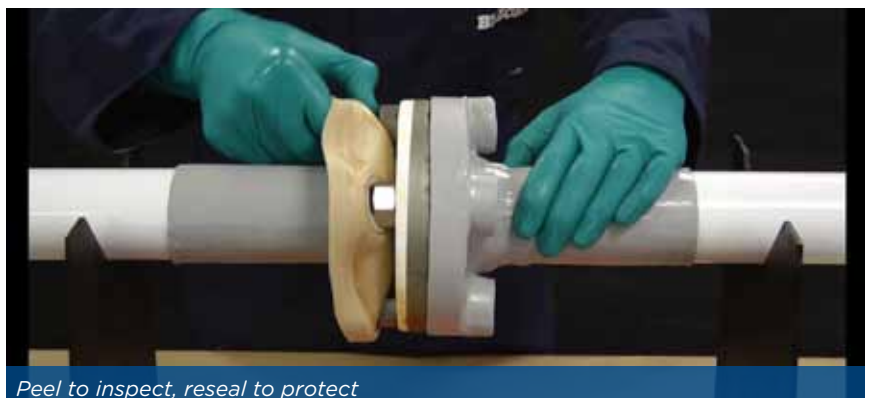
Peel to inspect, reseal to protect

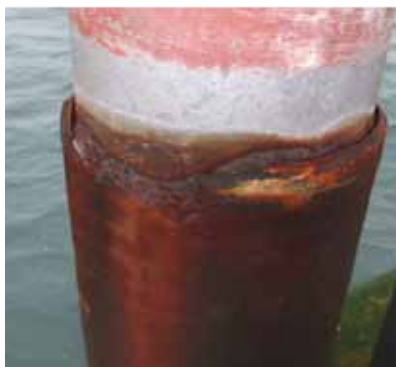
Corroded riser

Rubber cladding does not offer permanent protection and tends to deteriorate after a few years in service, with sea water corroding the steel underneath the cladding. Belzona offers a complete system, which restores corroded metal and repairs cladding in situ, sealing the neoprene boot topping of the riser, thus preventing further water permeation. Due to proven longevity of cladding edge sealing, marine engineers specify Belzona flexible solution on new risers to prevent water ingress between the cladding and the metal.

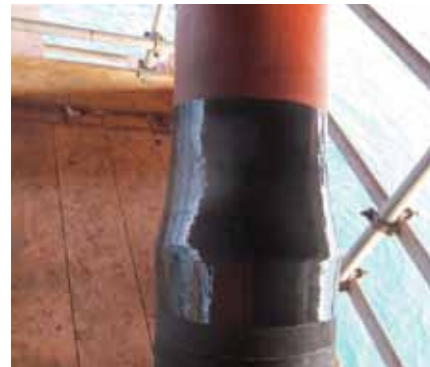
Corrosion repaired and cladding sealed

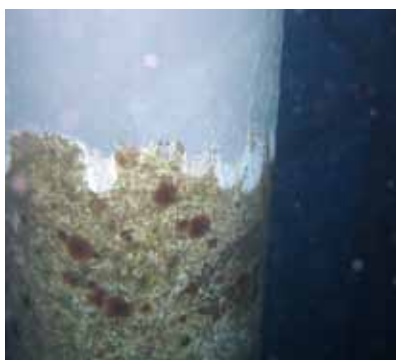
Corroded platform leg

Sea water movement with abrasive residues is capable of wearing away sacrificial protection and causing severe damage to the platform legs, particularly around the water line. Belzona surface-tolerant materials can be used to rapidly repair and prevent platform leg corrosion. Liquid-applied in situ and long lasting, the system forms a durable barrier between the substrate and the sea water.

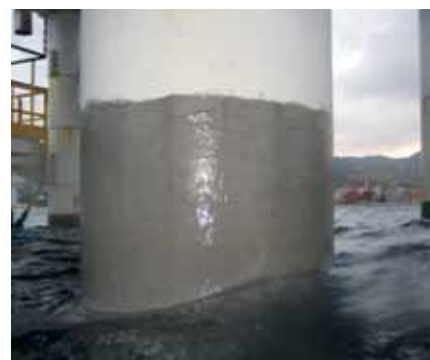
Coating applied

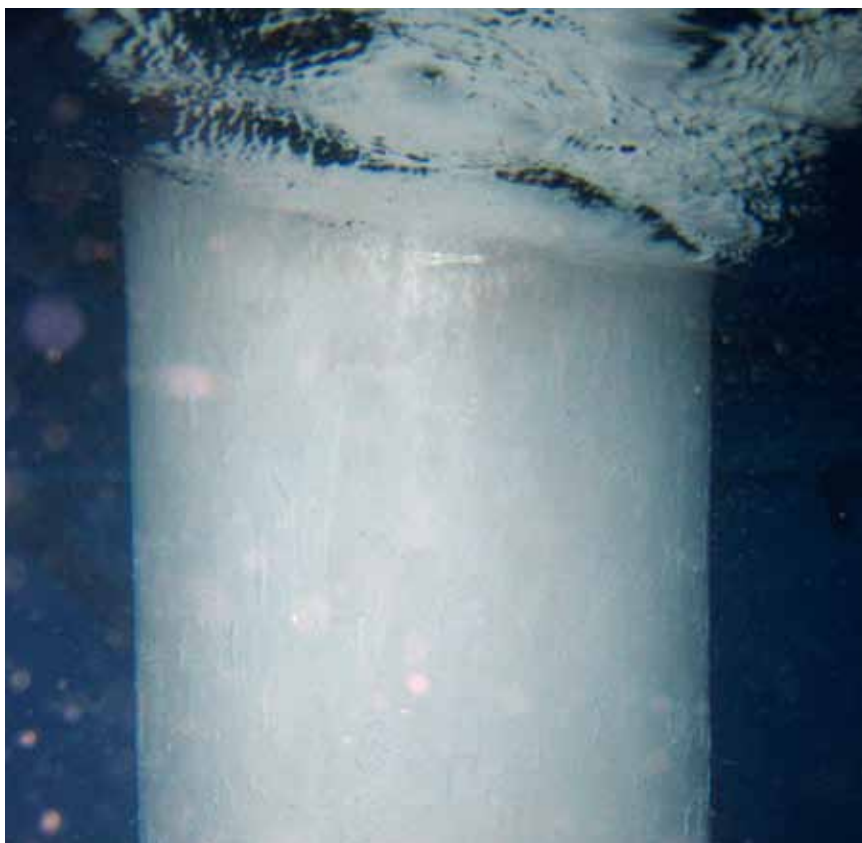
Inspected five years later

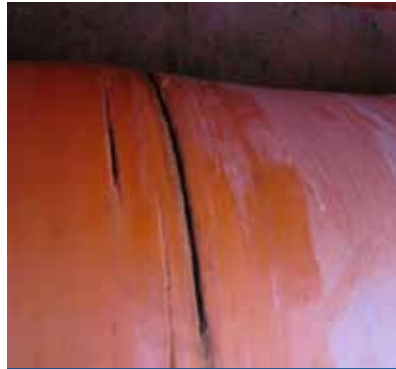
Hose damaged in transport

Hoses can be damaged in service or in transit and require a fast and durable repair solution. Belzona Elastomers adhere strongly to any type of hose and provide outstanding abrasion and impact resistance once the hose is put back in service. Belzona Elastomers are endorsed by reputable floating hose manufacturers as their recommended repair material. Corroded flange faces and internal surfaces can also be repaired and protected with the use of Belzona lining and flange face forming technology.

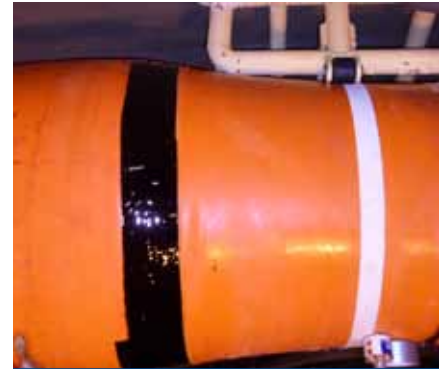
Belzona flexible repair

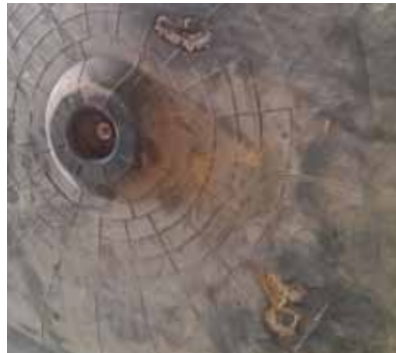
Deteriorated fender

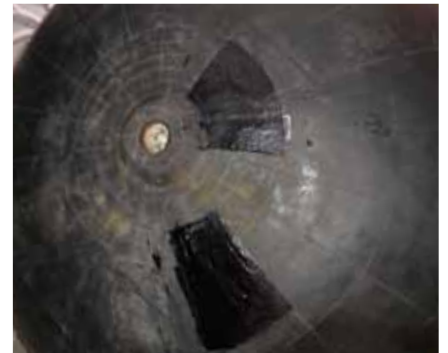
Fender repaired
