**MAINTENANCE OPERATIONS DEGRADATION OF
AIRFIELD PAVEMENT MARKINGS**

AIR FORCE INSTITUTE OF TECHNOLOGY

THESIS

March 2012

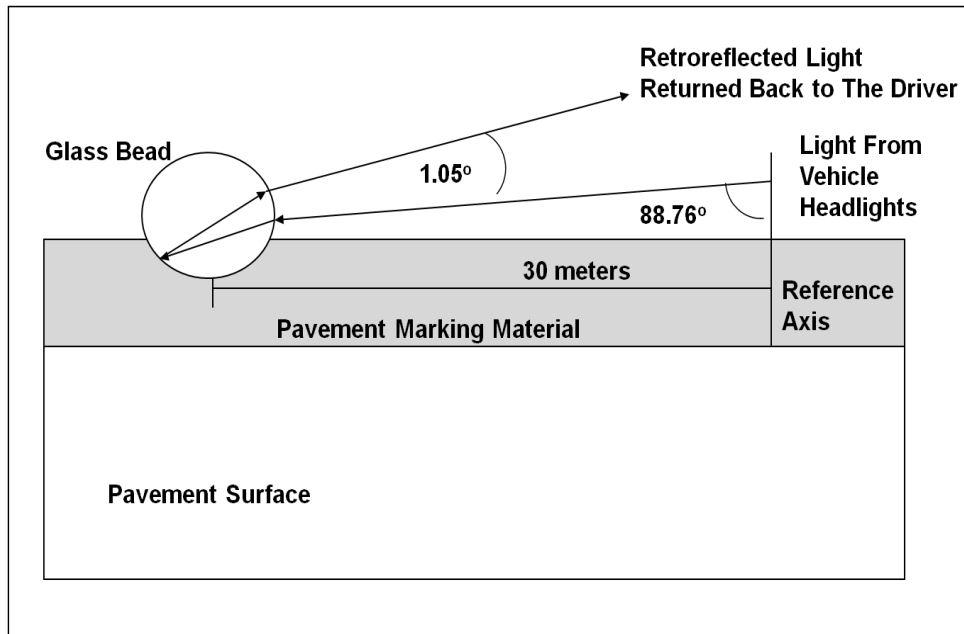
The ASTM specifies a 30-meter geometry for measuring retro-reflectivity for roadway markings. The geometry is based on the driver sitting 1.3 meters above the ground seeing the pavement marking 30 meters in front of the headlight. Figure 1 shows the corresponding angles of refractance and reflectance at the bead location (Needham, 2011). The ASTM specified 30-meter geometry provides a consistent basis for obtaining measurements. Even though the position of a light on an aircraft is much lower than the pilot, and the pilot sits much higher than a car driver, the USAF and FAA use the 30-meter geometry as the standard for measuring pavement marking retroreflectivity (Cyrus H. M., 2003).

Figure 1 : Illustration of Retro-reflectivity

Retro-reflectivity is one of the key measures of an airfield pavement marker's performance. As defined by the American Society for Testing and Materials (ASTM), it is the amount of light, which after emitted from a headlight is reflected from the pavement marker back to the driver (ASTM, 2005). Pavement markings contain glass beads protruding from the surface, allowing light to pass through. The light refracts off the back of the bead, picking up the marking color, and then reflects back to the driver. The value of the reflection (R_L) is measured in millicandelas per meter squared of luminance ($\text{mcd}/\text{m}^2/\text{lux}$) and is known as the retro-reflectivity value.

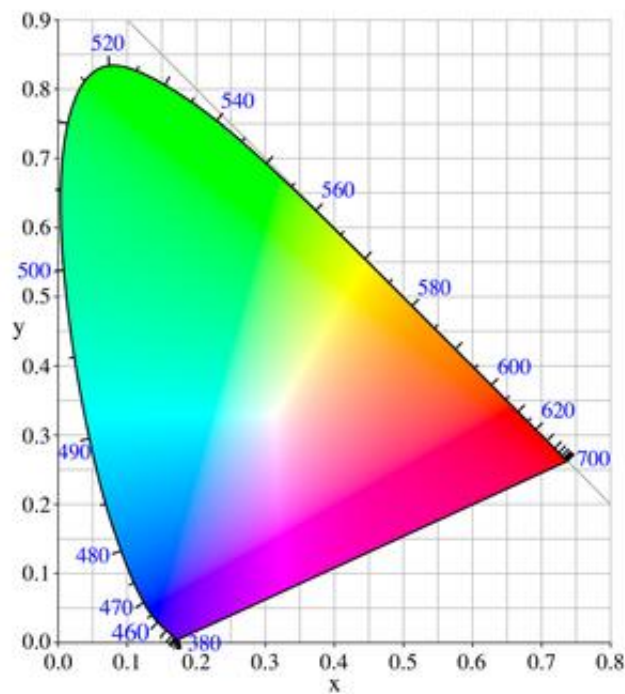
colors as close to their true color as the eye can distinguish. The researchers used a spectrophotometer to measure the values of chromaticity. The device reads the color of the sample, adjusting for the ambient light to produce an xy coordinate on the D₆₅ color chart. This xy coordinate shows what the true color of the sample is when under white light.

Figure 2: CIE 1931 D₆₅ Color Space Chromaticity Diagram

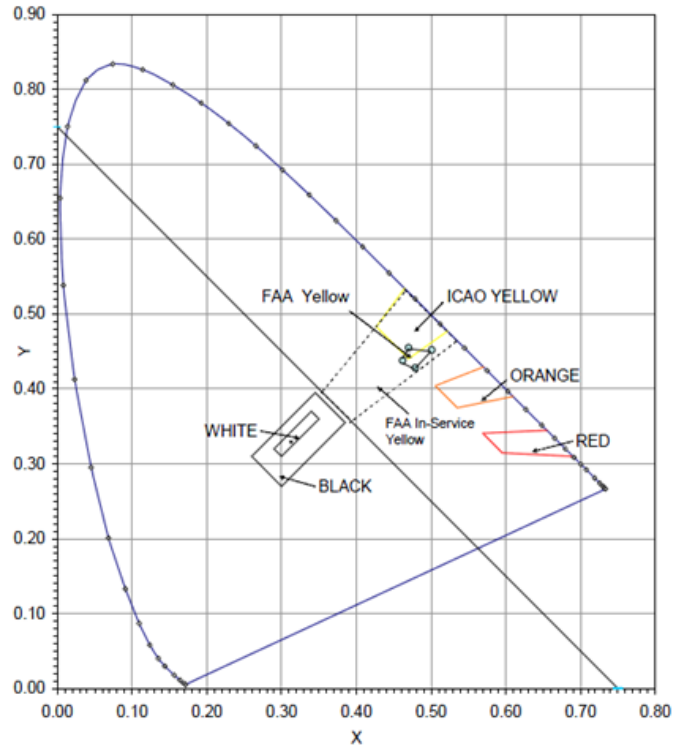
The FAA has established standards for the different colors of markings used on airfields. Each color has a box on the D₆₅ color chart. For a particular color to be within standards, the sample must fall within the specified corner points. Figure 3 shows the

FAA standard D65 color chart used for evaluating a pavement marking's failure. This research effort focuses on just the white color region.

Figure 3: FAA Standard Illuminant D₆₅ Color Chart

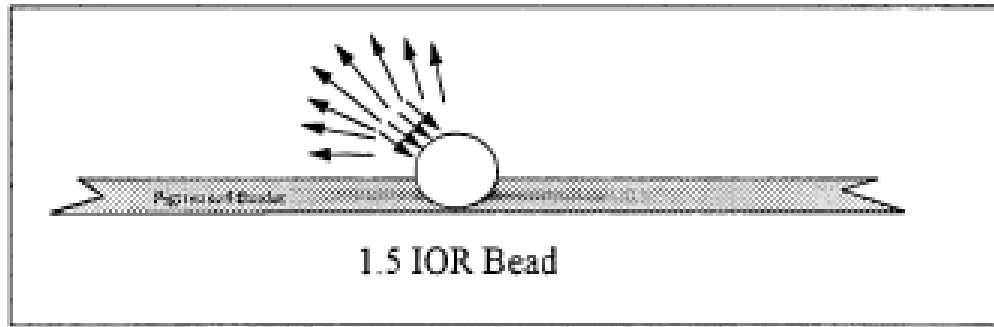
The study team concluded that even though the Type III beads had higher retroreflectance, a smaller amount of light was actually making it back to the pilot's eyes. This was due to the light entering the bead being returned in a very narrow band. Thus, unless the observer was in the narrow reflection band, the reflectance values would be very small. Opposed to this, Type I bead disperses the light in a wider range as shown in Figure 4 and Figure 5 and are thus easier to detect outside of a narrow band (Ates, 1995).

Figure 4: Type I Bead Retroreflectance Characteristics

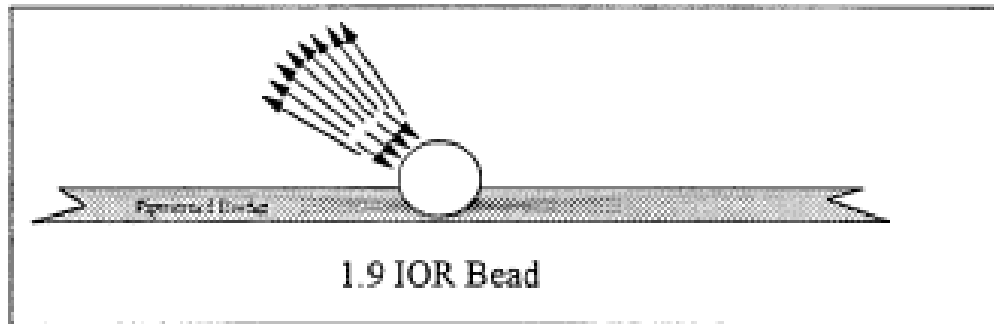
Figure 5: Type III Bead Retroreflectance Characteristics

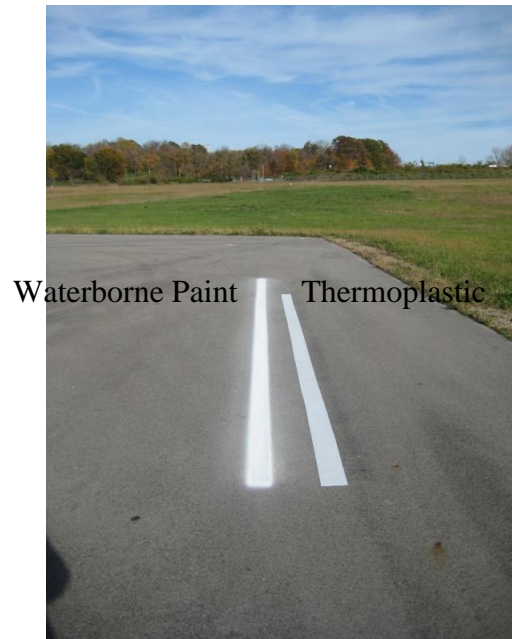
The experiment consists of two test decks of pavement markings. Each deck contains a stripe of waterborne paint and thermoplastic. The stripes of material are 30 ft long and 6 inches wide. The markings within each deck are spaced 12 inches apart. Figure 6 and Figure 7 show the test decks as placed on the asphalt runway for the National Museum of the United States Air Force on Wright-Patterson Air Force Base Area B. The runway is a semi-active runway with approximately ten take-offs and landings per year. The test decks have a sufficient buffer around them to allow for movement of machinery without having to traverse over the markings. Thus, the only factors affecting the markings are the applications of the prescribed treatments. Initial retroreflectivity and chromaticity readings were taken before any treatments were applied.

Figure 6: Chemical Treatment Test Deck

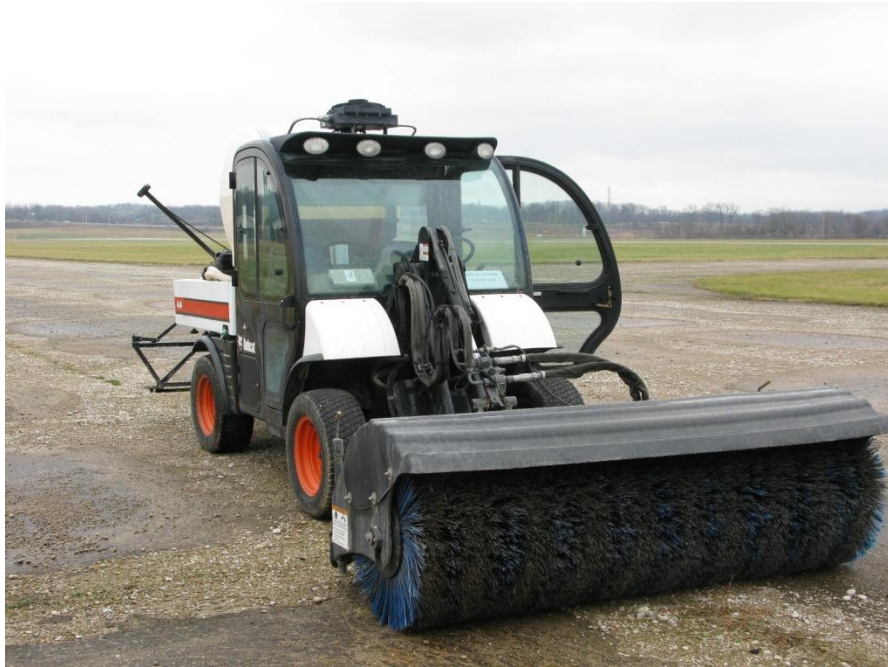
resort to high pressure abrasion techniques. For this experiment, the chemical was applied at the recommended coverage amounts, agitated using a roadway sweeper for four hours, and then washed off using pressurized water, below 2,000 psi, from a firefighting vehicle.

Figure 8: Toolcat Sweeper and Sprayer

3. Fill tank on Toolcat with approximately 50 gallons of water.
4. After chemical has set for 30 minutes start agitation.
5. Agitation consists of driving the Toolcat over the test section once every 10 minutes while operating the sweeping attachment, spraying water as necessary to ensure the chemical remains moist.

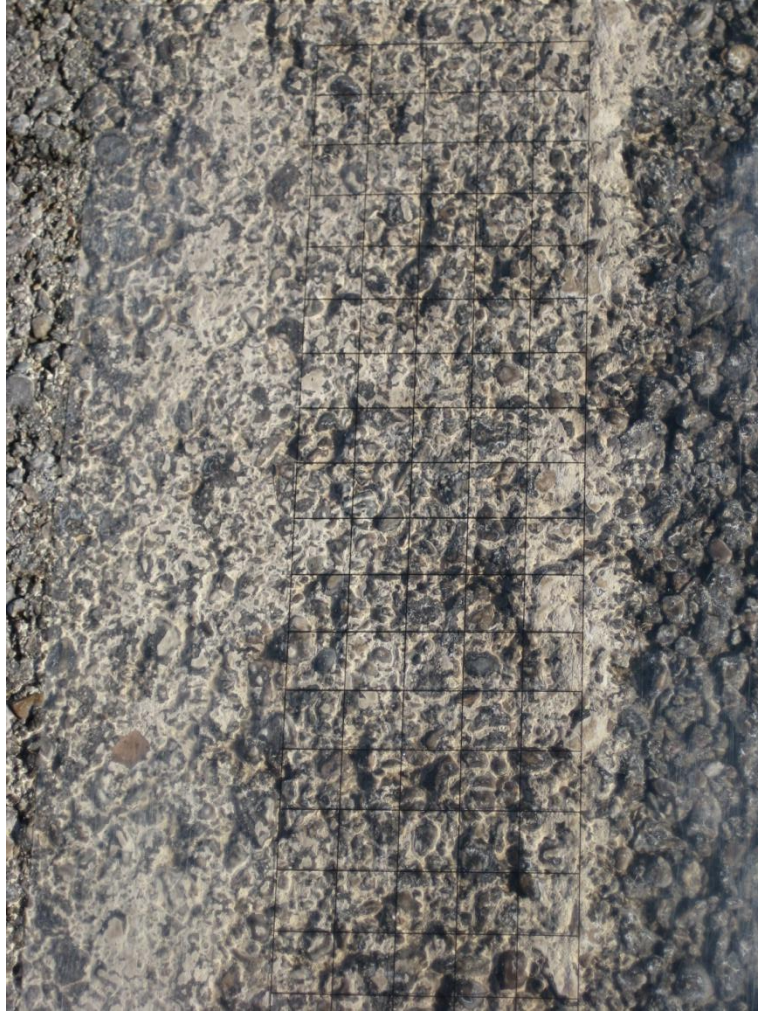
Coverage is evaluated using a 25 square inch transparent sheet. The sheet is divided into 100 blocks, each 0.25 inches square, with 20 rows and 5 columns. The researchers placed the sheet on the sample marking and counted the number of squares which showed pavement instead of just marking material as demonstrated in Figure 9. The number of squares showing more than 50 percent pavement was subtracted from 100 to give the percent coverage remaining. If the overall coverage is less than 50%, the marking fails.

Figure 9: Transparent Grid Used for Measuring Coverage

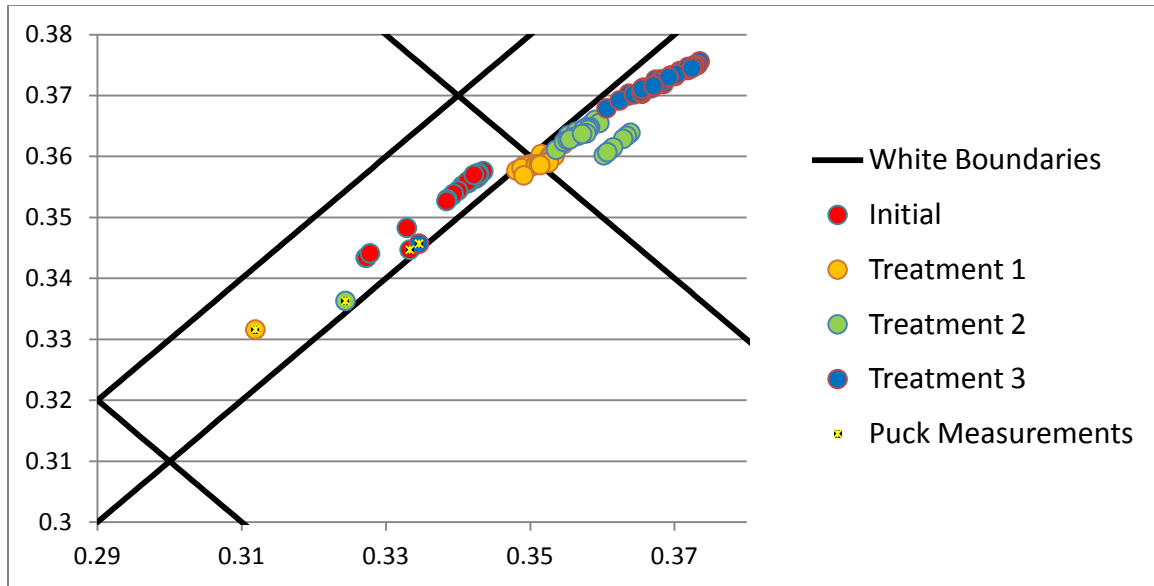
The paint which experienced the chemical treatment failed after the first treatment application. The retroreflectivity started with a mean above 200 mcd/m²/lux, but after the first treatment the mean had dropped below 90 mcd/m²/lux; a failing level according to both the USAF and the FAA. Additionally, the chromaticity levels which had started within the specified range had moved outside the range after every treatment application. Figure 10 shows the chromaticity values for the paint marking. The black box outlines the FAA approved area for a white pavement marking. Note the tendency of the marking to migrate to the upper right after each subsequent treatment. The only test which the paint did not fail was the coverage test. Visual inspection of the marking shows that even after the third treatment application, the marking was still above 80%, well above the specified 50% standard. On just a visual inspection the marking would have been considered passing on all accounts, but using retroreflectivity and chromaticity measurements, the marking failed after the first application.

Figure 10: Chemical Treatment Test Deck Waterborne Paint Chromaticity Measurements (nominal units)

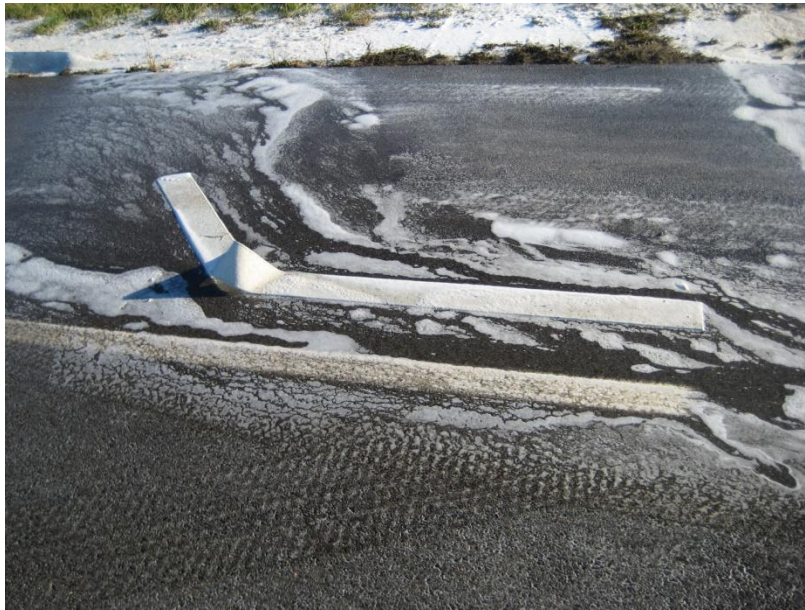
The thermoplastic marking which experienced the chemical treatments reacted vastly different than the paint marking. Throughout all the treatments, the thermoplastic maintained a passing level for retroreflectance. After the third treatment, the marking still maintained an average of $123 \text{ mcd/m}^2/\text{lux}$. However, this value was only obtained using three data points. During the washing process after the third treatment, most of the thermoplastic material experienced a catastrophic failure due to problems with surface bonding and peeled up from the asphalt surface as shown in Figure 11. The water pressure from the fire engine hand line, acting perpendicular to the pavement marking, dislodged the material and forced it off the asphalt. For future efforts, the water should be applied in parallel to the markings, not perpendicular. After the washing was complete, only the first three feet of the marking remained intact. Because of this, the

Figure 11: Catastrophic Failure of Thermoplastic

Within the paint stripe for the chemical treatment, each iteration of the treatment caused a significant change in every measured parameter with the single exception of the coverage value difference from the initial values to after the first treatment as shown in Table 6. Within the thermoplastic stripe for the chemical treatment the values in Table 7 demonstrate that only some of the parameters experienced significant changes. Retroreflectivity did not have a significant change after the third treatment. Chromaticity values in the x direction and the y direction did not have significant changes after the second treatment; the first and third treatments both had significant changes. Coverage did not change until after the third treatment when the thermoplastic experienced a catastrophic failure as shown earlier.

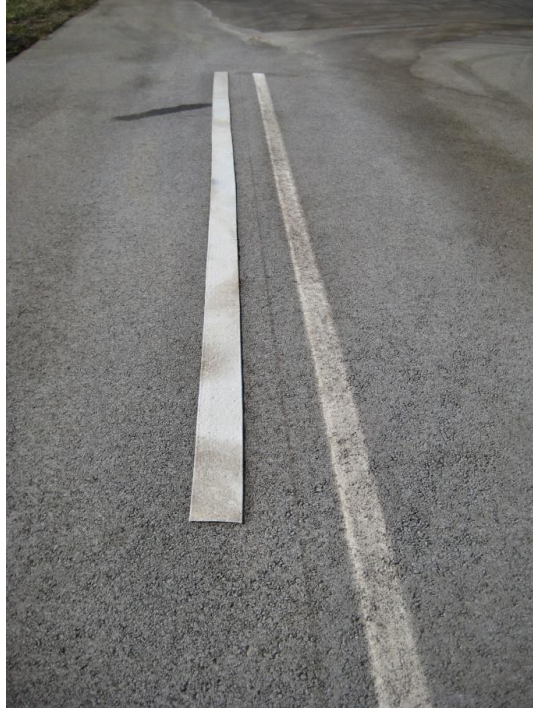
researchers could not obtain retroreflectance readings on anything but the first three feet. However, we were still able to collect chromaticity readings for the material which had peeled up. Figure 12 shows the material laid down in order to obtain the chromaticity readings. The researchers graphed the degradations for retroreflectance, and chromaticity in the x and y directions for both the waterborne paint and thermoplastic. The graphs and corresponding best fit regression lines with R^2 values are show in Figure 13, Figure 14, and Figure 15.

Figure 12: Thermoplastic Repositioned After Failure

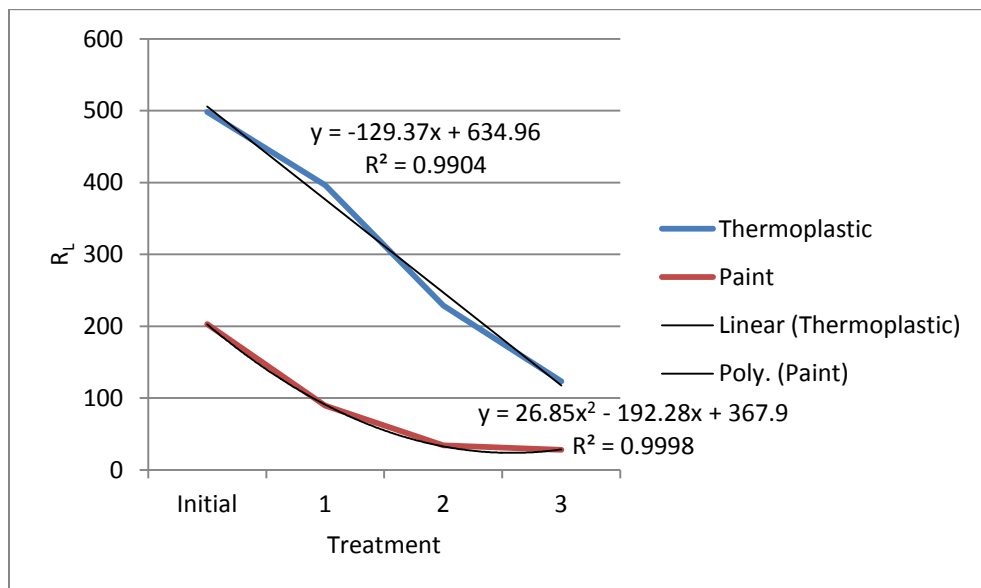
Figure 13: Chemical Treatment Retroreflectance (mcd/m²/lux)

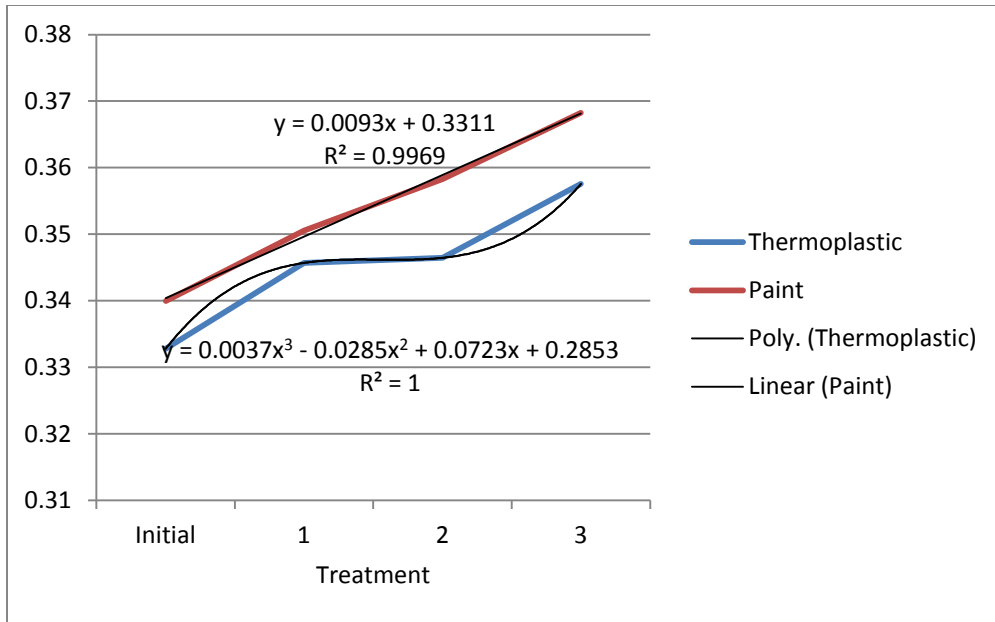
Figure 14: Chemical Treatment Chromaticity x

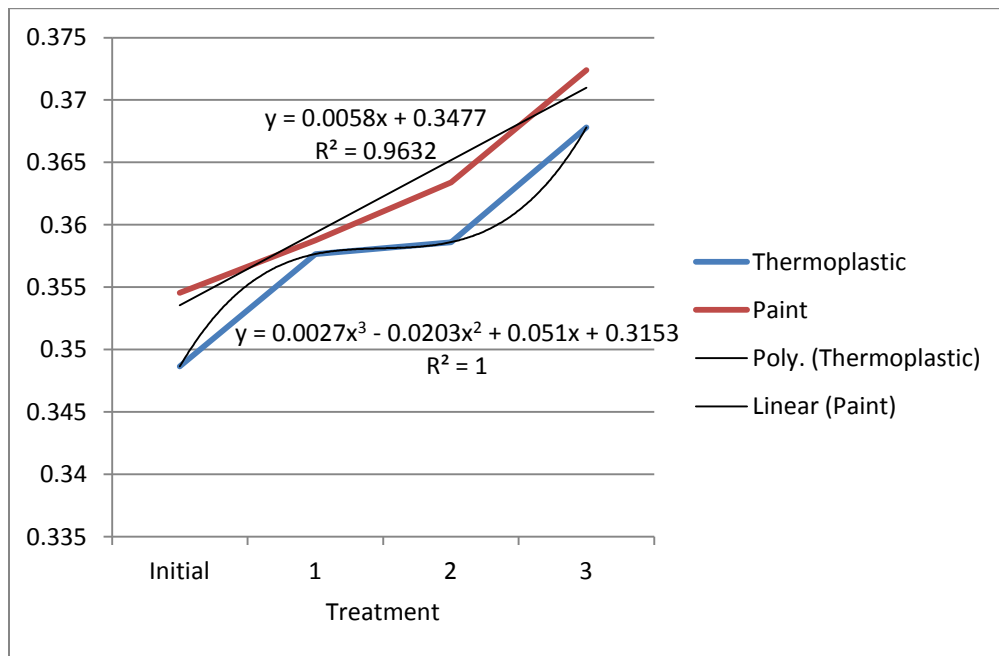
Figure 15: Chemical Treatment Chromaticity y

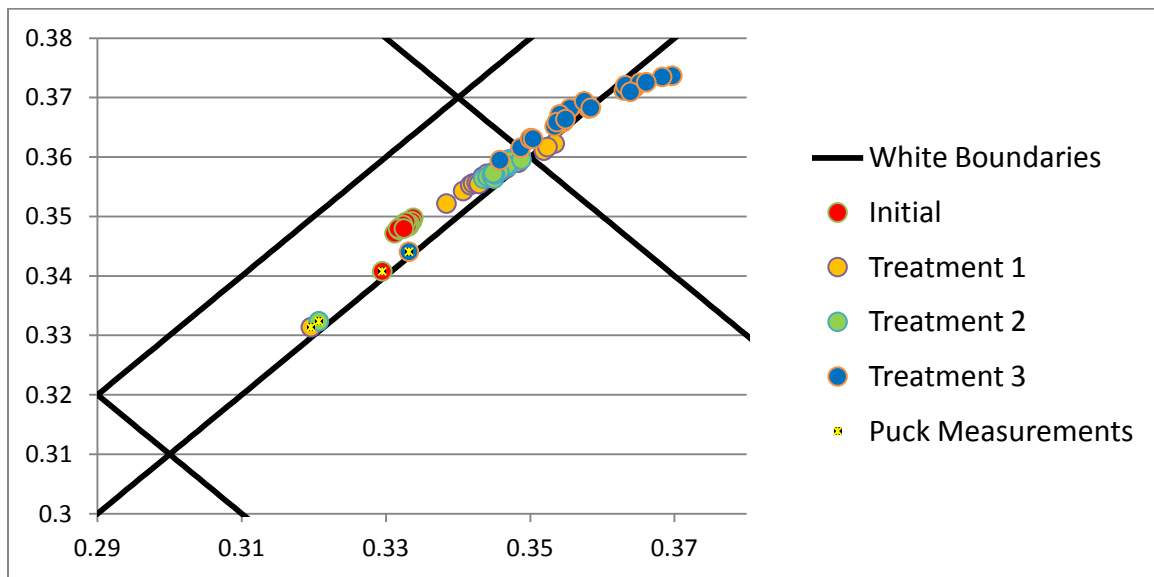
Charting the chromaticity readings reveals that after the third treatment, the marking was no longer inside the specified ranges. Figure 16 shows that the thermoplastic displays a similar trend to that of the waterborne paint in that the chromaticity readings tend to the upper right as chemical treatments are applied. A visual inspection of the thermoplastic material cross-section showed that the material retained a large majority of the reflective beads throughout its thickness. The main concern with this material is its adherence properties to the runway surface. This is consistent with what the FAA found in their evaluation of the material (Cyrus & Previti, 2008).

Figure 16: Chemical Treatment Test Deck Thermoplastic Chromaticity Measurements

the first treatment application, where thermoplastic failed in coverage and chromaticity after the third treatment. Based on a runway rubber removal schedule of twice per year, the thermoplastic would last one year longer than the paint. Thermoplastic's advantage comes with requiring fewer applications and thus less time the runway is down for maintenance.

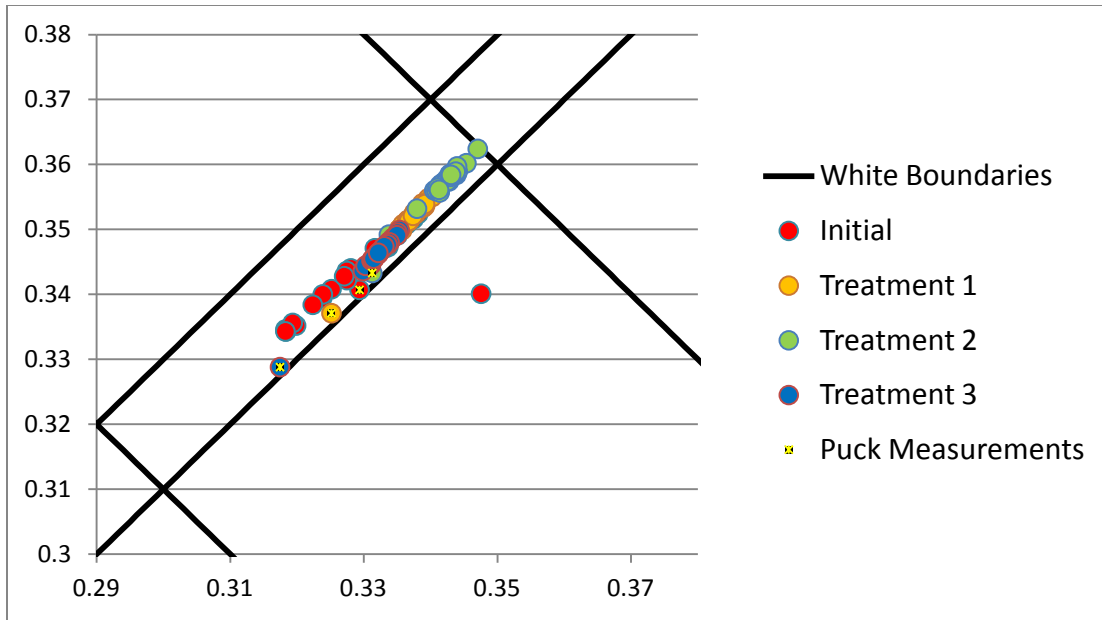
Upon a visual analysis of the marking materials, both the waterborne paint and the thermoplastic performed well. After the last application of the treatment, both materials still retained most of their coverage. However, the thermoplastic did chip up a bit, losing approximately 16 inches from one end. Due to the lack of debris in the area, we assume the sweeper broke the material into small pieces and ingested those pieces. Both materials still appeared white after the third treatment, and both appeared to have acceptable amounts of retroreflectance. Figure 17 and Figure 18 show that the markings' color did not deviate much from the initial values, and all stayed within the acceptable white range.

Figure 17: Sweeper Treatment Test Deck Waterborne Paint Chromaticity Measurements

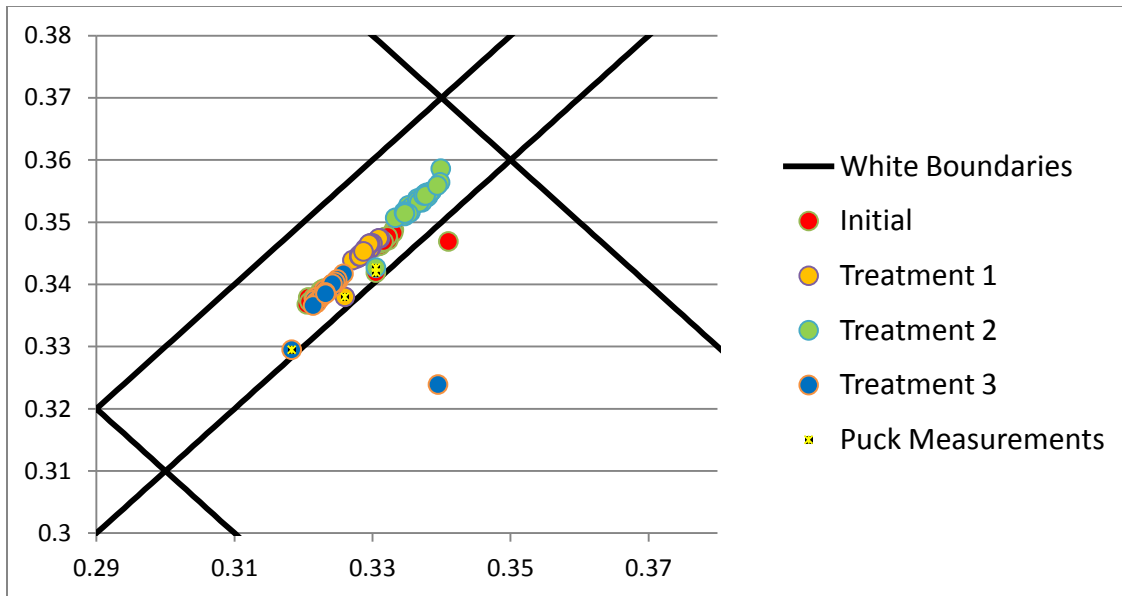
Figure 18: Sweeper Treatment Test Deck Thermoplastic Chromaticity Measurements
