## **ADDRESSING EROSIIVE CONDITIONS AT TWO ARCHAEOLOGICAL SITE AREAS AT MARINE CORPS BASE CAMP PENDLETON**

NINA M. HARRIS  
MARINE CORPS BASE CAMP PENDLETON

*Marine Corps Base Camp Pendleton addressed potential impacts from natural and man-made erosion at two areas within archaeological sites. We used a drone to produce a photogrammetry base-line survey at one archaeological site area for an ongoing erosion monitoring program, and three separate and combined landscape methods were used to treat one site for ongoing erosion. We present both the initial results of the drone monitoring survey at the first and the successful results of the use of corrective landscaping methods at the second.*

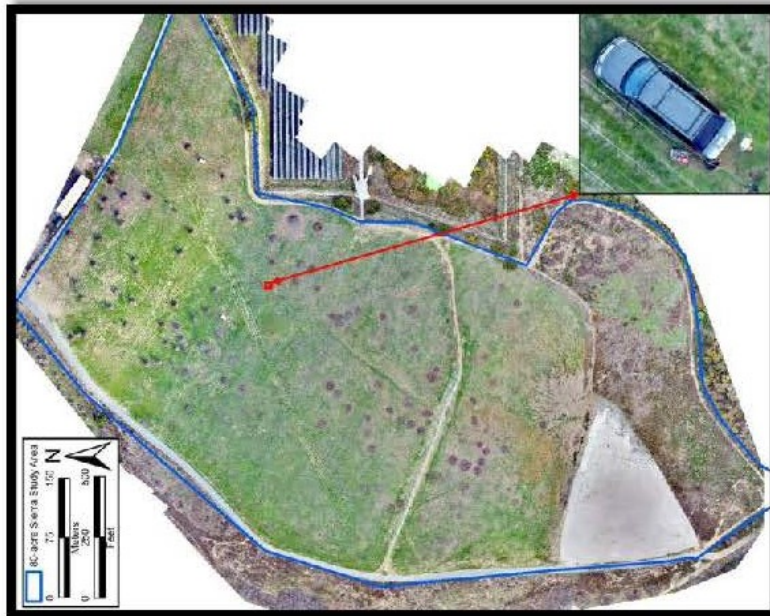
Figure 1. Image A Baseline Elevation Map Results from Total Station and GPS Data, and Image B Overview Aerial from Drone Photogrammetric Data with Insert Showing Quality of Data; white area is crushed rock on troop assemble area.

MCB CamPen contracted ASM Affiliates to provide monitoring services and report results (Daniels 2016 and 2018). Two methods of ground erosion monitoring were deployed: visual inspection (not specifically addressed here), and ground elevation data collection using two methods. The first ground elevation data collection method was accomplished using a total station coupled with global positioning system (GPS) data collecting on a 40-meter interval point grid system. Permanent survey datums were established with a Trimble GeoXH (10-meter accuracy). The datums were used as base stations for back sighting for the Nikon DTM-322 total station recordings. This data was intended to be used to track subtle changes in all-over ground elevations. This method of collection took over three days to complete proving to be slow and cumbersome for the purpose, and so the second survey method using a drone was deployed. The total station data was, however, collected as a base line data set and used as a comparison for the second survey method (Figure 1, Image A).

A second ground elevation data collection survey method employed photogrammetric Image-Based Modeling (IBM) using a drone equipped with a camera using a photogrammetric image capture method to collect 1.11 centimeter/pixel resolution for three-dimensional imagery. This process uses two-dimensional (2D) images to build 3D representations, employing Structure from Motion (SfM) 3D point cloud data, in this case for ground images with elevation data. The 80-acre subject area was flown using a Monarch-AG 002 unmanned quadcopter with a Sony A6000 camera using a 20-millimeter lens at an elevation above ground surface of 200 feet, traveling at 11 miles per hour (Figure 1, Image B). The aerial fly-over took a little over an hour.

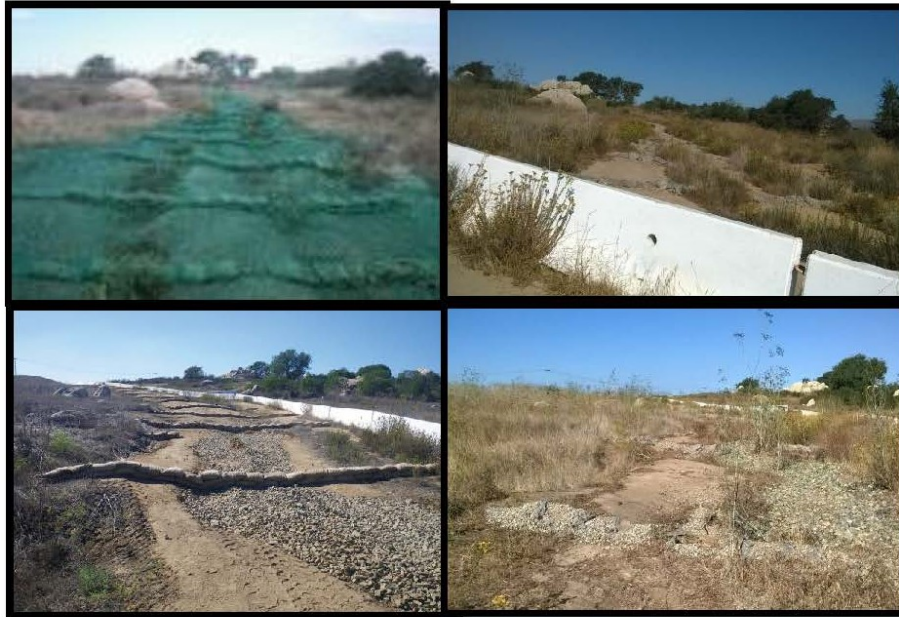
*Figure 4. Area B1: Inside K rail, (Top Left) Check Dams and Hydro Seeding, (Top Right) After Treatment and B2 Outside K Rails, (Bottom Left) 3-Inch Crushed Rock and Check Dams, and (Bottom Right) After Treatment.*

The B1 Area process included check dams and hydro-seeding. Upon review, while it was obvious that Area B1 wash had slowed, there were still some areas that did not take to hydro-seeding, probably due to the ground surface hardness. However, vegetation is taking hold in Area B1 and another year might improve the cover (Figure 5).

The plan in Area B2, included hydro-seed of the whole area, however it was decided that the check dams would assist in holding soil in place and that the vegetation would naturally fill in. While this is a work in progress, the results are as anticipated (see Figure 5). Area B3 was a remnant of an old dirt road, but the potential for the run-off to start cutting downslope was addressed using hydro-seeding (Figure 6).

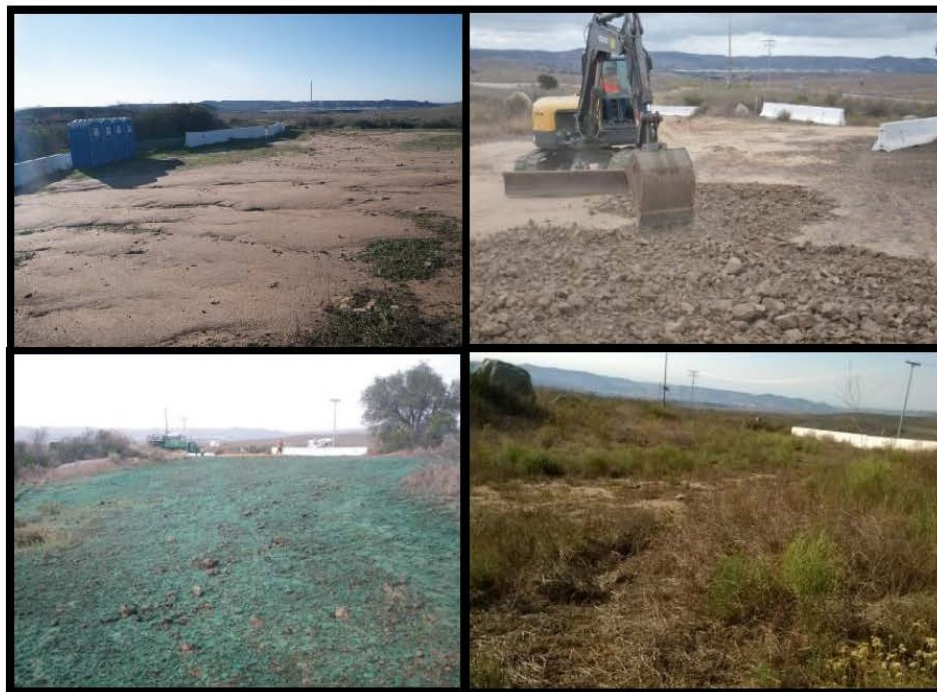
*Figure 5. Area A: Before Treatment, During Surface Scarifying/Roughing, Hydro Seeded, and After Treatment; Looking South.*

Before, during, and after treatment photographs were taken during the implementation of the erosion control program, and at about a year and a half afterwards, to document the progress and success of the treatment. The Area A process included scarification and hydro-seeding which had a very successful re-establishment of indigenous vegetation (Figure 4). The establishment of this vegetation will slow downslope run-off and wash in the B1 Area.

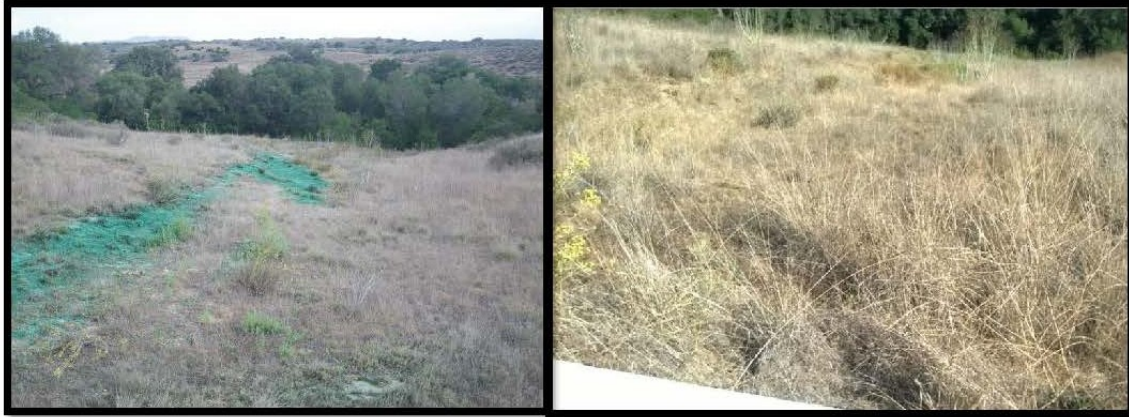
*Figure 6. Area B 3, Old Road Hydro Seeded, and After Treatment.*

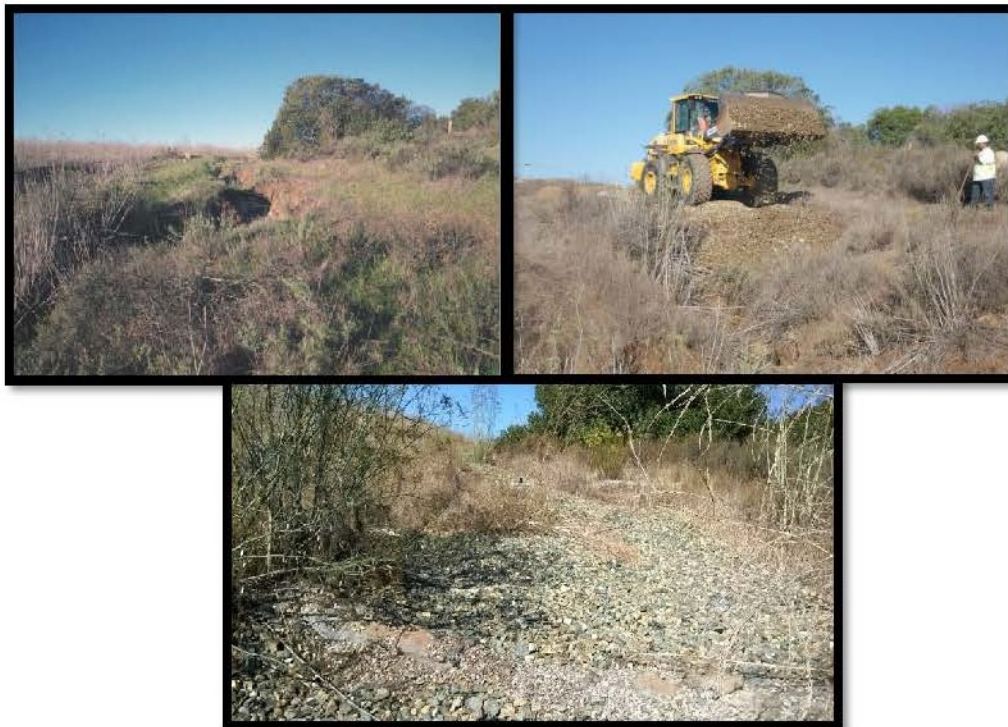
*Figure 7. Area C: Deep Drainage Looking South, Crushed Rock Placement and After Treatment with 3" Crushed Rock and Check Dams.*

Area C was the most challenging area requiring refined planning. Several decisions were made regarding size of crushed rock to use in the deep drainage areas. Initially class 2 base crushed rock (1 inch in size) was consider, however it was finally decided that the larger 3-inch rock base would hold in place better due to weight, while still letting the water pass through. In review, using this 3-inch rock base was the correct decision for this situation, since this held in place despite heavy winter rainfall that subsequently occurred (2016–2017; Figure 7).
