Journal of

Volume 23, Number 2 - April 2007 through June 2007

Martempering to Improve Wear Properties of Aircraft Brake Steel Rotors

By Dr. Sudershan Jetley

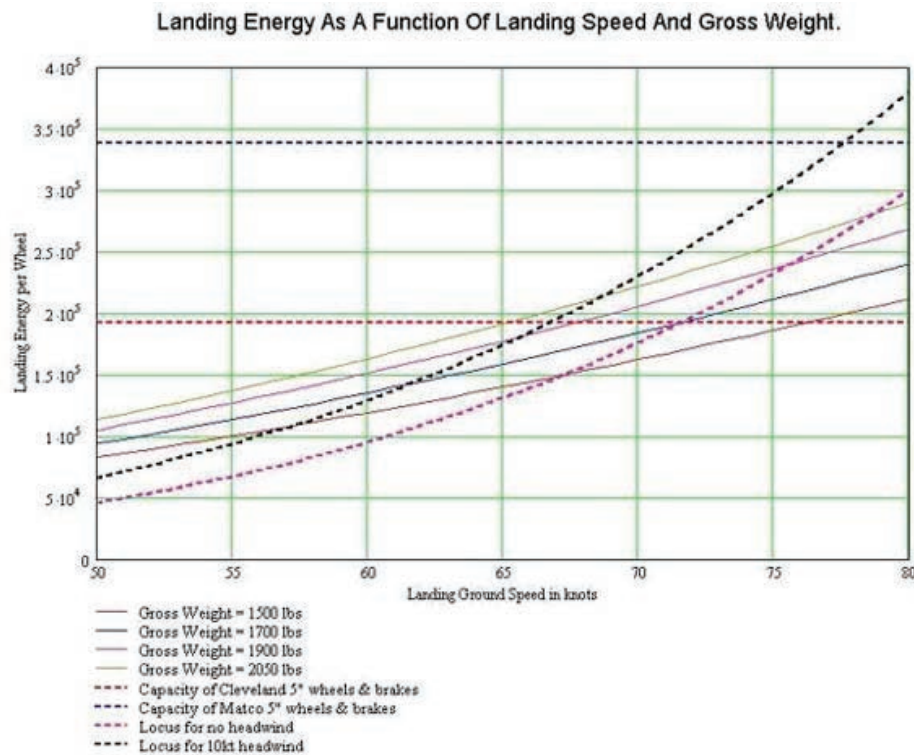
Figure1. Effects of Speed and Weight of aircraft on Landing Energy Per wheel (Johnson, 2006)

From these relationships, it can be seen that for a given aircraft, speed and weight are the governing factors in brake design. This is again seen in graphical form in figure1.

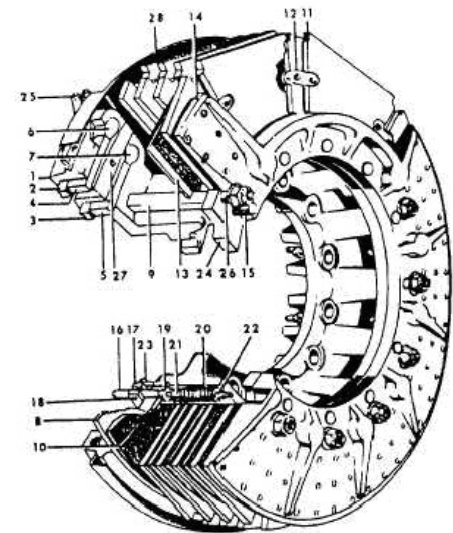
1. Carrier assembly
2. Piston cup (outer)
3. Piston cup (inner)
4. Piston (outer)
5. Piston (inner)
6. Piston end (outer)
7. Piston end (inner)
8. Pressure plate
9. Stator drive sleeve
10. Auxiliary stator and lining assembly
11. Rotor segment
12. Rotor link
13. Stator plate
14. Backing plate
15. Torque pin
16. Adjuster pin
17. Adjuster clamp
18. Adjuster screw
19. Adjuster washer
20. Adjuster return spring
21. Adjuster sleeve
22. Adjuster nut
23. Clamp hold down assembly
24. Shim
25. Bleeder screw
26. Drive sleeve bolt
27. Dust cover (inner)
28. Dust cover (outer)

Figure 2. Segmented rotor brake—cut-away view.

Pre World War II, the landing gear of aircraft was not retracted and stowed. However, with increased speed requirements it became necessary to retract and stow the landing gear to reduce drag. To meet these requirements, wheels became smaller to reduce stow space, leading to the development of multiple disc brakes (Aircraft Technology Engineering and Maintenance, 2000). This design has become standard and all large planes today use the multiple disc brakes. An example diagram of these brake assemblies is shown in figure 2 (Integrated publishing, 2006).

The essential part of the brake assemblies is a rotor rotating in contact against a stationary stator during braking. The industry primarily uses sintered, copper based alloys as stators and steel rotators.

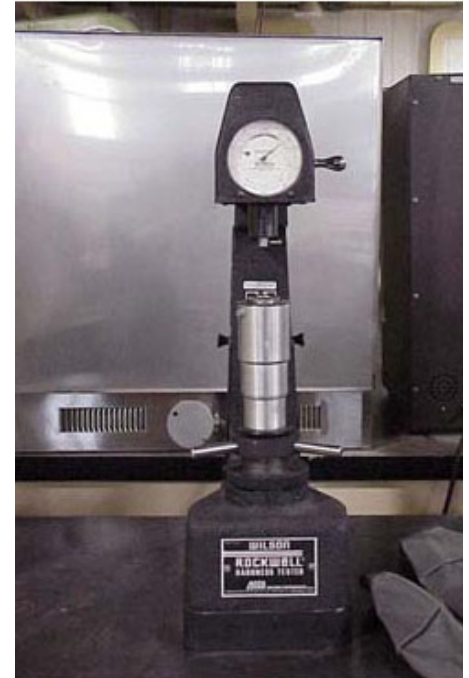
Figure 3. Rockwell Hardness Tester

1. Hardness Testing Machine
Wilson Rockwell Hardness Tester machine was used to measure hardness.

This is shown in figure 3. The Hardness machine can be used with several different scales including Rockwell A-G, H, and K. In this study Rockwell scales B and C were used.

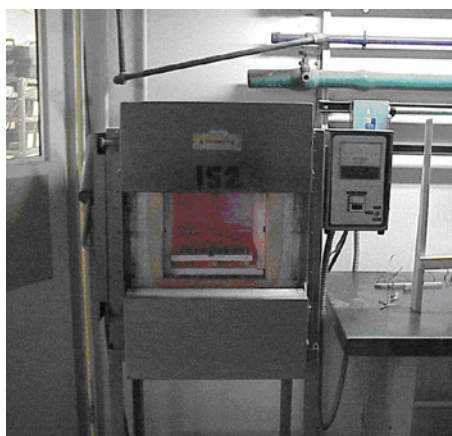
Figure 4. Large Electric Furnace

An electric oven was used to austenize the pucks before they were placed into the quenchant. Figure 4 is a photo of the furnace. The large furnace is made by Therolyne, and model number F-A1730. The furnace has a temperature range of 0° to 2500° F.

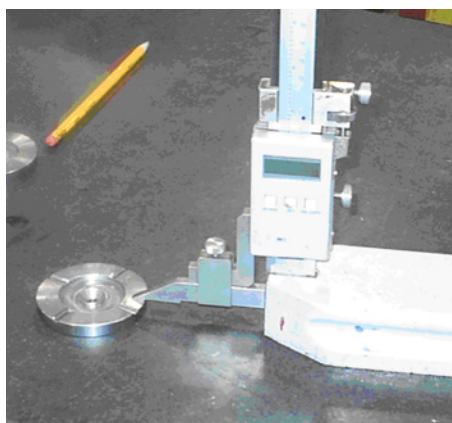
Figure 5. Height Gage / Thickness Measuring

North American Precision Inc. height gage was used to measure the thicknesses at eight different points on the puck. Three measurements at each position were taken to obtain the thickness. Figure 5 shows a close-up view of the gage.

The heights were recorded before and after the pucks were heat treated to see if there was any distortion in the axial direction after treatment. The pucks were thoroughly cleaned using sandpaper to remove any scale for the after heat treatment measurements. The set-up is shown in figure 5.

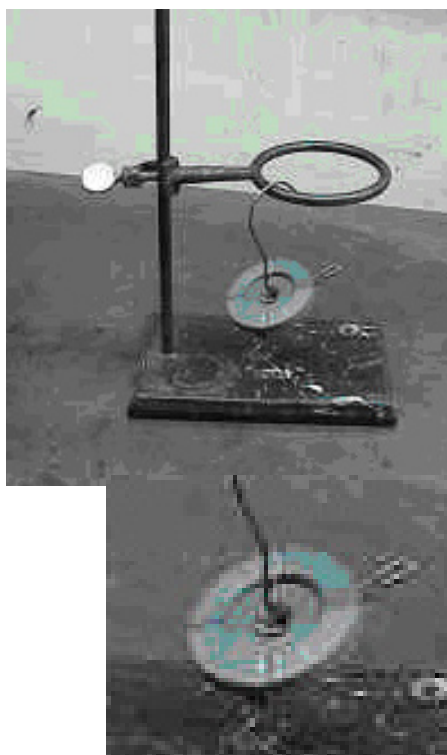
Figure 6. Beaker/Hanger set up and a close-up view

A beaker stand was used as the holding device for the pucks after treatment. The pucks were hung using wire coat hangers bent into a shape to hold them flat while entering the hot quenchant. This presented the maximum surface area during initial contact with the fluid, and so should cause maximum distortion. The coat hanger surface touching the pucks was minimized to avoid uneven cooling. Figure 6 shows this set-up.

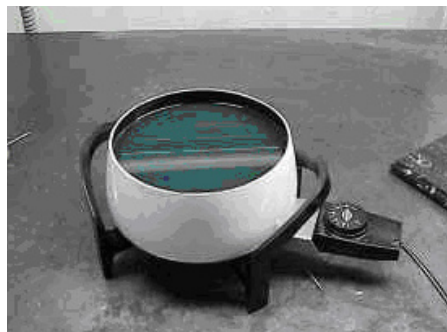
Figure 7. Electric Pot

An electric pot with a temperature setting control was used to quench the pucks. The electric pot is a domestic kitchen pot and has a half gallon holding capacity. The temperature range on the pot is 0° to 400° F. The temperature control was used to set the quenchant temperature and a 'Suregrip' thermocouple temperature probe was used to actually monitor the quenchant temperature. This probe has a temperature range of -40°F to 1994° F. Figure 7 is a photo of the electric pot.

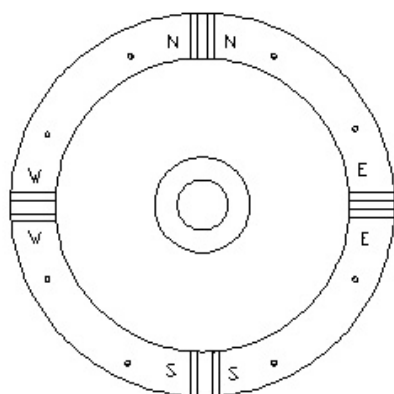
Figure 8: Labeled positions on a steel puck

In order to identify the different pucks, these were stamped with an identifying letter (A to T). In order to be consistent in the various measurements, these were labeled so that the measurement was done at approximately the same place and orientation. The labels consisted of stamped letters N, S, E, W, at two places, in the four directions so their orientation could be quickly found as shown figure 8.

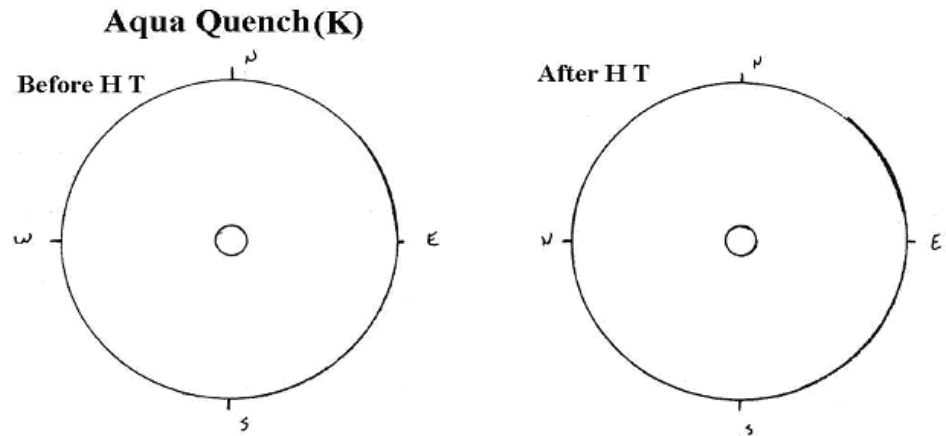
Figure 9. Example of a tracing to determine radial distortion

Although radial distortion is not of much importance in the functioning of the pucks, an attempt was made to measure this. As has been stated, the ideal method for measuring radial distortion would have been to use a profilometer or a CMM. In absence of such apparatus the above described tracing method was used. In all the eight parts used, no radial distortion was detected. An estimate of the accuracy of this method can be obtained as follows:

The visual error in the procedure of comparing the two tracings can be said to be half of the pencil line width, so it is in the order of 0.5 mm. Since the diameter of the puck was about 65 mm, the measurement error translates to 1.54 %. ($1\text{mm}/65\text{mm} * 100 = 1.54$). An example of the tracing is shown in figure 9.
