**Determination of Optimum Tack Coat Application Rate for
Geocomposite Membrane Use in
Roads and Overlaid Bridge Decks**

**Master of Science
In
Civil and Environmental Engineering**

**December 1999
Blacksburg, Virginia**

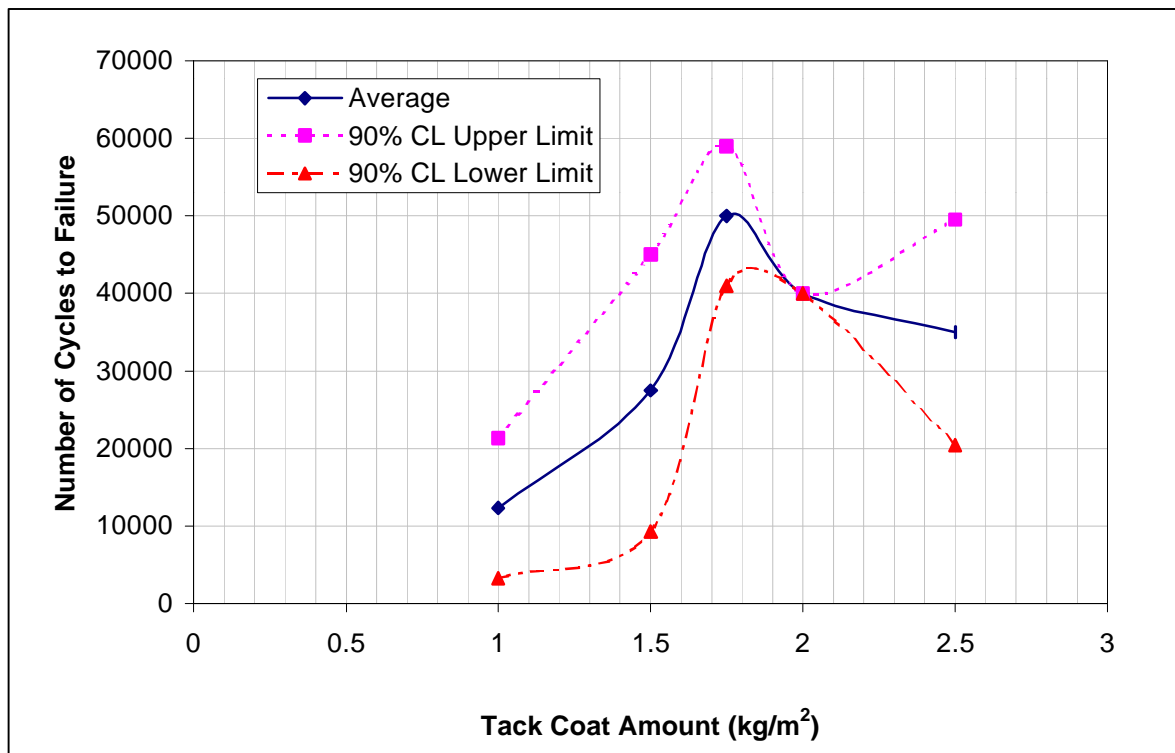
From the average value and 90% confidence limits of the number of cycles to failure for each tack coat application rate, a plot (Figure 4.2) was generated and used to determine the optimum tack coat application rate. The relationship between tack coat rate and the number of loading cycles to failure suggests that a tack coat rate of 1.75 kg/m² may provide the optimum performance.

Figure 4.2. Optimum Tack Coat Determination for Bridge Deck Specimens.

The variation in the number of loading cycles to failure can be attributed to several factors, including specimen preparation. It was evident that some of the tack coat was lost in the process of preparing specimens. This was due to the fact that the gyratory compactor mold was heated to mixing temperature when the concrete core and tack-coated geocomposite membrane were lowered into it. This caused some of the binder tack coat to soften and adhere to the side of the mold. Also, during the compaction process, additional tack coat was squeezed down onto the sides of the specimen in

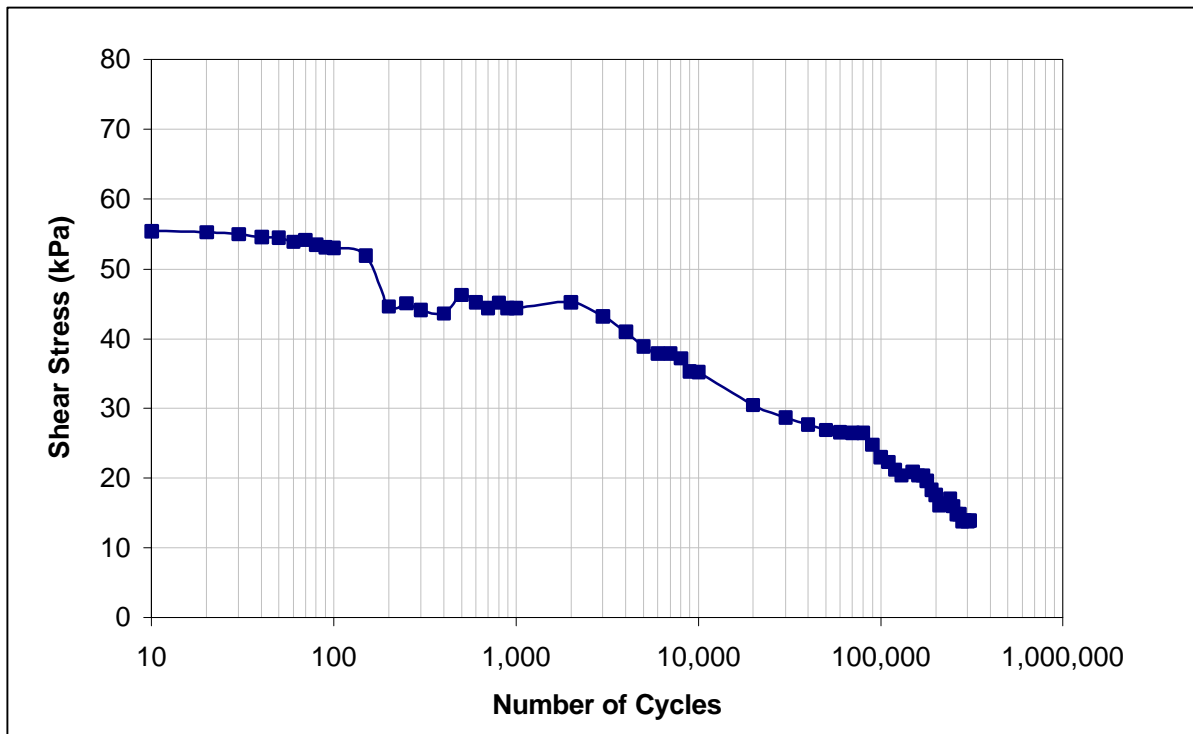
Figure 4.3 depicts data that is typical for most of the flexible pavement specimens tested. Each tack coat rate was tested in duplicate to ensure repeatability and accuracy among specimens with the same tack coat. However, during testing on some of the specimens, power failures caused a premature failure or some data to be lost. Due to this inconsistency, these specimens were disregarded for the determination of the optimum tack coat application rate. Table 4.2 shows the flexible pavement specimens that were deemed satisfactory to determine the optimum tack coat application rate. Number of cycles to failure represents the average of two tests, when applicable.

Figure 4.3. Typical Data for a Simulated Flexible Pavement Specimen.

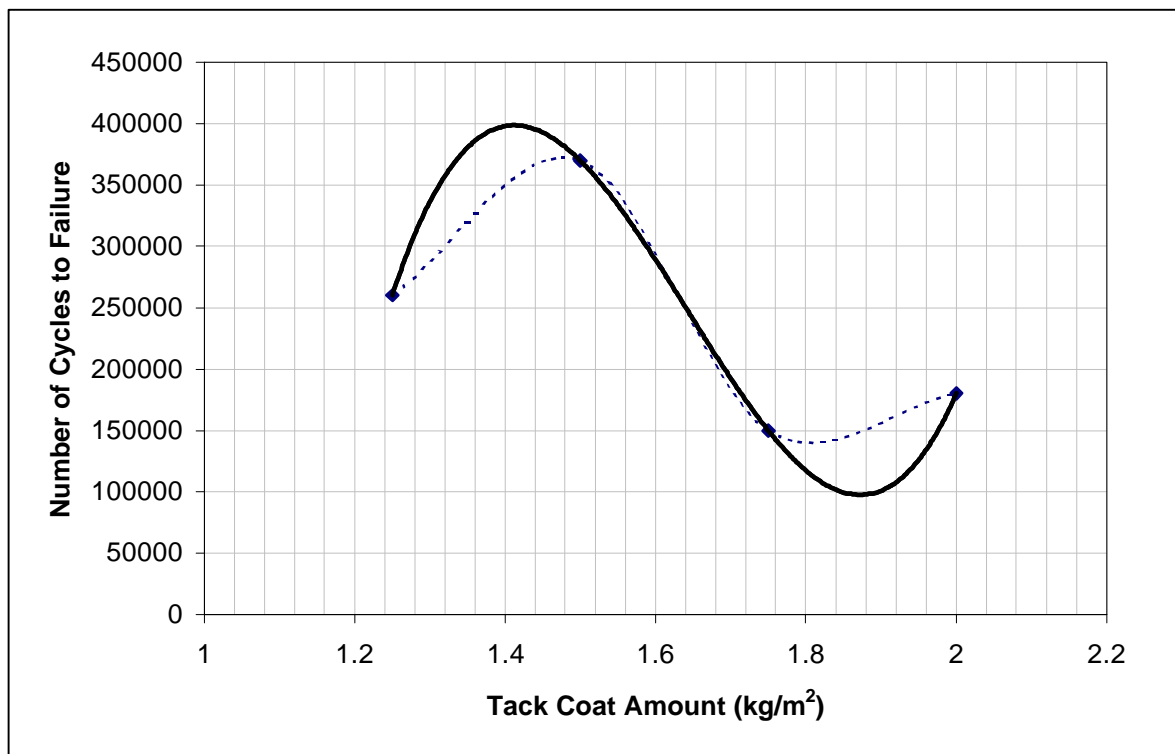
From the average number of cycles to failure in the above table, a plot was generated to determine the optimum tack coat application rate (Figure 4.4). A third order polynomial was fit to the data points, concluding that the optimum tack coat application rate for flexible pavement was 1.40 kg/m^2 . Using a PG 64-22 asphalt binder at a tack coat application rate of 1.40 kg/m^2 will provide a sufficient bond between the geocomposite membrane and the HMA layers. It is the author's opinion that when the geocomposite membrane is used on a newly paved layer in the same day, a tack coat application rate of 1.25 kg/m^2 may be sufficient. However, if the geocomposite membrane is placed after a day or more, a tack coat application rate of 1.40 kg/m^2 is recommended. This rate may be increased for rehabilitation as needed to rejuvenate the existing layer. However, the upper geocomposite surface may receive the rate application of 1.5 kg/m^2 if a surface mix is used, and 1.40 kg/m^2 if a base mix is used.

Figure 4.4. Optimum Tack Coat Determination for Flexible Pavement Specimens.

It was observed that control specimens with zero tack coat actually performed better than the other control specimens (0.45 kg/m² tack coat), producing a higher number of loading cycles to failure (Table 4.2). From this, it is obvious that there is no justification for the additional cost of a tack coat between HMA layers built in the same day; however, a minimum tack coat rate may be needed if construction of the next layer takes place after a day or more. For overlays, a tack coat is necessary as the binder of the existing layer is usually aged. The tack coat rate is dependent on the type and condition of the existing layer.

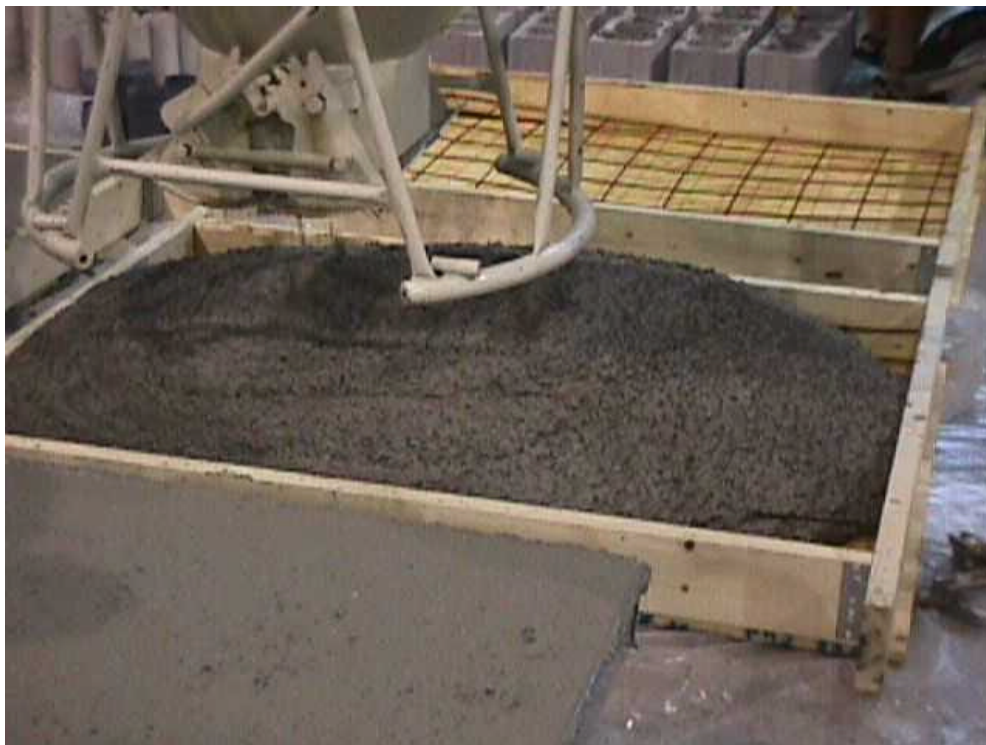
Figure A.1. Placing Concrete in Wood Forms.

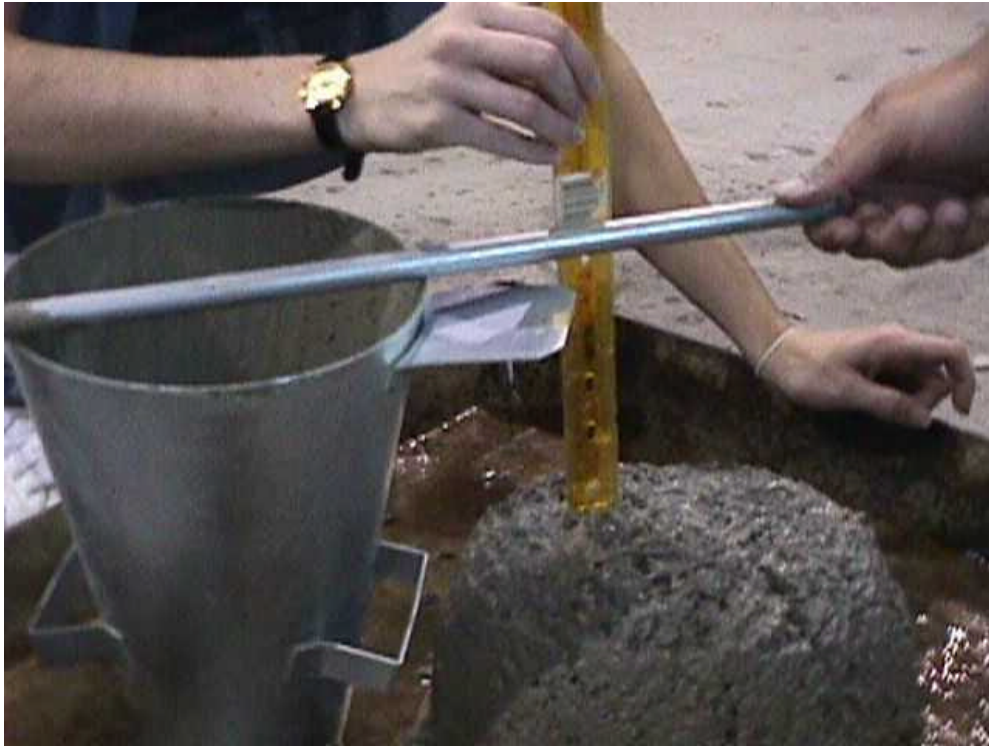
Figure A.2. Measuring the Slump of the Concrete.

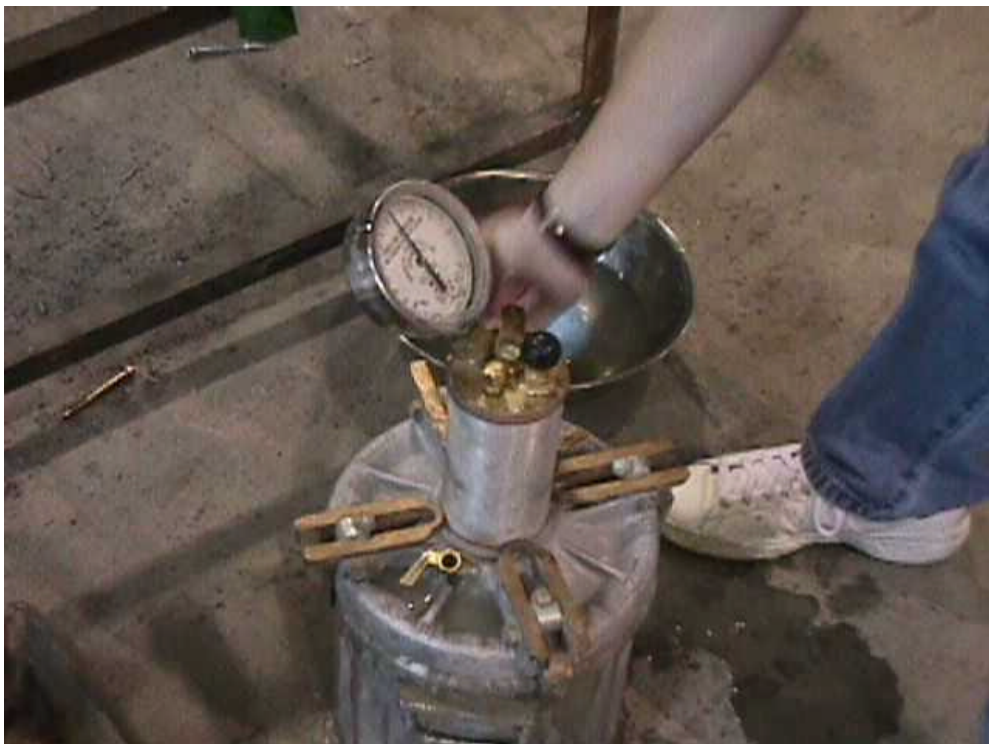
Figure A.3. Determining the Air Content of the Concrete Mix.

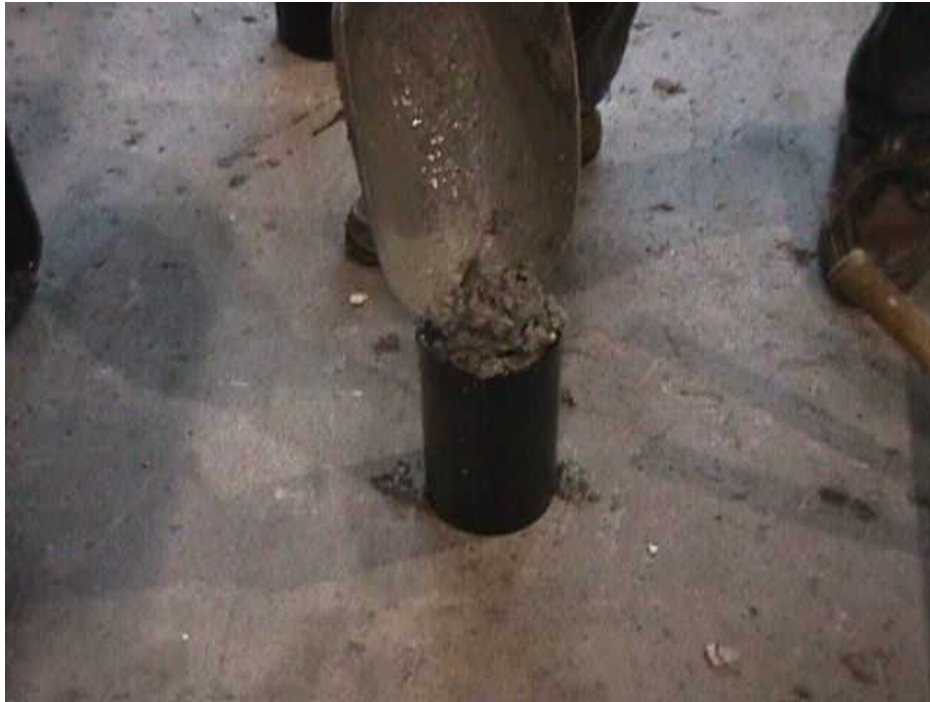
Figure A.4. Filling Cylinders for Compressive Tests at 7 and 28 days.

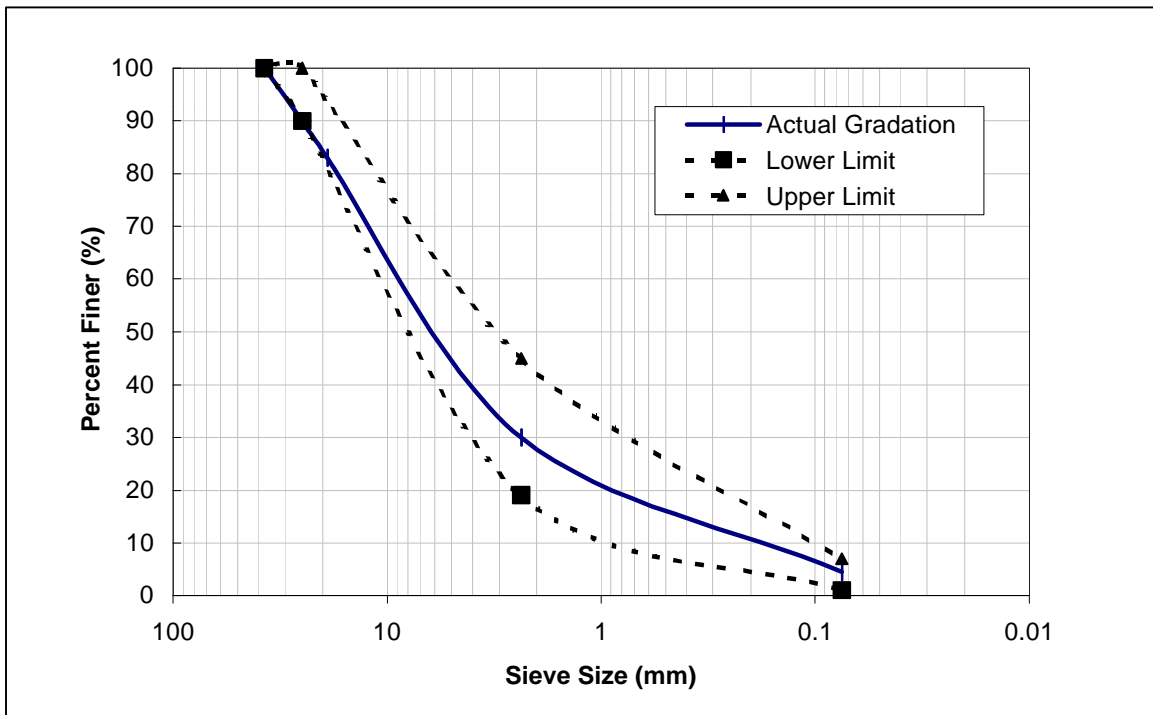
Figure A.6. Graphical Representation of BM-25.0 Gradation with Specification Limits.

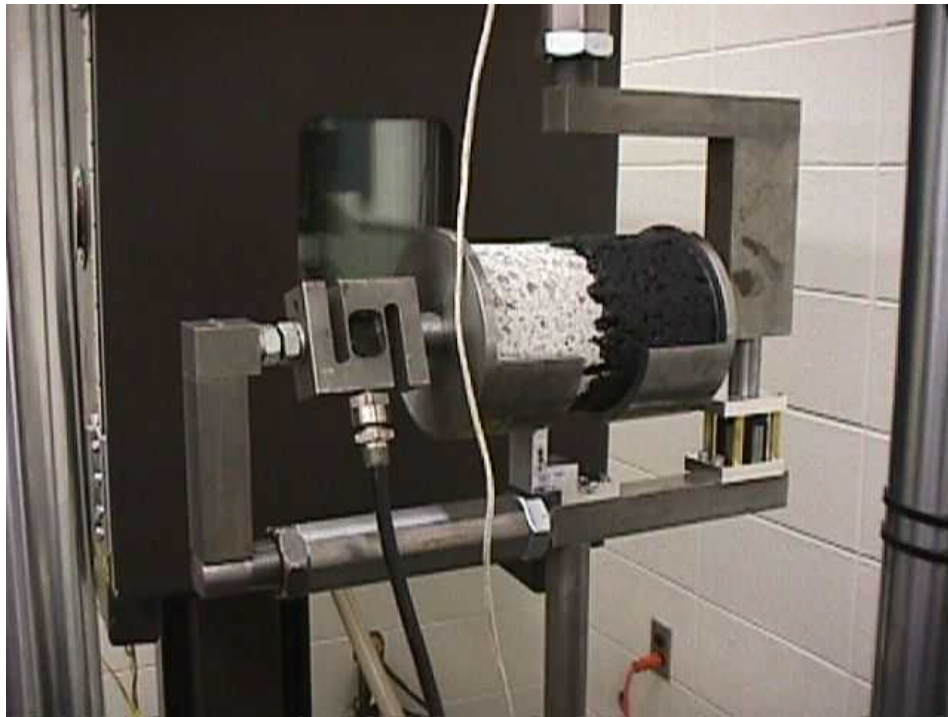
Figure B.3. Loading Simulated Bridge Deck Control Specimen into the Fixture.

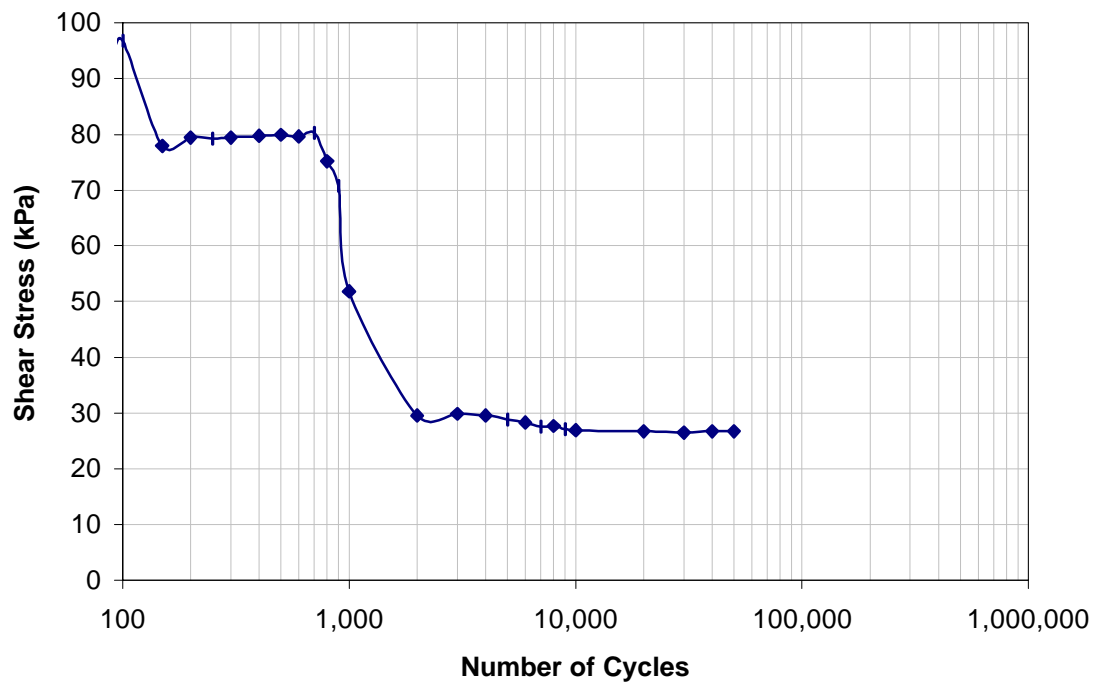
Figure C.1. Shear Stress versus Number of Loading Cycles for Specimen B1_0B.

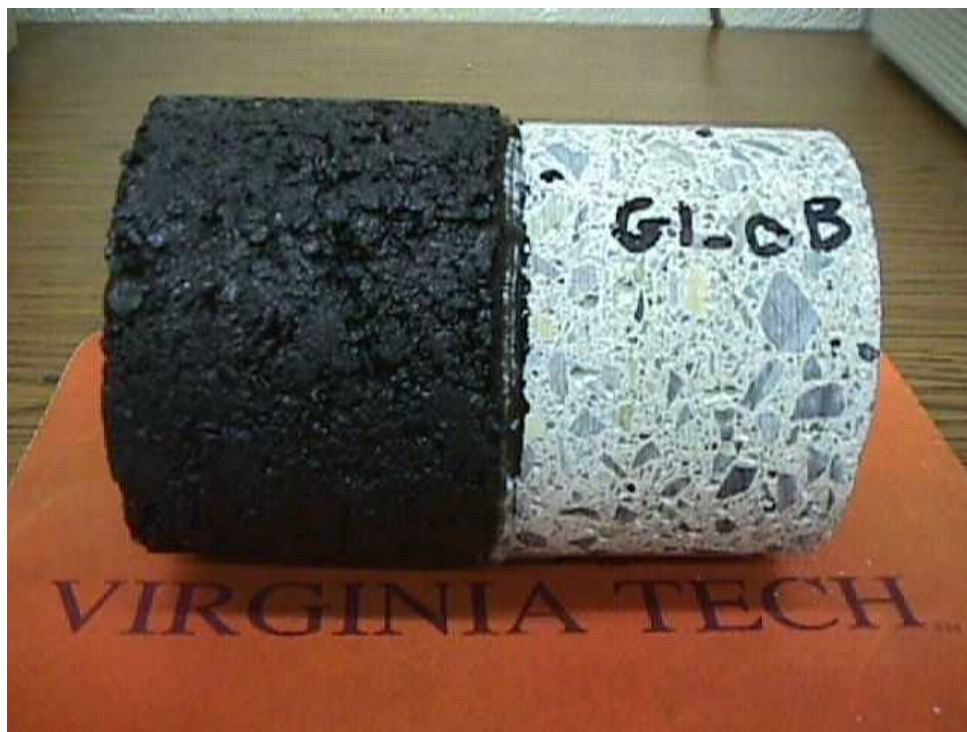
Figure C.24. Typical Simulated Bridge Deck Specimen before Failure.

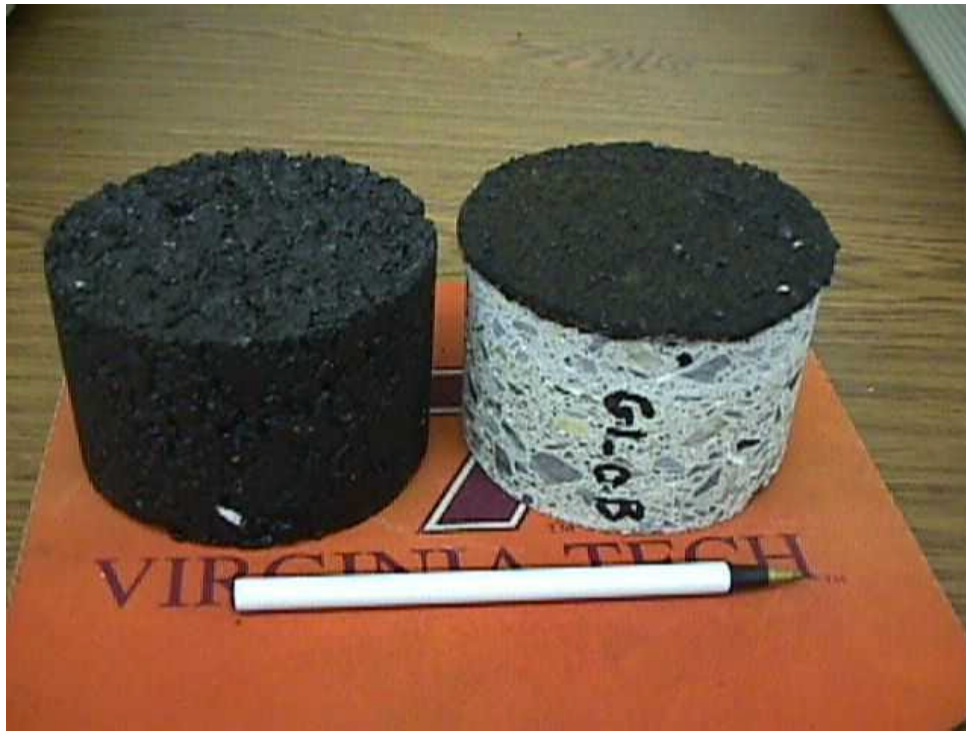
Figure C.25. Typical Simulated Bridge Deck Specimen after Failure.

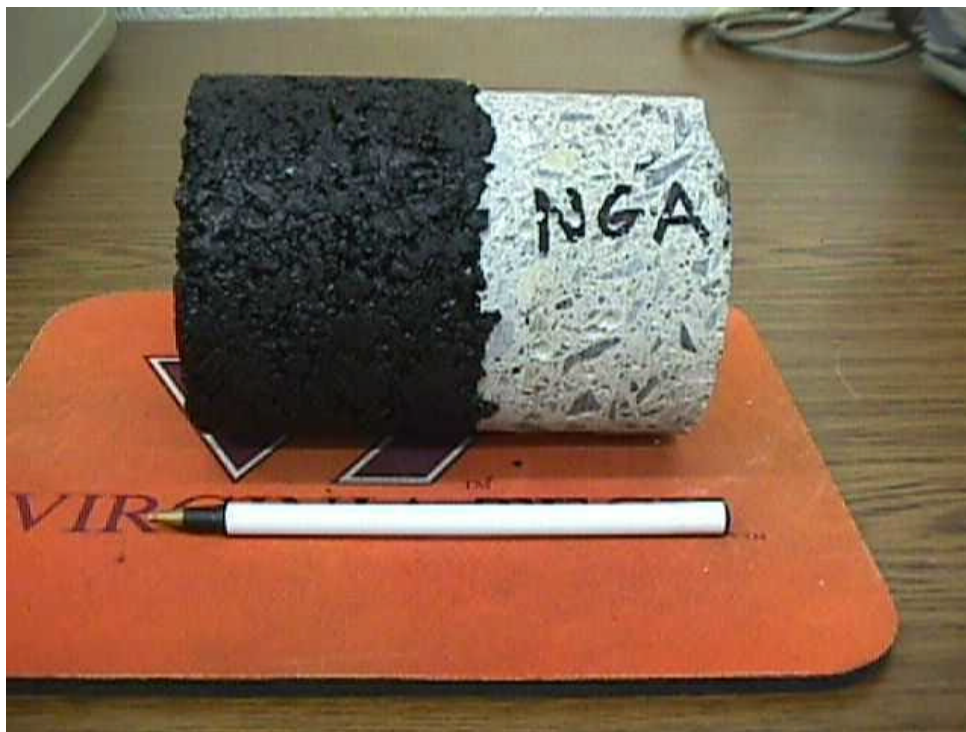
Figure C.26. Typical Control Bridge Deck Specimen before Failure.

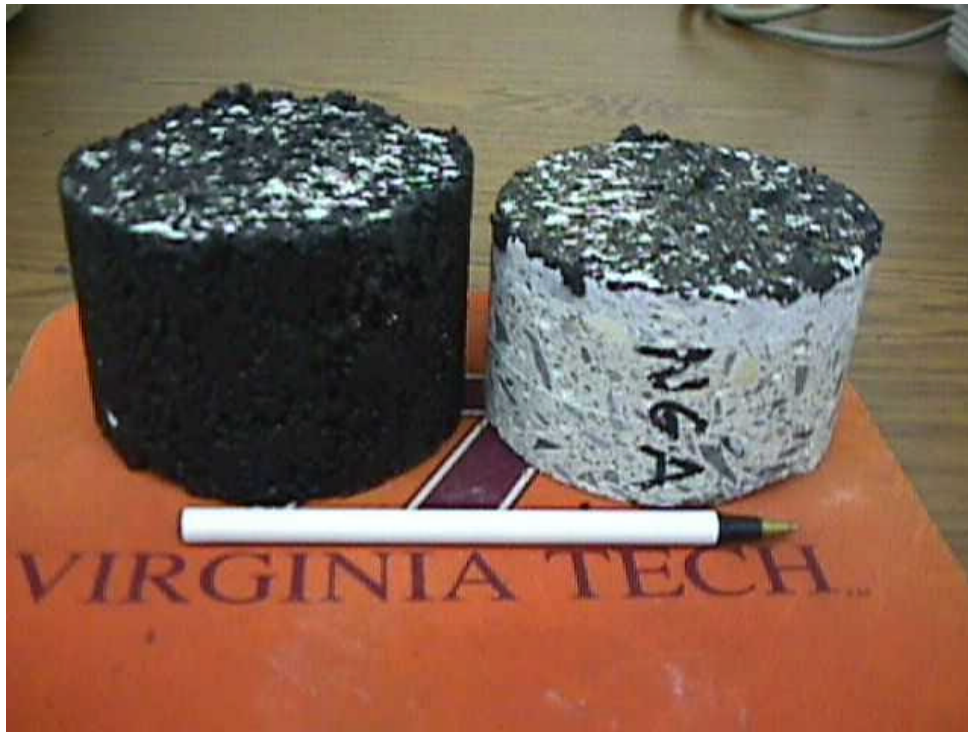
Figure C.27. Typical Bridge Deck Control Specimen after Failure.

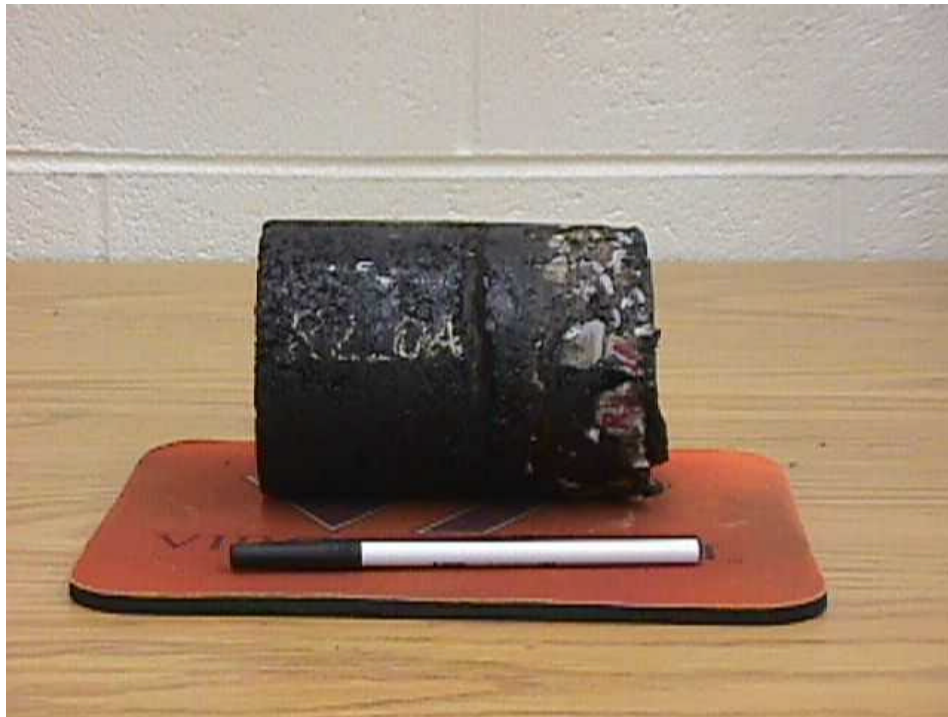
Figure D.9. Typical Road Specimen before Testing.

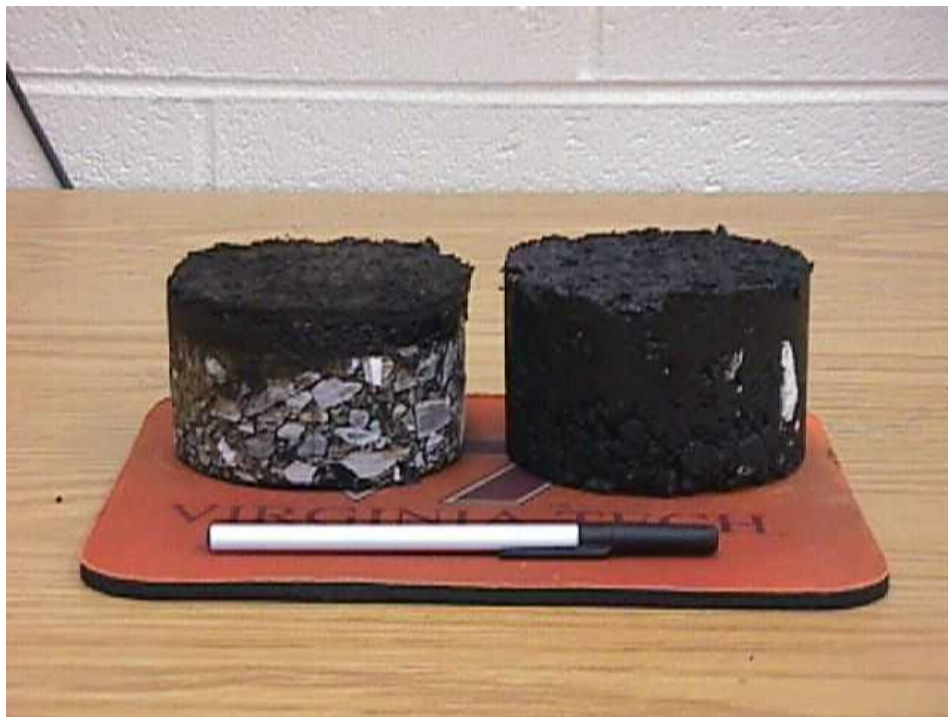
Figure D.10. Typical Road Specimen after Testing.

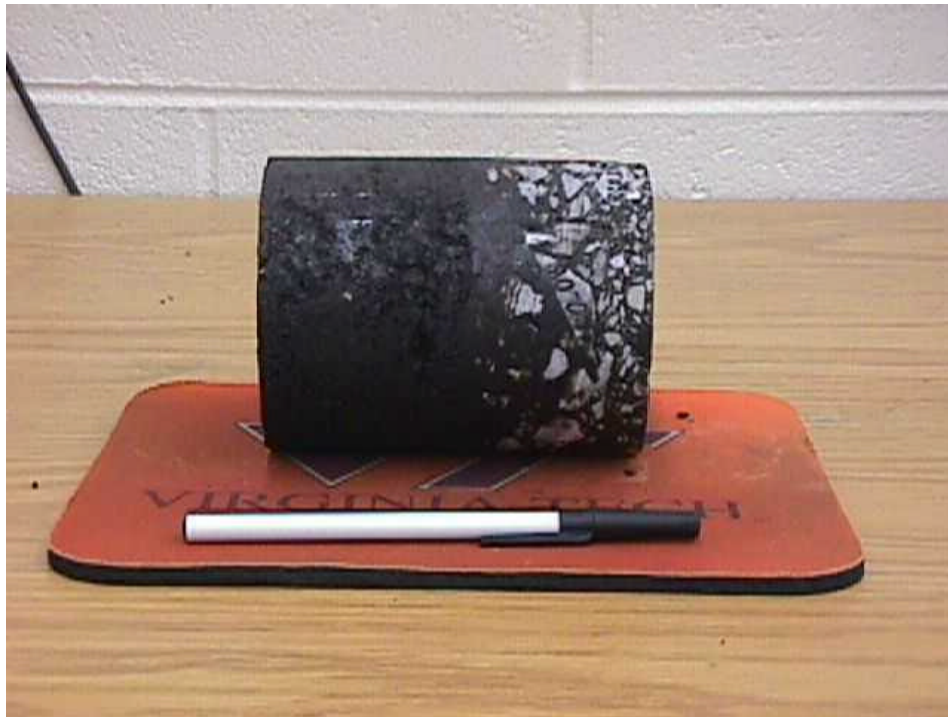
Figure D.11. Typical Road Control Specimen before Testing.
