# MECHANISMS OF CORROSION MICROCRACKS NUCLEATION IN 08X18N10T STAINLESS STEEL IN WATER SOLUTIONS AT 275 °C

**Karel Matocha**

VÍTKOVICE Research & Development , Ostrava , Czech Rep.

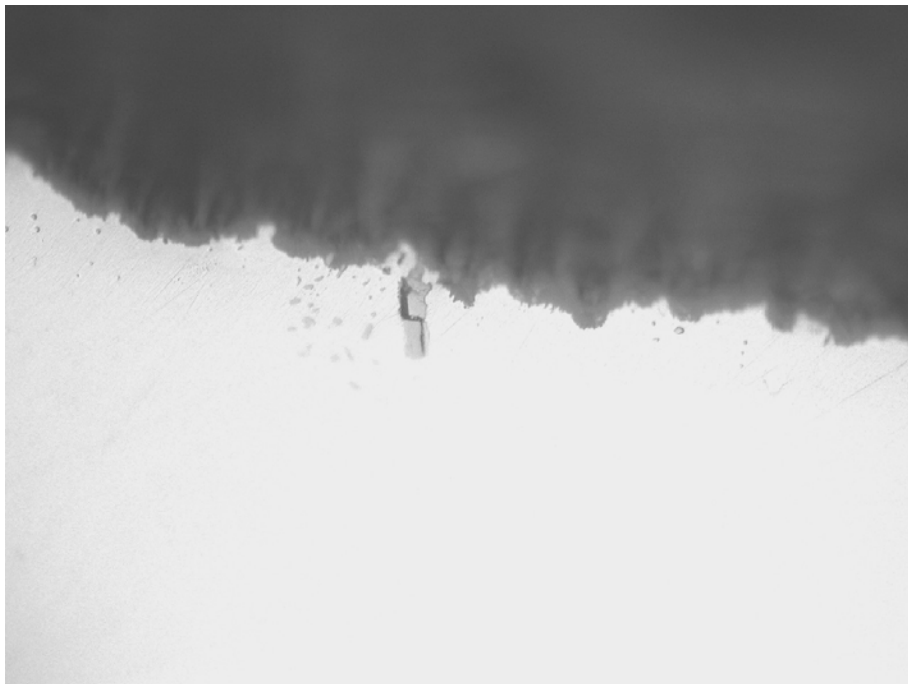
**zv. 500x**

Fig.4 Mechanical failure of inclusion (at matrix 08Ch18N10T) after loading in air at 275 °C,  $\varepsilon = 1,7 \%$ , exposition time 495 hours (cylindrical specimen 3 mm in diameter).

Longitudinal sections of the gage length of test specimen loaded to the total deformation of 1,7% revealed that nonmetallic inclusions of type  $\text{Ti}_4\text{C}_2\text{S}_2$  and  $\text{Ti}(\text{C},\text{N})$  serves as preferential nucleation sites of microcracks. Microcracks are nucleated at 275°C already in air due to either mechanical failure of nonmetallic inclusion/matrix interface (see Fig. 3) or mechanical failure of nonmetallic inclusion (see Fig. 4).

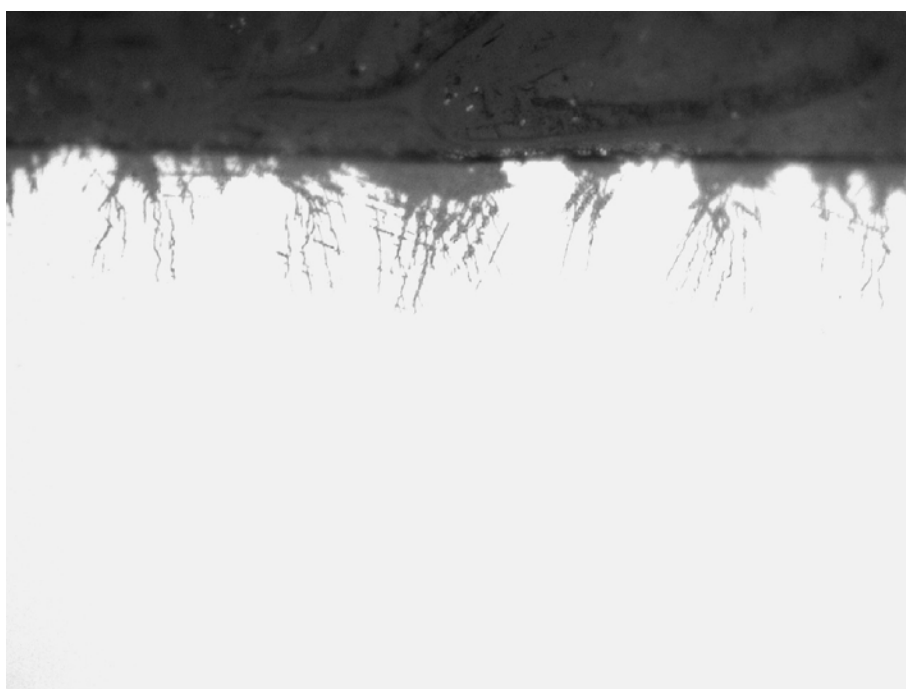
**zv. 1000x**

Fig.6 Microcracks nucleated from the bottoms of corrosion micropits on the surface of cylindrical specimen exposed in deaerated acid solution 500 ppm  $\text{Cl}^-$  prepared from HCl,  $\text{pH}_{275}$  1,85,  $\varepsilon = 1,7 \%$ , exposition time 240 hours

Another mechanism was observed on metallographic samples of test specimens exposed in deaerated acid solutions of  $\text{Cl}^-$  ions prepared from HCl. The microcracks were nucleated from the bottom of corrosion micropits observed on the fracture surfaces (see Fig. 5,6). The number of micropits is significantly dependent on concentration of  $\text{Cl}^-$  and high temperature pH of the solution. Fig.7 shows corrosion microcracks growing from both mechanically failed inclusions and from the micropits bottoms. Corrosion microcracks growing from failed inclusions intersecting the surface were found on test specimens exposed in deaerated acid solutions of  $\text{SO}_4^{2-}$  prepared from  $\text{H}_2\text{SO}_4$  (see Fig. 8). The character of these microcracks differs significantly of those nucleated from micropits in acid solutions prepared from HCl.
