Medium Voltage Aging Mechanism Update - 4

Cable Technology Laboratories
New Brunswick, NJ

Cable Users Group Meeting
Raleigh, NC
May 1-3, 2012

Deterioration of Shielded, 5 kV Black EPR Cable*

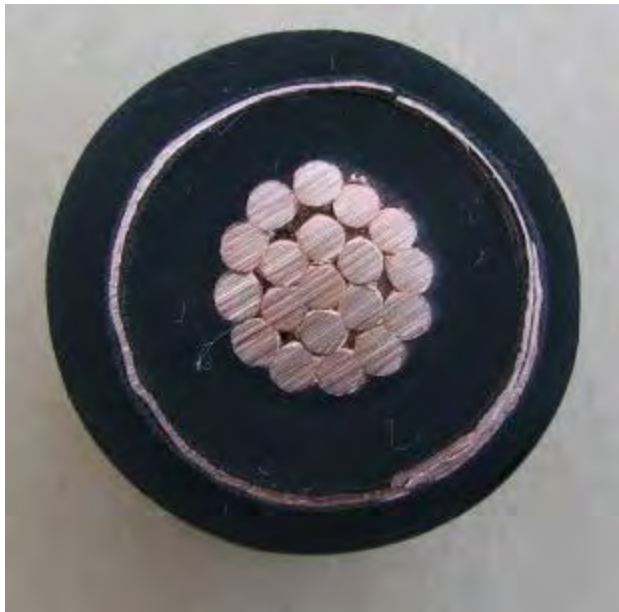
Cable Construction

Cable Description:
~1972, 5 kV, 3C, Black EPR Cable

Conductor:	2/0 AWG (67.4 mm ²) concentric stranded, coated copper
Conductor shield:	15 mil (0.38 mm) of extruded, semi-conducting compound
Insulation:	160 mil (4.1 mm) extruded, black EPR
Insulation shield:	semi-conducting, impregnated, fabric tape
Metallic shield:	single, coated copper tape
Separator:	woven fabric tape
Jacket:	107 mil (2.7 mm) (Hypalon or Neoprene)
Operating stress:	2400 V:170 mil = 14 V/mil (0.56 kV/mm)

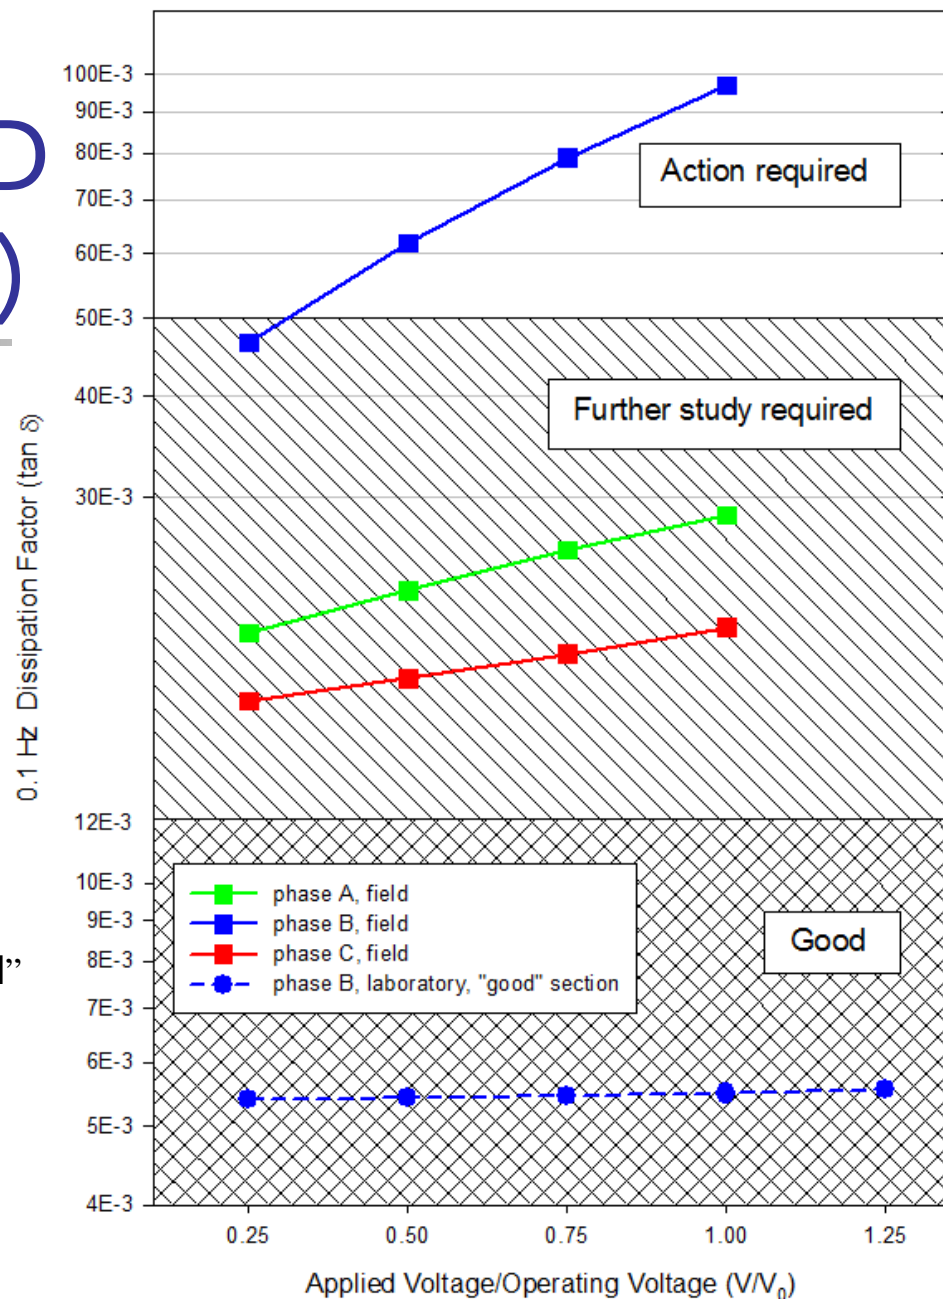
Field Results - TD (Average Values)

Limits “Good, Further Study Required, Action Required” taken from 2010 EPRI Report 102085, titled “Plant Support Engineering: Aging Management Program Guidance for Medium-Voltage Cable Systems for Nuclear Power Plants.”

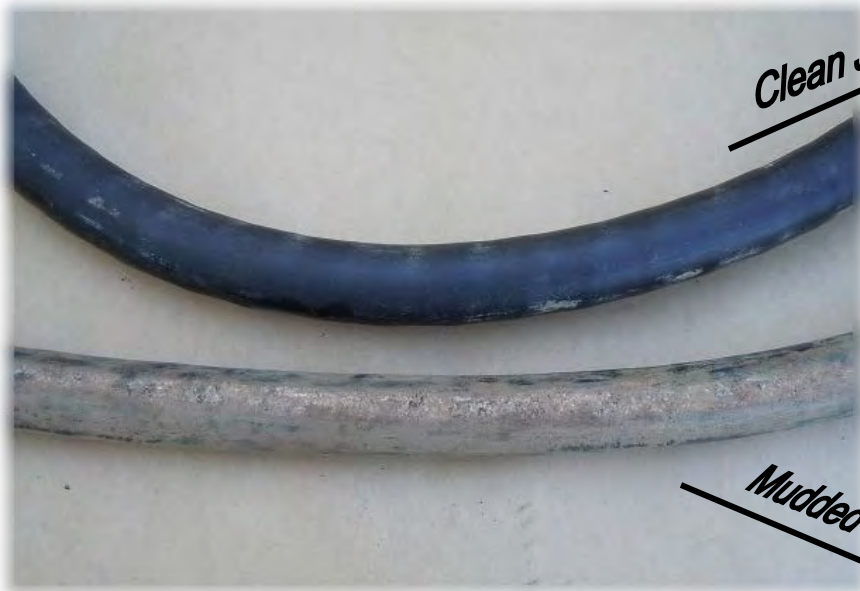
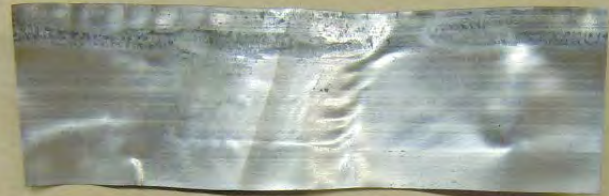
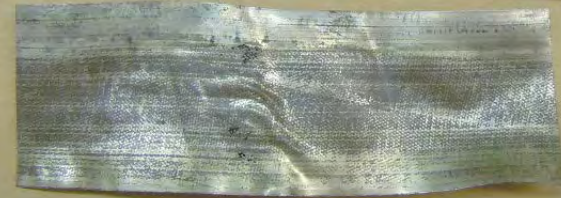
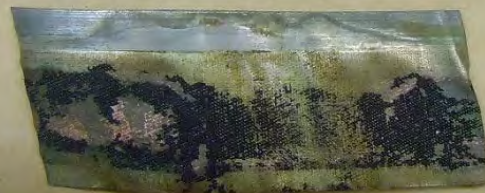
Metallic Shield Under Clean and Mud-covered Jacket

Clean Jacket

Inner
Surface

Outer
Surface

Mudded Jacket

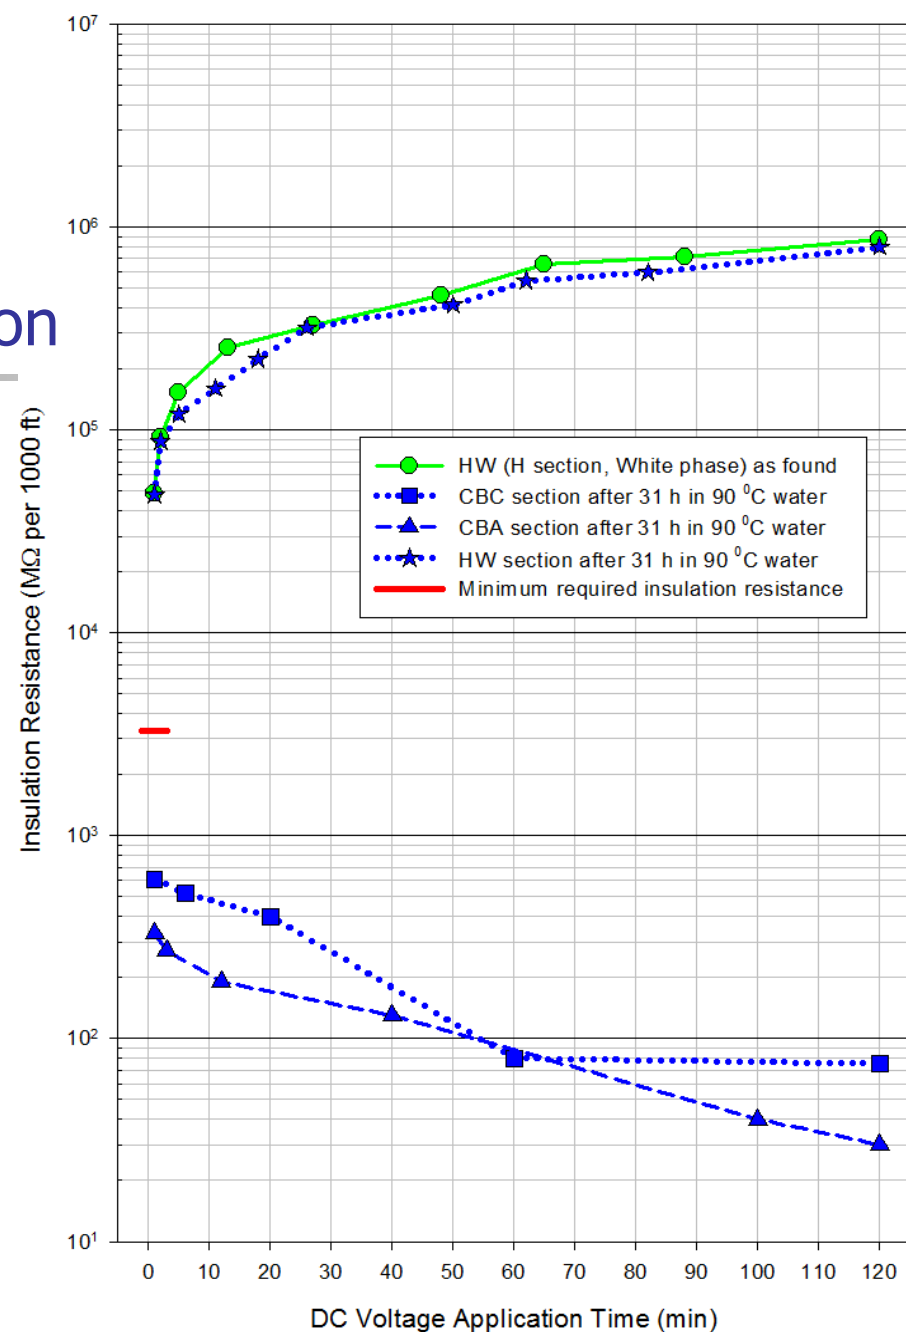
Looking Back (cont'd): Insulation Resistance vs. Time of Voltage Application

(another Black EPR cable)

Polarization Index:

Insulation Resistance after 10 min /
Insulation Resistance After 1 minute

Polarization index previously used as
indicator of insulation status made
sense.

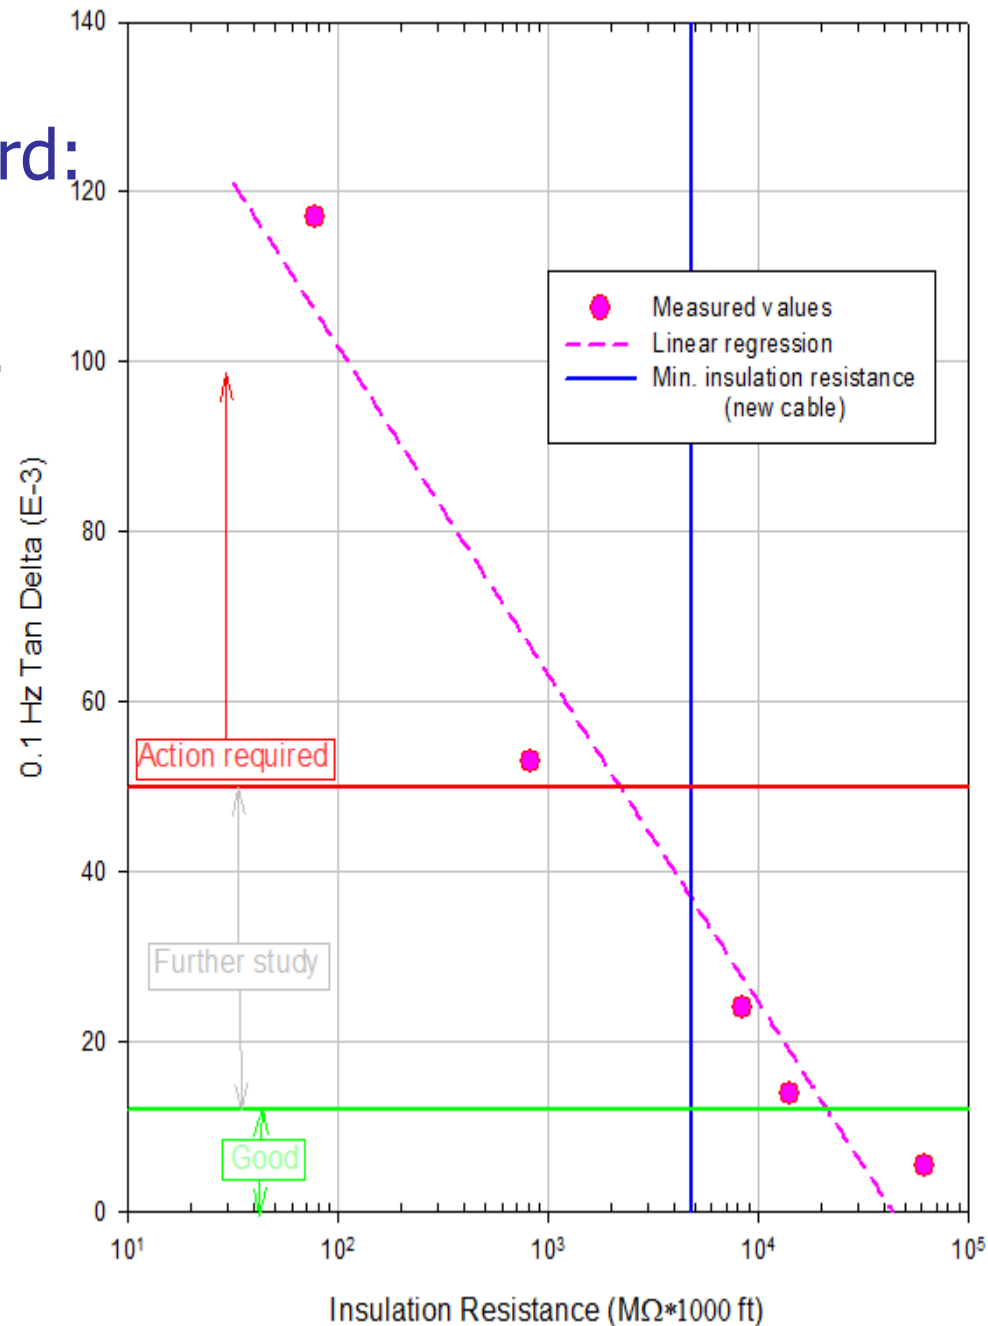
Looking Back & Forward: 0.1 Hz Tan Delta vs. Insulation Resistance

In wet aging, insulation resistance
correlates well with 0.1 Hz Tan Delta

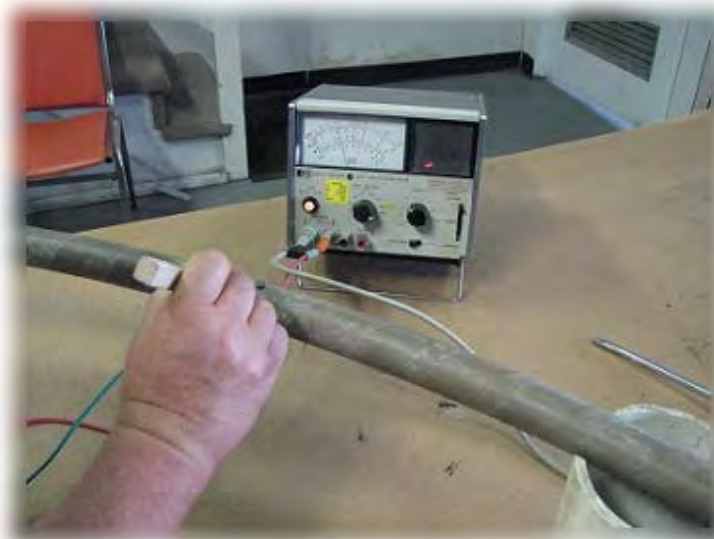
Search For Low Resistance Points

$$IR = 1.0 \times 10^9 \Omega = 12 \text{ M } \Omega \cdot 1000 \text{ ft}$$

- Cable failed at low test voltage of 6.5 kV ($2.7 V_0$) without observable partial discharge
- Low insulation resistance channels were present in the insulation. Lowest single channel resistance $\sim 1 \times 10^9 \Omega$
- At operating voltage, power dissipated in such a channel:
$$(2.4 \text{ kV})^2 / 1 \times 10^9 \Omega = 5.8 \text{ mW}$$
- Diameter of low resistance channel $\sim 20 \text{ mil} \rightarrow S = 0.2 \text{ mm}^2$
- Density of Dissipated power in a channel:
$$5.8 \times 10^{-3} \text{ W} / 0.2 \text{ mm}^2 = 29 \text{ mW} / \text{mm}^2$$

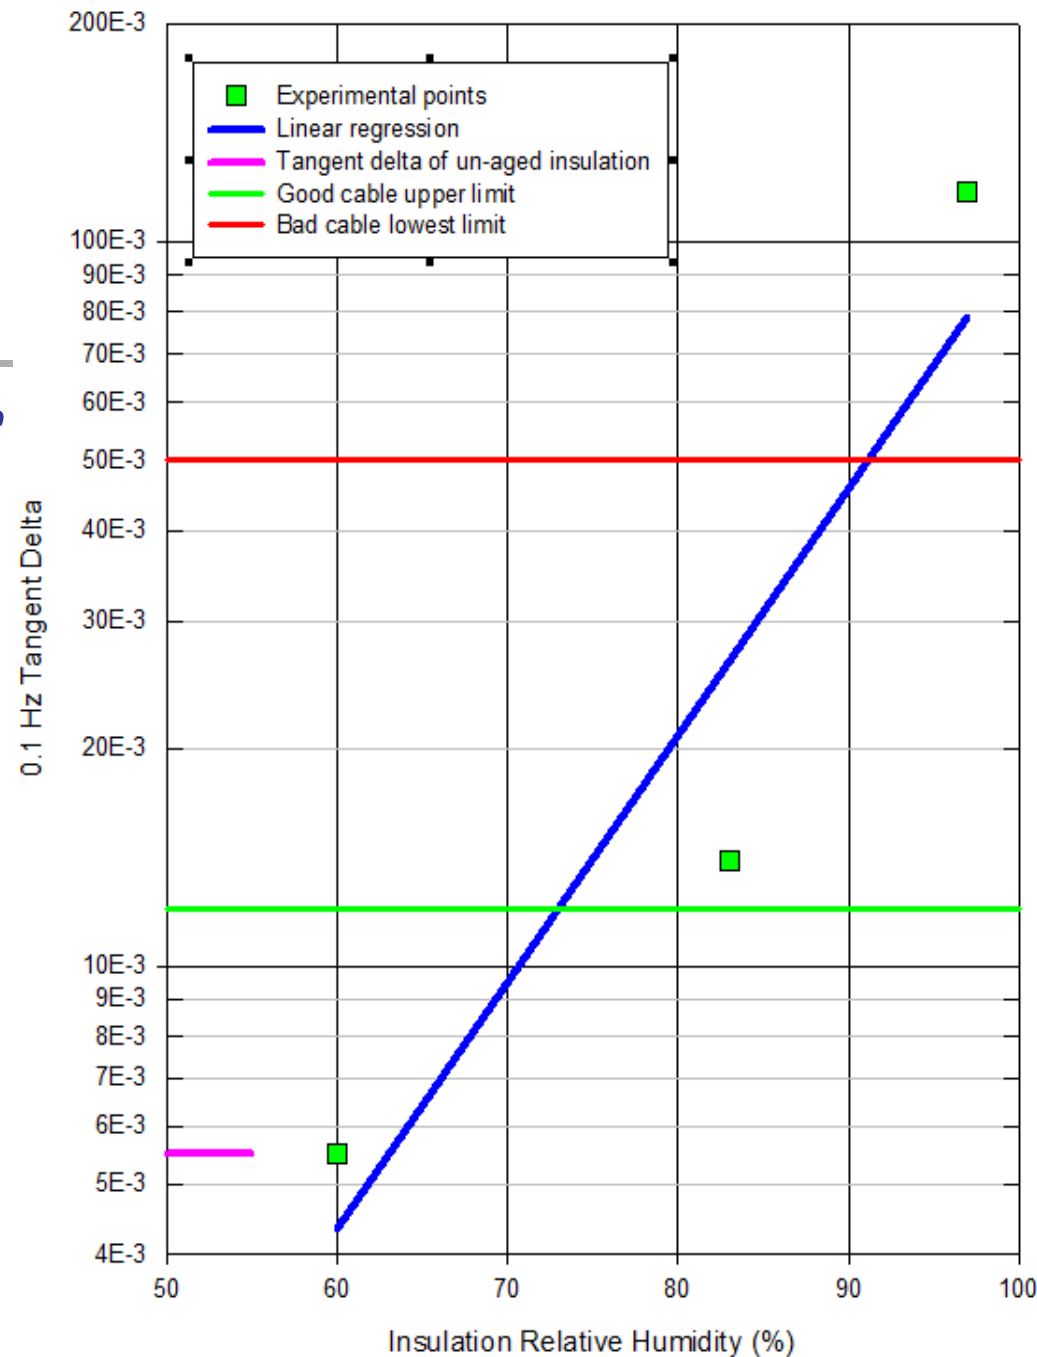
0.1 Hz Tan Delta vs. Insulation Relative Humidity

*(Black EPR insulated cable
after 35 years of service)*

- Very advanced aging of phase B indicated by high TD at voltages as low as $0.25 V_0$ and low insulation resistance
- Sections of B phase affected to a different degree by water
- Degree of insulation degradation correlates with insulation (air) relative humidity
- Cable failed in laboratory without observable partial discharge
- Cable's final “bucket kick” seems to be thermal runaway.

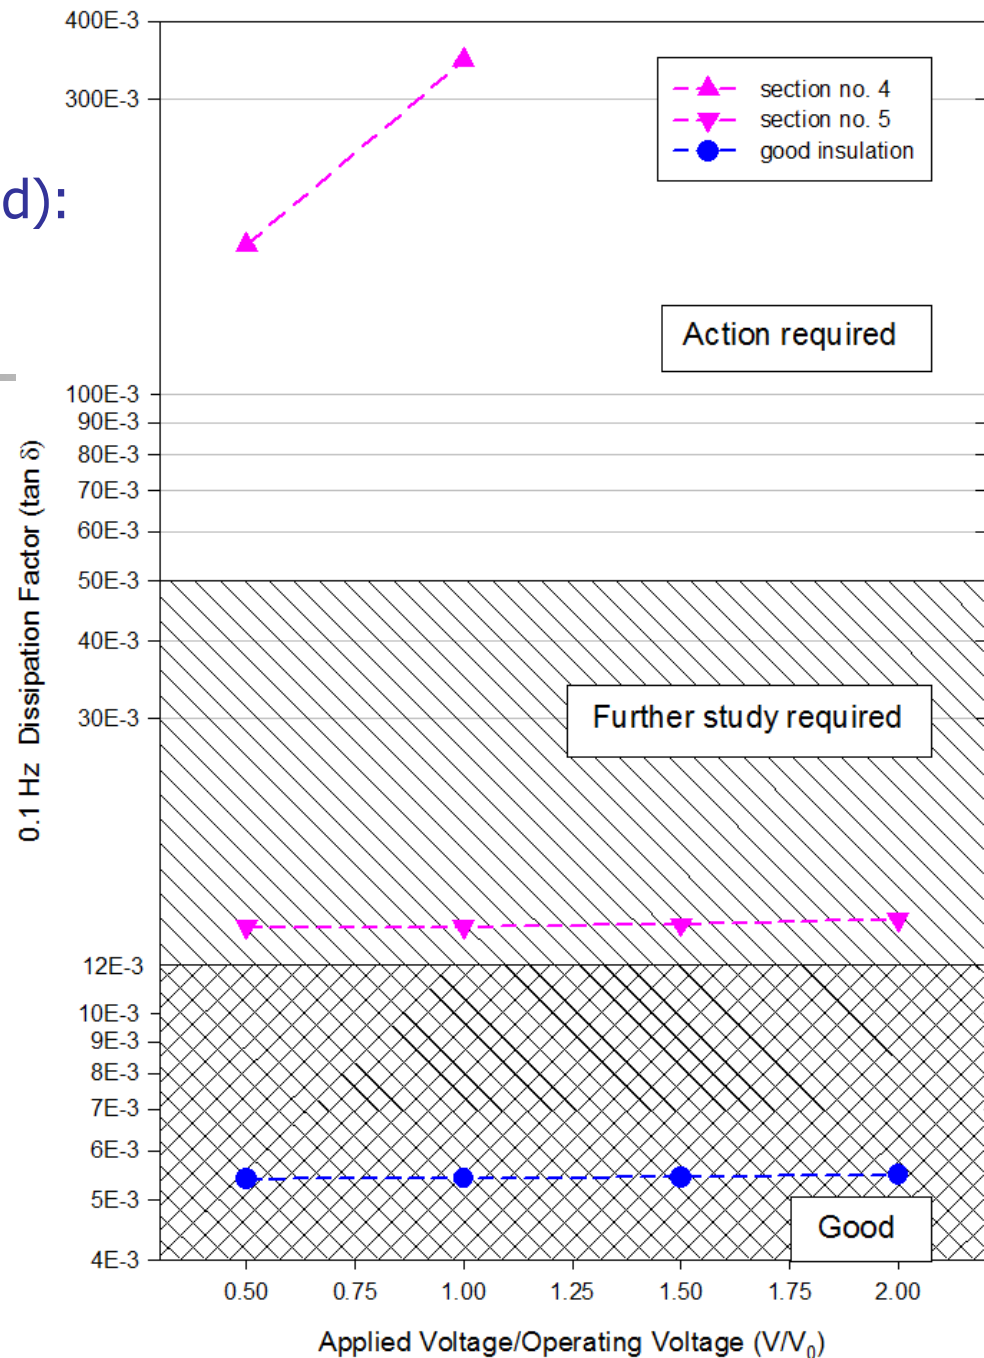
Laboratory Evaluation (cont'd): Black EPR, 5 kV Cable, in Service about 32 Years

Each section, 7 ft long

Section Number	Insulation Resistance, $M\Omega$
1	9E6
2	3E6
3	6E6
4	3E4
5	4E6
6	4E6
7	3E6
