MAINE EAST
MEP CONDITION ASSESSMENT

MAINE EAST HIGH SCHOOL

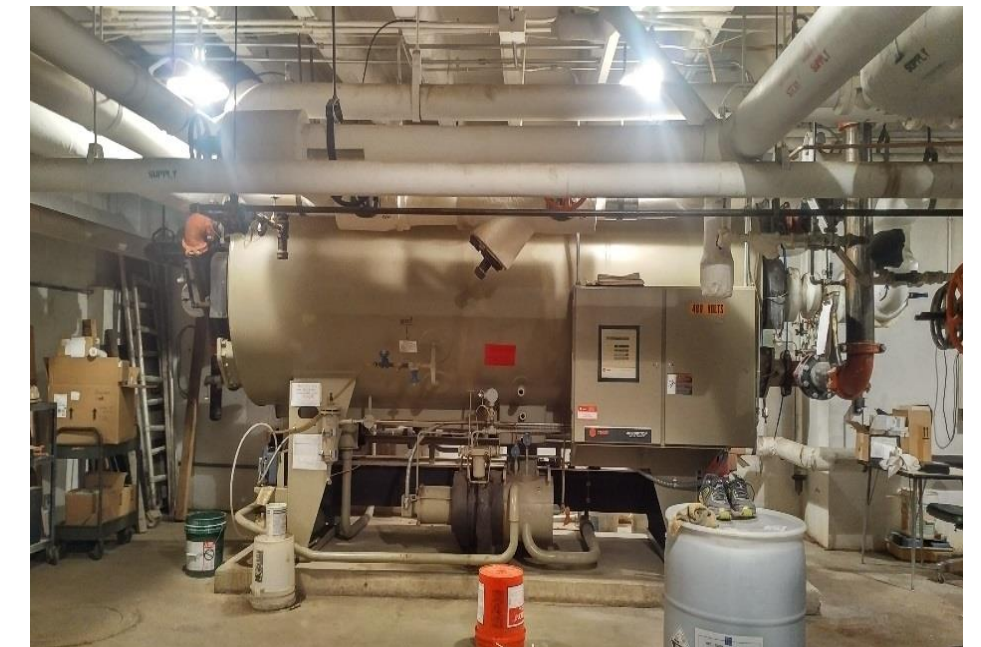
Center Court Chiller

Based on conversations with maintenance staff the two (2) 3-way condenser water valves serving these chillers do not function properly. Please reference the Cost Estimates section for additional details.

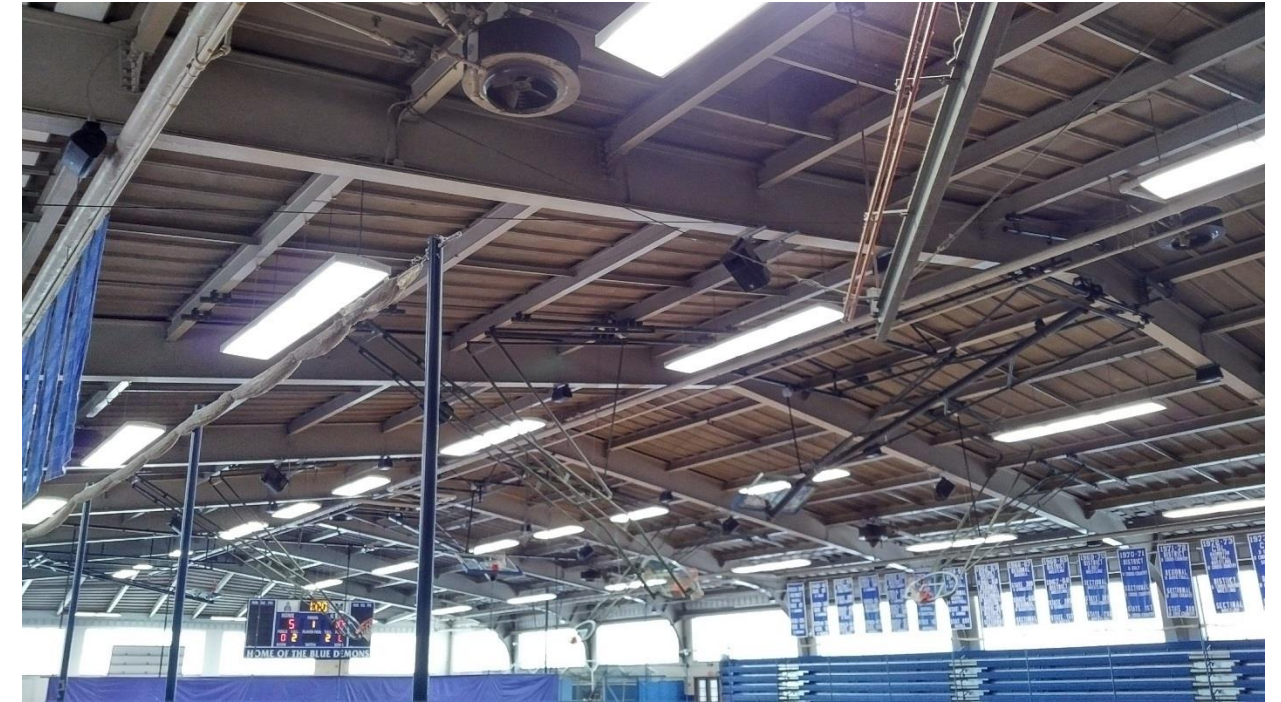
Fieldhouse Unit Heaters

The fieldhouse is heated by eleven (11) ceiling suspended steam unit heaters and there are six (6) ceiling mounted louvers that allow for fresh air infiltration. There is no means of cooling for the fieldhouse. Based on our observations, there appears to be a lack of adequate ventilation for this space given how many people may occupy it.

It is recommended to equip the fieldhouse with either two (2) or four (4) variable volume packaged rooftop units that utilize DX cooling and gas heating. Immense comfort and ventilation improvements would be satisfied with this upgrade. Please reference the Roof Top Unit Cost Estimates section for pricing details.

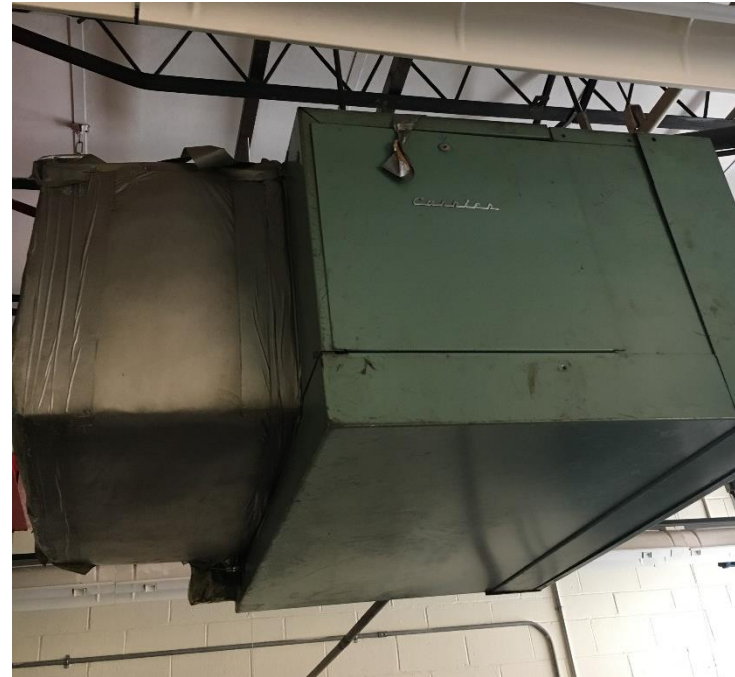
1. Copy Room AHU – This AHU is hung from the copy room ceiling and is thought to be from the 60s. It utilizes a DX cooling coil with an associated condensing unit on the roof to provide cooling only to this space. This AHU is aged beyond it's expected service life.
2. Boys' Team Sports Lower Level Locker Room AHU – This AHU is in the first-floor fan storage room adjacent to the fieldhouse and is believed to be from 1960s. It is equipped with a steam heating coil and serves the basement level boy's locker room. Elara is currently in the process of designing a replacement for this unit. Please refer to this project for further information.
3. Foyer AHU – This AHU is located in a closet adjacent to the foyer room on the south side of the building. This unit is equipped with a steam heating coil and a return fan. It is believed that this unit is from the 1960s.

Due to the aged condition of the Xerox Room AHU, it is recommended to replace it with a unit equipped with a DX cooling coil with an associated condensing unit and either steam, electric or hot water heating coil. Further evaluation would be required to determine which type of heating is most cost effective.

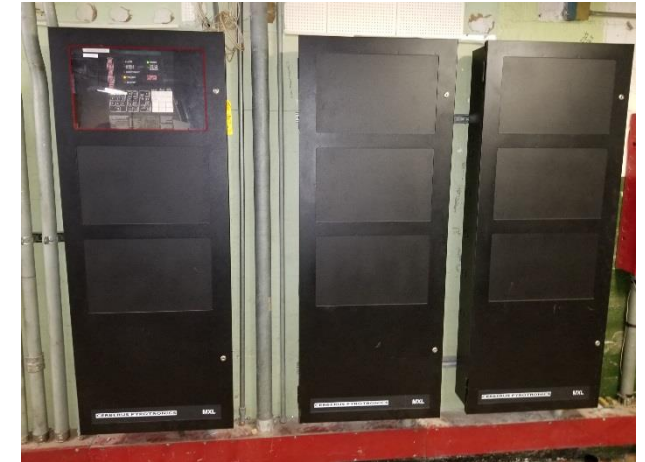
Fire Alarm Control Panel

The requirement of addressable devices requires the installation of new expansion cards in the existing fire alarm panel. There is not enough space in the existing fire alarm panel to install new cards, and due to the magnitude of new code requirements, it is recommended to install a completely new system that meets all requirements.

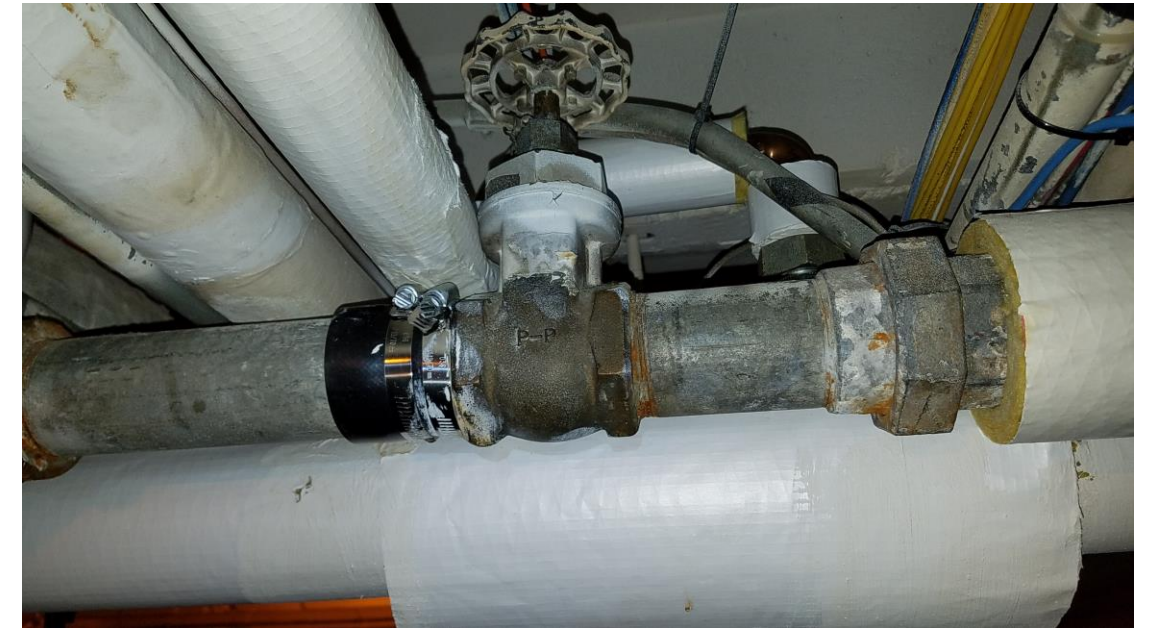
Sample of Failed Existing Galvanized Piping

Due to the fact that the piping is a) galvanized, b) corroding and generating rust/debris, especially on a water shut-downs, c) isolation valves failed/failing, d) check valves fowled/failed/failing or not present, e) balancing valves fowled/failed/failing or not present, and f) the resultant impact on the ability to balance the hot water recirculation the domestic cold water and hot water piping is recommended to be replaced. If replacement is necessary to be phased, the immediate focus should be on replacement of common horizontal piping, isolation valves, check valves, and balancing valves.

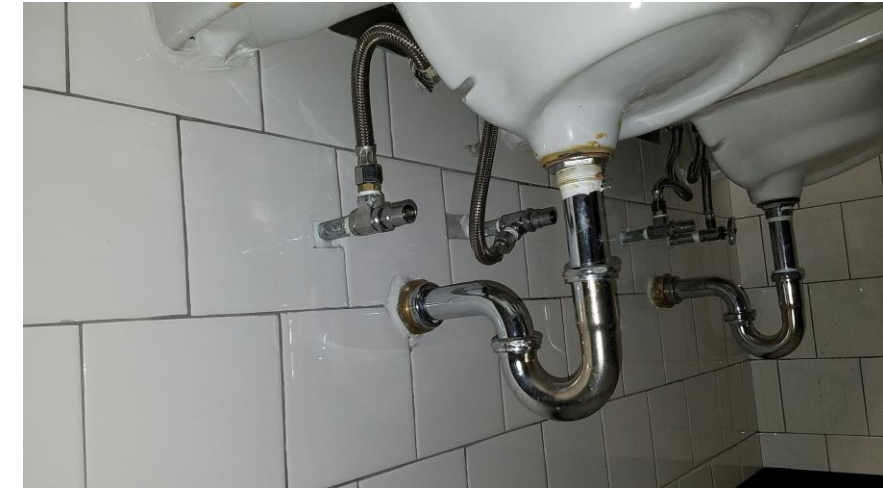
Existing Lavatories without TMV's

Existing thermostatic mixing valves in need of repair shall be repaired/replaced as part of necessary regular maintenance program.
