National Register of Historic Places  
Inventory—Nomination Form

9. Fire Station and City Hall

Location: 224 North Guadalupe Street

Historic Resources of San Marcos  
San Marcos, Hays County, Texas  
#9. Fire Station and City Hall

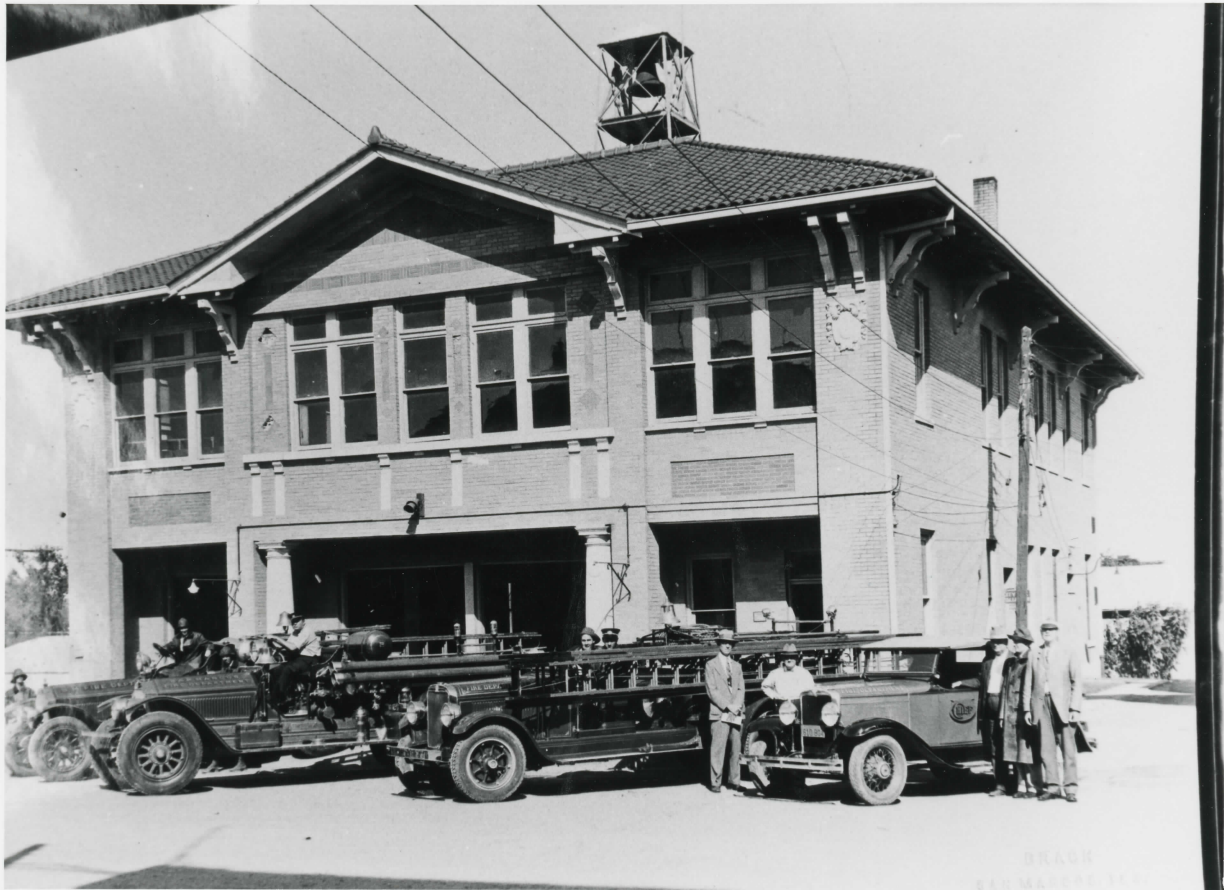
Photo 42 of 150.

Photo courtesy of San Marcos Public Library,  
taken c. 1915. Copy photo by Sally S. Victor  
negative property of HASM, on file at SMPL.

Southwest oblique, camera facing northeast.

Except for the west facade, which has windows with one-over-one lights, the windows have two-over-two lights. A historic photo shows that the 1/1s are original, and that their transoms, now filled in, were once clear. There are 11 windows lined regularly on the west second floor. On other walls they are arranged irregularly. A stranded second-floor door on the east wall shows that a stair has been removed there. All windows are on stone or concrete sills.

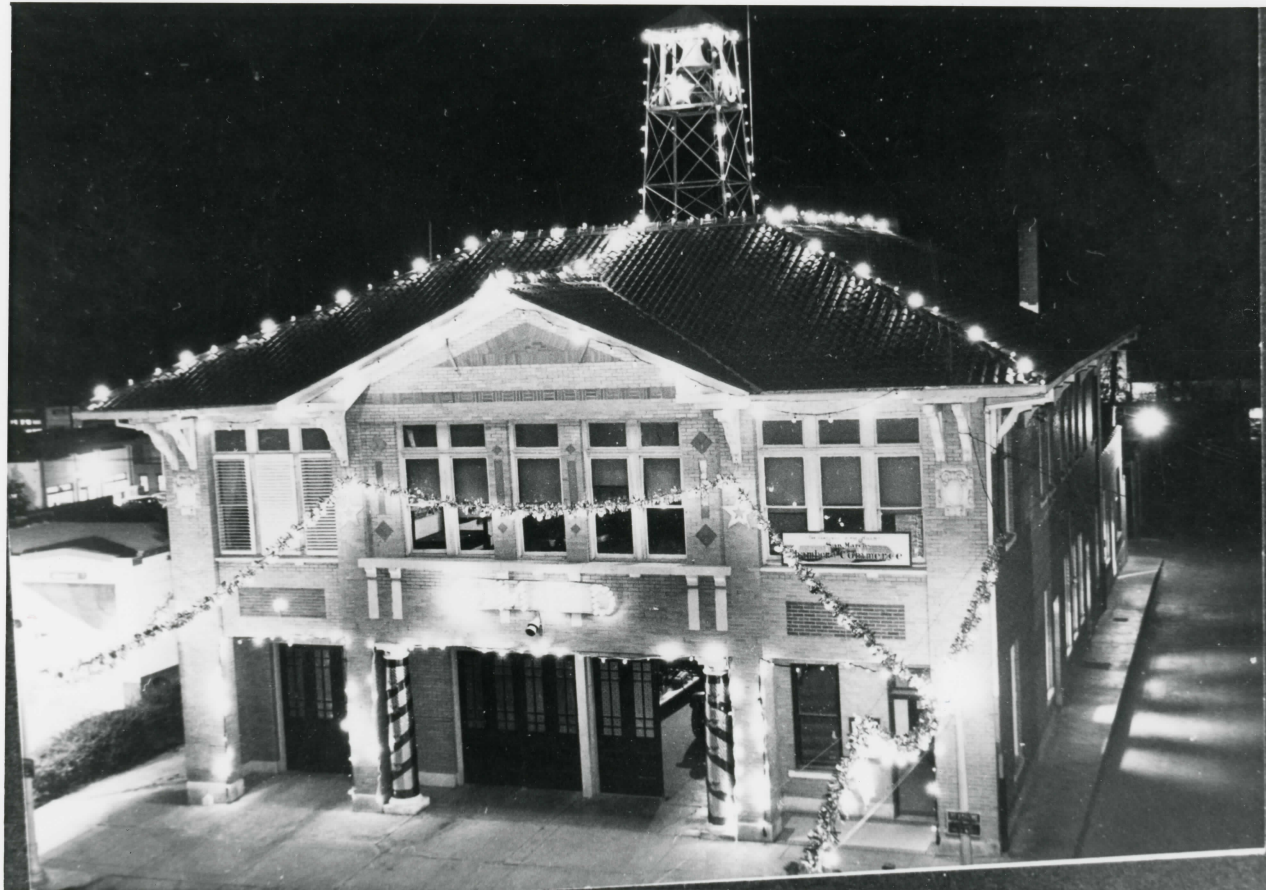
Photo courtesy of Tula Townsend Wyatt, taken  
1960. Copy photo by Sally S. Victor,  
negative property of HASM, on file at SMPL.

Southwest oblique, camera facing northeast.  
Photo 43 of 150.

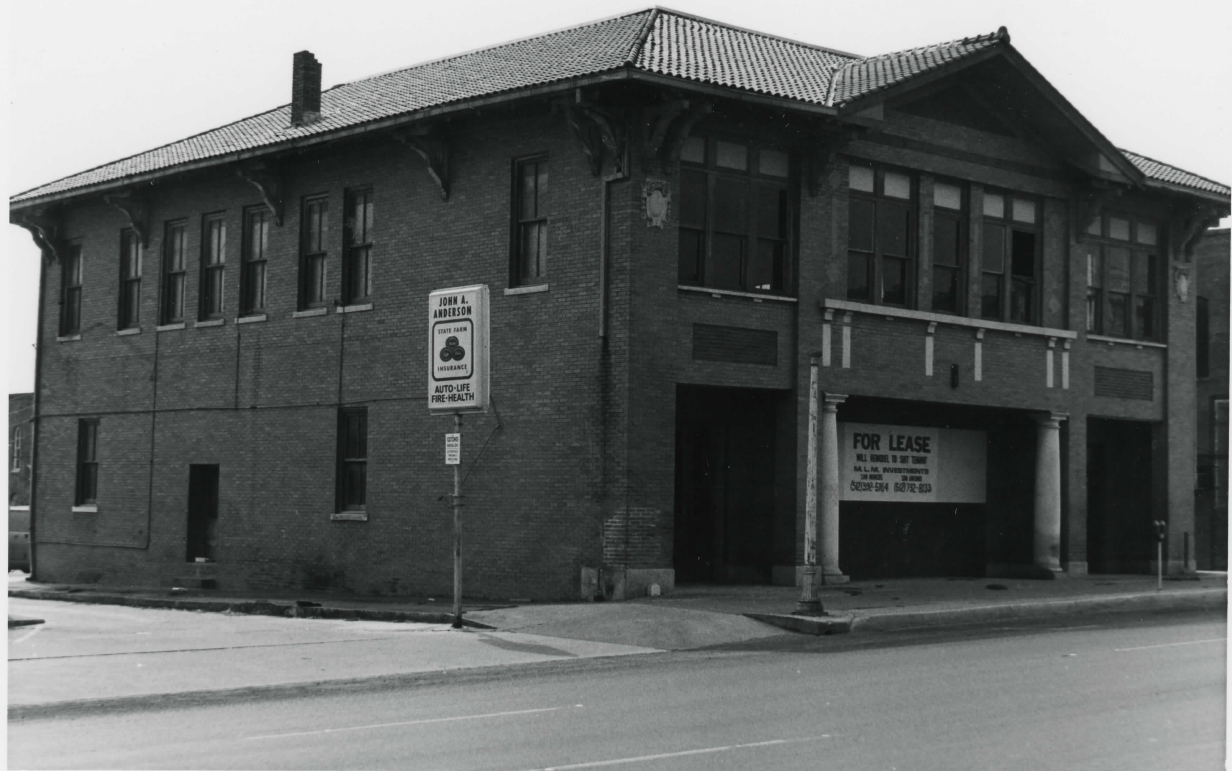
Photo by Lissa Anderson, June, 1982.  
Negative property of HASM, on file at SMPL.

Northwest oblique, camera facing southeast.  
Photo 44 of 150.

Decoration is concentrated on the front (west) facade. Three entrances (the central, multidoored one is hidden behind the "For Lease" sign) are inset to form an overhang supported by brick piers and, inside the piers, two unfluted Doric columns. On the wall surface dark brown brick, tiles, and concrete forms in geometric shapes contrast with the light brick. Stone or concrete cartouches at the corners add a softening touch. Dentils and openwork brackets, some of them paired, are found under the overhanging eaves.

The four-panel door at the northwest is like the eight doors of 10 lights each hidden behind the sign. At the southwest corner is a simple single door that leads to the long, narrow, city-hall section and a front stair. Interesting features in the city-hall area are the green and white octagonal tile floor and the vault doors that appear to be painted metal. One displays a lion's head, composite pilasters, and a dentiled entablature. The other has an acanthus-leaf frieze. Besides this room, its vaults, and the fire engine room, there is another room to the rear. The second floor is one large room, now open to the roof, devoid of detail. There is a brick chimney near the southeast corner. The only other major change to the building was the removal of the bell and its metal tower from the roof. It was feared that their weight would cause them to crash through.
