Anhydrous Ammonia Accident

November 18, 2011

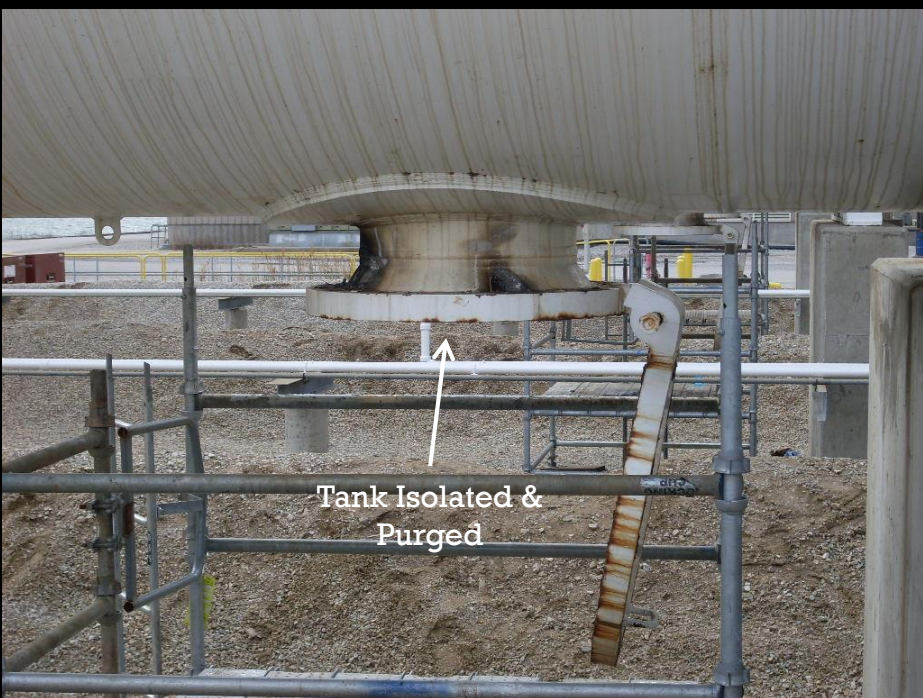
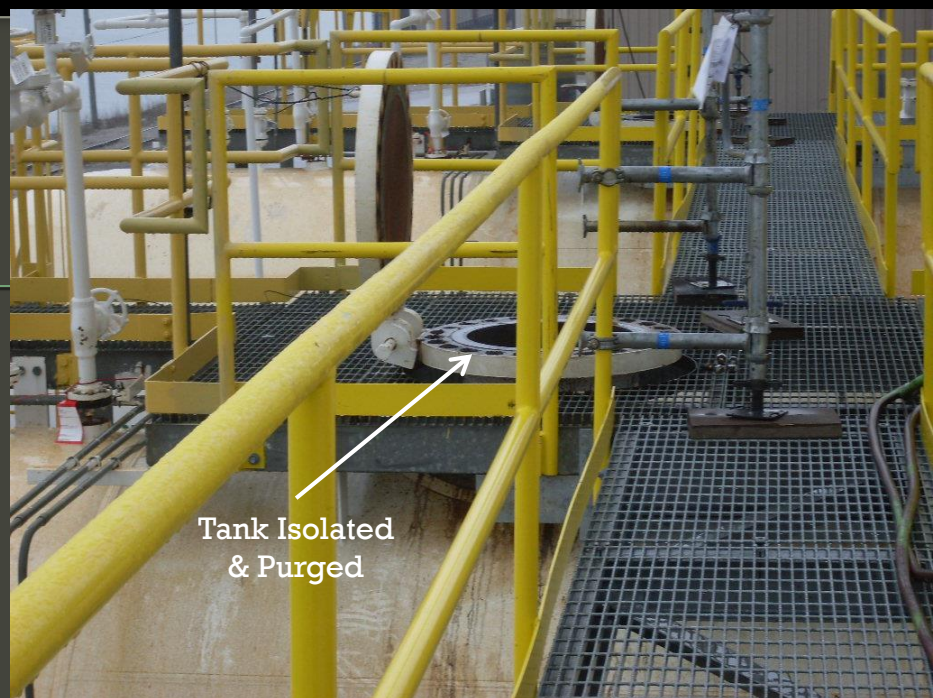
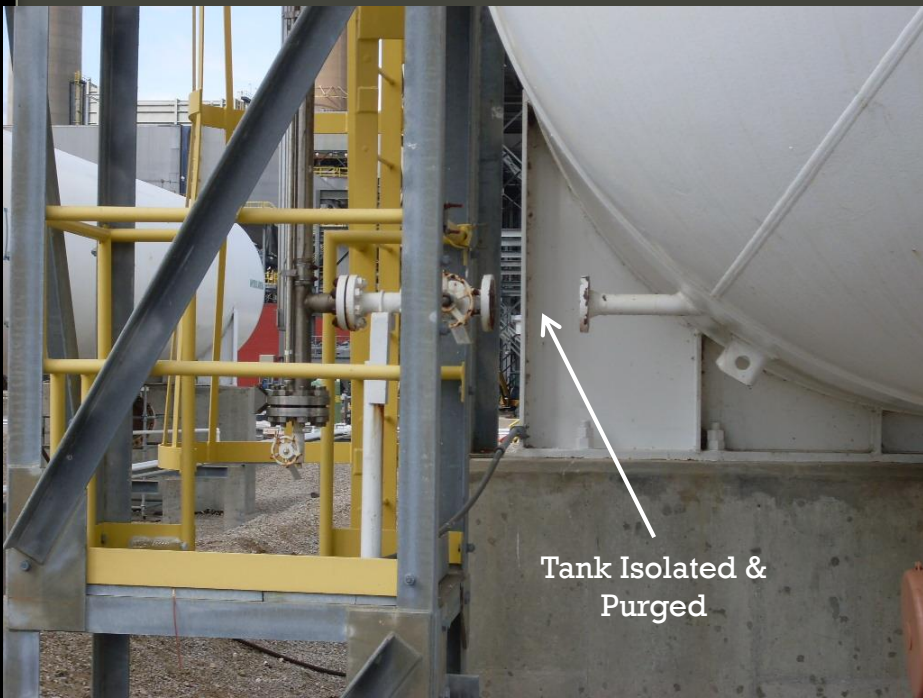
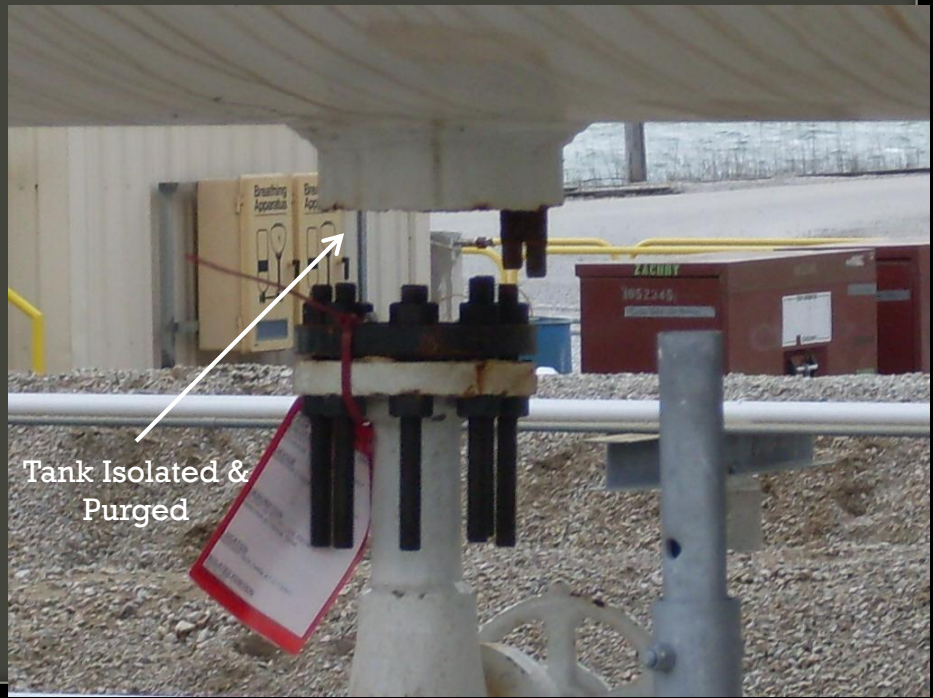
Valve that was being removed when accident occurred

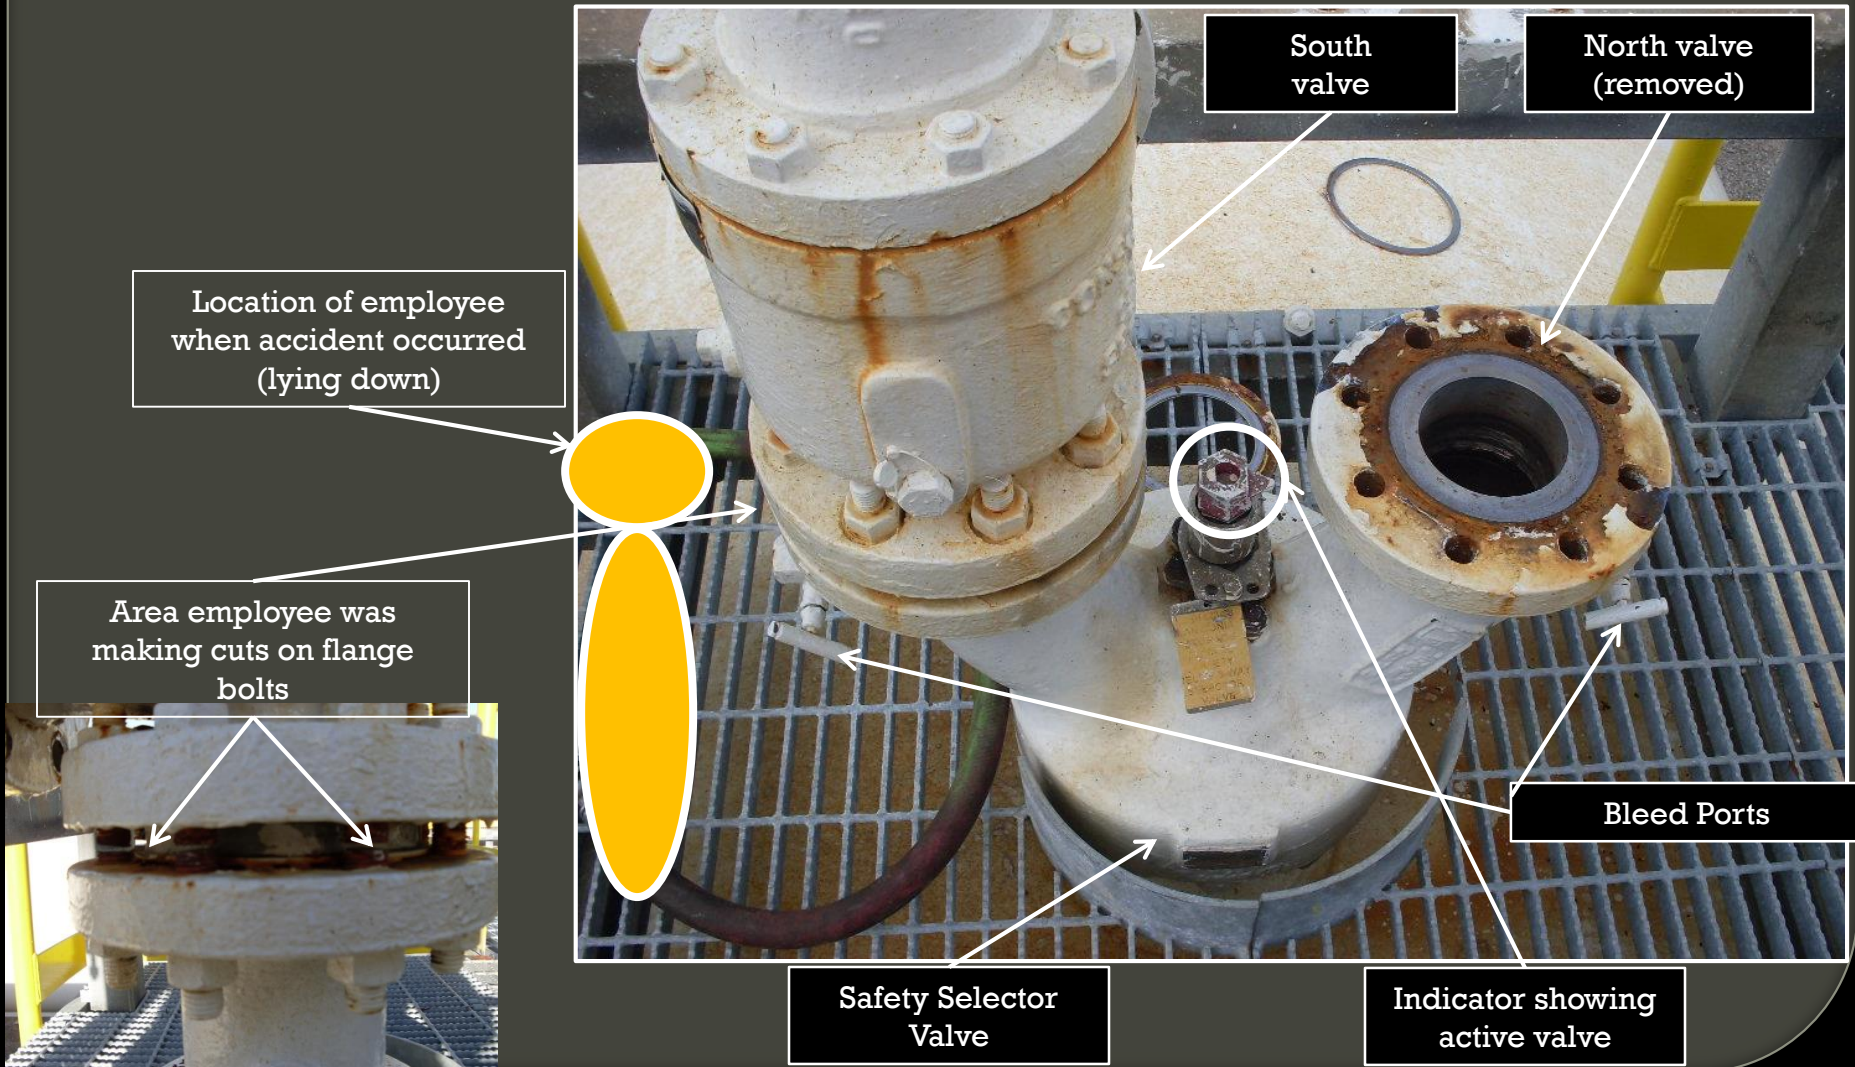
Safety selector valves on tanks “E” and “D” (RV’s removed)

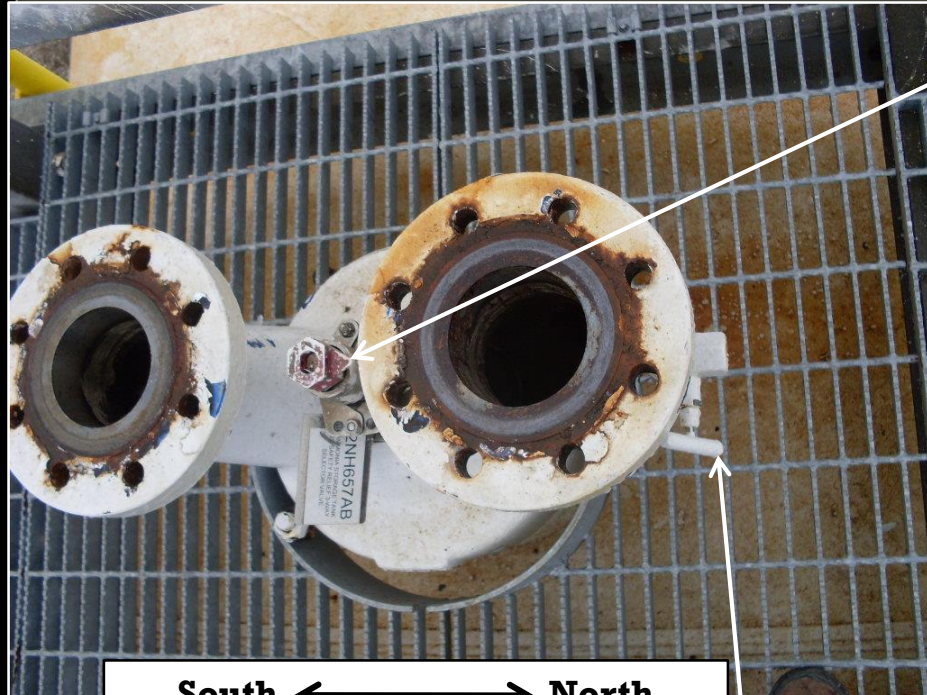
E-Valve

Indicator pointing toward north valve

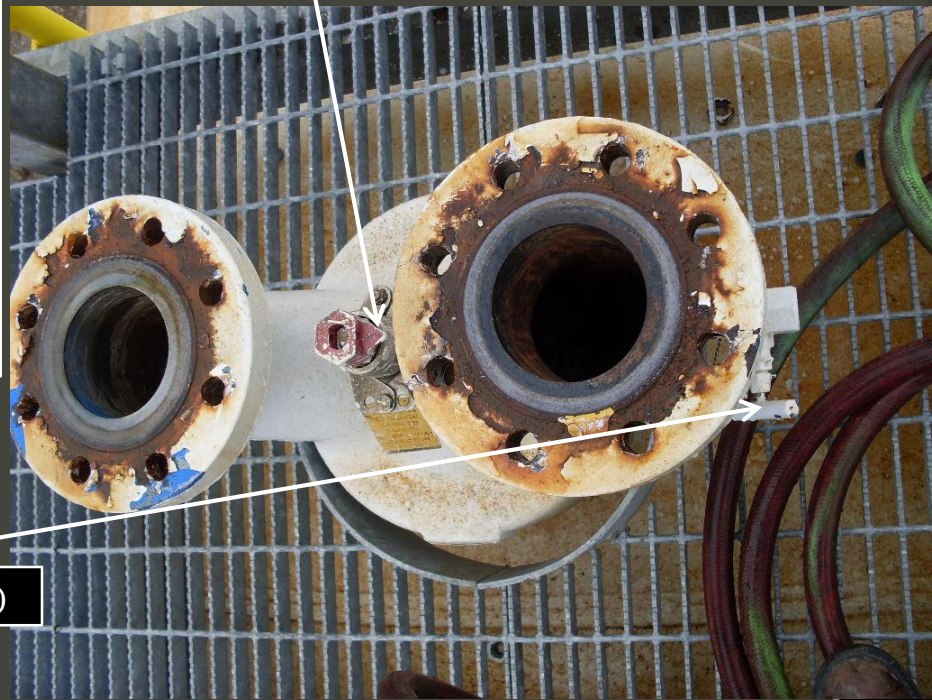
D-Valve

South ← → North

Bleed Valve open (north)

Safety Selector Valve “C” Tank

- “C” valve is the valve where the accident occurred.
- This is a view to get a prospective of the valve configuration
- Notice the bleeders north and south
- Note the indicator pointing north

- Review ammonia system procedures and LOTO's to include Safety Selector and all bleed valves, insuring all are identified, labeled, and utilized during servicing and maintenance work activities

- Perform pre-job briefs reviewing system and LOTTO procedures and specific hazards identified in task being performed.
- Ensure bleed valves are open and operate correctly

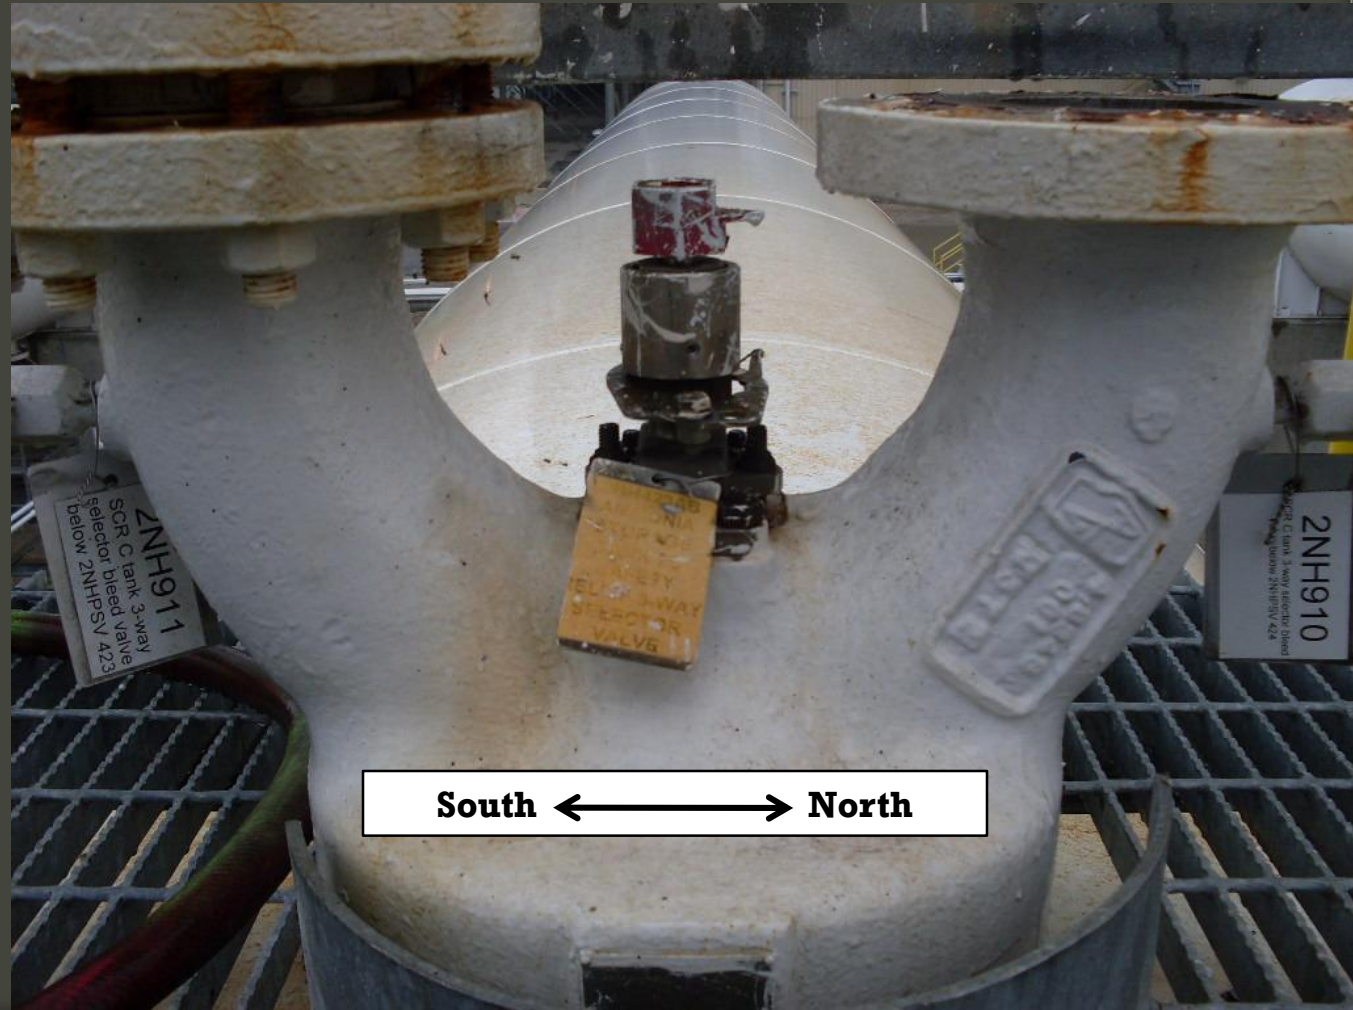
Picture looking down into the SSV

South (sealed port of the SSV)

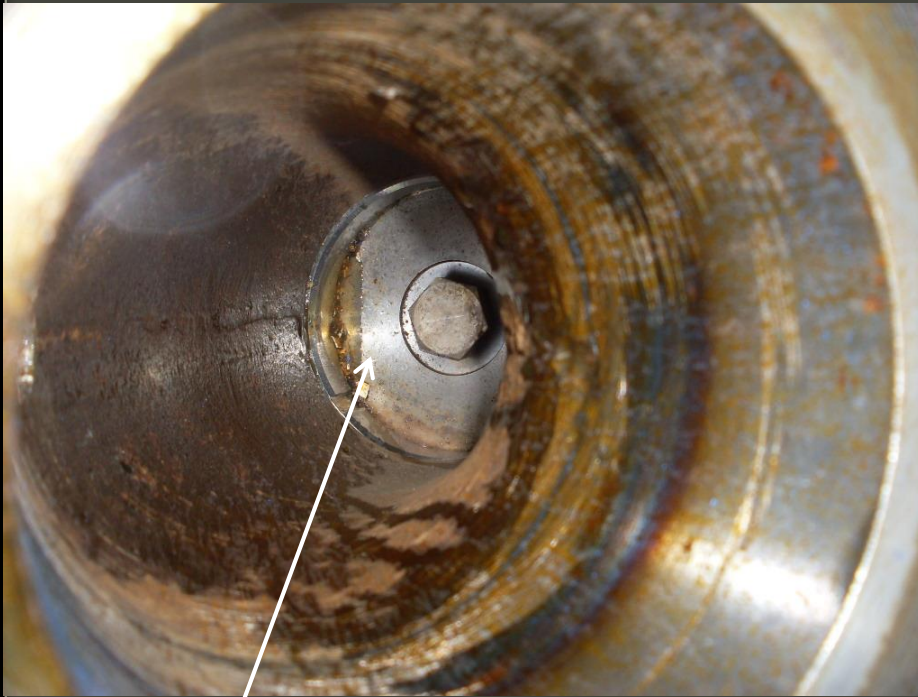
Isolation Disk (stand by position)

North (active port of the SSV)

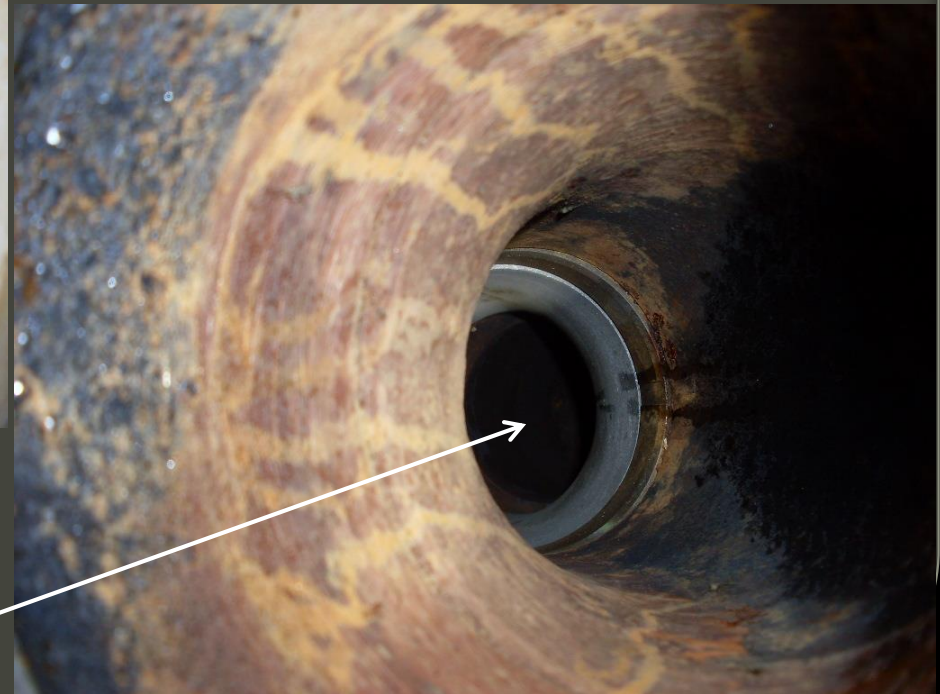
Active port opening
