Subject: Rumble Strips on Caltrans Roads Affecting Cyclists' Safety

Rumble Strip Details on Hwy 76 Bike Lanes

Rumble Strip Details on Mt. Palomar Route

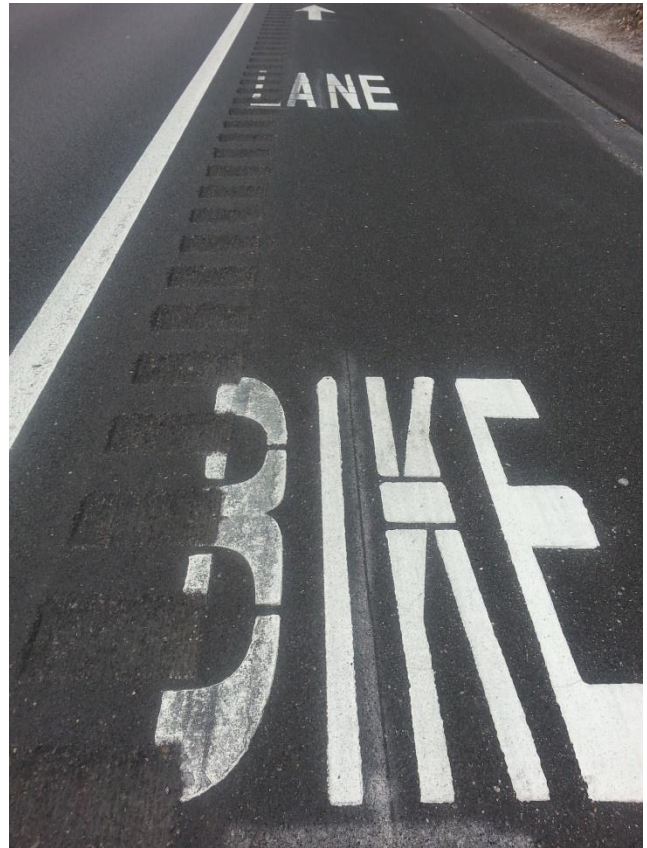
Rumble strips are actually placed **within** the bike lanes on Hwy 76 between Rancho Del Oro Dr on the east and Foussat Rd on the west. The first photo shown here is on the eastbound side and shows 12" rumble strips placed about 6" inside the bike lane stripe. The rumble strips even run through the "B" and "L" of the Bike Lane signage. At night, and in wet weather, the cyclist cues on the "Bike Lane" white letters, cannot even see the rumble strips, and when they are encountered creates a hazardous situation, which becomes worse with speed. The rumble strips are barely visible and a bicyclist encountering them unexpectedly while in a supposedly safe bike lane risks a serious accident when control is lost.

Note that Hwy 76 east of Rancho Del Oro Dr is under construction, with a full resurfacing imminent. Since Caltrans is put on notice here, we expect the resurfaced bike lanes will not contain these rumble strip hazards.

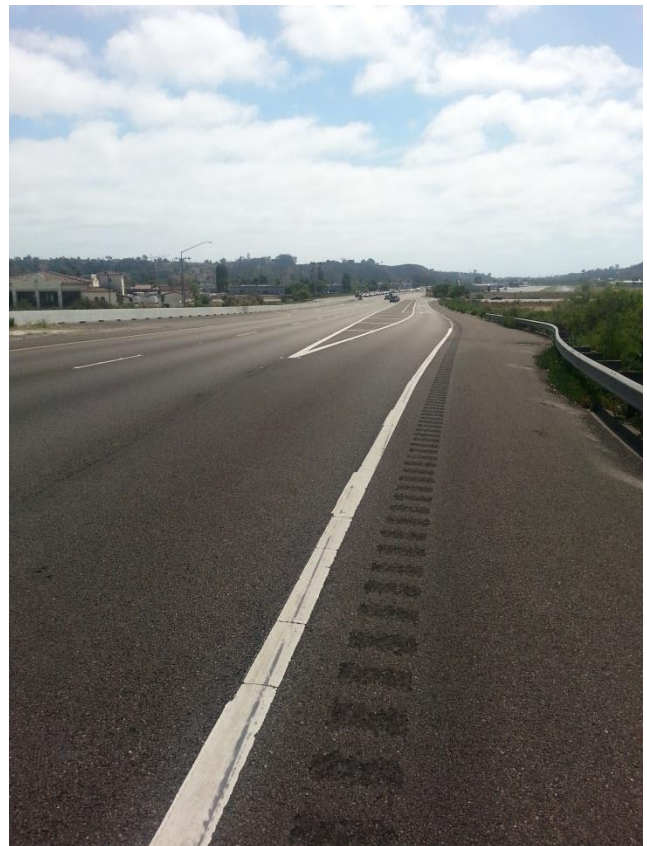
Rumble strips should have gaps in areas where bicyclists are expected to ride in order to maintain the safest position in the roadway. In this second photo of a Hwy 76 westbound bike lane approaching a right turn pocket at Foussat Rd, note that the rumble strip in the bike lane continues without gaps to the right of the edge stripe all the way up to the right turn. Meanwhile, in the distance the bike lane picks up to the left of the right turn pocket as it should. The only way that a cyclist traveling west through the intersection at Foussat Rd to continue into the bike lane ahead is to cross the rumble strips, which is even more unsafe as the crossing is at a non-perpendicular angle.

West of Foussat Rd, where the bike lane becomes the shoulder of a Class III Bike Route, this hazard at right turn pockets continues. There are no gaps in the rumble strips along the right turn pocket edge stripe and a through cyclist must cross the rumble strip hazard in order to continue westward.

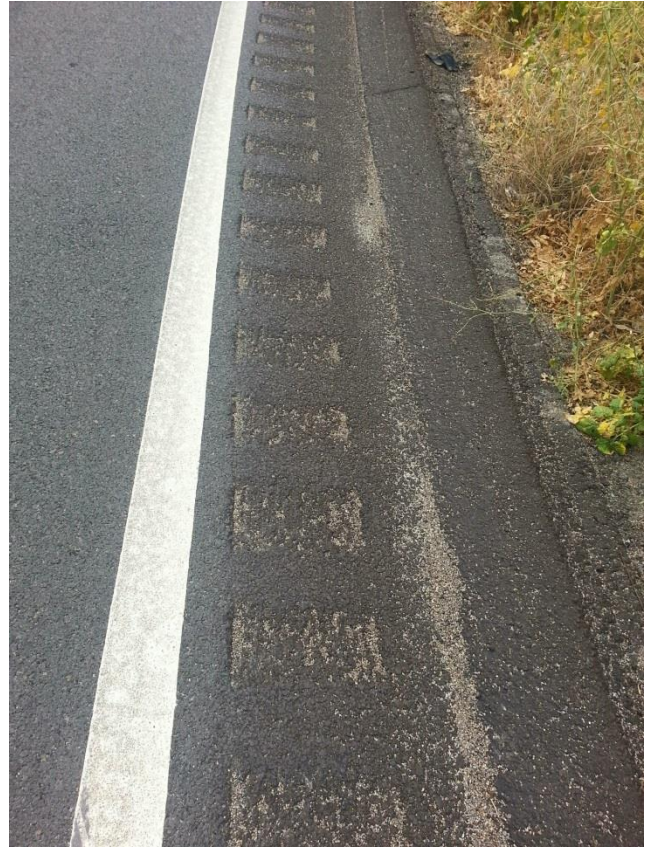
The first photo shown here is on the eastbound, uphill side of Hwy 76, near the start of the rumble strip treatment. These rumble strips are at least 12" wide (not the recommended 5-6") and are offset 3"-4" right of the edge line and the shoulder width is less than 3 feet, leaving a very narrow area for cyclists to ride to the right of the rumble strips. There are NO gaps – recall FHWA guidance of 10'-12' gaps every 40' to 60' on bicycle routes. If the reason for no gaps is that there are no Class III bicycle *route* signs in this area, then perhaps that should be considered. However, it cannot be argued that this is not a popular bicycling route. The depth of the rumble strips was not measured. The best safe place to ride now is **left of the shoulder stripe**.

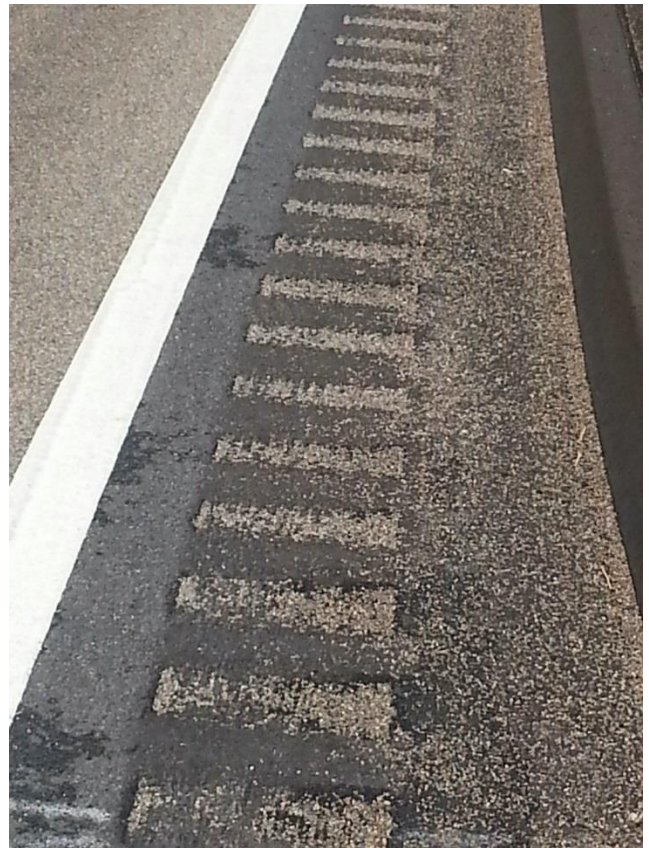
The second photo shows the same segment on the westbound, downhill side. Downhill bicycles speeds over 30 mph usually require the bicyclist to control the lane as riding in a narrow shoulder at high downhill speeds does not allow for safe hazard avoidance, which would require sudden swerves into the lane. By controlling the lane, it is clear to motorists that they must either pass the cyclist or wait patiently until the cyclist can find a safe place to move aside if multiple vehicles are being held up – a rare occurrence on the downhill side as the curved sections require motorists to travel at nearly the same speed. Nevertheless, a cyclist may inadvertently cross the right of the edge stripe, or he/she may be just riding too far right. It obviously would be suicidal to ride downhill to the right of the rumble strips as there is only 18"-24" riding width. Hitting those downhill rumble strips at **high speed is much more dangerous** than on the eastbound uphill side, where speeds are much slower in the 5(amateur)-15(pro) mph range.

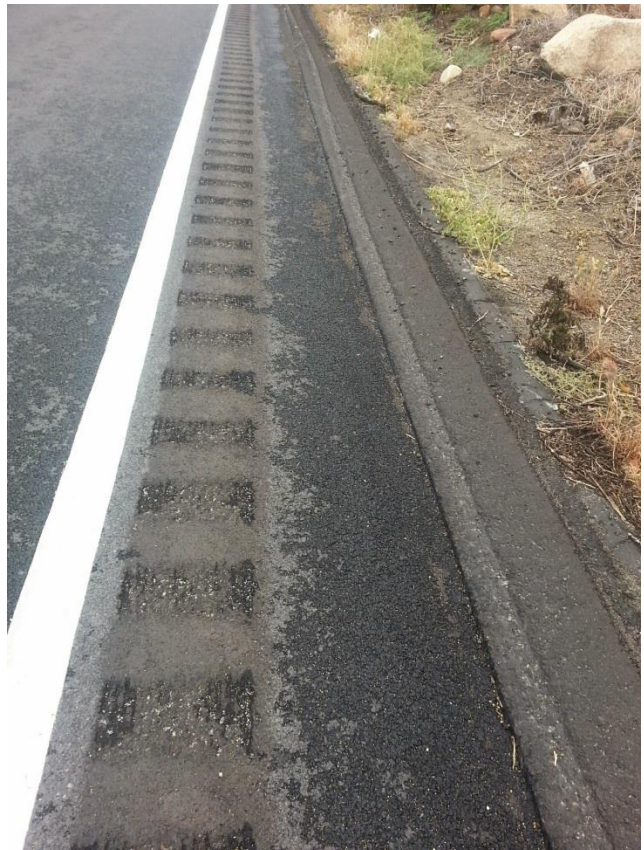
The third photo shows a segment with typical shoulder width, which is what most of the 2 miles on the uphill stretch now looks like. Note that there is very little room now to ride right of the rumble strip, where previously cyclists would sometimes ride two abreast. There are no gaps in the rumble strip treatment and the **safest place to ride is to the left of the shoulder stripe**, which is legal because, with 12' lane widths, these are sub-standard width lanes (i.e. too narrow to safely share side by side with motor vehicles).

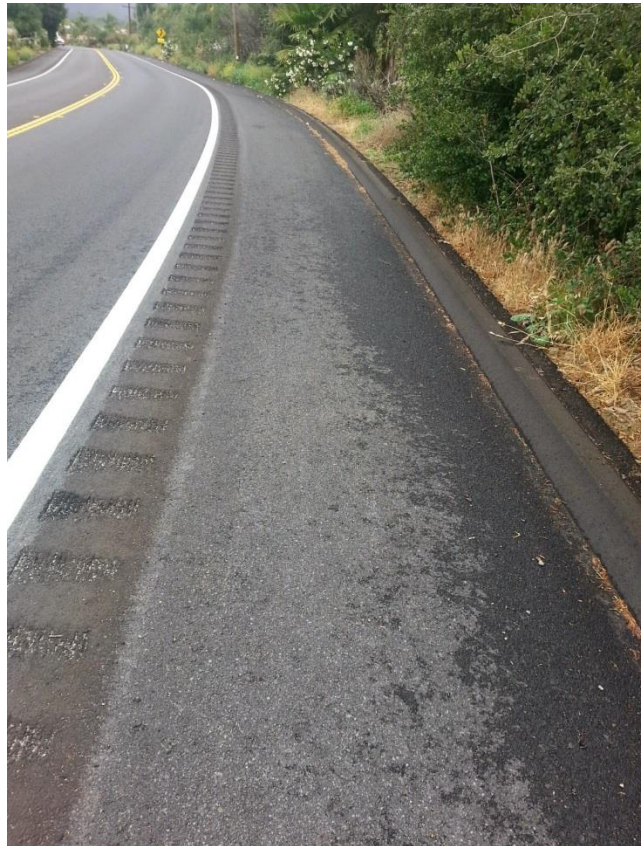
Finally, here is a photo of a stretch with a fairly wide 4'-5' riding area to the right of the rumble strips. There are only a few stretches like this of a couple hundred yards each at most. In the photo, this is a stretch with a 9% gradient, and cyclists are typically climbing this at different speeds, requiring faster cyclists to move left to pass the slower cyclists. Since there are no gaps in the rumble strips as recommended, this is either impossible or the faster cyclists must simply cross the rumble strip to make the pass, meaning the rumble strips are crossed twice, on each side of the pass. For the whole, approximately two mile stretch with rumble strips, there are just three to four breaks in the rumble strips eastbound and westbound each, all to accommodate driveways and/or turnouts. There are **no frequent gaps as recommended for cyclists**.
