# Technical Service Bulletin

SUBJECT:			No: <b>TSB-15-22-002</b>
<b>TC-SST TRANSMISSION &amp; MECHATRONIC ASSEMBLY DIAGNOSIS &amp; REPAIR – REVISED</b>			DATE: <b>July, 2015</b>
			MODEL: <b>See below</b>
CIRCULATE TO:	<input type="checkbox"/> GENERAL MANAGER	<input checked="" type="checkbox"/> PARTS MANAGER	<input checked="" type="checkbox"/> TECHNICIAN
<input checked="" type="checkbox"/> SERVICE ADVISOR	<input checked="" type="checkbox"/> SERVICE MANAGER	<input checked="" type="checkbox"/> WARRANTY PROCESSOR	<input type="checkbox"/> SALES MANAGER

Procedures are now available for W6DGA TC-SST Mechatronic Assembly (valve body and transmission control module) replacement. This TSB provides the necessary steps to complete diagnosis, replace the Mechatronic Assembly, and program the new electronic control unit.

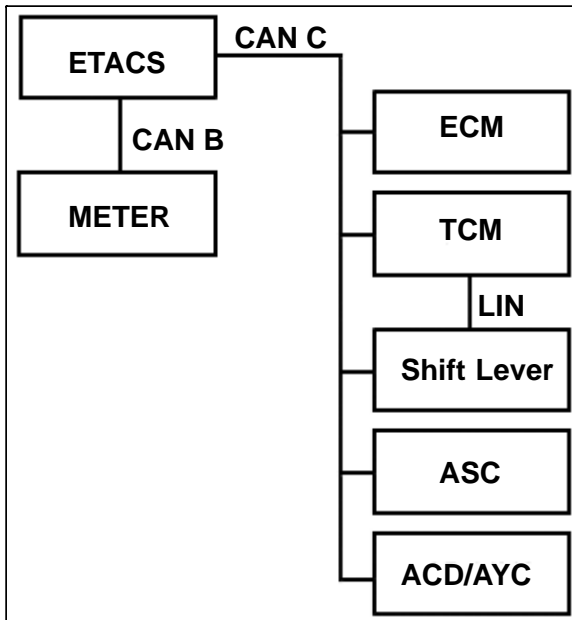
The TC-SST, like most of the vehicle's major components, is constantly communicating with other control units linked via the CAN C bus line. When diagnosing electrical issues, it is important to focus on proper electrical connections and communication. It also means that, similar to the vehicle's other control units, MUT-III must be used to program the TCM after replacement. Part of this TSB will focus on procedures for proper coding when replacing Mechatronic assemblies.

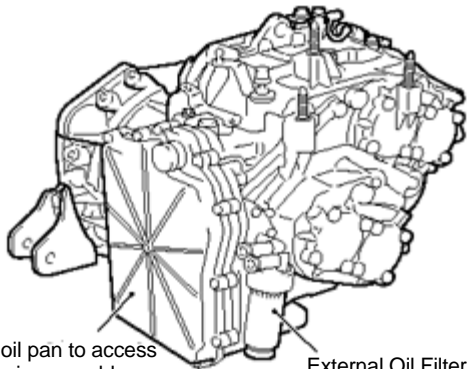
The TC-SST transmission has two filter elements. Only the external oil filter element and the Mechatronic Assembly can be replaced at this time.

The combined Mechatronic Valve Body and TCM are accessible under the oil pan.

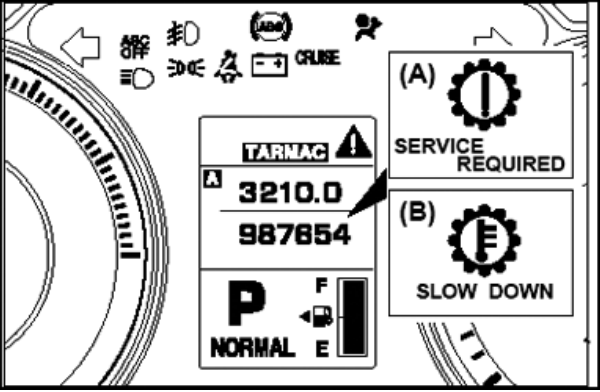
A. If the Service Required message is displayed, check for DTCs. B. If the Slow Down message is displayed, the transmission is overheating. Ask the customer if they have noticed this message displayed.  The SLOW DOWN message displays if transmission temperature exceeds 250°F. If the transmission temperature exceeds 260°F, the ECU and TCM will take steps to cool down the transmission including reducing power and disengaging the clutches.
DIAG2) Is there any aftermarket equipment (engine or transmission performance equipment, navigation units, gauges, tracking devices, etc.) installed on this vehicle? (Yes or No)  Pay special attention to those devices which can be linked to the vehicle communications networks (CAN B, CAN C, or LIN).	If aftermarket equipment is found, disconnect it or render it inoperative for the remainder of this diagnosis. Go to DIAG3.

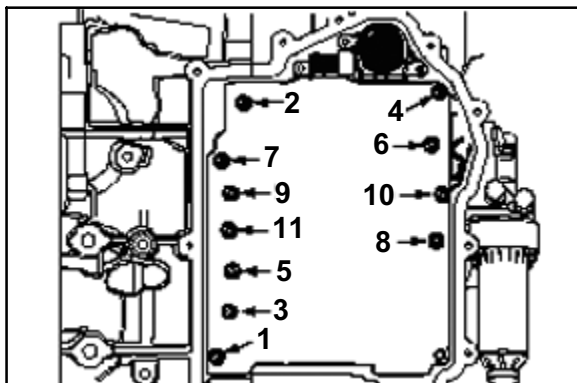
17. Remove the valve body bolts in the order shown. They can be discarded. New bolts for the valve body are included with the new Mechatronic assembly.
18. Carefully remove the Mechatronic assembly.

**TAKE EXTRA CARE WHEN REMOVING THE VALVE BODY. THERE ARE LONG SENSORS THAT CAN BREAK. BROKEN PIECES CAN EASILY FIND THEIR WAY INTO THE TRANSMISSION.**

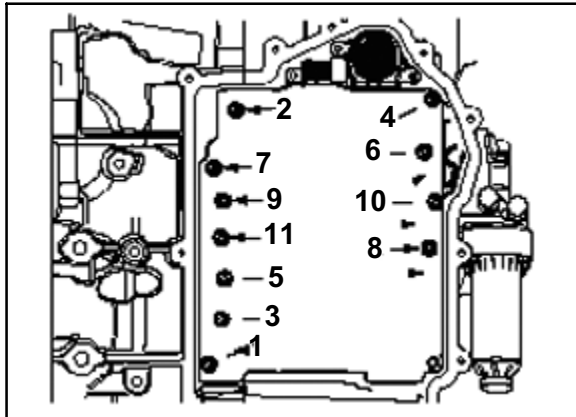
Replace with seals provided

23. On the new valve body, thoroughly lubricate the replacement sensor seals with TS-SST fluid and install them to the valve body.
24. Install the new Mechatronic assembly to the transmission using new bolts included with the new Mechatronic assembly.

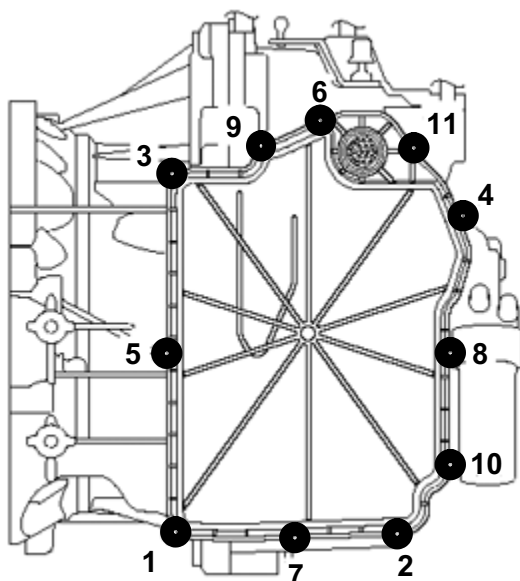
29. Install a NEW transmission side cover (p/n 2502A042) using new bolts included with the new cover. Torque to  $89 \pm 8$  in-lbs in the sequence shown at left.
