Performance Evaluation Test of the Peco Tracked Brush Blazer

January 2008

Prepared by
Institute for Defense Analyses
4850 Mark Center Drive
Alexandria, VA 22311-1882

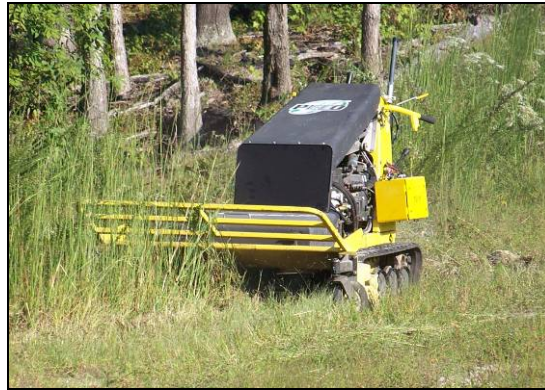
Figure 1: Peco Tracked Brush Blazer TBB-2001

The Peco Tracked Brush Blazer TBB-2001, referred to as the Peco Cutter, shown in Figure 1, is a heavy-duty brush cutter advertised as capable of cutting heavy undergrowth and trees up to 10 cm in diameter. It is equipped with a hydraulic track drive that gives the operator the ability to maneuver in all types of terrain, as well as perform 180-degree turns within its own length of 2.4 meters. Safety features of the Peco Cutter include a chain-guarded deck (Figure 2) and a front safety bar (Figure 3) to push over vegetation to be cut.

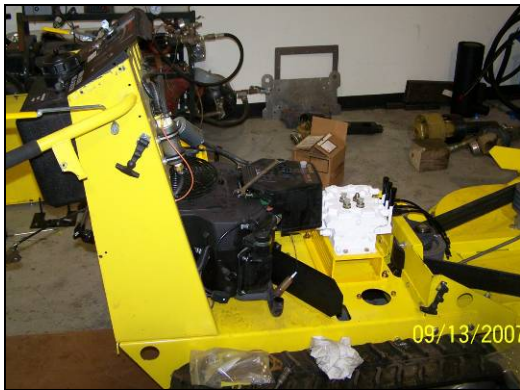
Figure 4: Peco Cutter Engine Before Modifications (Top Cover Removed in Photo)

Modifications to allow for push-button manual operations as well as remote operations were made by the Humanitarian Demining Program Office's vehicle fabrication shop at Ft. Belvoir. The Peco Cutter remote-control system enables operators to start and shut off the Peco Cutter engine remotely, enable and disable the cutter remotely, and continue line-of-sight operations for distances up to about 400 meters. Photos of the modifications can be found in Figures 4 through 10. Table 1 lists specifications for the Peco Cutter.

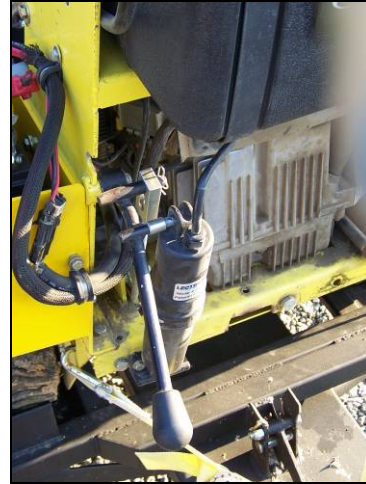
Figure 9: Cutter Engaging Lever After Modifications (Hydraulic Addition allows Operator Push-button Cutter Engagement)

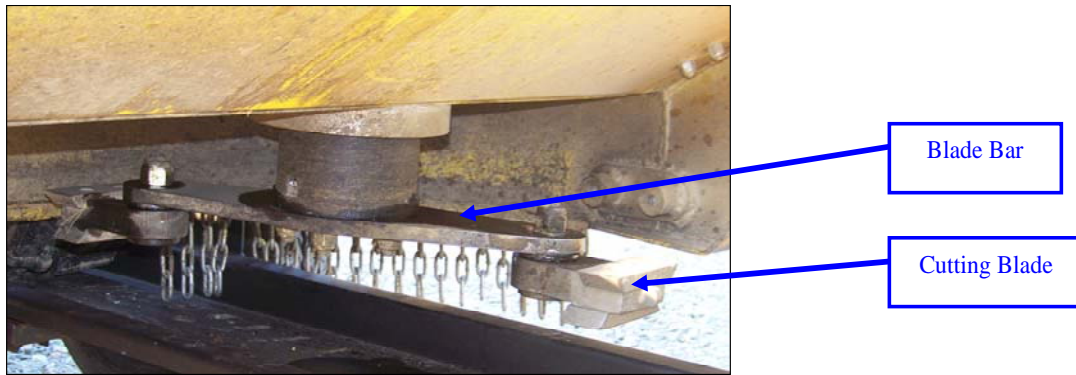
Figure 11: Blade Bar and Cutting Blade (Photo Taken from under the Cutting Deck)

| Peco Cutter TBB-2001 Brush Blazer | Measurement Dimension |
|--|---|
| Length, blade bar (see Figure 11) | 45.1 cm / 17.75 in |
| Length, cutting blade (see Figure 11) | 10.8 cm / 4.25 in |

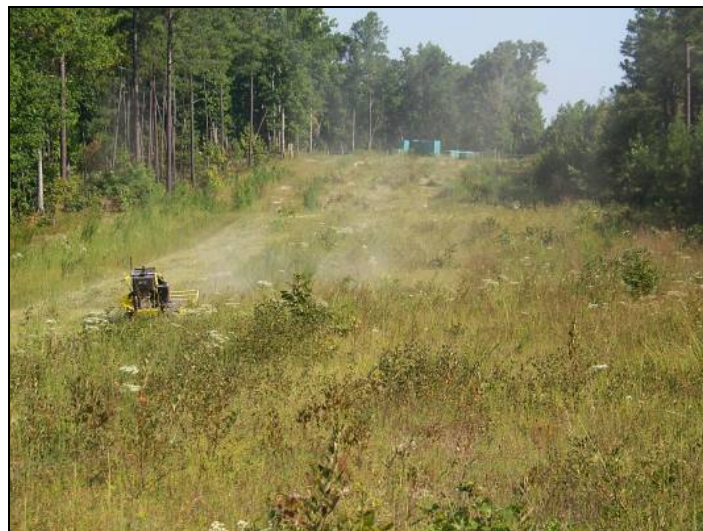
Figure 12: Test Site A, Category 1 Vegetation

Test Site A consisted of Category 1 vegetation within a 350 m × 60 m area, as shown in Figure 12. Category 1 vegetation is described as light vegetation with saplings up to 3 cm in diameter within level to slightly rolling terrain.

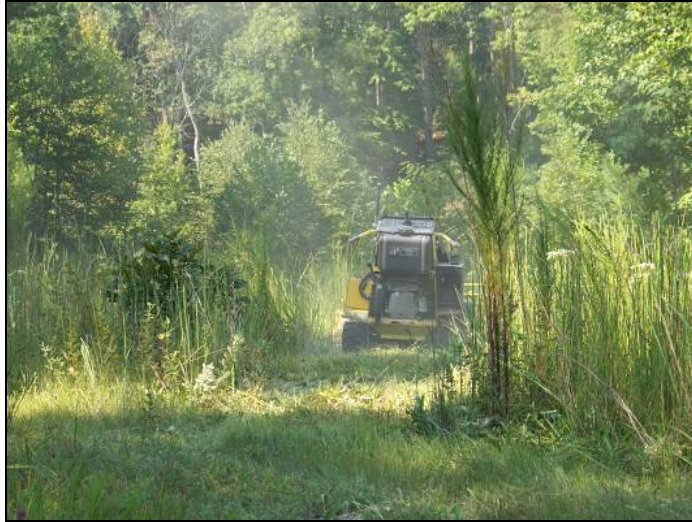
Figure 13: Test Site B, Category 2 Vegetation

Test Site B included Category 2 vegetation within a 30 m × 20 m downward sloping area, as shown in Figure 13. Category 2 vegetation consists of moderate vegetation with sparse brush and saplings up to 6 cm in diameter, within level or lightly rolling terrain with minimal ruts. The slope within Test Site B measured as a 10 degree angle of descent. Slight bumps were present throughout the area, and a 6.5 m × 0.5 m gully, with a depth of 26.7 cm, was discovered during testing.

toward, away, and cross-track from the operator’s location at distances up to 300 m. Test Site B (Category 2 vegetation) also posed no operational problems, even when the device was driven through an unseen gully measuring 0.5 m wide and 26.7 cm deep. The Peco Cutter was able to maintain stability and continue cutting operations. Within Test Site C (Category 3 vegetation), no major mobility problems arose; however, it was noted that the ability to push down (over)—and thus cut—10 cm diameter trees is largely dependent on the terrain’s soil. For trees located in soft, powdery soil, the Peco Cutter is unable to gain enough traction to push over the tree (this is discussed further in section 4.2). Table 2 has additional mobility measurements taken during the test.

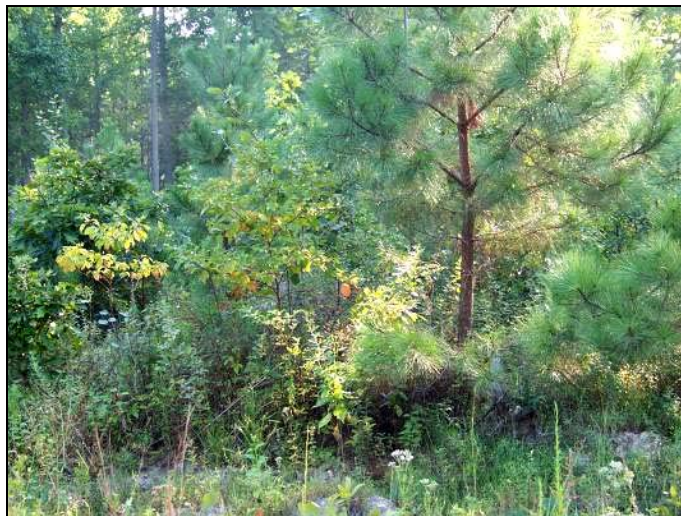
Figure 14: Test Site C, Category 3 Vegetation

The final test site, Test Site C, measured 15 m × 5 m and consisted of Category 3 vegetation (see Figure 14). Category 3 vegetation includes moderate vegetation with brush, saplings, and trees up to 10 cm in diameter, atop level or lightly rolling terrain with minimal ruts.

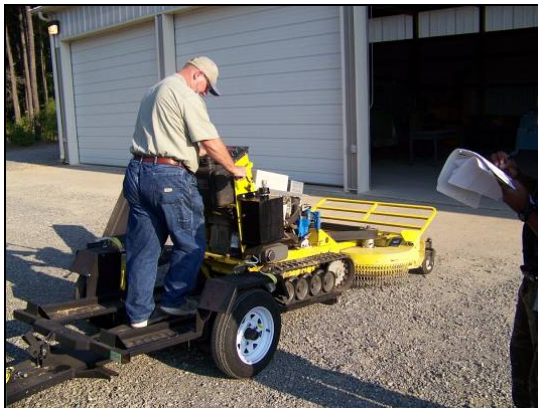
Figure 15: Off-Loading Peco Cutter

Manual operation of the Peco Cutter is necessary when loading and off-loading it from its travel trailer, as shown in Figure 15 and 16. Modifications to the Peco Cutter’s manual driving mechanism include the addition of a driving joystick to make it possible for any operator to control movement of the Peco Cutter. Throughout the test, manual operators were able to successfully load (and off-load) the Peco Cutter in less than 1 minute.

Movement of the Peco Cutter onto and off the trailer is performed manually by the operator as shown previously in Figures 15 and 16. The Peco Cutter was modified to include joystick-guided steering, making it possible for persons of all heights and physical strength to operate the Peco Cutter manually.

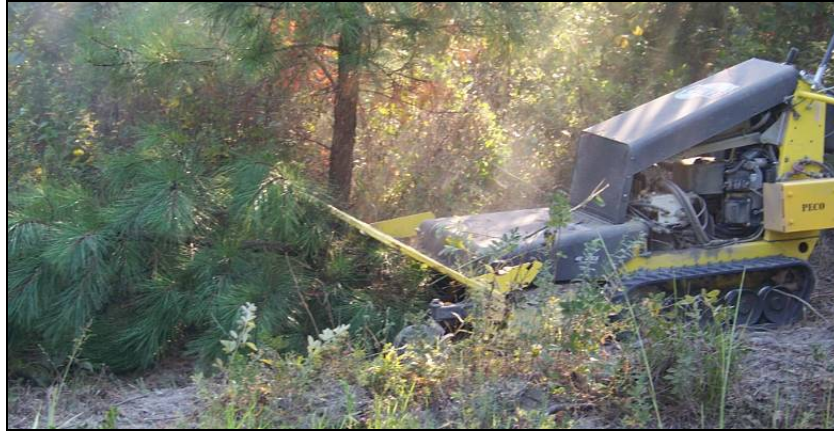
Figure 17: Cutting Heads Engaging Tree After Being Pushed by Safety Bar

The Peco Cutter is designed to cut vegetation and trees up to 10 cm in diameter with a “push and cut” technique that uses the front safety bar and the cutting heads. When the Peco Cutter approaches trees, saplings, or brush, the front safety bar pushes those items over until the cutting heads are able to reach the vegetation’s base. At this time, the cutter cuts the vegetation from the ground and will cut the remainder of it as the Peco Cutter drives over the fallen item (see Figure 17).

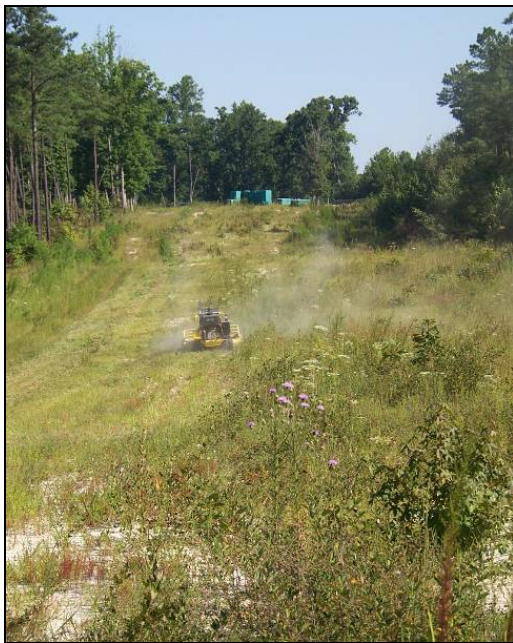
Figure 18: Cutting Operations, Test Site A

The Peco Cutter's cutting ability was tested against Category 1, Category 2, and Category 3 vegetation within Test Sites A, B, and C, respectively. In Test Site A, approximately 2,000 m² were cut, with no mobility or operational issues. Figures 18 and 19 show before and after cutting views of Test Site A.

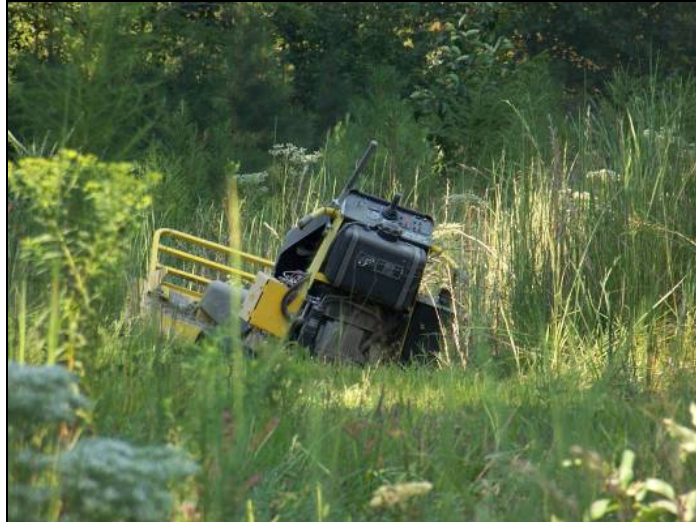
Figure 20: Peco Cutter Encountering 26.7 cm Deep Gully at Test Site B

Operational cutting on the downward slope of Test Site B was separated into two timed tests. For the first test, the cutter was operated for 40 minutes. This resulted in a cleared area of 29.3 m × 9.4 m (6.9 m²/min, or 413.1 m²/hr) over ground with an average slope of 6.5 degrees. During this test, the gully described in Section 3.2 was encountered, requiring the operator to perform special maneuvers to continue cutting operations around and through the rut (see Figure 20). The heaviest vegetation cut in this area was an 8 cm diameter tree.

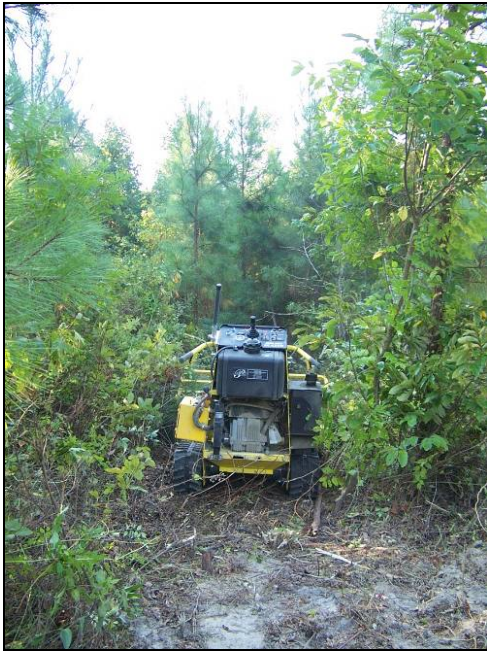
Figure 21: Peco Cutter Entering Test Site C

Test Site C operations were conducted to determine the capabilities and limitations of the Peco Cutter within Category 3 vegetation. In a 30-minute timed test, the Peco Cutter was able to successfully cut a 12 m × 3.4 m area (1.36 m²/min, or 81.6 m²/hr), which included two 10 cm diameter trees, several saplings, and dense vegetation. Before the start of the timed test, the Peco Cutter was not able to cut down a 10 cm tree because the soil around the tree was powdery and soft, with no vegetation or brush covering. This prevented the Peco Cutter from getting enough traction to push over the tree. Figures 21 and 22 show Test Site C operations.

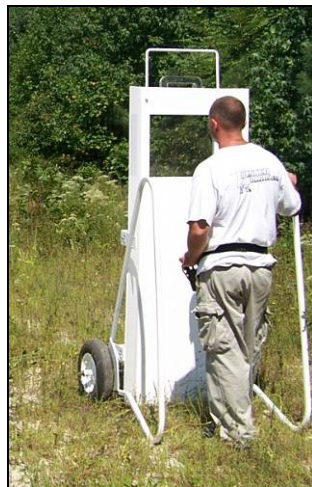
Figure 23: Operator's Shield

Throughout the test, the remote control was operated from behind a mobile shield at a minimum distance of 25 m from the Peco Cutter (see Figure 23). The shield plus the 25 m distance was determined to be a safe standoff for the operator in the event a mine is encountered.

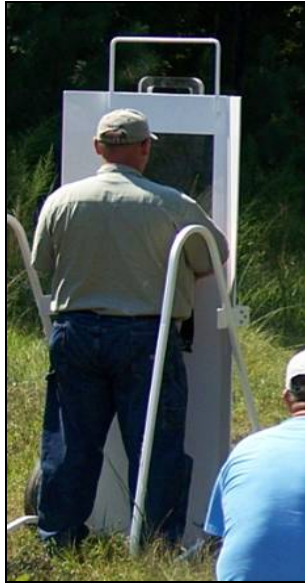
Figure 24: Operator Working Close to Shield

The remote antennas were initially mounted on the Peco Cutter and on the operator's remote-control device. As the operator stood behind and close to the shield, as shown in Figure 24, radio transmissions were blocked. The Peco Cutter's remote system was designed to shut down the vehicle if the communicating signal was lost. Thus, there were several instances when the Peco Cutter shut down due to interference from the shield. To remedy this problem, the remote control unit's antenna was removed and mounted on the top of the mobile shield (see Figure 25), and a connecting cable was run between the antenna and the remote-control unit as shown in Figure 26. Also, a hook was mounted to the inside of the shield, so the operator could continue operations without having to hold the remote device. With this configuration, remote operations were

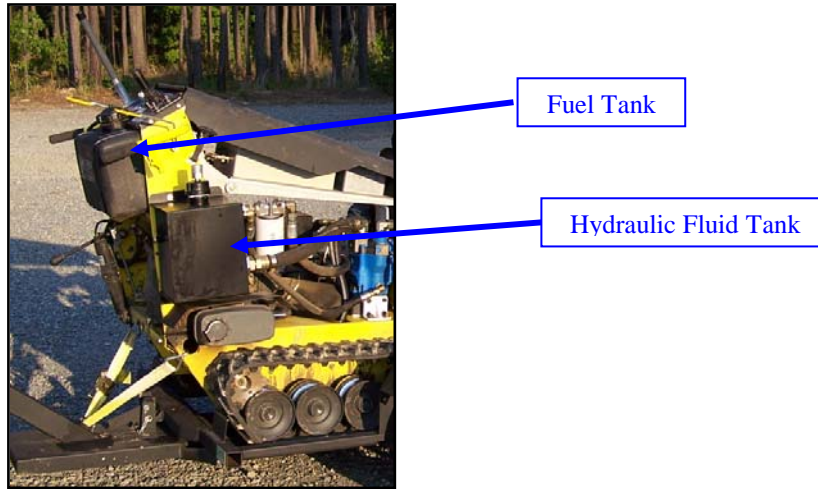
Figure 27: Fuel and Hydraulic Fluid Tanks

Fluids and fuel were checked and refilled daily before operations or as needed. The Peco Cutter uses unleaded gasoline and is equipped with a 5 (U.S.) gallon (18.9 liter) tank. The hydraulic fluid tank capacity is approximately 2.5 (U.S.) gallons (9.5 liters). Both the fuel and hydraulic tanks are located at the rear of the Peco Cutter (see Figure 27).

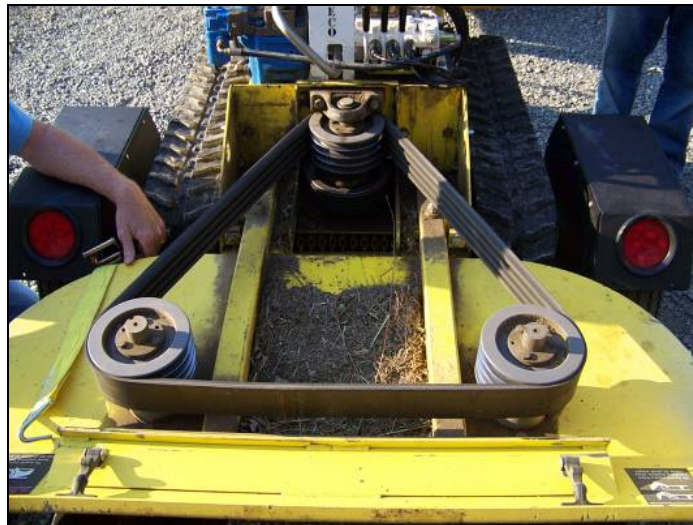
Figure 28: Cutting Blade Belt (Top Cover Removed for This Photo)

During the test, one maintenance issue arose. It was noticed that although the Peco Cutter’s cutting blades seemed to be rotating, the vegetation was not being cut. An inspection of the problem showed that the wide belt responsible for turning the blades was loose (see Figure 28). A quick adjustment to the tension rod was made, and the Peco Cutter resumed cutting. This repair took only a few minutes and required no tools.

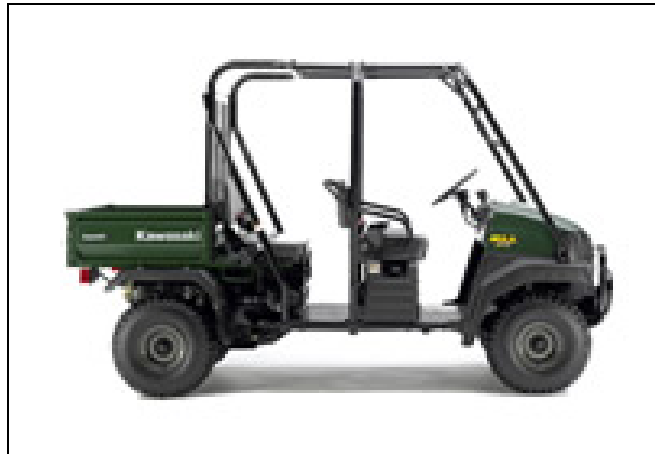
Figure 29: 4×4 Utility Vehicle, Used in the Damaged Vehicle Recovery Test

In addition to the manual recovery of a disabled vehicle, recovery by a small vehicle was also tested. A 4×4 utility vehicle, like the one shown in Figure 29, weighing 693.5 kg (1,528.9 lbs) was used to tow the Peco Cutter from its location. Although the utility vehicle was very close in weight to the Peco Cutter, it was able to successfully drag it several feet.

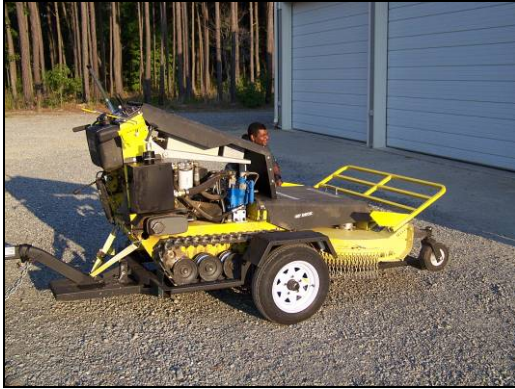
Figure 30: Peco Cutter, Strapped to Trailer

The Peco Cutter, its on-road traveling trailer, the operator's shield, and all mechanical and electronic spare parts are stowed in a 10 ft (3 m) shipping container. The Peco Cutter is shipped strapped to its trailer (Figure 30), and metal ramps are used for loading and off-loading the duo (Figure 31) into the container. A removable handle (Figure 32) is used to assist personnel in maneuvering the trailer into and out of the shipping container.

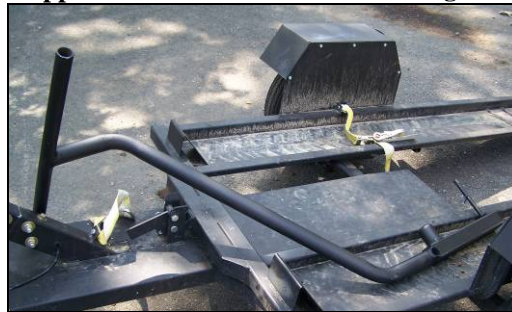
Figure 32: Trailer with Removable Handle (Handle is Lying on Trailer, Not Connected)

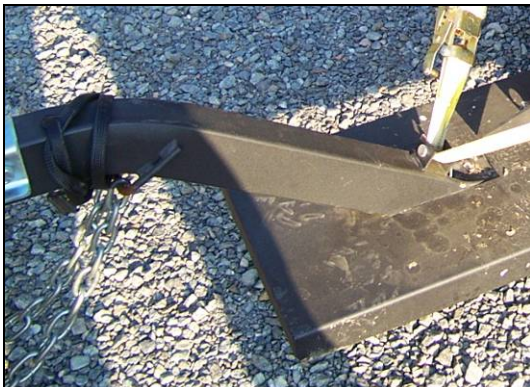
Figure 33: Trailer Connecting End, Before Modifications

To ensure that the trailer would fit into the container, a modification was made to the trailer's connecting end (as shown in Figures 33 and 34), making it removable. Table 3 shows specifications for the trailer.

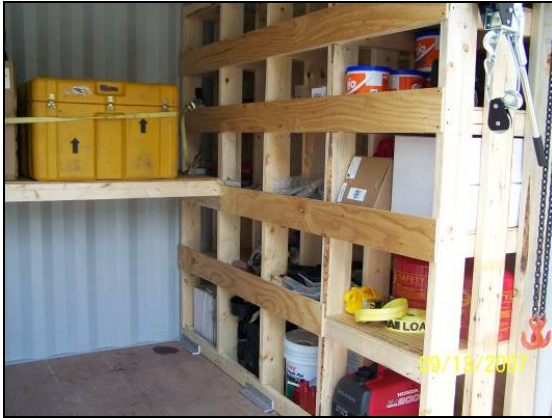
Figure 35: View of Inside Shipping Container

Spare parts are placed in bins within the container (Figure 35). The bins are labeled to assist operators and other personnel. Spare parts include tools, belts, tracks, circuit boards, electronic interfaces, cutting blades, and many other items necessary to

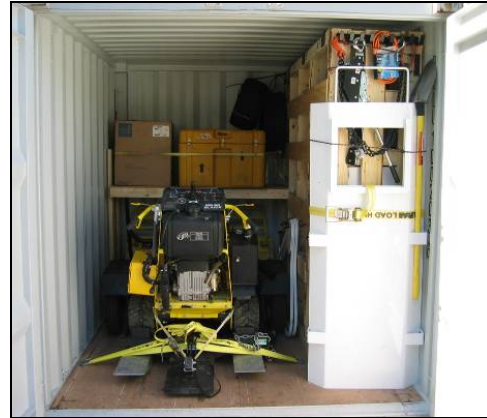
Figure 36: Packed Shipping Container

ensure continued operation of the Peco Cutter. Figure 36 shows the fully packed shipping container.
