Performance of High-rise Buildings during the 2011 Great East Japan Earthquake

Taiki Saito, Kouichi Morita, Toshihide Kashima & Takashi Hasegawa
Building Research Institute, Tsukuba, Japan

SUMMARY:

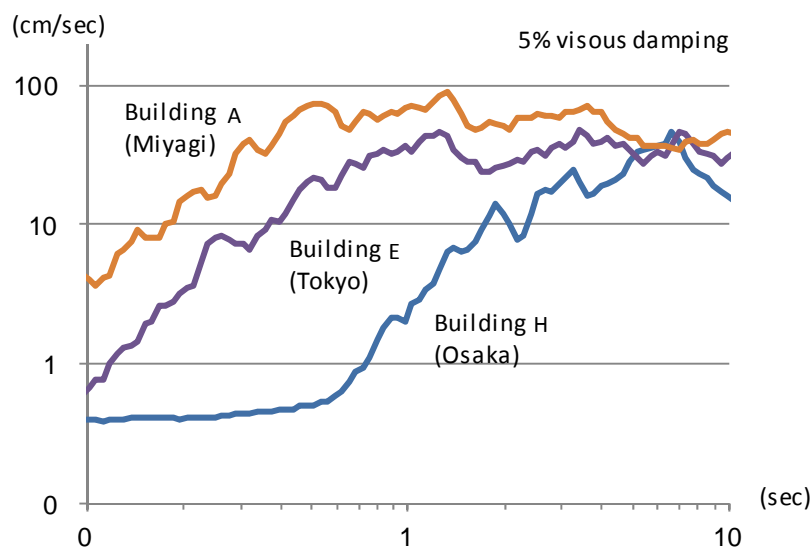
Figure 2 shows the velocity response spectra of the horizontal records at the lowest levels of the high-rise buildings in Miyagi, Tokyo and Osaka. The velocity spectra of Miyagi and Tokyo have strong component in the wide band period from 0.5 seconds to 10 seconds; therefore, it is considered not only high-rise buildings but also low-rise buildings were strongly shaken by the earthquake ground motions. On the other hand, the response spectrum of Osaka has a peak period of 6-7 seconds, and it was a typical long-period ground motion which shakes high-rise buildings.

Figure 2. Velocity response spectra in different areas in Japan

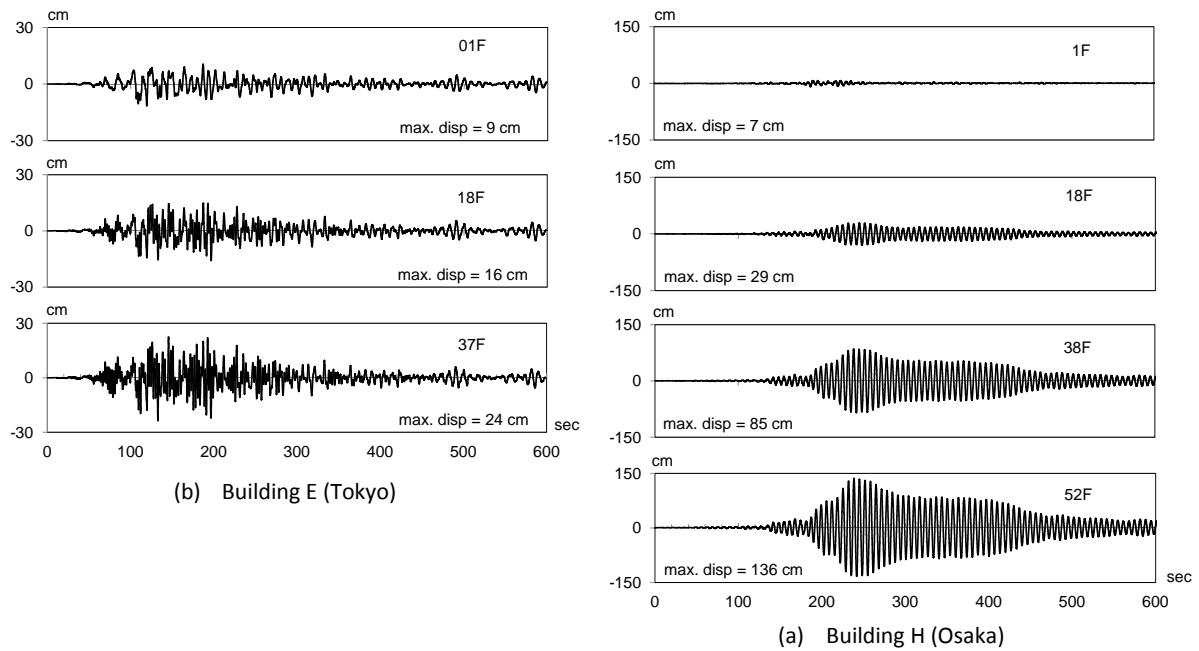
Figure 3. Displacement records of high-rise buildings in Tokyo and Osaka

Figure 3 shows the displacement records observed in different floors of high-rise buildings in Tokyo and Osaka. Whereas the maximum displacement at the top floor of Building E in Tokyo, 385 km away from the epicentre, was 24 cm, the large floor movement of 136 cm amplitude was observed at the 52th floor of Building H in Osaka, 770 km away from the epicentre. By this shaking, in Building E, all 32 lifts stopped and people were trapped in four of them. Damage to non-structural members such as falling of gypsum board and ceiling panels were observed extensively. To avoid such damage and keep safety and function of high-rise buildings at earthquake, this paper examines the observation records at the high-rise buildings from several perspectives.

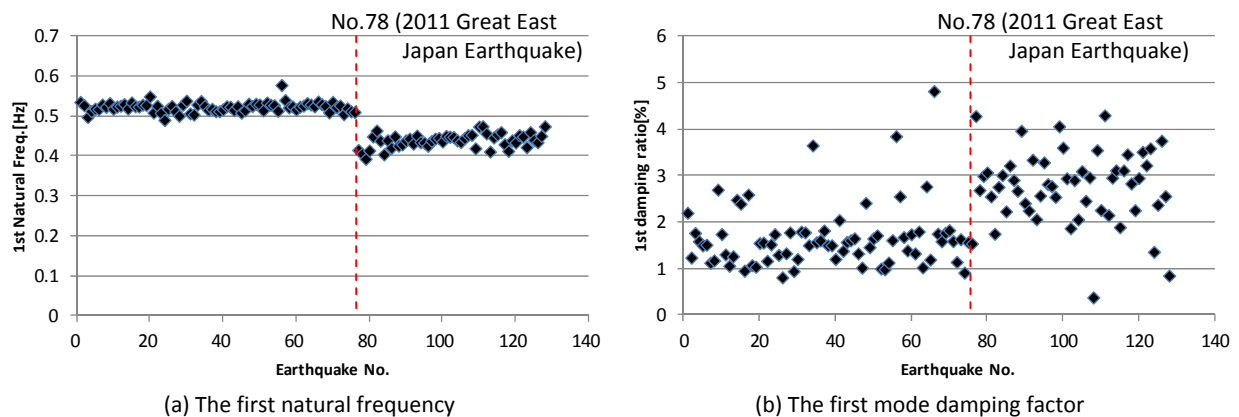
Figure 5. Vibration characteristics of reinforced concrete building (Building E, H1 direction)

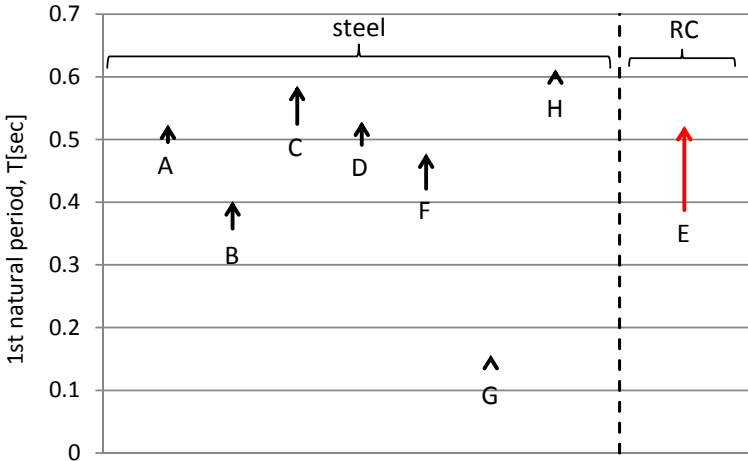
Change of the first natural frequency of all the high-rise buildings listed in Table 1 during the 2011 Great East Japan Earthquake is shown in Figure 6. The maximum change is around 5% for steel buildings. On the other hand, the rate of decrease of natural frequency of reinforced concrete is around 25%. Figure 7 shows the relationship between the first natural period and the first mode damping factor for steel high-rise buildings identified from observation records. The damping factor is distributed in the range of 1-3% and the product of the natural period and damping factor is taking a value between 3 and 6.

Figure 6. Change of the 1st natural frequency of high-rise buildings during the 2011 Great East Japan Earthquake

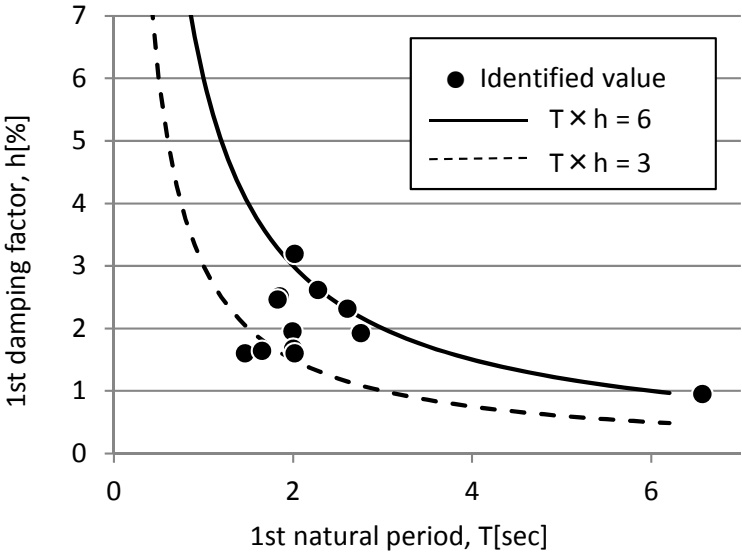
Figure 7. Relationship between natural period and damping factor for steel high-rise buildings

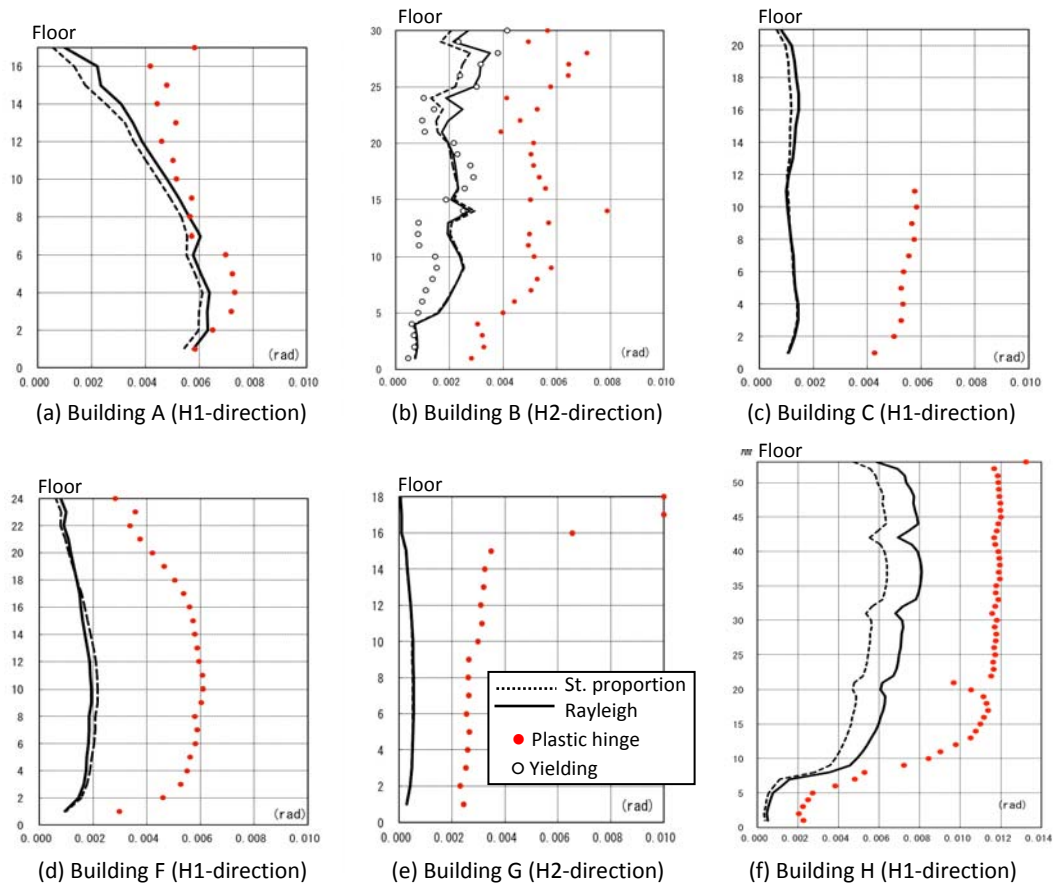
Earthquake response analysis of the high-rise buildings was carried out; where input ground motion is the observed acceleration record at the lowest layer of the building at the main shock. Figure 8 shows the results of the maximum story drift of each building comparing two types of damping; one is the stiffness proportional damping with 2% damping factor (dotted line) and another one is the Rayleigh type damping using the identified first and second mode damping factors (solid line). Red dot indicates the drift level of the first plastic hinge of structural elements and white circle of Building B indicates the yielding drift of steel damper devices. Except Building A in Miyagi Prefecture, other responses are within elastic range of structural members. The drift response of Building B exceeds the yielding drift of steel dampers. The response of Rayleigh type damping is slightly larger than that of stiffness proportional damping.

Figure 8. Comparison of the maximum story drift

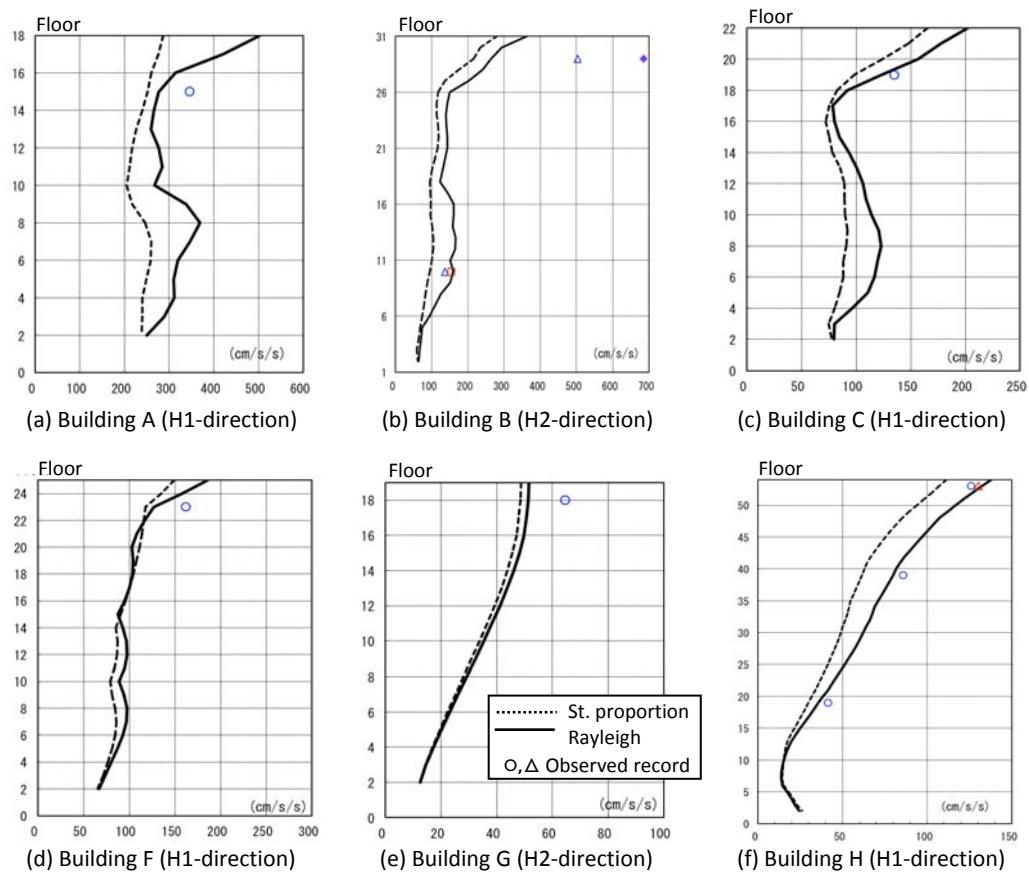
Figure 9 shows the results of the maximum acceleration of each building comparing two types of damping. White circle indicates the acceleration value from the observed record. The acceleration response of Rayleigh type damping is larger than that of stiffness proportional damping and much closer to the observed one.

Figure 9. Comparison of the maximum acceleration

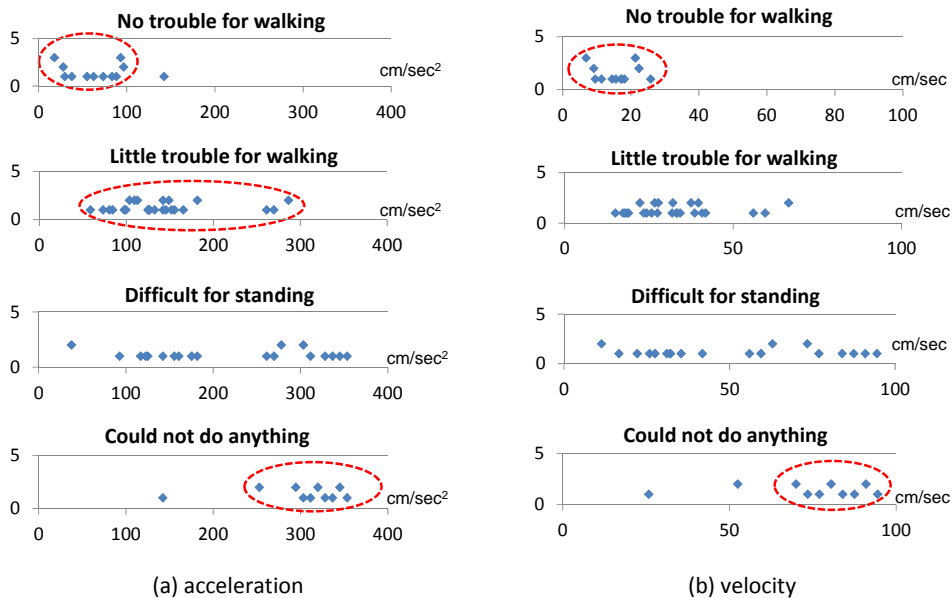
Figure 11 shows the answers about difficulty of action during the shaking of earthquake. The answer of “No trouble for walking” distributes in less than 100 gal of acceleration and 20 kine (= cm/sec) of velocity. On the other hand, the answer of “Could not do anything” distributes in more than 300 gal and 70 kine.

Figure 11. Difficulty of action during shaking

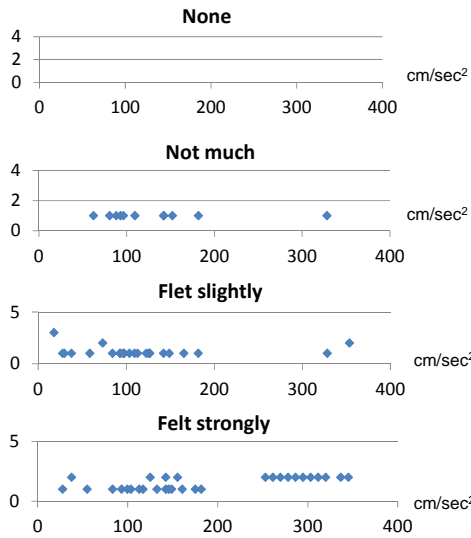
Figure 12 indicates the answers about a sense of fear during the shaking of earthquake. There are many answers of “Felt strongly” and “Felt slightly”, but little relationship between floor acceleration. There was an opinion that they felt the fear because of the long time shaking.

Figure 12. Sense of fear

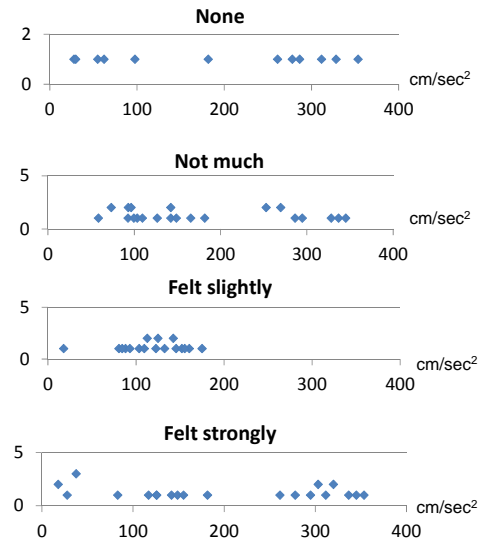
Figure 13 indicates the answers about a sense of anxiety or sickness during the shaking of earthquake. There was a variety of answers, and the relationship between the floor acceleration is not seen much. Some people answered that they felt like seasickness because of the long time shaking.

Figure 13. Sense of anxiety or sickness

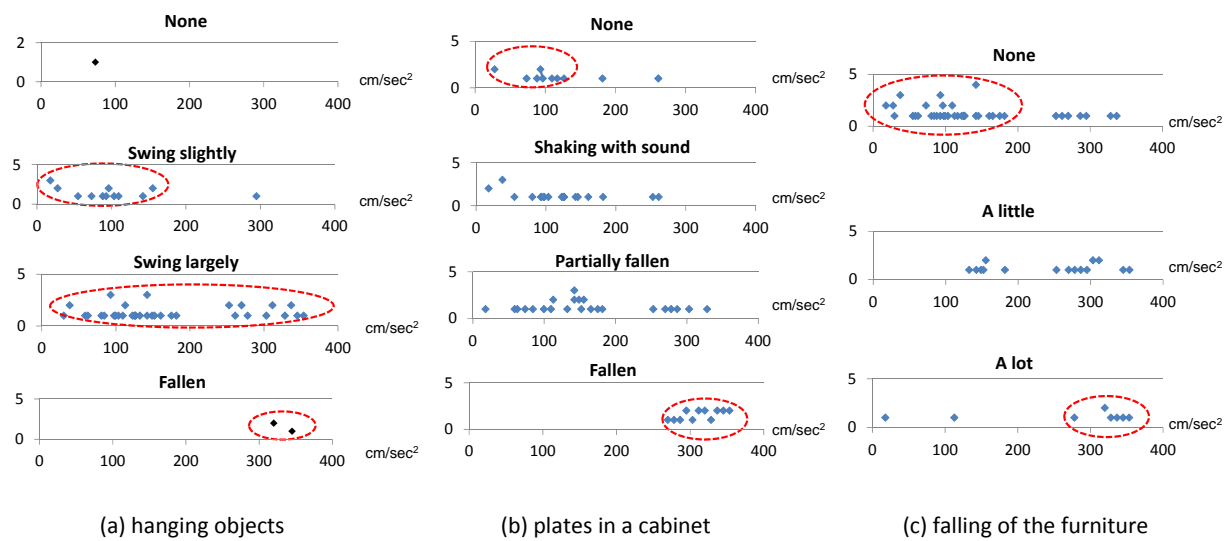
The movement of hanging objects in a room is answered in Figure 14-(a). The objects have fallen over 300 gal. The movement of plates in a cabinet has strong correlation with the floor acceleration as shown in Figure 14-(b). Although there was no movement in less than 120 gal, the plates have fallen in more than 250 gal. Figure 14-(c) shows the answers related to falling furniture such as a bookcase or chest of drawers. A lot of furniture has fallen in a range greater than 300 gal. According to the formula proposed by Architectural Institute of Japan (AIJ), the limit acceleration of the fall of slender furniture is approximately 250 gal that correspond to the results of the survey as shown in Figure 15.

(a) hanging objects

(b) plates in a cabinet

(c) falling of the furniture

Figure 14. Damage to the contents in a room
