Phase Two Environmental Site Assessment Report

Existing Agricultural Property
King Street
Port Perry, Ontario

Report for Delpark Homes (Port Perry) Inc.

65 Sunray Street, Whitby, Ontario, Canada L1N 8Y3
11148414 | 01 | Report No. 2 | June, 2017

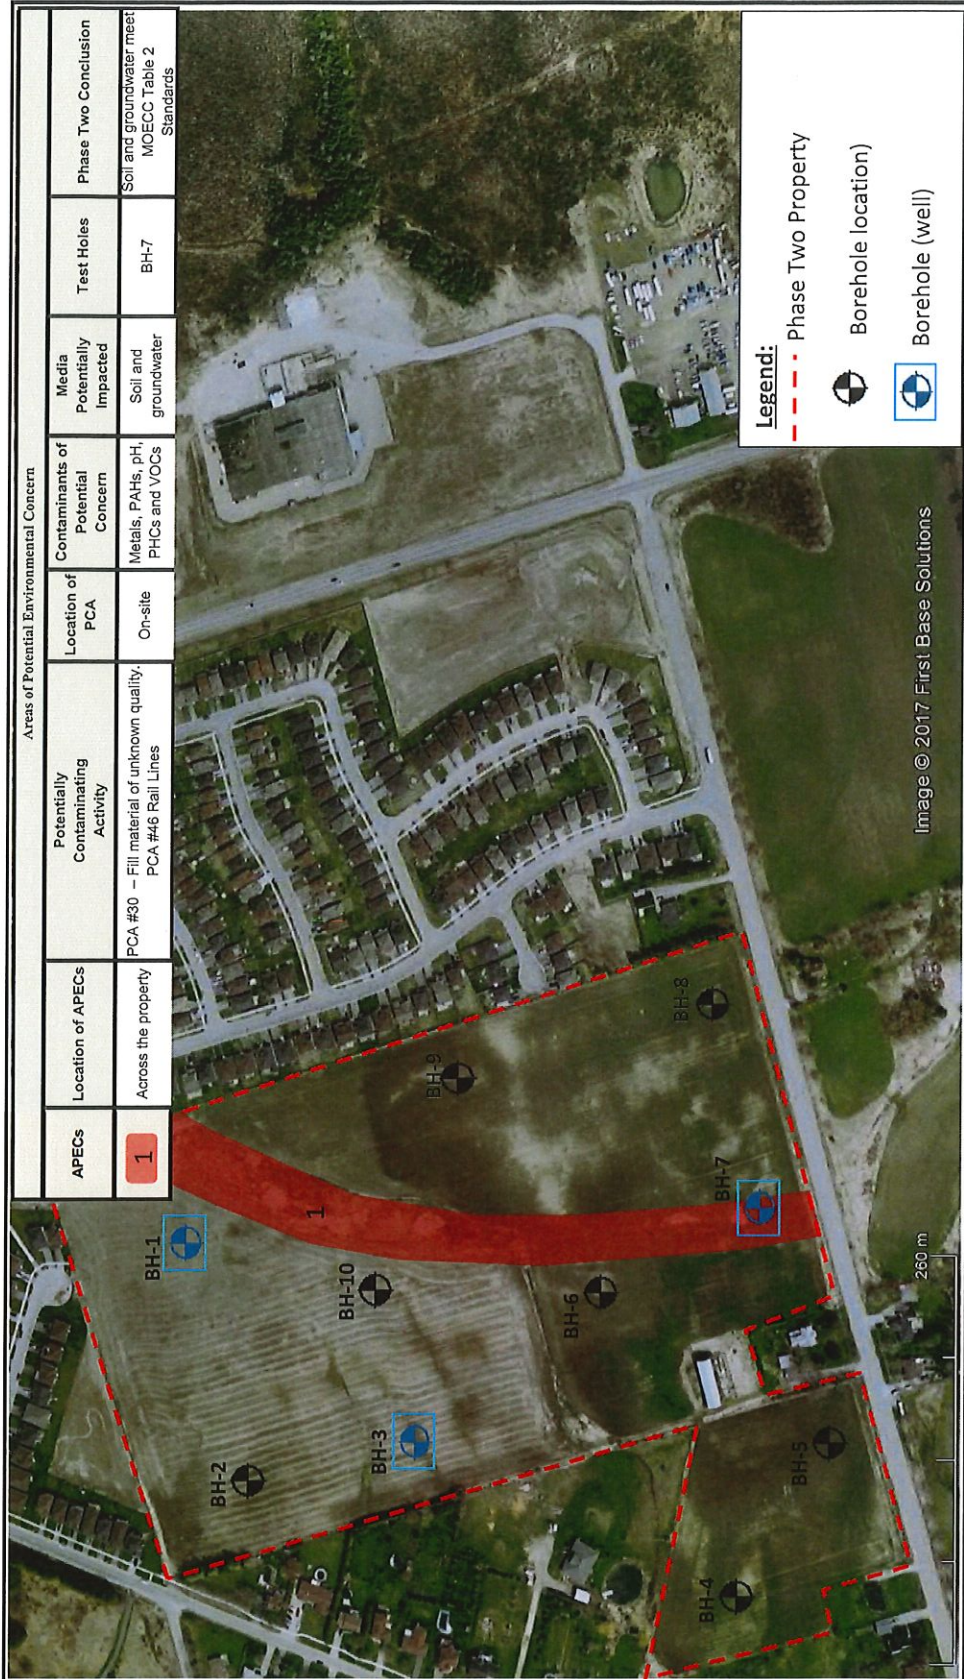
Areas of Potential Environmental Concern				
APECs	Location of APECs	Potentially Contaminating Activity	Location of PCA	Contaminants of Potential Concern
1	Across the property	PCA #30 - Fill material of unknown quality, PCA #46 Rail Lines	On-site	Metals, PAHs, pH, PHCs and VOCs
				Media Potentially Impacted
				Soil and groundwater
				Test Holes
				BH-7
				Phase Two Conclusion
				Soil and groundwater meet MOECC Table 2 Standards

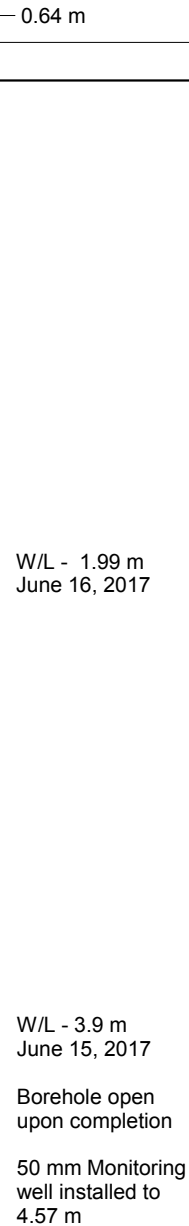
BOREHOLE No.: BH-8

0.0		GROUND SURFACE		%	%	ppm	N	10	20	30	40	50	60	70	80	90		
				TOPSOIL - (300 mm)																
1		0.30		FILL - Brown Sandy Silt, Little Gravel, Occas. Organics (Rootlets), Moist, Loose	SS-1	29	17	0	6	×	○									
2		0.5																		
3		1.0																		
4					SS-2	42	3	0	9	○	×									
5		1.52		SILTY SAND - Light Brown Silty Sand, With Gravel, Moist, Compact	SS-3	63	11	0	26	○	×									
6		2.0																		
7																				
8		2.29		Grading To Grey, Dense, Seepage Observed At 3.3 m	SS-4	83	10	0	40	○		×								
9		2.5																		
10		3.0																		
11		3.5			SS-5	92	14	0	42	○		×								
12																				
13		4.0																		
14																				
15		4.57		Very Dense																
16		4.85		END OF BOREHOLE	SS-6	100	6	0	100+	○								×		
17		5.0																		
18		5.5

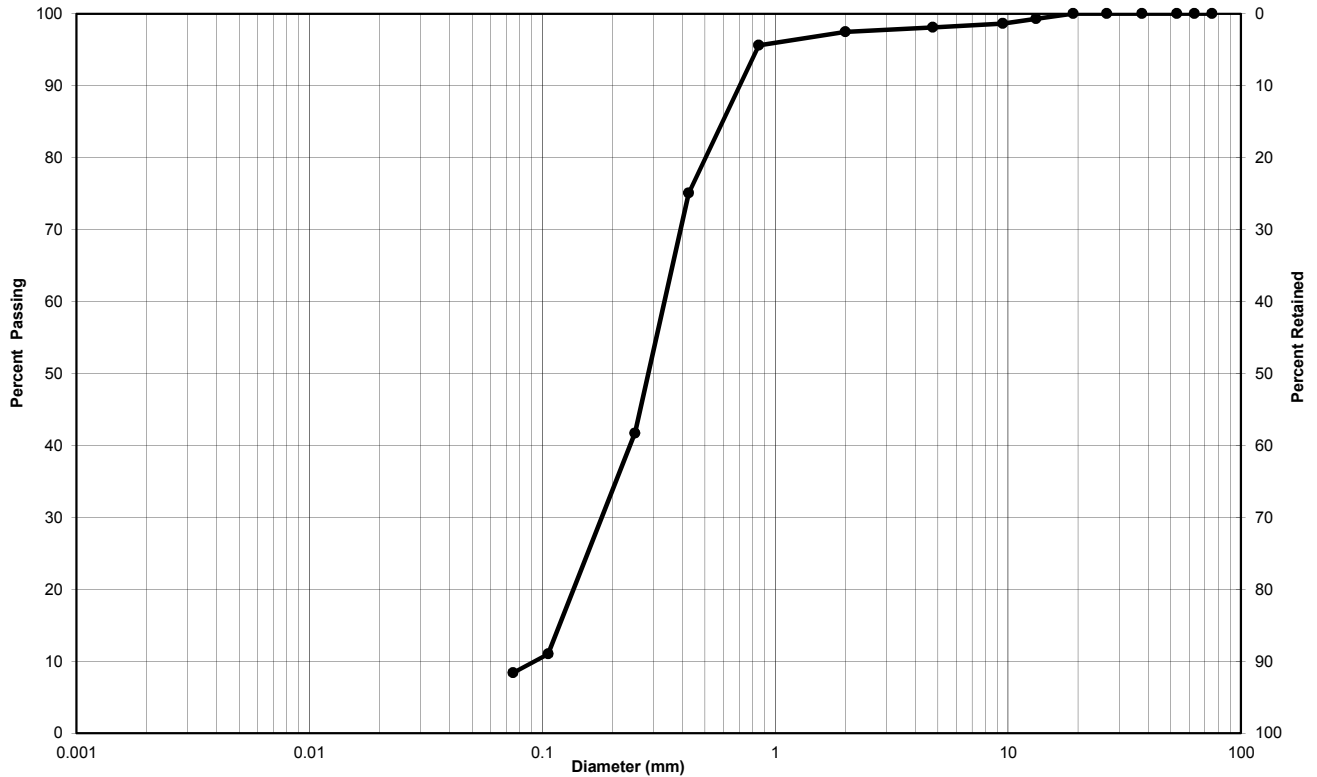
Borehole no.: BH-1 **Sample no.:** SS-4

Soil Description	Gravel	Sand	Clay & Silt
BH-1 SS-4	2	90	8

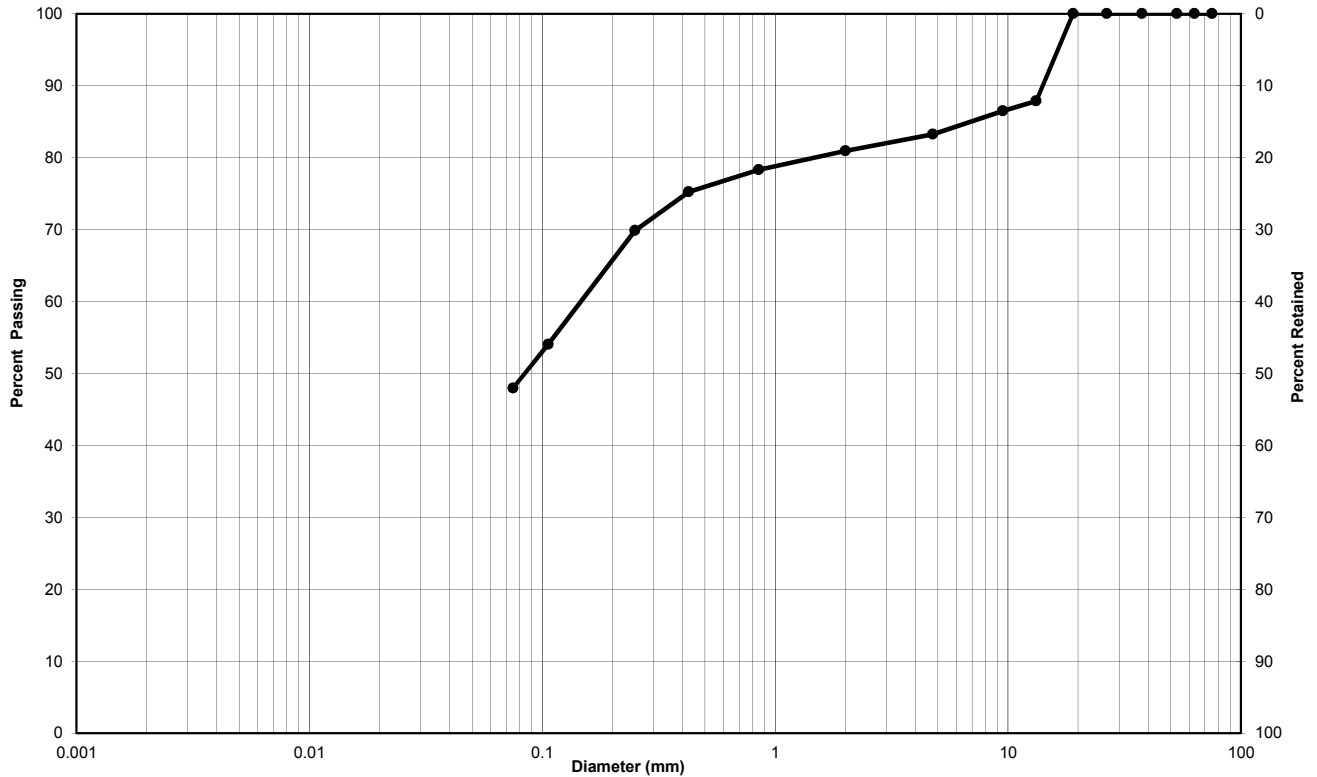
Borehole no.: BH-6 **Sample no.:** SS-3

Soil Description	Gravel	Sand	Clay & Silt
BH-6 SS-3	17	35	48

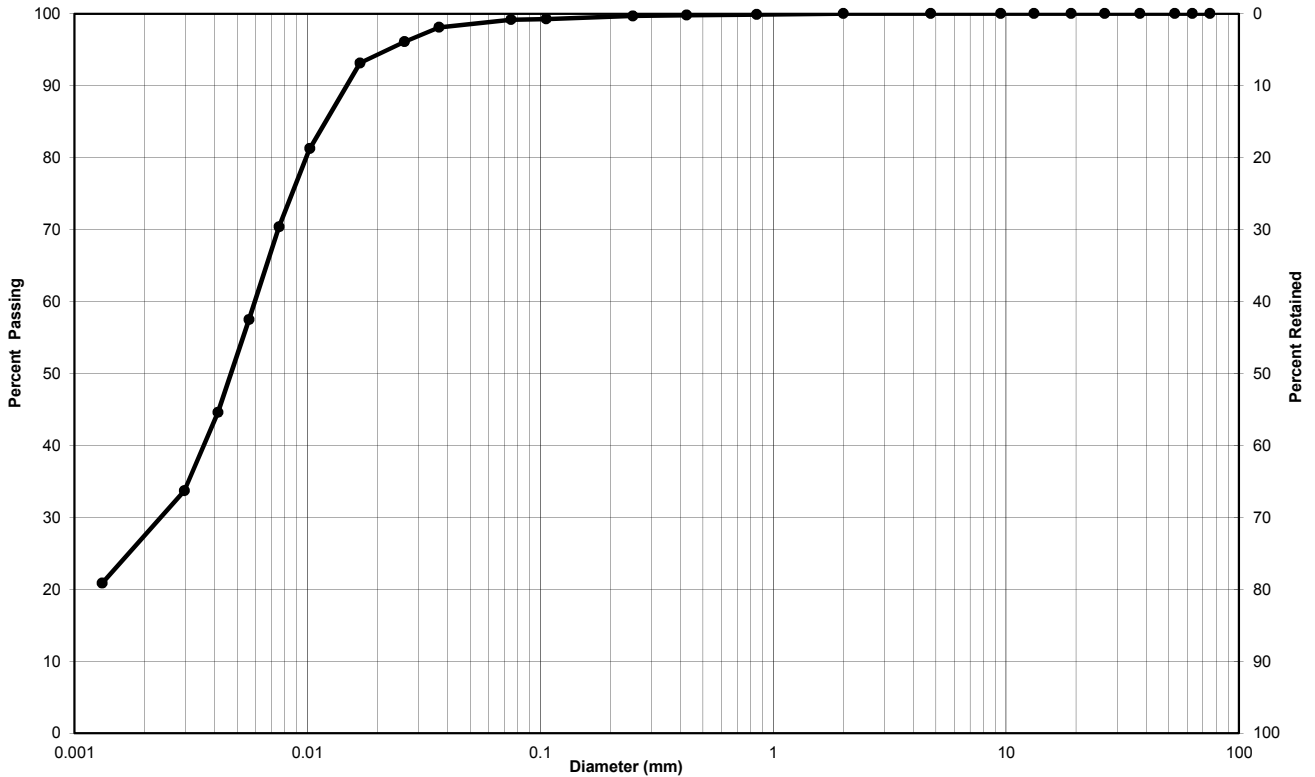
Borehole no.: BH-9 **Sample no.:** SS-3

Soil Description	Gravel	Sand	Clay & Silt
BH-9 SS-3	0	1	99
