Pipeline Condition Assessment and Rehabilitation

Jeff Austin
Water System Consultant
Advanced Solutions

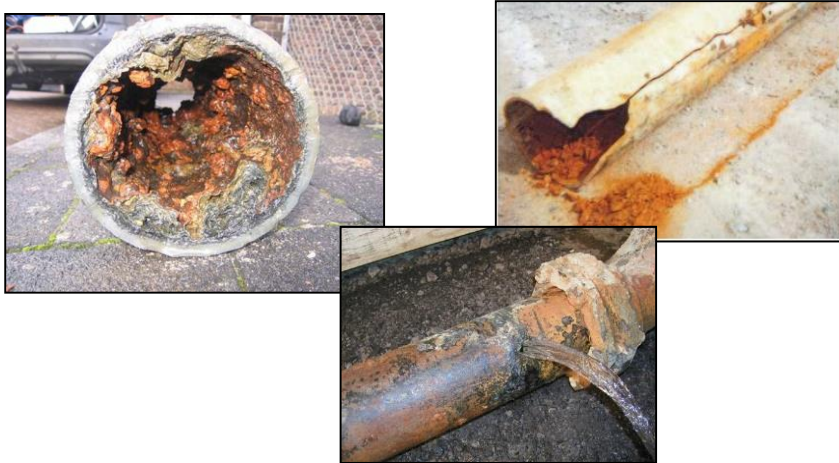
Example of concrete water pipe failure

Example of Cast Iron Pipe Corrosion

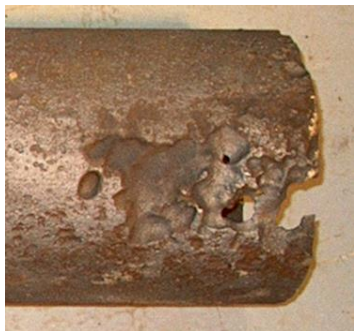
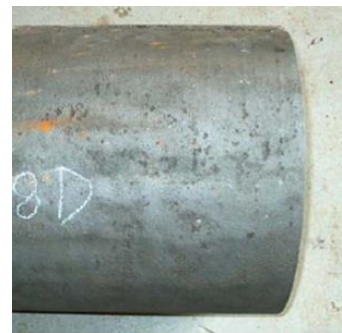
Pipeline 1	Pipeline 2
Installed 1860	Installed 1860
Brown sandy soil	Brown clay soil
Moderate soil corrosivity	Moderate soil corrosivity
Results: 31% degraded	Results: 1% degraded
Condition: Poor	Condition: Good

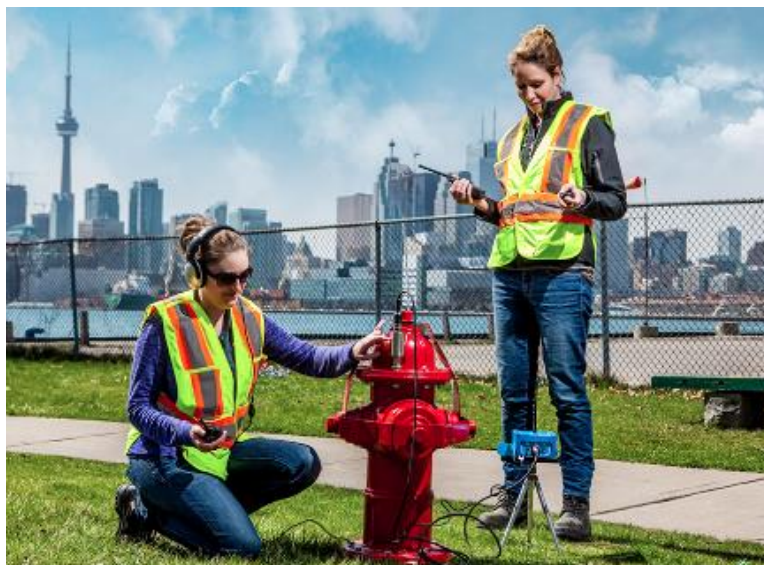
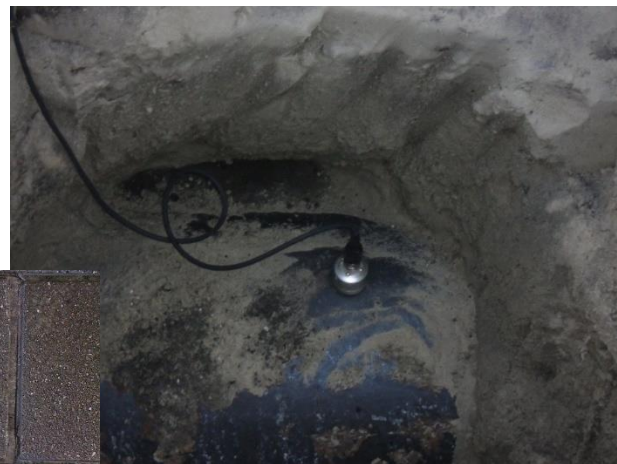
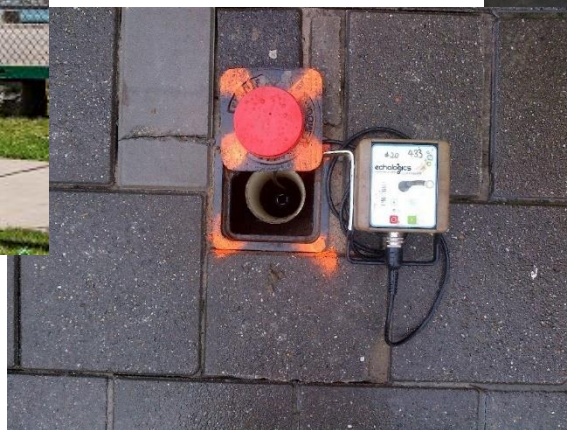
Sensors to be placed on Hydrants, valves or directly on top of the main

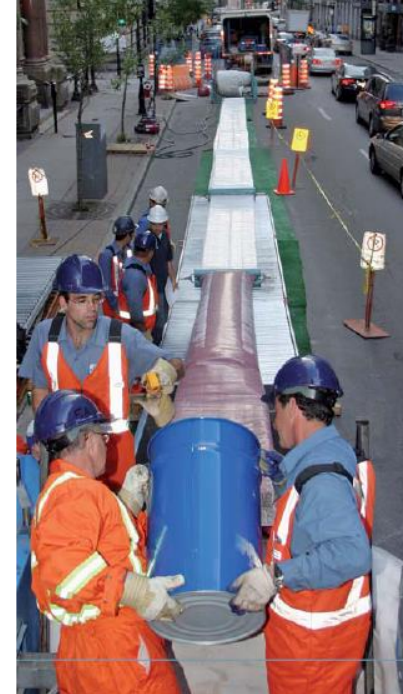
- **Fabric tube impregnated with thermosetting resin**
- **Inserted in host pipe and heat cured – 2 Methods**
 - Pulled into host pipe and expanded by water pressure
 - Liner turned inside out (Inversion)

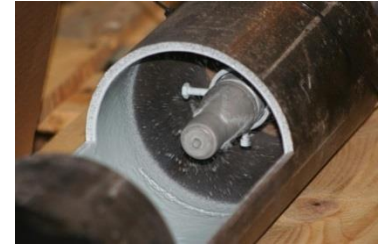
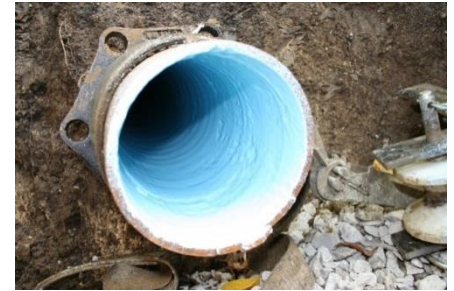
- Thorough cleaning of host pipe
- Spray host pipe with a thin lining of resin (typically 1mm thick)

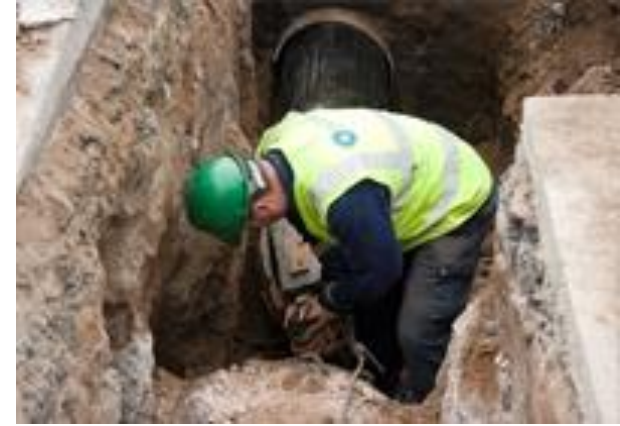
- **HPPE pipe is pulled into host pipe**

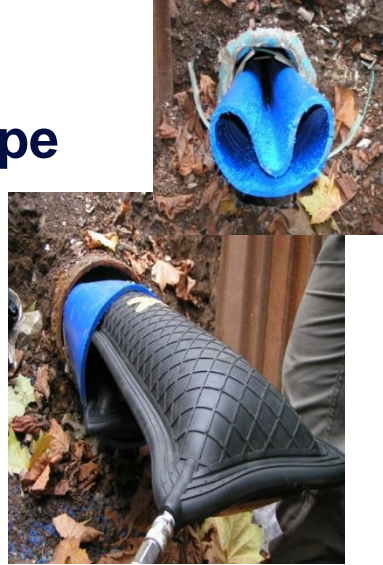
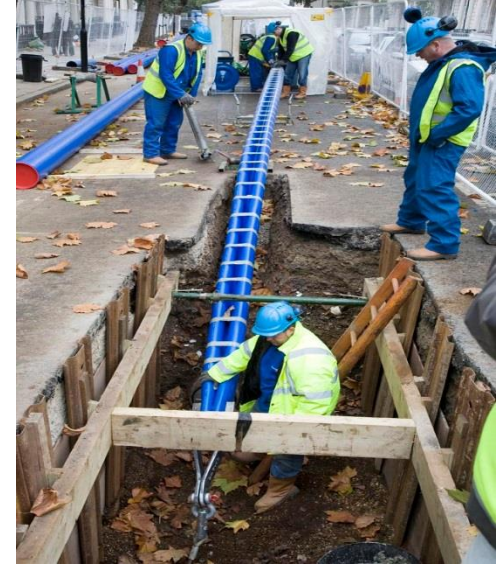
- Liner is heated and folded
- Liner is winched into host pipe and reshaped by heat and pressure

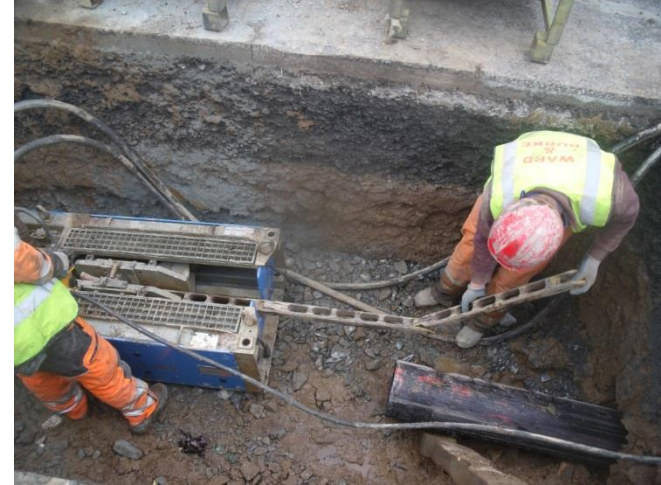
- HPPE pipe is attached to bursting head
- Break and displace host pipe
- Pull replacement pipe into the void

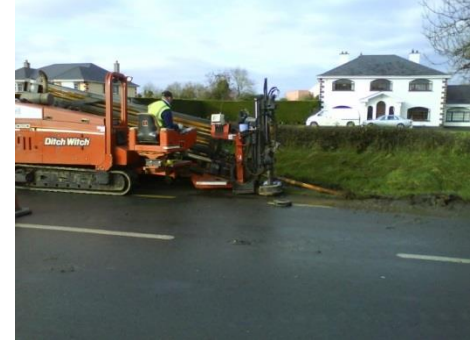
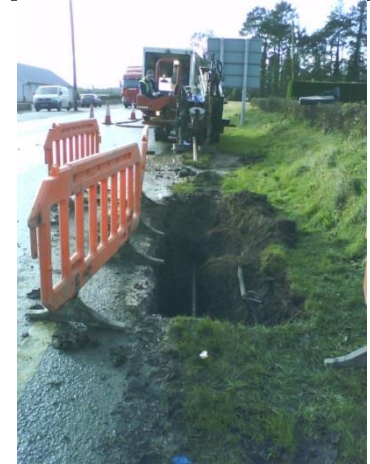
- Pilot bore to line and grade
- Reamer and new HPPE pipe pulled through in reverse direction

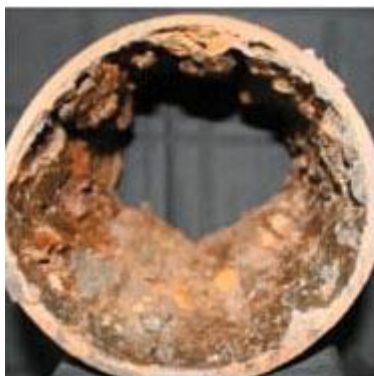
Before

Severely corroded

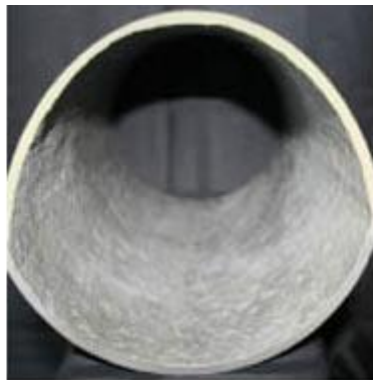
During

Completely cleaned

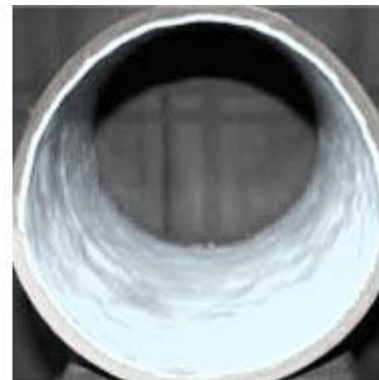
After

Epoxy lined

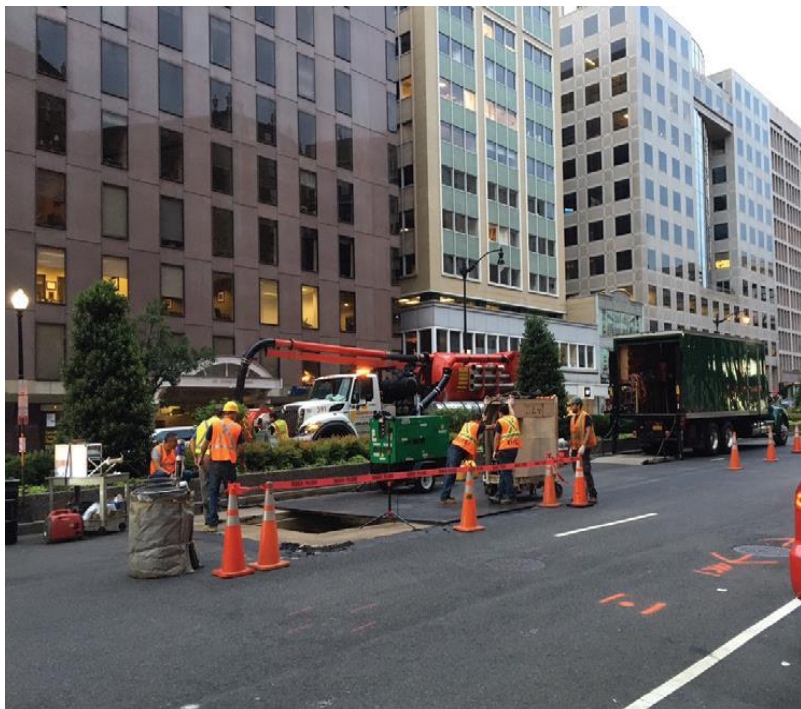
Merrick Road – New York American Water Works

- Restored a 100-year-old water main with a history of leaks, severe corrosion and poor water quality in Massapequa, NY
- Successfully lined over a 2 month period in Spring 2016
- Using our proprietary SIPP process, a structural 3 mil (1/8th") epoxy coating was evenly applied through the entire length of 2 miles of 12" cast iron domestic water pipe under strict zero-VOC policy
- Developed logistics to minimize disruption to 4-lane highway, despite multiple adverse conditions, such as multiple trapezoid sweeps, including underneath small rivers and other utility services

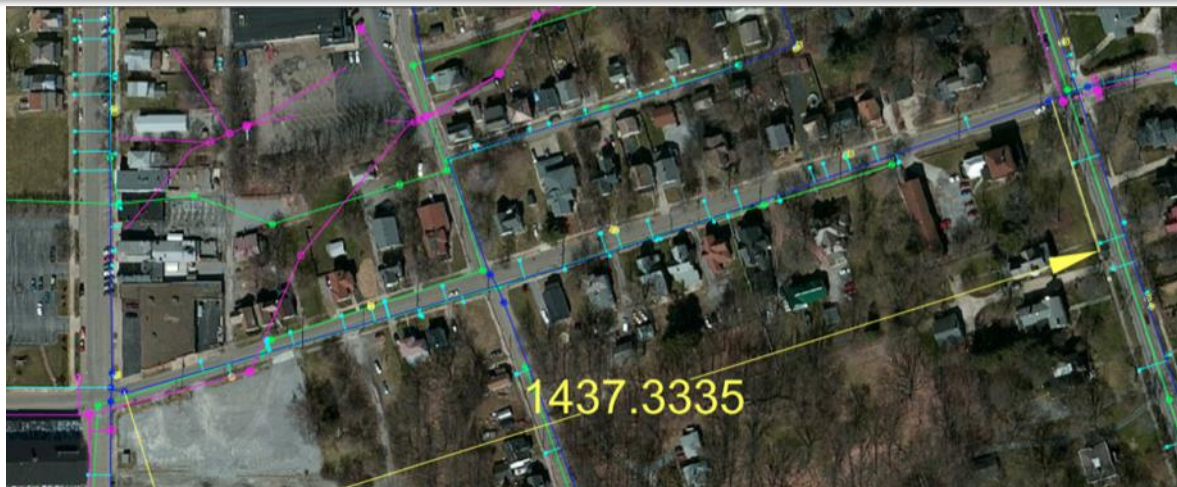
Franklin Avenue - Salem, Ohio

Time Required

3-5 days

4-6 weeks

**4 access points
needing just 3 feet of pipe access**

Trench the entire street causing
severe and long traffic disruptions
