Pitched roof coverings series

3. Weathering details & fixing

This session provides guidance on weathering details and fixing requirements.

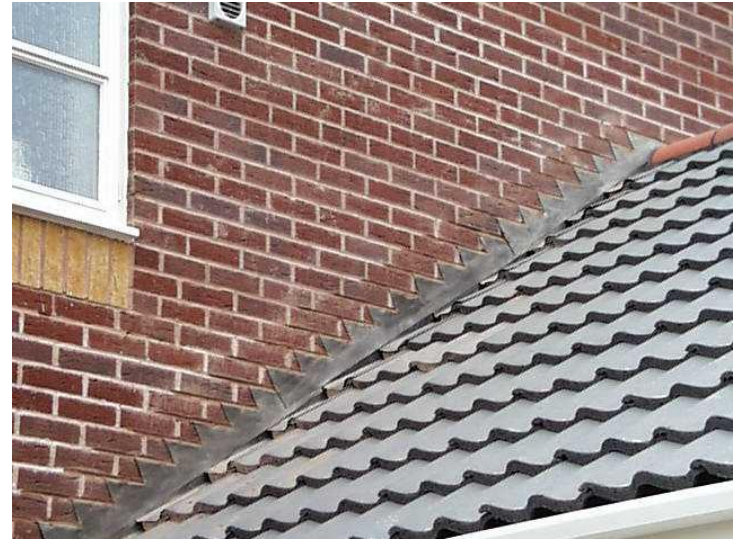
If weathering details are unclear then seek the appropriate clarification and avoid ad-hoc details.

Images from **NHBC** claims/inspection services

1. This ad-hoc approach will lead to failure!

2. This damage to the underlay can lead to problems with wind assisted rain/snow ingress.

3. The underlay detail at abutments is important if weather ingress issues are to be avoided.

4. Clearly detailing like this must be avoided. If in doubt seek appropriate advice.

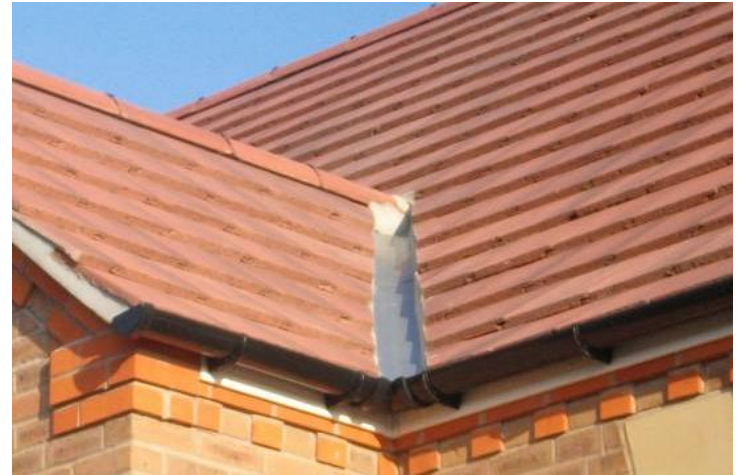
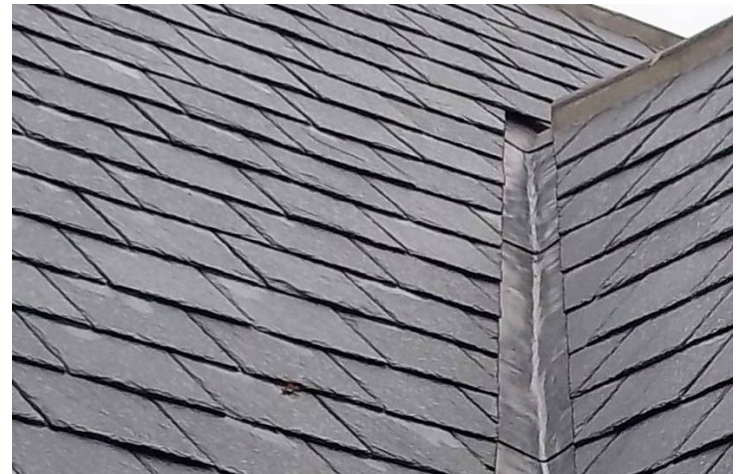
Flashing and weathering detailing - head of valley detail

Avoid running ridge tiles over the valley head as shown in the top image. The mortar depth becomes excessive and prone to failure. This detail often conceals the lack of a lead saddle to the head of the valley.

The bottom right-hand image shows the detail which represents good craftsmanship.

A saddle flashing should be used where a ridge meets the main roof.

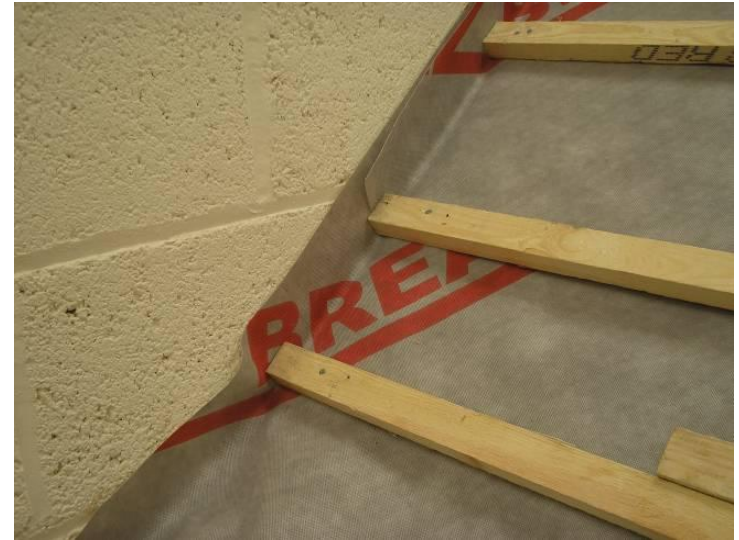
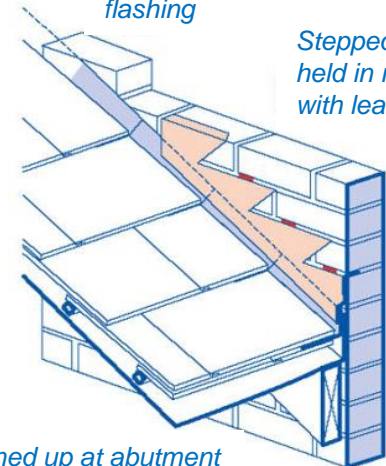
Soakers beneath each tile overlapped by lead flashing

Stepped lead flashing held in mortar joints with lead wedges

Underlay turned up at abutment

The underlay should be turned up at least 100mm at all abutments to prevent wind assisted rain and snow being blown into the roof space. The underlay will need to be adequately supported at abutments and consideration should be given to the position of the last rafter relative to the wall.

Where a pitched roof abuts the wall at an angle, a stepped cavity tray linked to a stepped flashing should be used. Stepped flashings should be cut from a strip at least 150mm wide.

Soakers or a secret gutter should be installed at abutments where plain or flat interlocking tiles are used.

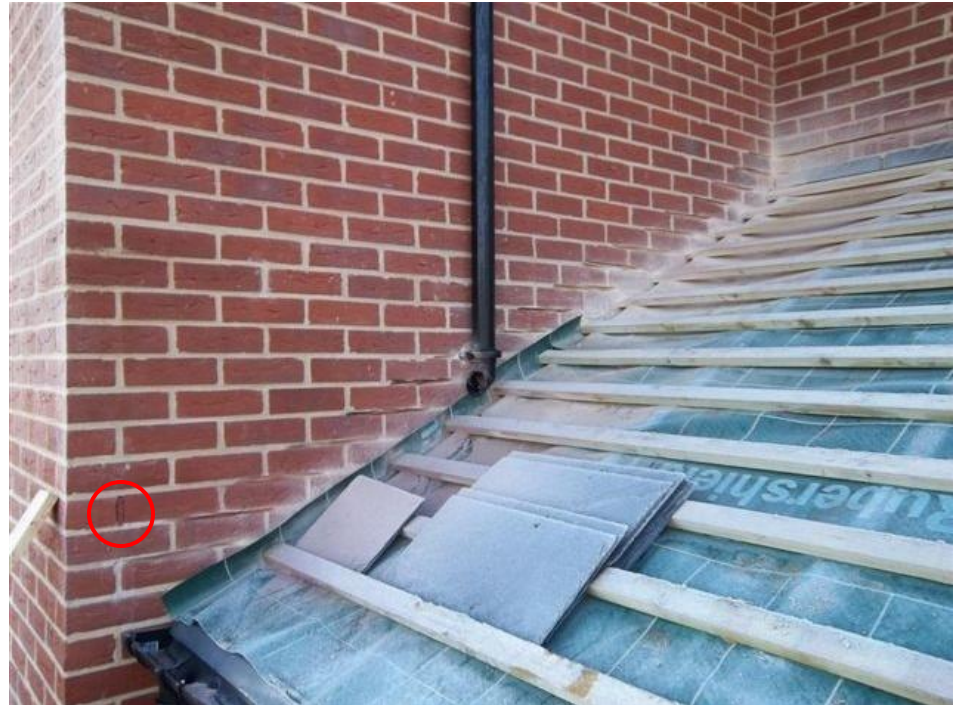
Flashing and weathering - cavity tray interface at abutments

1. The position of the weep hole (circled) suggests that the cavity tray is installed too high!
2. The bed joints have been 'ground out' to accommodate the correct flashing position relative to the roof covering, but will the flashings link with the cavity trays?
3. If the cavity trays are in the correct position, have they been damaged by the grinding out process?
4. The underlay does not appear to have sufficient upstand towards the top of the inclined roof abutment!

Where flashings link with cavity trays, rake out 25mm of mortar below the dpc before the mortar sets, to allow for the flashing to be tucked in. This is the preferred approach.

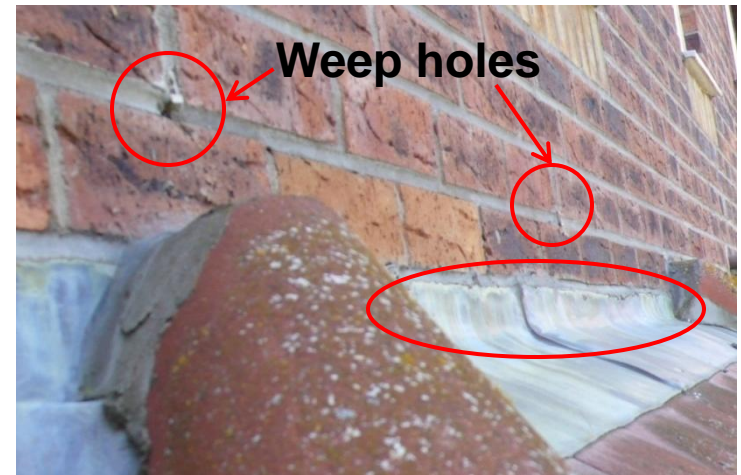
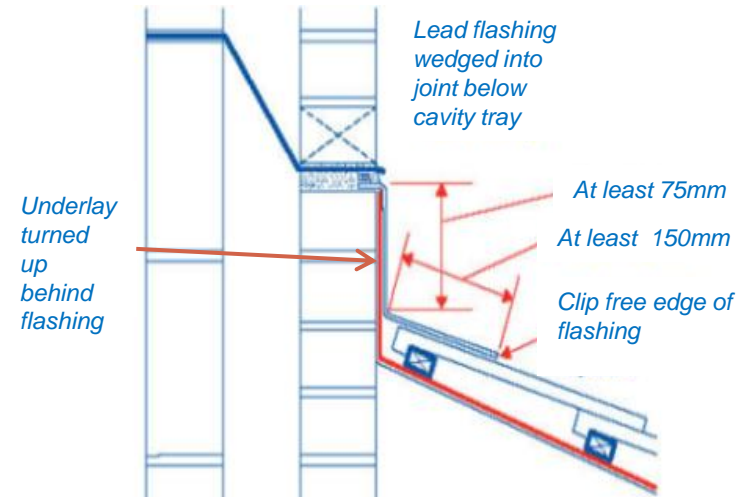
If the cavity tray has been installed at the wrong height to link with the flashing, this will need to be addressed. Where flashings link with cavity trays, rake out 25mm of mortar below the cavity tray to allow for the flashing to be tucked in. In the top image the flashing should have been taken up higher to meet with the cavity tray.

The use of disc cutters to create the recess for the flashing can damage the cavity tray and should therefore be avoided.

All abutments should be weatherproofed using non-ferrous metal flashings. Lead flashings should be at least code 4 (colour coded blue). Where required, soakers are normally code 3 (colour coded green). Normally, lead flashings should not exceed 1.5m in length, with laps of not less than 100mm.

Flashing should be tucked into a mortar joint 25mm deep and at least 75mm above the tiling level and lead wedged into place. The joint should then be pointed with mortar or using suitable exterior grade sealant.

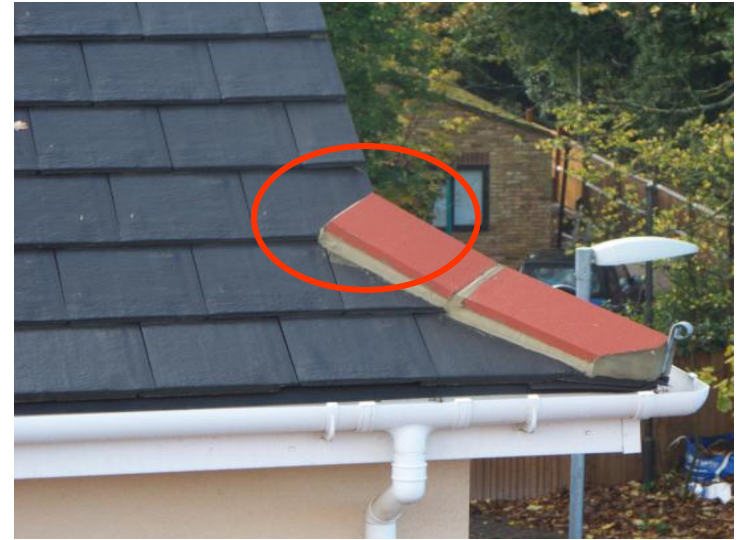
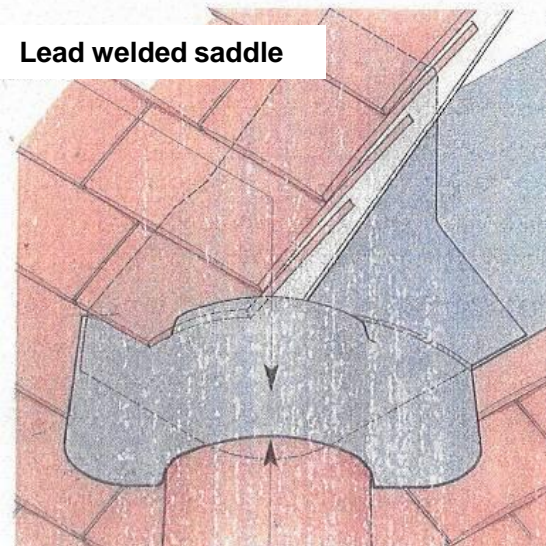
Flashing and weathering - Dutch gable detail

The top image is of a Dutch gable, and whilst initially this looks like a neat job, the long term durability must be considered. NHBC looks for saddle flashings to be provided here to prevent water running off the main roof areas and behind the hip tiles through the inevitable cracks that will form between the mortar fillet and hip tile.

Reliance upon the underlay for weather proofing is not a robust solution. Instead a lead saddle should be neatly dressed and fitted as shown in the lower image.

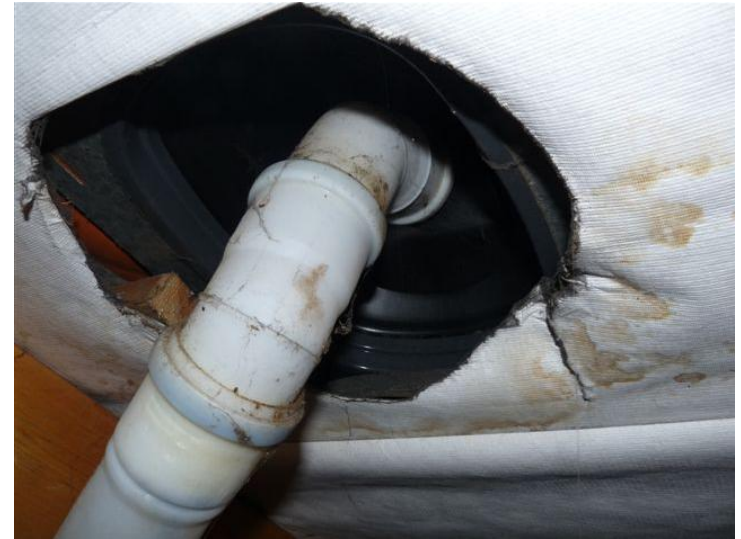
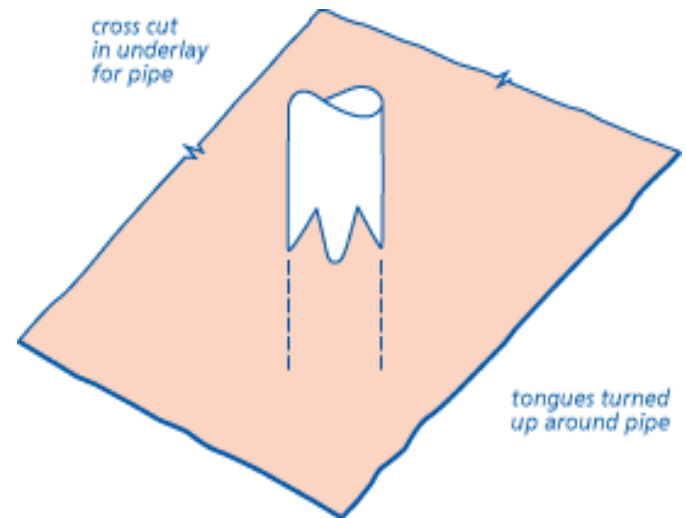
Flashing and weathering detailing - roof projections

Particular care is needed where soil ventilation pipes/proprietary 'ventilation tiles', project through the underlay. Torn underlay around soil ventilation pipes/proprietary 'ventilation tiles' can lead to weather ingress resulting in the ceiling underneath becoming wet and stained.

With soil ventilation pipe projections; cut a small cross in the underlay and sleeve over the pipe so that the tongues of the underlay turn up. A purpose-made one-piece flashing and upstand should be used around pipes projections through tile/slate coverings.

Proprietary 'ventilation tiles' usually come supplied with purpose made soaker tray.

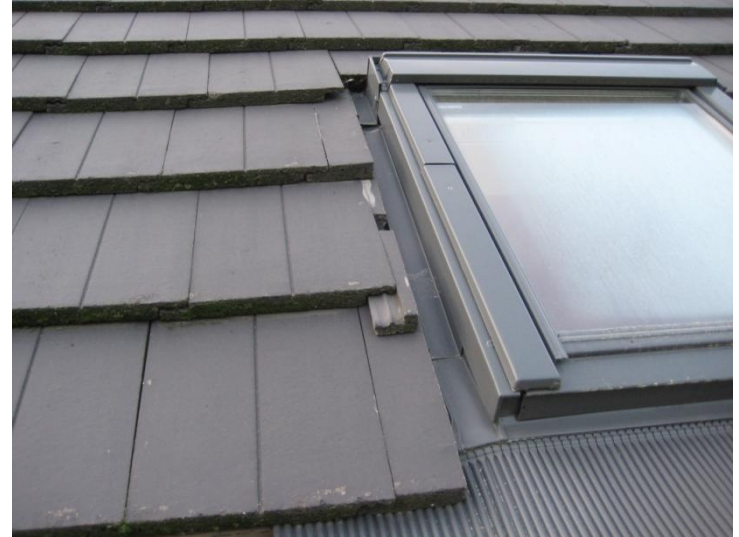
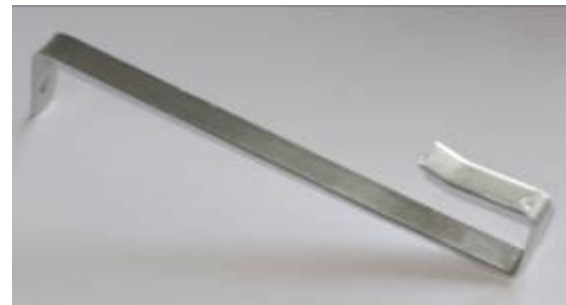
Where small tiles cuts are unavoidable, seek technical advice from the manufacturer. Many offer special clipping arrangements, additional mechanical fixings or specialist adhesives to bond tiles together.

Where appropriate, establish the tolerance range of the flashing detail to determine if the cut line can be adjusted.

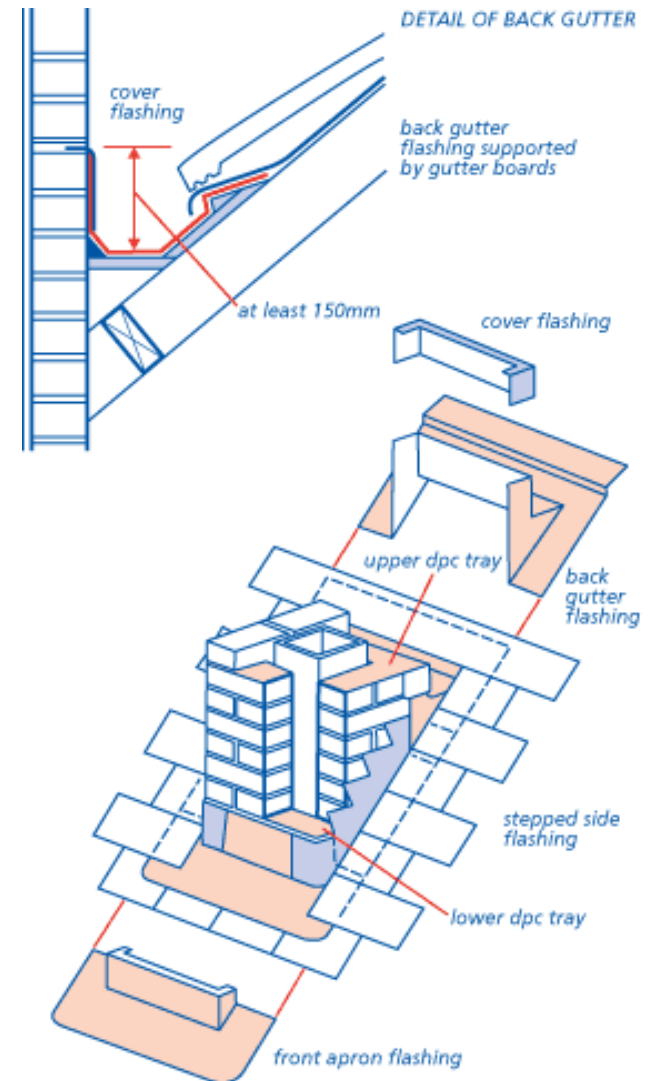
Flashing and weathering detailing - chimneys

Lead flashings associated with chimney structures require careful detailing of the masonry work in order to ensure that the dpc's are incorporated at the correct heights above the roof covering. Chimney flashings should link with the chimney dpc trays.

Underlay should have a minimum upstand of 100mm at the chimney abutments.

In addition, timber support to the back gutter lead work is equally important. Adequate support will prevent the lead work becoming depressed and/or sagging and causing potential weather ingress issues.

Again it is vitally important that the lead work is firmly fixed/wedged into place in line with good practice, due to its exposed nature.

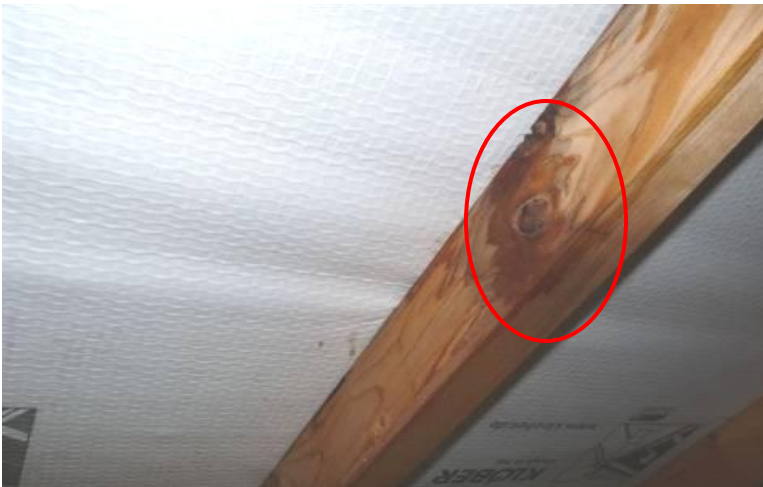
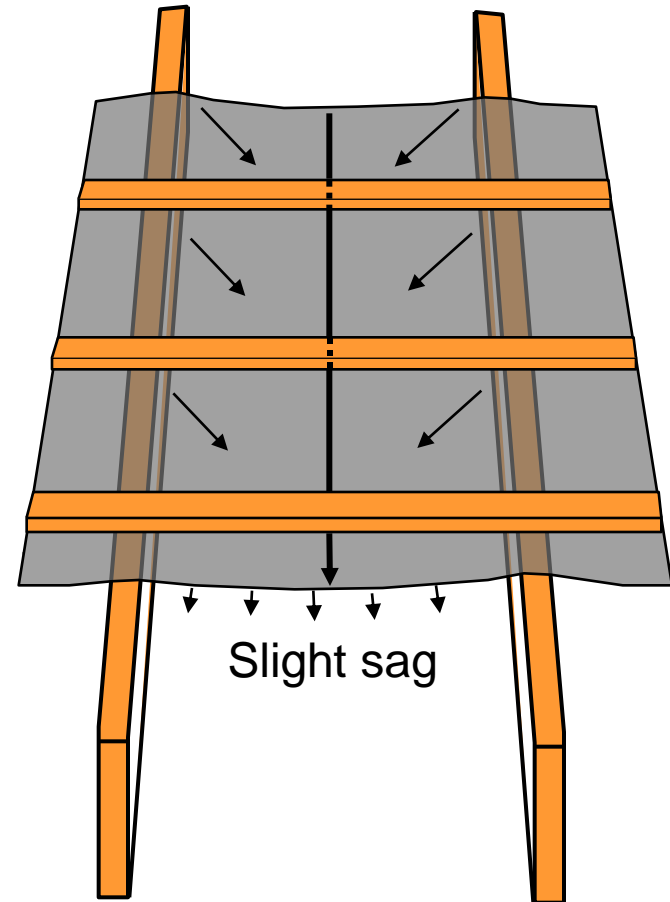
Flashing and weathering detailing - underlay

Slight sag required to under felt to enable water to drain to gutter, rather than collect at the battens.

If the underlay is too tight, any water will run down the underlay until it reaches a batten, from there it will collect until it eventually seeps through the batten nail holes in the underlay. The image below is an example of this failure.

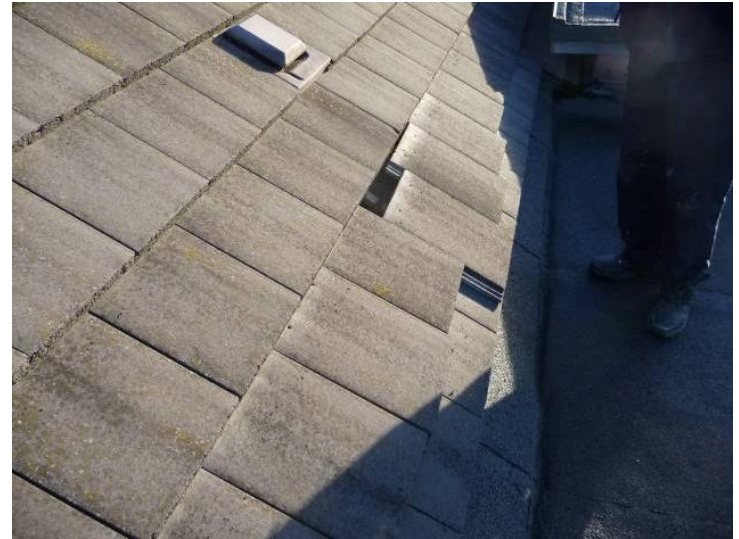
Careful setting out will improve the finished appearance of the roof and helps to avoid problems such as unequal overhangs at verges and often makes it possible to avoid excessive tile cutting at abutments, chimneys and similar obstructions. Small sections of cut tiles are difficult to fix and should be avoided. This can be achieved by incorporating tile sizes such as double size tiles, tile and a half or half tiles where these are available.

Single lap Interlocking tiles have a tolerance of approximately 3mm in the joint. For double lapped plain tiles and slates, joints should be slightly open. This allows some flexibility in setting out and should avoid tile cutting.

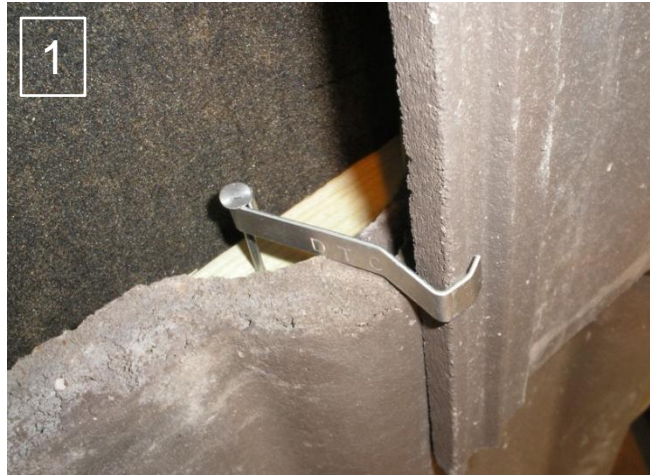
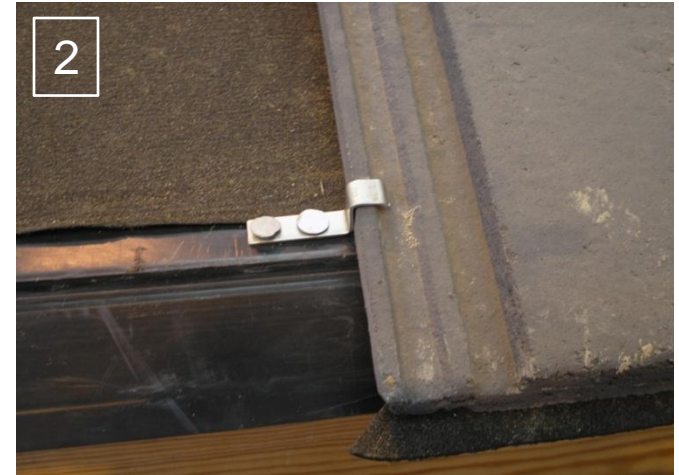
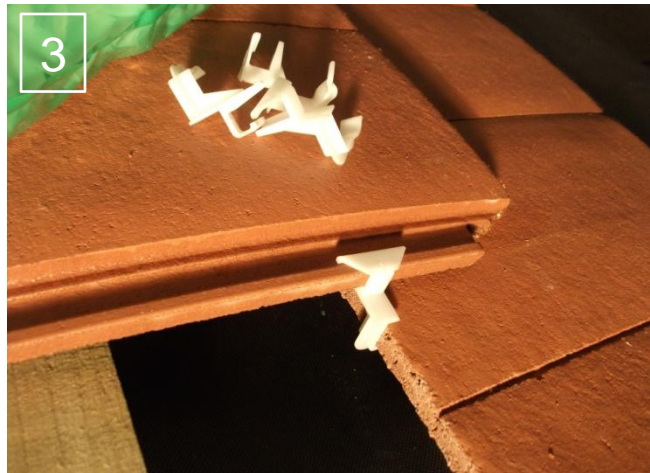
Nailing and fixing - tile clips

1. A typical general tile clip.

2. A typical eaves tile clip.

3. A typical tile to tile clip.

In addition to standard nailing, and verge clips, many fixing specifications will require additional clipping to all or certain specified tiles.

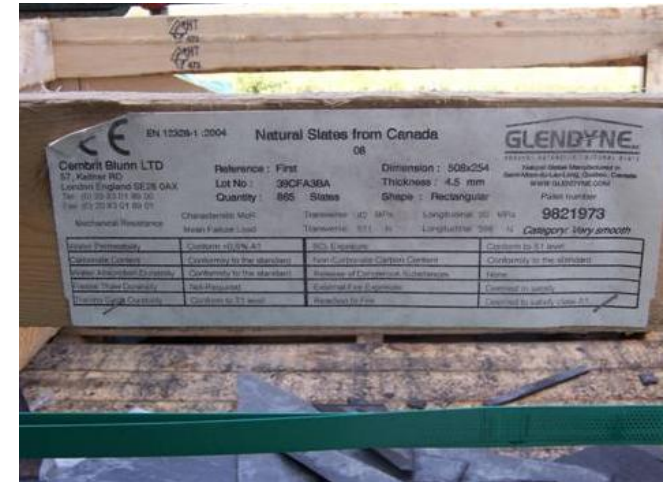
Slate packing crate showing BS EN reference

- clay tiles and fittings to BS EN 1304
- concrete tiles and fittings to BS EN 490 and BS EN 491
- fibre cement slates and fittings to BS EN 492
- natural slates- only certain grades to BS EN 12326 are acceptable to NHBC (see Appendix 7.2– G)
