# Pre-Construction, Construction, and Post-Construction Final Monitoring Report for Greenland Meadows: July 2007- November 2013

Water Quality Certification#2005-003, In Compliance with Condition E-10,d

Prepared by  
The University of New Hampshire Stormwater Center  
March 2014

**New England Development, RT 33, Greenland, NH**

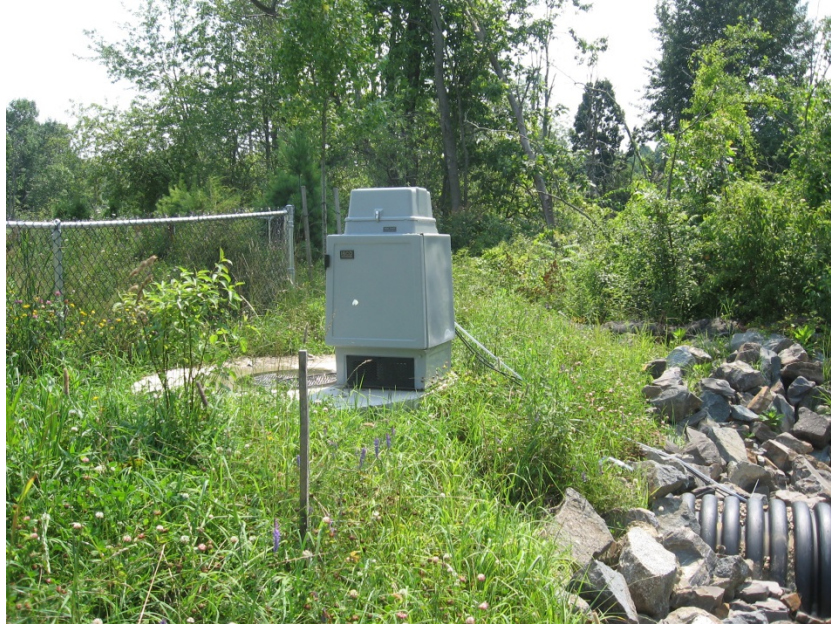
**Figure 4: Teledyne ISCO 6712 Refrigerated Sampler installed at effluent location of subsurface gravel wetland.**

Teledyne ISCO 6712 Refrigerated samplers (Figure 4) were used to monitor water quantity and water quality during storm events. Each sampler was outfitted with either an ISCO 720 Submerged Probe or ISCO 730 Bubbler module to continuously monitor water depth throughout each sampled rain event. YSI 600XL Multi-parameter Sondes are installed for real-time monitoring of pH, temperature, dissolved oxygen, and conductivity and recorded at 5 minute intervals. The samplers are equipped with twenty-four 1 liter sample bottles inside the refrigerated compartment and kept at 4°C at all times. The samplers are programmed to sample 100 milliliter aliquots at flow-weighted intervals into twenty-four 1 liter containers allowing for a maximum of 240 samples per event. The sampling program is designed to ensure adequate coverage of the storm event and is adjusted to accommodate seasonal fluctuations in rainfall patterns. Rejection criteria included minimum rainfall depth of 0.1 inches, minimum of 10 aliquots per sampling event, and at least 70% coverage of the total storm volume.
