NASA/TP—2018-219787

Preload Loss in a Spacecraft Fastener via Vibration-Induced Unwinding

*Christopher DellaCorte and S. Adam Howard
Glenn Research Center, Cleveland, Ohio*

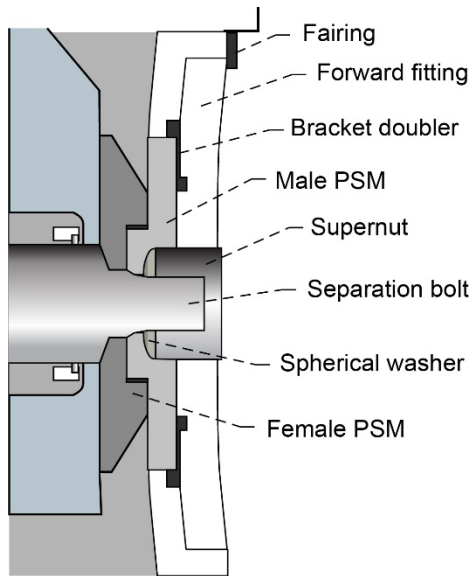
Figure 3.—Pyramidal Separation Mechanism (PSM) cross section (Ref. 1).

interfaces. Two PSMs connect the upper end of each of the three fairing panel segments to the spacecraft. Figure 3 shows a cross section of a typical PSM cup-cone device.

Dimensional measurements were made of the PSM components clamped between the separation bolt and the supernut. These components (depicted in Figure 3) include the male and female cone and cup and the spherical load washer against which the jackbolts contact. Localized wear marks in the Canadize® coating were noted in many places but most notably on the cup-cone faces near the centrally located separation bolt and on the angled cup-cone surfaces. However, profilometry measurements indicate that very little material removal appears to have occurred. Indeed, the PSM cups and cones were still well within dimensional tolerances. Further confounding the forensic efforts, the PSM cups and cones had been tested previously as part of a series of subcomponent level life tests (Ref. 1). It could not be determined whether the wear marks on the Canadize® coatings were the result of earlier tests or the present vibration test campaign that resulted in the PSM preload loss. In any case, the magnitude of observed wear was not consistent with the levels of preload loss observed.

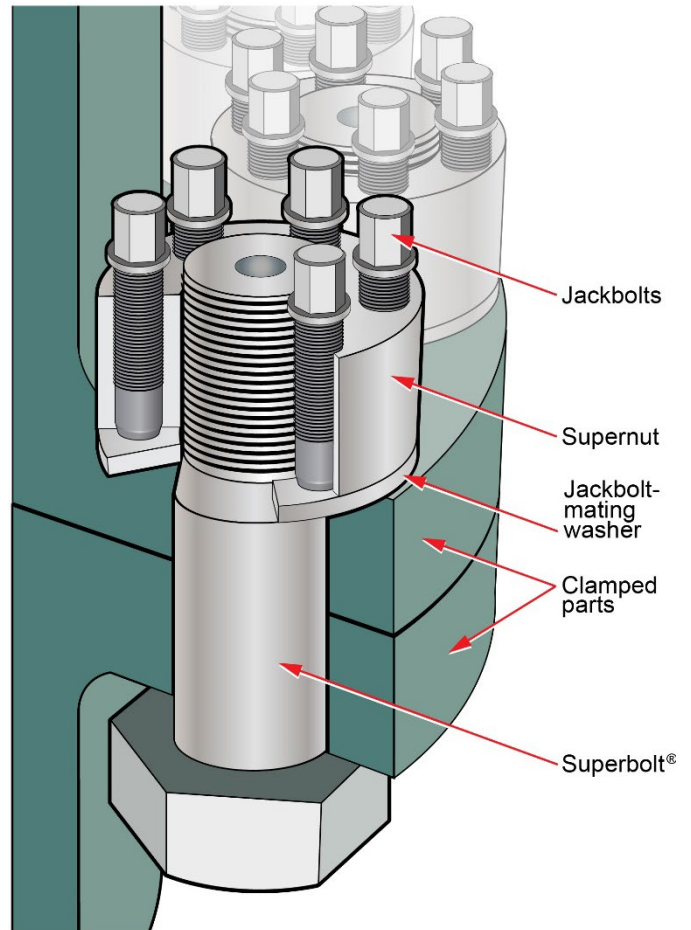
Figure 4.—Typical Superbolt[®] assembly showing operating principles. Images from manufacturer catalog (www.fairfieldindustrialsales.com).

In order to facilitate tightening of the separation bolt to the proper preload, a Superbolt® multi-jackbolt tensioner (MJT) (Nord-Lock, Inc.), also known as a Superbolt® supernut, is used. The supernut is a threaded ring, which contains a circumferentially placed set of jackbolts that when tightened pull the threaded ring away from the bolt against the clamped parts, thus stretching the bolt while minimizing torque at the separation plane. Figure 4 shows a typical supernut-bolt style fastener.

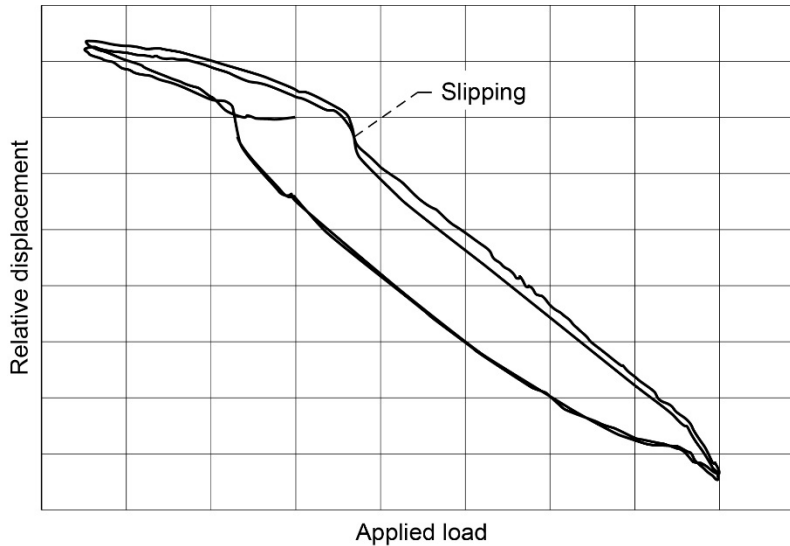
Figure 5.—Pyramidal Separation Mechanism load versus displacement. Note slip occurs due to lubrication and the presence of a small clearance between plate surfaces (Ref. 1).

A major consequence of lubricating the cup-cone surfaces is their propensity to slip when heavily loaded. Indeed, during oscillatory load-stiffness tests of the PSM (Ref. 1), slip was noted as depicted in Figure 5. The magnitude of the slip is small and limited to the small clearance between the cup-cone surfaces.

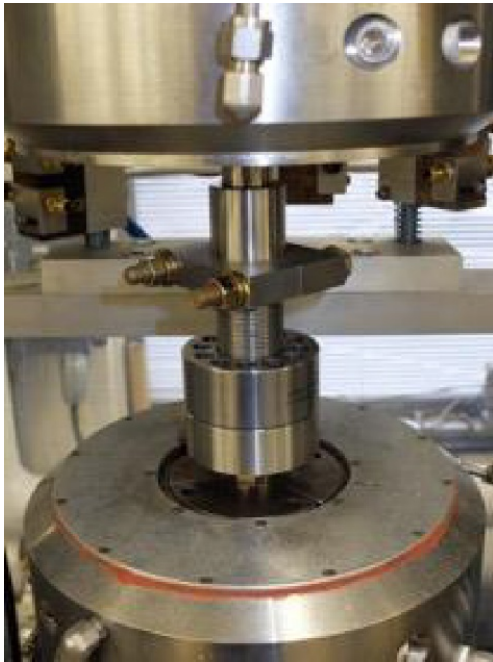
Figure 8.—Supernut-separation bolt loaded in load frame to measure prevailing (thread friction) torque.

With this setup, axial loads between 2,267.96 to 20,411.66 kg (5,000 to 45,000 lb) are applied to the threaded joint while a rotary actuator is used to turn the bolts and record breakaway and running torque. Rotation was at constant speed and data were acquired until a steady-state torque at each of the three

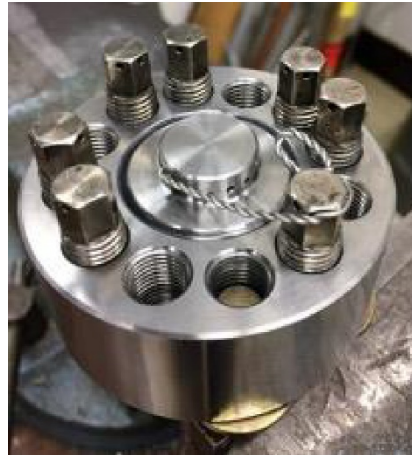
Figure 11.—Supernut-separation bolt safety wire configuration using improper angled alignment with correct winding direction around a large diameter center post.

Also tested was a single wire using a separation bolt with a large-diameter raised-wire connection intended to increase the rotational diameter of the wire to enhance restraining torque (Figure 11).

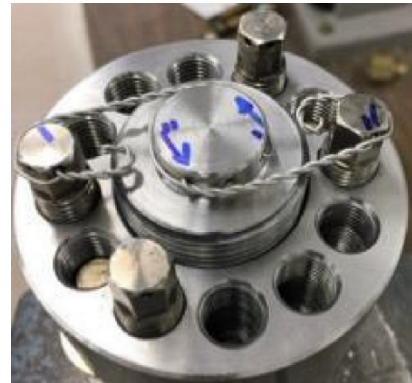
Figure 12.—Supernut-separation bolt safety multiple-wire configuration using proper horizontal alignment with correct winding direction around a large-diameter center post.

Lastly, multiple wires were tested in all configurations. Figure 12 shows a double lock wire arrangement with a coincident axial wire attachment.

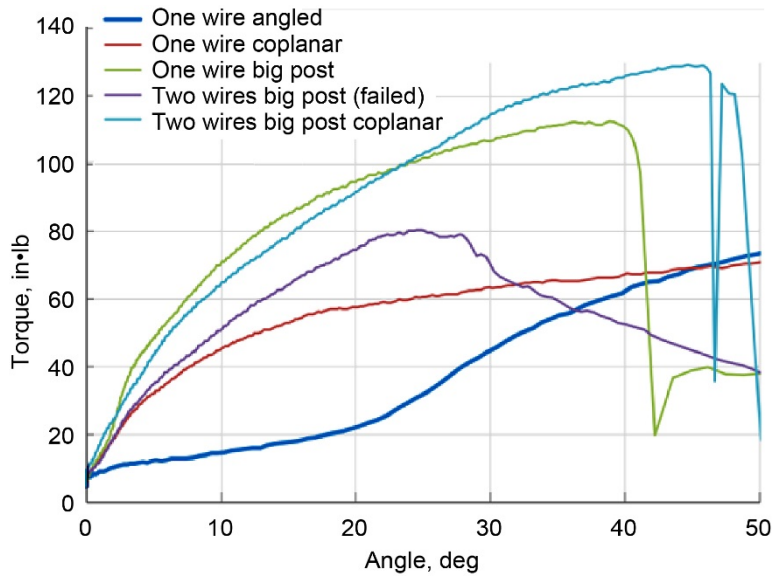
Figure 13.—Torque required to rotate the supernut-separation bolt against different safety wire configurations over a large angle.

The data for the lock wire experiments are summarized in Figure 13.

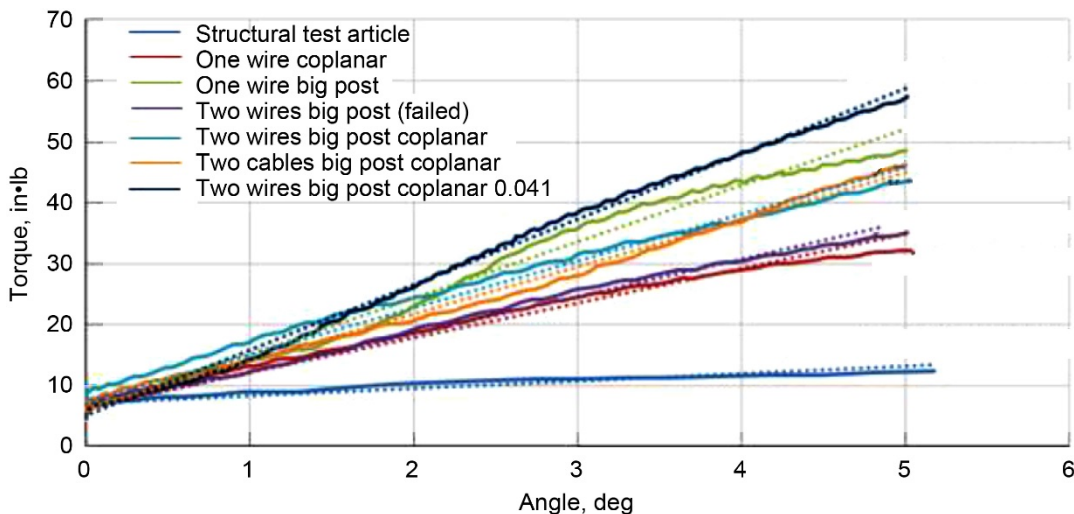
Figure 14.—Torque required to rotate the supernut-separation bolt against different safety wire configurations over the very first 5° (with stiffness curve fits).

This observation is noted in the fastener standard (Ref. 9). Figure 14 replots the available data for only the first critical 5° of rotation. Here you can see that the STA configuration, where the central wire was wrapped in the backward direction, offers essentially no torque restraint. However, even the best wire configuration using two large diameter wires (1.041 mm (0.041 in.)) wrapped correctly around a large center post only offers ~6.78 N•m (~60 in•lb) of restraint.

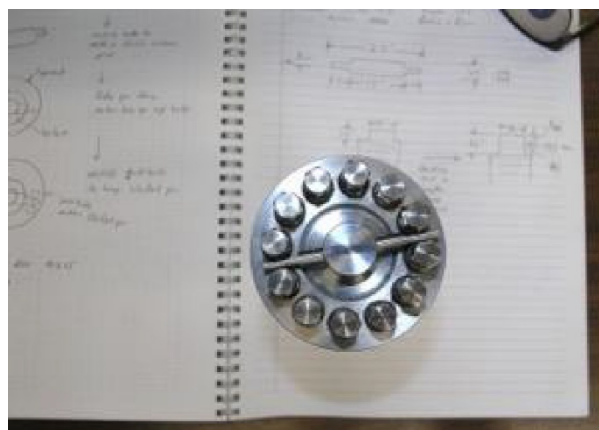
Figure 18.—Bladed cotter pin used for positive locking of supernut-separation bolt.

A sensible recovery plan is to provide positive locking features, such as cotter pins, that are capable of restraining levels of unwind torque that represent a significant percentage of the prevailing torque. Going forward, it is recommended to continue experimental and analytical investigations to quantify unwind forces with respect to environmental (loads, vibrations, etc.) and other factors. The results of such investigations could lead to valuable design guidance for the proper engineering of bolted joints.

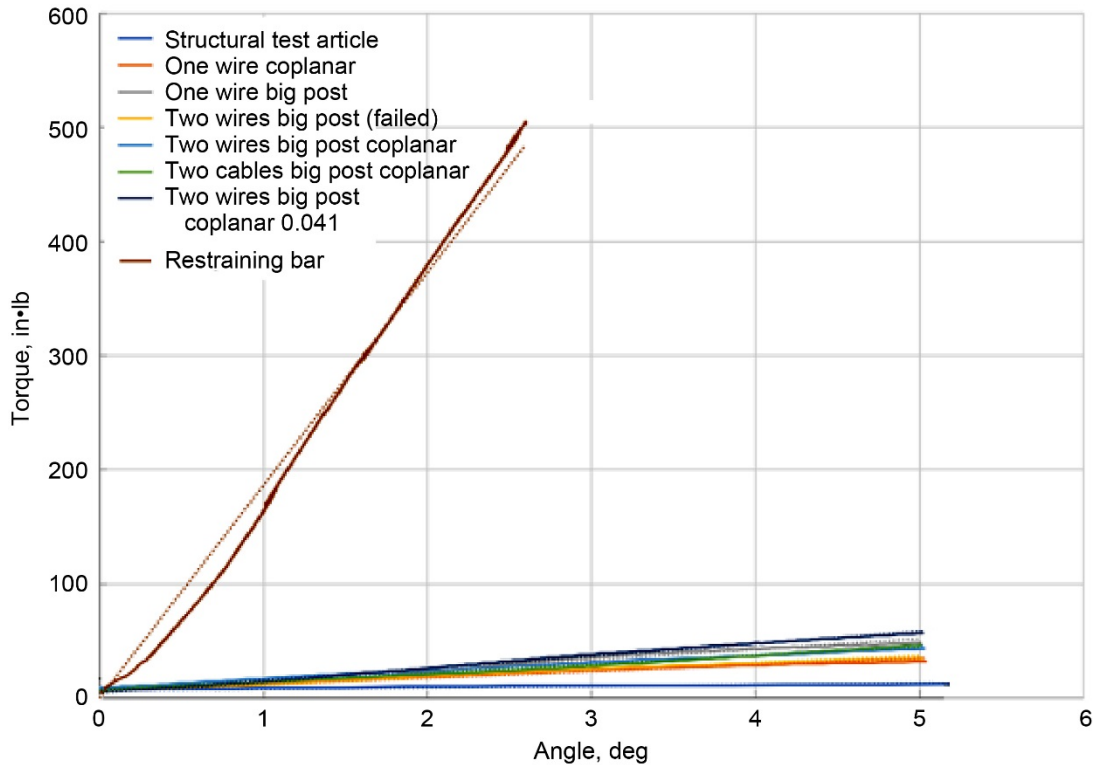
Figure 19.—Unwind torque versus angle of rotation for the bladed cotter pin used for positive locking of supernut-separation bolt.

The approach is a much more effective restraint than the safety wires as shown in Figure 19, which plots the unwind force for the bladed cotter pin alongside the data shown previously for the safety wire.
