Ford CFT 30 Introduction

Presented by: Bill Brayton ATRA Senior Research Technician

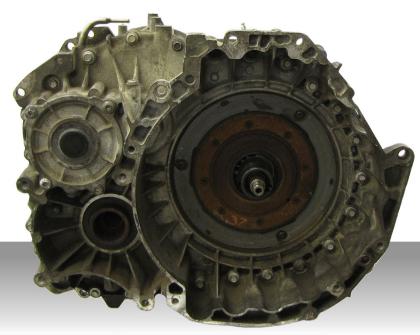
- Uses Motorcraft CVT designed fluid
- No discreet gear shifts and no interruptions in power flow during accelerations
- Infinite number of gear ratios so the optimum engine operating point can be found
- Uses a drive chain not a belt
- A single planetary is used to change the rotation of the pulley assembly for forward
 - and reverse driving ranges
- The TCM is internally mounted to the valve body (Mechatronic)

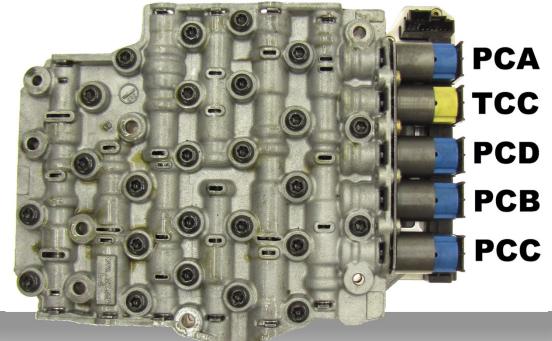
Solenoid Identification

The valve body has five solenoids: a main pressure control solenoid (PCA-A), torque converter clutch solenoid (TCC), primary pulley pressure solenoid (PCB), secondary pulley pressure solenoid (PCC), and forward and reverse clutch apply solenoid (PCD). All solenoids measure at 5.4 Ohms.

- 1. PCA Mainline Pressure Solenoid
- 2. 2. PCB Primary Variator Pressure
- 3. 3. PCC Secondary Variator Pressure
- 4. 4. PCD Forward and Reverse Clutch
- 5. 5. TCC Application Pressure TCC

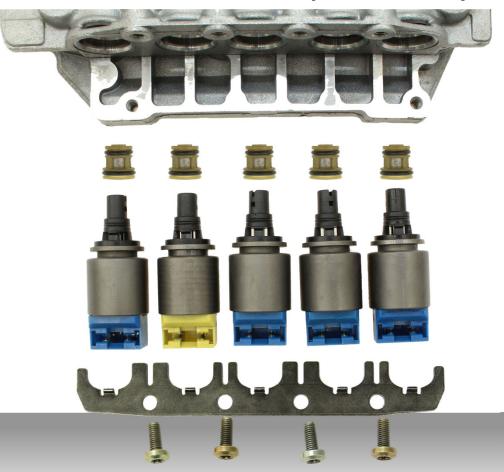
Solenoid Identification (continued)

Always

remove the solenoids to inspect the

solenoid

screens. Replace if torn or damaged

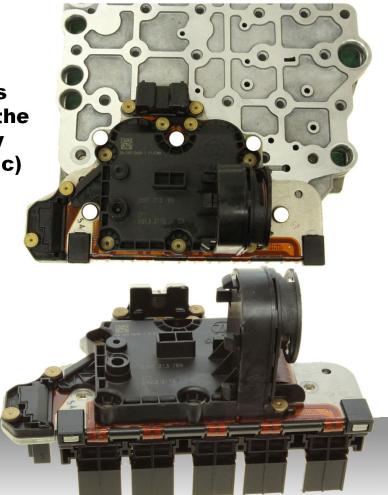
Valve body identification

The TCM is mounted to the valve body (Mechatronic)

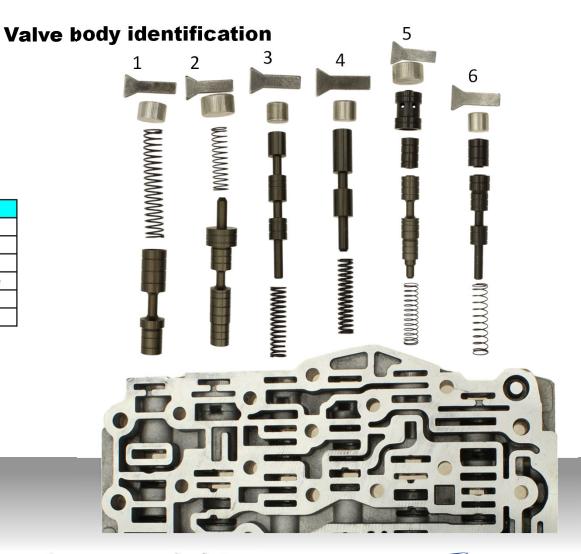
CFT 30 Valve Identification		
1	Converter Safety Valve		
2	Secondary Valve		
3	Emergency Valve		
4	Pressure Reducing Valve		
5	Primary Valve		
6	Clutch 1 Valve

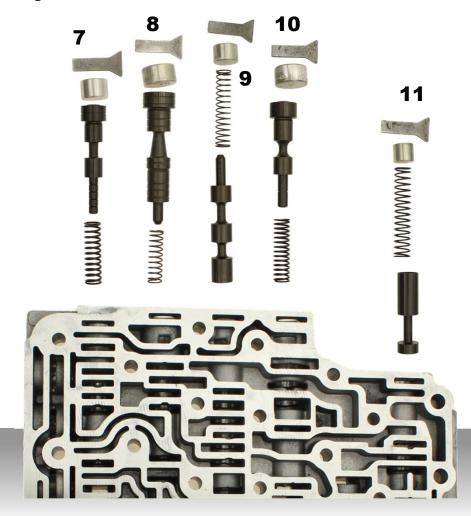
Valve body identification

CFT 30 Valve Identification		
7	Lube Valve		
8	Main Pressure Valve		
9	Converter Pressure Valve		
10	Converter Clutch Valve		
11	Clutch Valve

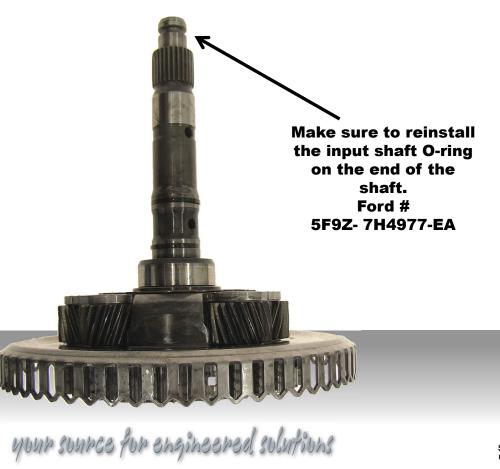
No TCC Operation

During the rebuild process you may not notice the input shaft O-ring is missing. The vehicle may have come in with a no torque converter clutch operation or a DTC related to the torque converter operation. Make sure to reinstall the input shaft O-ring on the end of the shaft.

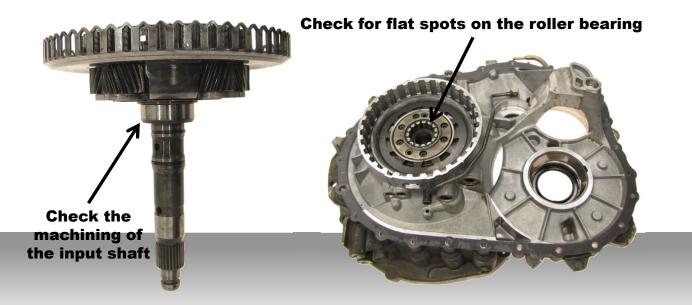
Noises While Driving (continued)

Step 1:

Whine / thump / knock in park and neutral with engine running that goes away when vehicle is put into drive. Noise may come back when vehicle starts to move. This may be caused by machining of the input shaft or flat spots on the roller bearing. For diagnosis first use chassis ears to pinpoint the noise to transaxle area. If the noise is from the transaxle, monitor Turbine Shaft Speed (TSS_SRC) PID using scan tool. If the noise goes away as TSS_SRC goes to 0, when vehicle is put in gear, replace input shaft and bearing.

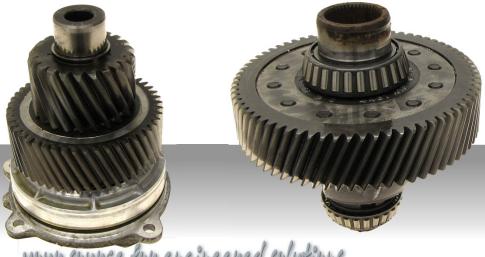
Noises While Driving (continued)

Step 2:

Tick noise on deceleration from 20 MPH (32 Km/h) to a stop. This may be caused by the differential ring gear. For front wheel drive (FWD), if the noise is isolated to the final drive area of the transmission, replace the differential assembly and transfer gear. If the vehicle is an all wheel drive (AWD), remove the power transfer unit (PTU) assembly, reinstall the halfshafts, disconnect the differential electronic module (DEM) and road test.

If the noise goes away, the condition is isolated to the AWD system (not CVT related). If the noise is still present, replace the transaxle differential and transfer gear and shim the differential assembly and set proper preload. All replacement differential assemblies are serviced with bearings installed. AWD differentials are serviced with the inner seal installed. Outer bearing races are not packaged with replacement differential/bearing assemblies and will also require replacement.
