Product Safety Recall

N212328760 Front Passenger Airbag Takata Inflator

– Priority Group 6

Release Date: March 2021

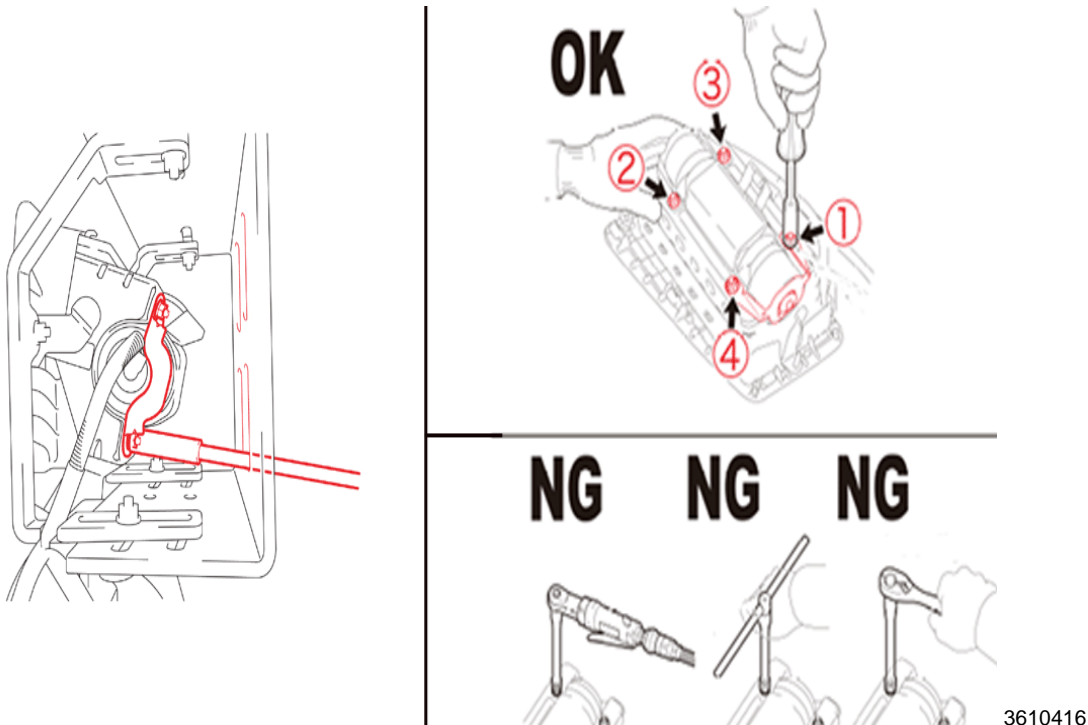
22. Tighten four (4) *NEW* plate nuts evenly in several increments in the order shown in the illustration using a 10-mm socket driver while pushing on the inflator against the alignment tab.

Note: The inflator should be netted out against the alignment tab prior to tightening the nuts. You will encounter some resistance during tightening because these nuts are self-locking nuts. **Torque Specification: 6.5 Nm (56 in-lb).**

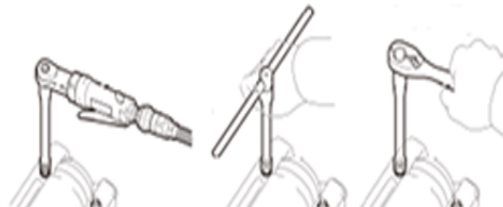
3610416

14. Tighten four (4) *NEW* plate nuts evenly in several increments in the order shown in the illustration using a 10-mm socket driver while pushing the inflator. You will encounter some resistance during tightening because these nuts are self-locking nuts. **Torque Specification: 6.5 Nm (57.53 in-lb).**
