Report on  
Geotechnical Investigation

Proposed Community Centre  
24 Treelands Drive, Yamba

Prepared for  
Northrop Consulting Engineers Pty Ltd

Project 209696.00  
March 2022

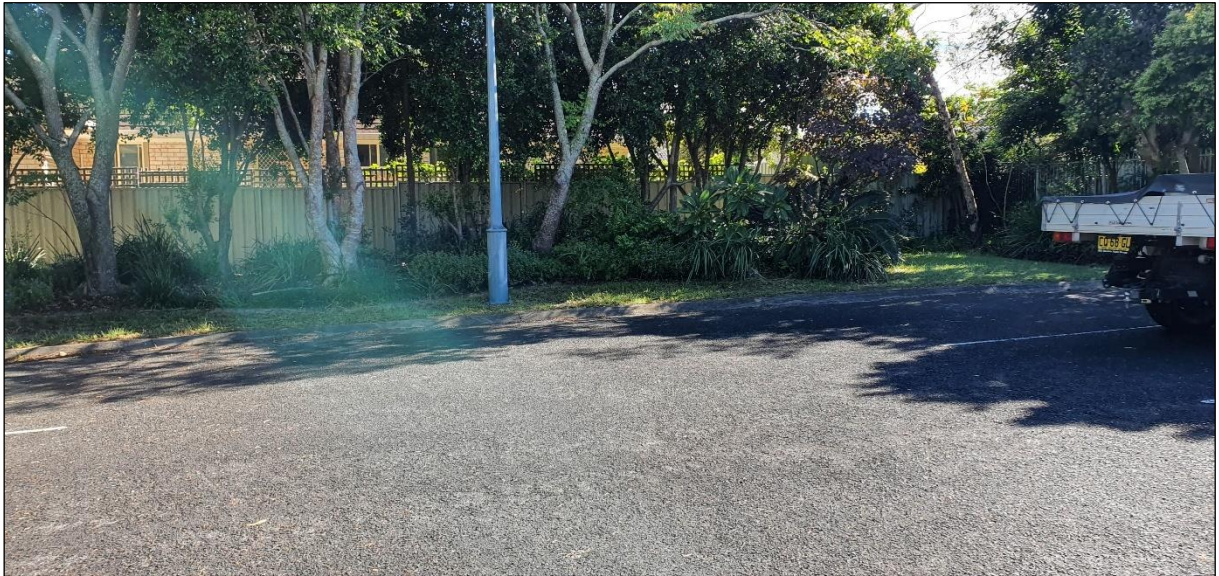
**Figure 1: View north-east of the carpark in the western part of the site.**

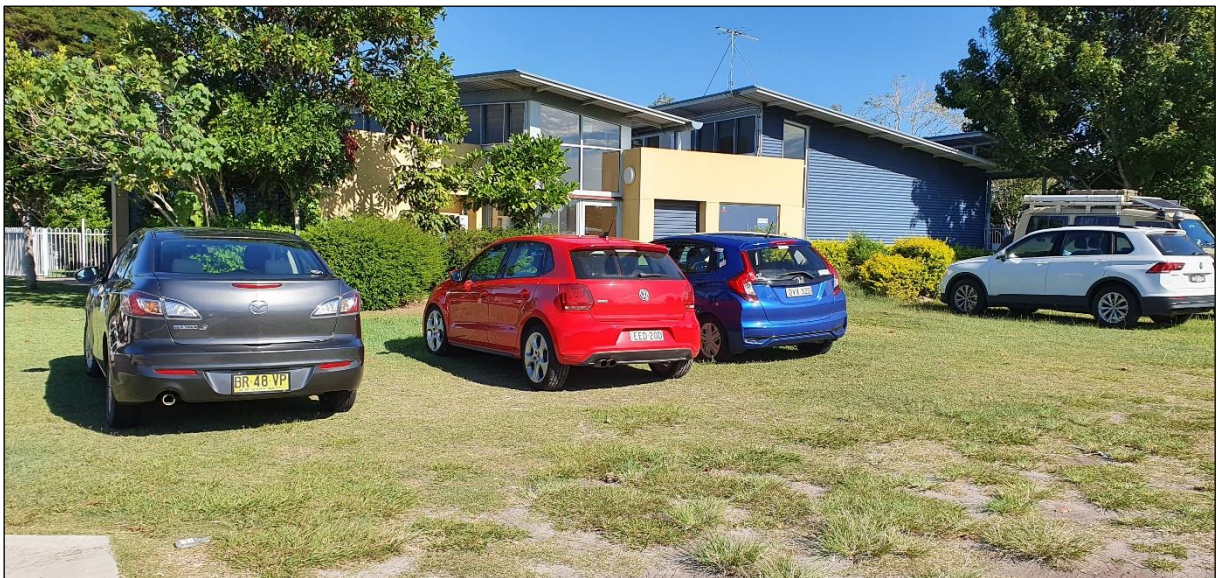
**Figure 2: View west of the eastern part of the site.**

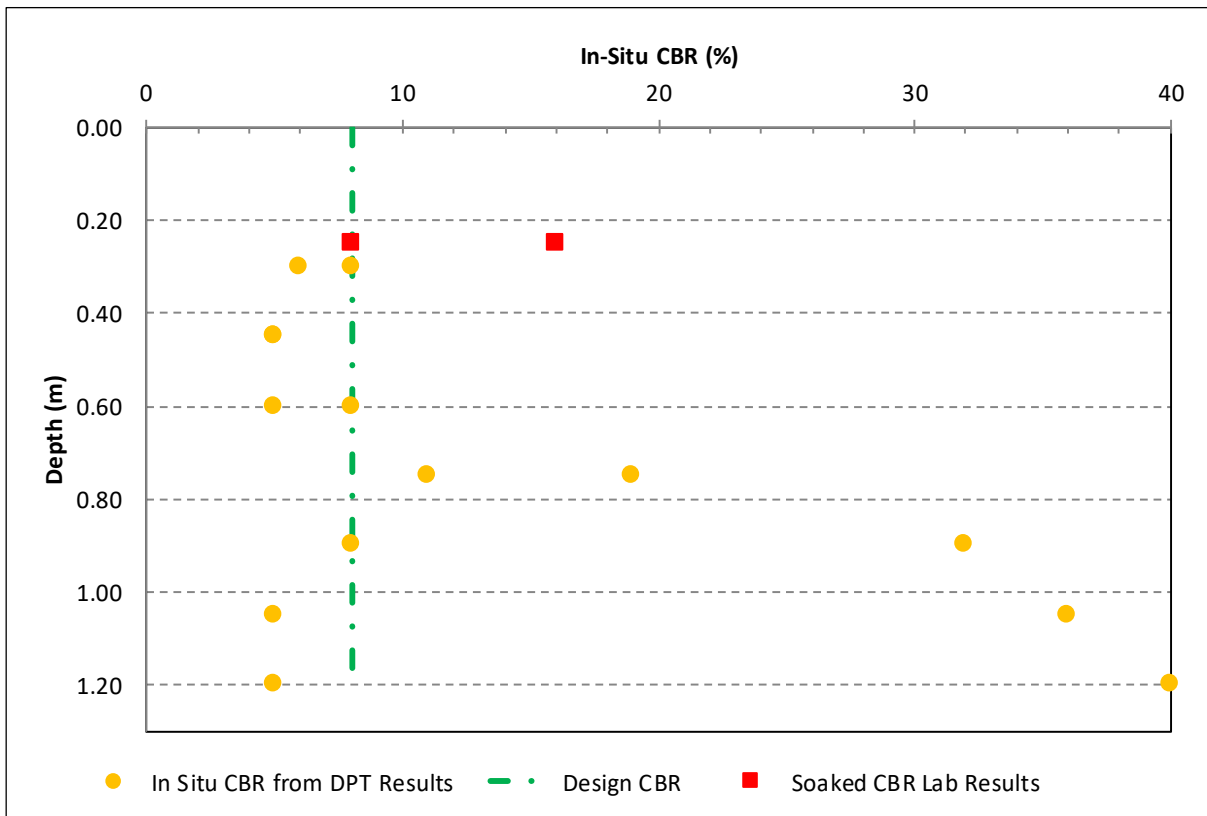
The correlated results of all the in situ dynamic penetrometer tests have been plotted against depth and are presented in Figure 3, which also presents the soaked CBR tests for comparison purposes. The CBR values derived from DPT tests from ground level to 0.15 m depth are excluded from Figure 7 as it is assumed this material will be stripped from the site prior to construction of the access roads and sealed carparks.

Figure 3: In situ CBR based on correlation with DPT and laboratory test results against depth.

Based on the results of the in-situ testing and soaked CBR test results a design CBR of 8% is recommended.
