Railway Accident at Great Belt Bridge

January 2th 2019

Accident Investigation Board Denmark

The Great Belt accident January 2th 2019

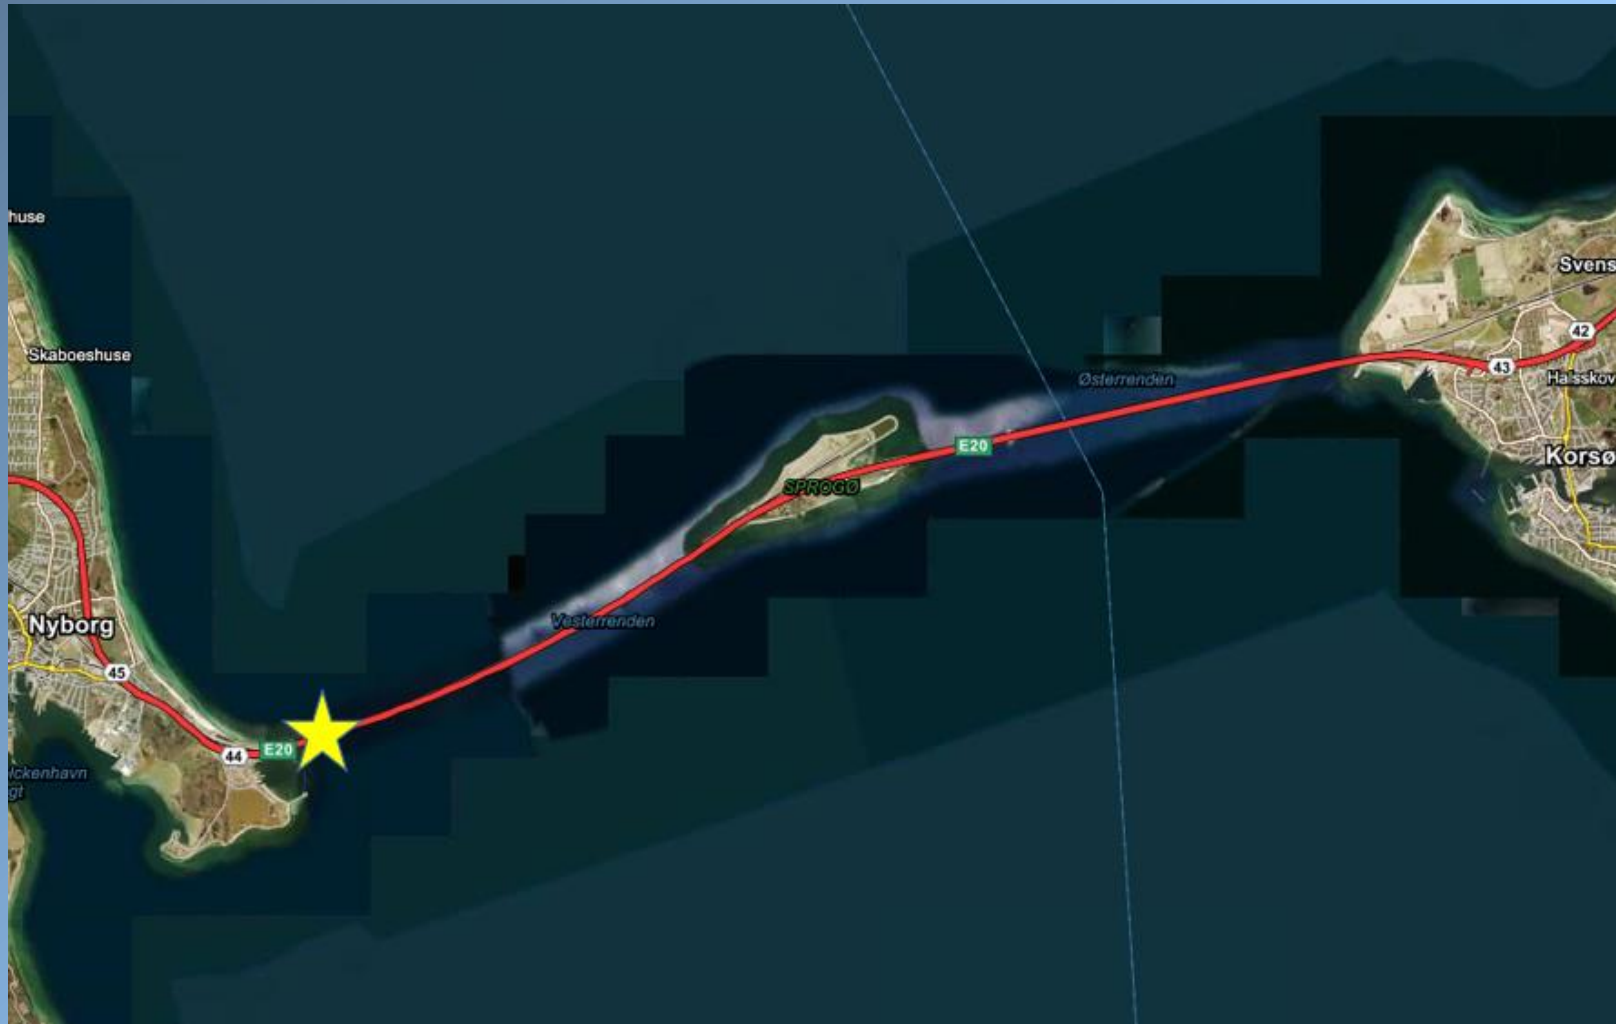
January 2th 2019 - where

- 07:20 Freight train G 9233 entered the western bridge (from Sprogø) towards Funen (BR185 locomotive, 8 (double) pocket waggons type Sdggmrs).
- The speed of L 210 was 121 km/h - and the speed of G 9233 was 119 km/h.
- There was strong / heavy wind (average wind about 21,5 m/s, peaks were higher).
- The wind direction was North – South => across the bridge.
- Shortly before the end / start of the low bridge (brofæste) the two trains passed each other (7:29).

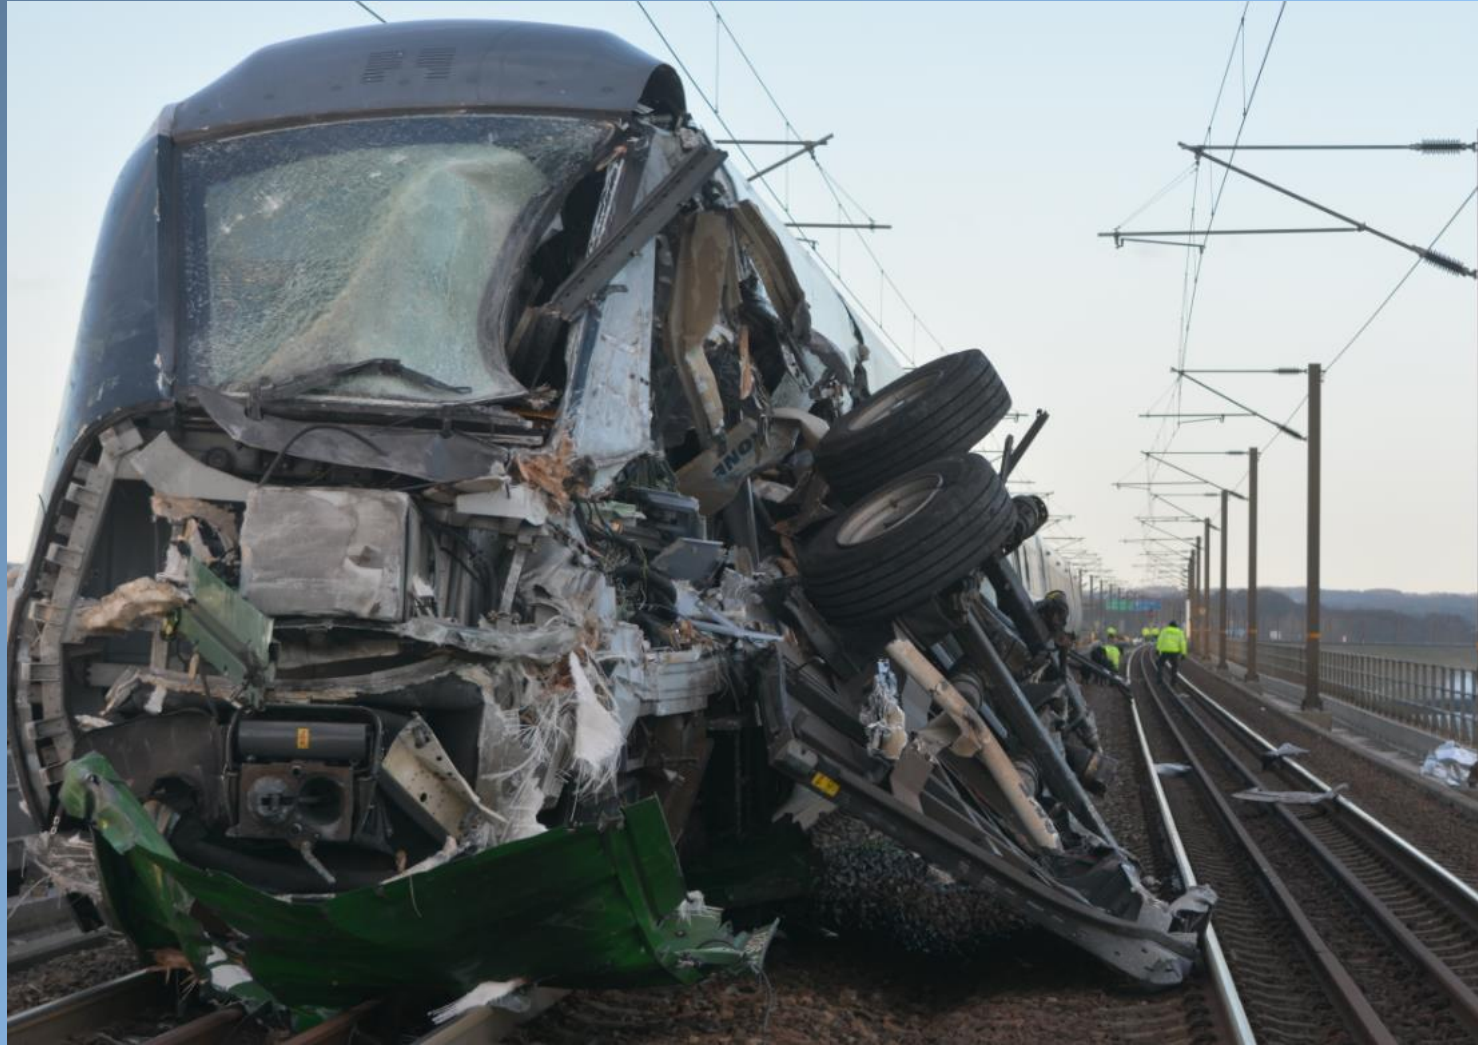
January 2th 2019

It was quite early clear that the passenger train has collided with a semi-trailer coming from the first twin pocket wagon after the locomotive.

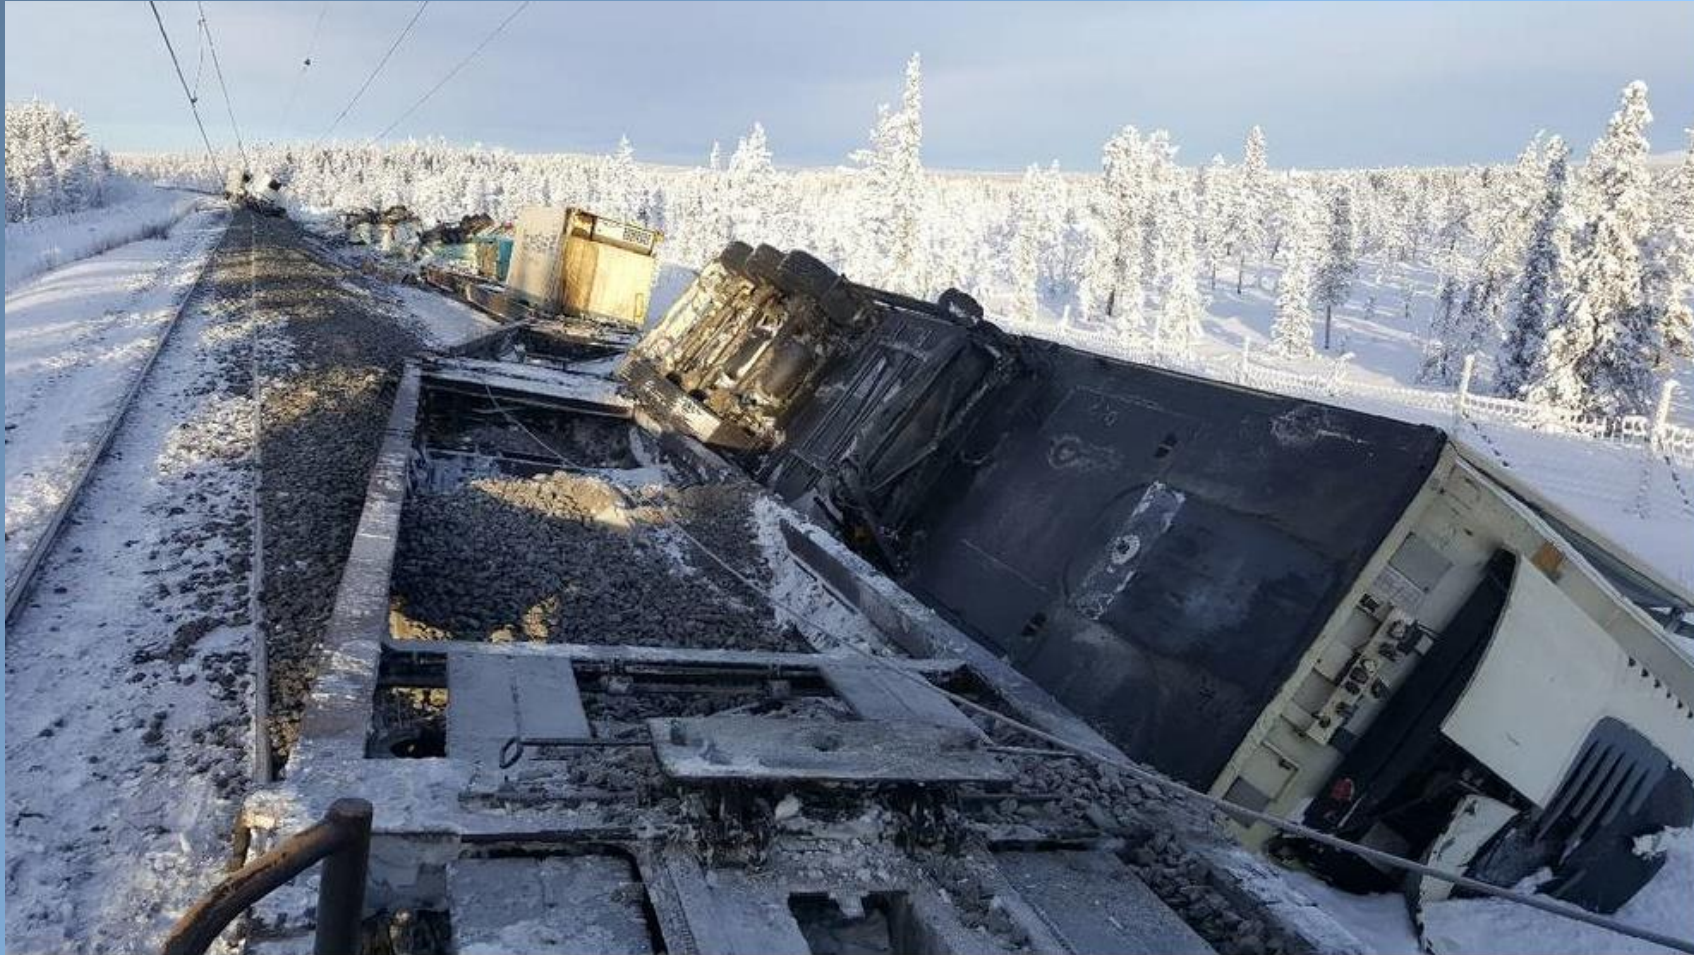
Derailment in Sweden February 6th 2019 (picture from a newspaper)
