## **Rapid Detection of Fatigue Cracking in Steel Anchor Rods Using the Impulse Response Method**

Final Report for  
NCHRP IDEA Project 175

Prepared by:  
Wesley Keller, Ph.D., P.E.  
Rachel Cohen  
Shamim Pakzad, Ph.D.  
Stephen Pessiki, Ph.D.  
Lehigh University

*June 2017*

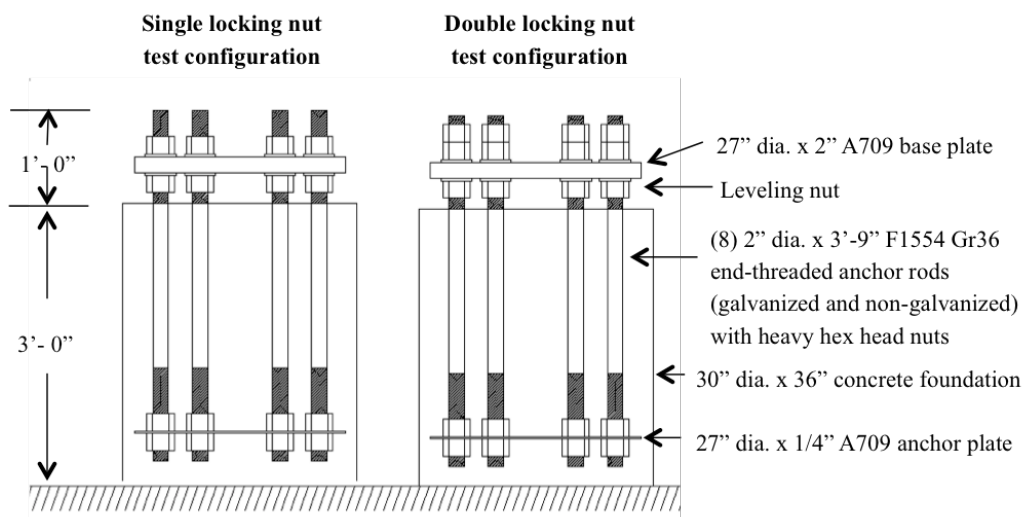
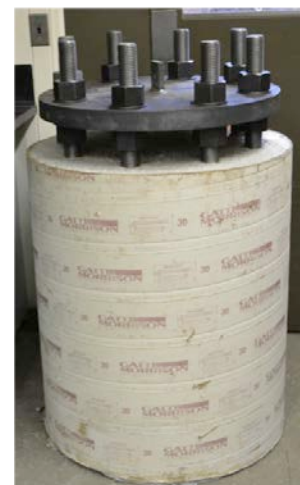
The main focus of the research was an experimental evaluation of the proposed method for fatigue crack detection. A full-scale structure-foundation anchorage assembly was constructed for this purpose (see figure above). To perform a test, an accelerometer is coupled to the top surface of an anchor rod, and the surface is struck with an instrumented hammer. Typical surface acceleration records are shown below for an uncracked rod (black) and for a rod with a crack at the base of the leveling nut (red) that extends for 1/10 of the rod diameter.

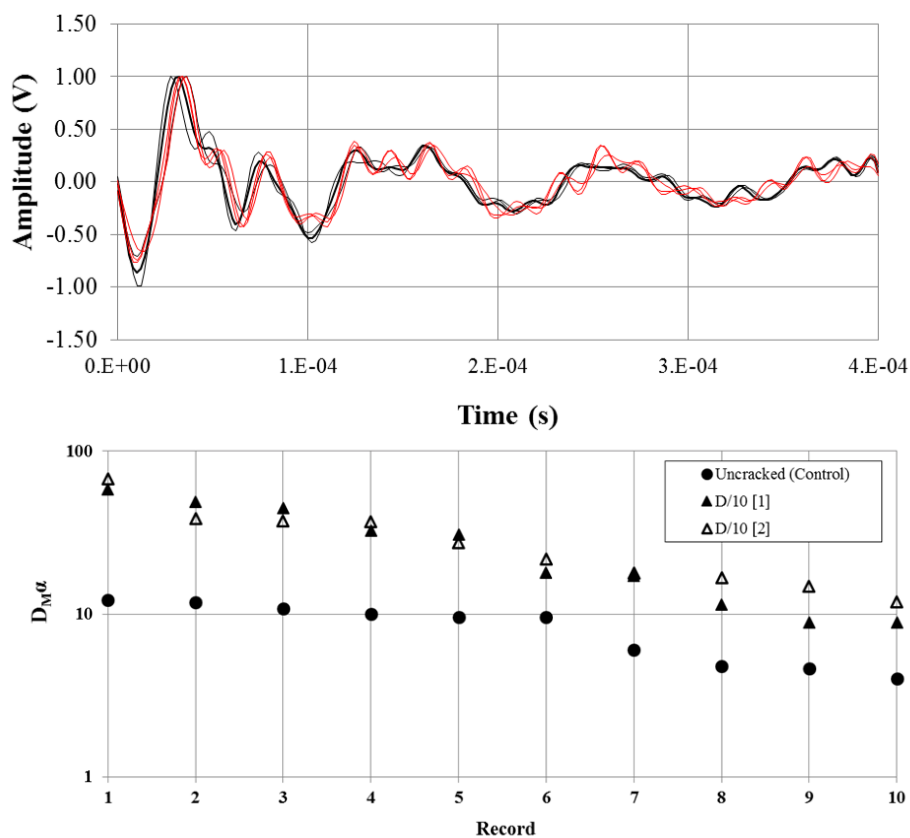
comparison. Autoregressive models (AR) are a particular classification of regression models that relate the current value of a predicted time series to past values of the same series. In this research, the AR models were used to fit accelerometer recordings normalized by the applied impulse. The figure below shows Mahalanobis distance for regression models fitting the surface acceleration response during the 2P reflection for an uncracked rod, and for two tests of the rod with a crack extending to 1/10 of the rod diameter D. The presence of the crack is evident in the result.

From the experimental program it was found that by establishing a baseline measurement for an uncracked rod, and evaluating the change in Mahalanobis distance between the alpha coefficients of regression models fitting the test data, the test method was able to identify artificial cracks at the base of the leveling nut (a region known to be susceptible to fatigue cracking), extending 1/4 and 1/2 of the rod diameter in depth, with at least 95% confidence.

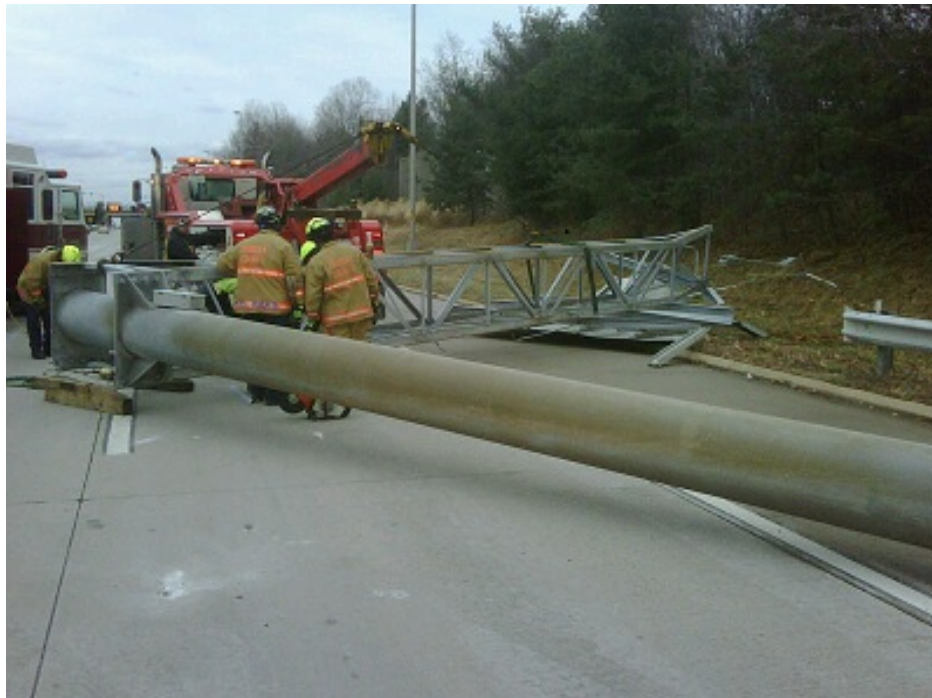
**FIGURE 1 Sign structure collapse due to fatigue-induced anchor rod failure, Fairfax, VA (2012) (7).**

Fatigue cracking in sign, signal, and luminaire structures due to wind-induced vibration is a widespread problem that threatens public safety and impacts structural maintenance and repair expenditures. While research in this area has helped to mitigate the problem by improving design and detailing guidelines (1-5), the large inventory of auxiliary highway structures with deficient designs, coupled with the uncertainty in site-specific wind exposure and the complexity of wind-induced vibration phenomena, suggest that ongoing issues with fatigue cracking in auxiliary highway structures should be anticipated. In recent sign structure failures in New Hampshire in 2010 (6) and Virginia in 2012 (Figure 1) (7), structural collapse was triggered by fatigue failure of the steel anchor rods tying the structure to its foundation. As an illustration of the pervasiveness of fatigue cracking in auxiliary sign structure anchor rods, the Virginia Department of Transportation (VDOT) identified two cracked anchor rods in a second cantilevered sign structure along Interstate 95 within the first 25 inspections following the 2012 collapse (8). The structure was promptly removed from service.

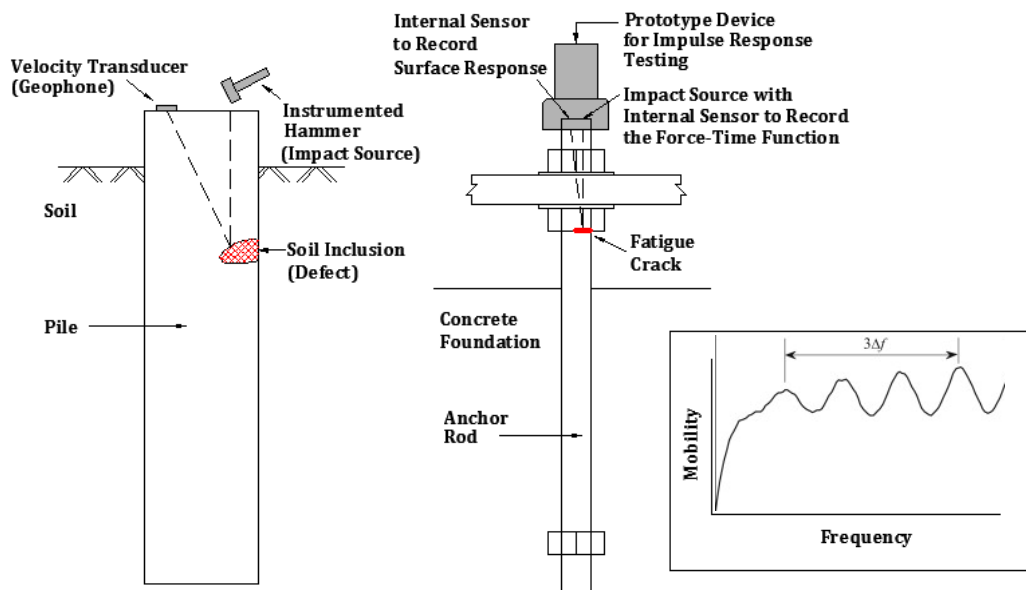
**FIGURE 4 Comparison of impulse response testing of piles and anchor rods.**

As illustrated in Figure 4, an analogy can be drawn between a steel anchor rod partially embedded in a concrete foundation and a concrete pile partially embedded in soil. The basic approach of impulse response testing of steel anchor rods is therefore comparable to its current use in pile integrity testing, but at a smaller length scale and with a higher degree of geometric complexity. In terms of scale and due to the smaller dimensions, the impact source for anchor rod testing must contain higher frequency content than what is generated in pile integrity testing. This can be accomplished by reducing the contact time (duration) of the impact. The additional geometric complexities of anchorage systems (i.e. additional reflective surfaces) complicate signal processing and data interpretation.

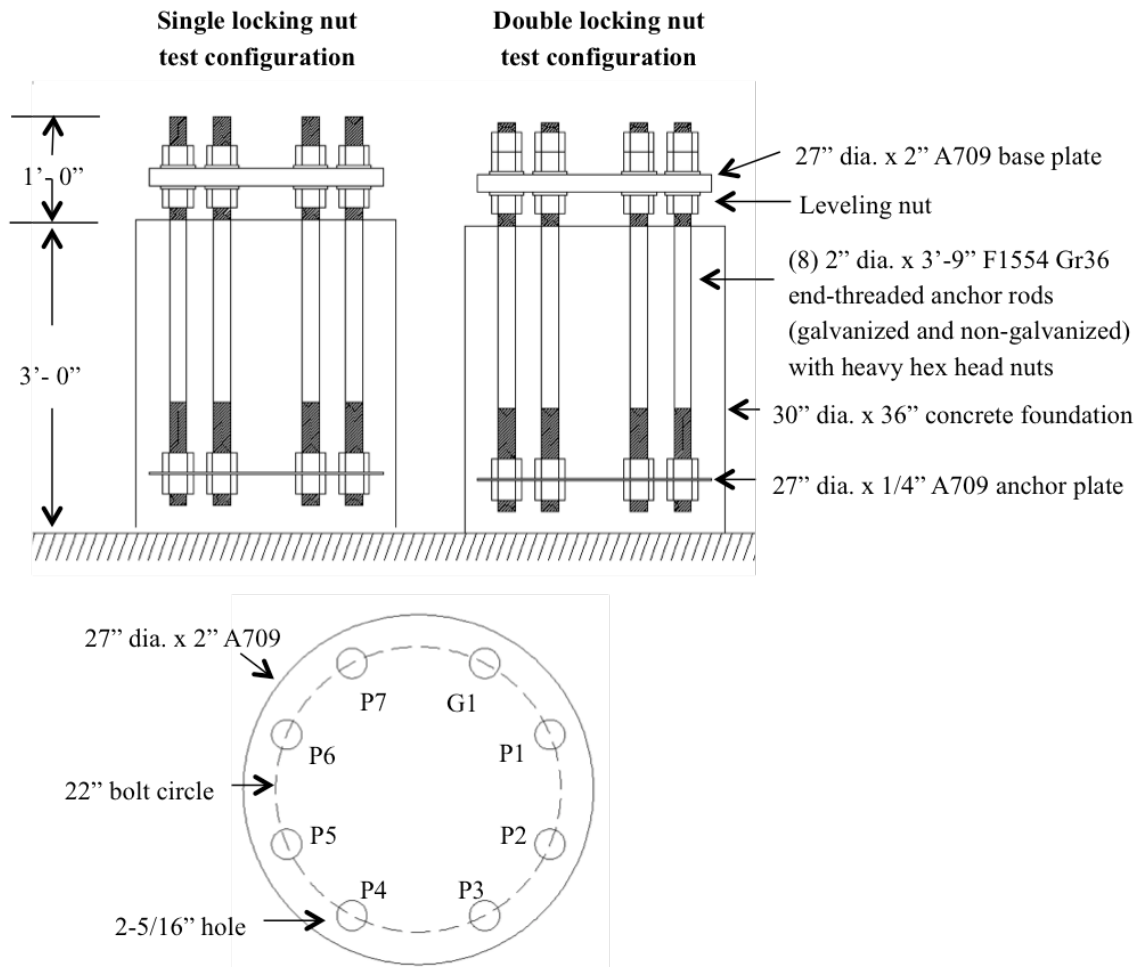
**FIGURE 5 Structure-foundation anchorage assembly showing both single locking nut and double locking nut test configurations. Anchor rod designations are galvanized (G1) and non-galvanized (P1-P7) end-threaded F1554 Gr36 anchor rods with heavy hex head nuts and washers.**

Figure 5 shows dimensioned drawings of the full-scale structure-foundation anchorage assembly constructed for the experiments. The assembly is composed of a 30 in dia. x 36 in deep concrete foundation with eight 2 in dia. x 3 ft-9 in F1554 Gr36 steel anchor rods. The base plate for the assembly is a 27 in dia. x 2 in A709 steel section with a 22 in bolt circle and 2-5/16 in dia. holes. The offset dimension between the bottom of the base plate and the top of the concrete foundation is 4.25 in. The assembly also includes an embedded 27 in dia. x 1/4 in A709 steel anchor plate that is located 7 in from the base of the foundation. The heavy hex nuts used in the assembly are 3.5 in (width across flats) x 2-13/64 in thick. The anchor rod-to-base plate connection uses 4 in dia. x 1/4 in washers, while the anchor rod-to-anchor plate connection excludes washers. In this report, the anchor rod nuts located below the base plate are designated as the ‘leveling nuts’, while the nuts located above the base plate are designated as ‘locking nuts’. The assembly was configured to study both single locking nut and double locking nut construction.

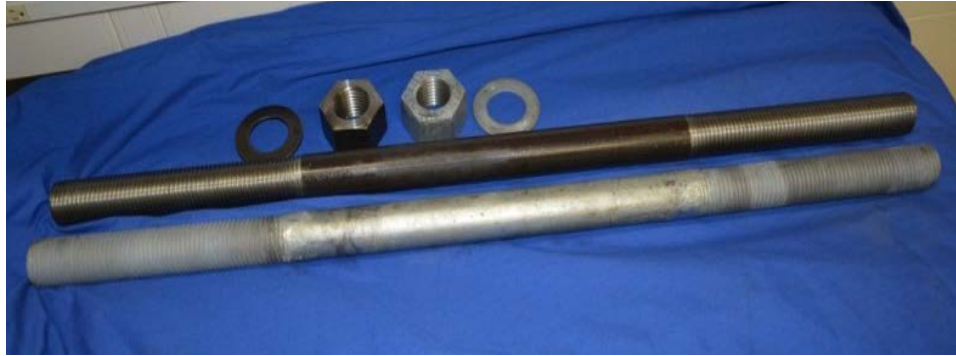
**FIGURE 6** Photograph of anchor rods, nuts and washers.

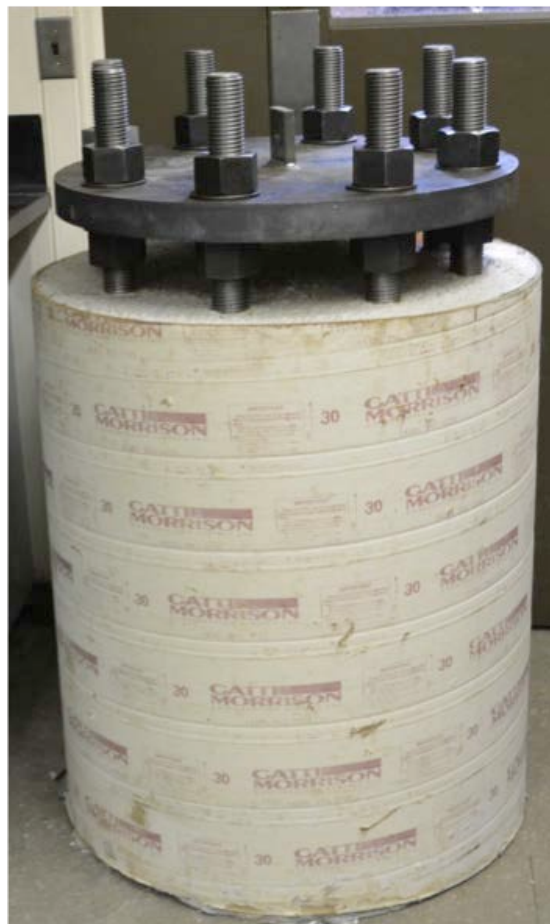
**FIGURE 7** Photograph of the completed structure-foundation test specimen.

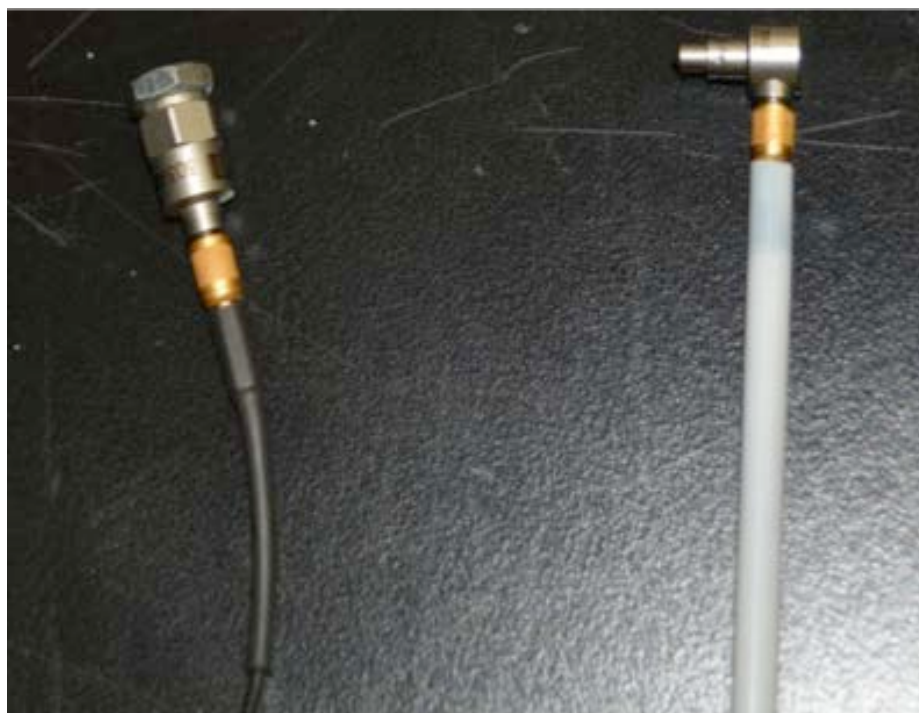
**FIGURE 8 PCB piezoelectric accelerometer (left) and instrumented hammer (right).**

Early experimental work focused on the development of test parameters (equipment and procedures) that impact the ability to generate reliable and repeatable measurements. The test parameters included impact source, signal duration and filtering, transducer coupling, and impact-measurement location. From this development work, the following general test parameters were determined and used in the experiments described later in this chapter. The tests were conducted using the piezoelectric accelerometer and instrumented hammer shown in Figure 8. The accelerometer was a PCB Series 303A Quartz (piezoelectric) accelerometer that exhibits a flat response range ( $\pm 5\%$ ) out to 10 kHz and a resonant frequency of 70 kHz. The instrumented hammer was manufactured by PCB and was specially designed for this type of testing.

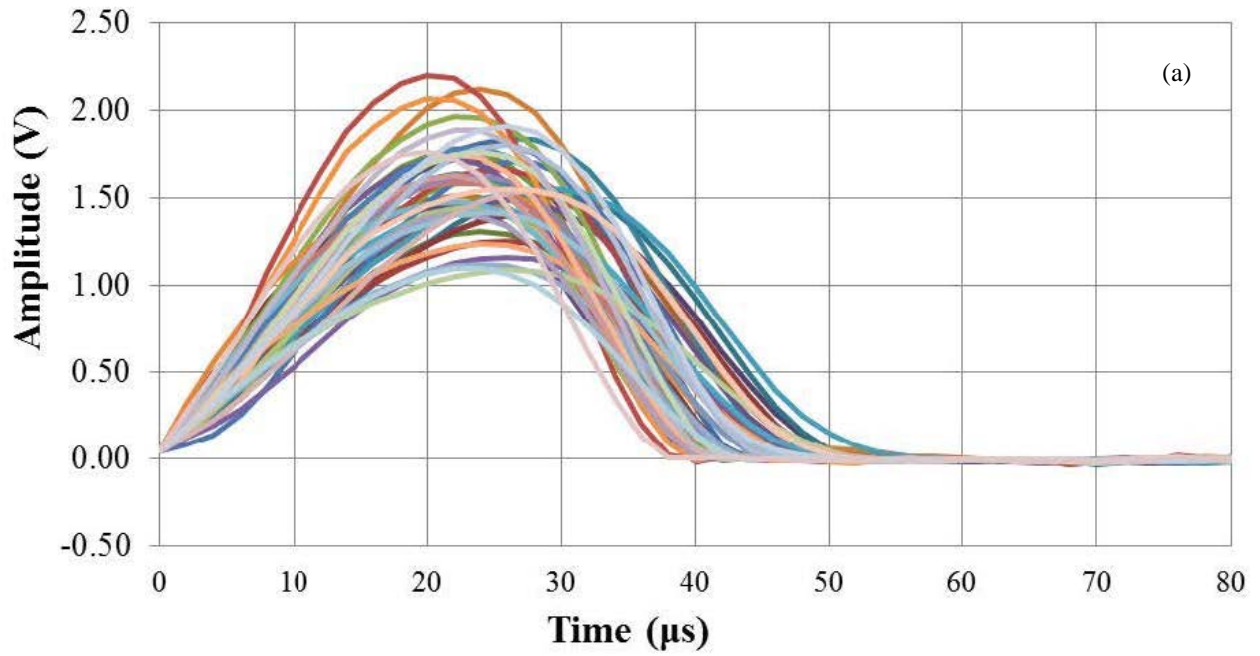
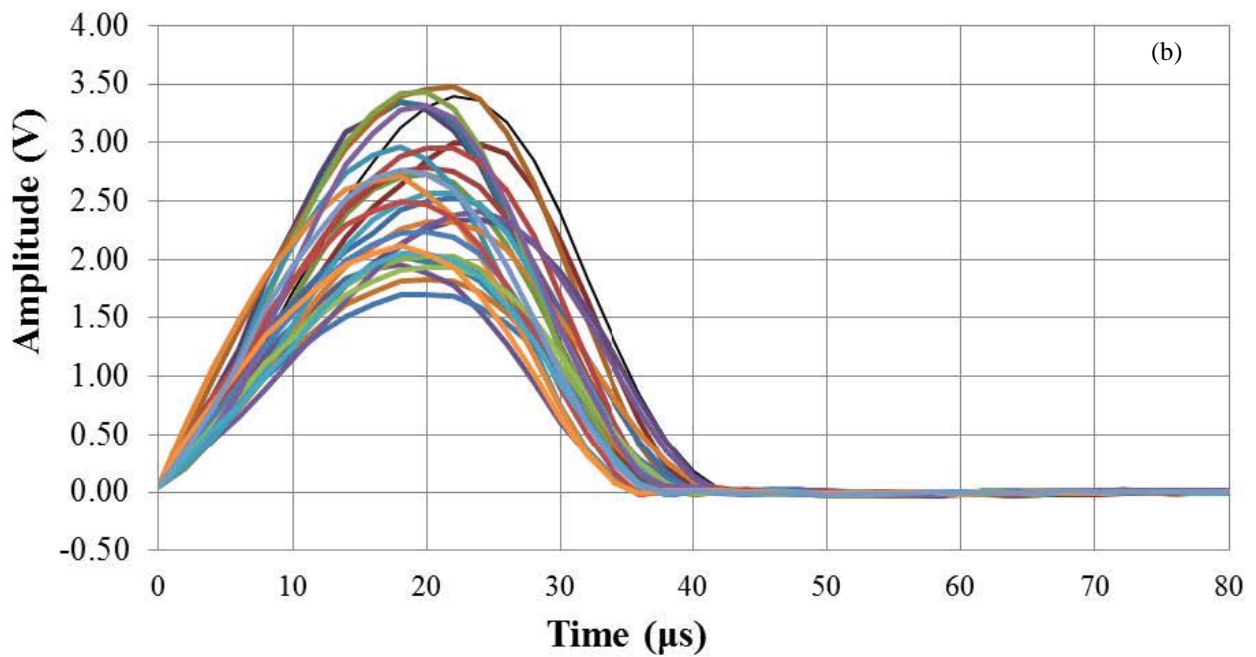
**FIGURE 9** Impact records: (a) hand-held hammer strikes; and, (b) spring-assisted strikes (50 records each)

Force-time records for the hand-held and spring-assisted hammer strikes are shown in Figure 9(a). Fifty tests were conducted for each approach. The contact time for the hand-held strikes ranged from approximately 40-50  $\mu$ s. For these contact times, the maximum frequency of useful energy imparted on the specimen is between 25-31 kHz (Sansalone and Streett, 1997), which is greater than the required crack detection frequency range of 10-20 kHz. The corresponding force-time records for the spring-assisted hammer strike approach are shown in Figure 9(b). The contact times were slightly shorter (ranging from approximately 35-40  $\mu$ s) but the pulse shape and imparted frequency content were comparable with the hand-held approach. No significant advantage was therefore found with the spring-assisted device, so impact loading from the hand-held instrumented hammer was determined to provide sufficient input for this study. As discussed later in the report, an eventual integrated testing device could be made to better control impact repeatability (location, magnitude and duration).

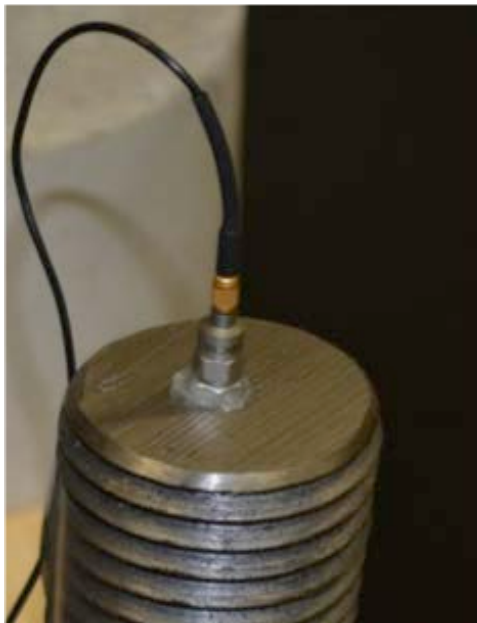
**FIGURE 10 Accelerometer mounted on the top surface of a test rod with high vacuum grease coupling agent.**

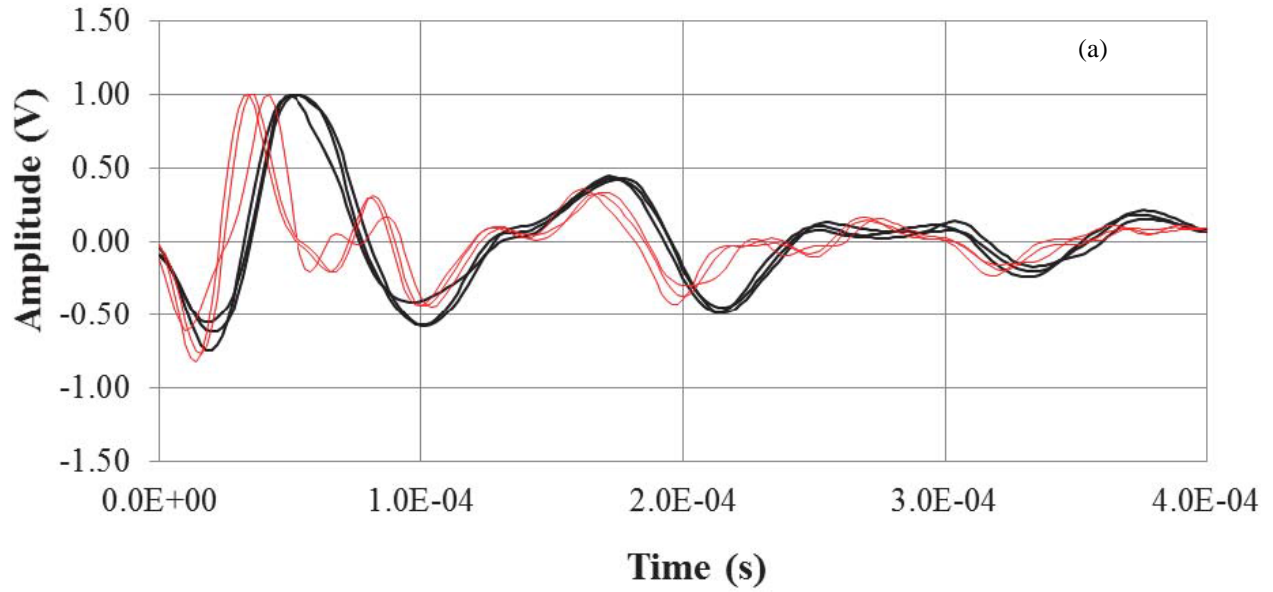
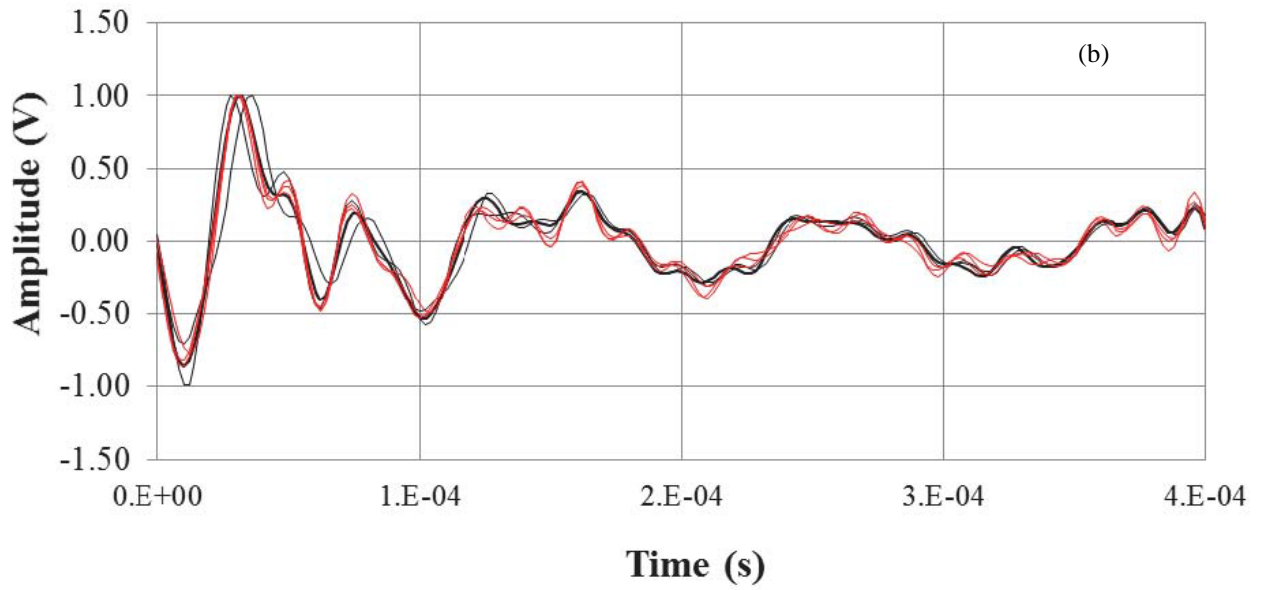
**FIGURE 11** Surface acceleration recordings for an uncracked anchor rod measured for two accelerometer installations: (a) grease-coupling; and, (b) mechanical attachment. Installation 1 shown in black and installation 2 shown in red.

accelerometer could be threaded directly into of the rod. Mechanical fastening of the accelerometer to the rod was shown to greatly improve test repeatability compared to grease-coupling (Figure 11). It is believed that a similar coupling condition can be achieved through a more practical means in the prototype testing device by spring loaded or magnetic attachment.

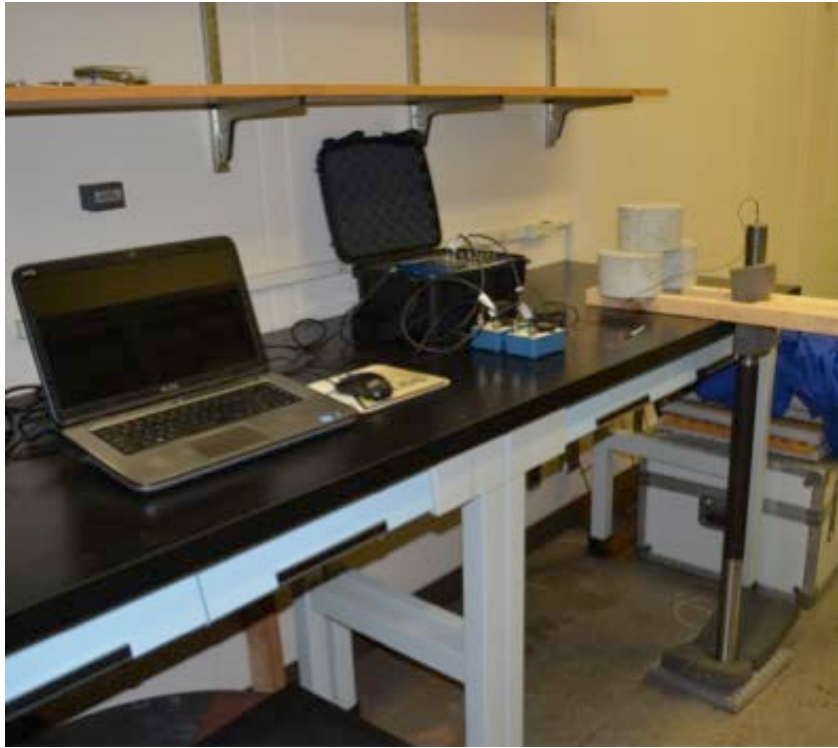
**FIGURE 12** Test set-up for a single isolated anchor rod.

12 shows the test setup for a single isolated rod test without the concrete foundation. Details for the rods were presented earlier. During testing, the bottom end of the rod was placed on a layer of foam padding, and the top end was wrapped in a second piece of foam, and held upright by light wood framing. The foam padding was used to acoustically separate the rods from its surroundings. Figure 13 shows the test setup for the isolated embedded rods (i.e. without the base plate, washers and nuts). The concrete foundation was supported on wood blocking during testing.

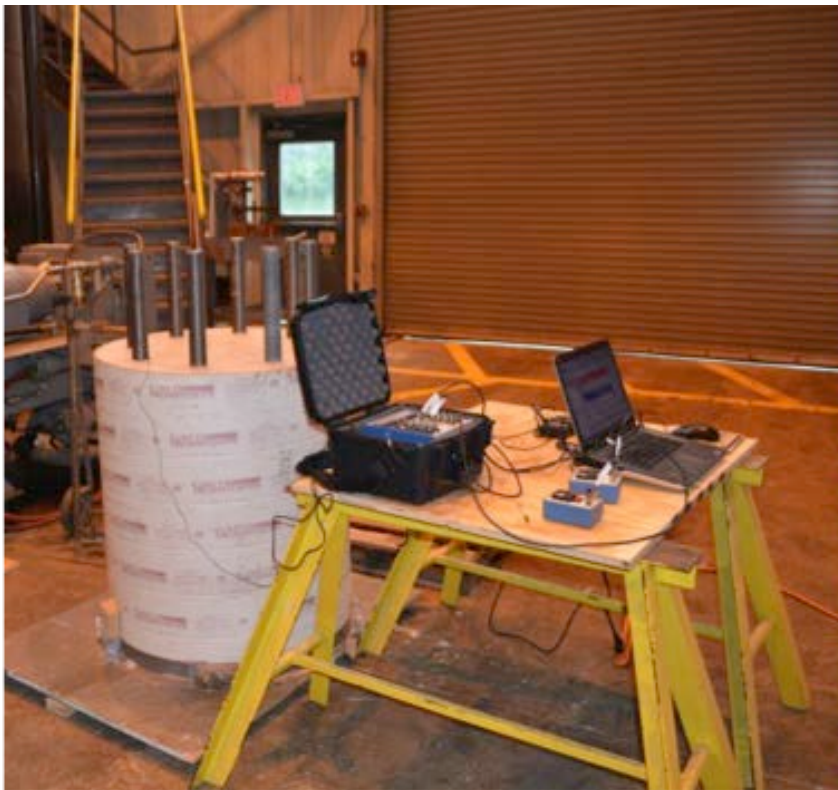
**FIGURE 13** Test set-up for embedded rods without base plate, washers and nuts.

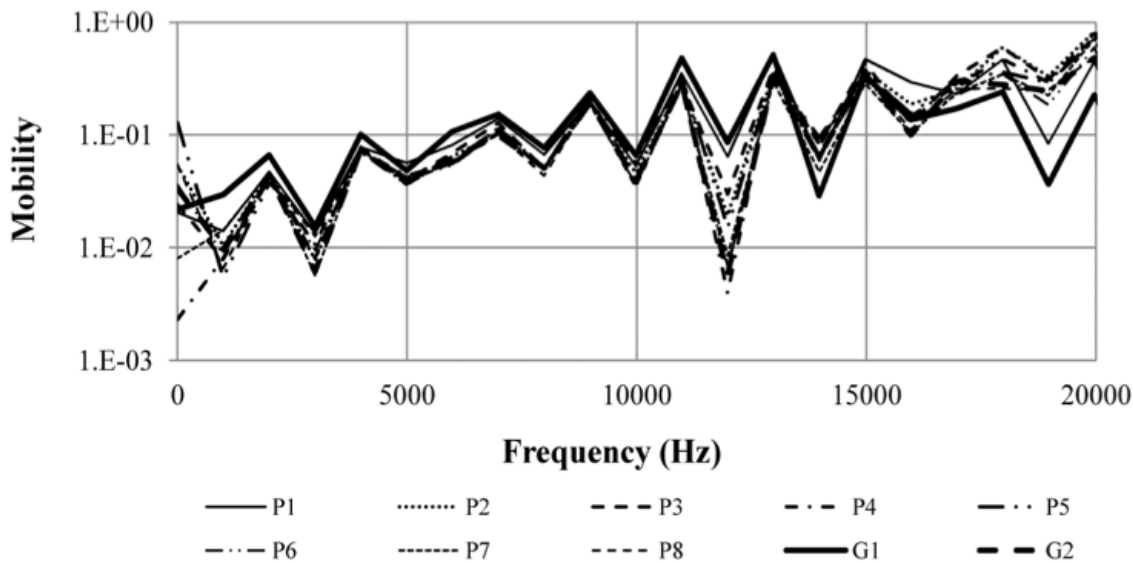
**FIGURE 14** Mobility spectra for tests of isolated rods P1-P8 and G1-G2.

The resultant response spectrum is the mobility spectra (system transfer function or mobility plot as described in Chapter 1). Both the isolated and embedded rod tests produced consistent mobility spectra within the frequency range of interest (2-20 kHz), where the peak at 2 kHz in the isolated test spectra is indicative of resonant stress wave reflections from the rod ends, and the 10-20 kHz range is the anticipated resonant frequency content for stress wave reflections from known fatigue crack locations in the completed assembly. In general, the mobility spectra were in good agreement between individual tests of the same rod and between tests of different rods in the assembly, as shown in Figures 14 and 15. It is noted that the mobility spectra for the embedded rod tests exhibited a smoother high frequency range due to an increase in material damping.

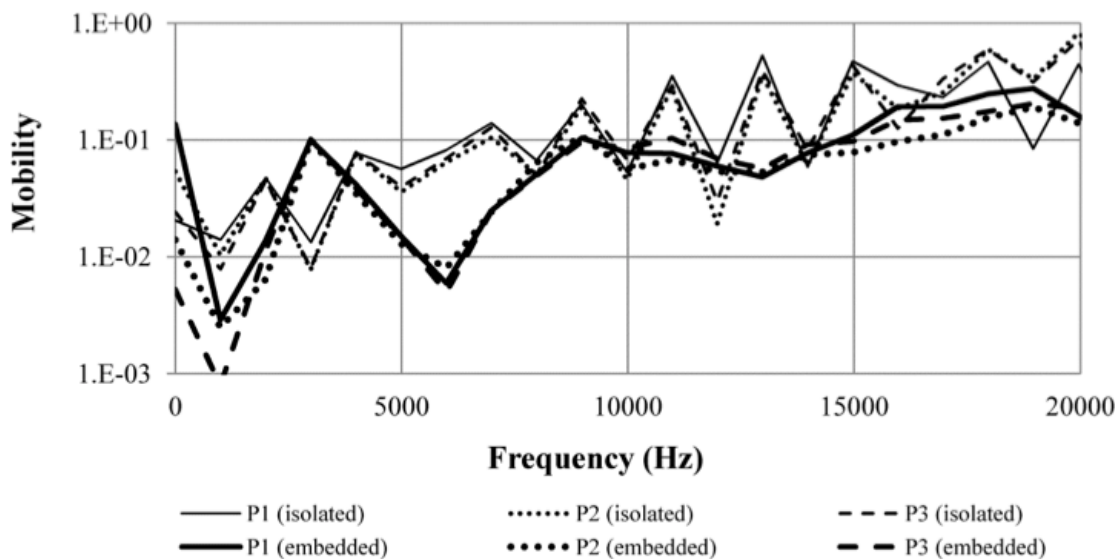
**FIGURE 15** Mobility spectra for tests of isolated and embedded rods (without baseplate, washers and nuts) rods P1-P3.

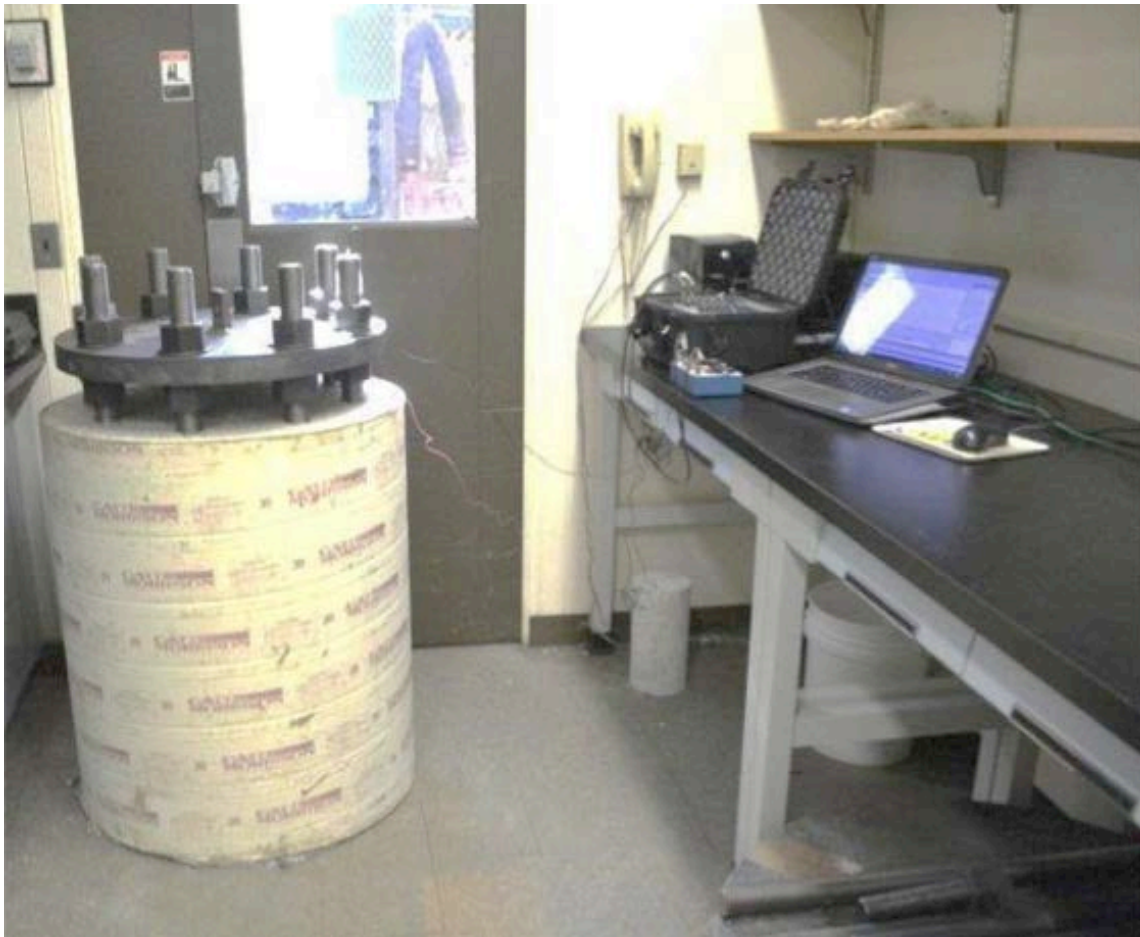
**FIGURE 16** Baseline testing of the completed structure-foundation anchorage assembly.

This section of the report describes baseline tests performed on the structure-foundation anchorage assembly to characterize impulse response measurements for uncracked anchor rods and to evaluate the effect of anchorage construction (specifically, side contact between the anchor rods and base plate) on crack detection. A photograph of the completed structure-foundation anchorage assembly is shown in Figure 16.

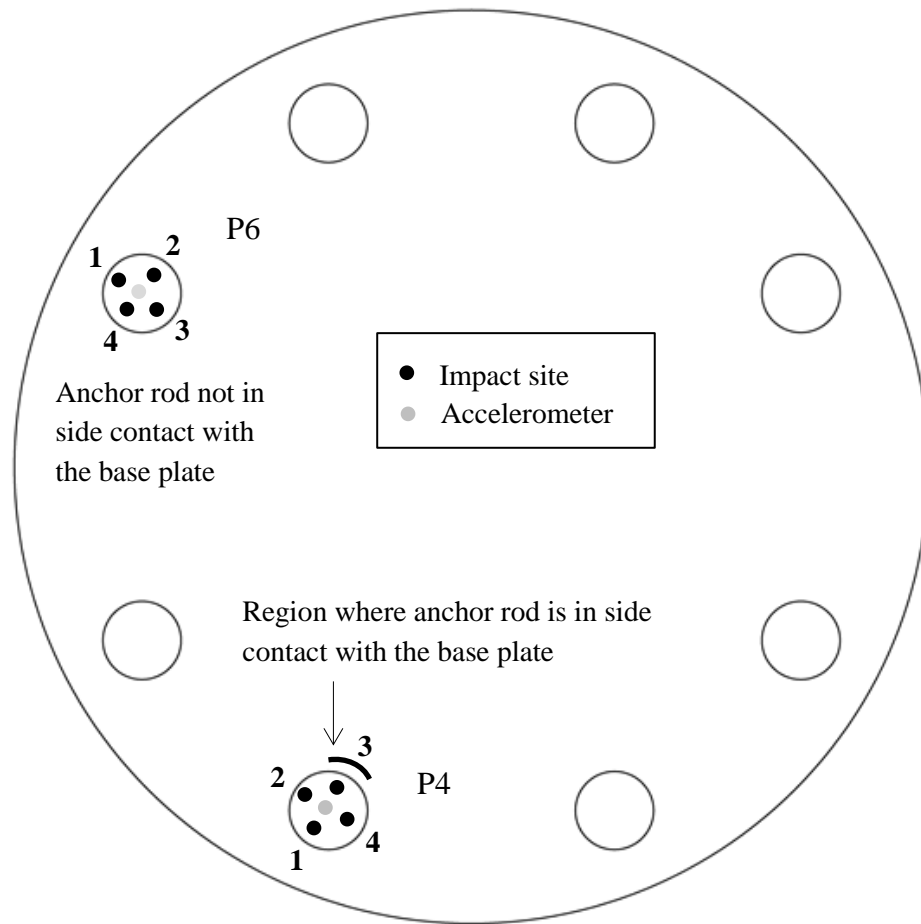
**Figure 17 Test configuration for baseline measurements of rods P4 and P6.**

Similar to the isolated and embedded rod tests without anchorage hardware, the accelerometer was mounted on the top surface of the rod (near the center) using a high vacuum grease coupling agent (non-tap installation), and the instrumented hammer was used to impart an impulse at four designated impact sites. The notation used to describe the impact sites is shown in Figure 17. For each rod, the impact sites are labeled 1 through 4 in a clockwise direction from the outer surface of the rod. This is illustrated for rods P4 and P6 in Figure 17.

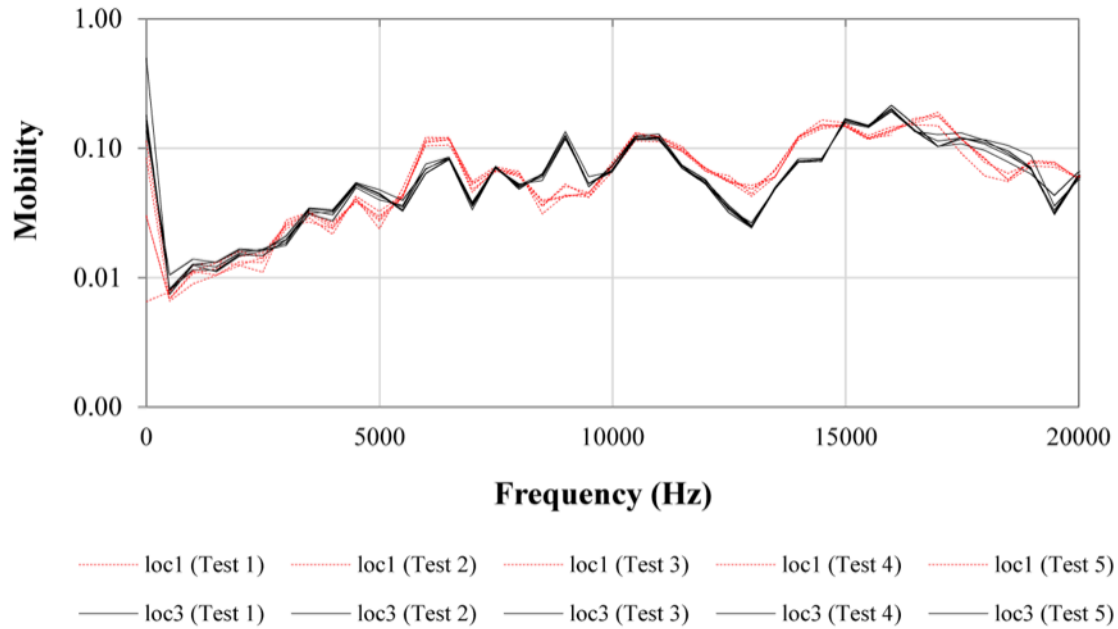
**FIGURE 18** Baseline mobility spectra for rod P6 which passes through the baseplate hole without direct contact with the baseplate (impact at locations 1 and 3).

The mobility spectra show relatively high repeatability for tests using the same transducer installation but exhibit more variability between different installations, as illustrated in Figures 18 and 19. It is noted that these tests utilized grease coupling and that, as discussed in 3.3.2, tapping can significantly improve measurement repeatability between different installations. The mobility spectra are generated for impacts at locations 1 and 3 (identified as loc1 and loc3 in the figure legends). Rod P6 passes through the base plate hole without direct contact, while rod P4 bears against the interior surface of the plate. As anticipated, side contact alters wave propagation within the rod, altering the mobility signature (as evidenced by the discrepancies in mobility between P4 and P6). Side contact also appears to exacerbate the issue with

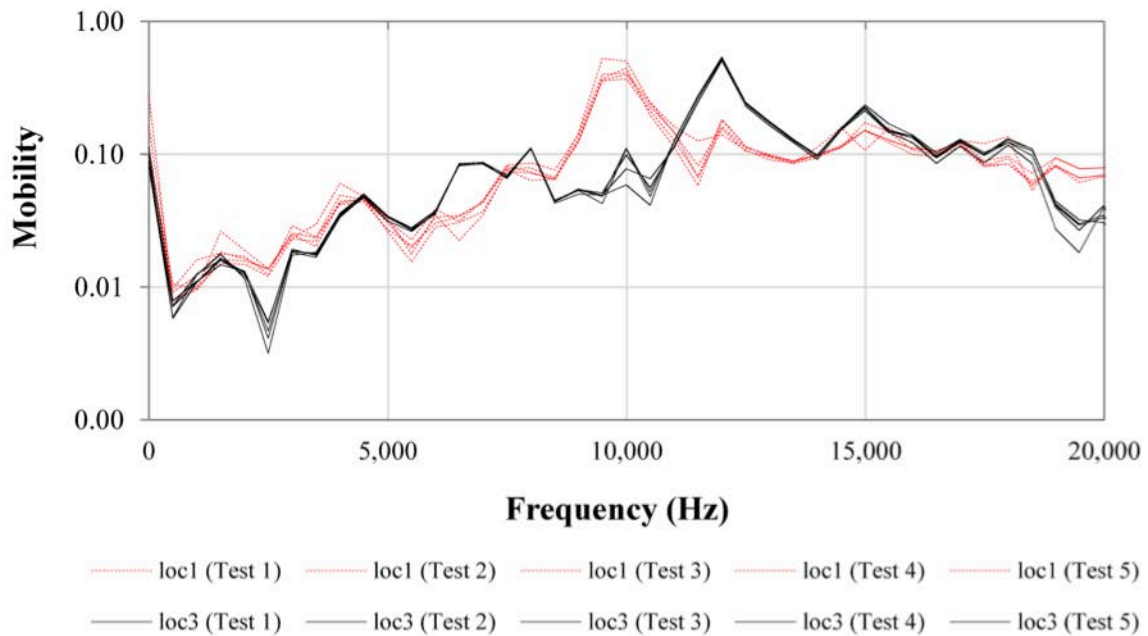
**FIGURE 19** Baseline mobility spectra for rod P4 which bears against the baseplate where the rod passes through the baseplate hole (impact at locations 1 and 3).

inconsistent measurements between similar transducer installations. When comparing mobility spectra, anchor rod-base plate contact will complicate signal interpretation, and therefore crack detection, for scenarios where a healthy (uncracked rod) baseline measurement is not available.

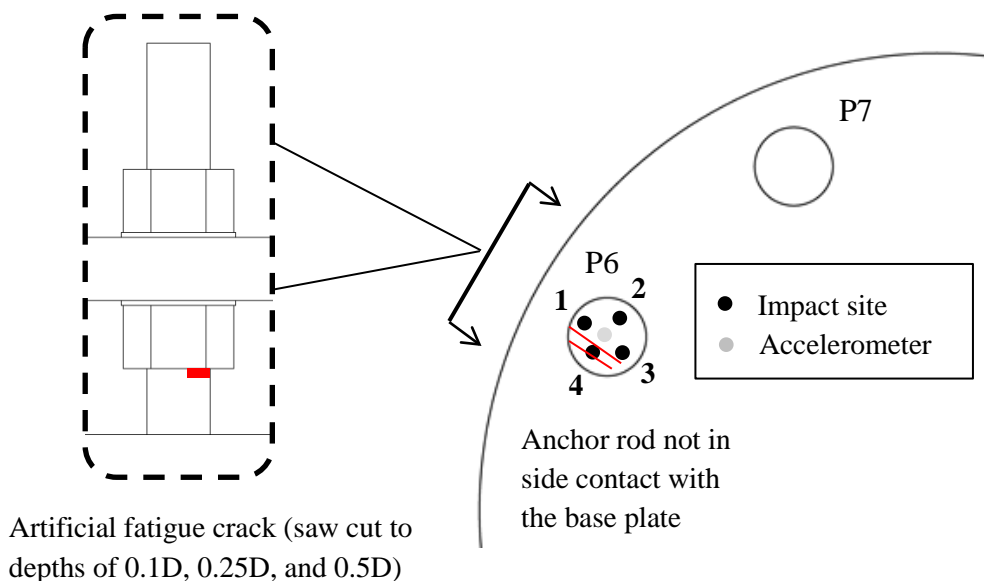
**FIGURE 20** Test configuration for the crack detection studies.

All crack detection tests were performed on the same structure-foundation anchorage assembly described earlier in the report. Artificial cracks were introduced by saw cutting the rod at the base of the leveling nut (Figure 20). This crack location was selected based on experimental tests by Frank (1) and Kaczinski et al. (2) on the fatigue performance of anchorage connections under cyclic loading. Crack depths of 1/10, 1/4, and 1/2 of the rod diameter (D) were investigated. Each crack was introduced near location 4 since the threading in this location allowed for the closest placement of the crack to the base of the leveling nut. Field experience and testing has shown that cracking generally initiates in a groove near the first thread engagement due to non-uniform stress distribution in the threaded connection. This places the crack near an abrupt geometric transition in the assembly (i.e. the base of the leveling nut). Since geometric transitions cause stress wave reflections in the absence of a crack, this crack location is problematic from a detection standpoint because the inherent geometric reflections can mask the resonant crack reflections.

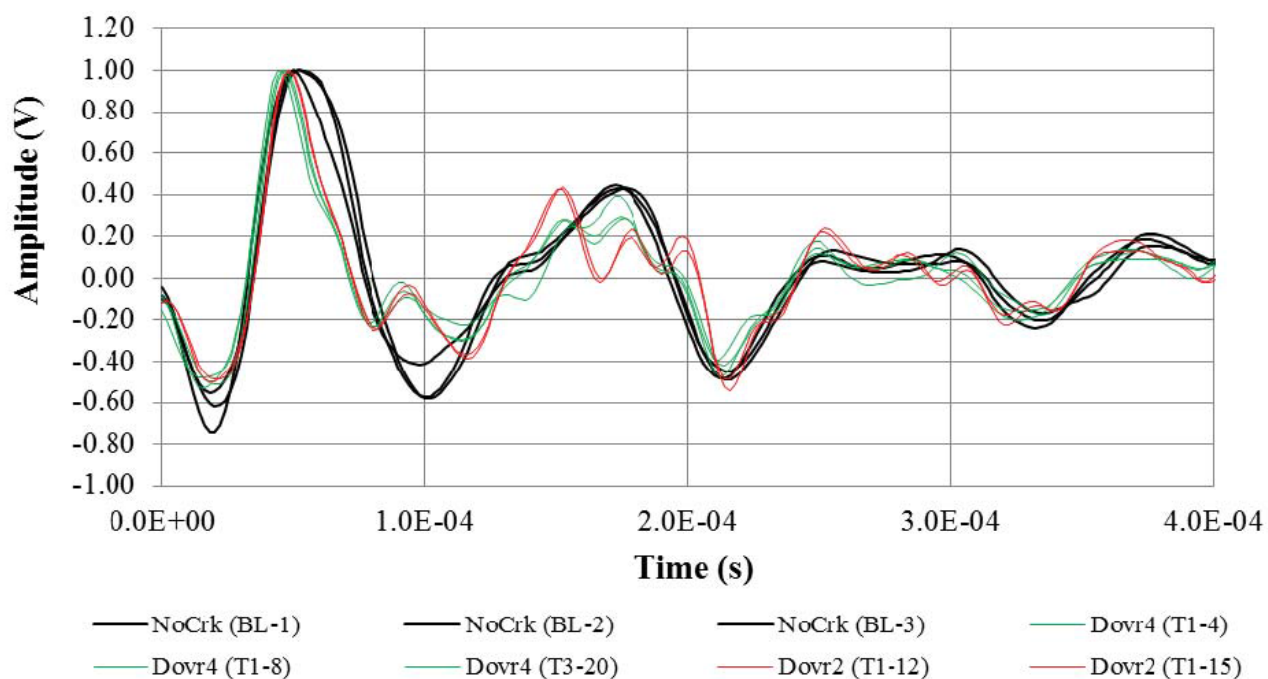
**FIGURE 21** Surface acceleration recordings for rod P5 (single locking nut configuration): uncracked condition (black); D/4 crack (green); and D/2 crack (red)

Figure 21 presents surface acceleration recordings for anchor rod P5 (single locking nut configuration) in the uncracked condition and with D/4 (1/4 of the effective diameter) and D/2 (1/2 of effective diameter) cracks at the base of the leveling nut, where D is the diameter of the rod. The data in Figure 21 was generated for an impact load applied in the quadrant over the crack surface. The presence of a crack at the base of the leveling nut appears to alter the tension wave that is reflected back to the rod surface from the base of the leveling nut, designed as the 2P reflection. This reflection in the uncracked condition is due to the abrupt change in geometry and results in the downward motion of the rod surface around 0.1 ms. Attenuation of the reflected tension wave could be attributed with crack alternation of the reflective boundary. The effect of the crack appears to damp out relatively quickly and is notably absent from the 4P reflection. Similar results were obtained for anchor rod P2 (double locking nut configuration). Figure 22 presents surface acceleration recordings for the uncracked condition and with a D/10 crack (1/10 of the effective diameter) located at the base of the leveling nut. Similar to the single nut configuration, the peak associated with the 2P reflection is lessened when a crack is present.

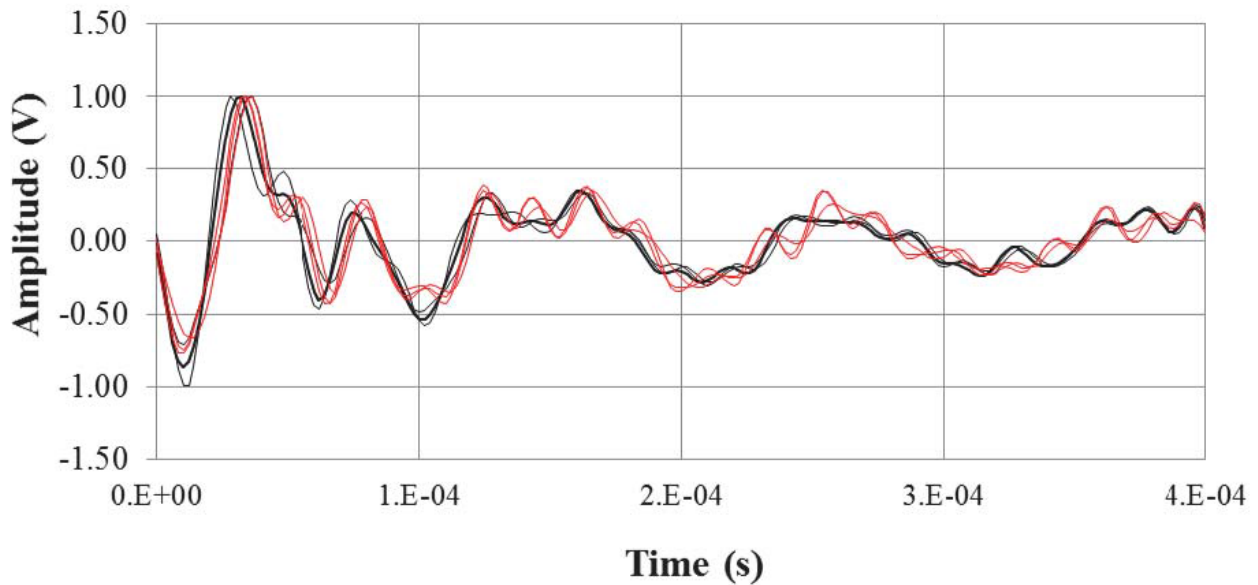
**FIGURE 22 Surface acceleration recordings for an anchor rod P2 (double locking nut configuration): uncracked condition (black) and with a D/10 crack at the base of the leveling nut (red)**

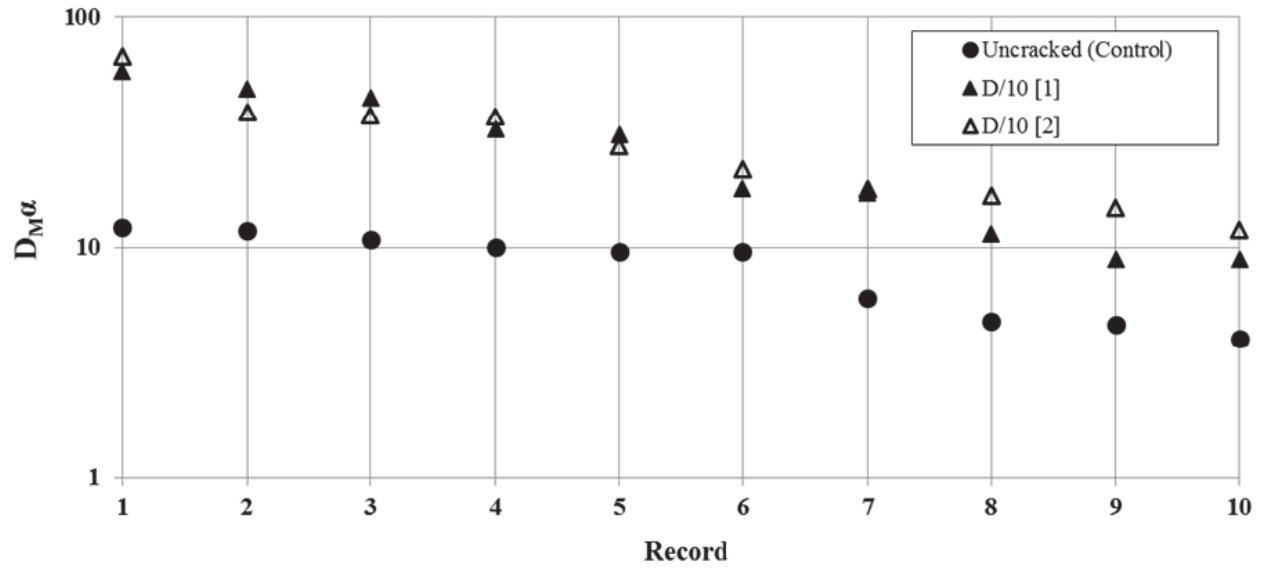
**FIGURE 23** Mahalanobis distance for regression models fitting the surface acceleration response during the 2P reflection

Damage feature calculations from the test measurements were performed using the DIT (Damage Identification Toolsuite) software developed by Pakzad et al. (18). By fitting a regression model to window the 2P region of the waveforms in Figure 22, the presence of the D/10 crack can be clearly and consistently detected by evaluating the regression coefficients through the single, scalar Mahalanobis distance parameter ( $DM\alpha$ ). As illustrated in Figure 23, the distance parameter is consistently larger for the cracked condition compared with control data for the uncracked condition (> 95% confidence in crack detection).

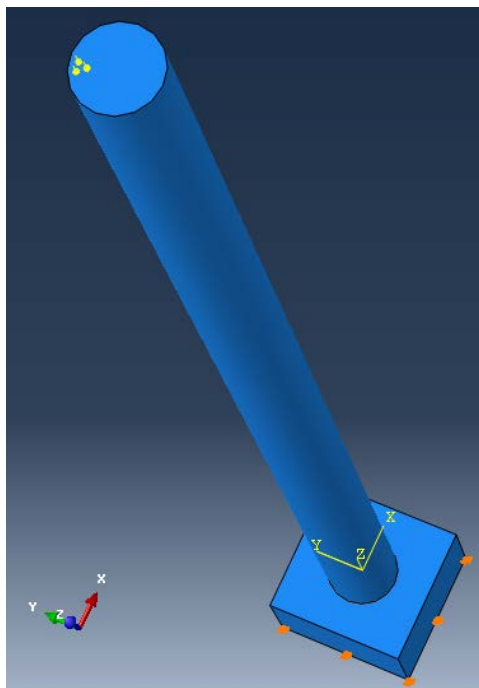
**FIGURE 24** Finite element model of an isolated rod.

The initial modeling effort focused on impulse response tests of an isolated rod. A solid, 45 in long, 2 in diameter unthreaded rod was modeled to match the overall dimensions of the actual rod specimens. Similar to the physical experiment, the rod was supported on a flexible foam base (Figure 24). The support material was modeled as a 4 in x 4 in x 3 in block of polystyrene, and it served as a tunable flexible foundation to control numerical noise at the boundary conditions due to the artificial concentration of reaction forces. A tie constraint was used to merge the bottom surface of the rod and the top surface of the polystyrene base.
