## **Rapid Detection of Fatigue Cracking in Steel Anchor Rods Using the Impulse Response Method**

Final Report for  
NCHRP IDEA Project 175

Prepared by:  
Wesley Keller, Ph.D., P.E.  
Rachel Cohen  
Shamim Pakzad, Ph.D.  
Stephen Pessiki, Ph.D.  
Lehigh University

*June 2017*

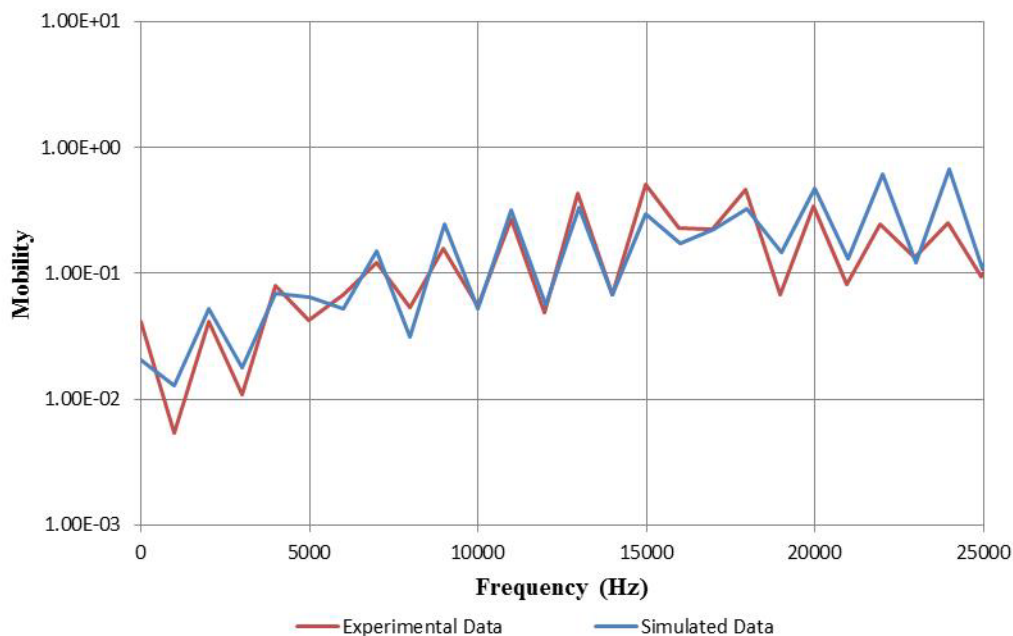
**FIGURE 25 Experimental and simulated mobility spectra for an isolated rod.**

0.1  $\mu$ s to satisfy the CFL stability criterion. The impact force was distributed to nine adjacent nodes located on the surface of the rod. Time-history records of surface displacement, velocity, and acceleration were produced and converted to mobility spectra for comparison with the experimental tests. Figure 25 presents the experimental and simulated mobility spectra for an isolated rod test. In general, excellent agreement was found within the frequency range of interest.

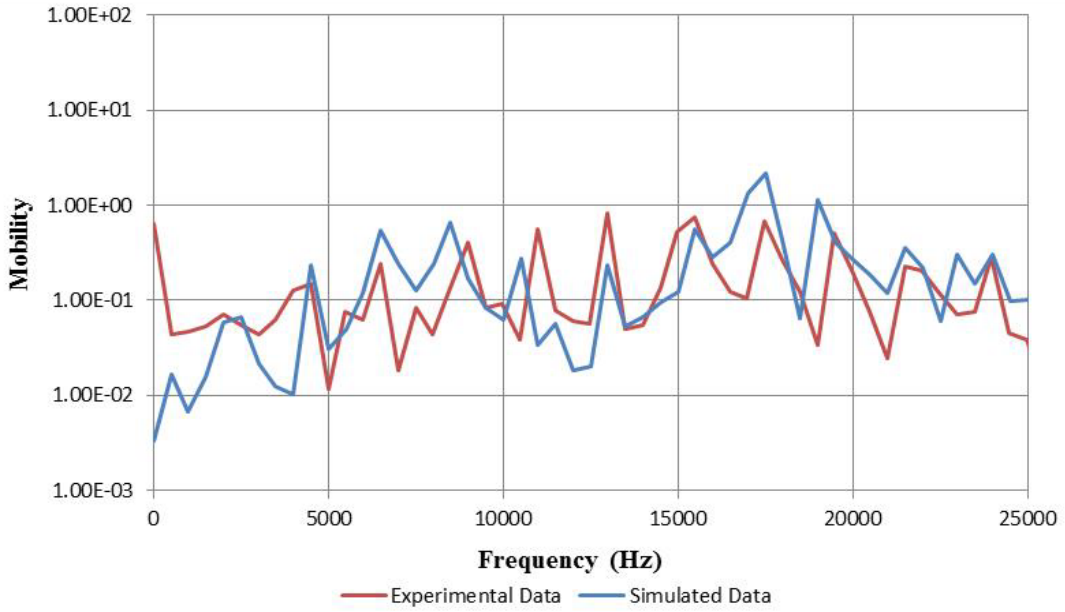
**FIGURE 26** Experimental and simulated mobility spectra for an isolated rod with a loose fitting nut.

Figures 26 and 27 compare experimental and simulated mobility spectra for models considering a single loose fitting nut and two nuts tightened against each other, respectively. In general, the use of an idealized perfectly constrained boundary along the rod-nut interface in the model poorly approximates the thread engagement in the physical connection. As

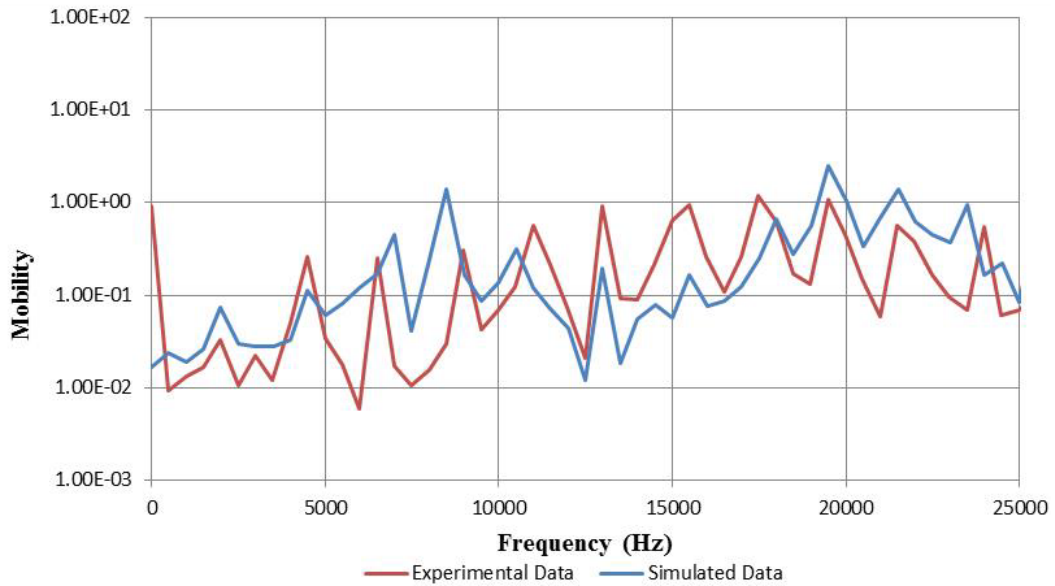
**FIGURE 27** Experimental and simulated mobility spectra for an isolated rod with two nuts tightened against each other.

expected, the modeling approach provides marginally better results for the case with two nuts tightened against each other since the threads are subject to greater contact forces.

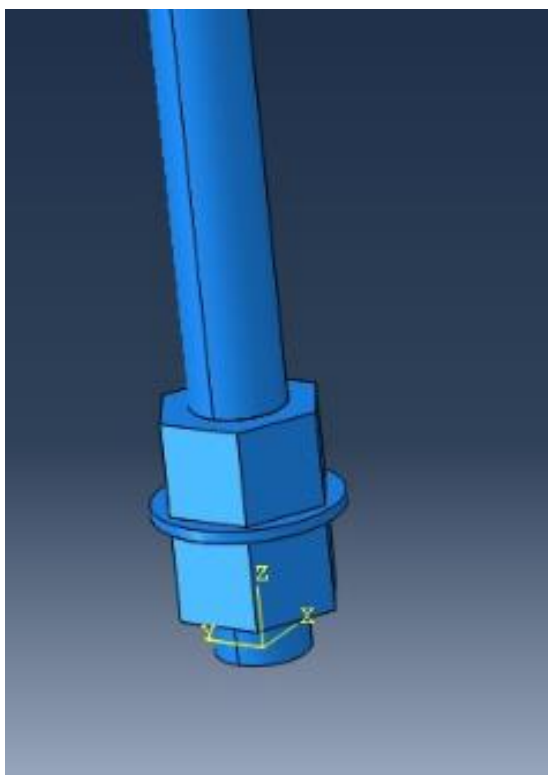
**FIGURE 28** Anchorage detail of embedded rod with nuts for the embedded rod model (concrete omitted from the image).

An embedded rod model was developed to study the influence of the concrete encasement. This model included an embedded anchorage detail with two heavy hex nuts and a partial model of the embedded anchorage plate (Figure 28), dimensioned to match the structure-foundation anchorage assembly described in Chapter 3. The concrete encasement was modeled with a cylindrical region, which was tied to the outer surface of the anchor rod (Figure 29). A comparison of experimental and simulated mobility spectra is provided in Figure 30. The model effectively captures the diffusive damping of the composite system (smoother distribution) and reasonably replicates the frequency content.

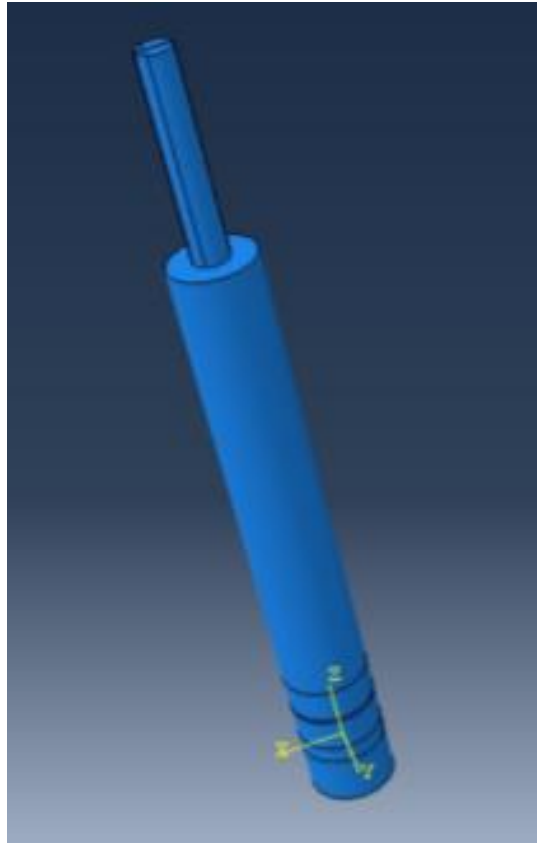
FIGURE 29 Finite element model of the embedded rod assembly.

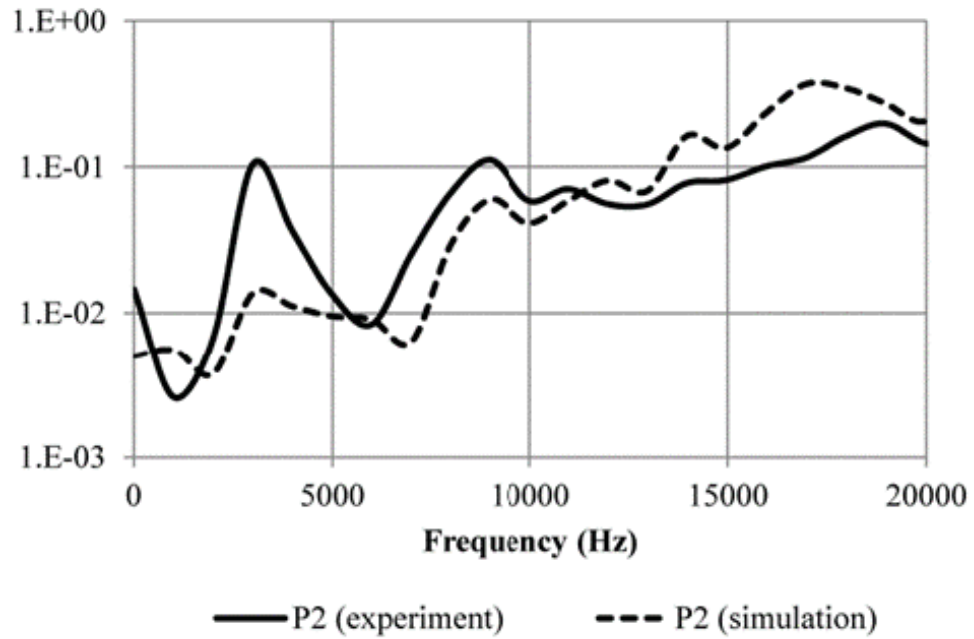
FIGURE 30 Experimental and simulated mobility spectra for an embedded rod
