Rebuilding The CAT 3208 Diesel

By Roy Berndt

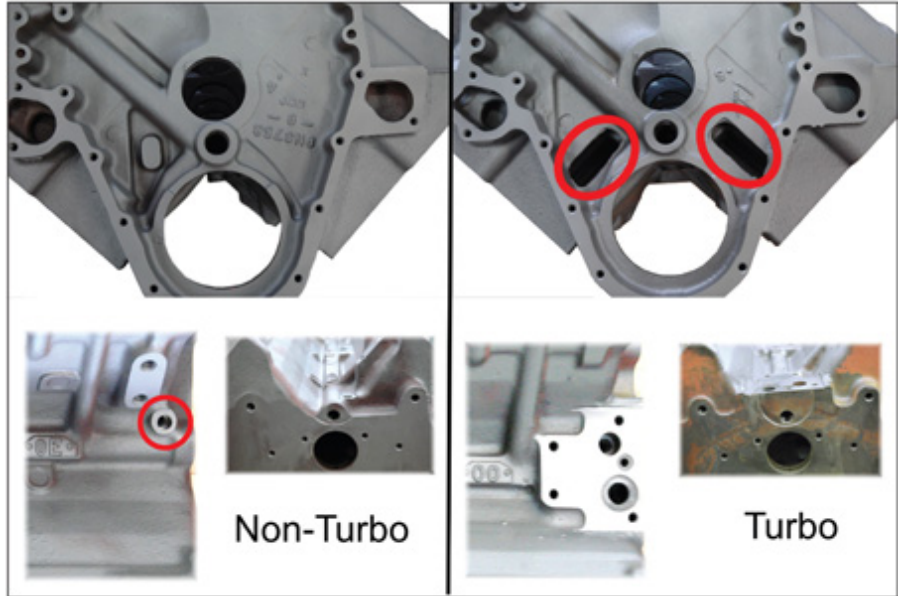
Figure 1.

The turbo block has two vents for the lifter chambers of the block that the non-turbo does not have. **Figure 1** shows the rear lower extremity of the “V” of both blocks. The non-turbo block is plain and just follows suit with the rest of the casting. The counter bored and threaded hole (red circle) is where the camshaft thrust bolt is installed. The turbo block on the right has a cast and machined turbocharger mounting flange in the rear of the block at the bottom of the “V” with oil feed and drain back in between the mounting bolt holes. In the rear of the blocks you can see the last cam bearing bore and the main oil galley plug threaded bore just above it and you get a better view of the breadth of the mounting boss.

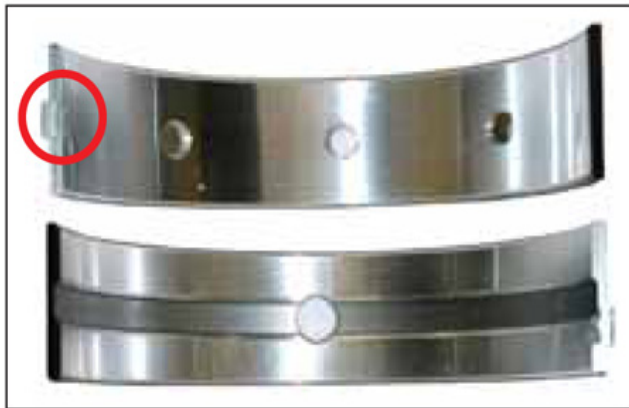
Figure 2.

You also need to pay attention to the #1 main bearing housing bore register in the block. If it has a center bearing tab locator (**Figure 2**) you will use the three-hole main bearing since that register also has a groove cut into it. If it has the offset bearing locator tab in the main bearing housing bore the block will have a plain single hole main bearing bore register.

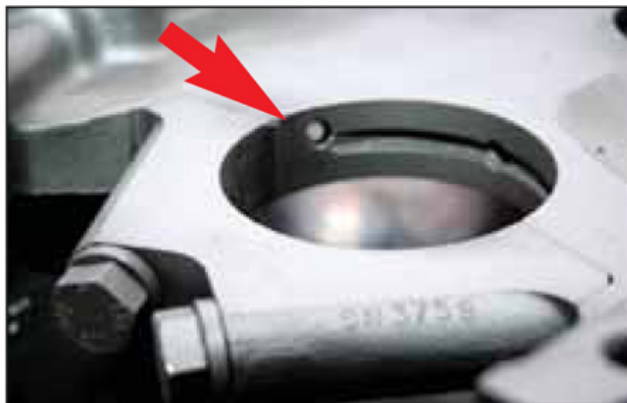
Figure 3.

Turbo blocks also have piston-cooling jets/nozzles that feed off of the main bearings (see **Figure 3**). You may find non-turbo blocks that have been machined for these nozzles but actually have plugs installed.

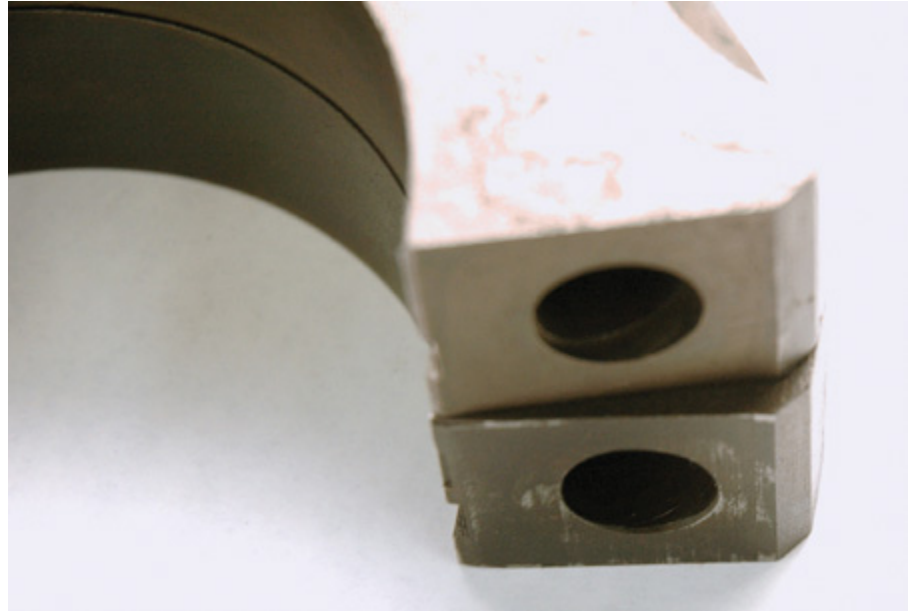
Figure 4.

Early 3208 non-turbo blocks had a slightly steeper main bearing cap parting line angle. I was unable to determine a serial number break as to when that happened but if you're salvaging main caps for block repairs you will want to be aware of it (see **Figure 4**). One worldly piece of advice on main caps: they need to be tight in the register in the main saddle. If you have a cap that is loose (one that slides in and out with little or no resistance), it has stretched and is out of round. If you have a main cap that is "kind of" loose but still measures in spec, you will probably have a premature main bearing failure at that location. If the caps are tight enough that you need to struggle to get them out of the register, preferably having to wiggle them back and forth, you will be perfect.

If you need to, reclaim the register area of the cap and mill the register face back to a dimension that will keep the cap good and tight in the block register. Then align bore the block, but remember that you have a stacked gear train with this engine, so you shouldn't be moving centerlines if you want your gears to work.

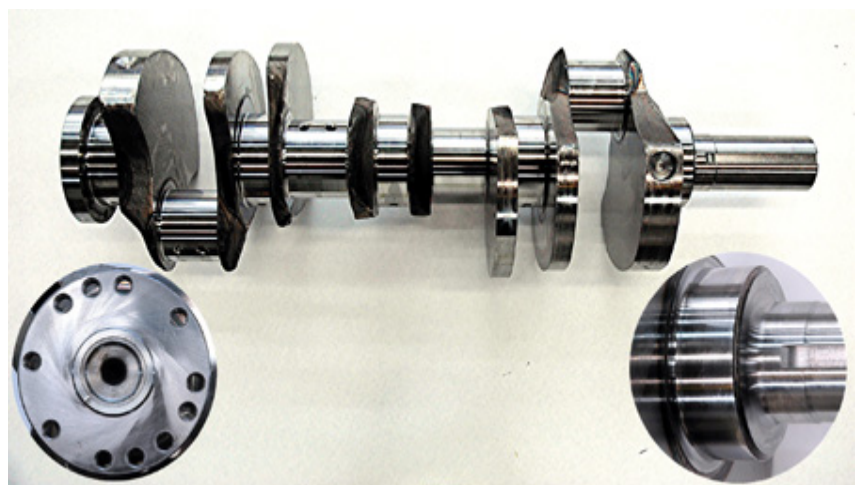
Figure 5.

The 3208 engine utilizes a forged steel crankshaft with true ground radii – they are not rolled. Pick this crankshaft up once and you will know why they are not. There was no scrimping on metal on this Caterpillar crank. You can have an 8- or 10-bolt flywheel flange (**Figure 5**) and they both have the same bolt

pattern. If you use an 8-bolt flywheel on a 10-bolt crankshaft, be sure to install two plugs with sealer into the unoccupied holes or you will leak oil badly.

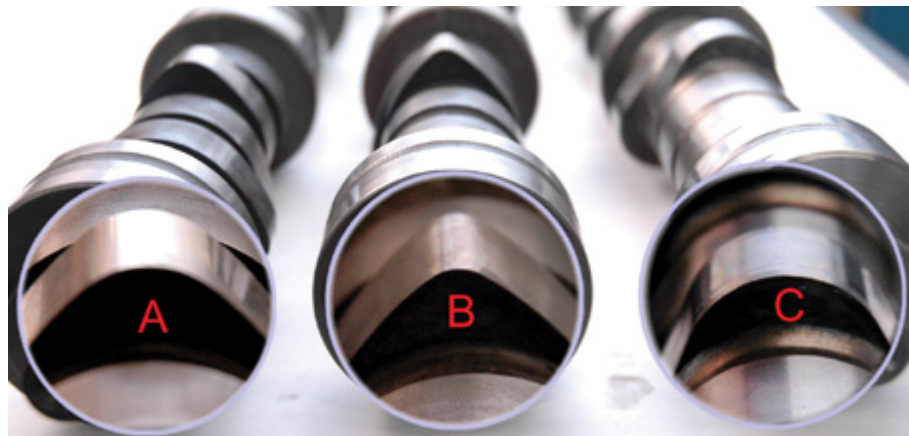
In its first iteration, the 3208 was a naturally aspirated engine with a flat tappet/lifter camshaft made of cast iron. Take a look at **Figure 6** and you'll see this camshaft in the middle (letter B). The end of the camshaft has an inset photo to help you identify the lobe profile.

Figure 6. There are three camshafts for the 3208. Left to right, we have (A) flat tappet turbo; (B) non-turbo flat tappet; and (C) roller lifter turbo.

The second camshaft was the flat tappet cam in the turbocharged engines and is identified by the letter A. Again the lobe profile is superimposed on the end of the camshaft. Take note of the much gentler lobe peak profile – this is also a cast iron camshaft. The last and final camshaft (letter C) was the roller lifter camshaft. Made of steel, this camshaft is hardened to withstand the point contact of the roller lifter.

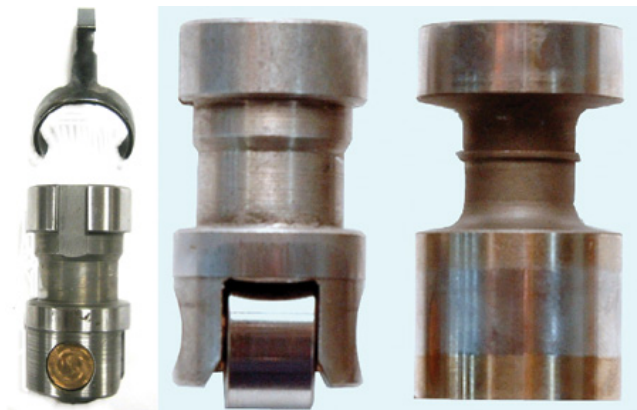
Figure 7.

The lifters are readily identified by their appearance and there is nothing too confusing about these (see **Figure 7**). In the center is the roller lifter and on the right is the flat lifter. The roller lifter is used in combination with the steel camshaft. The roller lifter is secured in the lifter bore with a clip to prevent it from turning. These are mechanical lifters only: there are no hydraulic lifters used in a 3208 engine

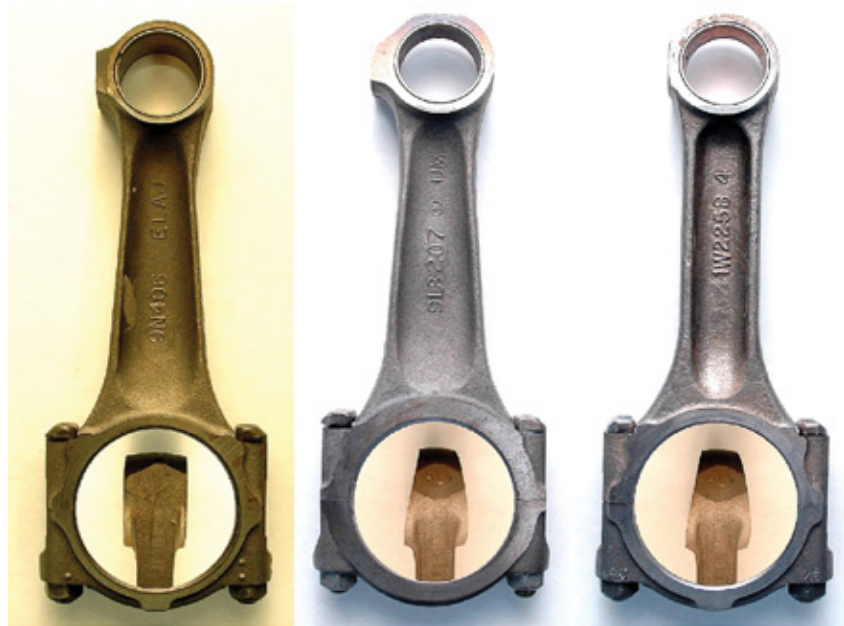
Figure 8.

There are three different connecting rods used in the 3208, and as with all the other components what you'll use depends on what you have. **Figure 8** explains the differences.

The first series connecting rod is shown on the left. This rod is used with a piston that has straight-sided wrist pin bores in the ID of the piston (see **Figure 11**). The second connecting rod was a tapered pin connecting rod used with pistons that had additional material up under the piston crown creating a tapered wrist pin boss on the ID of the piston. Many remanufacturers today will machine straight pin boss rods to a tapered pin rod to reduce part numbers and rod core management for naturally aspirated engines. You can put a tapered rod into a straight pin piston but not vice-versa.

A word to the wise, however: even if you purchase the correct fixture tooling to install the tapered pin bushings you still run the risk of having a bushing turn in the rod eye (as a warranty) due to bushing distress and distortion. Heat the pin eye and nitrogen the bushing, index the bushing and drop it in the rod. The last connecting rod on the right is the turbo rod. This one features an enhanced beam and increased strength.

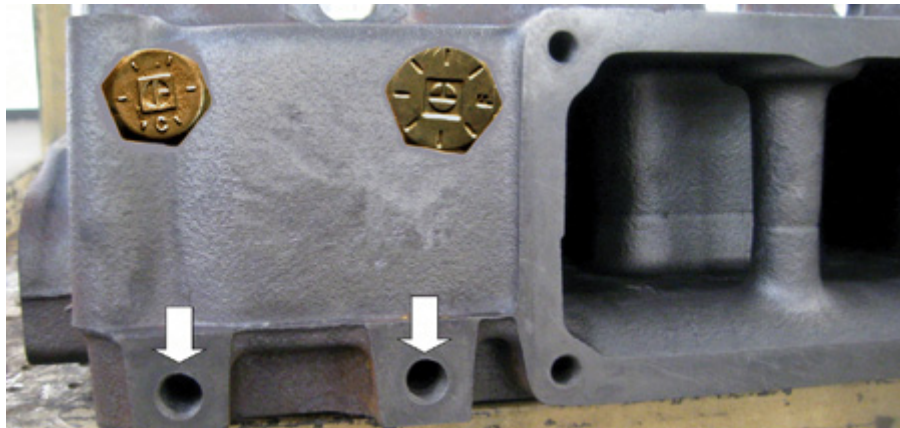
Figure 9.

The cylinder head for the 3208 is pretty uncomplicated and yet complex. The only real difference between the head casting for a turbo and non-turbo engine is that the lift bracket holes on the cylinder head are different. The non-turbo cylinder head is 3/8" x 16 pitch thread and the turbo head is 1/2" x 13 (**Figure 9**). That is the simple part, however when it comes to the valves, springs and valve seat inserts, that is dependent on the serial and arrangement number.

Early 3208 engines used 6 ID dash lines on the head of the bolt and were torqued at 95 ft. lbs. while the 7 dash (one mark is a letter) head bolts are torqued to 110 and 120 ft.lbs., depending on their location.

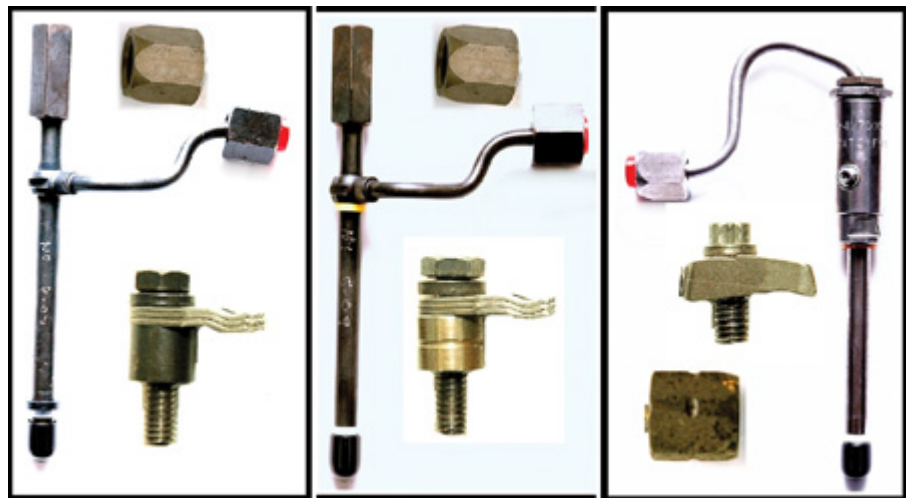
Figure 10.

There have been three fuel injectors used on the 3208 engine (as shown in **Figure 10**). The one on the far left is referred to as the “S” injector because it was the injector used on the “40S” serial number series engines. You must use the hold down shown with this injector. It is .500” tall with a smooth OD of the spacer barrel. You will also need to use .063” ID fuel lines that you can identify by the smooth OD line nut also shown.

The injector and components shown in the center belong to the “Y” injector because its use was primarily with the 32Y serial number series engines, although it did bleed into the 51Z engines as well and some turbo engines (02Z and 03Z). This injector requires a different hold down with a spacer that is .475” tall as indicated

by the groove on the OD of the barrel. This injector also uses the .063” ID fuel line with the smooth line nut. Another quick identifier for these two injectors is the black gas seal on the “S” injector and the yellow seal on the “Y” injector (an easy way to remember is “Y” for yellow seal).

The “7000” series injector is completely different in appearance and there is no chance of mixing this one up. This injector must use a .072” ID fuel line that can be identified by the “Notched”

fuel line nut as shown. When this injector is used in the lower horsepower naturally aspirated 3208 engine it will have an injector tip orifice diameter of .290 mm and when used in the higher horsepower turbo engine the injector tip orifice has a diameter of .315 mm. Other diameters of orifice sizes are also used for various different specific applications.

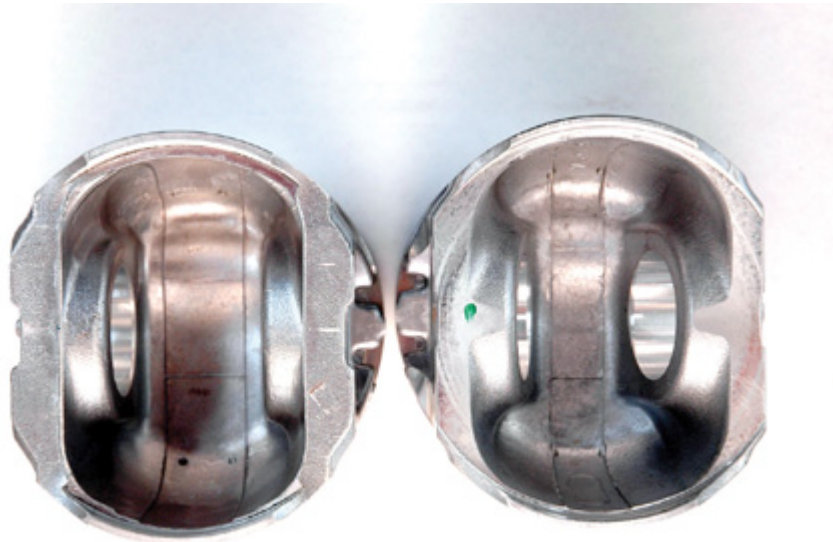
Figure 11.

The piston bottoms shown in **Figure 11** show the straight pin bore piston on the left that can be used with either a straight pin or tapered pin connecting rod. The piston on the right has the tapered pin bore and, as you can see, there is a substantial amount of additional support for the piston head. Only the tapered pin bore connecting rod can be used with this piston.

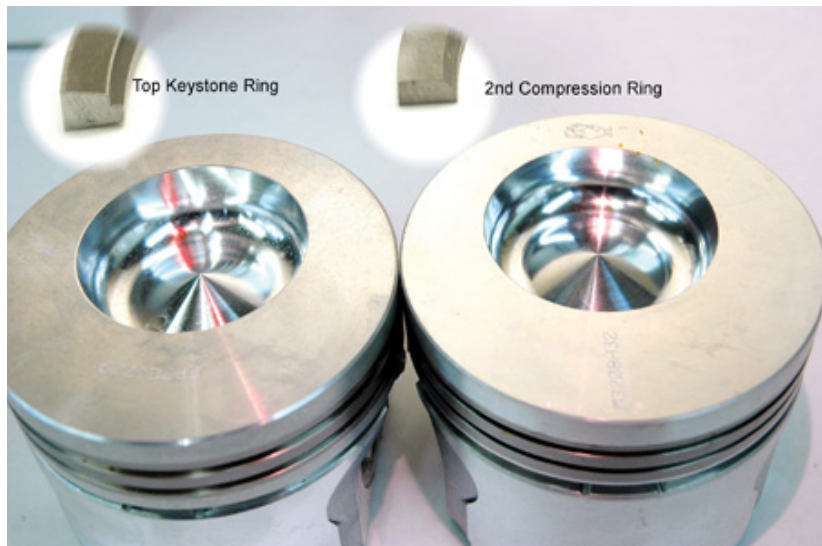
Figure 12.

The piston on the left of **Figure 12** is a non-turbo piston with a fuel swirl bowl volume of approximately 54cc, while the piston on the right for the turbo is approximately 59cc. Mixing them up can render poor results in runability.

The pistons shown are all three-ring pistons. Caterpillar produced a three-ring piston only for some turbo application but never for a naturally aspirated engine. Instead, two-ring pistons were used in these versions. The two-ring piston was only available as a conventional type ring groove while the three-ring pistons use a top Keystone ring (see illustration).

Use the three-ring piston as your choice of piston: it's a superior replacement for the two ring and you'll never use a two ring in place of a three ring. Naturally aspirated pistons come with three different compression ratios: 16.5:1, 17.5:1 and 18.2:1. Turbo pistons primarily have a compression ratio of 16.5:1, though there are some lower horsepower turbo engines for California applications, which have a 17.5:1 compression ratio.

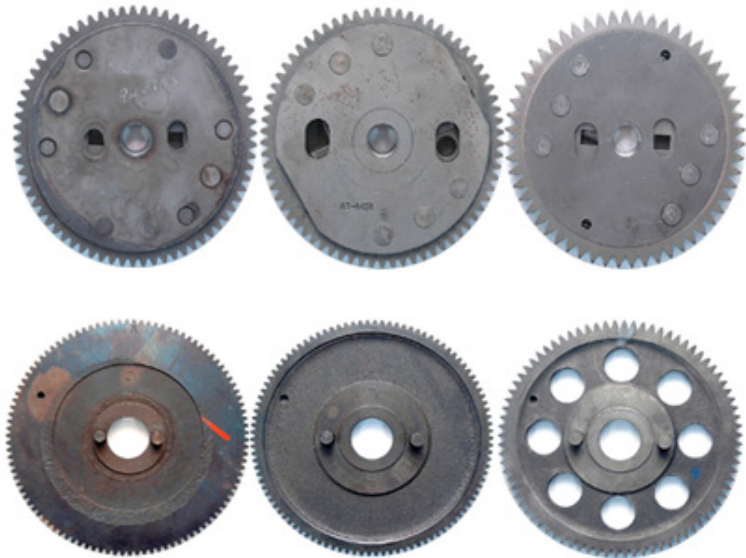
Figure 13.

In **Figure 13** you can see that the CAT 3208 used one of three camshaft drive gears and three different type injection pump timing advance units. On the left, the narrow drive pin set for the advance unit (notice how close the pins are to the center hole of the gear) shows these gears are for a naturally aspirated engine. The unit in the center has the wider pin location for the cam advance unit and is used for turbocharged applications. Note that both of these timing gears have a higher count of teeth and a shallower profile. The gear on the far right is the last rendition with fewer teeth and a much more aggressive tooth pattern and was used for high horsepower applications.

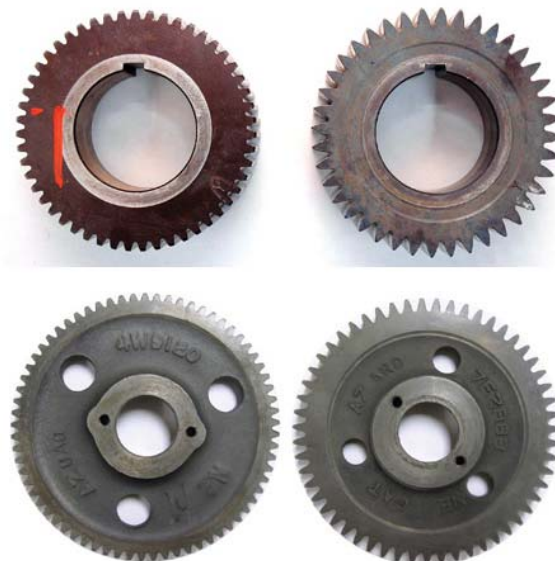
Figure 14.

There are only two crank and injection pump timing gears. As shown in **Figure 14** you'll find either a fine tooth or a coarse tooth gear in this position.

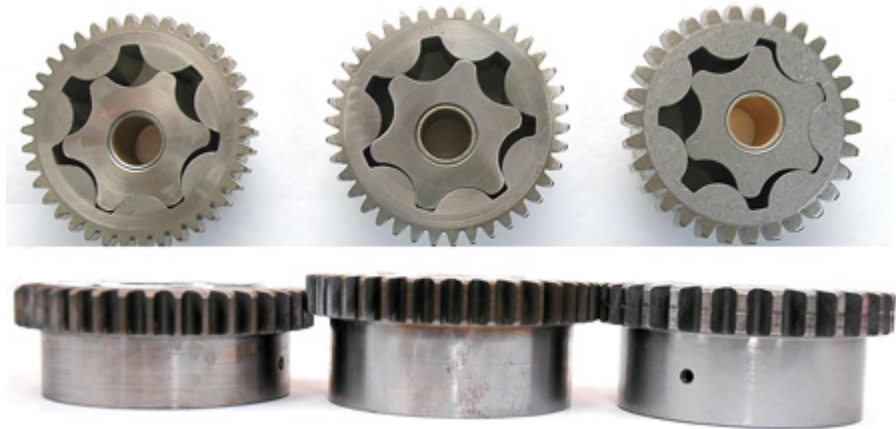
Figure 15.

The 3208 diesel engine had three different oil pump gears. As shown in **Figure 15** from left to right, the early shallow gear oil pump corresponds with the like front cover and pump bushing. The center gear is the taller, higher volume oil pump with the matching front cover and bushing as well. Both of these gears have the higher count shallow profile teeth and the last gear is the same height, however, it has the coarse, more aggressive tooth pattern. Since many of these components may potentially be changed out in the field, knowing the appearance of all of the variations could save a lot of grief and sorrow because an incorrect tooth pattern component was installed. The oil pump tooth pattern always has to be matched to the crank gear pattern. However you may find the tooth pattern can split between coarse and fine pattern on the same engine. Example: Crank gear, cam gear and oil pump fine gear pattern and advance gear and injection pump gear have a coarse pattern or vice versa. injection pump gear have a coarse pattern or vice versa.

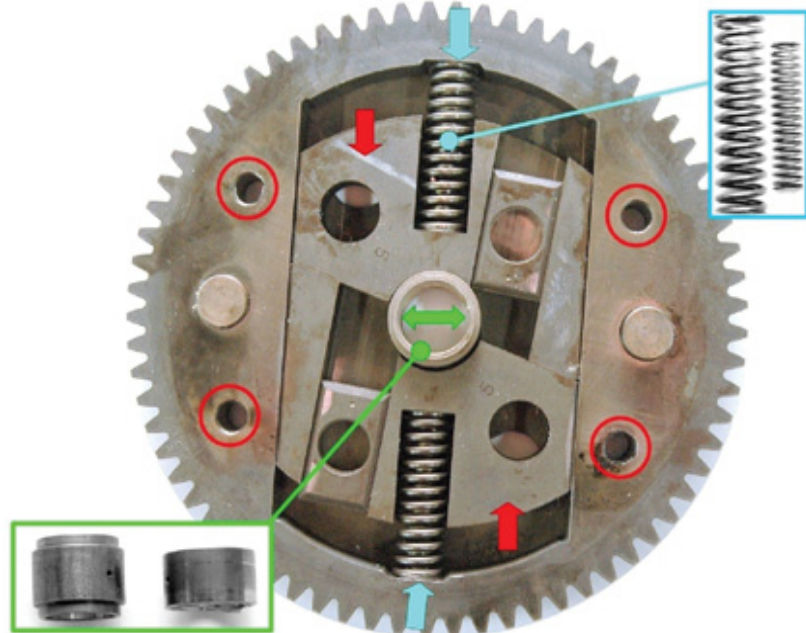
Figure 16.

The dowel size and spacing are different between an advance gear for a naturally aspirated and turbo engine (see gear train info). The turbo dowels are bigger in diameter and further apart. The advance unit in the lower portion photo as shown in **Figure 16** is an assembled advance assembly for a naturally aspirated engine that is 5° advanced, as evidenced by the 5 that may be scribed or stamped into the cover plate. Note the four red dots: these are the location of the 4 rivets that, when drilled out, expose the internals of the advance unit as shown in the upper portion of **Figure 16**. The four red circles at the top are those same drilled rivet locations. The upper portion shows a turbo advance gear, size of the holes in the slides and spacing.

The weights (two red arrows) show the two sliding tapered parallels (note the 5 stamped on them) that are driven by two slides between them. Those two slides are driven by the two dowels off the front of the camshaft timing gear. As centrifugal force of the unit's rotation speed increases the weights push against the force of the springs which will cause the slides to make a change in the angle correlation between the injection pump camshaft and the engine camshaft, thus advancing the injection pump timing the amount indicated on the face plate.

The light blue arrows show the resistance springs. As shown in the inset image what looks like one spring is actually two, one fitting inside of the other. These can break and without drilling this unit open you will never know, until you get improper advance of the injection pump resulting in poor power or possible white smoking. The green double arrow shows you the center hub of the unit that has narrow ledges which centers in the cover plates. You can also see that if the narrow ledges fracture (inset image right) that will also result in improper advance action.

These units were not designed to be disassembled but to be replaced, so if you are not inclined to drill and rivet, my suggestion is to replace. Just because it worked before does not mean that it will work again after the reman process. Lubrication oil for the timing advance unit comes from drilled holes that connect with the front bearing for the engine camshaft. The function of the advance unit can be checked with a dynamic timing device.

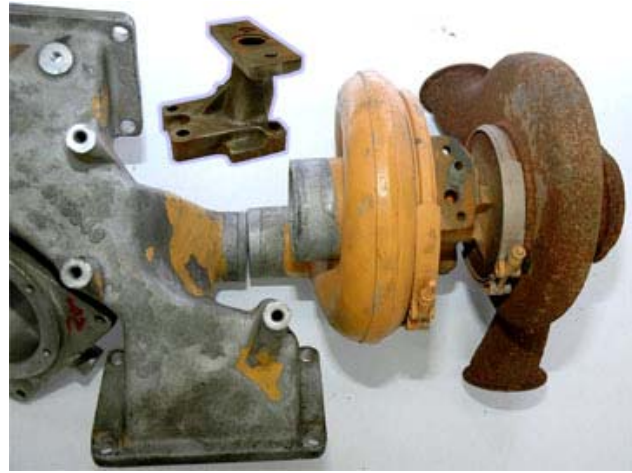
Figure 17.

Early 3208 engines used a Schwitzer turbo that required a riser that bolted to the block and the turbo then bolted to the riser (see **Figure 17**). This riser required ports for oil flow for the turbo and added an additional surface that could potentially have a leak. It sat higher and required more hood clearance. Air Research designed a turbo specific to the 3208 that mounted directly to the block and sat lower down into the valley (see **Figure 18**). Again the serial number and arrangement number will tell you which one that you have. They do not interchange without making a lot of modifications.

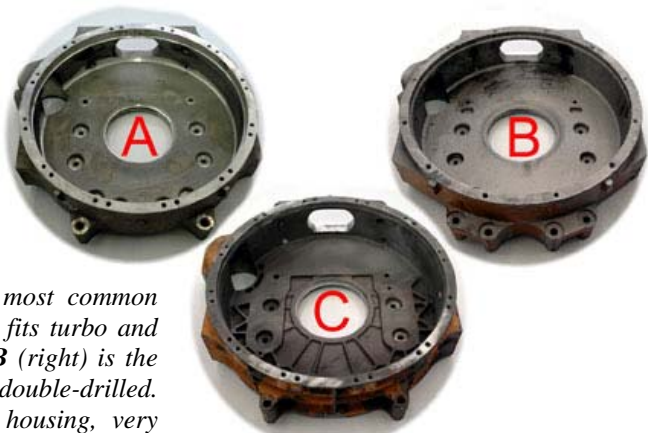
Figure 19 shows the three most common bellhousings used on the 3208 engine. Bellhousing A is used on both turbo and non-turbo applications. It is an SAE 2 and is double-drilled at the top on the inside (which would be on the bottom of the image) this bell housing uses a paper gasket seal to the block. B is the early design SAE 2 used with non-turbo engines and is single drilled at the top for mounting bolts and also uses a paper gasket to the block. C is the latest light weight bell housing used and is also a SAE 2 and double drilled at the top and uses sealer only between the bell housing and block.

Figure 19. The images to the right show the 3 most common bellhousings used in the Cat 3208. **Version A** (left) fits turbo and non-turbo engines, SAE 2, double-drilled. **Version B** (right) is the early design for 3208 non-turbo engines, SAE 2, not double-drilled. **Version C** (bottom) is the latest design flywheel housing, very lightweight, SAE 2, double-drilled, required in some applications.

There are some SAE 3 bell housings used in off-road applications and of course the serial number and arrangement number will give you that information. It is absolutely critical that the bell housing be dial indicated in relationship to the crankshaft for alignment prior to final torque. Failure to do so will result in bell housing fracture.
