SI B64 07 17
Heating and Air Conditioning

RECALL 17V-676: BLOWER MOTOR WIRING

RE: Recall 17V-676: Blower Motor Wiring B64 07 17

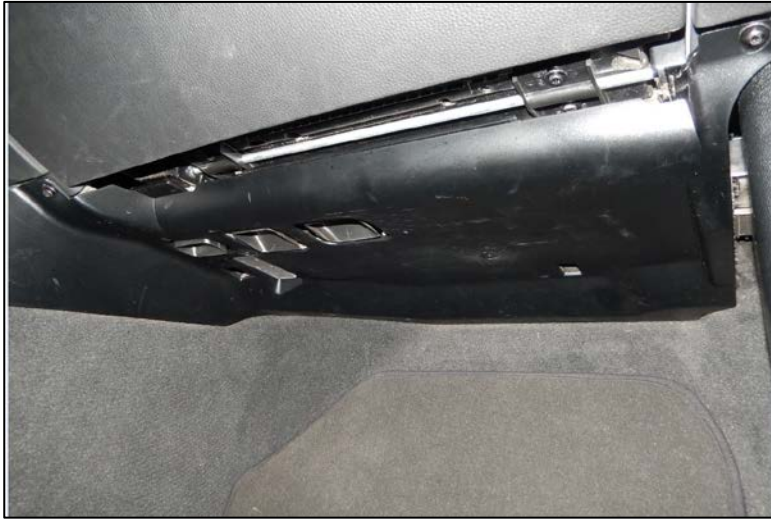
Disconnect the battery before performing this repair per repair instructions "61 20 900 Disconnecting and connecting battery ground lead".

Remove the passenger front lower dash trim and glove box per repair instructions "51 16 360 Removing and installing right glove box" or "51 16 366 Removing and installing right glove box (with airbag) with housing" or "51 16 366 Removing and installing right glovebox with housing".

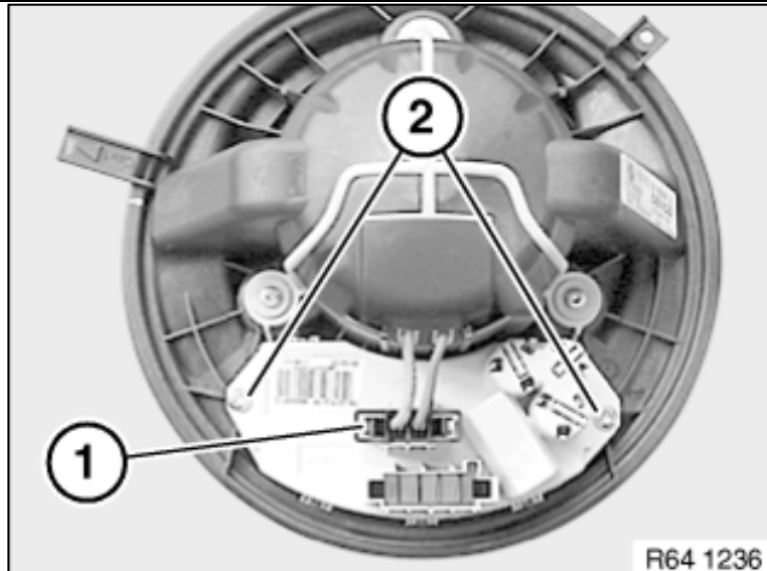
Locate the blower regulator and disconnect **ONLY** the motor connector (1).

Leave the other wiring harness connector connected (Do not disconnect).

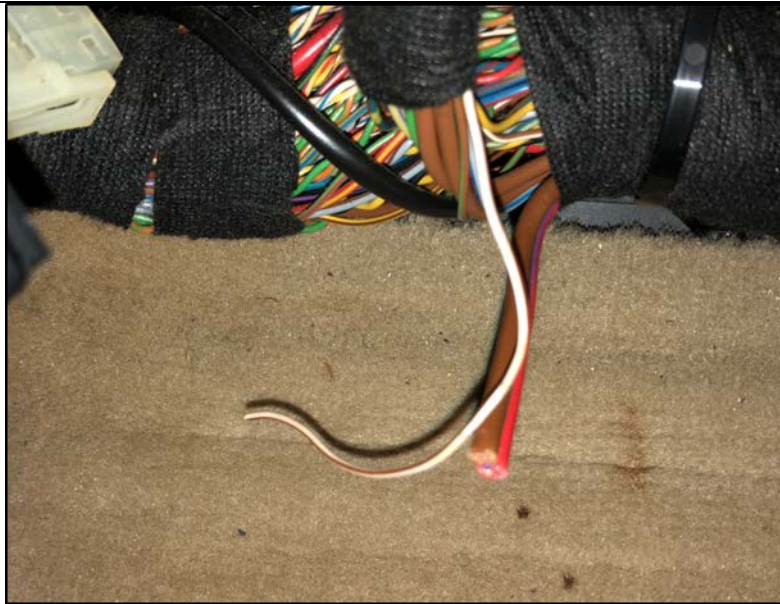
Cut the wiring on the vehicle side for the Red/Violet (**vehicles prior to 3/2007 may have a Red/Blue wire**) and Brown wire as close to the main harness as possible (These 2 wires will no longer be used).

Cut the White/Brown wire leaving about 4-5 inches of wire coming out of the main harness (this will be used and spliced into the repair harness).

Replace the blower regulator by removing the 2 screws (2).

Prepare for shipping (all parts will be collected).

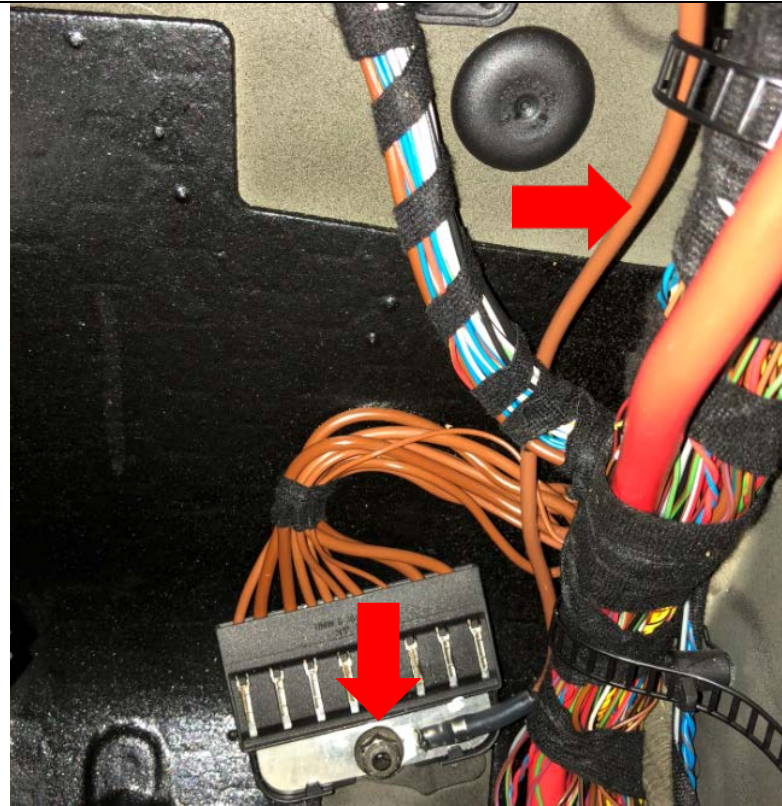
Remove the lower passenger side A-pillar trim.

Carefully lift the carpet from the passenger side footwell area.

Route the Brown wire from the repair harness down to the ground point location.

Remove the nut from the ground point and install the wire end onto the stud and torque to 8Nm using a torque wrench.

Reinstall the carpet and A-pillar trim.
