Recall Campaign 16V-071: Driver's Front Air Bag Module E83

This Service Information bulletin supersedes SI B65 15 16 dated **August 2016 for E83** vehicles only.

E83 (X3)

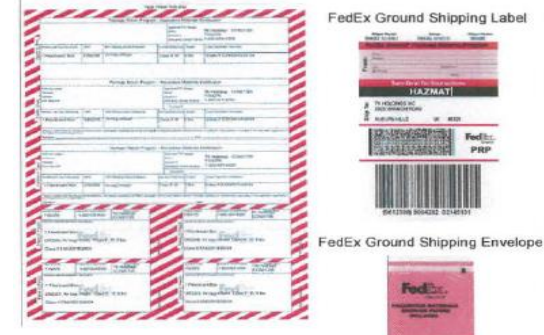
1. Shipping Documents

OP 900PRP Hazardous Materials Certification Form

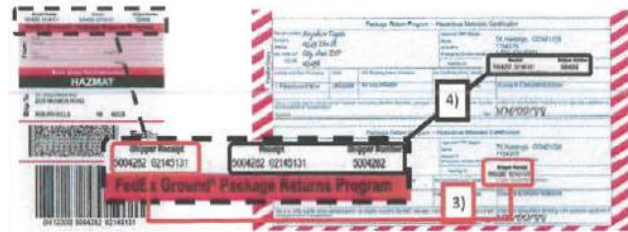
- Peel off the SHIPPER RECEIPT from the top of the FedEx Ground PRP Shipping label, place it in the Tracking ID box on the Customer Copy of the OP 900PRP form. **3)**

- Peel off the RECEIPT & SHIPPER NUMBER from the top of the FedEx Ground PRP Shipping label, and place it in the Tracking ID box on the FedEx Copy. **4)**

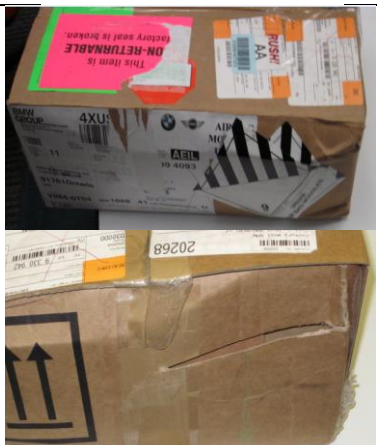
PACKAGE REFERENCE GUIDE

Hazardous materials packaging "Damage" can be classified into one or more of the following different types. They include:

Damage Type	NO
L	<p>Labeling Packages with improper labeling are NOT acceptable, particularly, if the labels obscure other required marks and labels.</p>

I	<p>Improper Packing Improper packing is always unacceptable. The packages must be properly packaged to prevent movement in all directions.</p>

O	<p>Other Damages Multiple damages, such as those that may affect the integrity of the package. Others are not as severe and may be acceptable. If questionable, repackage the material.</p>

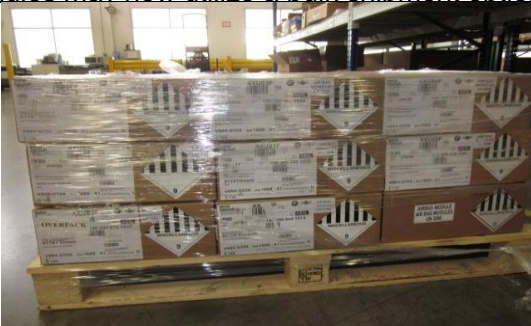
<p>1 Stacking:</p> <p>Place the safety device and shrink-wrap them on the pallet.</p> <p><u>(no more than 60 inches in height).</u></p>

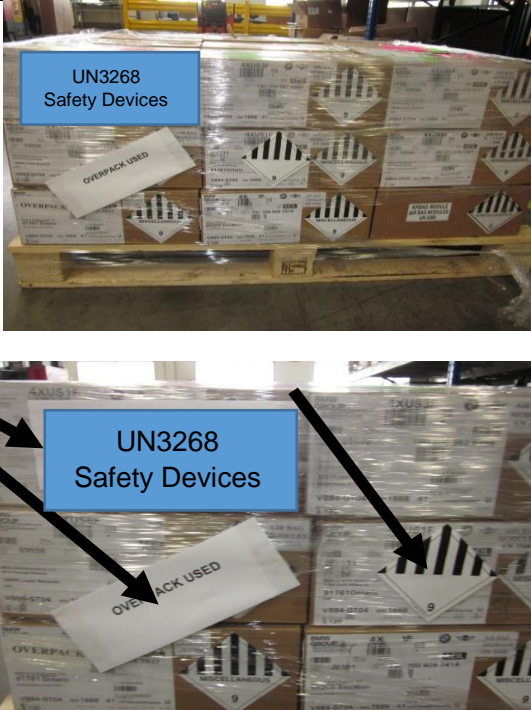
<p>2 Labeling:</p> <p>Put the following labels on both sides of the skid:</p> <ul style="list-style-type: none">- Class 9- UN3268 (Safety devices)*- OVERPACK USED* <p>*Can be printed on Letter Size paper using Microsoft Word</p>
