REPORT ON COMPARATIVE AIR LEAKAGE PERFORMANCE:
Knight Wall with Carlisle 705FR-A and Dow Styrofoam Ultra SL
Compared To
Z-Girts with Carlisle 705FR-A and Roxul CavityRock

PROJECT: Knight Wall and Z-Girt Air Leakage Evaluation

LOCATION: Sanford Contracting
1400 Iron Horse Park
North Billerica, Massachusetts

PROJECT NUMBER: 31855

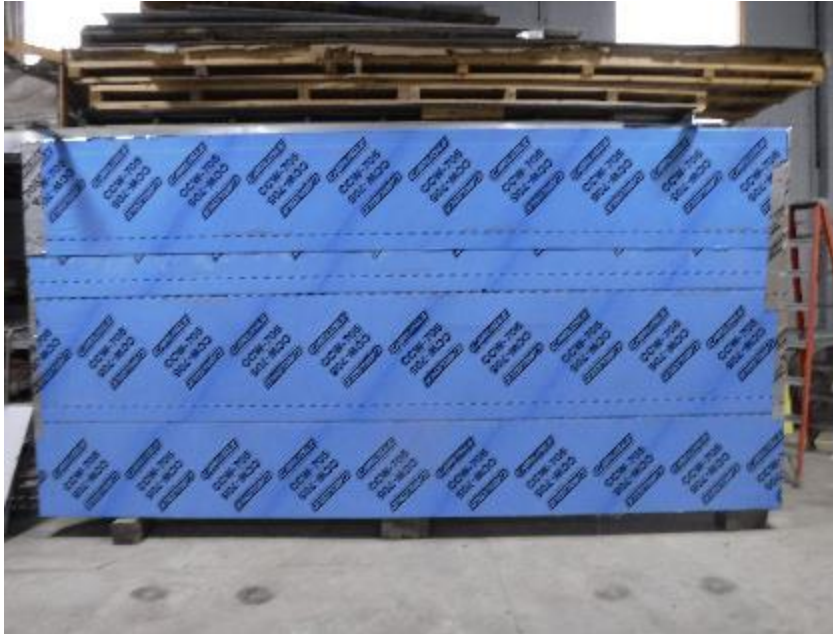
Photograph No. 1

Air Infiltration Chamber

Backside of Mockup wall
with Carlisle CCW-705
AVB.

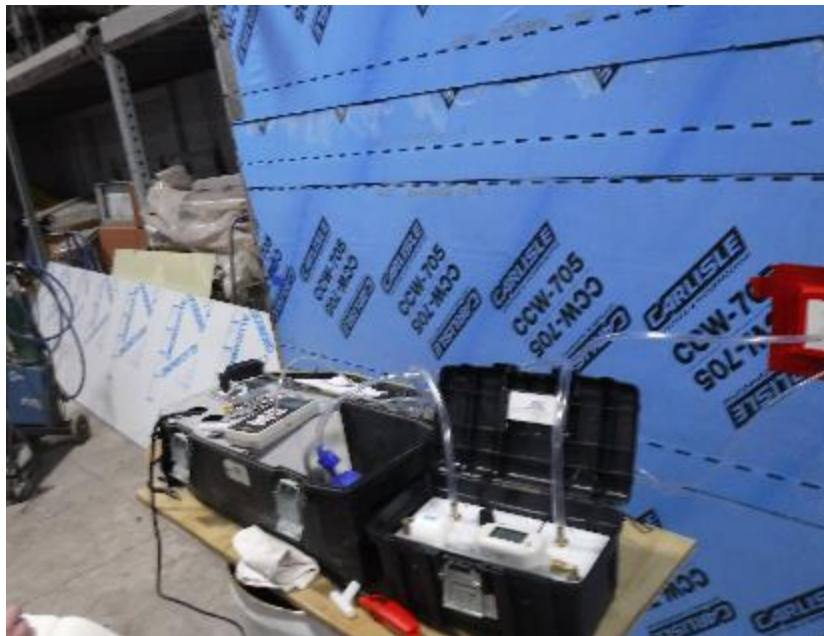
Photograph No. 2

Air Infiltration test
apparatus installed

Tests were conducted using a portable test unit consisting of a regulated vacuum blower, a digital flow meter and digital manometer all connected to the mockup wall assembly. Calibration of all measurement equipment maintained with National Institute of Standards and Technology (NIST) traceability. Additionally, two remote thermometers were utilized throughout the testing to record variations in temperature and humidity inside and outside the test chamber.

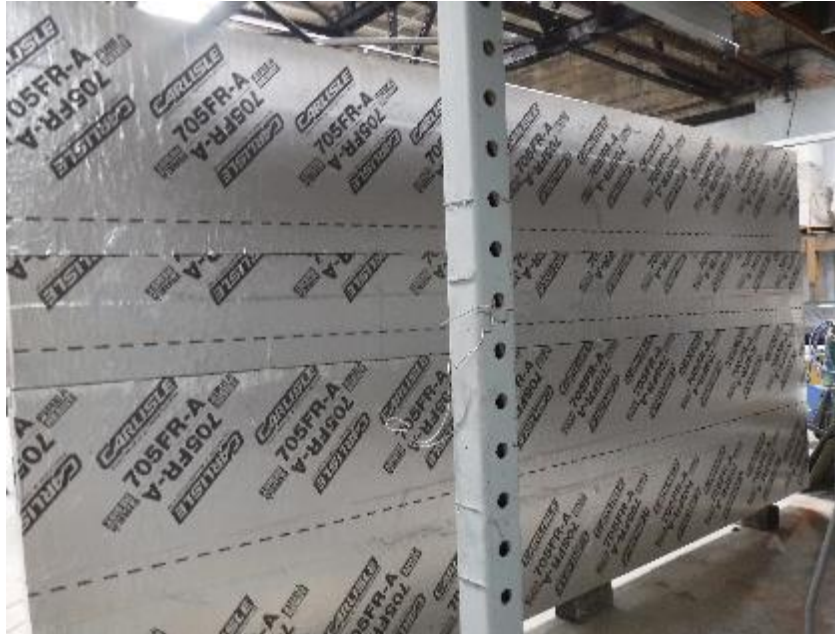
Photograph No. 3

Front side of mockup with Carlisle 705FR-A AVB prior to installation of Z-Girt or Knight Wall system.

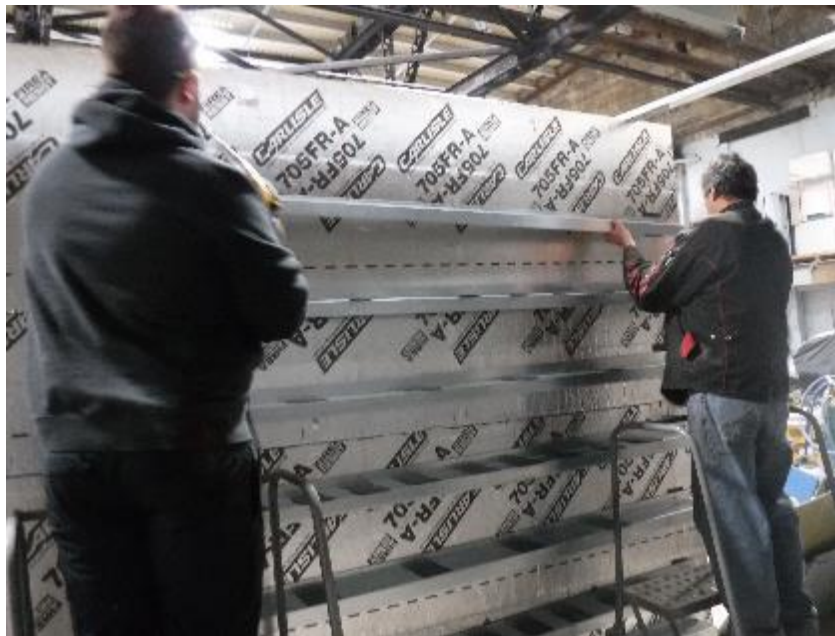
Photograph No. 4

Z-Girts being installed on right (from exterior) half of mockup assembly

The following Z-Girt system was constructed on the right (from exterior) half of the mockup wall assembly.

- 16 gauge Horizontal Z-Girt spaced 12" O.C., Top Z-Girt spaced 16" O.C.
- Every other Z-Girt fastened with one ¼" x 2" self-tapping fastener spaced 8" O.C. Other Z-Girts fastener spacing is 16" O.C.
- 1/8" plastic shim placed between Z-girt and AVB at each fastener location.
- 4" Roxul CavityRock mineral fiber insulation
- Dow Corning 790 silicone sealant over fastener heads

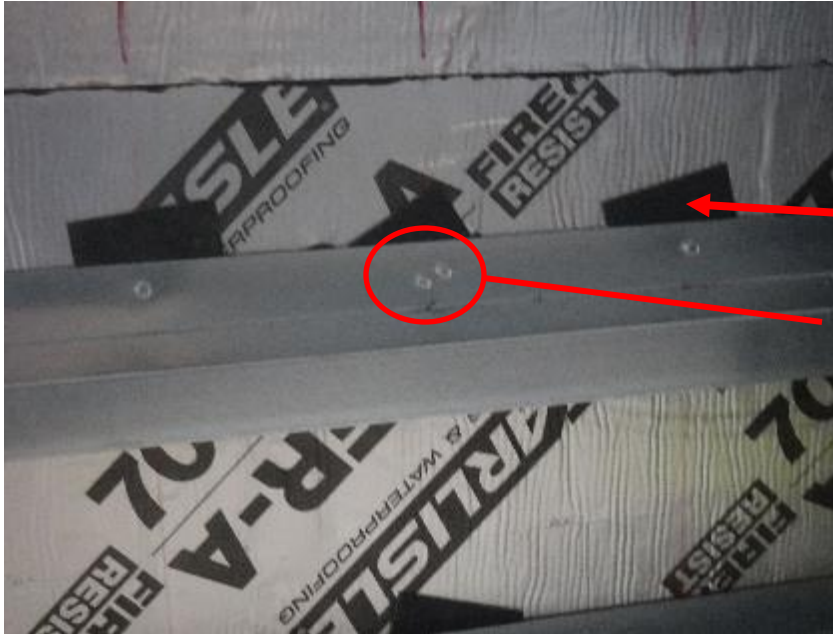
Photograph No. 5

Z-Girt installation

Thermally isolations spacers behind each fastener.

Missed stud resulting in second penetration

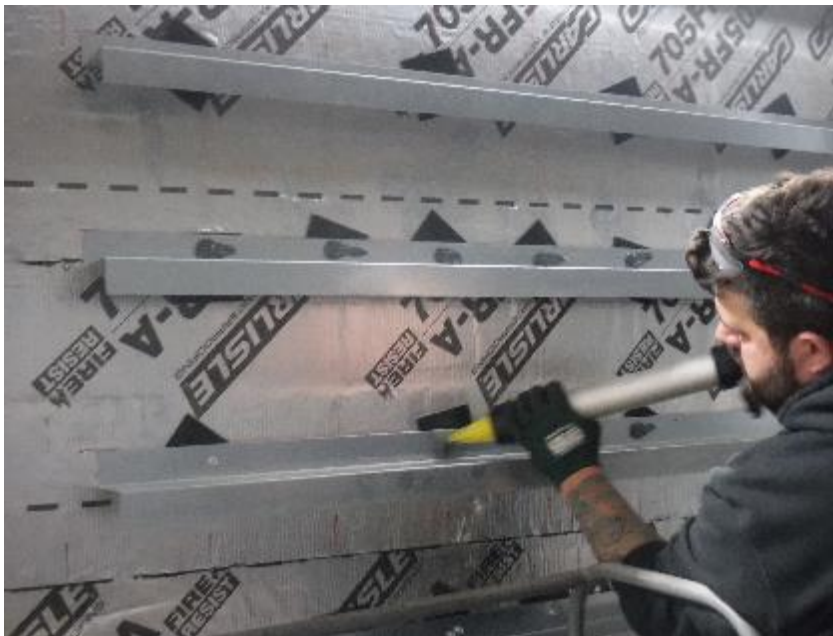
Photograph No. 6

Z-Girt Installation

Sealant being applied over all fasteners

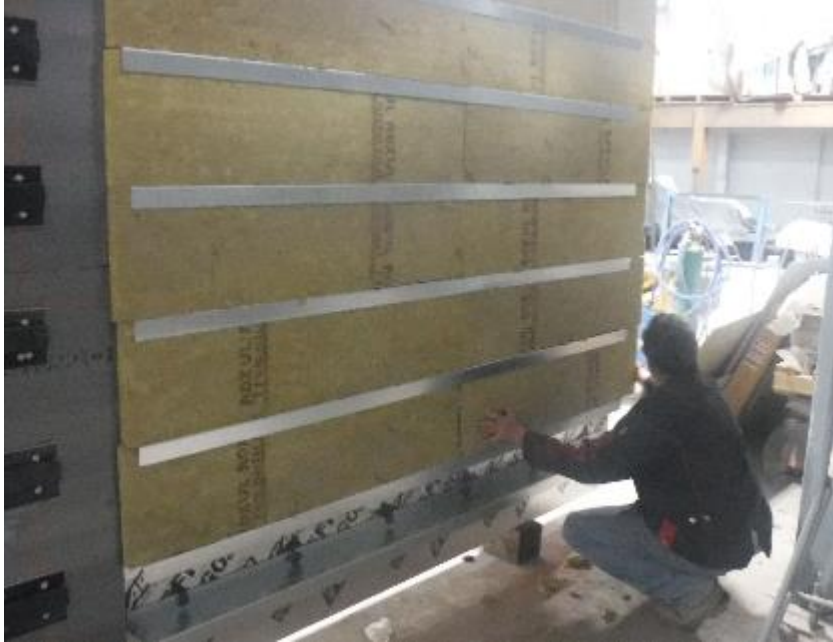
Photograph No. 7

Z-Girt Installation

4" mineral fiber
insulation installed to z-
girts

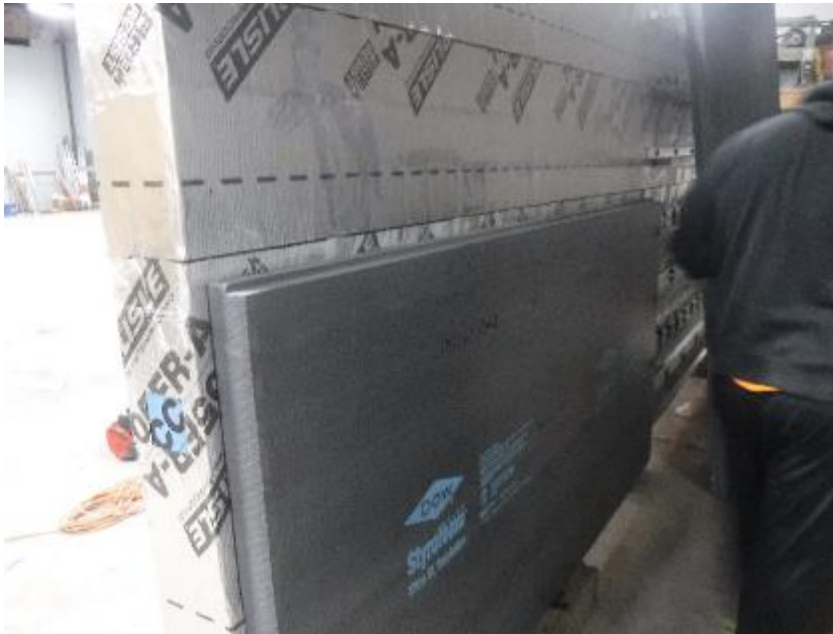
Photograph No. 8

Knight Wall Installation

3" rigid Dow insulation
placement for Knight
Wall System

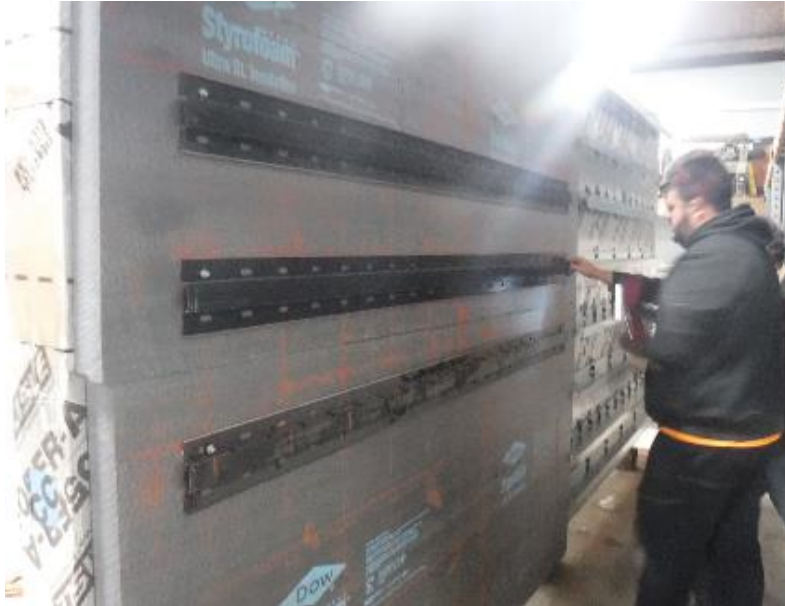
Photograph No. 9
Knight Wall Installation
HCl-GIRTs being installed

- 18 gauge Horizontal HCI-GIRT vertically spaced 12" O.C., Top HCI GIRT spaced 16" O.C.
- Every other HCI-GIRT fastened with 2 fasteners, 8" O.C. Other HCI-Girt fastened with 2 fasteners, 16" O.C. Self-tapping fasteners installed with ThermaStop thermal insulating washer.
- 3" Dow Styrofoam Ultra SL Insulation

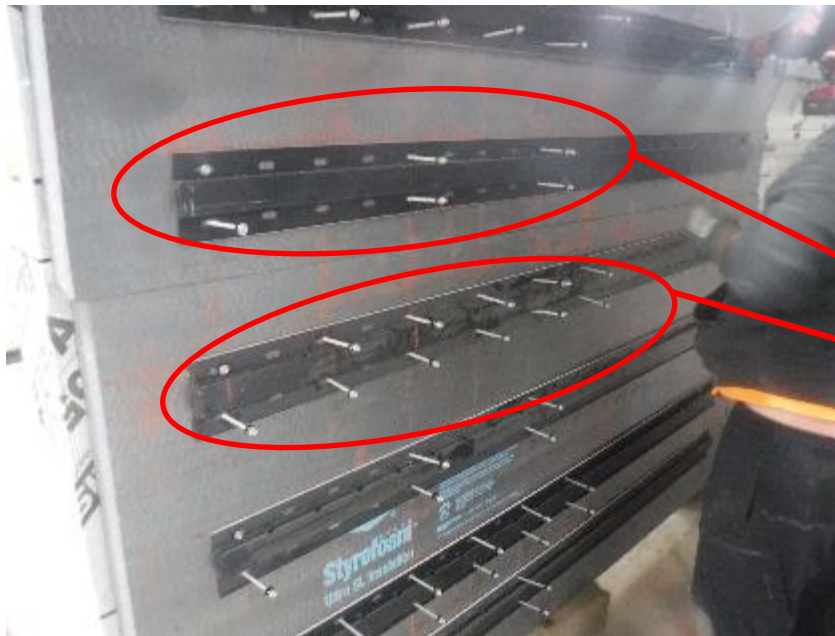
Photograph No. 10
Knight Wall Installation
Fastener placement.
16" O.C.
8" O.C

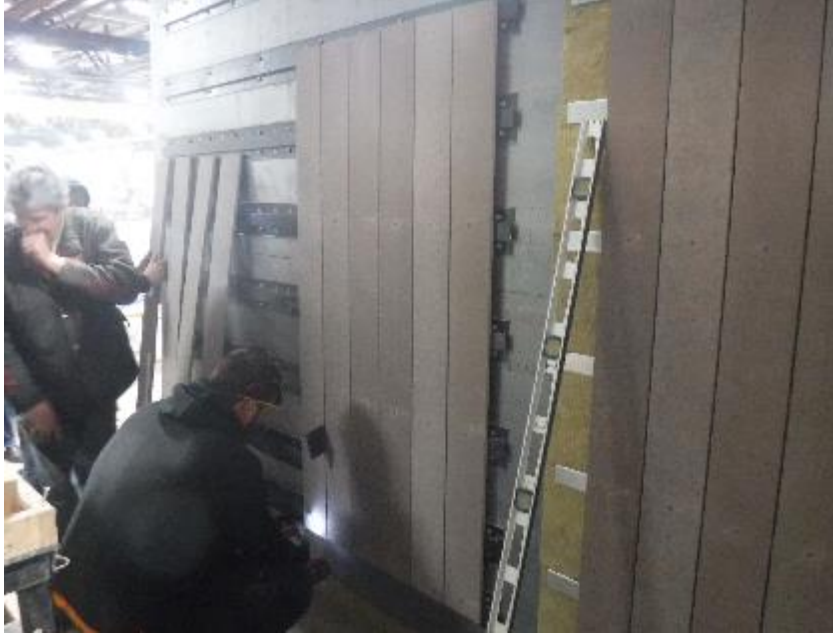
Photograph No. 11

Cladding installed to both Z-Girt and Knight Wall System

- Rieder Oko Skin 5.79" x 70.87" x 1/2" with 1/8" space between boards. Cladding installed vertically.
- 14 total boards installed on each system.
- Exterior cladding only fastened to girts where fastener spacing is 16" O.C.

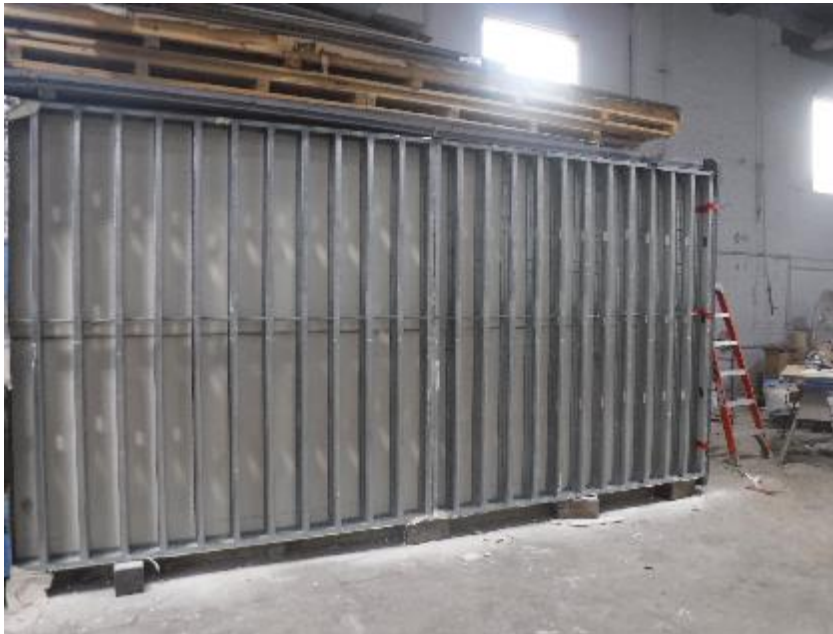
Photograph No. 12

Densglass removed from back (interior) side of mockup wall to expose studs and inboard side of sheathing.

- After completion of the air infiltration measurement, the interior side of the mockup wall assembly was removed and the studs and inboard side of the sheathing exposed.

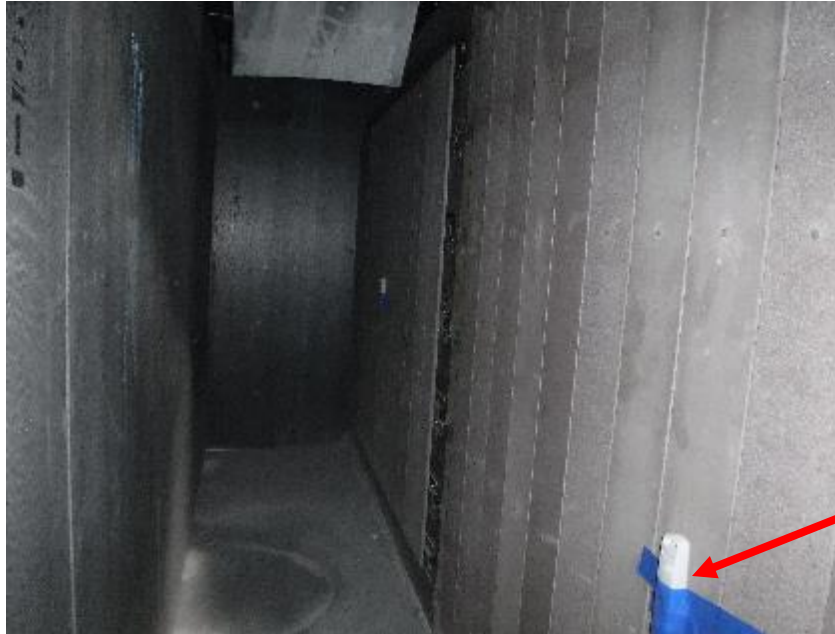
Photograph No. 13

Interior of thermal chamber

Mockup wall to right of photo

Remote thermometer

- On the exterior side of the wall, an enclosure was constructed of DOW Styrofoam insulation panels to form a thermal chamber. The Styrofoam panels were secured to the top and ends of the mockup assembly and an insulated panel was placed on the concrete floor at the base of the wall. The thermal chamber had a depth of approximately three feet off the face of the mockup wall.

- Remote thermal sensors were placed on the face of the cladding (approximately 4' off the floor) in the middle of each of the two wall systems.
- Liquid Nitrogen was introduced through the top of the thermal chamber at the mid-point between the two systems being evaluated.

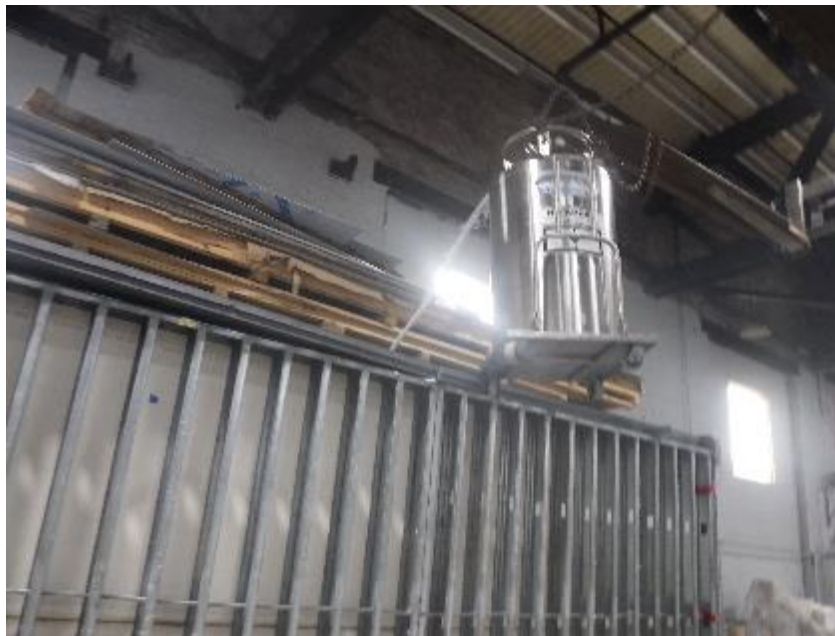
Photograph No. 14

Liquid Nitrogen Tank
above thermal chamber

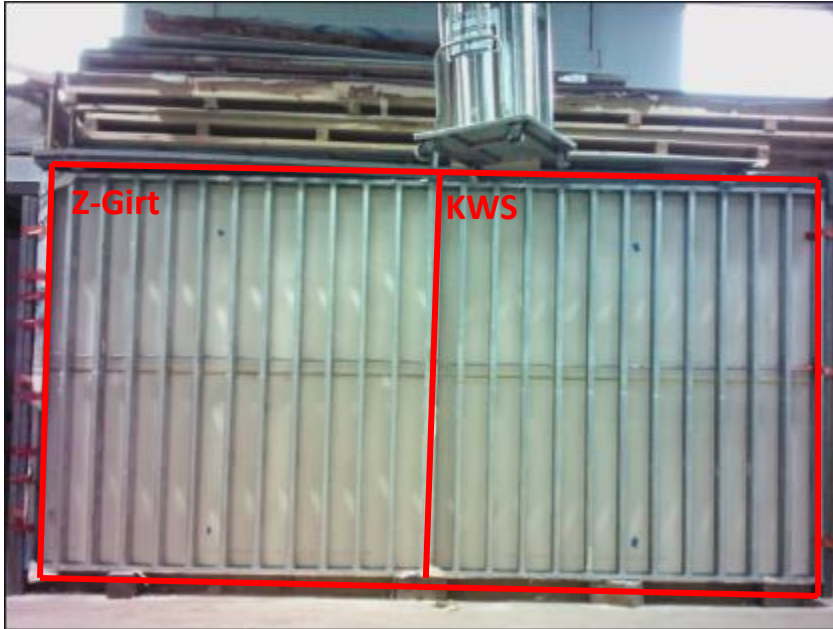
Photograph No. 15

Mockup wall. Z-Girt system on left. Knight Wall System (KWS) on right

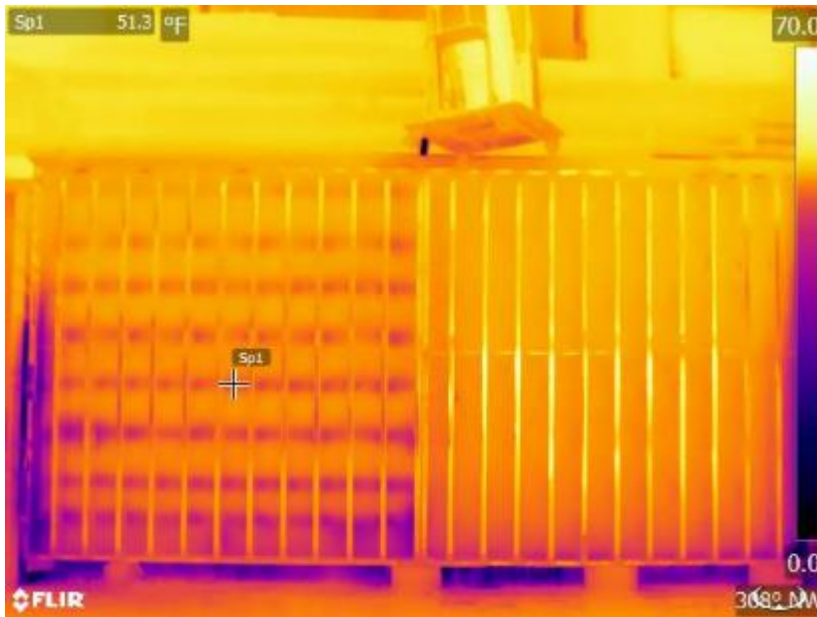
Photograph No. 18

Approximately 1 hour into test, thermal imaging began to clearly indicate location of thermal isolation pads used on the Z-Girt system.

Cold transfer began to appear on the Z-Girt half of the mockup wall approximately 30 minutes into the thermal test. The infrared images revealed horizontal lines at the locations of the z-girts. As the testing progressed the images became more defined and the outline of the 1/8" plastic pads used as thermal isolators became apparent. Although the spacers set the z-girts a 1/8" off the face of the wall, the transfer of cold through the DensGlass was clearly visible.

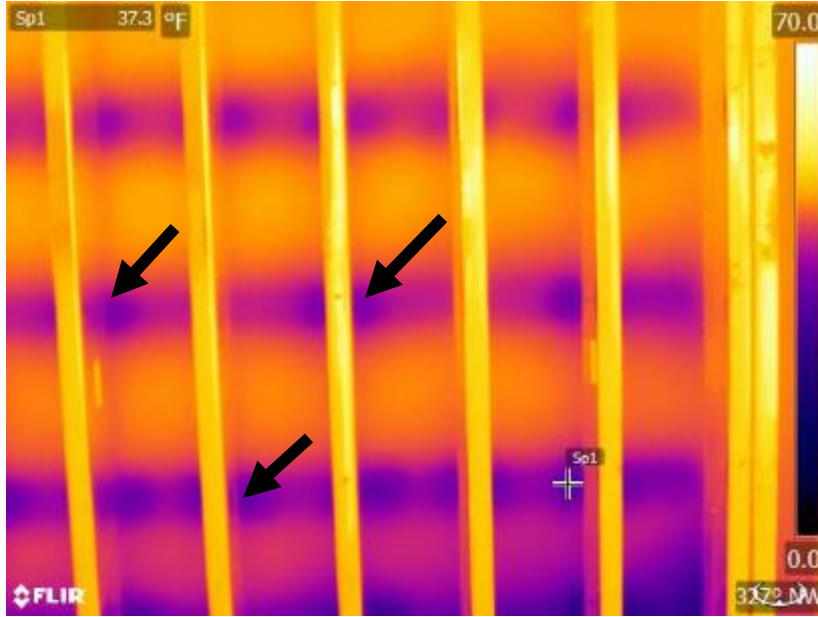
Photograph No. 21

Close up of Z-Girt section of mockup wall.

Darker locations along the horizontal lines are the location of the thermal spacer. This was verified by the screw penetrations at these locations.

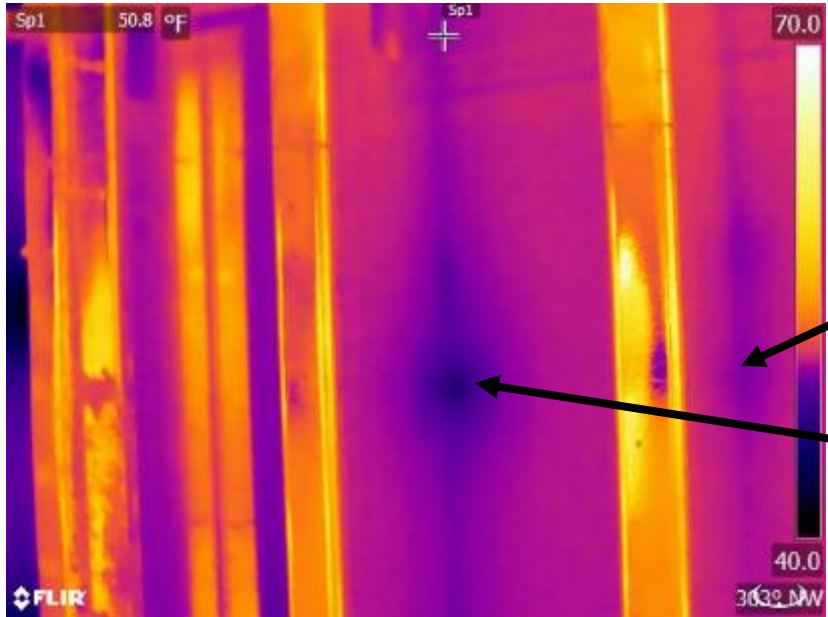
Photograph No. 23

Knight Wall system. Thermal transfer was considerably less noticeable on the Knight Wall half of the mockup. Cool areas were observed at fastener locations at the stud

Missed screw

Bright yellow areas along edge of studs is reflection of heat sources in room such as people.

The thermal images on the Knight Wall half of the mockup were considerably less dramatic and the thermal image appeared relatively uniform when viewing the entire wall at once. In close up views, cooler areas were observed along the edges of the studs at the screw penetration locations. The cooler locations along the studs began to appear approximately an hour and a half into the test. The most pronounced cool spots on the Knight Wall half were at the two screw "misses" (double screws).
