Report on Engineering Geological Investigation:
Test pit logs in KwaMhlanga for RDP houses development.

2012

Location: Mpumalanga (KwaMhlanga)

University of Pretoria

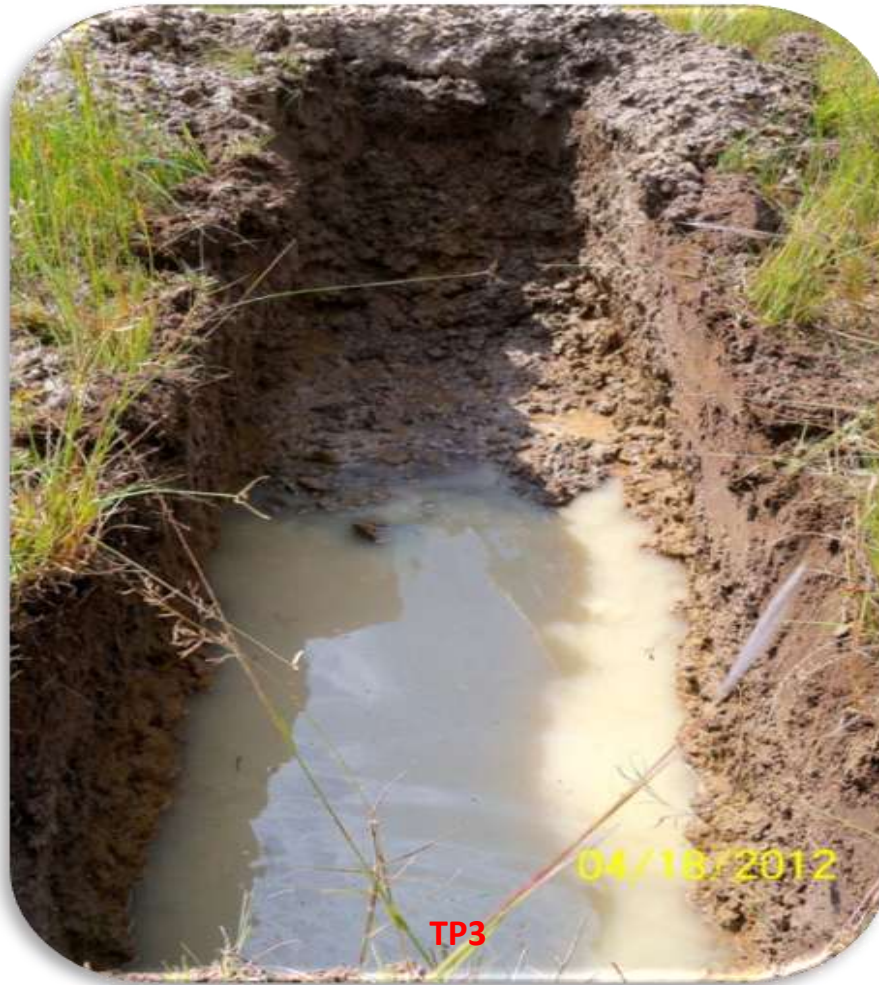
Figure 3: Hydrogeological conditions illustration on a third test pit profile.

The investigation site was characterised by perched waters, wetland delineations and dense green vegetation cover. Figure 2 clearly illustrates areas covered by vegetation and most of these areas consist of perched waters. Area characterised by wetland delineation is marked by a red bordered area in figure 2. Nine test pits contained perched waters at depth less than 2.5 m below the surface and other part of the site was covered with water at the surface. There is a stream that runs across the site and south western part of the site is dry with dense soils. The figure below is a profile of a third pit which was 0.95m deep from the surface. Immediately after excavating 0.4m, sidewalls started to collapse with increase in moisture and at depth of

0.5m we intersected groundwater seepage. At depth between 0.5-0.95m, there was abundance of pebbles and cobbles with very wet soils and increased seepage. Description of hydrogeological conditions of all test pits is given in the APPENDIX C.

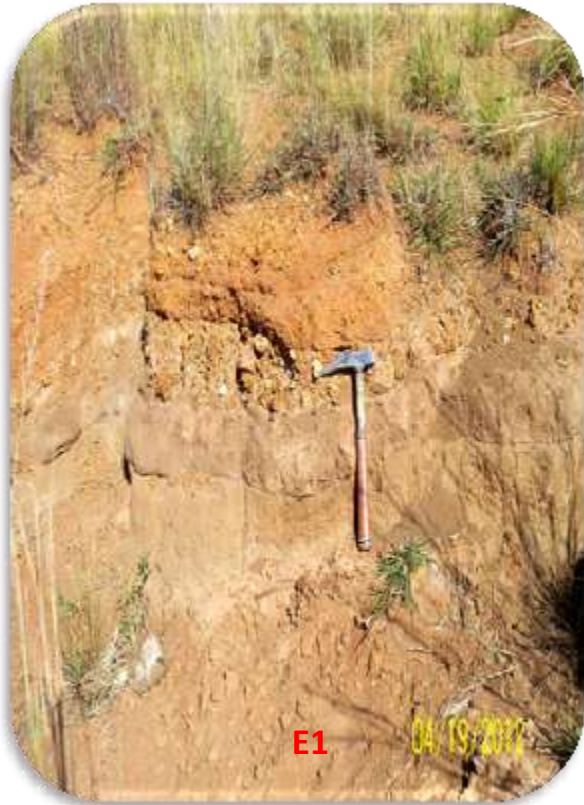
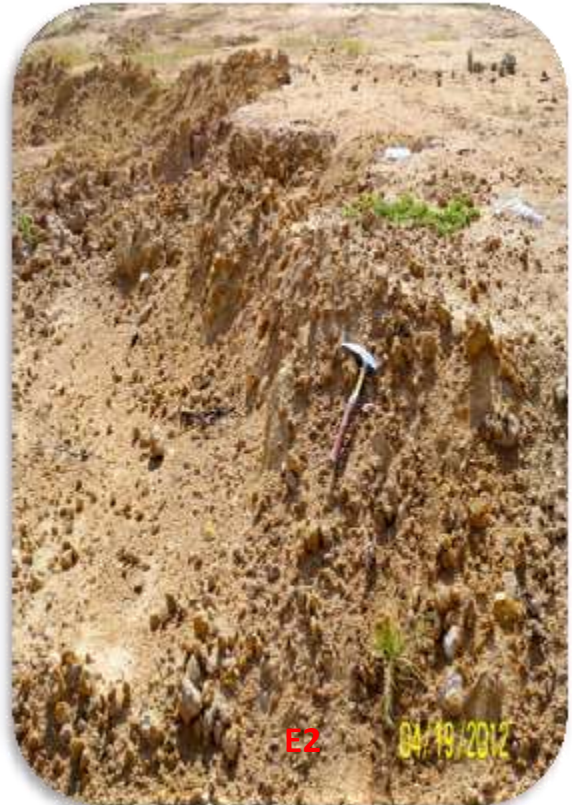
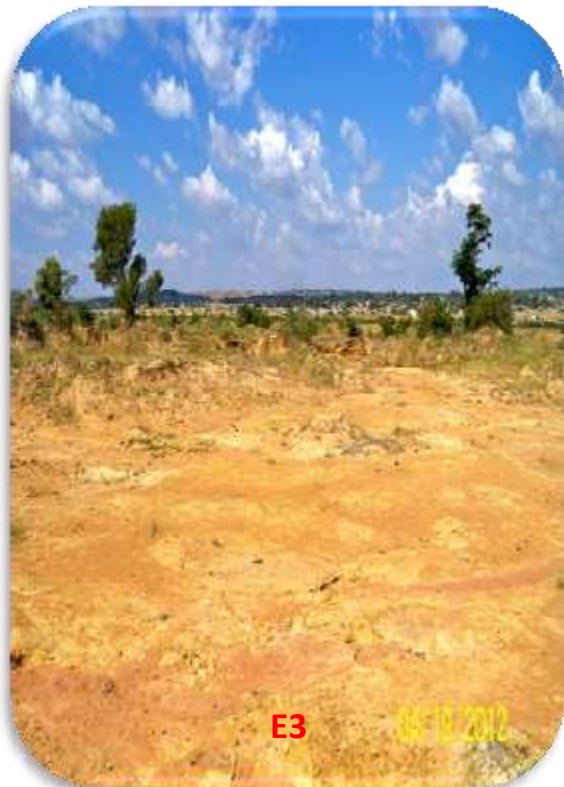
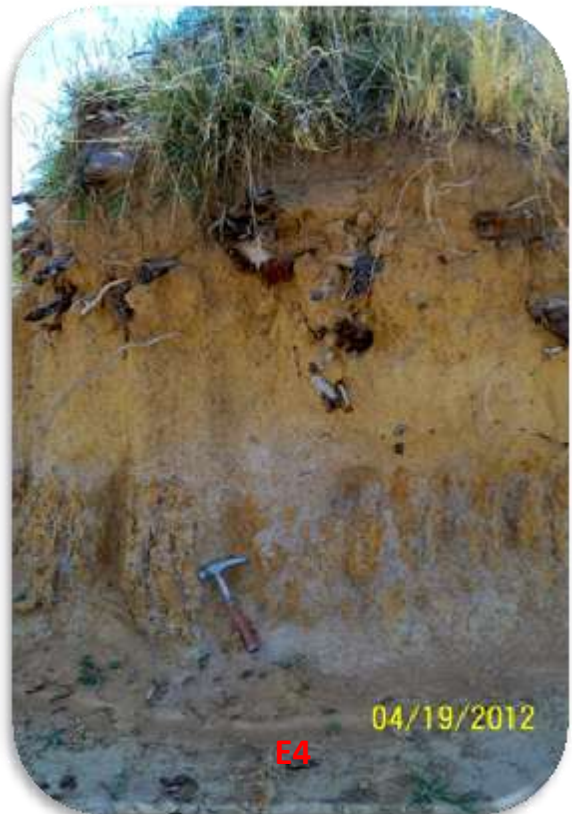
Appendix A. Photographic exposure of the area and soil features

Majority of soil type across the whole area of study is silty sands with minority of clay. The soil type is commonly characterised by light brown-red to orange and grey colours, with loose topsoil comprising of abundant grass and plant roots extending to a depth of about 30cm in average. The silty sand grains are approximately 2mm in diameter and the predominating sand grains are quartz grains in most cases.

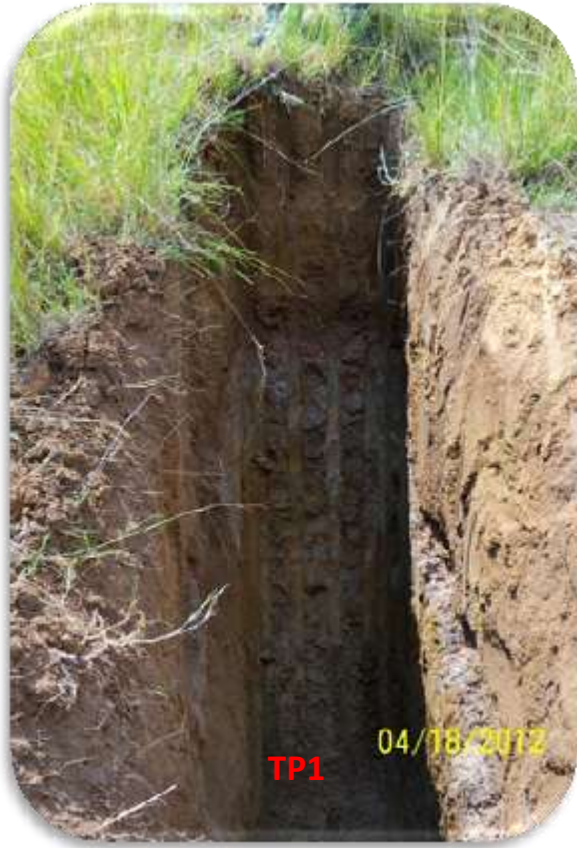
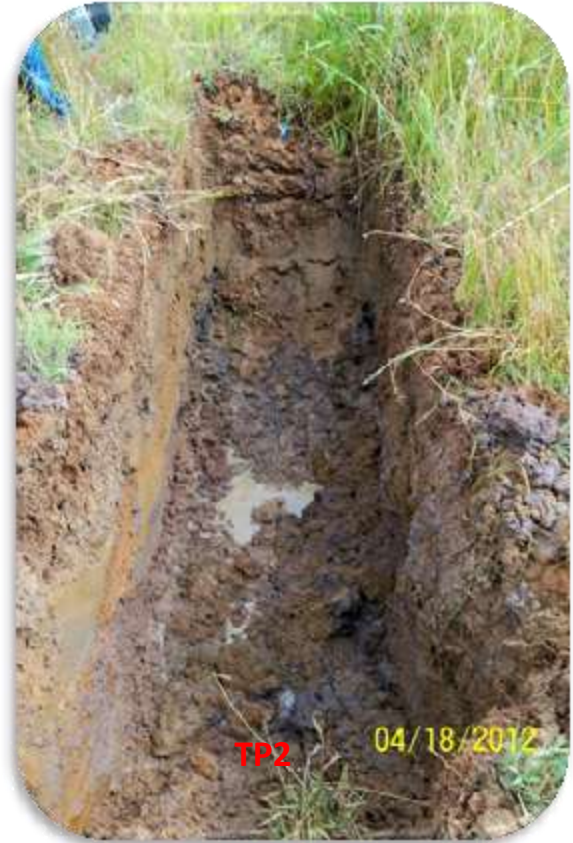
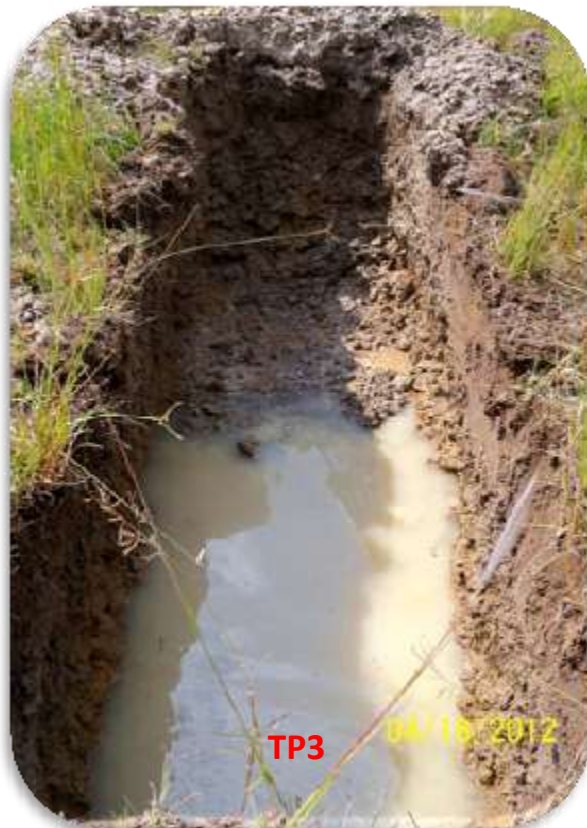
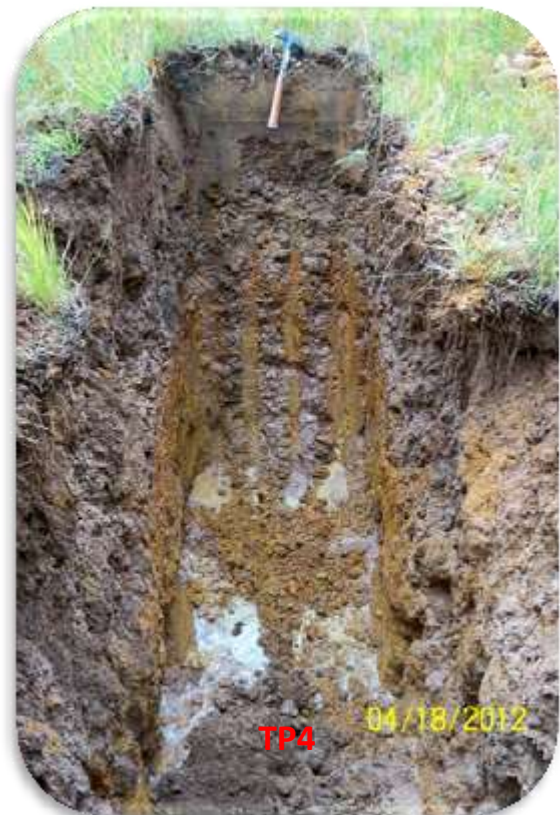
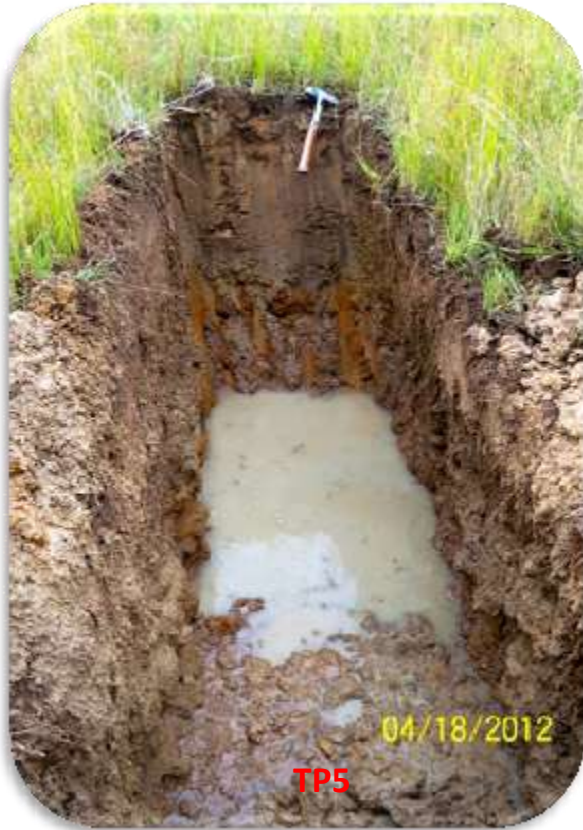
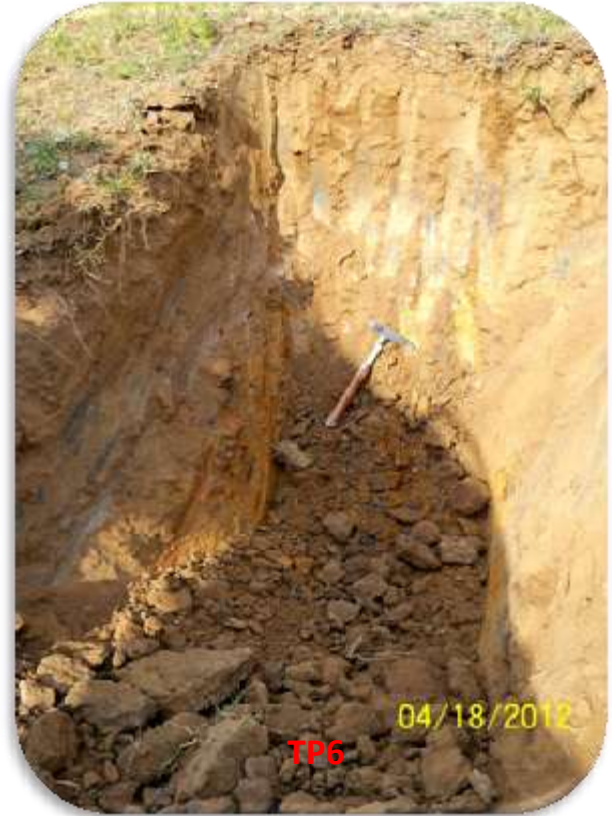
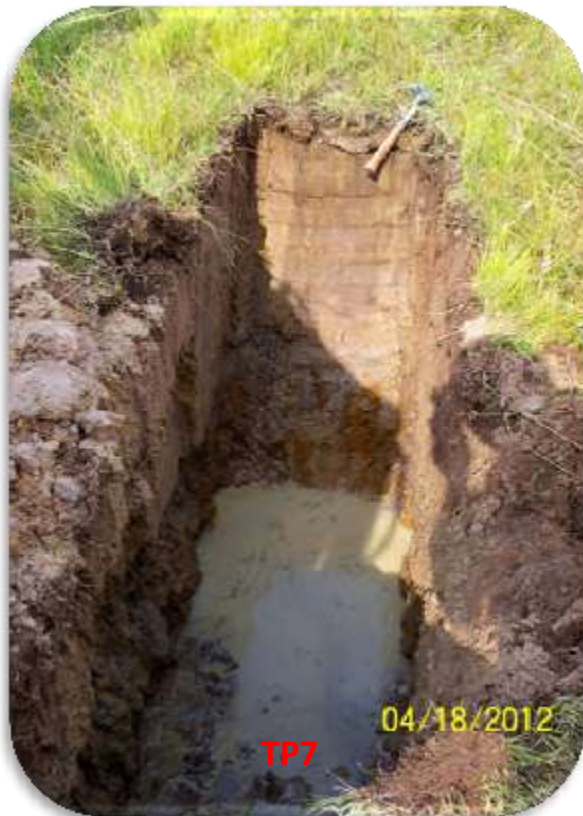
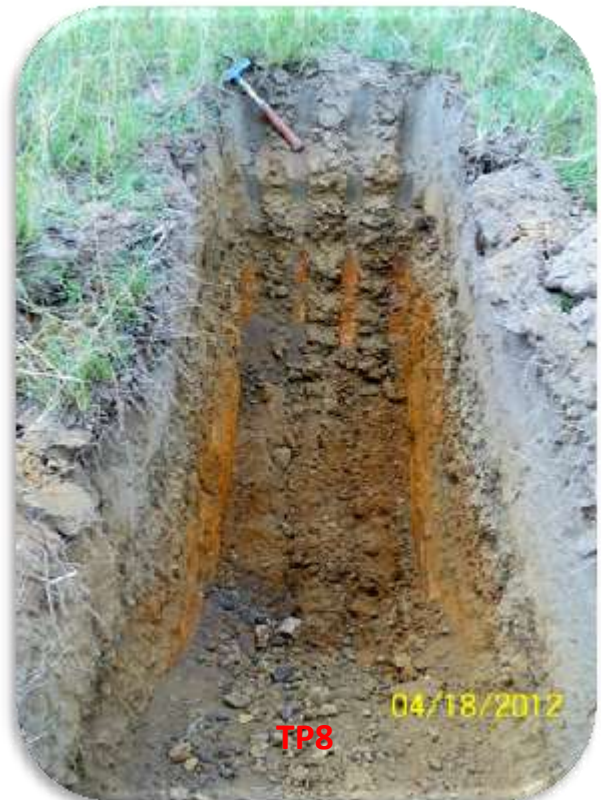
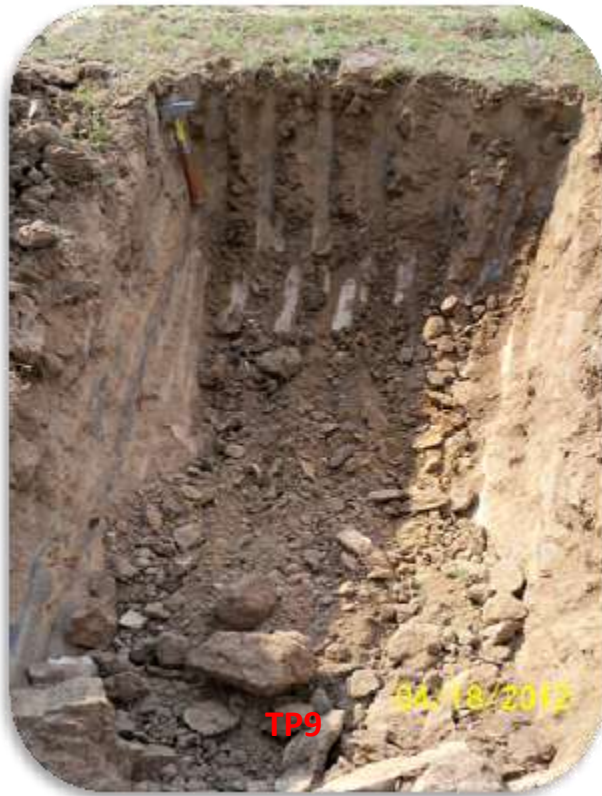
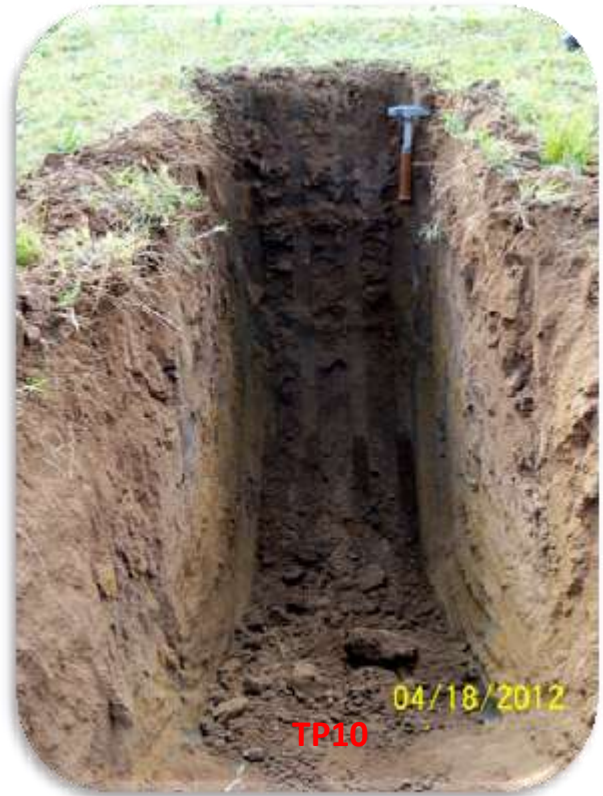
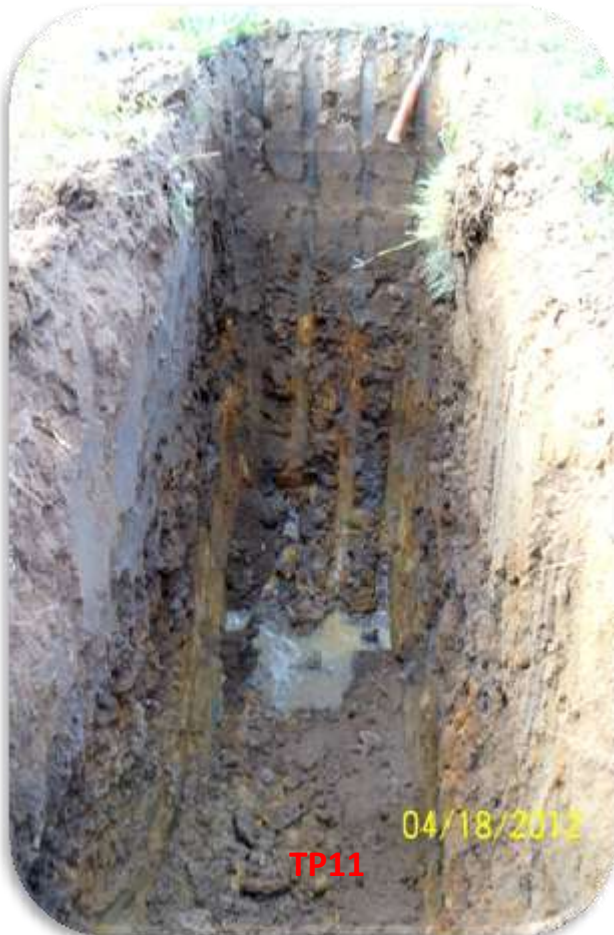
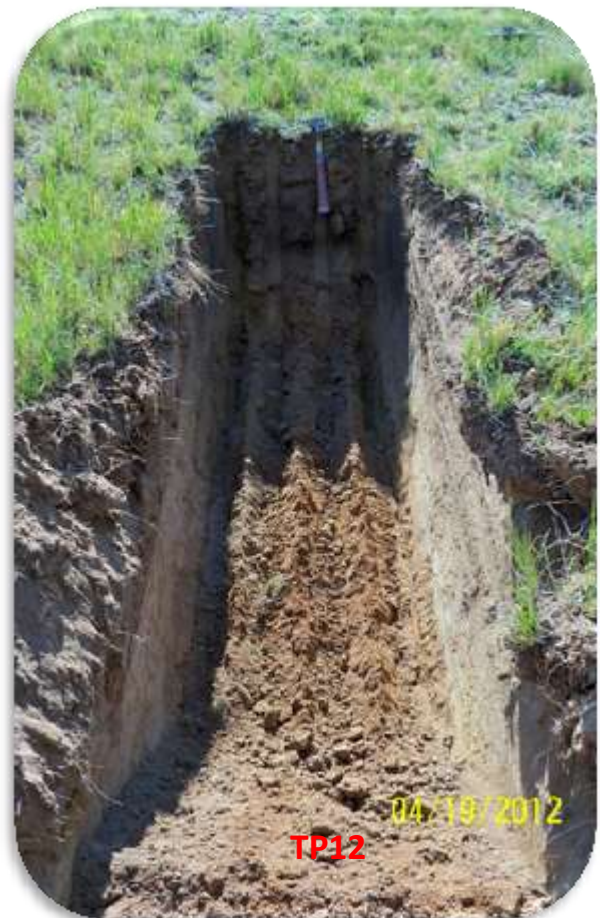
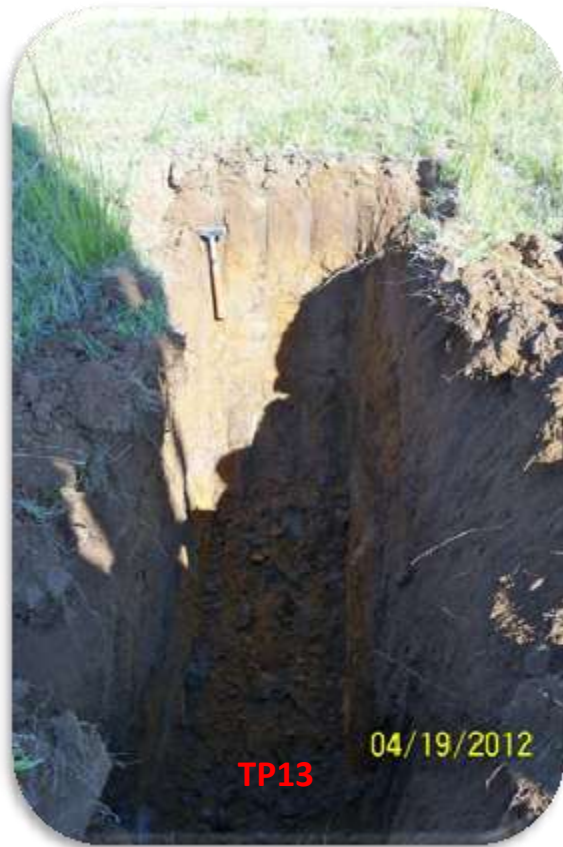
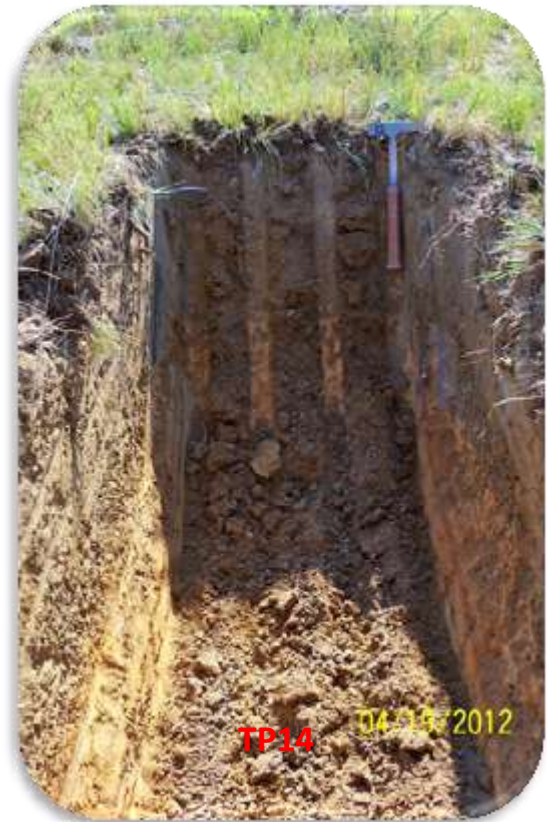
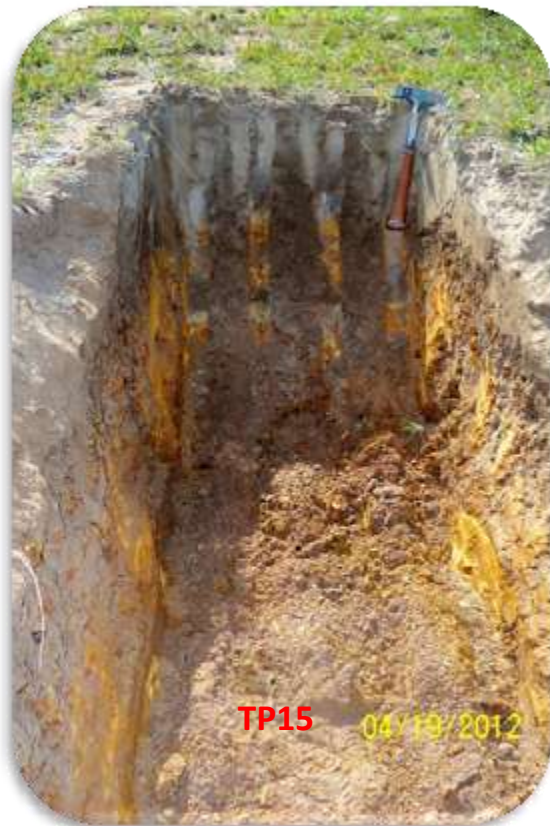
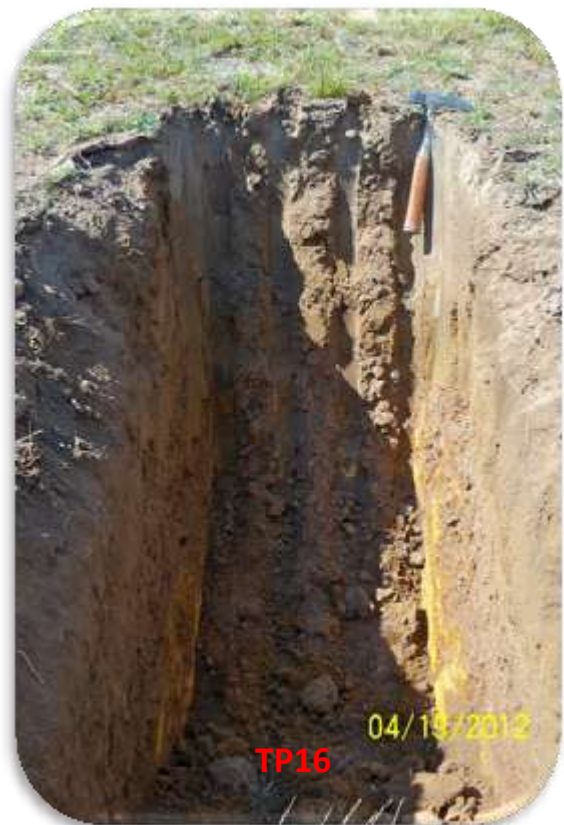
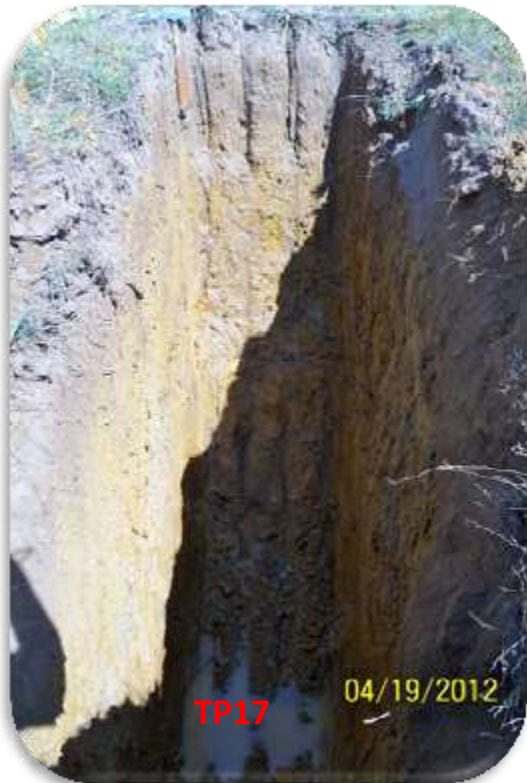
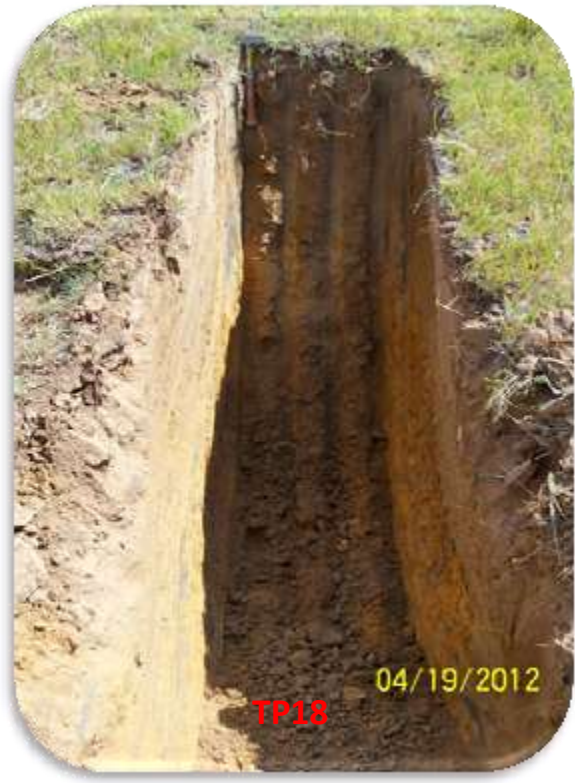
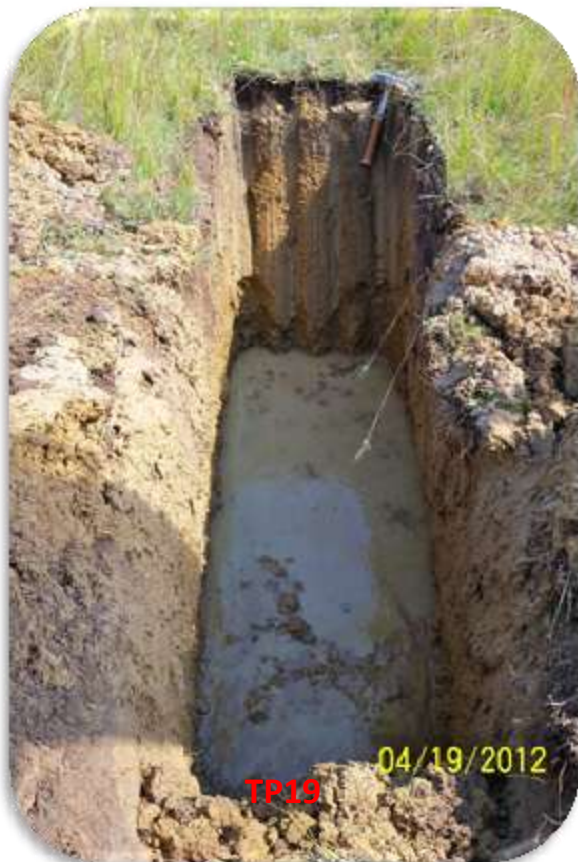
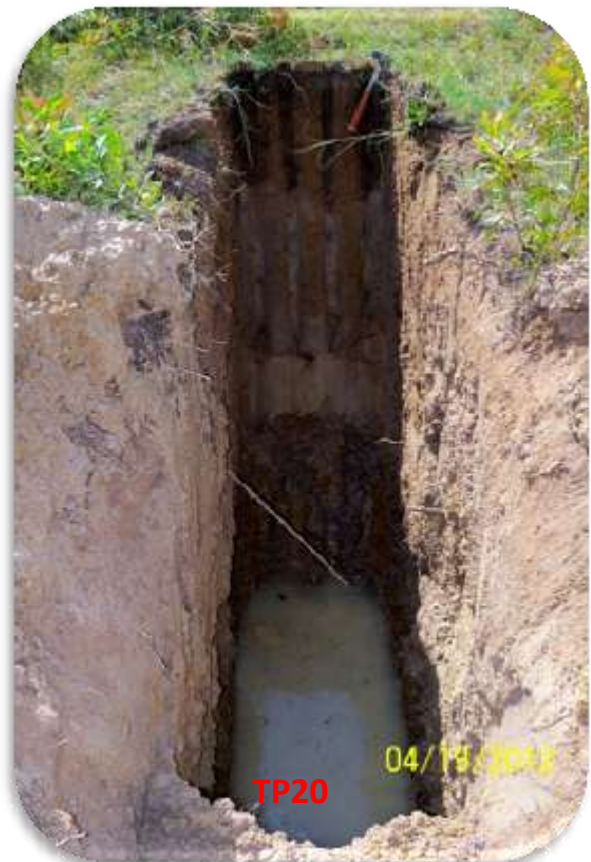
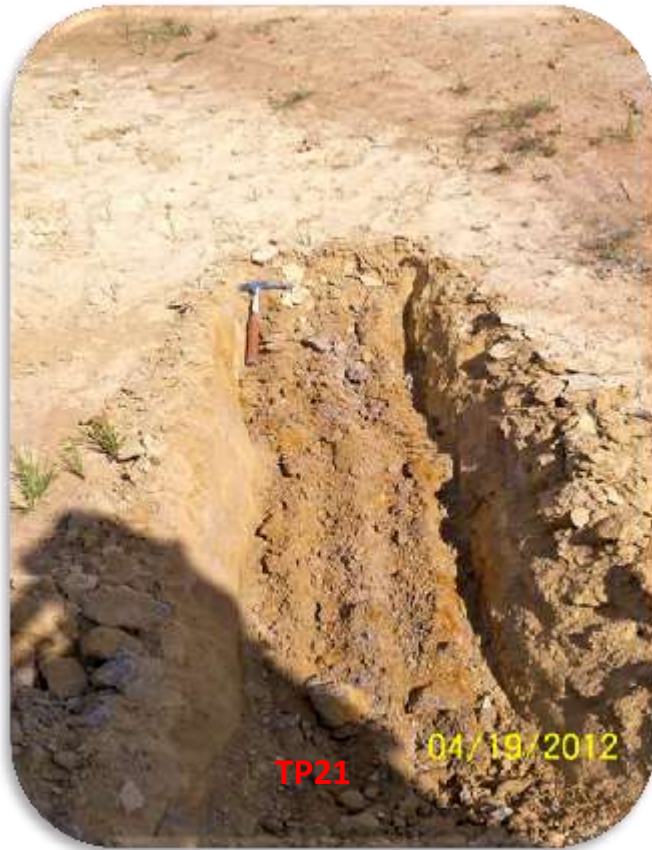
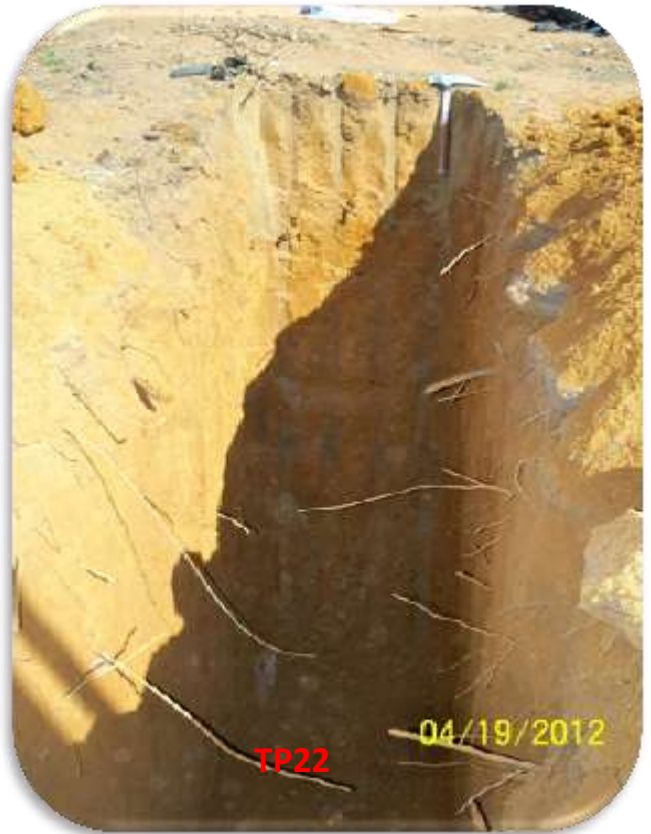
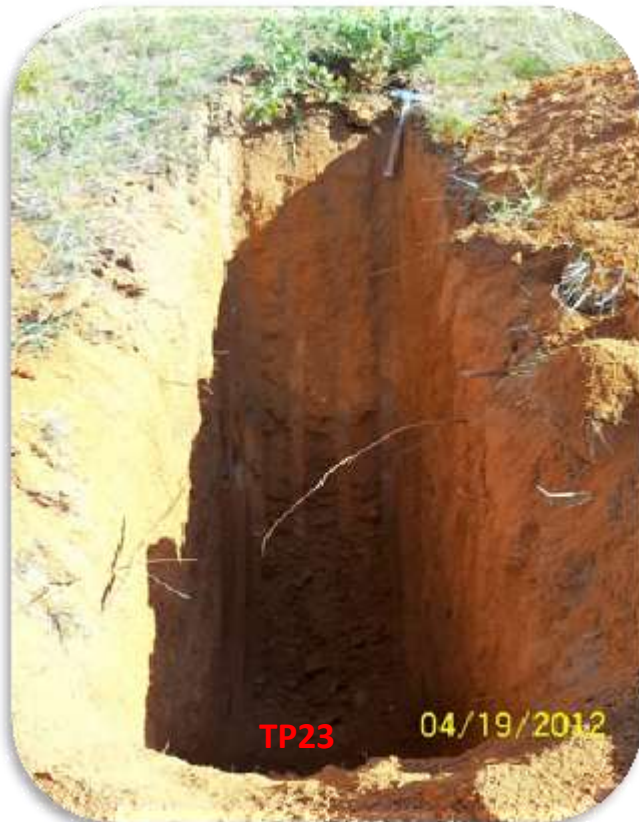
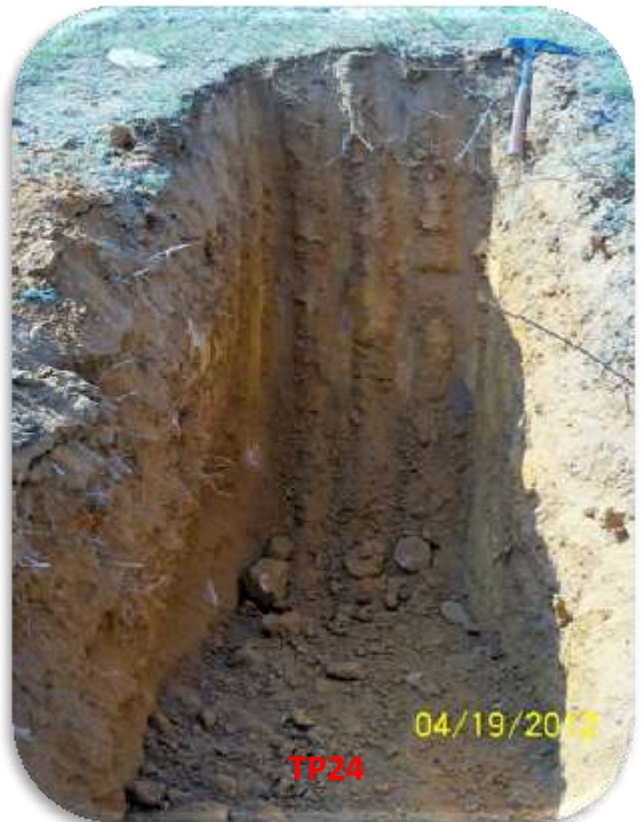
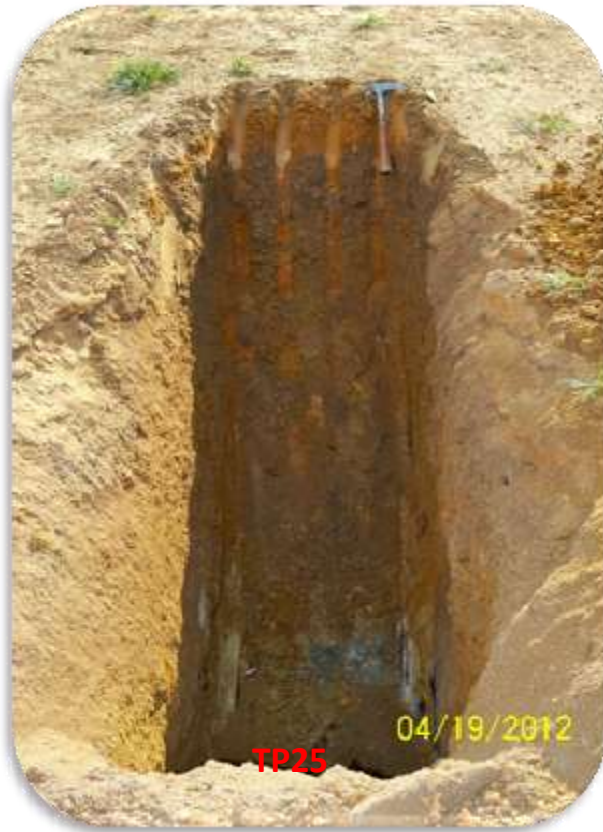
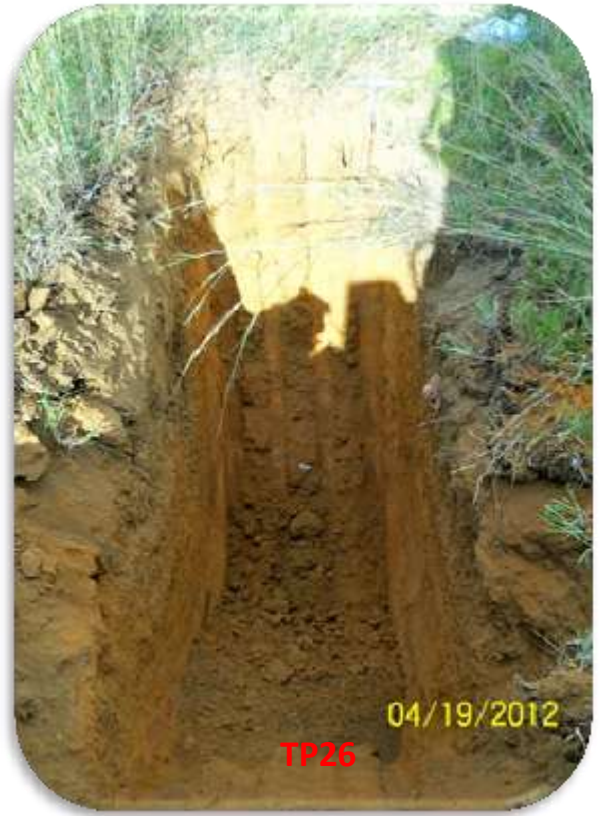
Appendix B. Photographic soil profiles of all test pits

Number of Test pits	GPS coordinates	Depth (m)	MSSCCO profile description	Notes
TP1	25°22'55.91"S 028°42'41.93"E	0.00-0.30	Slightly moist, light red, loose, shattered, silty fine sand, Topsoil with abundant roots.	5 Final depth at 2.60m. Refusal on Granite Bedrock. 6 Groundwater seepage at 1.00m.
