Report to the University of Hawaii at Manoa on the Hydrogen/Oxygen Explosion of March 16, 2016

Report 1: Technical Analysis of Accident

Prepared by the UC Center for Laboratory Safety, June 29, 2016

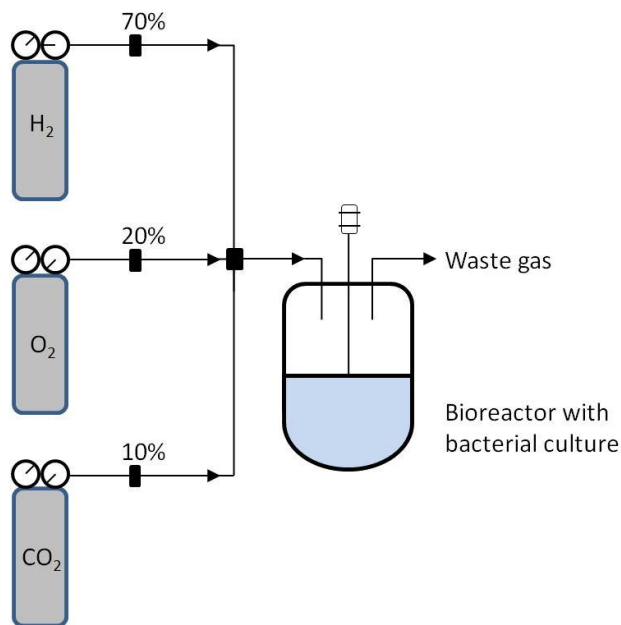
Figure 1: Generic process diagram of gas connections to an open gas system bioreactor in the UH lab showing typical gas percentages.

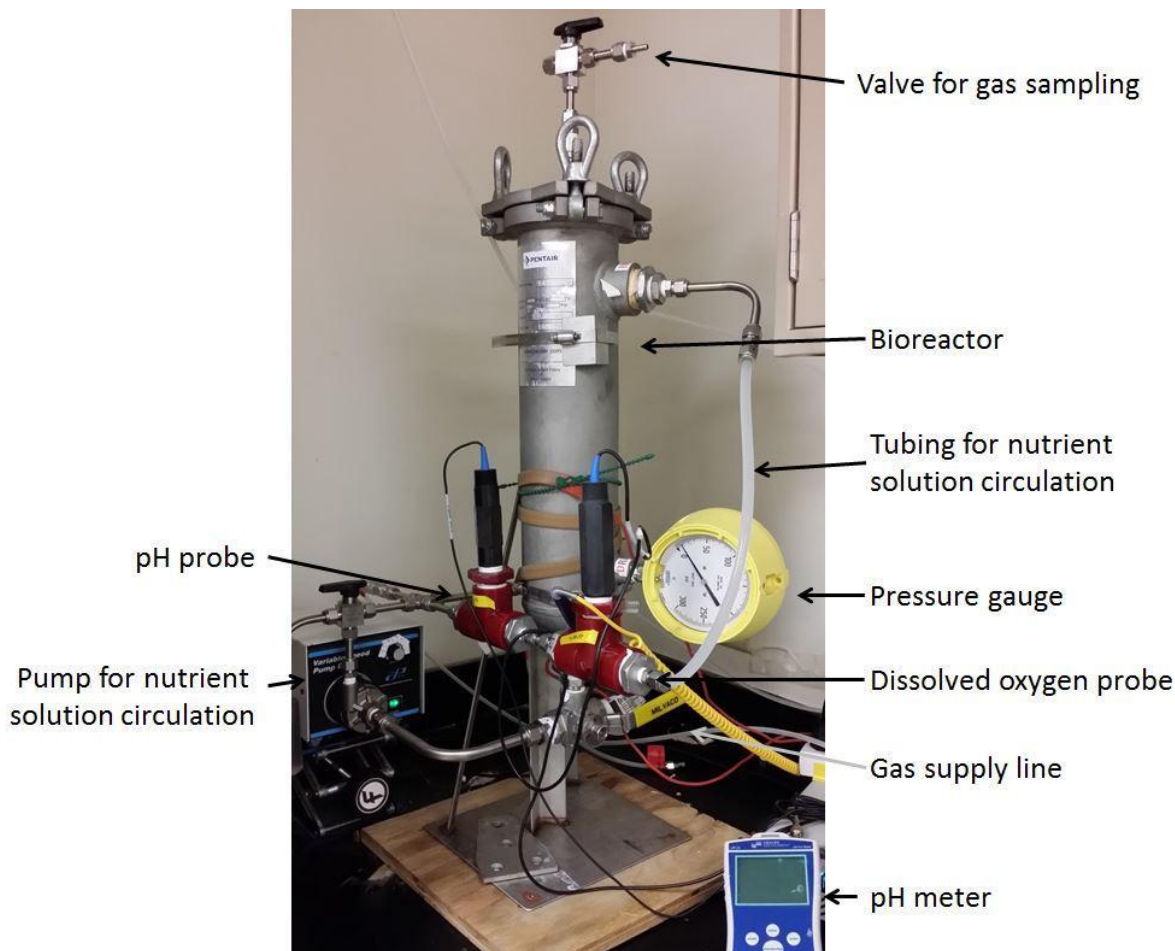
Figure 2: Bioreactor used for pressurized closed system bacterial cell culture. The gas supply line connects in the rear of the bioreactor (not visible) and transports gases from the storage tank. A gas mass flow meter installed between the tank and the bioreactor controls the gas flow rate (not shown).

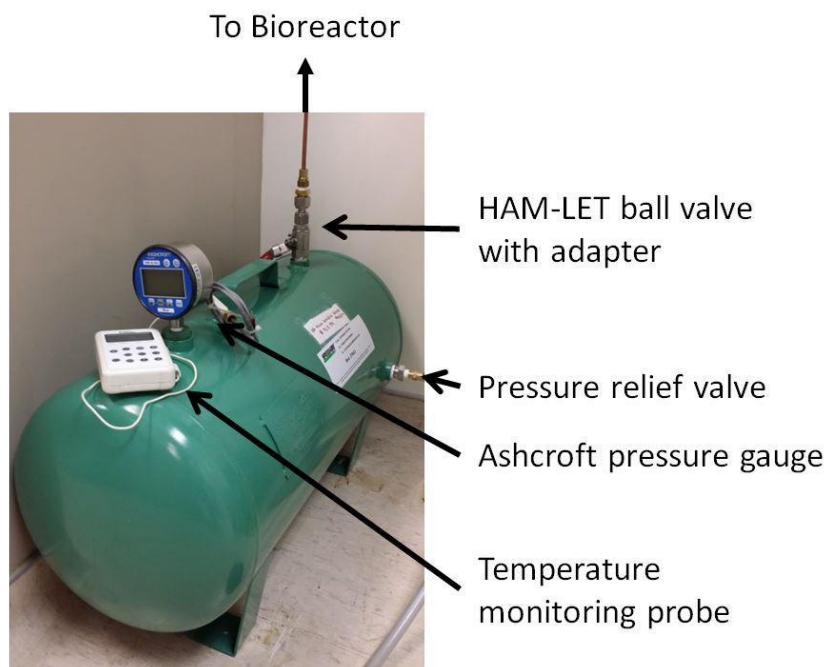
Figure 3: The 13 gallon (50 liter) gas storage tank is shown when connected to the bioreactor. In this image the HAM-LET stainless steel (SS) ball valve is plumbed with copper tubing for gas flow to a gas mass flow controller (not shown). The same ball valve was also used to fill gases into the tank and to remove gas samples for analysis using PE tubing. The red handle attached to the valve (barely visible) moves the valve between the open and closed position, but was blocked from being fully open due to contacting the tank. The pressure relief valve served to release accidental overpressure. The Ashcroft pressure gauge was used to measure the tank's pressure when preparing gas mixture and to follow gas consumption during experimental runs. Wires extending from the back of the gauge could be connected to continuously transmit pressure data, however, they were never used. Tank temperature was initially monitored with a temperature reader; the device was found stored in a drawer by the Investigative Team.

equipped with an Ashcroft digital pressure gauge¹⁸ rated for 300 psig, a ¼" stainless steel ball valve¹⁹ for admitting gas in and out, an air safety pressure relief valve, and a drain plug at the bottom of the tank (not visible in Figure 3). The gas tank was ASME certified²⁰ with a use pressure of 140 psig and a Maximum Allowable Working Pressure (MAWP) of 168 psig. A 165 psig pressure relief valve was installed by the manufacturer as ASME requires the relief valve to be at or less than the MAWP. Teflon tape²¹ at the gauge and ball valve NPT threads were added by the researchers as a metal lubricant.²²

- Speedaire operating instructions provide safety guidelines stating that the tank is “designed and intended to be used for dry air only.” They also state “Do not use this tank to store or disperse liquids or flammable gases.” and “Failure to comply with these guidelines could result in personal injury and/or property damage due to air tank failure.” This is an inexpensive tank for a homeowner or industrial user to store compressed air.

- The Ashcroft digital pressure gauge was not designed nor certified to be intrinsically safe⁴⁰ Intrinsically safe devices are systems that have been tested at a 3rd party laboratory and proven to be safe for use in a flammable environment by limiting the energy, electrical and thermal, that could cause an ignition.

- The HAM-LET stainless steel ball valve served as crude control device to add gas from the gas cylinders to the air tank. It also served to withdraw a sample of the explosive gas mixture for Gas Chromatography (GC) analysis. A partially opened stainless steel ball valve can ignite the explosive gas mixture due to flow friction caused by high velocity flow.

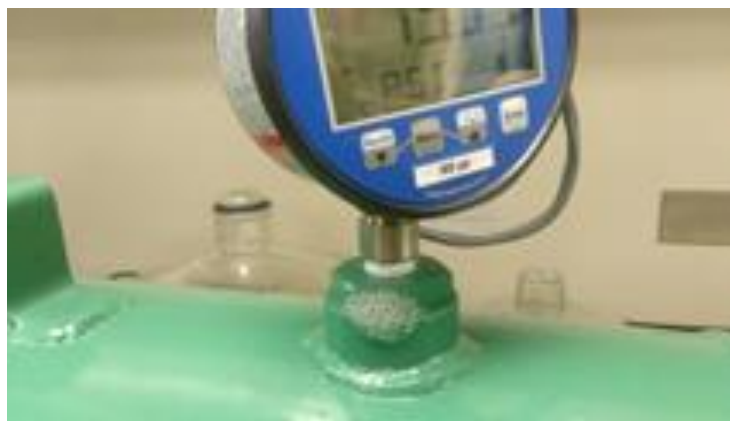
Figure 4: An air leak test done by the postdoctoral researcher using a soap solution indicated air leaks at the gauge and outlet valve reducing bushings (not shown).

After assembling the tank, the postdoctoral researcher tested the tank for leaks in December 2015 by pressurizing it with the building's air supply. She noticed a leak at the gauge reducing bushing (Figure 4) and later also at the drain valve reducing bushing. Both are straight threaded connections that are sealed

with a O ring. She contacted the science instrument technician at the School of Ocean and Earth Science and Technology who replaced badly cracked and compressed O-rings at both bushings that were installed by the tank fabricator. When working on the drain plug the technician noticed rust falling out of the tank. Rust was also observed by the Investigative Team when remnants of the tank were examined (Figure 5). The rust was likely a result of water used for the hydrostatic testing of the tank. During his interview, the technician specifically commented that he assumed the tank would only be used for air and had he been told that it would be used for hydrogen gas, he would not have worked on the tank. He was aware of special requirements for hydrogen gas tanks.

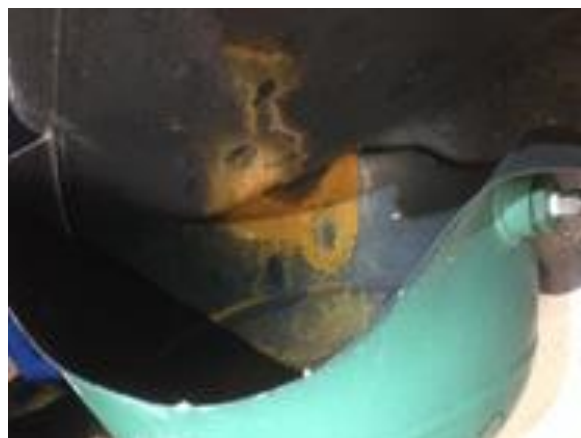
Figure 5: Rust inside the damaged gas storage tank as observed by the Investigative Team.

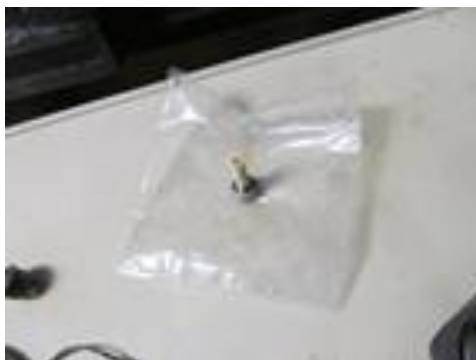
Figure 6: Gas sampling bag found in the UH laboratory with polyethylene tubing attached.

- Sampling of the tank mixture at pressures of 90 psig and higher using a ball valve and a thin fluorinated ethylene propylene (FEP) 500 mL sampling bag is not a safe practice. The bag pressure could easily have exceeded the burst pressure of <20 psig. A needle valve would be a safer valve to control the flow of a gas sample. In addition, the sample bag was friction fitted over a plastic tube stub rather than attached by a threaded connection and could have easily been dislodged during filling.
- However, any type of valve could cause flow friction and be a point of ignition for an explosive gas mixture and the sampling bag could generate an electro static discharge that could have also ignited the explosive gas mixture. Thus, standard practices with nonreactive gases are not directly transferable to explosive gases.

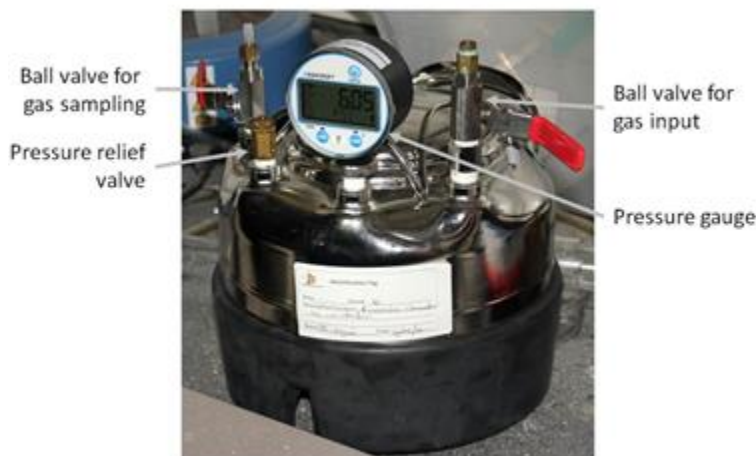
Figure 7: Pressure vessel (1 gallon). The pressure vessel as shown here was equipped with an Ashcroft pressure gauge, a pressure relief valve and two ball valves. When found, the pressure gauge showed an unusually high pressure of 60.5 psig.

The day before the devastating accident, the postdoctoral researcher reported a “cracking” sound inside the vessel after she had pushed the On/Off button on the Ashcroft pressure gauge³⁵. She had already pressurized the vessel with the specified gas mixture and was about to place it into the incubator oven. Following the noise, the postdoctoral researcher noticed an immediate drop in pressure as hydrogen and oxygen had probably reacted to form water vapor that condensed³⁶. She opened the vessel and noticed a burning smell. The petri dishes were cracked and discolored³⁷. The gas mixture in the incubator may not have been well mixed. As a result a deflagrating reaction occurred that did not transition to a detonation that would have ruptured the incubator.

The postdoctoral researcher was clearly alarmed as she reported the incident to her PI and also to another postdoctoral researcher in the lab³⁸. The PI advised her not to use the vessel again³⁹, however, the Investigative Team found the pressure vessel inside the 30°C incubator oven during their investigation of the UH laboratory. The vessel was pressurized to 60.5 psig and contained bacterial cultures. It was equipped with an Ashcroft pressure gauge, which was sent out for forensic examination. Based on the gauge’s manufacturing date (January 2016), the gauge was the same as the one used during the near miss event.

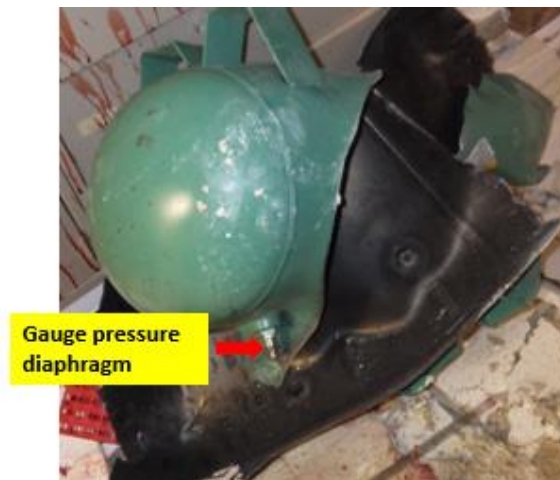
The tank was violently ripped apart just beyond the pressure gauge which was the origin of the ignition source based on the way the tank ruptured. The reaction propagated horizontally down the tank blowing out the opposite end cap. Figure 9 shows the tank as found by HFD.

Figure 9: Large section of gas storage tank on floor to the left of the Biosafety Cabinet as found by HFD.

A large section of the tank was violently rolled outward as it tore open. Metal tearing is common to a pressure vessel rupture due to sudden overpressures caused by a deflagrating reaction. The vessel stretches to the elastic limit and ruptures at a point. The escaping gas and the reaction will cause the metal to tear away from the failure point. This tearing is evident in the sharp edges created where the tank came apart. It was propelled upward into the refrigerator and freezer doors (Figures 10 and 11) and then bounced upward, impacting the top panel of the biosafety cabinet. It finally came to a rest on the floor to the left of the biosafety cabinet.

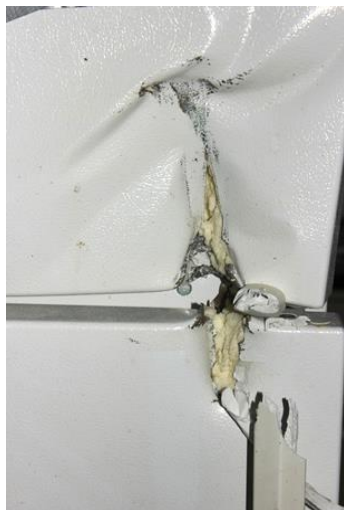
Figure 10: Damage to a -20°C refrigerator and freezer doors in the POST 30 laboratory. The doors show severe impact damage by the gas storage tank piece shown below. The paint residue on the doors match the tank's paint.

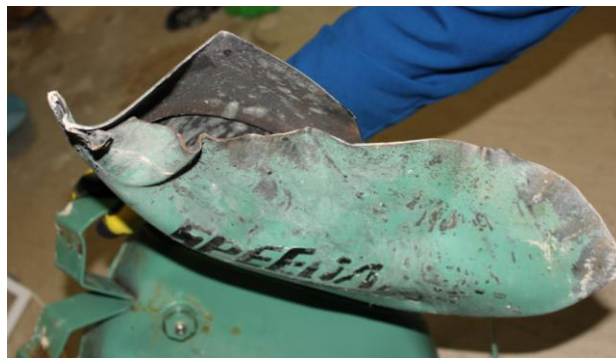
Figure 11: The impact distorted edge of the tank that most likely punctured the refrigerator and freezer doors

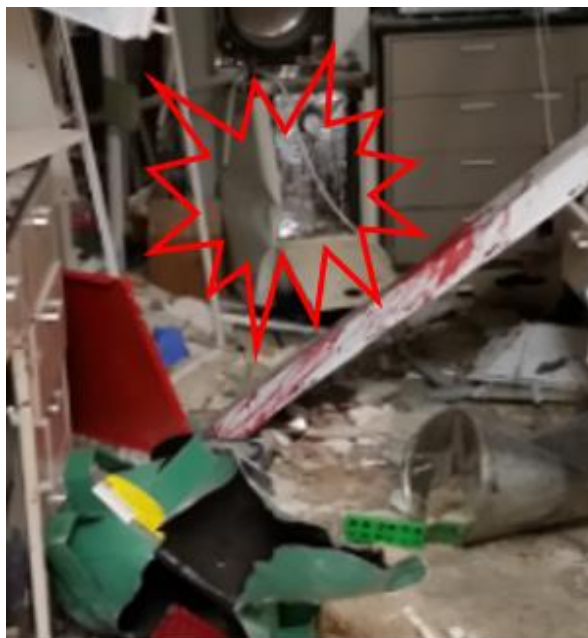
The end cap of the tank impacted the autoclave to the right of the refrigerator (Figures 12 and 13). It then bounced off the floor in front of the biosafety cabinet, finally coming to a rest on the floor to the left of the cabinet to the right of where the large piece of the tank landed.

Figure 12: Autoclave impact damage from the smaller tank piece

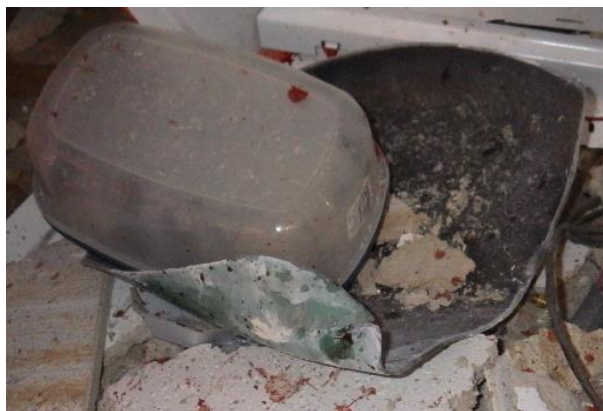
Figure 13: Piece of tank that impacted the autoclave on the floor to left of the biosafety cabinet as found by HFD.

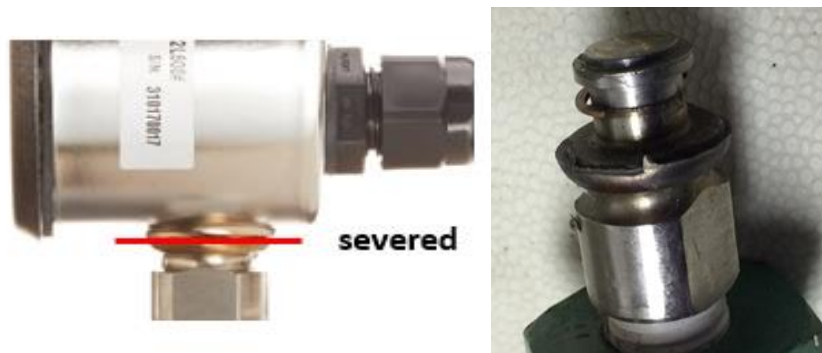
As the large section of the tank was ripping apart, the ball valve assembly bushing was completely torn from the tank around the weld and propelled straight upward into the light fixture directly above it. The impact was so severe that it drove the light panel into the ventilation duct above it damaging it. One section of the large tank piece also rolled inward until it impacted the pressure gauge severing it at the pressure diaphragm stem. (Figures 14 - 17). The pressure gauge stem remained in the reducing bushing that was screwed into the gas storage tank.

Figures 14 and 15: Pressure gauge stem before (new) and after accident.

The investigator stated that the bottom where it was connected to the sensor diaphragm on the tank was mushroomed. As seen in Figures 14 and 15, the gauge was severed at the mushroom which housed the pressure diaphragm.

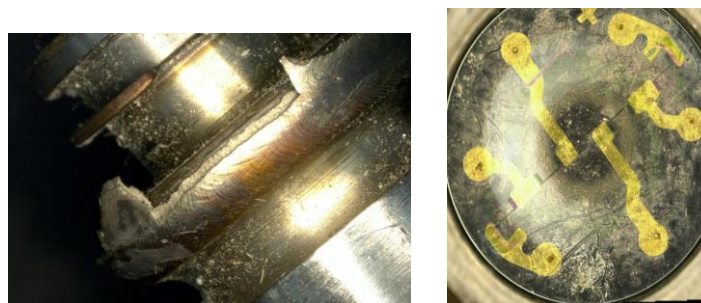
Figures 16 and 17: Microscopic views of the sensor housing tear and the pressure diaphragm that remained on the tank. Other photos show traces of copper on the diaphragm where the wire leads were torn off during the incident.

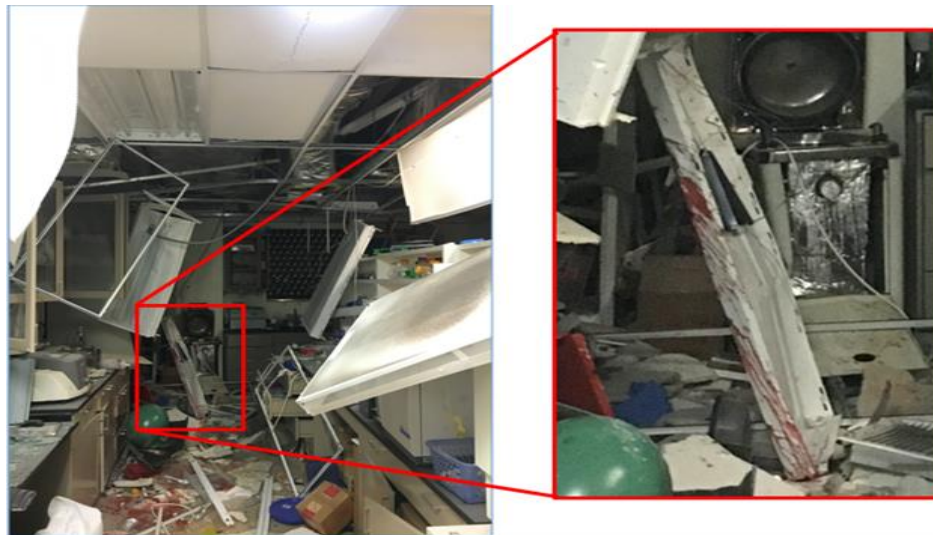
Figures 18 and 19: Photographs taken during HFD⁴⁸ response of the explosion scene with torn down ceiling plates and light fixtures. Both pieces of the tank landed to the left of the Biosafety Cabinet. The autoclave with its lid open is visible in the background. Blood from the injured postdoctoral researcher is visible in various places. The inset shows a ceiling light panel from in front of the biosafety cabinet that was impacted by the ball valve assembly and a remnant of the gas storage tank (green) can be seen in the lower left corner.

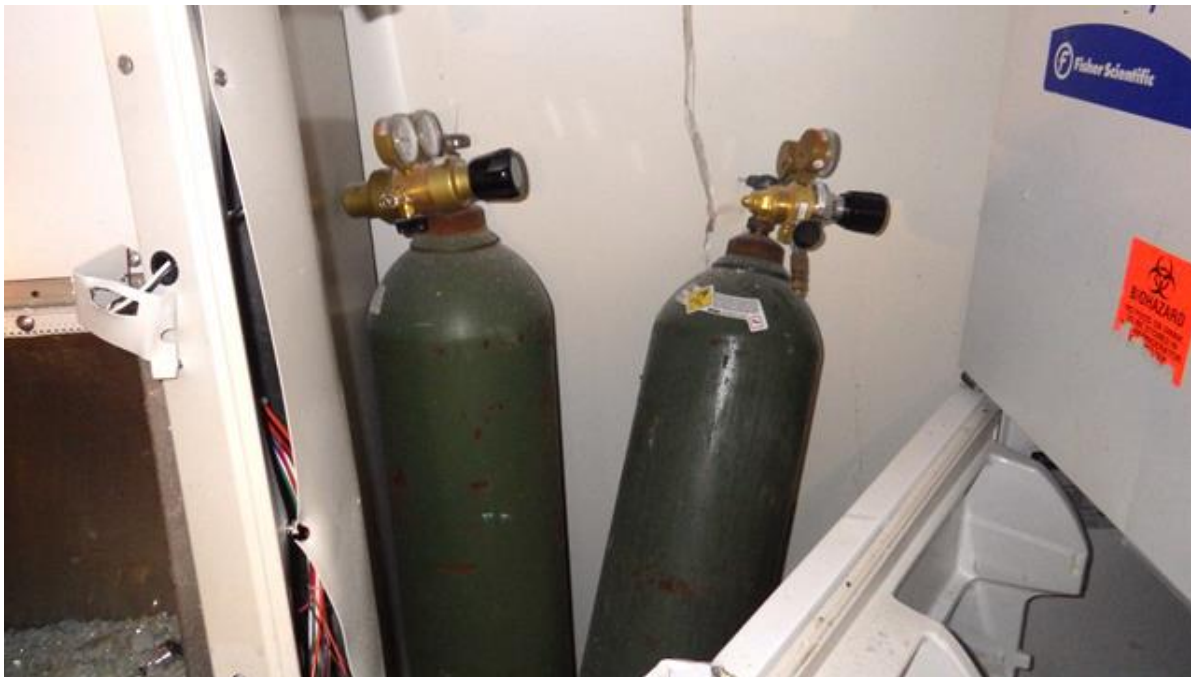
Figure 21: Oxygen cylinders used to fill the gas storage tank (standing upright) and used for the second postdoctoral researcher's ongoing experiment (tilted). The latter oxygen cylinder was open at the time of the explosion.

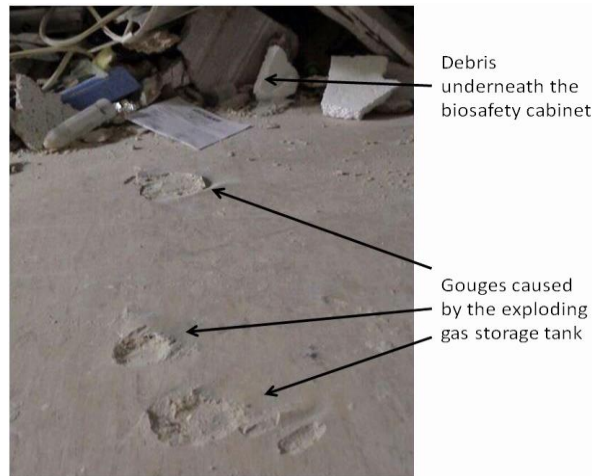
Figure 22: Gouges on floor caused by the exploding gas storage tank near the biosafety cabinet.

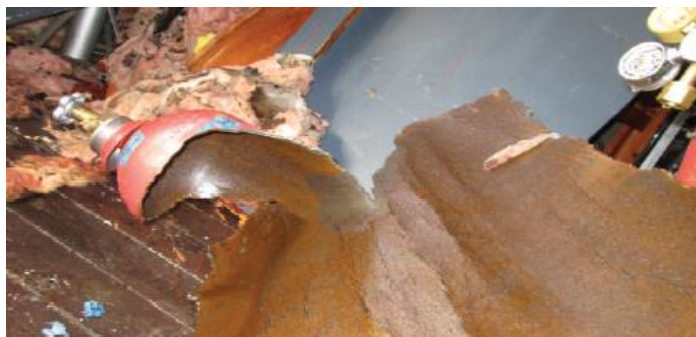
Figure 24: Cylinder embrittlement; note jagged edge and interior surface cracks⁵⁵

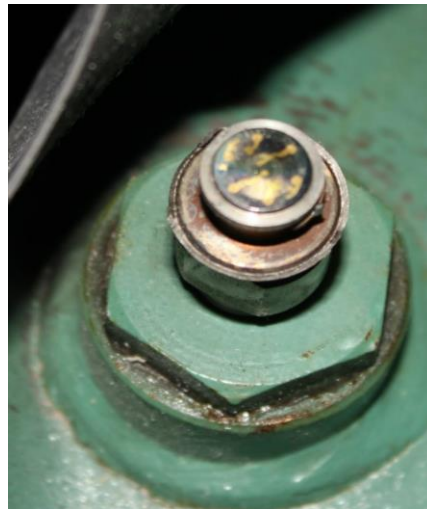
The Ashcroft digital pressure gauge⁶⁹ employs a thin pressure diaphragm made of 17-4 PH stainless steel where strain sensors are attached which are employed to determine the gas pressure (Figure 26). This is the “wetted” material that came into contact with gas mixture inside the tank⁷⁰. Under high temperatures hydrogen can permeate through the steel diaphragm. Testing by WHA International demonstrated that the diaphragm left on the stem from the pressure gauge on the gas tank was gas leak tight under Helium pressure. Similarly, the diaphragm on an identical new Ashcroft pressure gauge was also leak tight. Threading of the pressure gauge stem into the gas tank bushing, and the bushing into the gas tank, were leak tested by the postdoctoral researcher. Therefore leakage of the explosive gas mixture into the body of the pressure gauge where it was ignited by the electrical circuitry did not occur.

Figure 26: Pressure gauge diaphragm still attached to the threaded gauge stem that was still threaded into a bushing on the tank. On the external surface (non-wetted side) of the diaphragm one can see markings where the strain sensors were attached to the diaphragm.

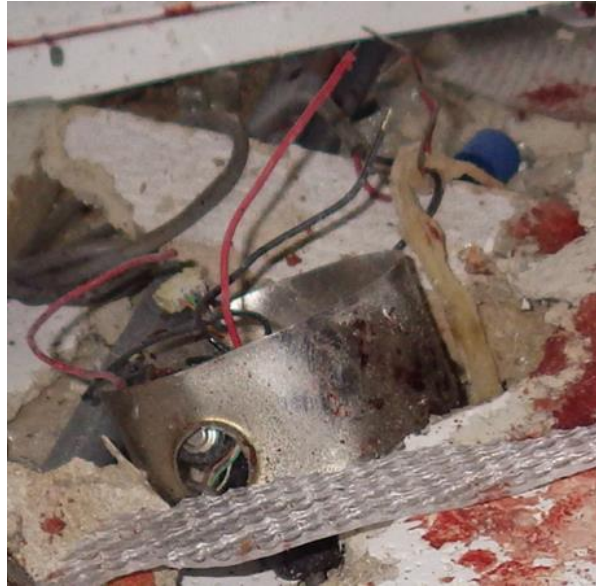
Physical evidence shows that the pressure gauge from the tank came apart in multiple pieces. HFD Fire Investigator stated that when he visually inspected the pressure gauge metal housing that evening and it did not appear to be severely damaged due to physical impact (Figure 27).

Figure 27: Pressure gauge housing as found by HFD

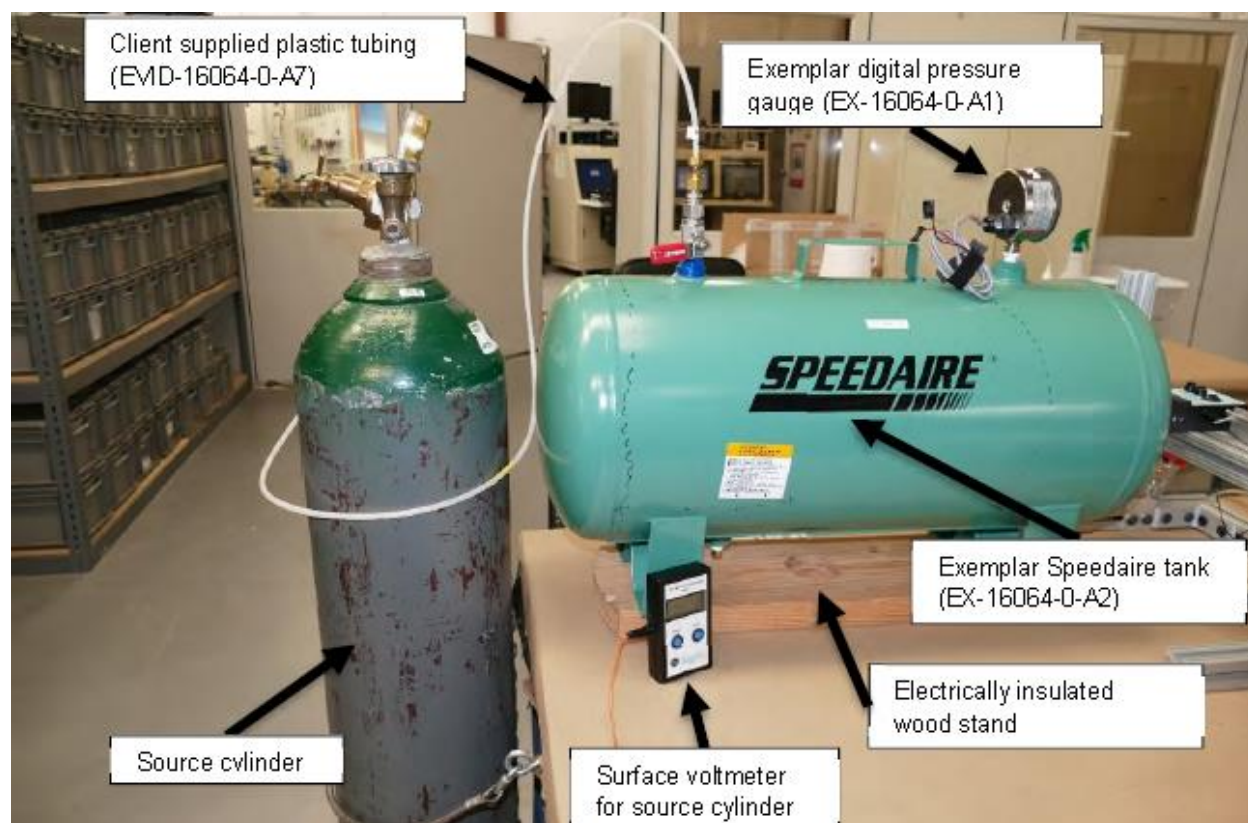
Figure 29: Exemplar tank and attachments used in testing.

The pressure gauge diaphragm was microscopically examined and there appeared to be no physical damage to the surface. It was installed on the exemplar tank and pressurized with helium to 120 psig. A thermal conductivity gas leak detector with a sensitivity of 10^{-5} cc/sec helium leak rate was used to “sniff” around the diaphragm and threads. No leak was found despite the physical trauma it experienced. The operation of the leak detector was confirmed when it was used at the ball valve assembly reducing bushing which leaked at the same location as was reported with the POST 30 tank. The surface of the diaphragm appeared to have a clear coating and was electrically non conductive.

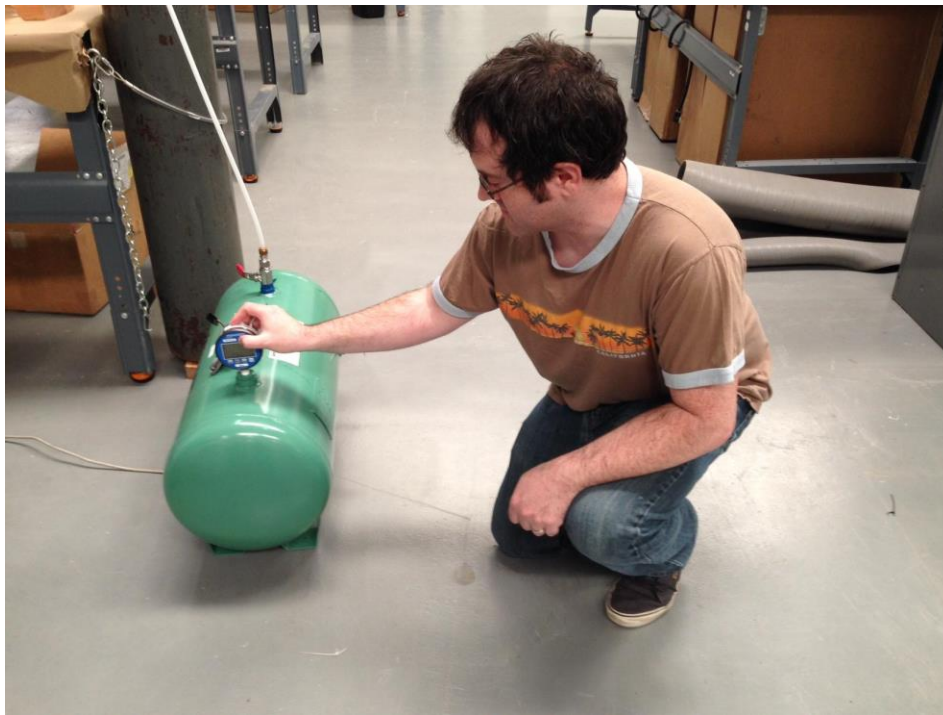
Figure 31: WHA engineer testing static electricity discharge by simultaneously touching the pressure gauge housing and pressing the gauge's On/Off switch

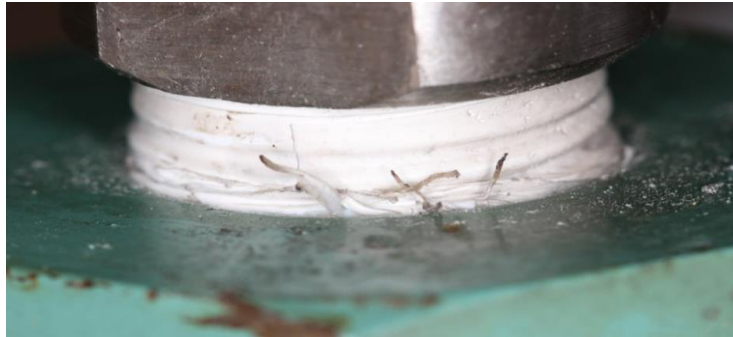
Other interesting findings that could not be pursued included Teflon tape that appeared to be burnt and melted on the gauge sensor stem (Figure 32). There was also pitting observed. Without further examination by destructive and chemical analysis, no further conclusions can be made.

Figure 32: Photo of gauge stem Teflon tape that appears to be charred and melted.

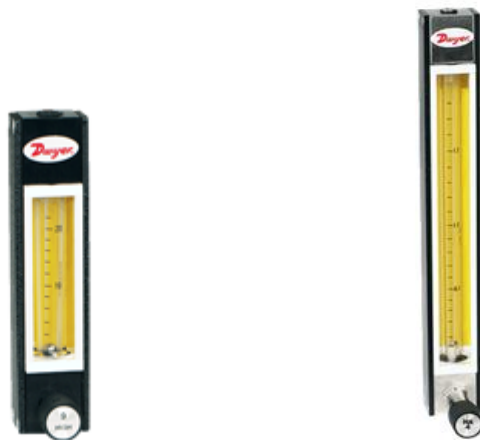
Rotameter operation is based on the variable area principle: fluid flow raises a float in a tapered tube, increasing the area for passage of the fluid. The greater the flow, the higher the float is raised. The height of the float is directly proportional to the flow rate. With liquids, the float is raised by a combination of the buoyancy of the liquid and the velocity head of the fluid. With gases, buoyancy is negligible, and the float responds to the velocity head alone. The float moves up or down in the tube in proportion to the fluid flowrate and the annular area between the float and the tube wall. The float reaches a stable position in the tube when the upward force exerted by the flowing fluid equals the downward gravitational force exerted by the weight of the float. A change in flowrate upsets this balance of forces. The float then moves up or down, changing the annular area until it again reaches a position where the forces are in equilibrium. To satisfy the force equation, the rotameter float assumes a distinct position for every constant flow rate. However, it is important to note that because the float position is gravity dependent, rotameters must be vertically oriented and mounted.

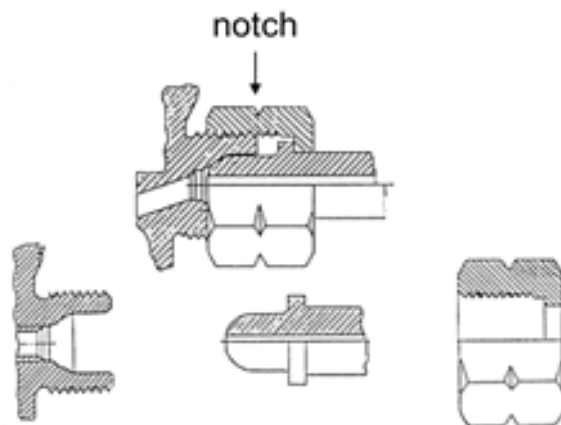
Cylinder valve outlet connections are selected based on the gas characteristics. A variety of valve outlet connections are used to prevent incompatible gases from being connected together. Hydrogen for example has a CGA 350 connection which is a nipple seal with a nut that is a left handed thread. Oxygen is a CGA 540 which is also a nipple seal but the same size nut is a right handed thread. The universal rule worldwide is to have a notch on the nut to indicate that it is left handed. A CGA 350 connection is shown in the following figure.

Schematic of CGA 350 connection for hydrogen gas.

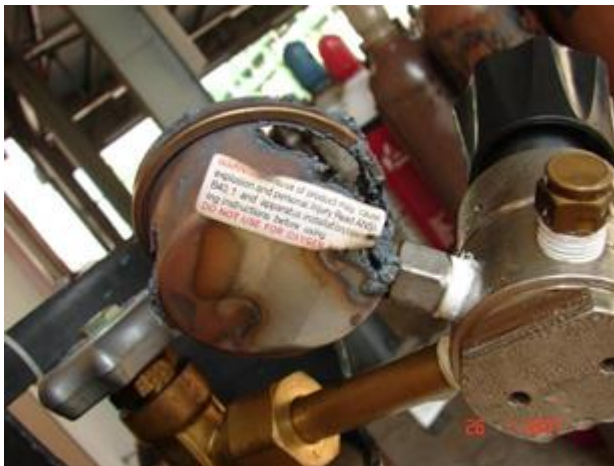
- Accidents have occurred when users needing an oxygen regulator replaced the CGA connection from a regulator used in another service with a CGA 540 connection and attached it to the oxygen cylinder. When the cylinder valve was opened, the adiabatic compression heat reached the autoignition temperature of the contaminant in pure oxygen.

Regulator used for another gas service was adapted for oxygen use and exploded when the cylinder valve was opened.
