Whole-body vibration on construction, mining and quarrying machines

Evaluation of emission and estimated
exposure levels

Prepared by **Silsoe Research Institute**
for the Health and Safety Executive 2005

RESEARCH REPORT 400

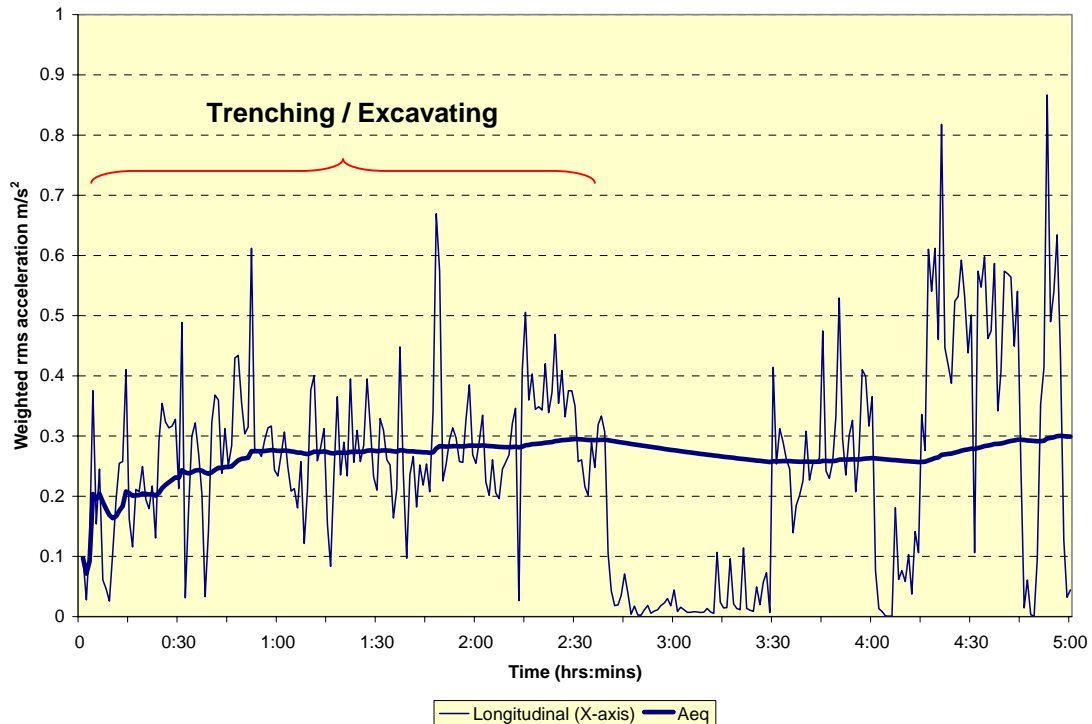
Figure A1.1.2 JCB 4CX backhoe loader:- time history of weighted 1-minute rms seat accelerations (X-axis) and equivalent continuous rms acceleration (Aeq) – entire measurement period

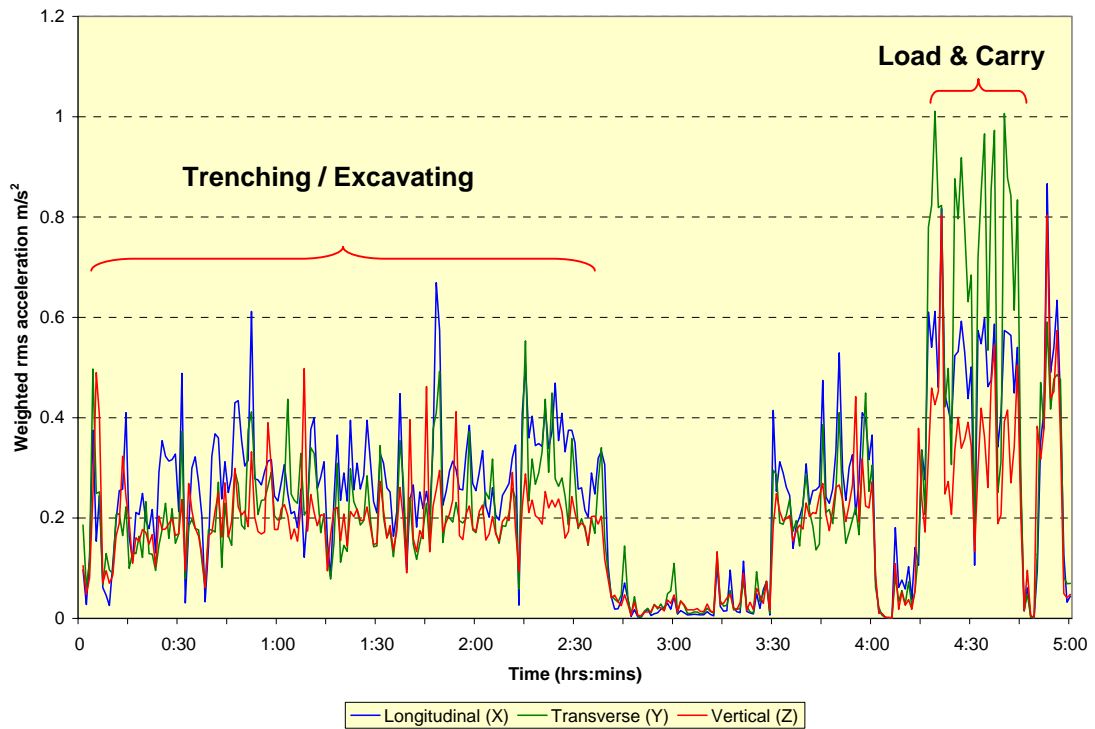
Figure A1.1.3 JCB 4CX backhoe loader:- time histories of weighted 1-minute rms seat accelerations (X, Y and Z-axes) – entire measurement period

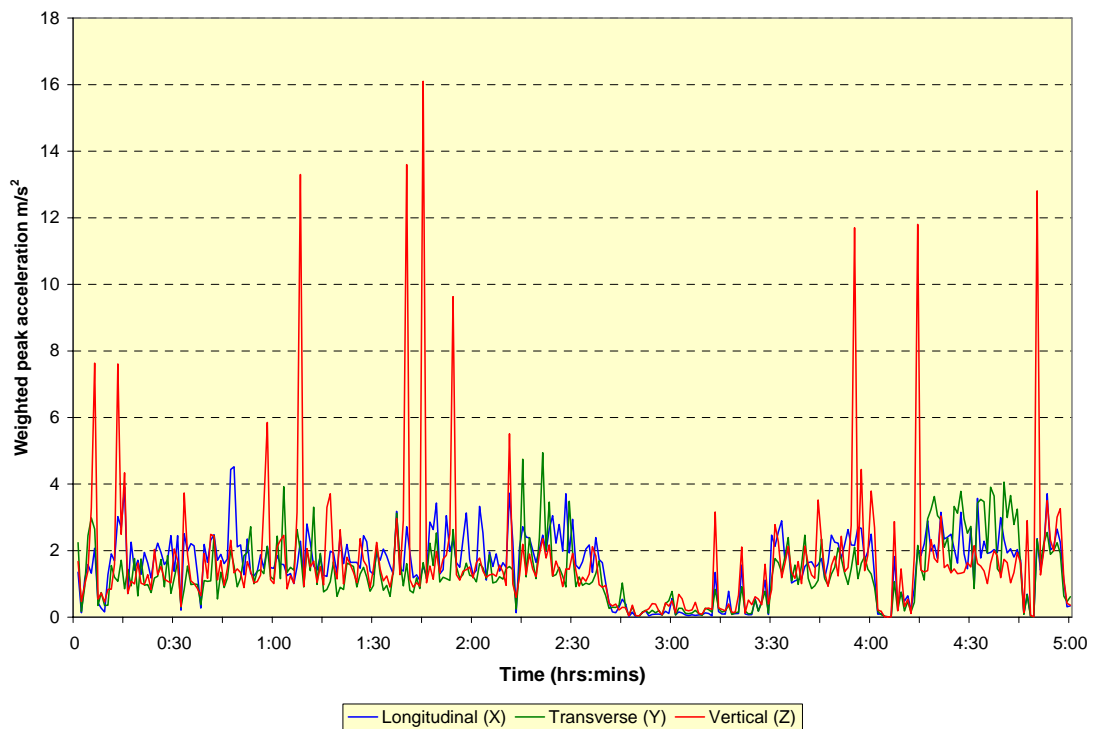
Figure A1.1.4 JCB 4CX backhoe loader:- time histories of weighted 1-minute peak seat accelerations (X, Y and Z-axes) – entire measurement period

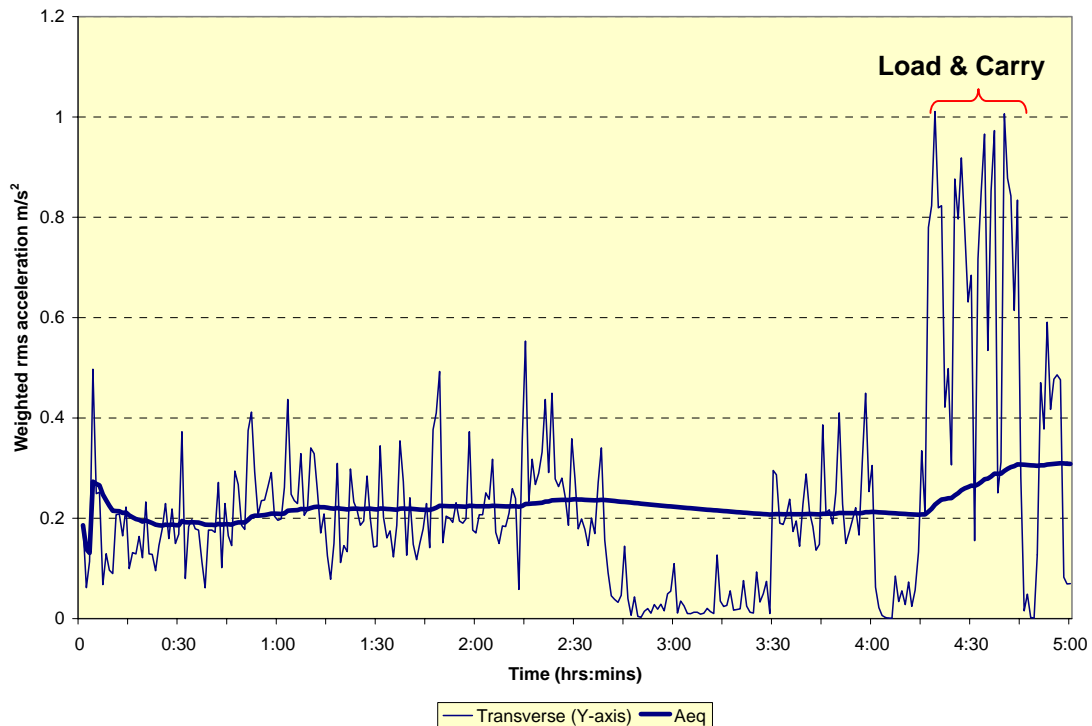
Figure A1.1.6 JCB 4CX backhoe loader:- time history of weighted 1-minute rms seat accelerations (Y-axis) and equivalent continuous rms acceleration (Aeq) – entire measurement period

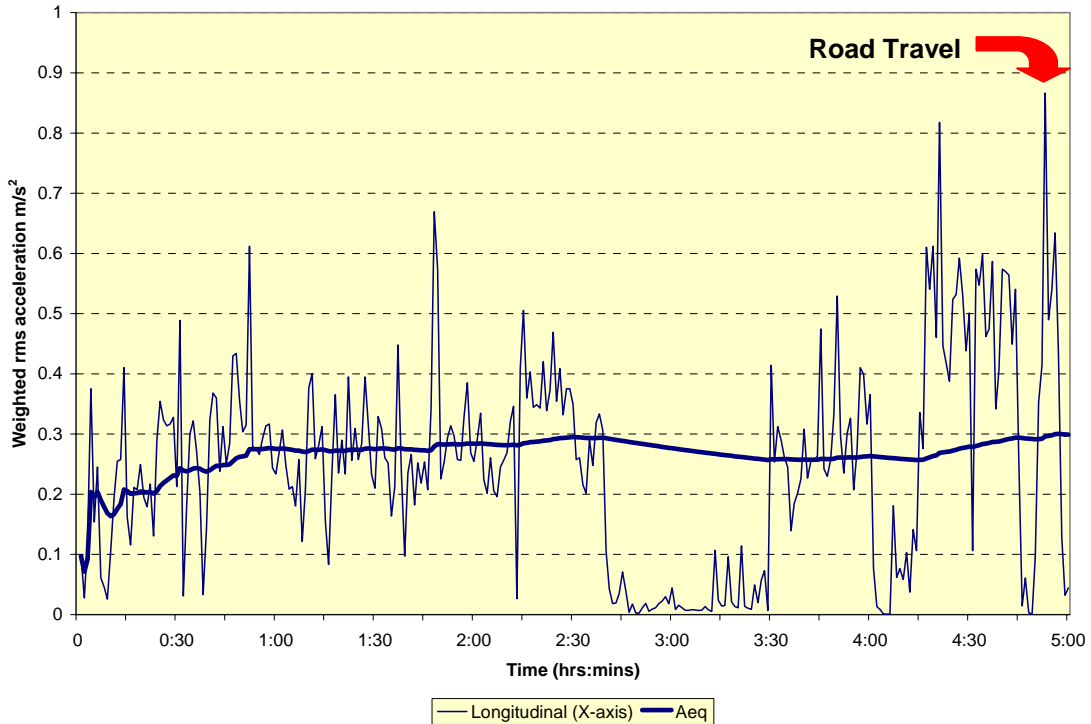
Figure A1.1.11 JCB 4CX backhoe loader:- time history of weighted 1-minute rms seat accelerations (X-axis) and equivalent continuous rms acceleration (Aeq) – entire measurement period

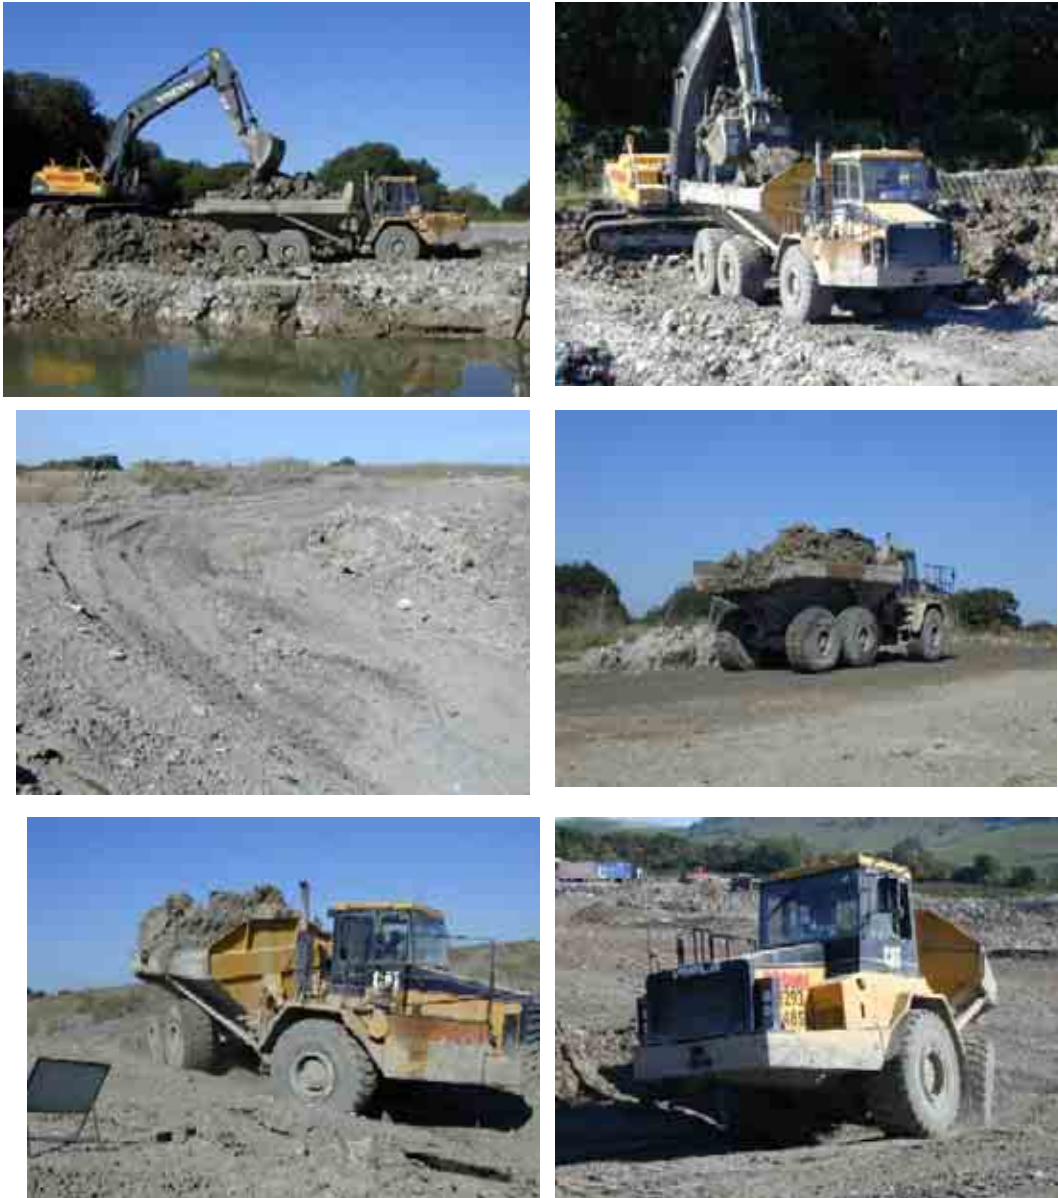
Figure A1.3.1 Caterpillar D250E 25-tonne articulated dump truck at work on-site

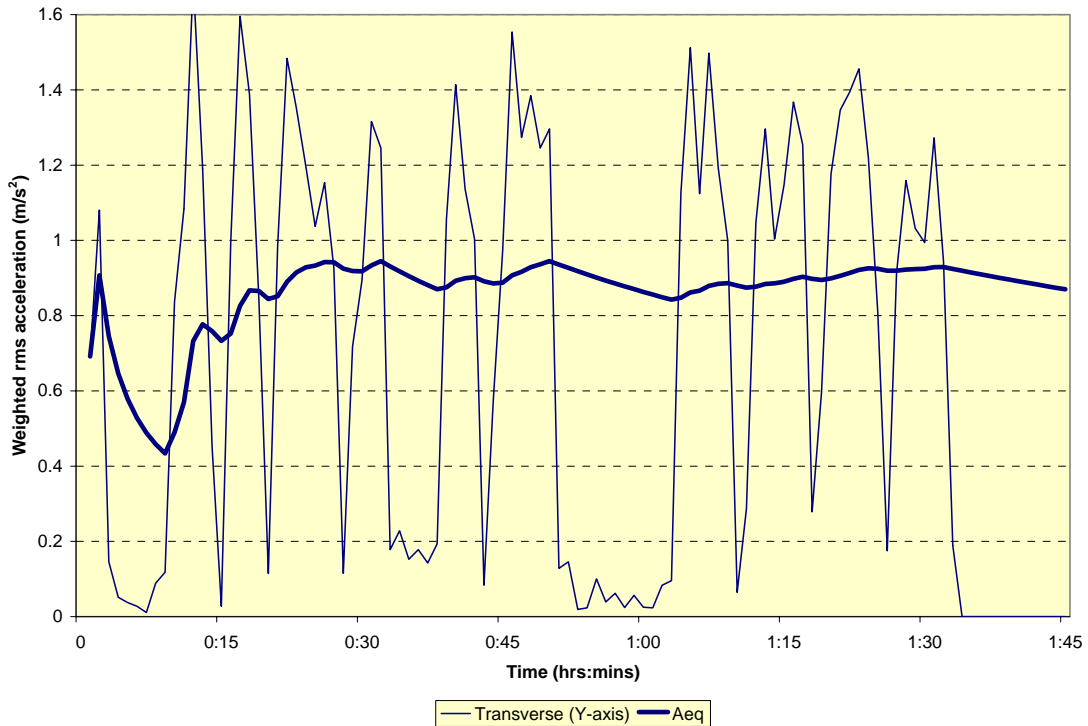
Figure A1.3.2 Caterpillar 25-tonne Articulated Dump Truck:- time history of weighted 1-minute rms seat accelerations (Y-axis) and equivalent continuous rms acceleration (Aeq)

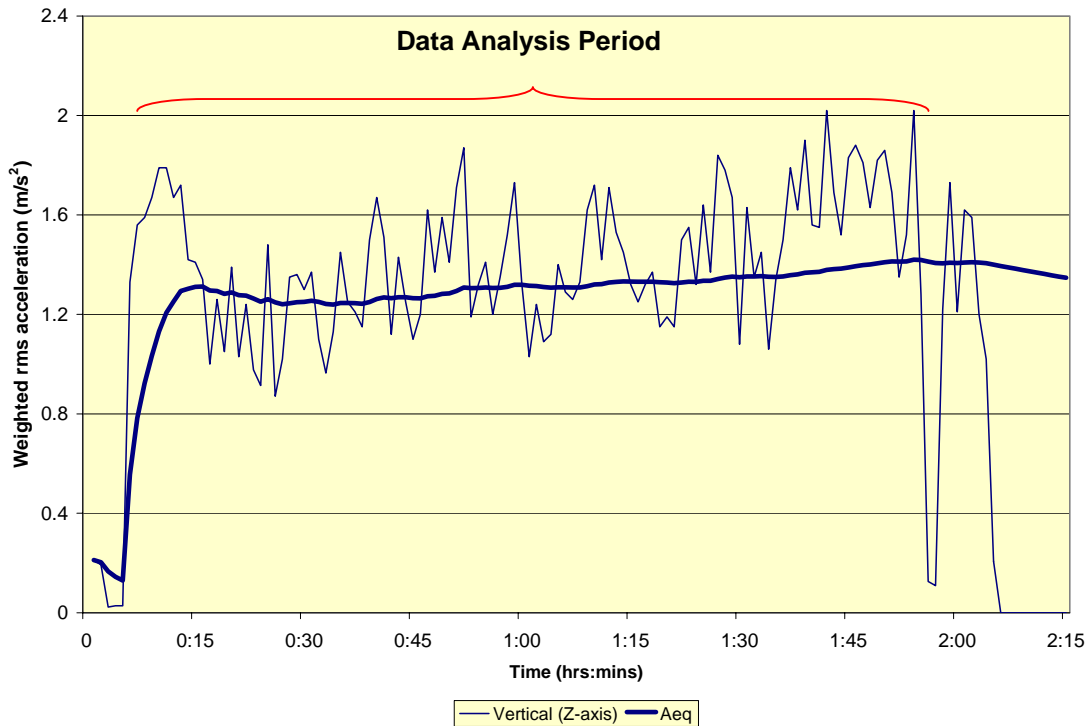
Figure A1.4.2 Komatsu Dozer:- time history of weighted 1-minute rms seat accelerations (Z-axis) and equivalent continuous rms acceleration (Aeq)

The vibration encountered had most of its energy at frequencies above 5 Hz; primarily a result of the characteristic vibration frequency spectrum generated by the dozer’s track undercarriage (soil conditions being soft / moderate). However, the SEAT value in this instance was 1.16. This application or rather the frequency distribution of vertical (Z) axis vibration energy, places a significant demand upon a suspension seat, albeit one well within its capabilities if properly maintained and replaced at the end of its service life (~ 4000 hrs). This had not occurred in this application, the dozer having reached 8600 operating hours with the original seat. An appropriate seat for such a machine, properly maintained, should have a SEAT value of about 0.6, which would reduce the operator’s WBV exposure to a much more moderate level.

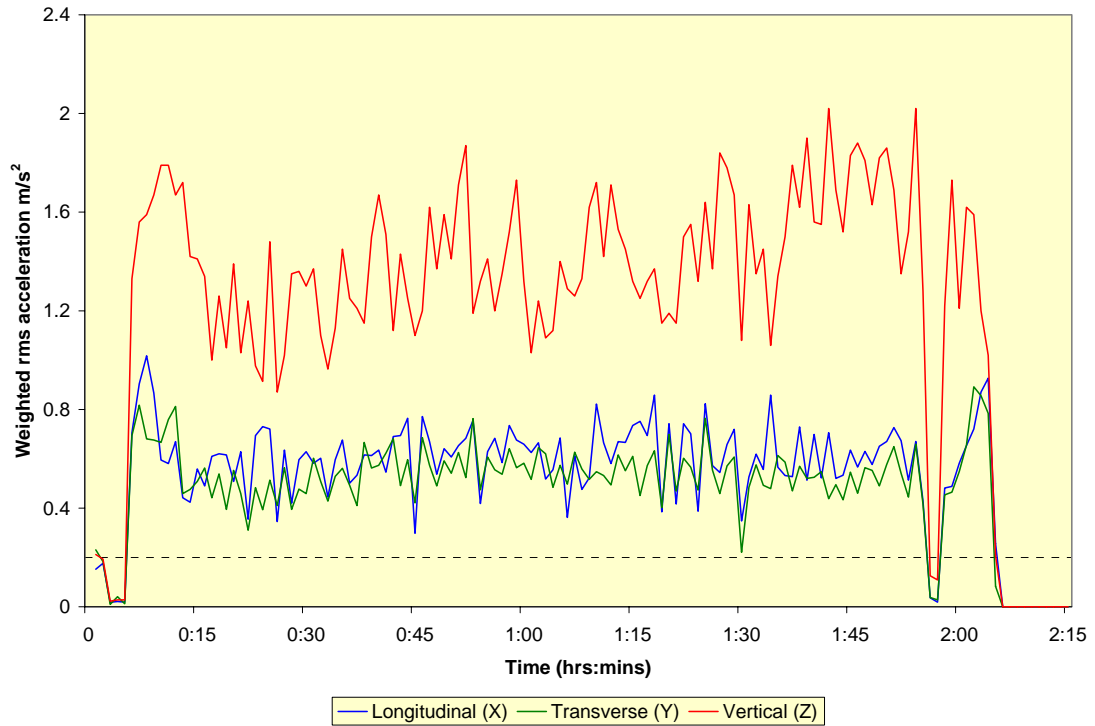
Figure A1.4.3 Komatsu Dozer:- time histories of weighted 1-minute rms seat accelerations (X, Y and Z-axes)

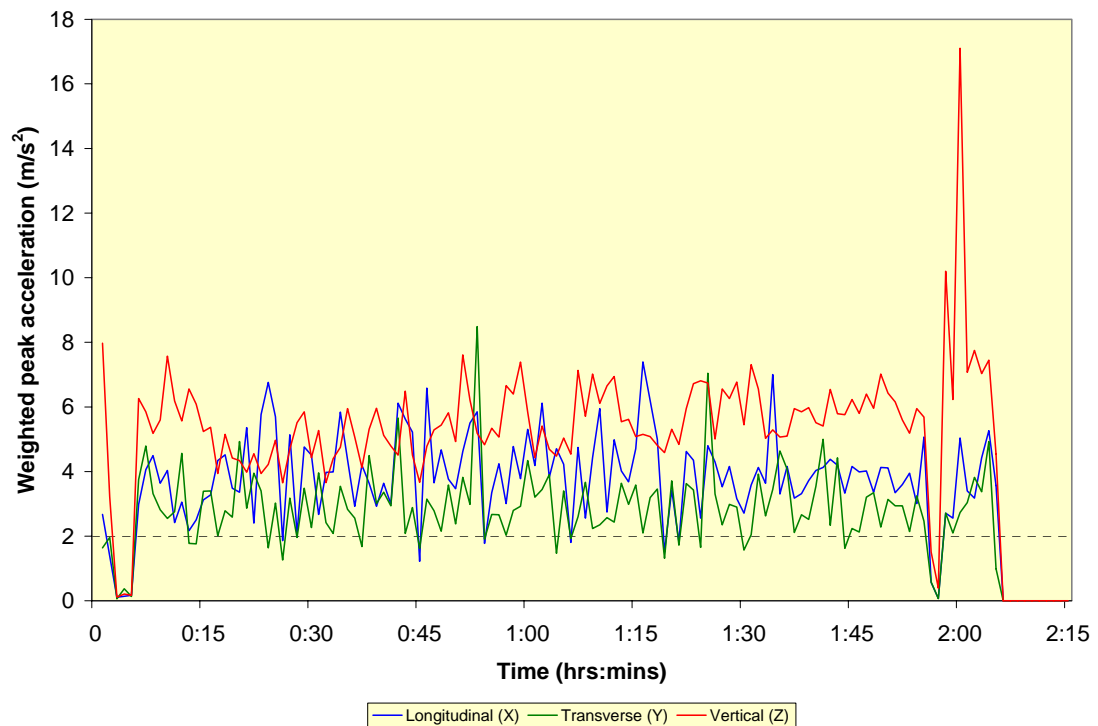
Figure A1.4.4 Komatsu Dozer:- time histories of weighted 1-minute peak seat accelerations (X, Y and Z-axes)

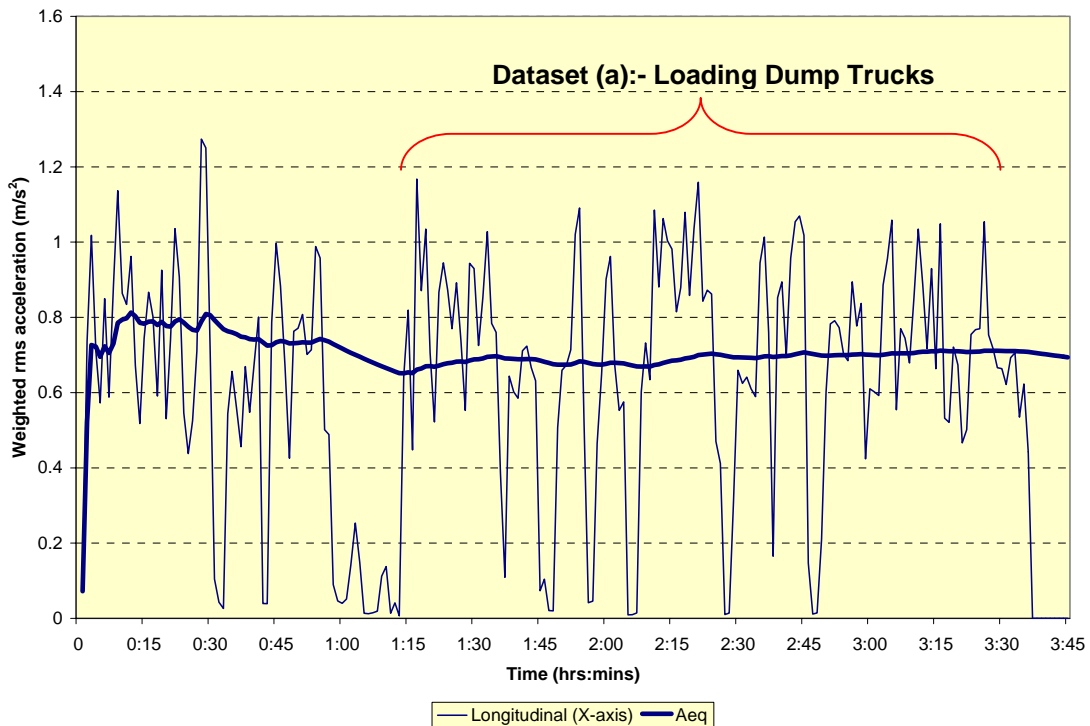
Figure A1.5.2 Liebherr Face Shovel:- time history of weighted 1-minute rms seat accelerations (X-axis) and equivalent continuous rms acceleration (Aeq) – entire recording period

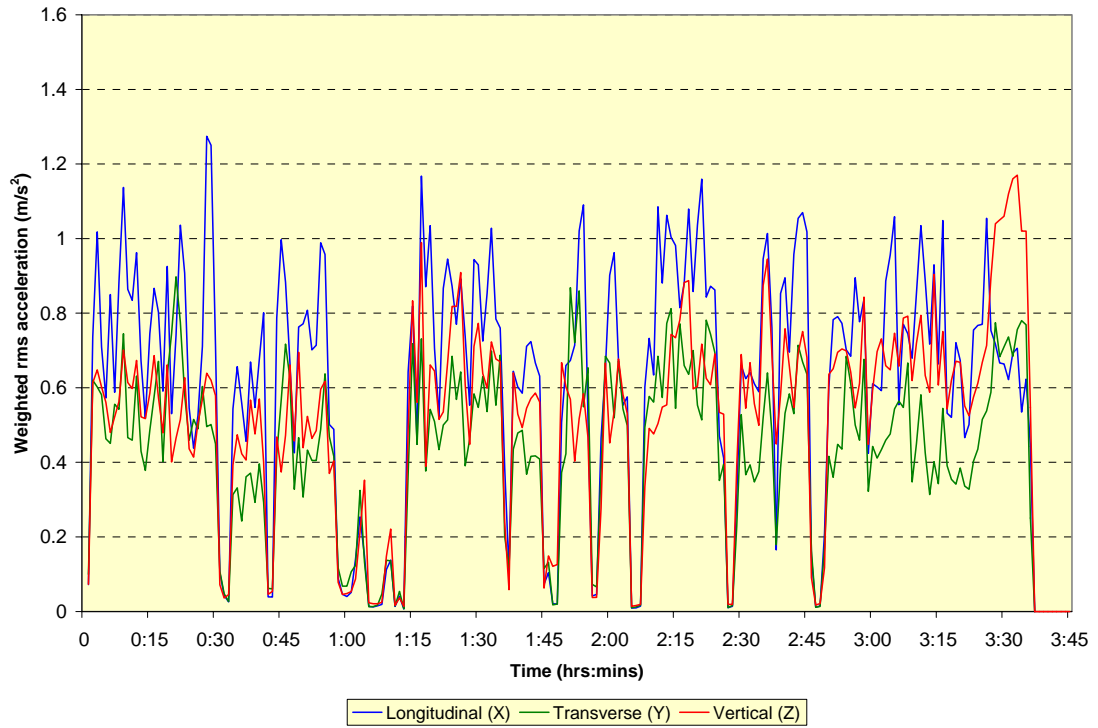
Figure A1.5.3 Liebherr Face Shovel:- time histories of weighted 1-minute rms seat accelerations (X, Y and Z-axes) – entire recording period

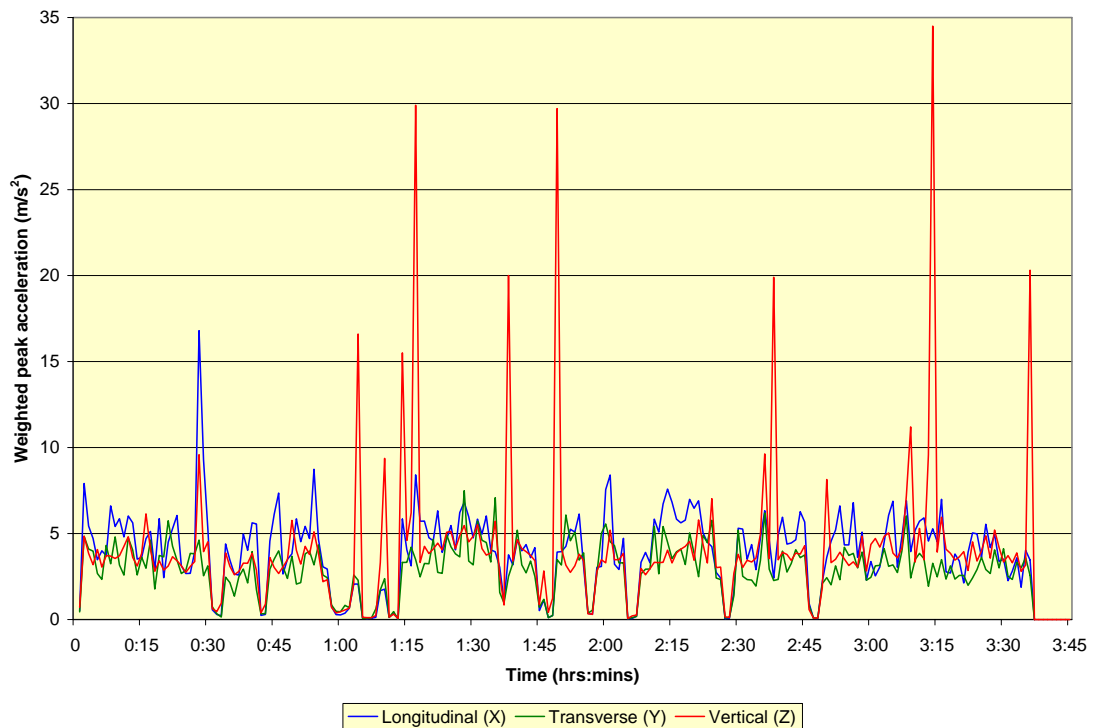
Figure A1.5.4 Liebherr Face Shovel:- time histories of weighted 1-minute peak seat accelerations (X, Y and Z-axes) – entire recording period

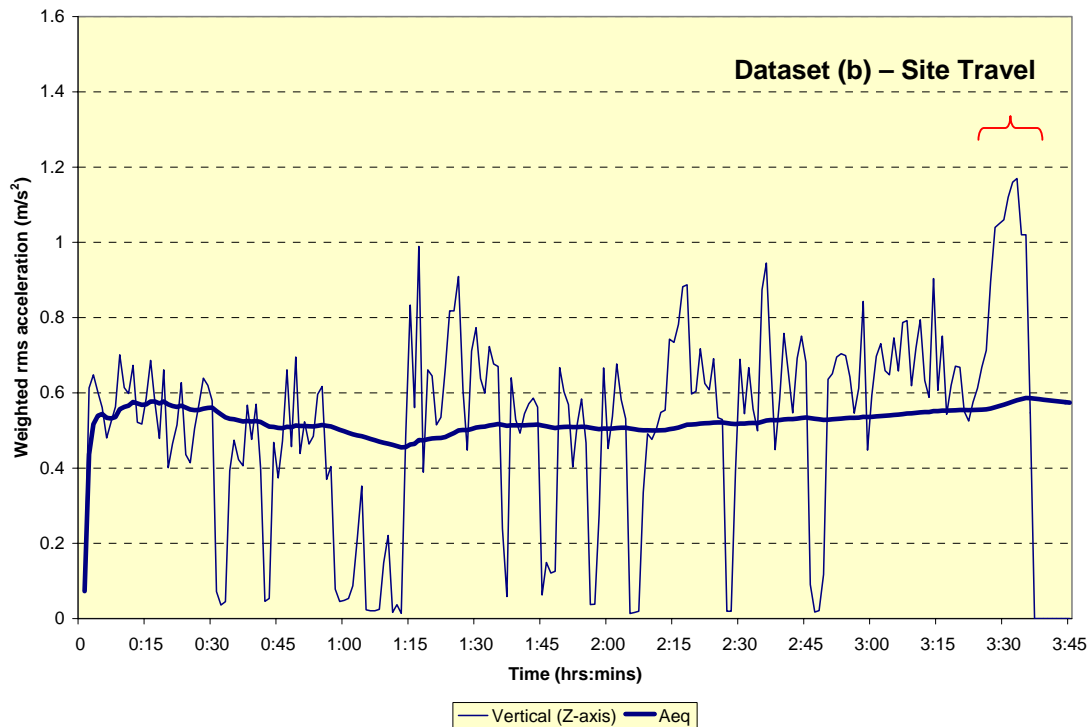
Figure A1.5.9 Liebherr Face Shovel:- time history of weighted 1-minute rms seat accelerations (Z-axis) and equivalent continuous rms acceleration (Aeq):- entire recording period

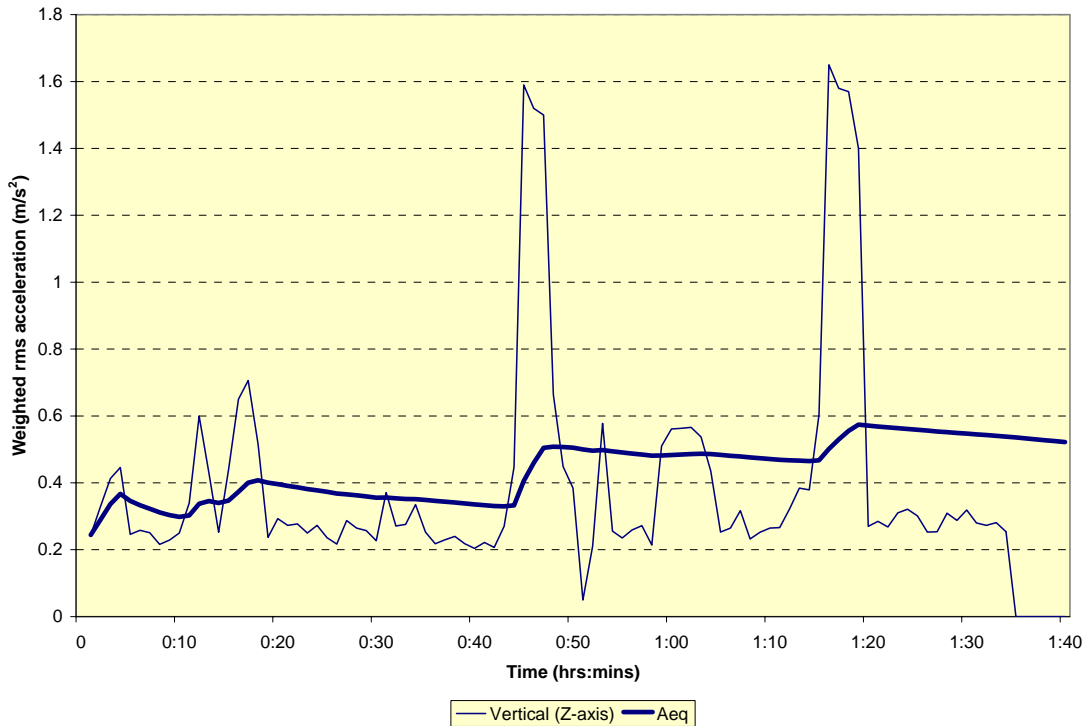
Figure A1.6.2 Bomag BW161 10-tonne twin drum vibrating roller:- time history of weighted 1-minute rms seat accelerations (Z-axis) and equivalent continuous rms acceleration (Aeq) – entire recording period

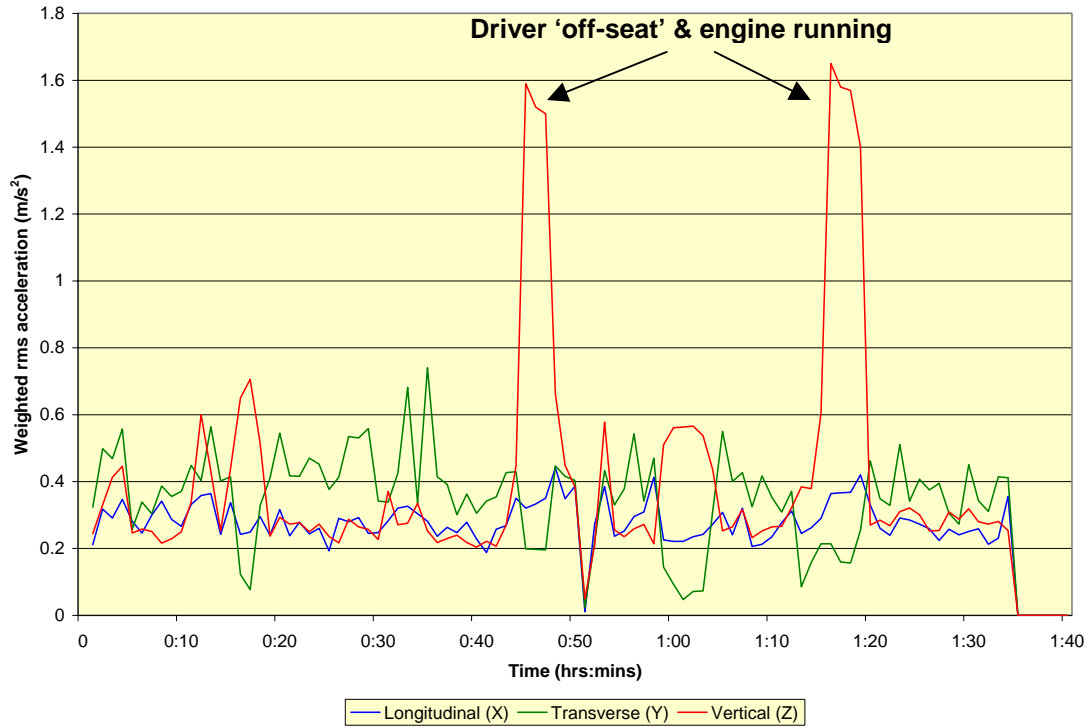
Figure A1.6.3 Bomag BW161 10-tonne twin drum vibrating roller:- time histories of weighted 1-minute rms seat accelerations (X, Y and Z-axes)

- Periods of machine idleness (at engine tickover) and/or operator absence from the driver's seat appear to cause higher Z-axis WBV values;
- Datasets derived from periods when the driver is "on-seat" generate significantly lower Z-axis WBV levels than those relating to the entire measurement period (particularly for "seat" WBV values);
- High Z-axis rms seat acceleration values (see Figure A1.6.3) appear to coincide with the periods when the driver is "off-seat" (see Figure A1.6.4).

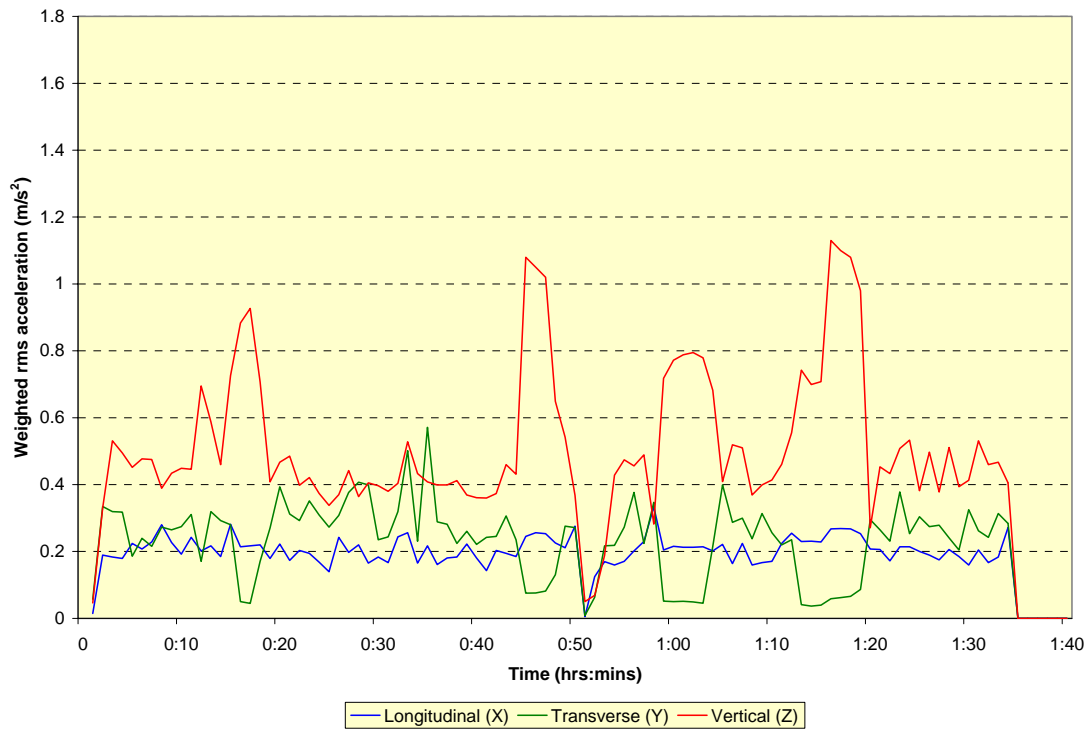
Figure A1.6.5 Bomag BW161 10-tonne twin drum vibrating roller:- time histories of weighted 1-minute rms floor accelerations (X, Y and Z-axes)

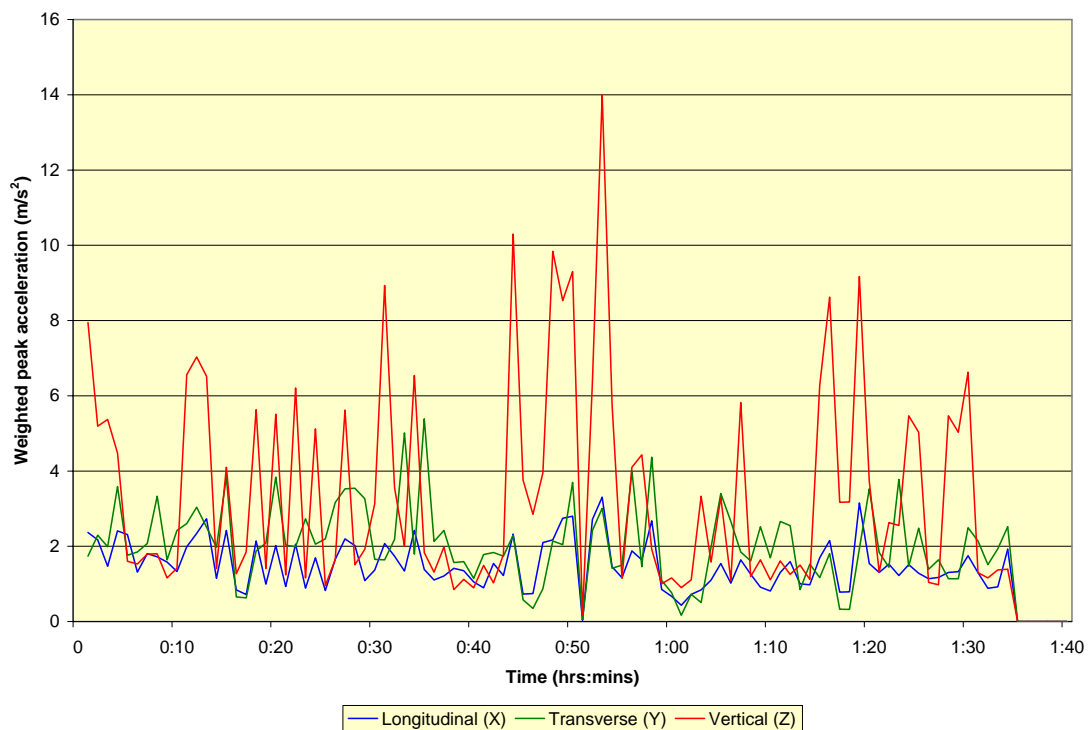
Figure A1.6.6 Bomag BW161 10-tonne twin drum vibrating roller:- time histories of weighted 1-minute peak seat accelerations (X, Y and Z-axes)

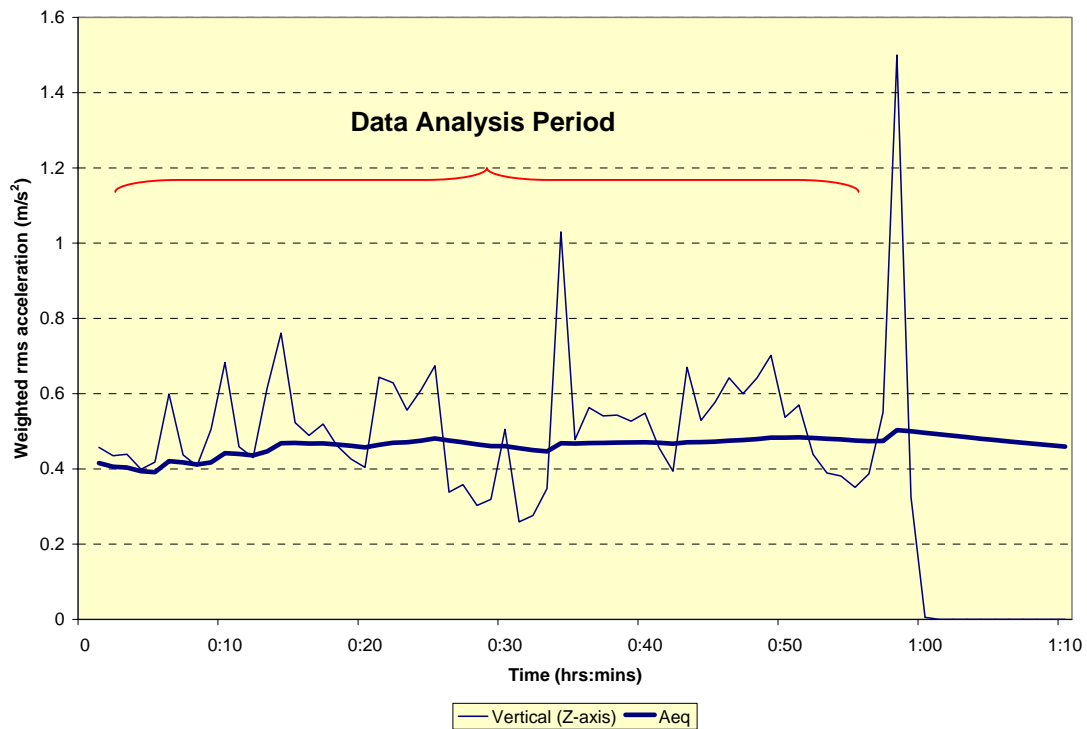
Figure A1.7.2 Bomag BW138 4-tonne twin drum vibrating roller:- time history of weighted 1-minute rms seat accelerations (Z-axis) and equivalent continuous rms acceleration (Aeq)

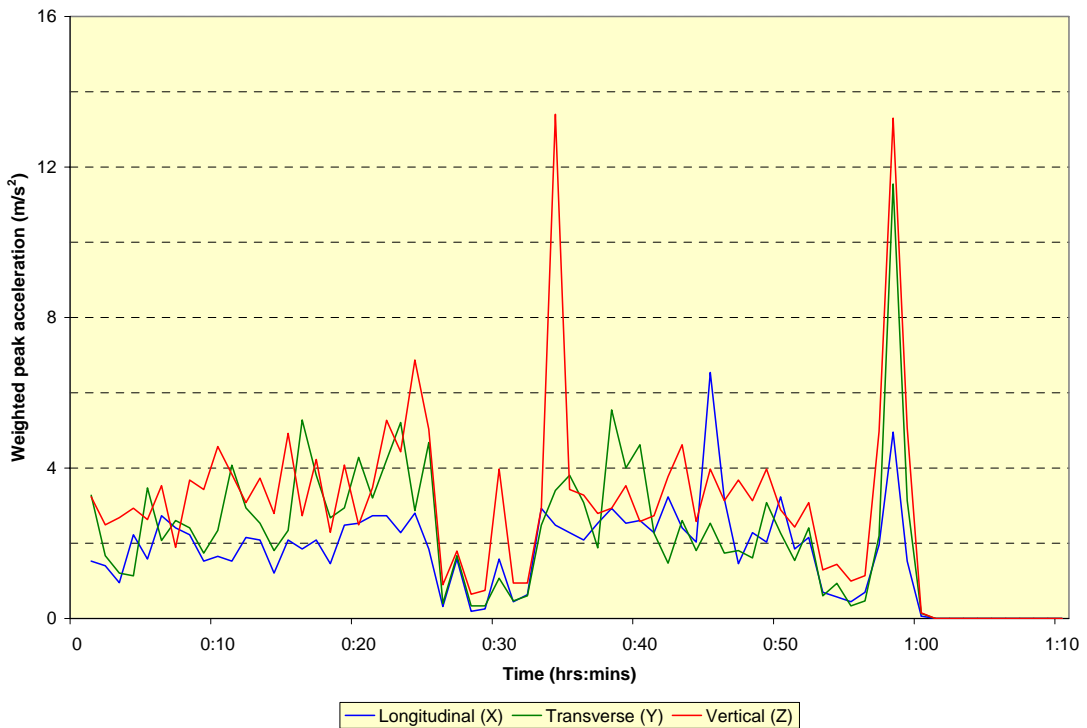
Figure A1.7.4 Bomag BW138 4-tonne twin drum vibrating roller:- time histories of weighted 1-minute peak seat accelerations (X, Y and Z-axes)

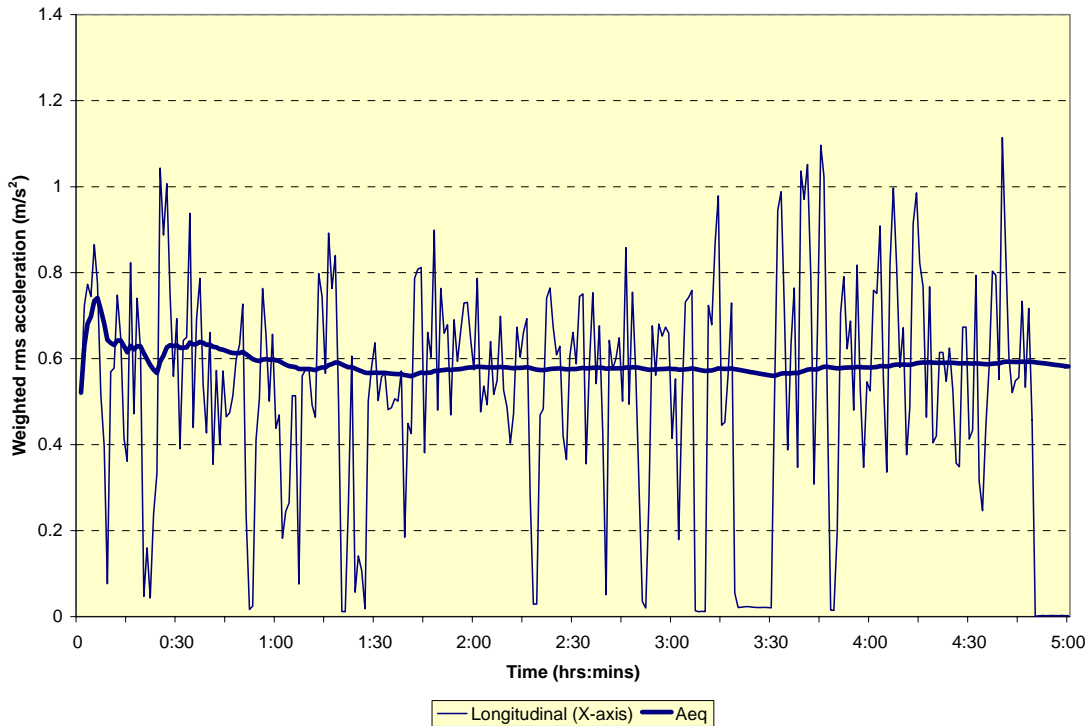
Figure A1.8.2 CAT 950F II articulated loading shovel:- time history of weighted 1-minute rms seat accelerations (X-axis) and equivalent continuous rms acceleration (Aeq)

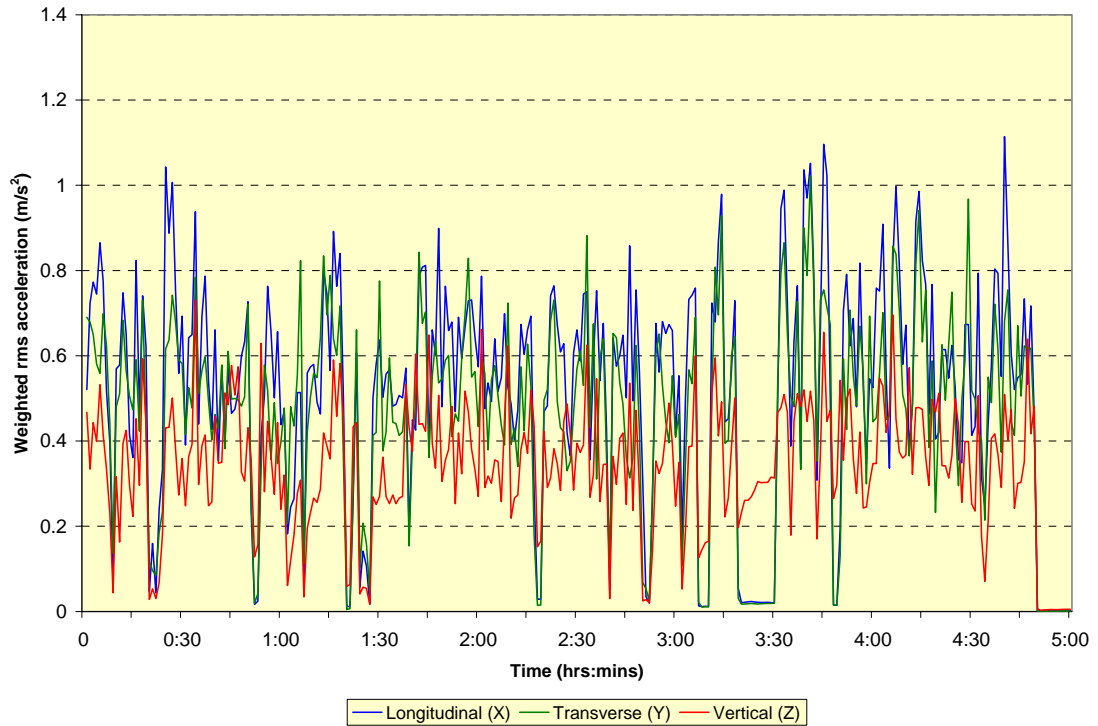
Figure A1.8.3 CAT 950F II articulated loading shovel:- time histories of weighted 1-minute rms seat accelerations (X, Y and Z-axes)

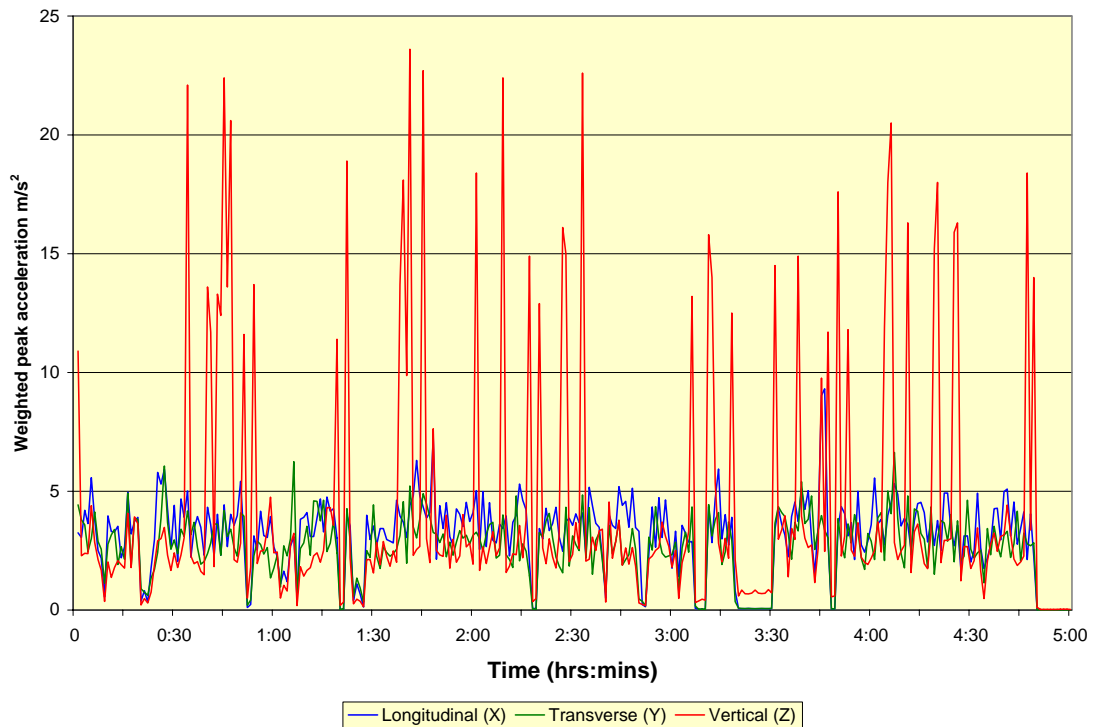
Figure A1.8.4 CAT 950F II articulated loading shovel:- time histories of weighted 1-minute peak seat accelerations (X, Y and Z-axes)

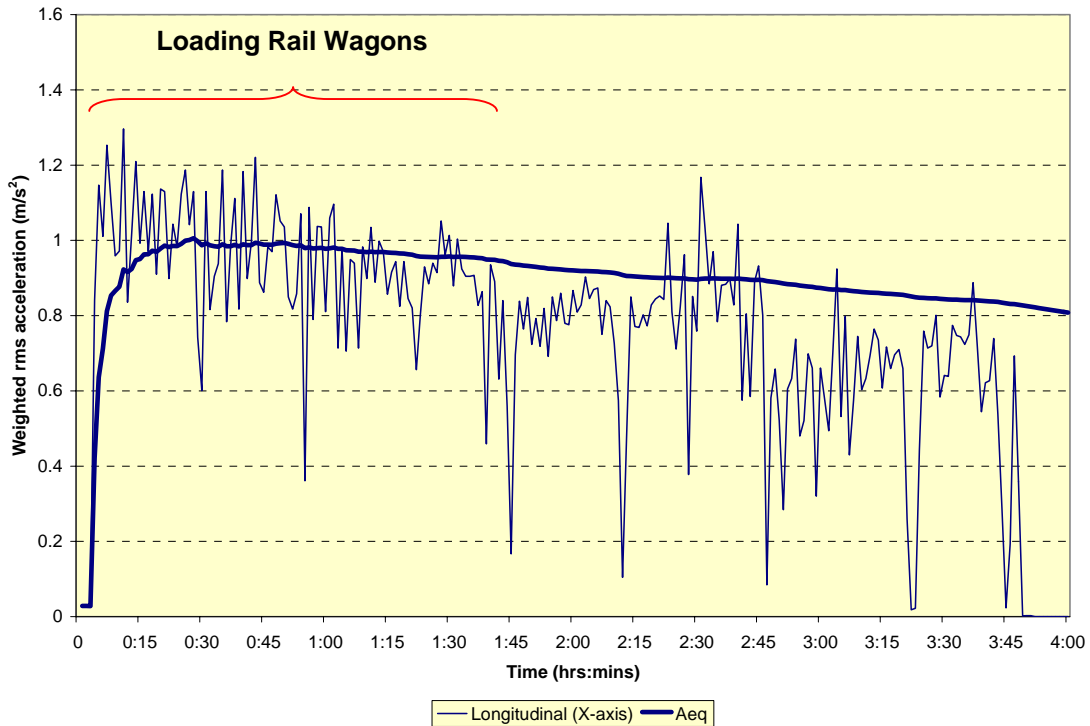
Figure A1.9.2 CAT 970F articulated loading shovel:- time history of weighted 1-minute rms seat accelerations (X-axis) and equivalent continuous rms acceleration (Aeq) – entire recording period

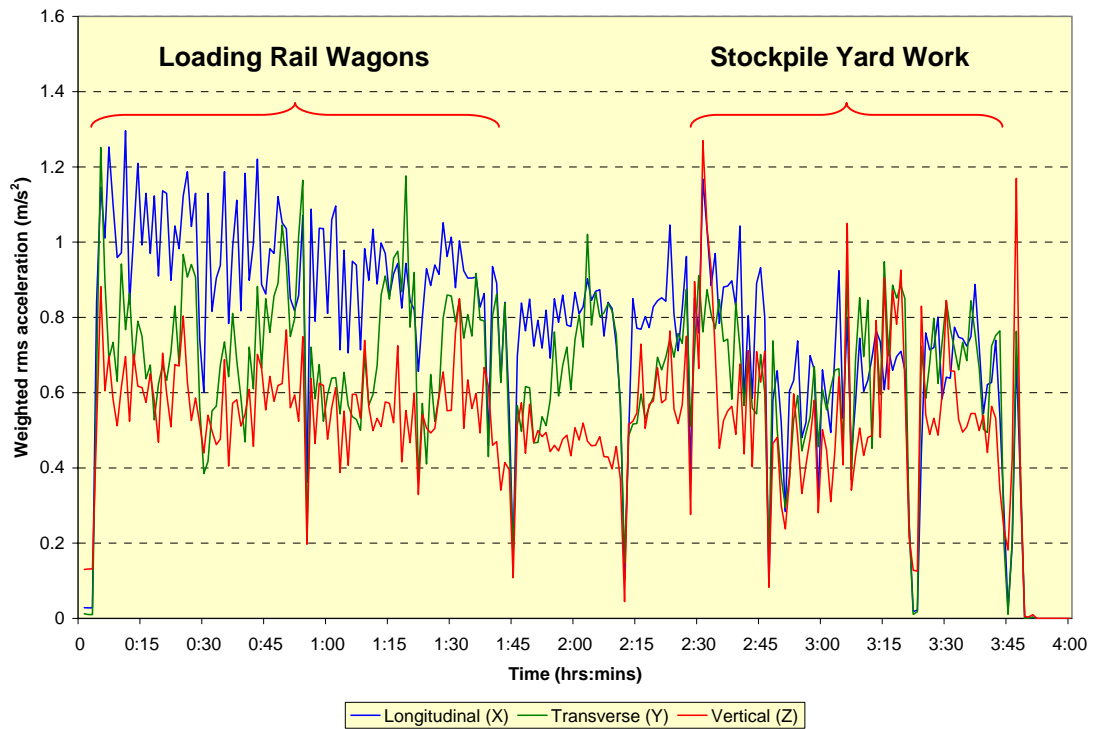
Figure A1.9.3 CAT 970F articulated loading shovel:- time histories of weighted 1-minute rms seat accelerations (X, Y and Z-axes) – entire recording period

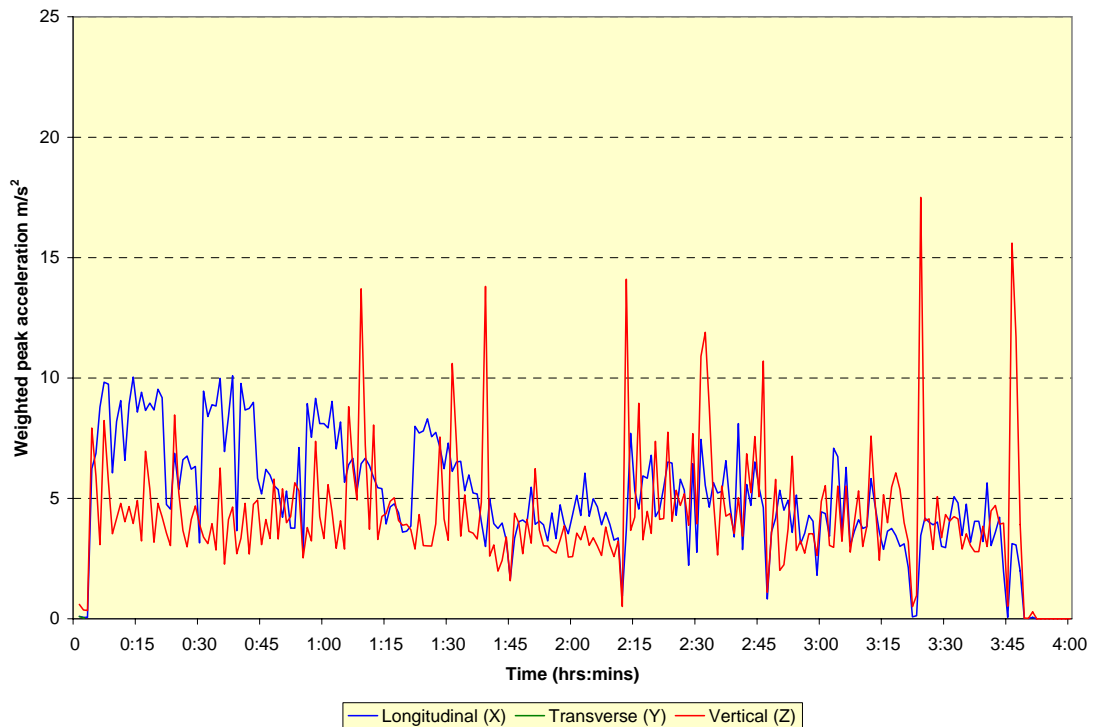
Figure A1.9.4 CAT 970F articulated loading shovel:- time histories of weighted 1-minute peak seat accelerations (X, Y and Z-axes) – entire recording period
