Whole-body vibration on construction, mining and quarrying machines

Evaluation of emission and estimated
exposure levels

Prepared by **Silsoe Research Institute**
for the Health and Safety Executive 2005

RESEARCH REPORT 400

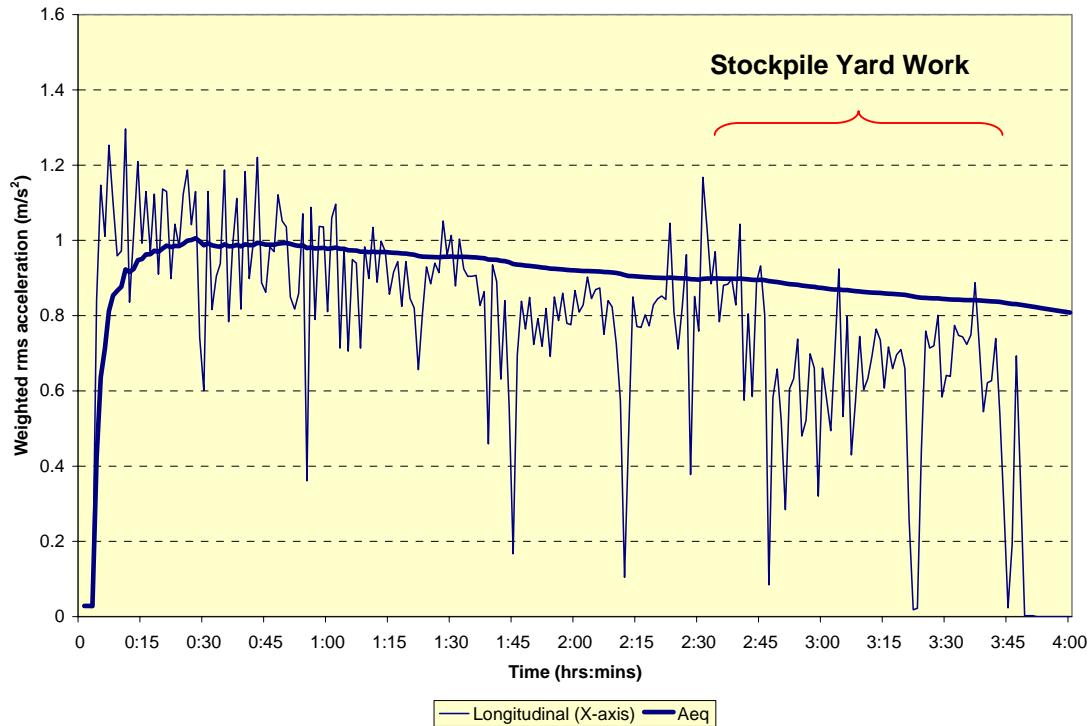
Figure A1.9.9 CAT 970F articulated loading shovel:- time history of weighted 1-minute rms seat accelerations (X-axis) and equivalent continuous rms acceleration (Aeq) – entire recording period

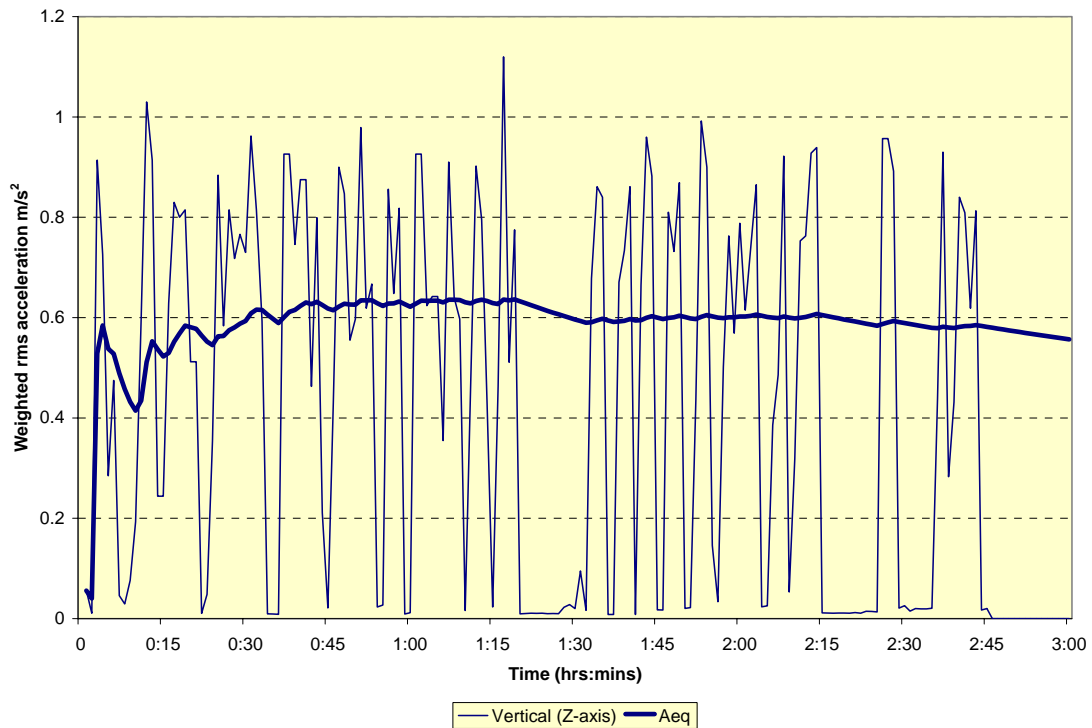
Figure A1.11.3 Linde 2.5 tonne fork lift truck:- time history of weighted 1-minute rms seat accelerations (Z-axis) and equivalent continuous rms acceleration (Aeq)

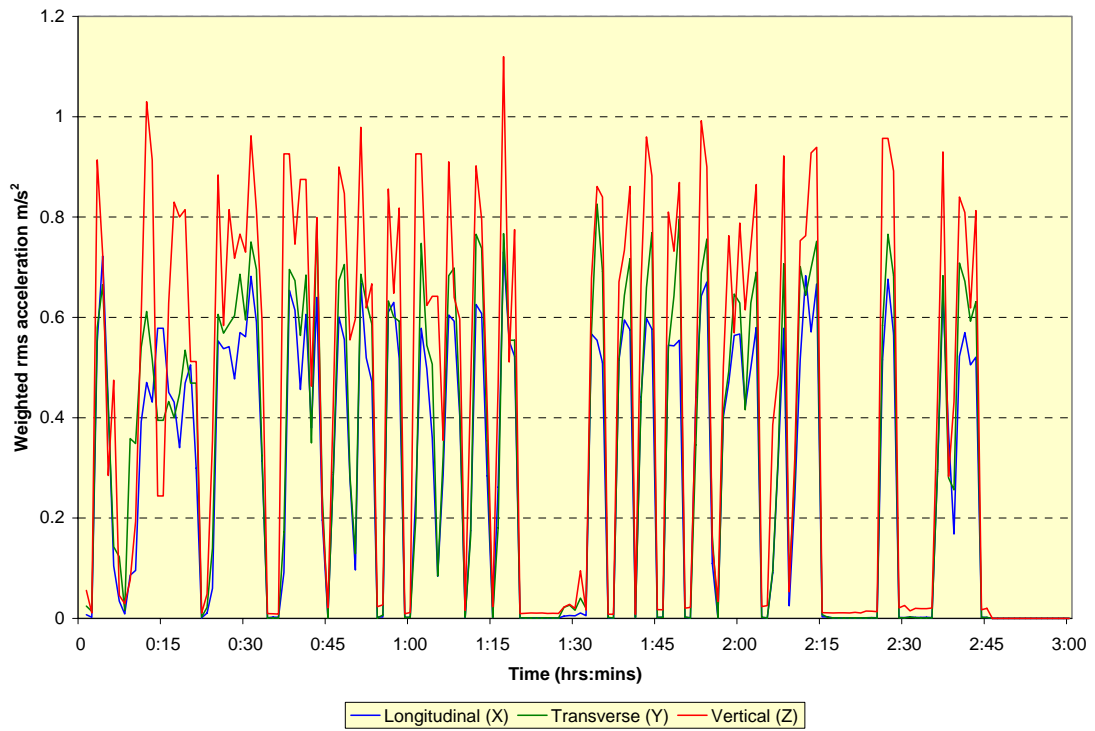
Figure A1.11.4 Linde 2.5 tonne fork lift truck:- time histories of weighted 1-minute rms seat accelerations (X, Y and Z-axes)

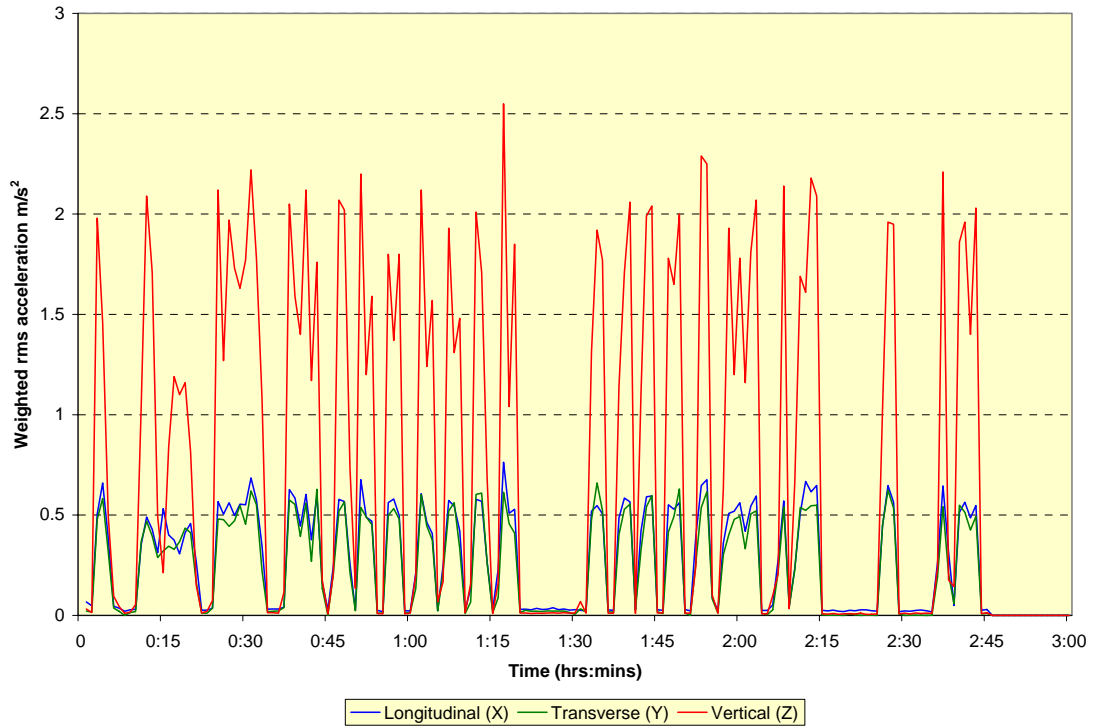
Figure A1.11.6 Linde 2.5 tonne fork lift truck:- time histories of weighted 1-minute rms floor accelerations (X, Y and Z-axes)

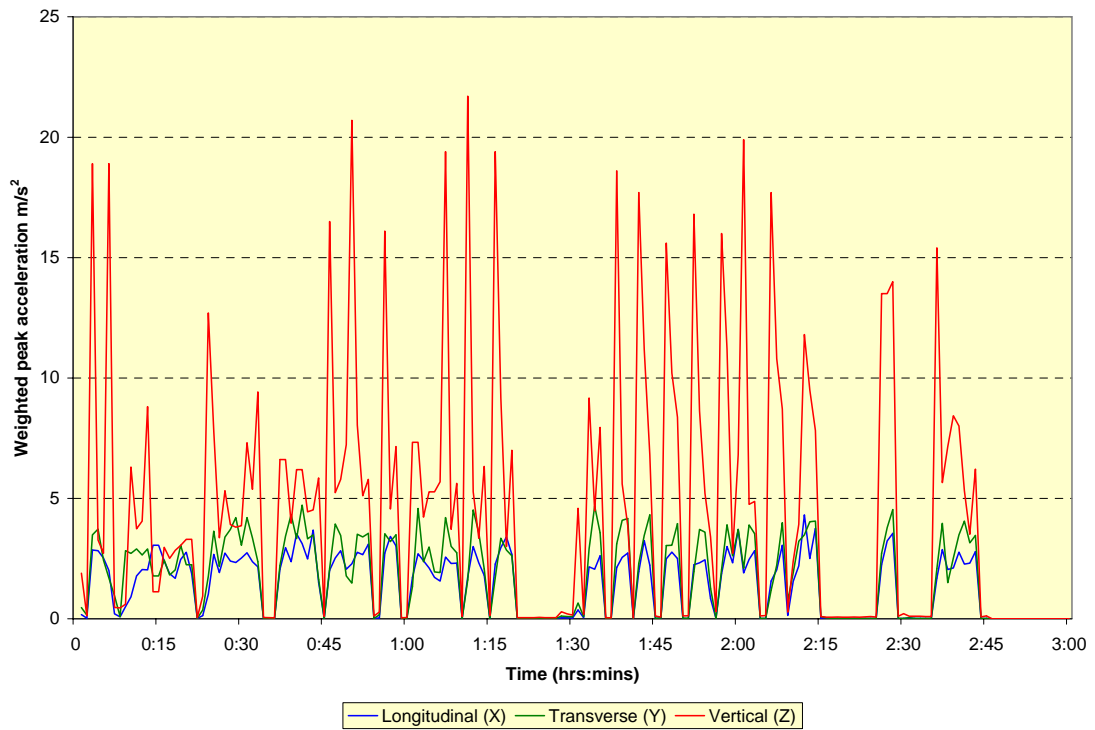
Figure A1.11.7 Linde 2.5 tonne fork lift truck:- time histories of weighted 1-minute peak seat accelerations (X, Y and Z-axes)

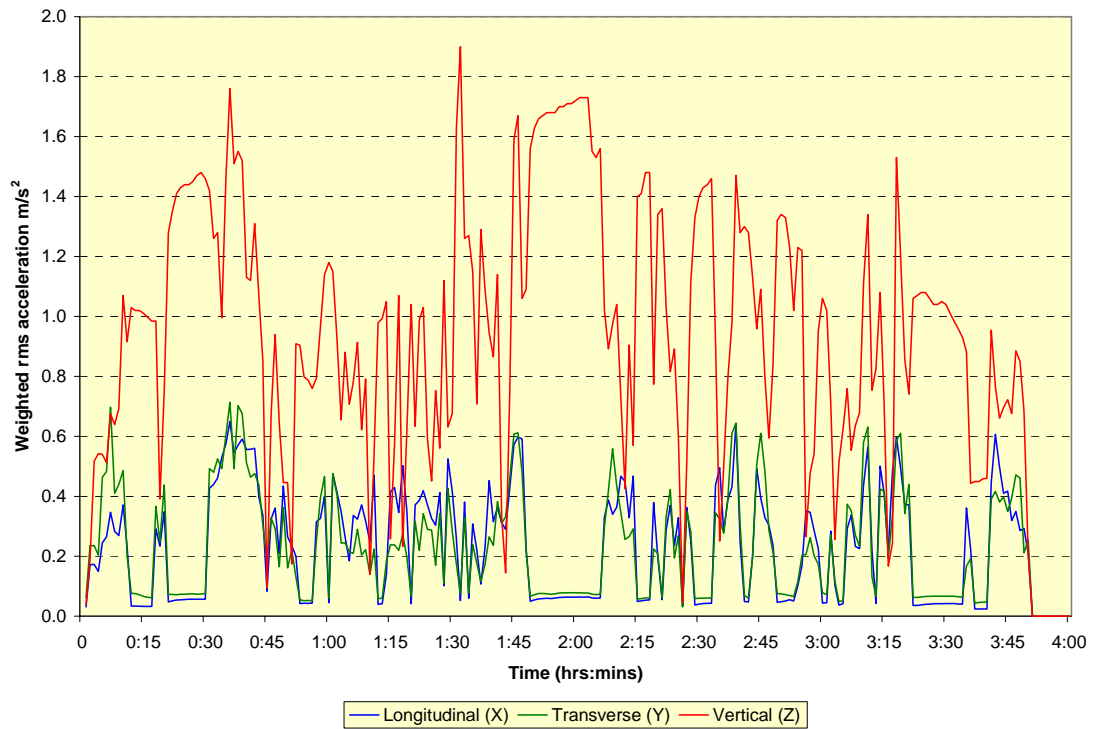
Figure A1.12.4 CAT D70 6.5 tonne fork lift truck:- time histories of weighted 1-minute rms seat accelerations (X, Y and Z-axes)

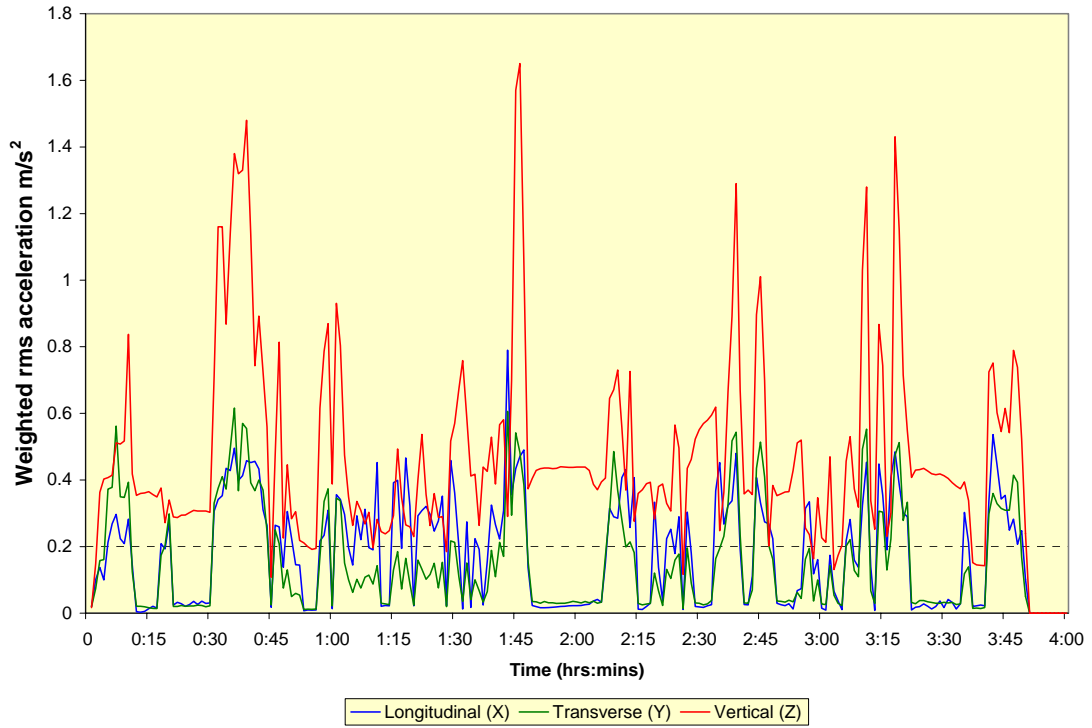
Figure A1.12.6 CAT D70 6.5 tonne fork lift truck:- time histories of weighted 1-minute rms floor accelerations (X, Y and Z-axes)

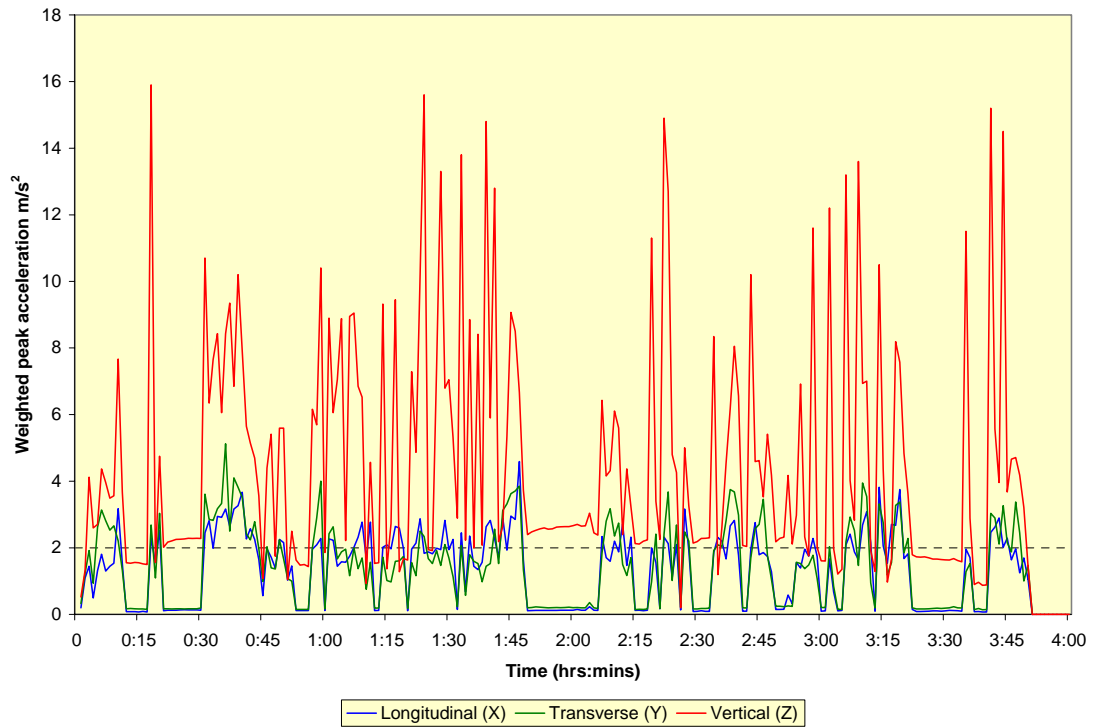
Figure A1.12.7 CAT D70 6.5 tonne fork lift truck:- time histories of weighted 1-minute peak seat accelerations (X, Y and Z-axes)

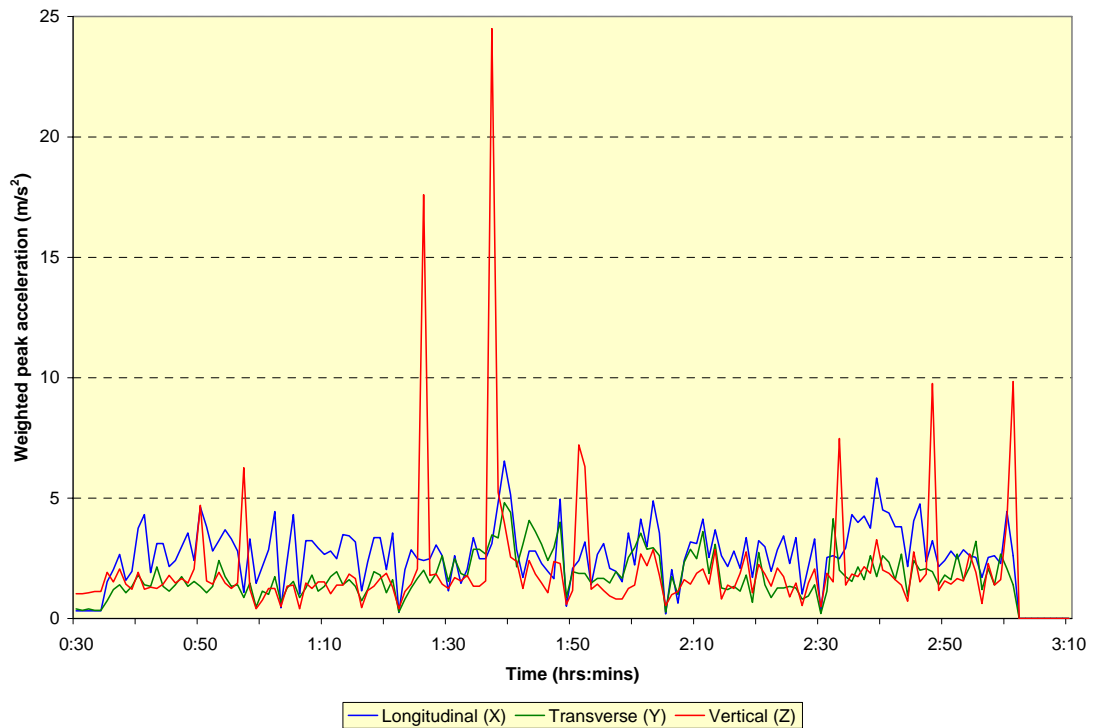
Figure A1.13.4 Volvo EC15B compact 360° excavator:- time histories of weighted 1-minute peak seat accelerations (X, Y and Z-axes)

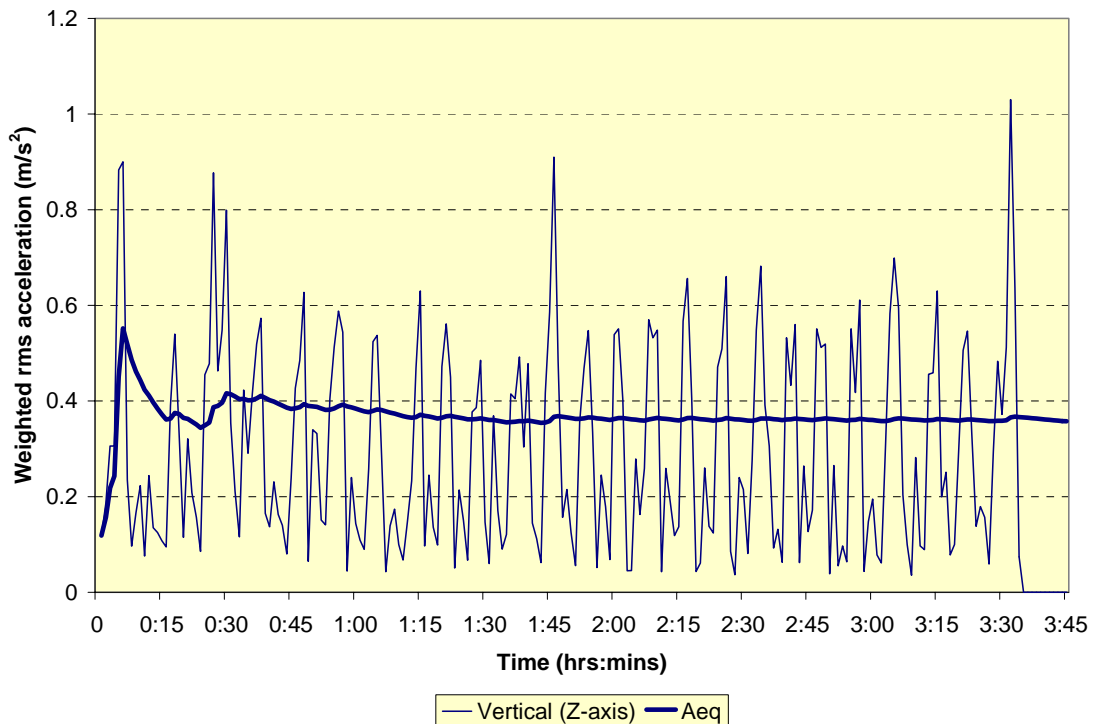
Figure A1.14.2 CAT Rigid Dump Truck:- time history of weighted 1-minute rms seat accelerations (Z-axis) and equivalent continuous rms acceleration (Aeq)

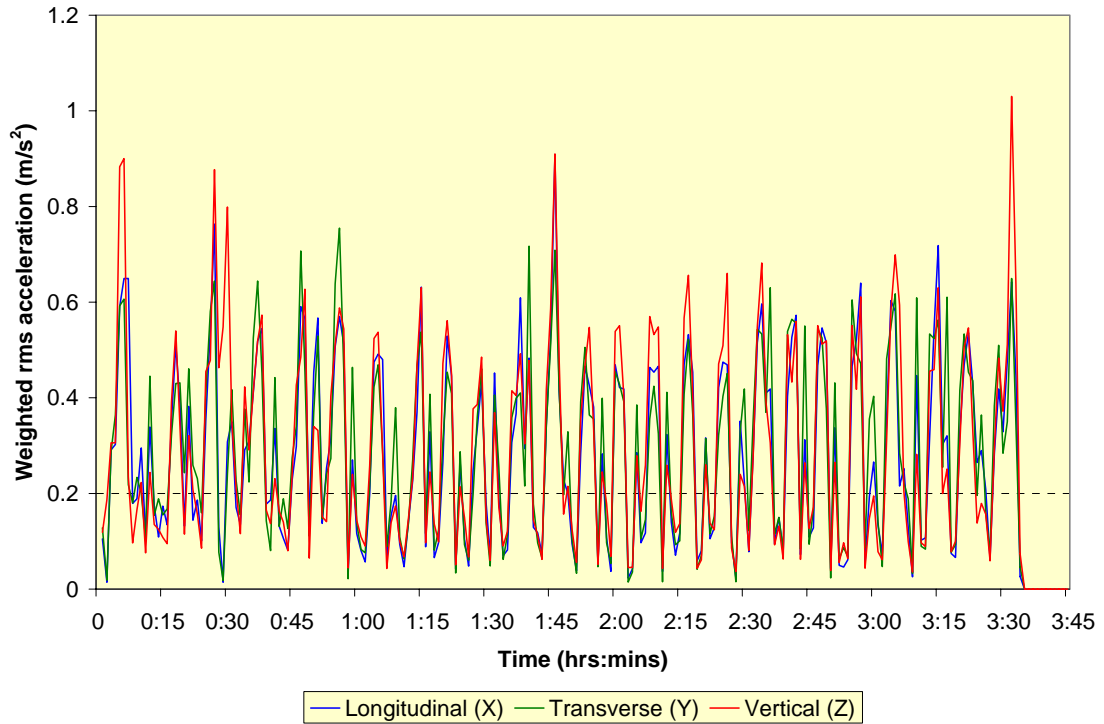
Figure A1.14.3 CAT Rigid Dump Truck:- time histories of weighted 1-minute rms seat accelerations (X, Y and Z-axes)

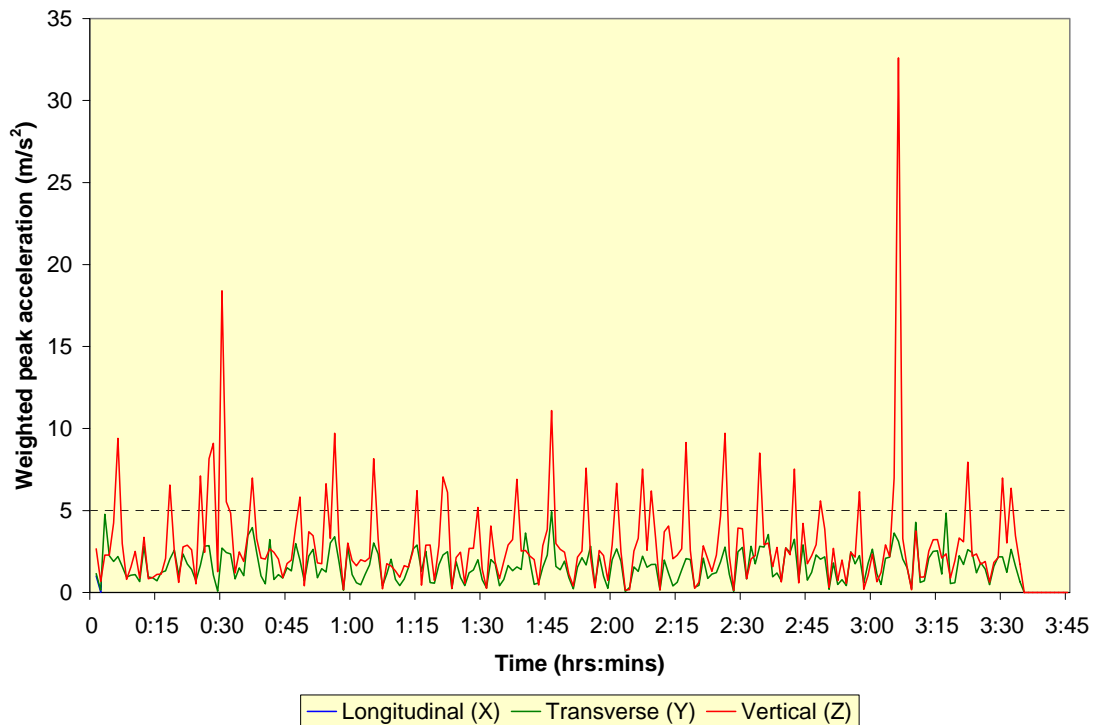
Figure A1.14.4 CAT Rigid Dump Truck:- time histories of weighted 1-minute peak seat accelerations (X, Y and Z-axes)

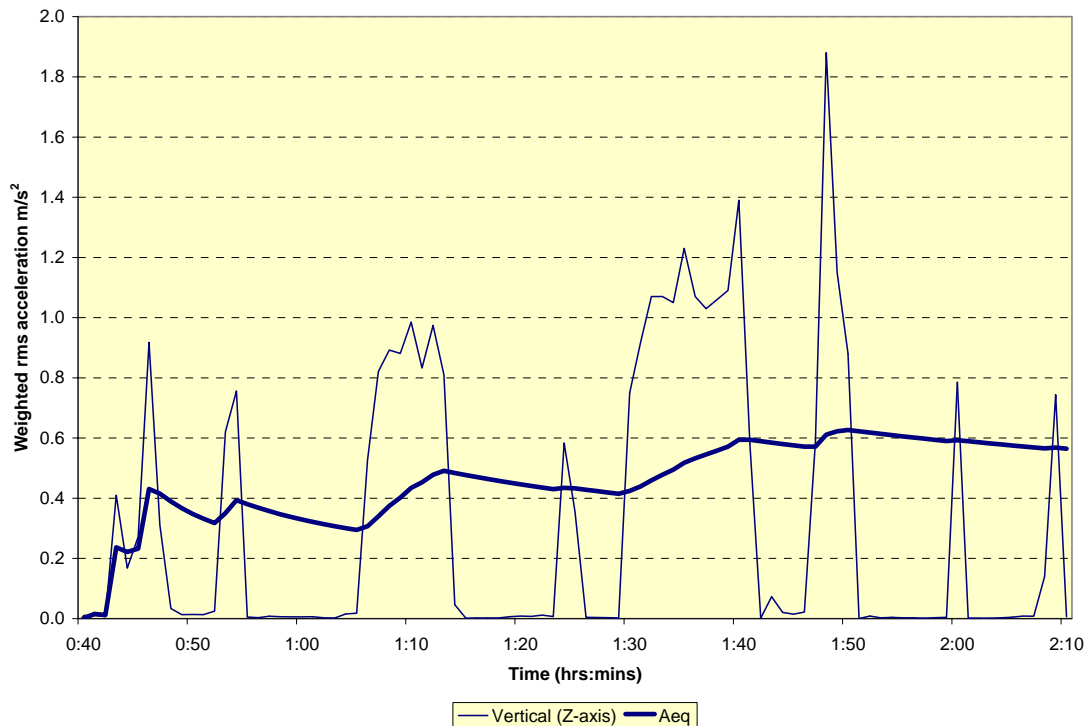
Figure A1.15.2 CAT Skidsteer Loader:- time history of weighted 1-minute rms seat accelerations (Z-axis) and equivalent continuous rms acceleration (Aeq)

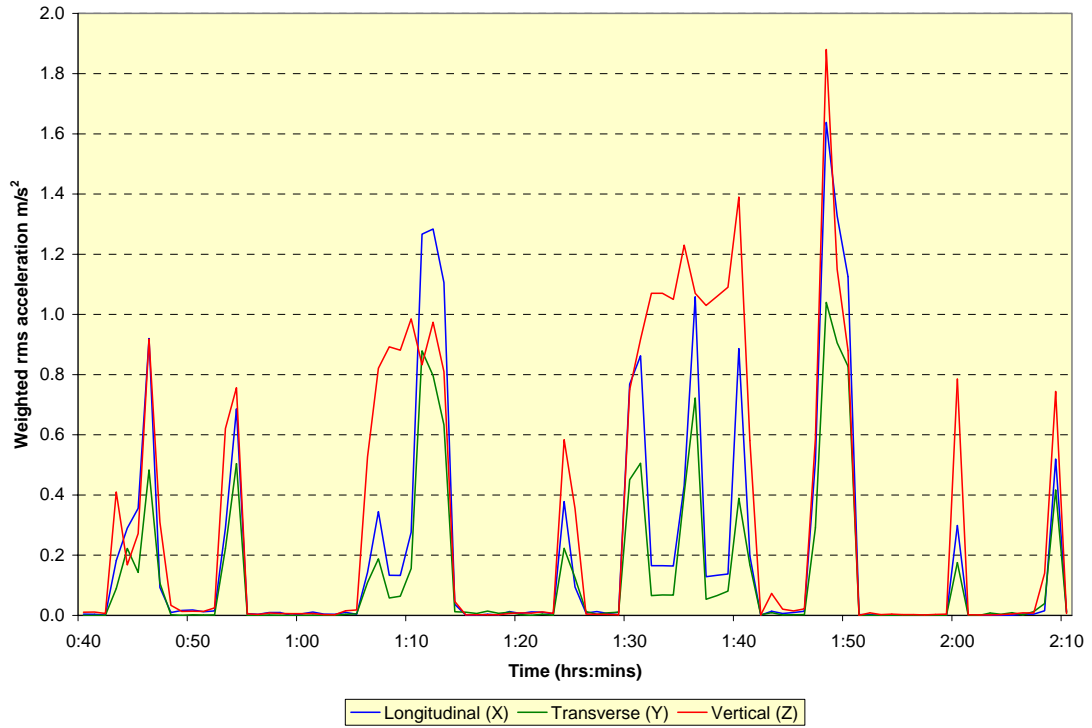
Figure A1.15.3 CAT Skidsteer Loader:- time histories of weighted 1-minute rms seat accelerations (X, Y and Z-axes)

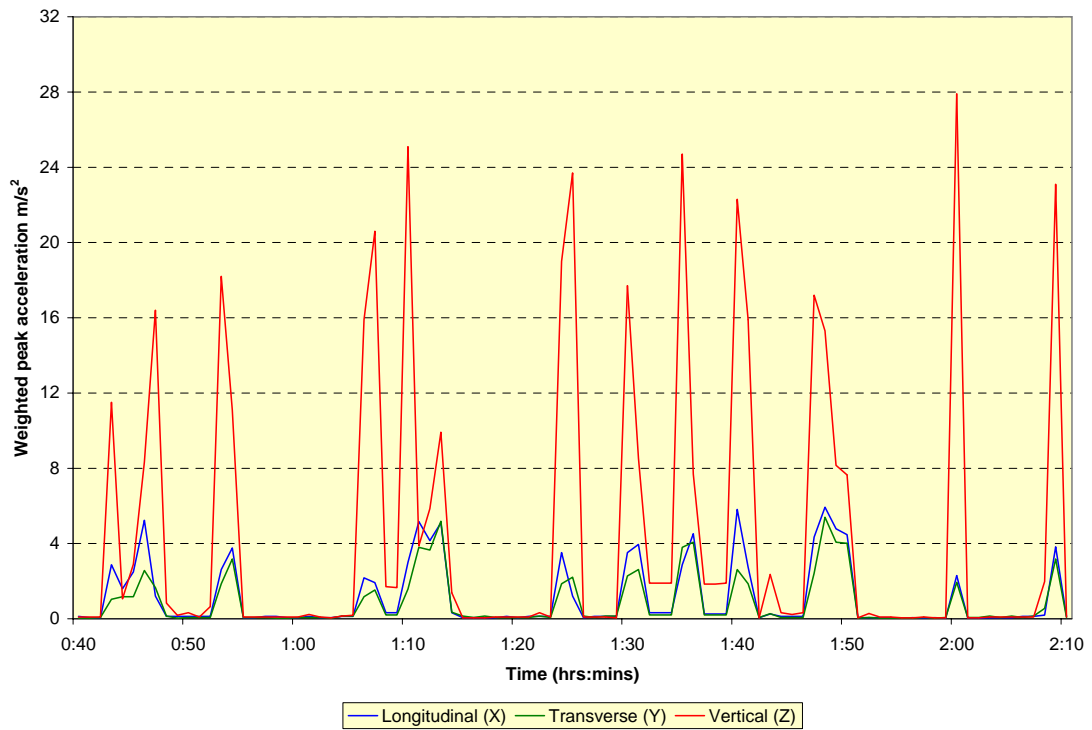
Figure A1.15.4 CAT Skidsteer Loader:- time histories of weighted 1-minute peak seat accelerations (X, Y and Z-axes)

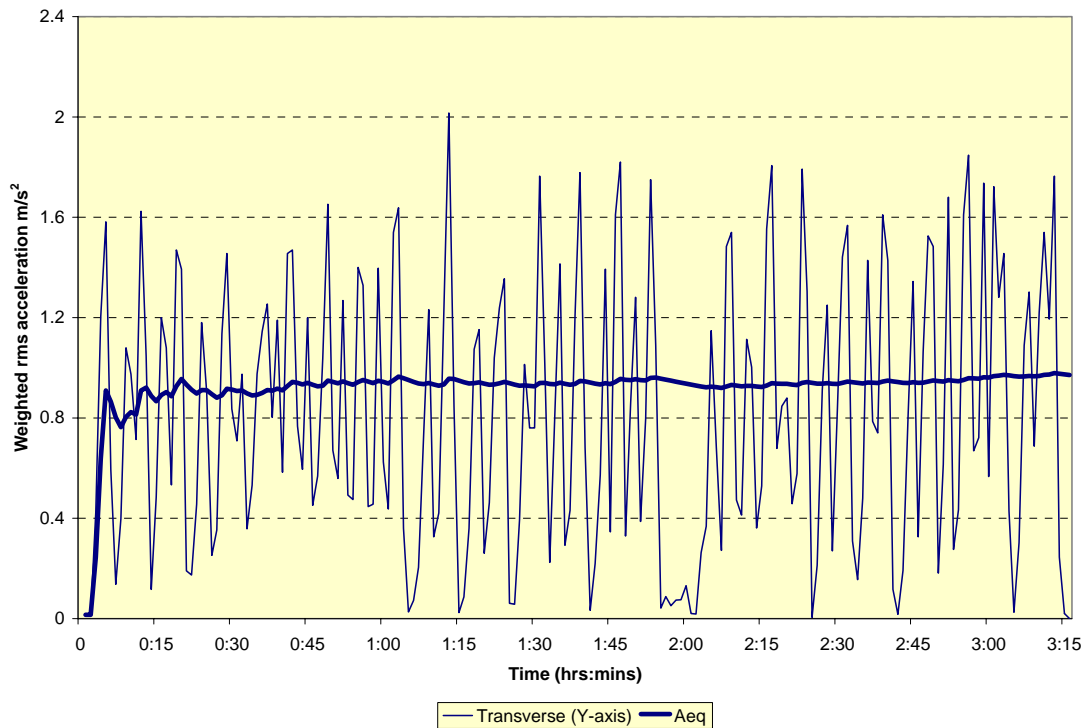
Figure A1.16.3 CAT Wheeled Scraper:- time history of weighted 1-minute rms seat accelerations (Z-axis) and equivalent continuous rms acceleration (Aeq)

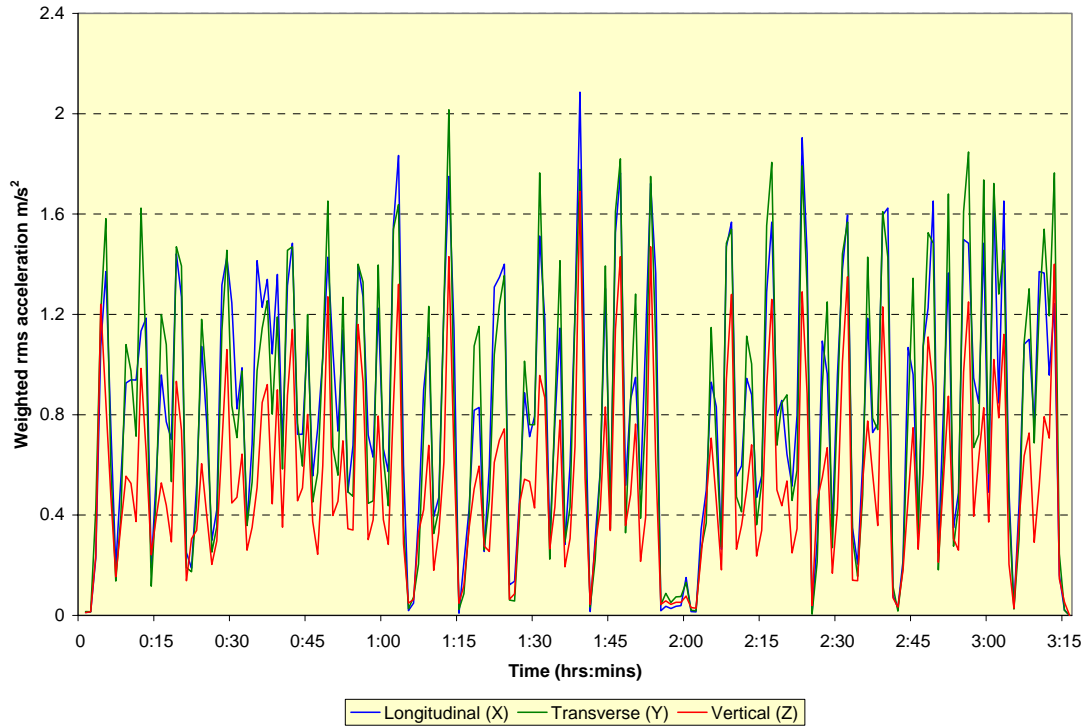
Figure A1.16.4 CAT Wheeled Scraper:- time histories of weighted 1-minute rms seat accelerations (X, Y and Z-axes)

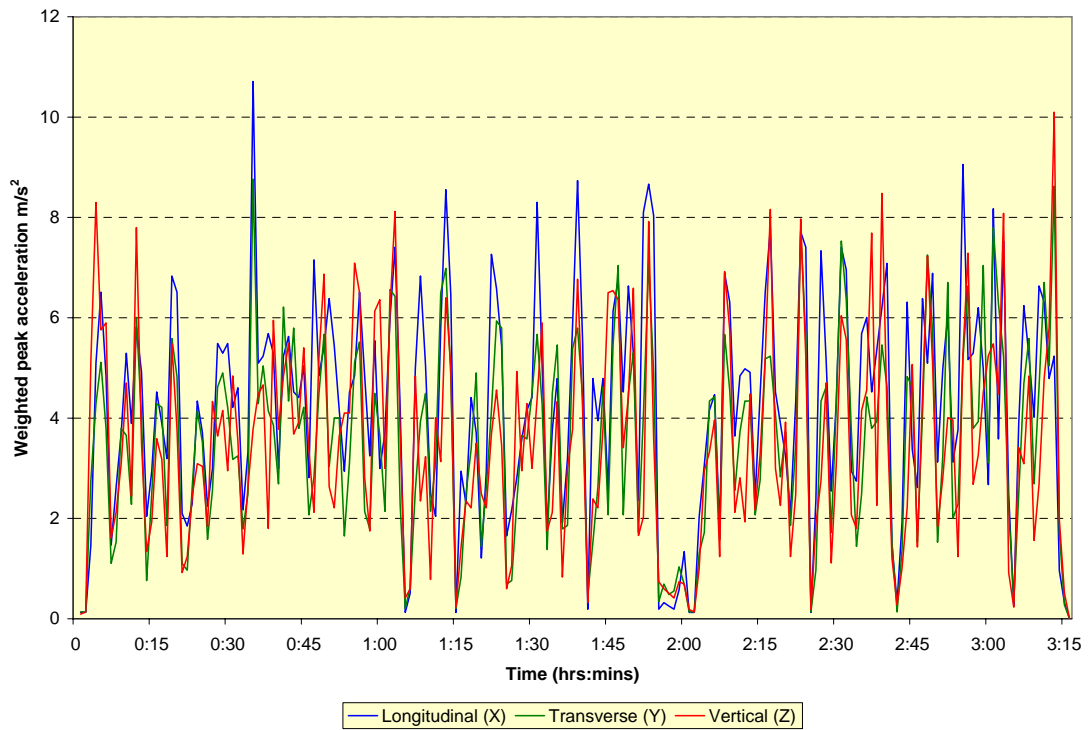
Figure A1.16.5 CAT Wheeled Scraper:- time histories of weighted 1-minute peak seat accelerations (X, Y and Z-axes)
