**ROTARY FUEL INJECTION PUMP WEAR TESTING
USING A 30%/70% ATJ/F-24 FUEL BLEND**

**INTERIM REPORT
TFLRF No. 488**

**U.S. Army TARDEC Fuels and Lubricants Research Facility
Southwest Research Institute® (SwRI®)
San Antonio, TX**

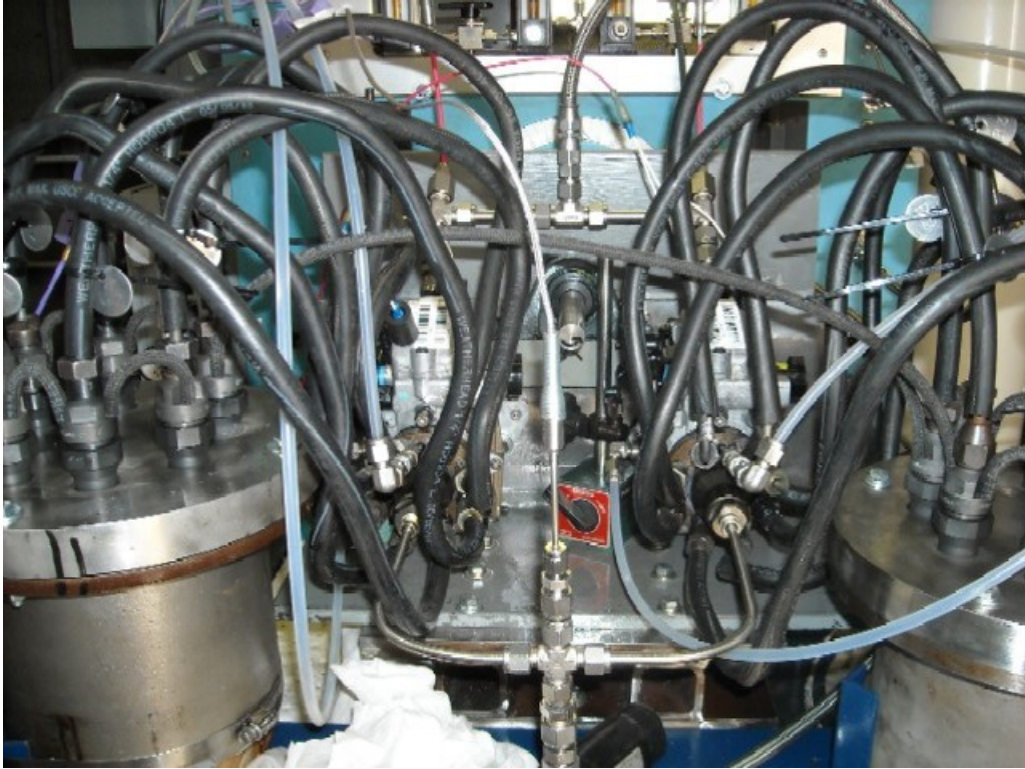
Figure 3. Dual Stanadyne Rotary Fuel Injection Pumps Mounted on Stand with Fuel Injectors

The high-pressure outlets from the pumps were connected to eight Bosch Model O432217276 fuel injectors for a 6.5LT engine and assembled in a collection canister. Fuel from both canisters was then returned to the 55-gallon drum. A separate line was used to return excess fuel from the governor housing to the fuel supply. Fuel-to-water heat exchangers on both the return lines from the injector canisters and the governor housing were used to cool the fuel. The test stand with pumps mounted is shown in Figure 3.

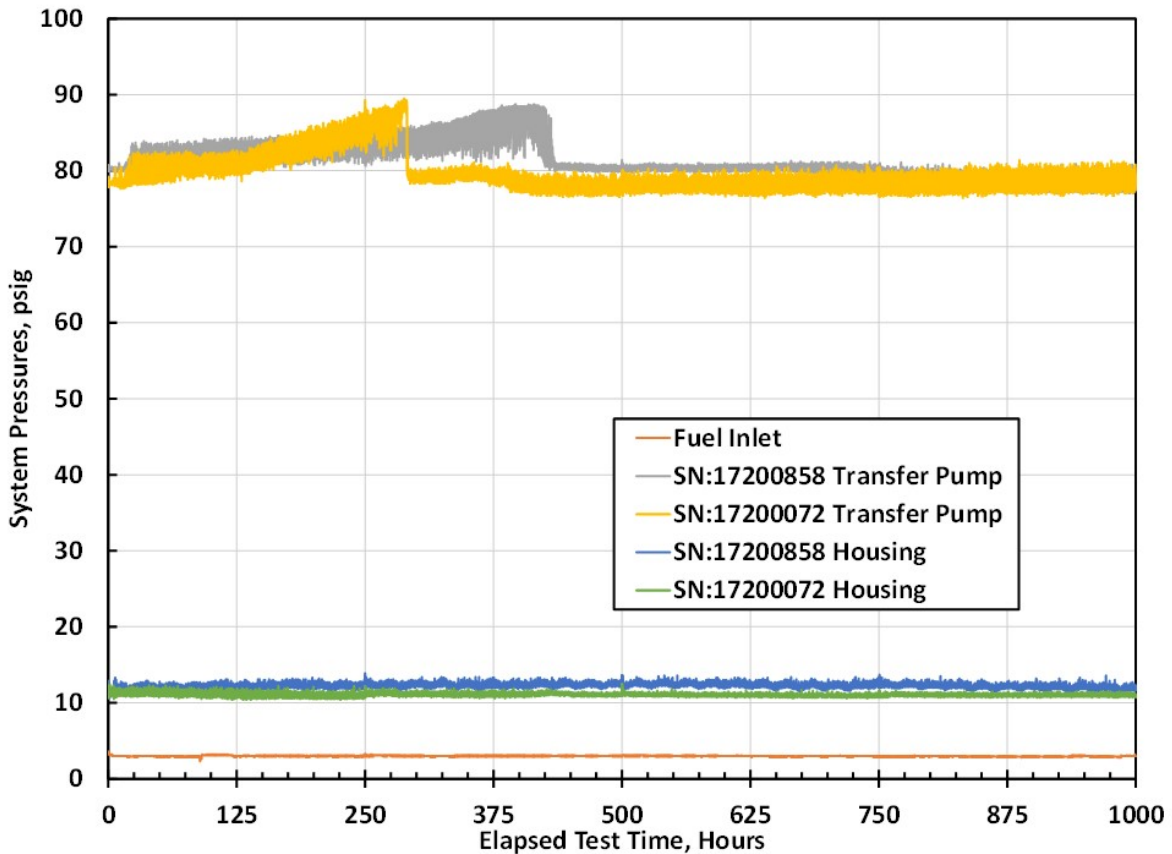
Figure 11. Injection Pump Pressure Histories for 30/70 ATJ/F-24 with 24-ppm CI/LI Fuel Evaluation at 40 °C

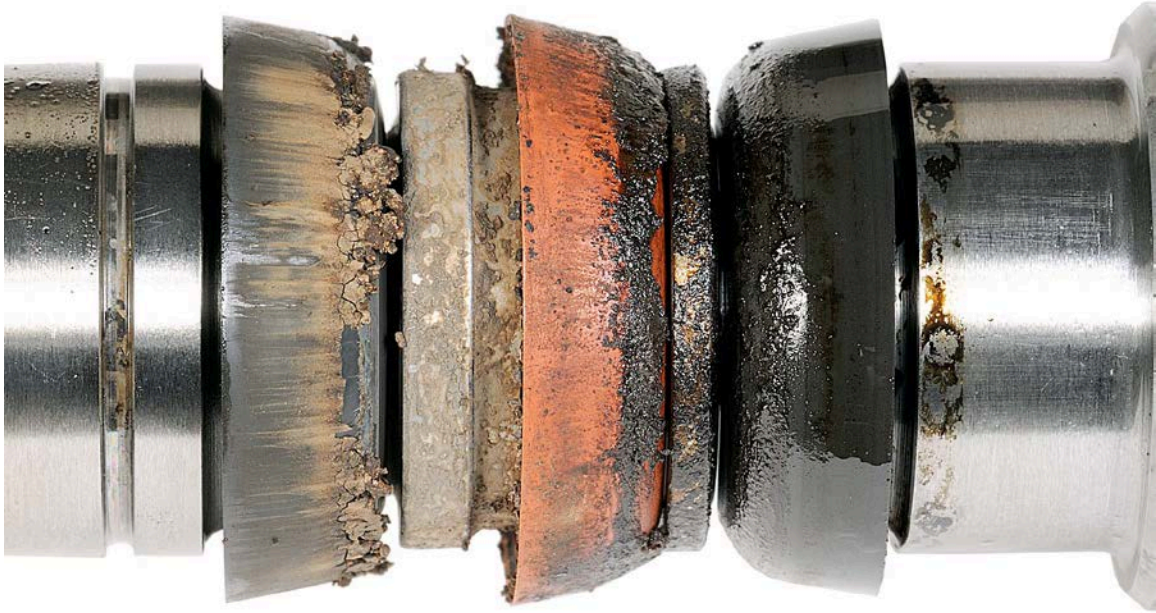
Figure 16. Pump SN:17200043 Driveshaft Seal Deposits with 1000-Hours Testing with 30/70 ATJ/F-24 with 24-ppm CI/LI Fuel at 77 °C

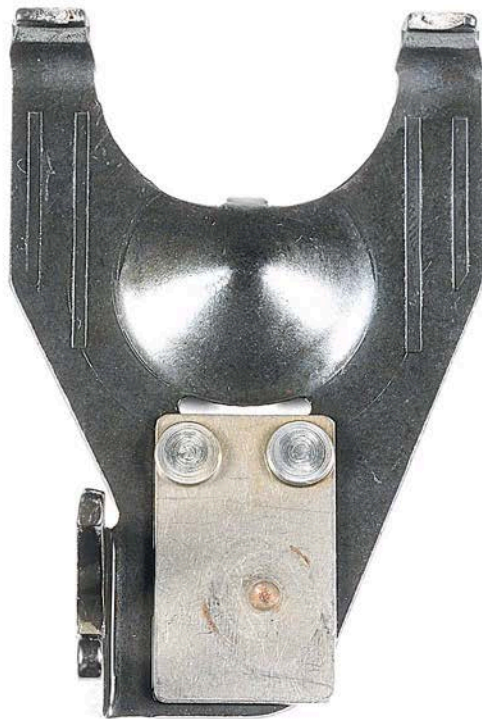
Figure 17. Pump SN:17200043 Governor Fork Wear on Tines and Tab with 1000-Hours Testing with 30/70 ATJ/F-24 with 24-ppm CI/LI Fuel at 77 °C

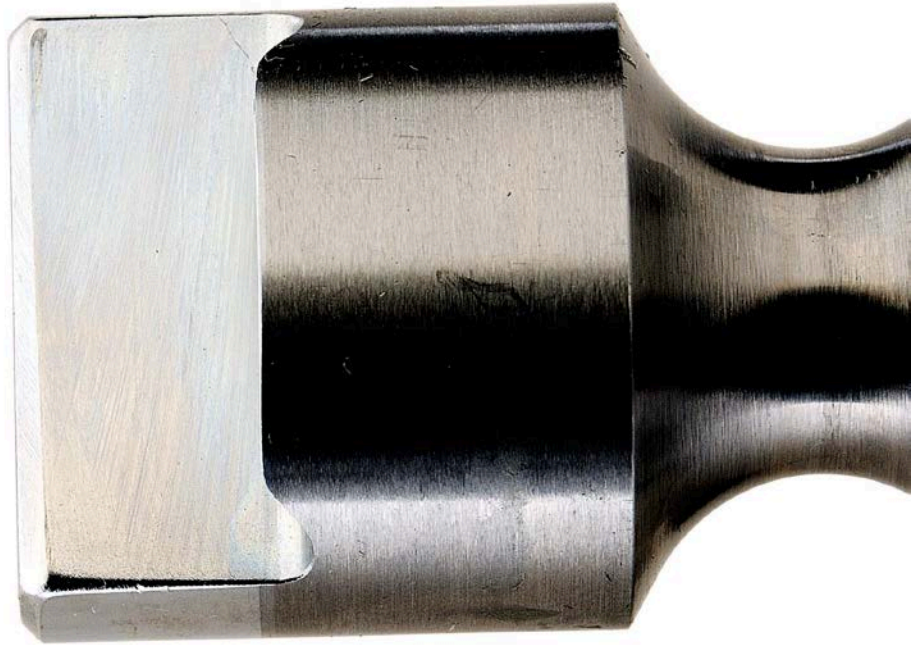
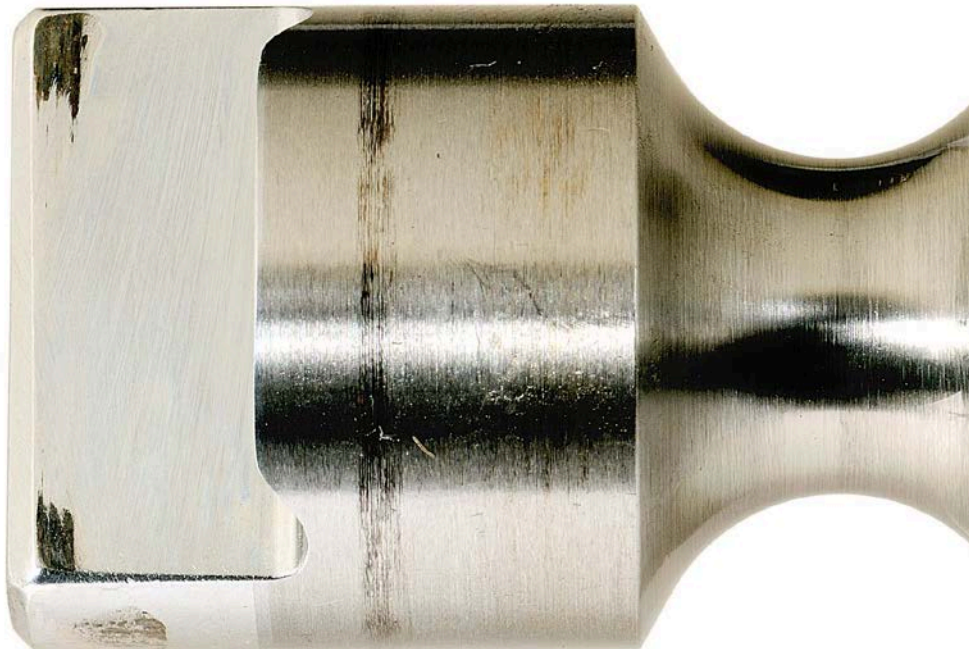
Figure 32 and Figure 33 show the condition of the injection pump drive shaft drive tang that transmits torque to the hydraulic section of the pump from the engine. Figure 32 and Figure 33 reveal only minor wear scars that indicates backlash and timing were not affected with the ATJ/F-24 fuel with 24-ppm CI/LI at elevated temperature after 1000-hours.

Figure 32. Pump SN:17200043 Driveshaft Drive Tang before Testing with 30/70 ATJ/F-24 with 24-ppm CI/LI Fuel at 77 °C

Figure 33. Pump SN:17200043 Driveshaft Drive Tang with 1000-Hours Testing with 30/70 ATJ/F-24 with 24-ppm CI/LI Fuel at 77 °C

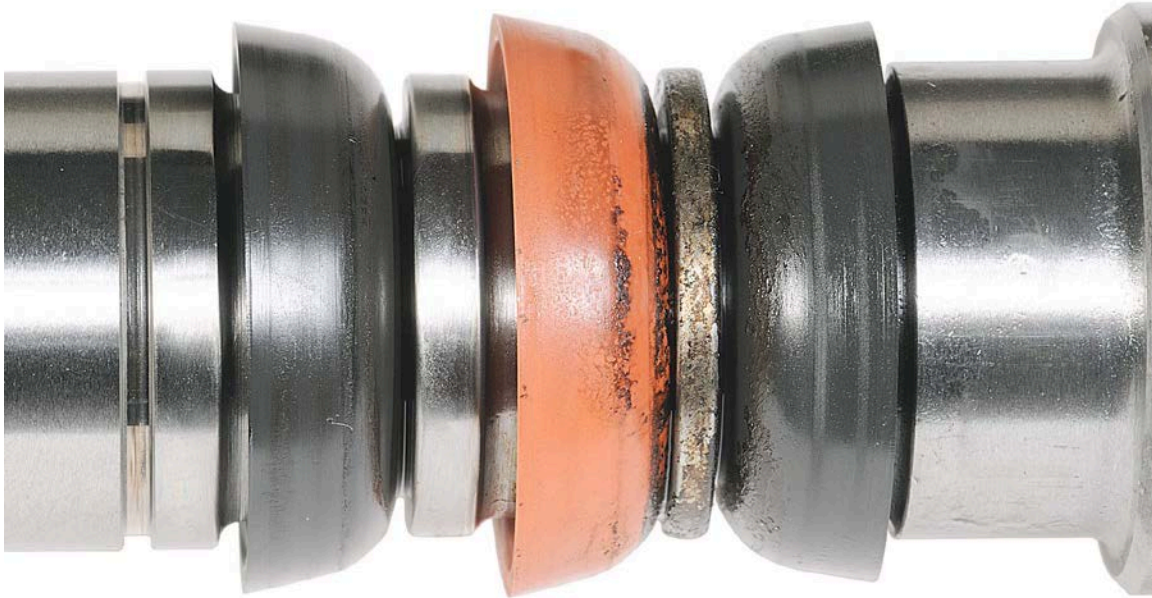
Figure 36. Pump SN:17200045 Driveshaft Seal Deposits with 1000-Hours Testing with 30/70 ATJ/F-24 with 24-ppm CI/LI Fuel at 77 °C

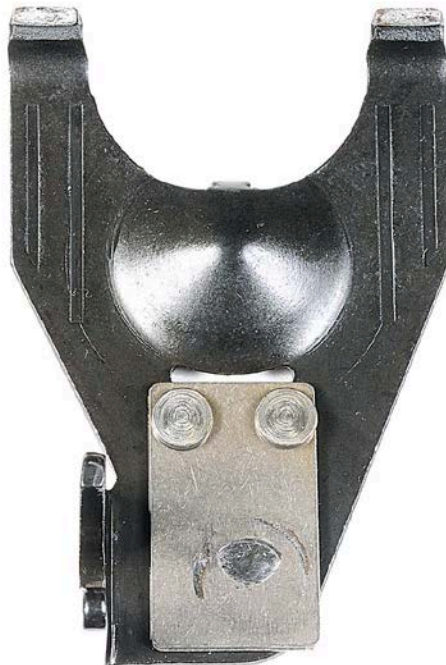
Figure 37. Pump SN:17200045 Governor Fork Wear on Tines and Tab with 1000-Hours Testing with 30/70 ATJ/F-24 with 24-ppm CI/LI Fuel at 77 °C

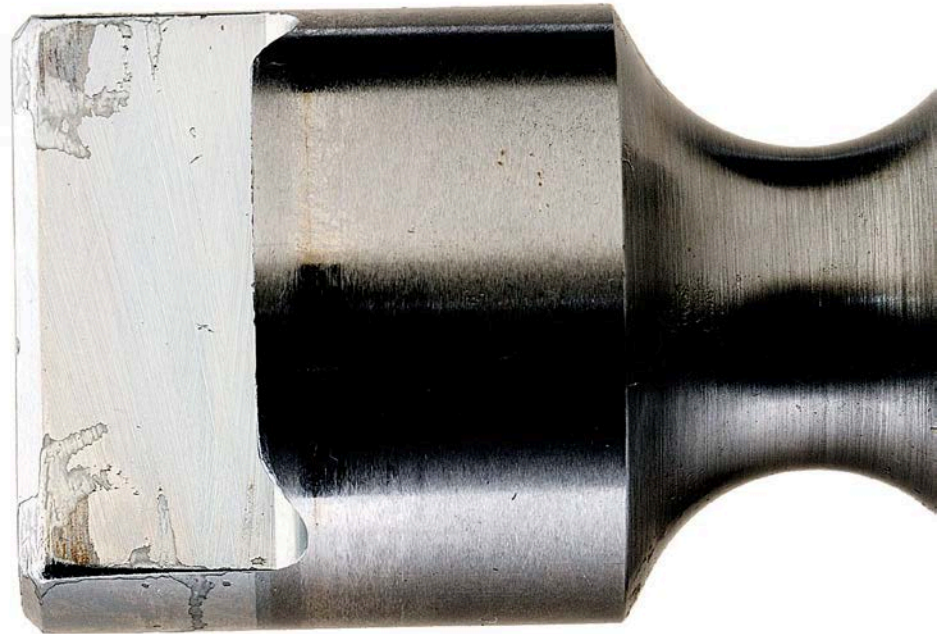
Figure 52 and Figure 53 show the condition of the injection pump drive shaft drive tang that transmits torque to the hydraulic section of the pump from the engine. Of interest is the new drive tang in Figure 52 reveals unusual surface conditions for a new part. Figure 53 reveals a moderate wear scar that indicates some backlash was occurring. For both pumps the cumulative effect of all the worn components contributed to the performance degradation with the ATJ/F-24 fuel with 24-ppm CI/LI at 77 °C fuel inlet temperature.

Figure 52. Pump SN:17200045 Driveshaft Drive Tang before Testing with 30/70 ATJ/F-24 with 24-ppm CI/LI Fuel at 77 °C

Figure 53. Pump SN:17200045 Driveshaft Drive Tang with 1000-Hours Testing with 30/70 ATJ/F-24 with 24-ppm CI/LI Fuel at 77 °C
