RTS EUROPE Ltd TWIN FRICTION INSTALL GUIDELINES AND CLUTCH SYSTEM TROUBLESHOOTING

Main Examples of Install Error or Driver Mis-Use

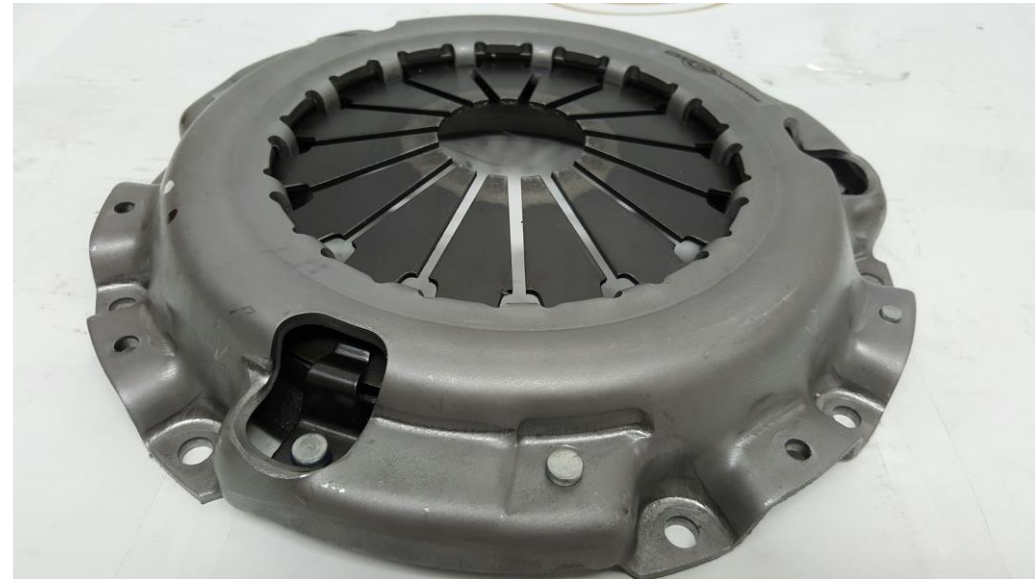
RTS EUROPE Ductile Steel Clutch Covers

Ductile Steel can be bent without breaking, whereas **cast iron is brittle** and breaks when bent. ... **Ductile Steel** consists of **Steel**, carbon, silicon, manganese, magnesium, phosphorous and sulphur. Tin and copper are also sometimes found. **Ductile iron** also consists of nodular graphite, which gives it flexibility. Cheaper / lower grade brands use Cast Iron covers as it's a cheaper alternative and most often are made in either China or the Far East. Cast Iron covers are mass produced and often are designed to fit multiple applications to save on cost. RTS Ductile Steel Clutch Covers are designed to fit each application only. We never use Rationalised designs unlike many competitive brands.

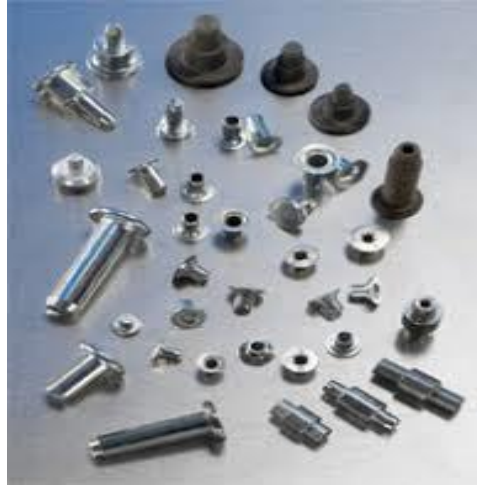
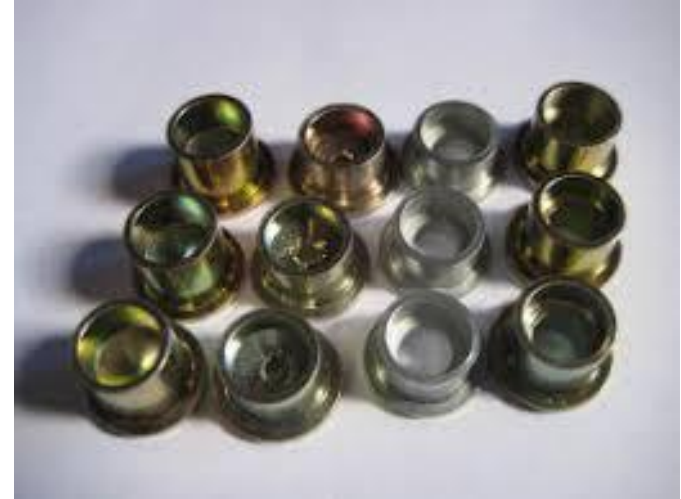
Clutch Rivets

The rivets and spacers are plated in chrome free zinc (5 microns zinc and enhanced trivalent passivation.). Alternatively they can be finished to suit customer requirements. Most standard sizes are held in stock. All clutch applications use OE rivet specifications. All riveting and Friction plate building is carried out in the United Kingdom and not mass produced. Each Clutch Cover and Friction plate whether standard or performance are balanced and a full run off test is carried out at our Cheshire Engineering facility.

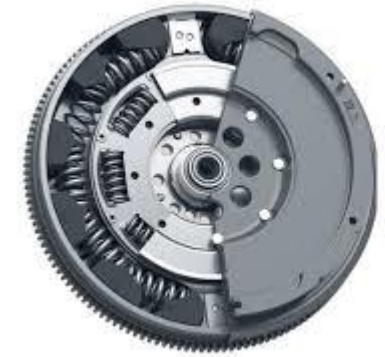
Dual Mass Flywheels - Bulletin

The Dual Mass Flywheel (DMF) is designed to isolate torsional crankshaft pikes created by diesel engines with high compression ratios. By separating the mass of the flywheel between the diesel engine and the transmission, torsional spikes can be isolated, eliminating potential damage to the transmission gear teeth.

The damper springs that are visible on the engine side of the DMF are designed to dampen heavy torsional spikes that occur when the diesel engine's torsional frequency matches the torsional frequency of the transmission. When the torsional frequencies match (have the same amplitude), severe damage can occur to the transmission if not isolated. These flywheels isolate the torsional frequency match between the engine and transmission to an rpm range below the operating range of the engine (usually 200-400 rpm). These springs only work hard when the engine passes through 200-400 rpm when the vehicle is being either started or shut down.

The DMF damper springs and/or the nylon retainers usually fail because the diesel engine is not running correctly. Bad fuel injectors, worn piston rings, bad valves, etc., will change the resonant frequency of the engine. A change in the resonant frequency of the engine can force the torsional frequency match between the engine and the DMF to fall within the operating range of the engine. This forces the damper springs to work continuously, resulting in failure.

The friction ring located between the inner and outer flywheel is designed to allow the inner and outer flywheel to slip. This feature saves the transmission from damage when torque loads exceed the vehicle rating of the transmission. The friction ring will wear out if excessive torque loads are continuously applied. Loading the vehicle beyond the rated load capacity is often the root cause of friction ring failures in Dual Mass Flywheels.

A sealed double row center ball bearing carries the load between the inner and outer halves of the DMF. The leading cause of center bearing failure is often related to out of balance vibration caused by not aligning the pressure plate with the DMF dowel pins. The center bearing may also fail if a worn transmission input shaft destroys the clutch pilot bearing or if the rated load/towing capacity of the vehicle is exceeded.

The pilot bearing supplied is a caged needle roller bearing. If it fails, the transmission input shaft must be repaired or replaced. If the input shaft is not repaired correctly or replaced, the lack of input shaft support will result in DMF Center Bearing failure

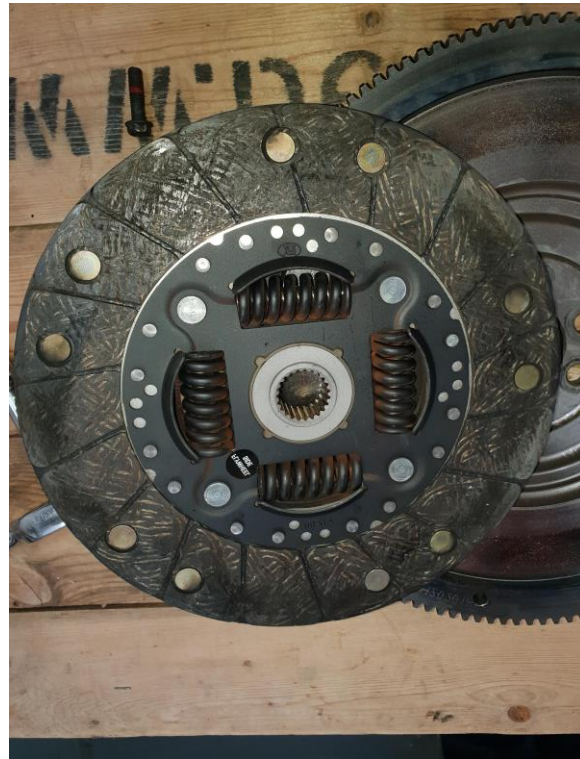
Miss-Aligned Friction plate showing inconsistent wear on the edge of the friction plate. No consistent wear visible.

From 01/12/2019 RTS Europe Ltd will not be accepting any returns of Twin friction Self Adjusting Clutch applications unless proof of the correct SAC alignment tool has been used. (Part no. 400 0237 10)

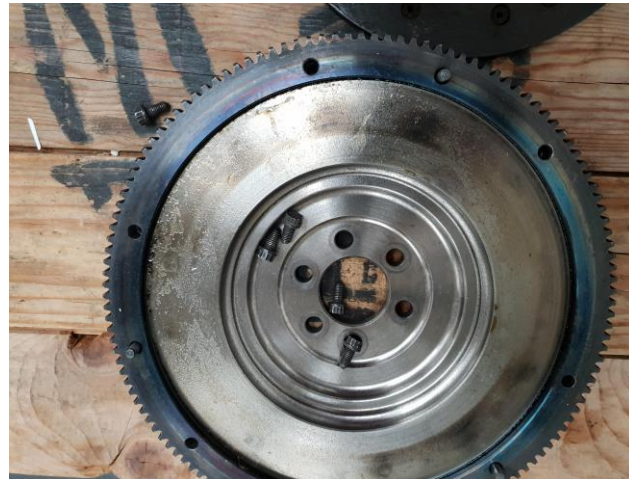
Left:

Flywheel with inconsistent heat marks. This is a classic case of miss-alignment as the clutch has not been installed with the correct alignment (part no. 400 0237 10) for assembling the clutch

Right:

Flywheel with consistent wear correctly lined up too clutch kit.

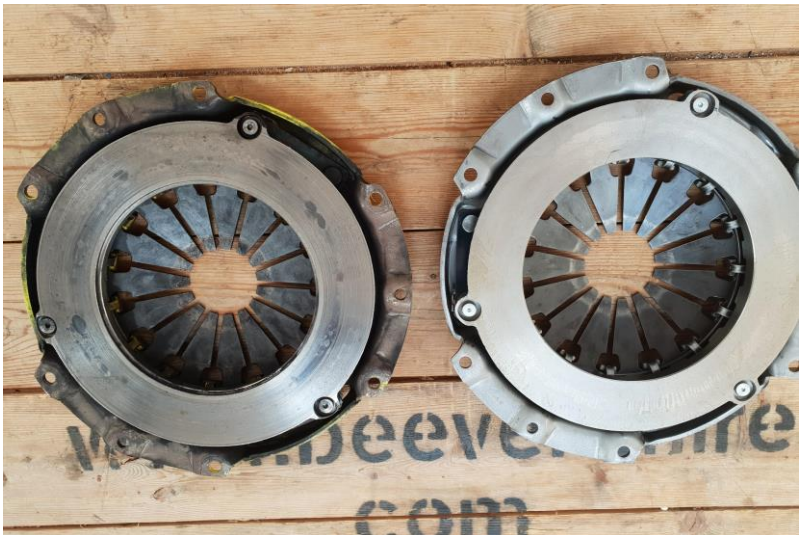
Contamination of Friction plate:

Oil and grease have contaminated the friction paddle segments resulting in slippage. You can see oil and grease marks on each pad with grease contamination on the Hub core. This can be caused by install error, damaged CSC or other transmission parts failing around the clutch.

Comparison of a new clutch cover and a contaminated clutch cover. This contamination has been moved from the friction plate to the cover and has now effected the clutches performance.
