“1/4 Scale” Ballistic Evaluation Motor (BEM)

4<sup>th</sup> Static firing report

Rev. 2007/01/28

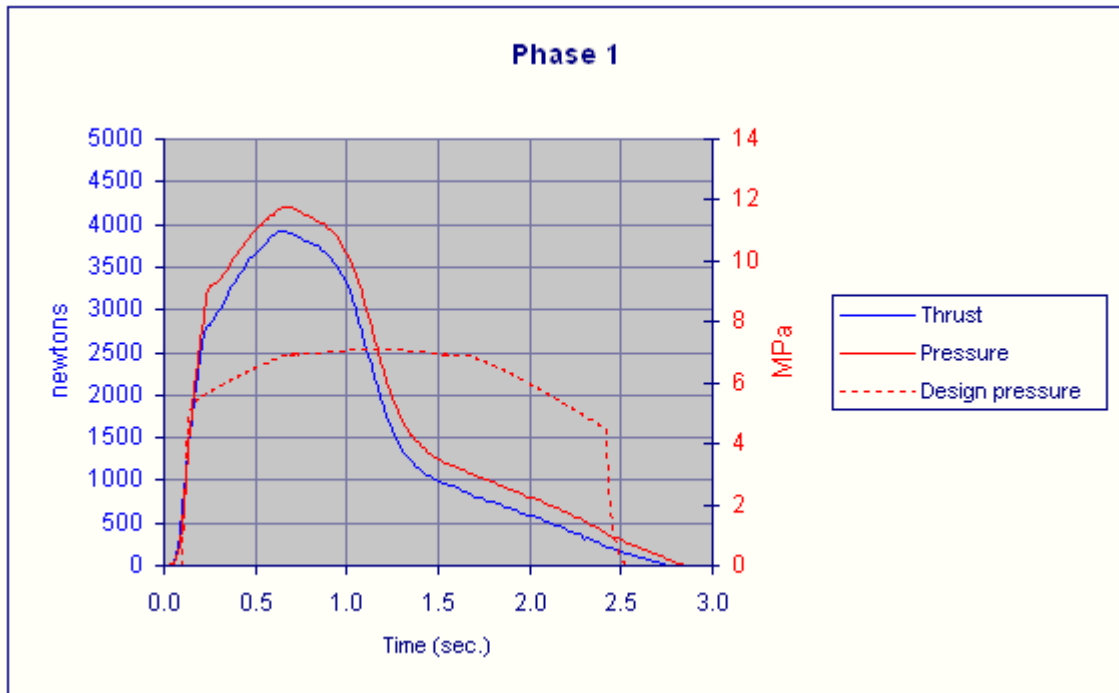
**Figure 1b –1<sup>st</sup> phase thrust and chamber pressure data (SI units)**

Data was successfully collected for thrust, chamber pressure, and casing temperature. The thrust and pressure curves are shown in Figures 1 and 2. The design pressure, as determined by SRM.XLS, is shown for comparison. Clearly, the 1<sup>st</sup> phase firing experienced erosive burning with enhanced burn rate which produced a chamber pressure well in excess of the MEOP. The 2<sup>nd</sup> phase thrust and pressure curves exhibit behaviour closer to the design condition. However, it can be seen by the slow ramp up that delayed ignition was apparent. It is possible that some or all of the propellant segment end faces did not ignite immediately. Spikes can be seen in the 2<sup>nd</sup> phase pressure and thrust curves, near the end of the burn. These spikes coincide with “blackish” smoke that momentarily issued from the nozzle, as seen in the videos. As such, it is probable that the spikes were a result of inhibitor or insulation material being expelled through the nozzle.

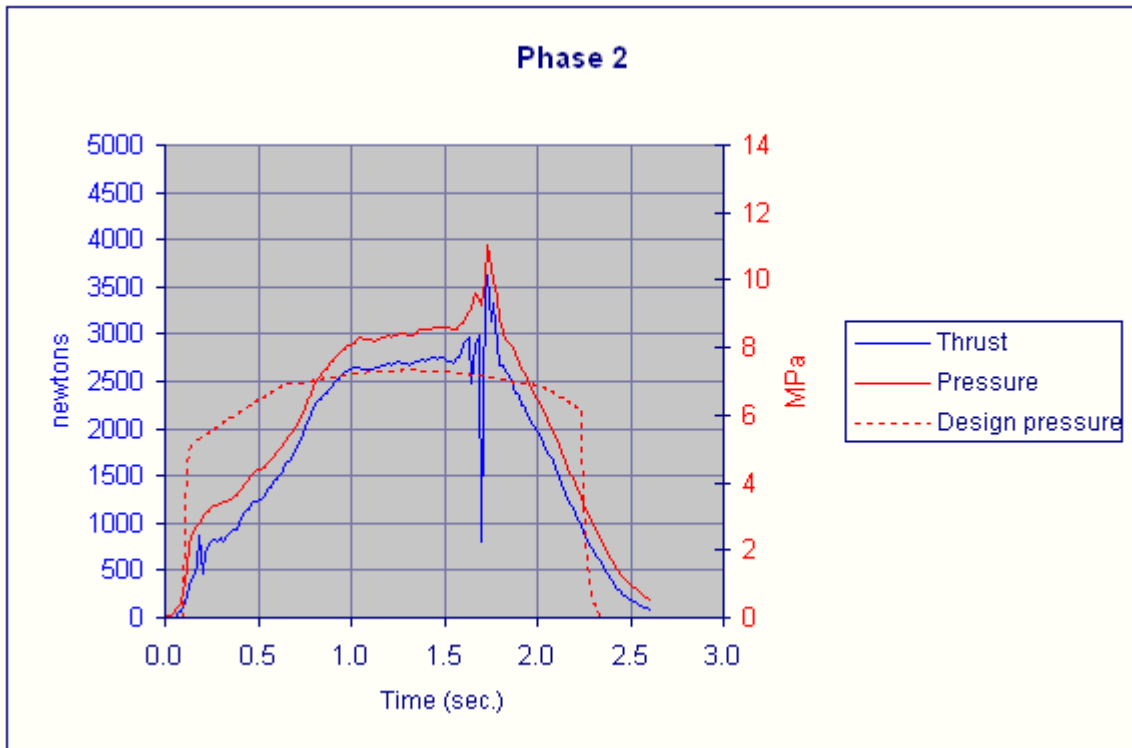
**Figure 2b – 2<sup>nd</sup> phase thrust and chamber pressure data (SI units)**

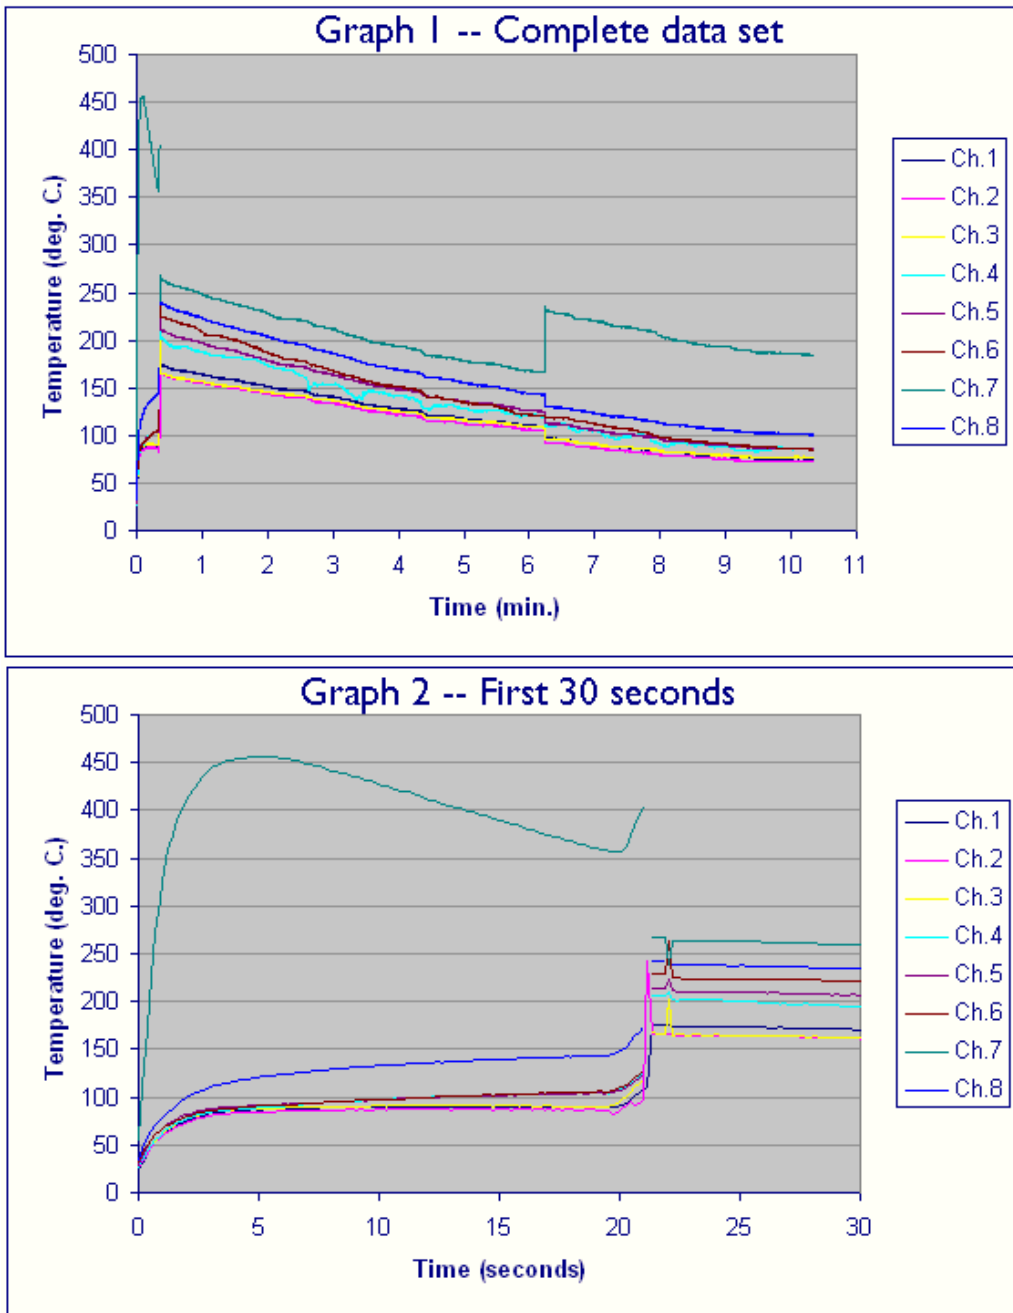
**Figure 3 – Thermal data. Note: Sensors #4 & #5 were mounted on opposite sides of the motor and sensor #7 on nozzle throat**

Thermal data is shown in Figure 3. Maximum temperature on the casing outer surface was maintained below 150° C. (300° F) prior to 2<sup>nd</sup> phase firing. As soon as the 2<sup>nd</sup> phase began firing, the rise in casing temperature was extreme. This was immediately followed by an apparent fault in the thermal data acquisition, and the temperatures recorded following this event were clearly invalid. A similar fault occurred approximately 6 minutes later during motor cool down. The exact reason for the fault is currently unknown, however, it is speculated that attachment of the thermocouples directly to the conductive metallic casing could be to blame.

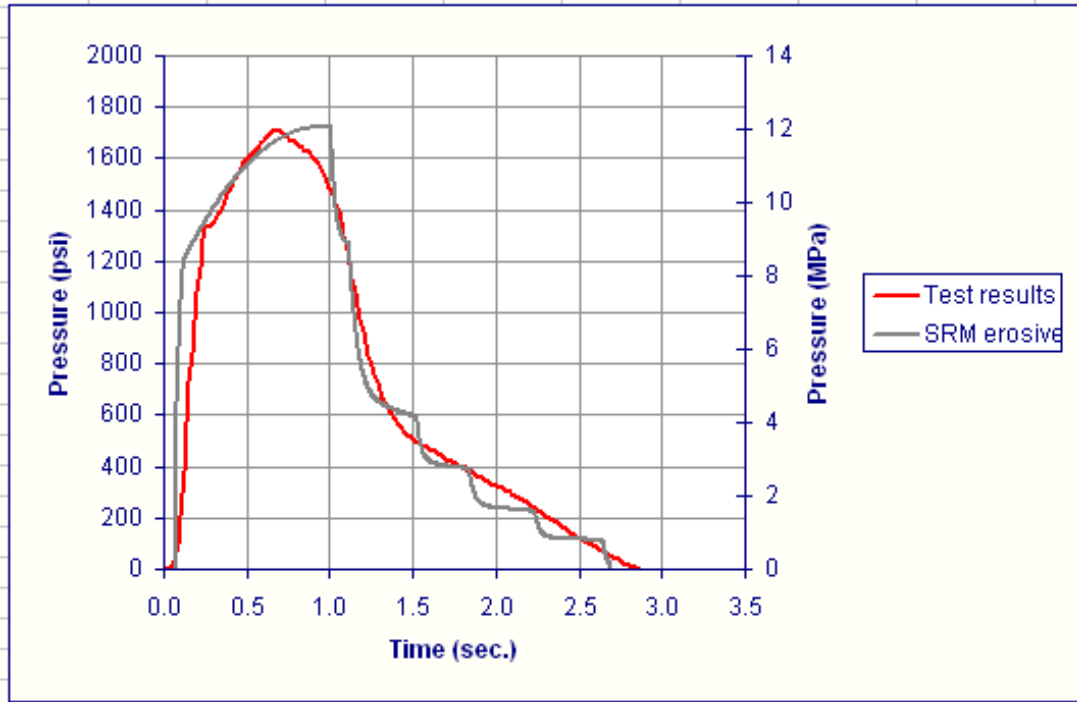
Figure 4 – Comparison of actual 1<sup>st</sup> phase pressure curve to SRM.XLS simulation with erosive burning

To determine if “conventional” erosive burning was responsible for the 1<sup>st</sup> phase pressure/thrust profile, the erosive burning capability of SRM.XLS was modified to more realistically simulate erosive burning. The erosive burning that is modeled in SRM.XLS is based on the *multiplicative law*, whereby the standard *Saint Robert's* model for burn rate,  $r$ , is factored up to account for enhanced burning due to flow velocity through the grain core:

The original version of SRM.XLS uses a simplification by applying the same erosive factor over the entire grain length. The modification that was subsequently made allows for an erosive factor that more realistically varies from *zero at the top segment* to a *maximum value at the lowest segment* (i.e. proportional to flow velocity). Trial values of  $G^*$  and  $k_v$  were then inputted to see if the resulting pressure curve would match the actual pressure curve for the 1<sup>st</sup> phase firing. The result of this analysis is shown in Figure 4. It can be seen that the simulated curve matches well to the actual curve. As such, it appears that conventional erosive burning was exhibited. The values used in the modified SRM.XLS were

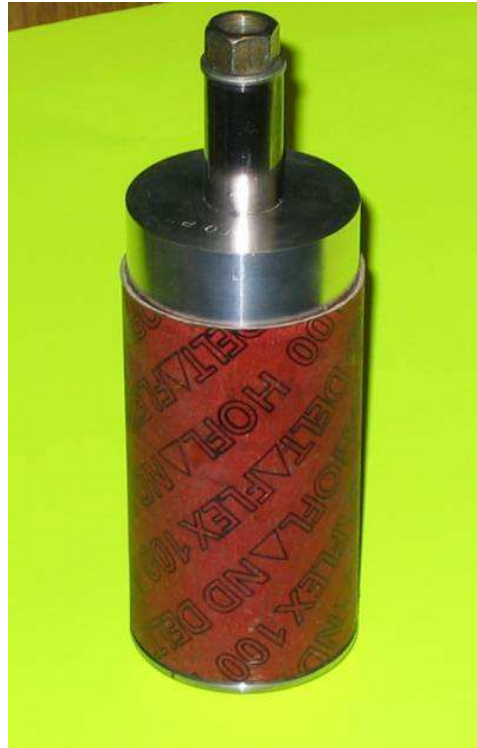
**Photo 1 – Grain segment casting mould used for 1<sup>st</sup> phase**

Propellant was cast into an inhibitor tube fabricated from “*Deltaflex 100*” heat-resistant gasket material. Just prior to casting, the tube was lined on the inside with a coating of melted sorbitol to aid in bonding the propellant to the tube material. After the propellant slurry was loaded into the tube, the propellant was “clamped” to squeeze out any trapped air. The casting tube with clamping apparatus is illustrated in Photo 1.

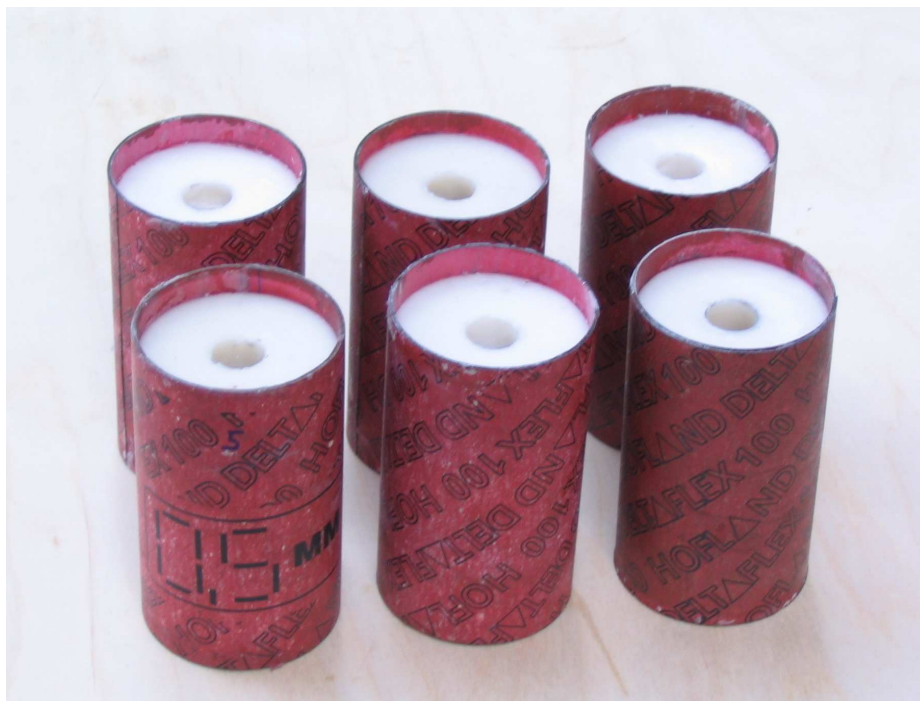
**Photo 2 – Propellant grain segments prior to coating ends with ignition primer**

The faces of all segments were coated with ignition primer consisting of a blend of potassium nitrate, charcoal and a small percentage of sulfur. Coating was achieved by mixing the primer in 70% IPA and painting the slurry onto the propellant surface. The finished segments are illustrated in Photo 2

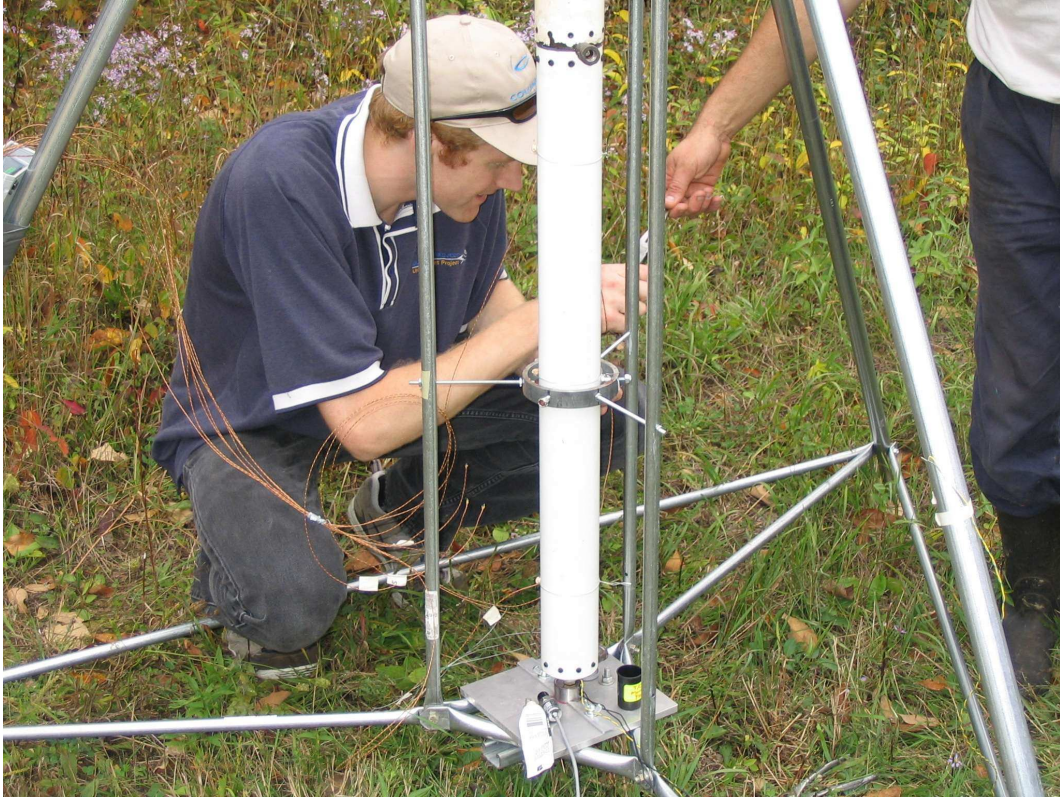
**Photo 5 – Daniel mounting thermocouples on motor**

As was the case for the 3<sup>rd</sup> BEM firing, thermal sensors were again mounted on the rocket motor casing. A total of eight sensors were used. However, the location of sensor #7 was changed, having been relocated from the aft region of the 1<sup>st</sup> phase casing to the nozzle throat. The intention of mounting a sensor on the throat was to have a time base datum point for the thermal data.

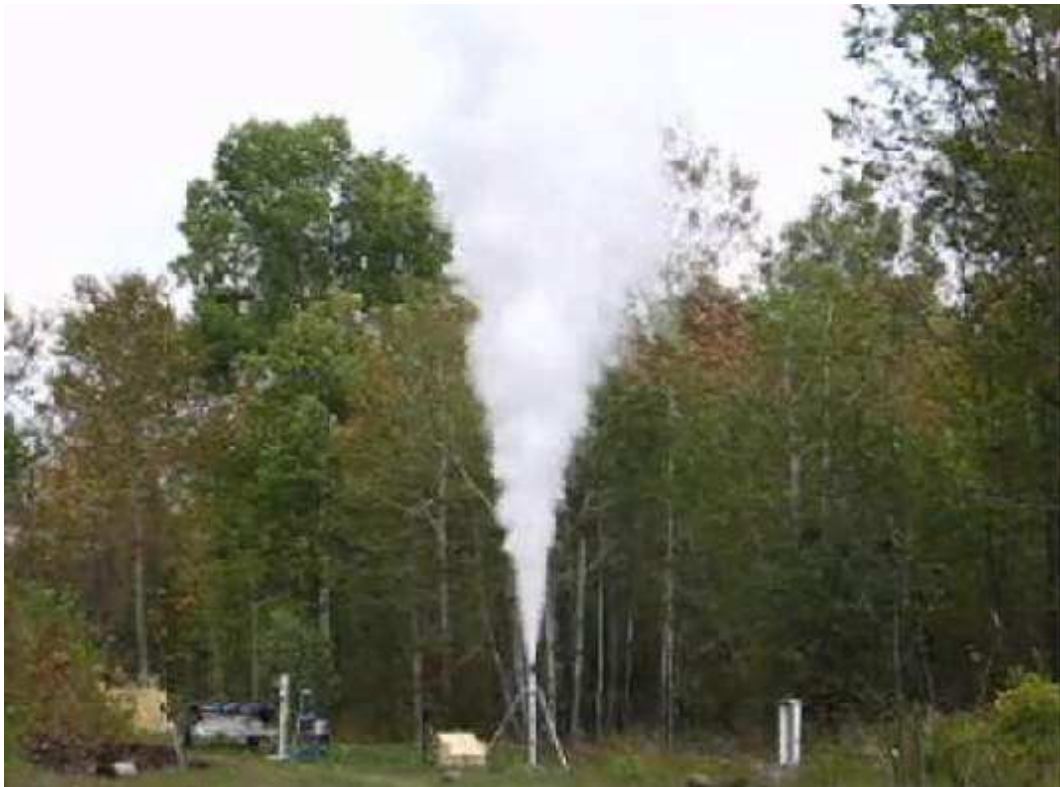
**Photo 6 – Motor under full 1<sup>st</sup> phase thrust**

The motor came up to operating condition rapidly, even more so than with the first BEM firings. The pyrogens and burst diaphragms were clearly effective in this regard.

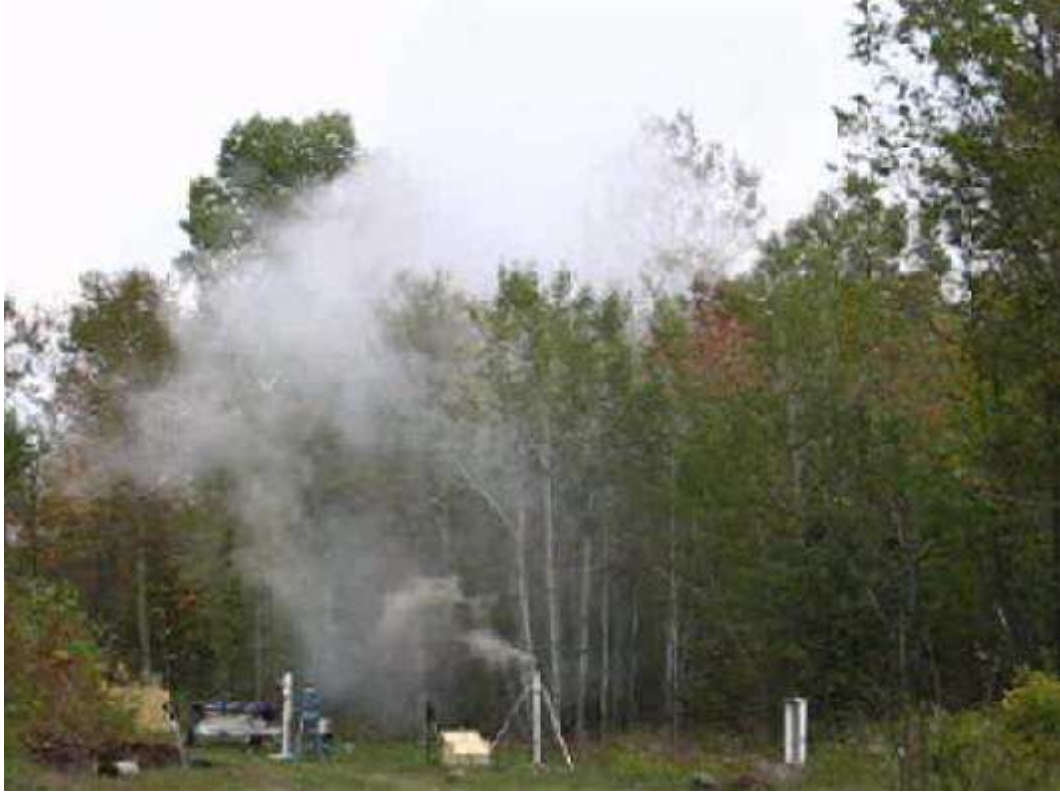
**Photo 7 – Following burnout of 1<sup>st</sup> phase, smoke issues from burning delay plug**

The delay plug once again functioned as intended and successfully isolated the 1<sup>st</sup> and 2<sup>nd</sup> phase chambers during the 1<sup>st</sup> phase burn, and was successfully consumed prior to 2<sup>nd</sup> phase firing. This was true for all four BEM firings.

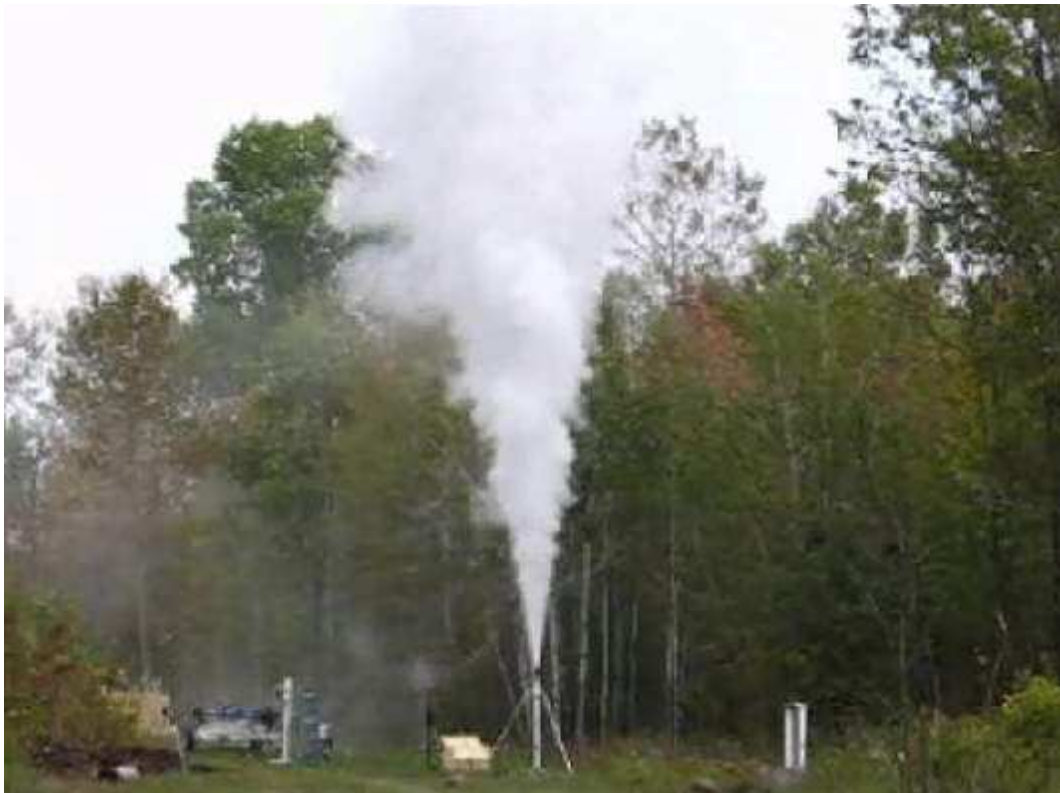
**Photo 8 – Motor under full 2<sup>nd</sup> phase thrust**

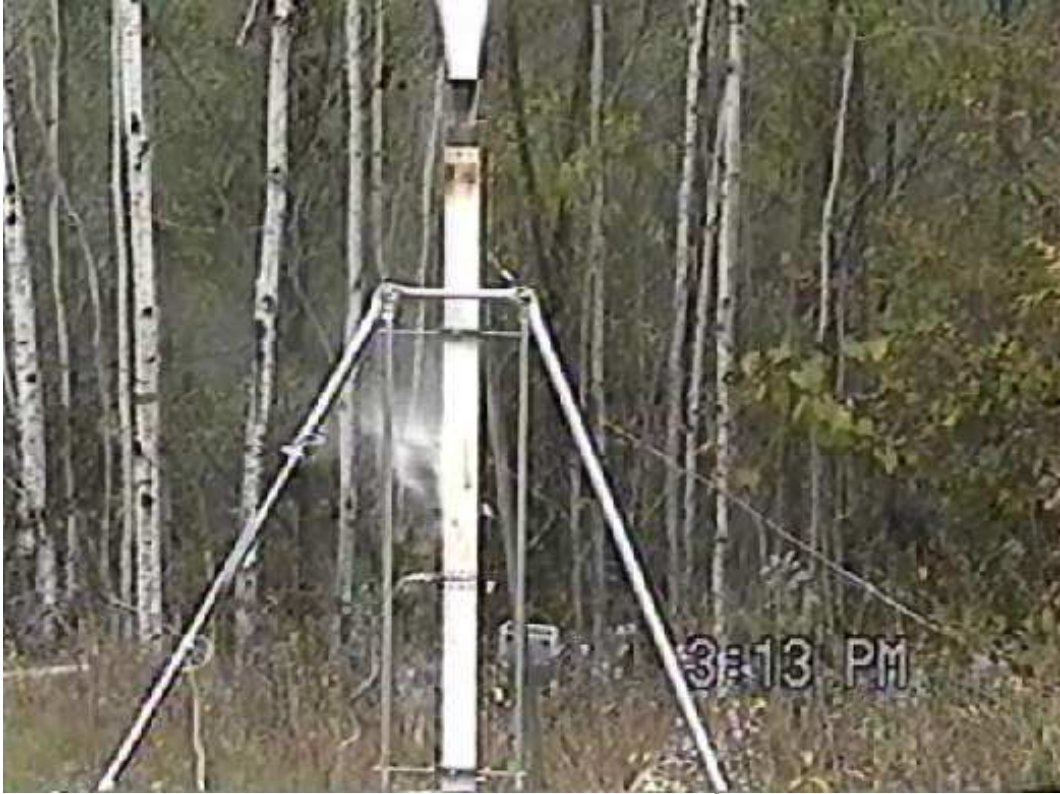
**Photo 9 – Close-up view of motor during 2<sup>nd</sup> phase operation**

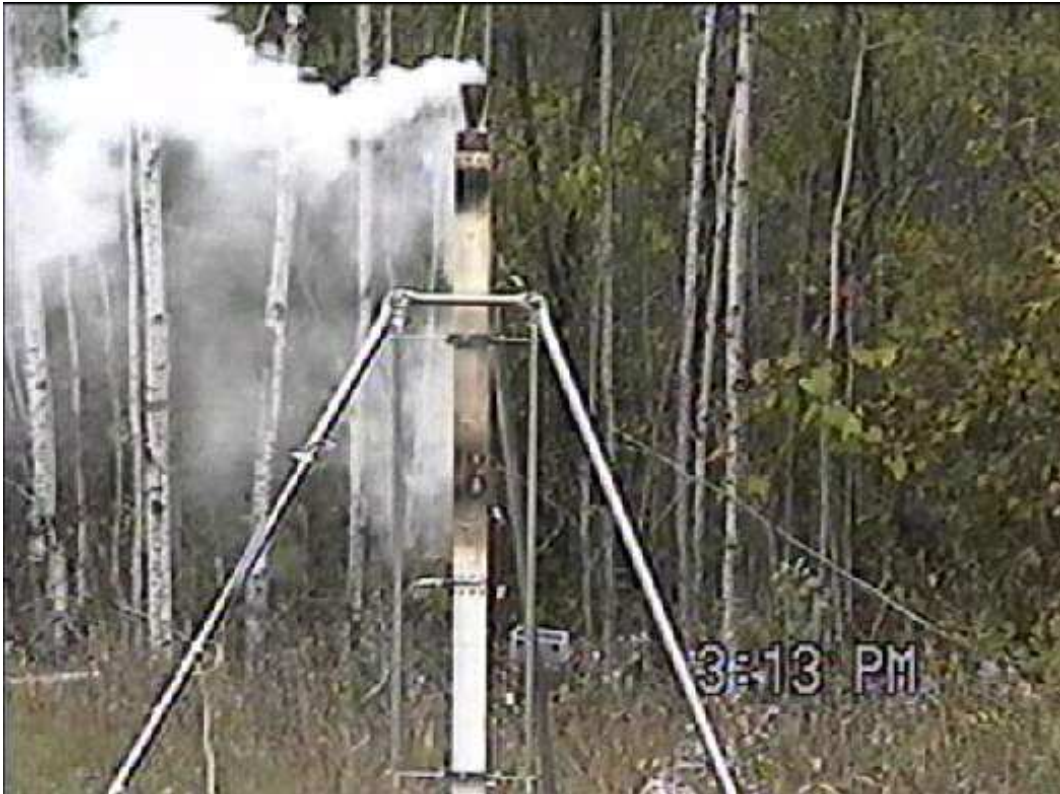
**Photo 10 – Motor smoulders following burnout**

A post-firing teardown of the motor showed it to be in excellent condition. Debris from the second phase grain inhibitor was found nested in the mid-bulkhead throat. This was likely the cause of the unusual whistling sound that was heard. Examination of the video showed a plume of black smoke that erupted briefly during the second burn, which was undoubtedly a sizeable fragment of ejected inhibitor material.
