School Assessment Report

School: Centennial Academy

Report: Dec 15, 2014

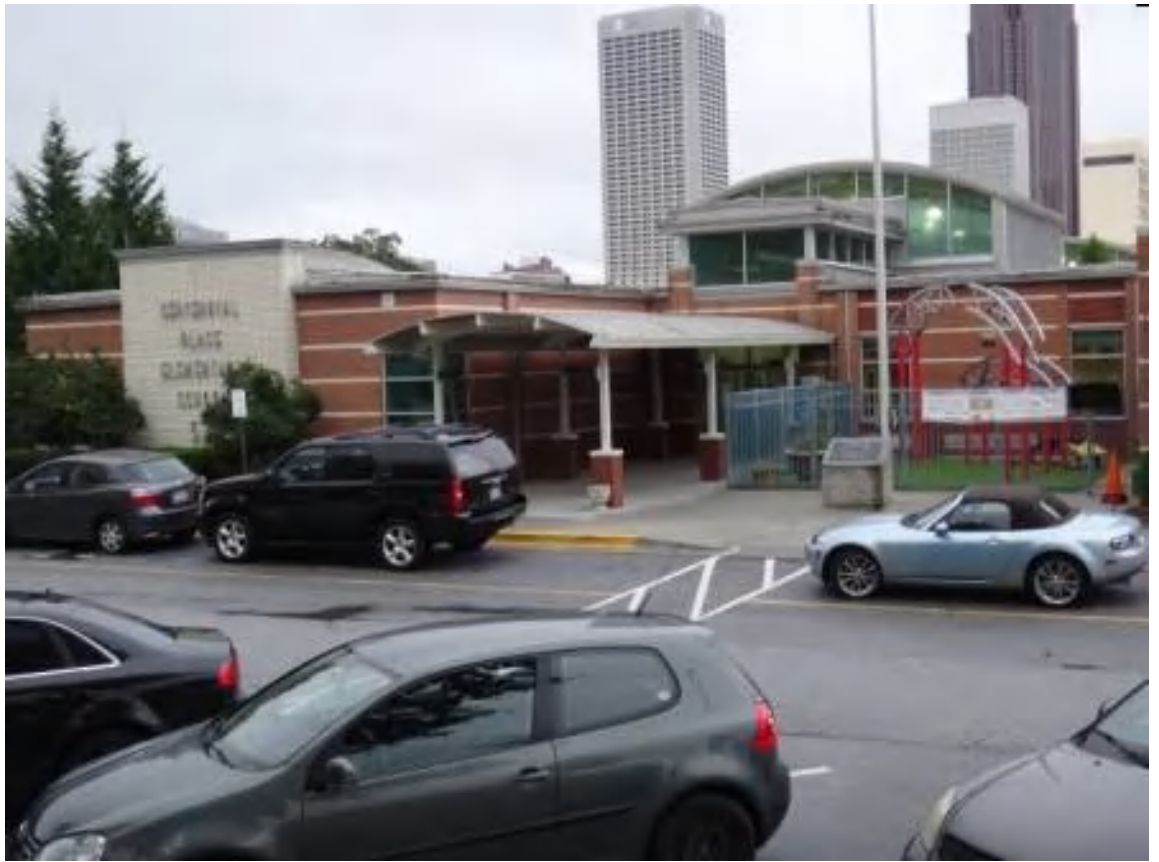
The Centennial Academy at Centennial Place Elementary School consists of (1) main school building and (1) ancillary building located at 531 Luckie St., in Atlanta, GA. The original campus was constructed in 1998. The school campus and site are well maintained in good overall condition.

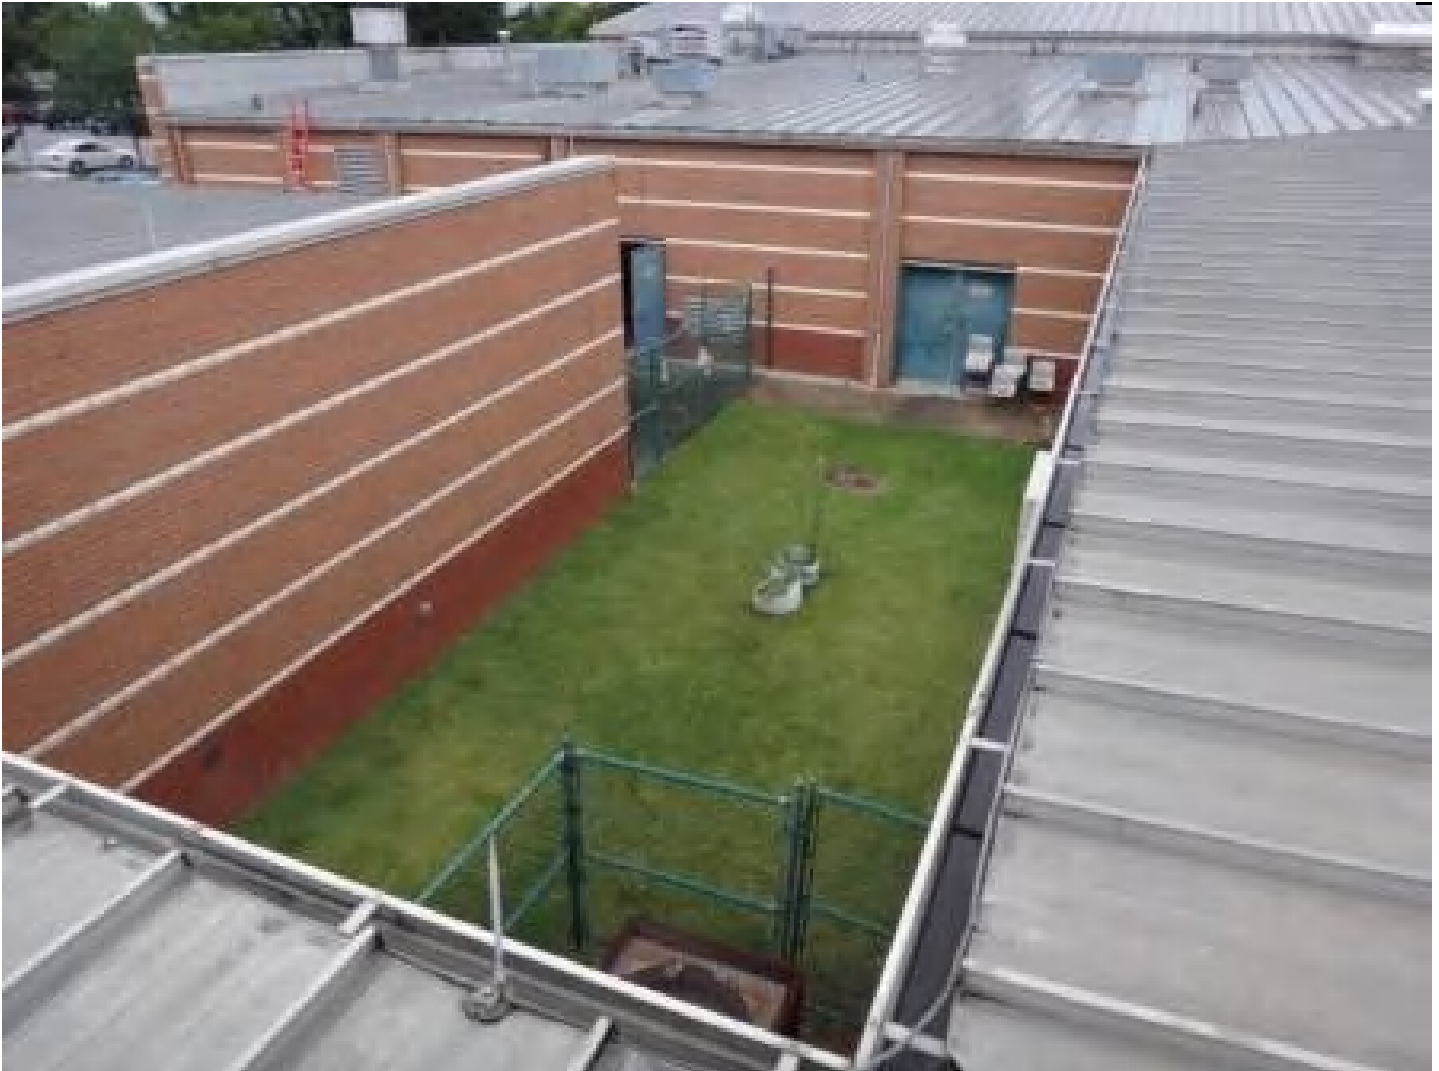
Year Built:	1998
Gross Area (SF):	63,806
Replacement Value:	\$11,766,165
Repair Cost:	\$2,126,226
Total FCI:	18.07%
Total RSLI:	17%

The superstructure is steel frame. Floor construction is slab on-grade. Roof construction is steel. The exterior enclosure is comprised of walls with brick veneer over CMU. Exterior windows are aluminum frame with fixed and operable panes. Exterior doors are both aluminum and hollow metal with glazing. Roofing is both low slope and sloped with standing seam metal coverings throughout. There are reported roof leaks.

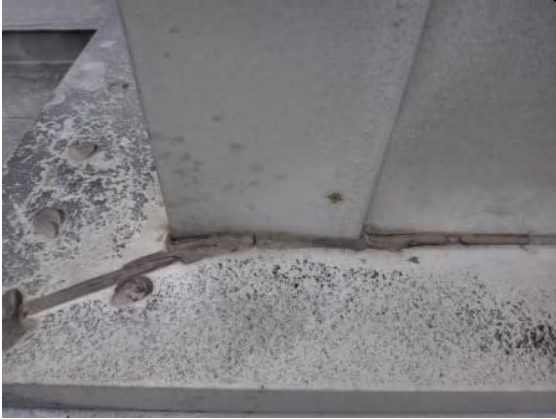
Analysis: The system is in use and functioning with an estimated remaining service life as indicated in the report section "Condition/Replacement Budget Detail". The system was installed in 1998. It has a 20-year service life. However, in the assessment, it was found to be currently deficient.

Distress: Failing

Notes: Replace sealants and provide flashing repairs to roof coverings system.

Recomm.: The system should be replaced.

Correction: Roof and flashing repair.

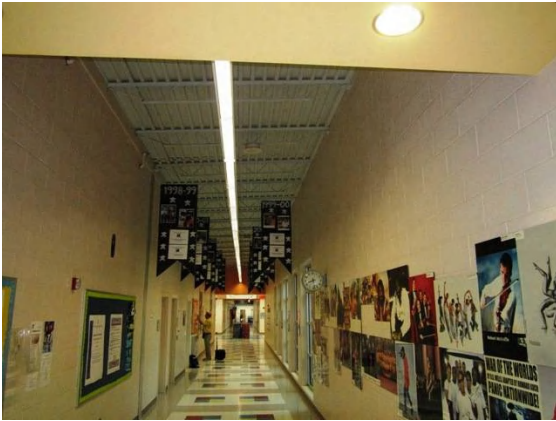
Analysis: The system is missing.

Distress: Missing

Notes: All corridors lack HVAC distribution system - leading to inadequate AC/Heat in corridors.

Recomm.: The system should be installed.

Correction: Replace HVAC Distribution System (SF)

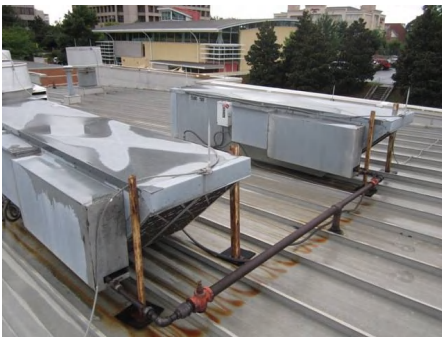
Analysis: The system age is either beyond expected life or does not meet its intended performance under the Guidelines. The system may be in service and functioning but it is recommended to be replaced due to probable increased condition budget needs, the potential failure of its components, or in order to meet the performance Guidelines for this system. The system was installed in 1998. It has a 15-year service life. However, in the assessment, it was found to be currently deficient.

Recomm.: The system should be replaced.

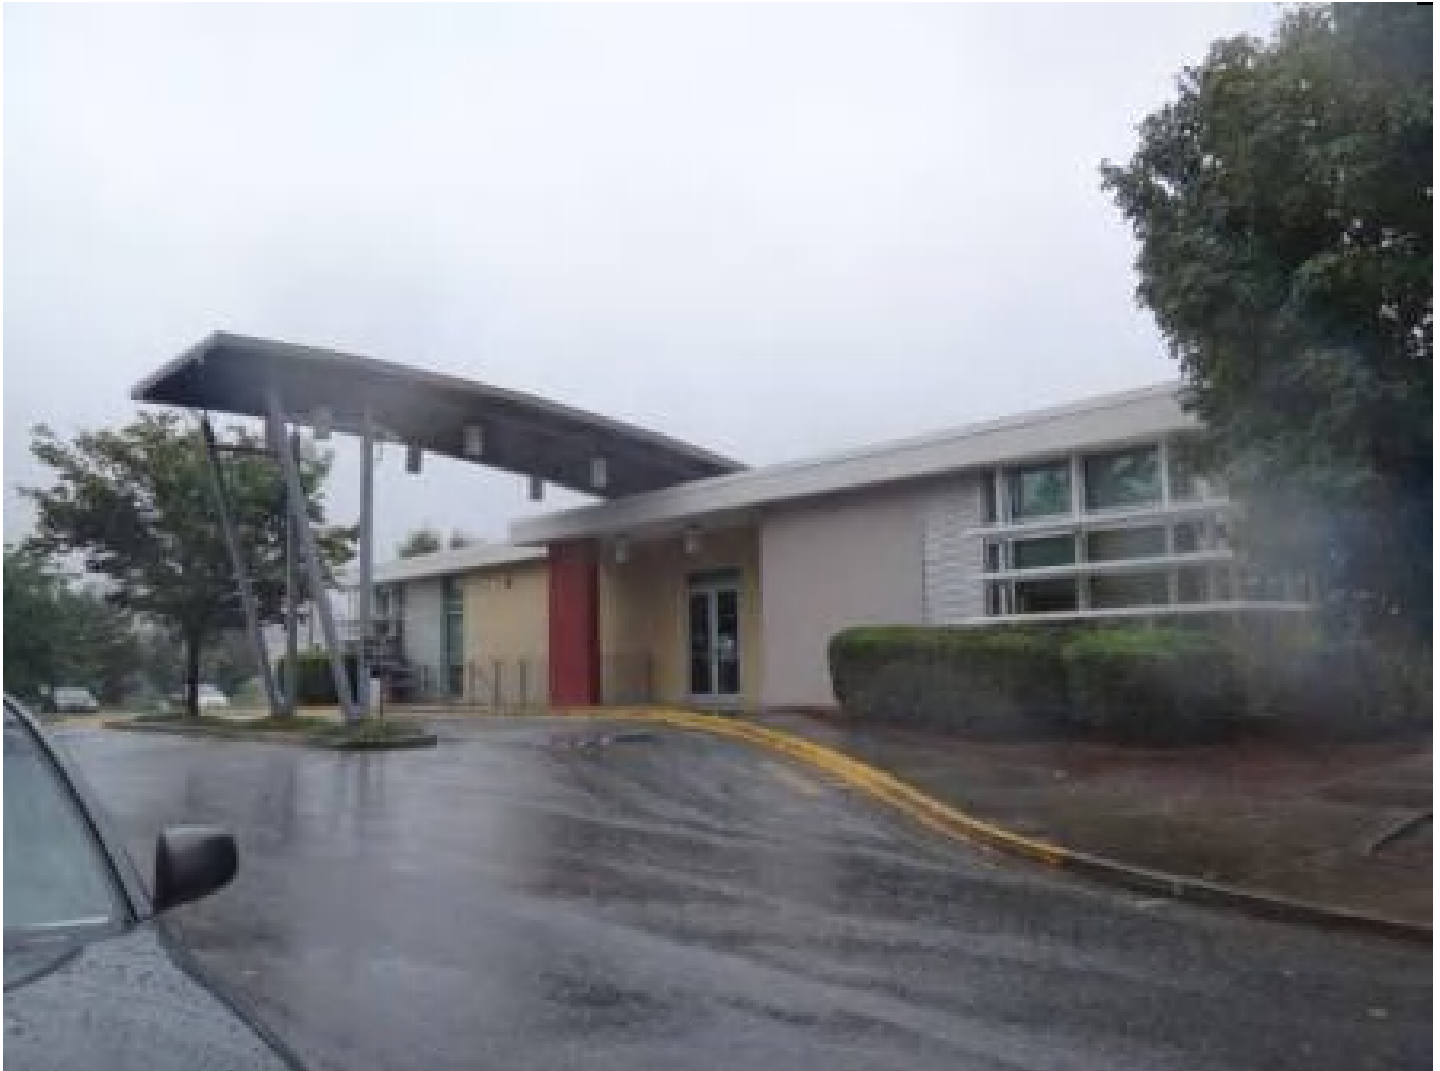
Year Built:	1998
Gross Area (SF):	22,800
Replacement Value:	\$3,966,682
Repair Cost:	\$464,338
Total FCI:	11.71%
Total RSLI:	13%

The superstructure is steel frame. Floor construction is slab on-grade. Roof construction is steel. The exterior enclosure is comprised of walls with brick veneer, metal siding and E.I.F.S. over CMU. Exterior windows are aluminum frame with mostly fixed panes. Exterior doors are aluminum frame with glazing. Roofing is sloped with standing seam metal coverings. The roof is in good condition with no reported leaks.

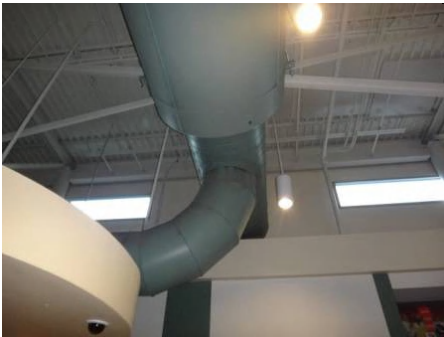
Analysis: The system age is either beyond expected life or does not meet its intended performance under the Guidelines. The system may be in service and functioning but it is recommended to be replaced due to probable increased condition budget needs, the potential failure of its components, or in order to meet the performance Guidelines for this system. The system was installed in 1998. It has a 15-year service life. However, in the assessment, it was found to be currently deficient.

Location: 1998 Gym/YMCA
Distress: Beyond Expected Life
Category: Deferred Maintenance
Priority: 3 - Necessary (Years 2-5)
Correction: Renew System
Qty: 1-Ea.
Condition Budget: \$189,824

Recomm.: The system should be replaced.

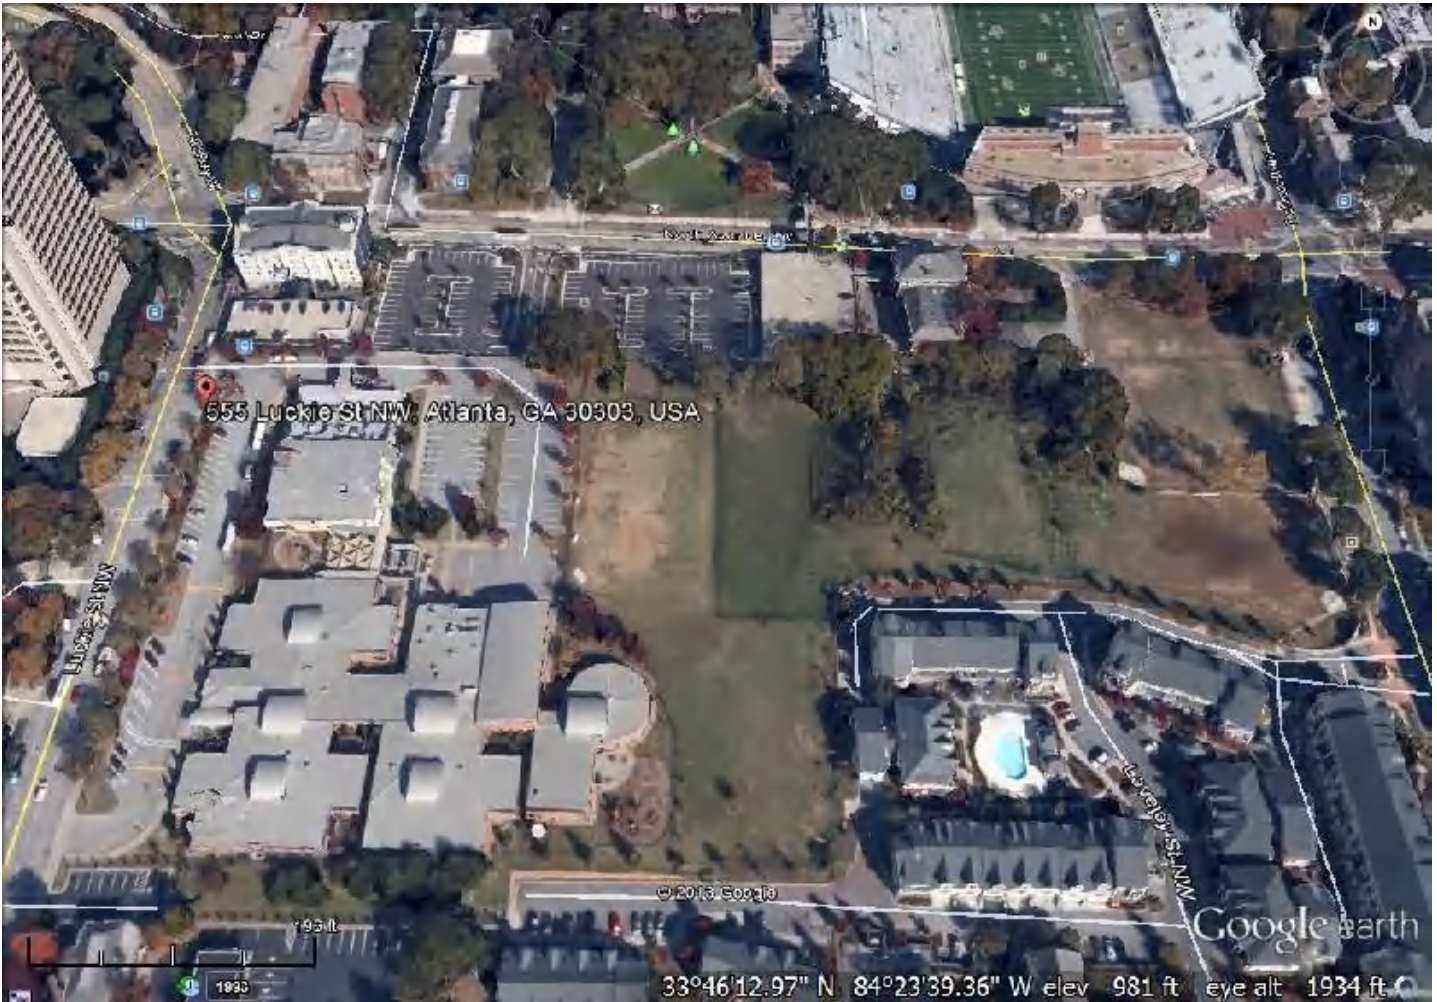
Site Summary

Site Acreage
 Replacement Value: \$2,388,924

Condition Budget:	\$104,768
Total FCI:	4.39%
Total RSLI:	48%
Condition Score:	85.13

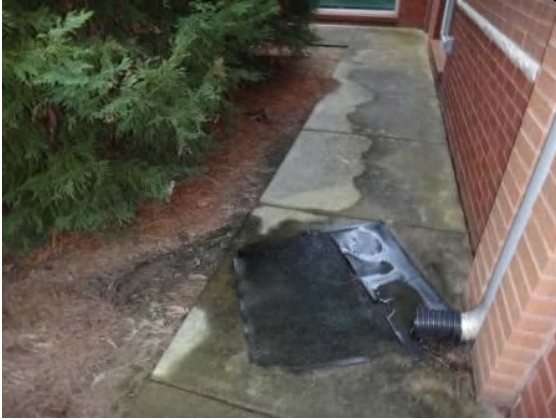
System: G3030 - Storm Sewer

Analysis: The system age is either beyond expected life or does not meet its intended performance under the Guidelines. The system may be in service and functioning but it is recommended to be replaced due to probable increased condition budget needs, the potential failure of its components, or in order to meet the performance Guidelines for this system. The system was installed in 1998. It has a 50-year service life. However, in the assessment, it was found to be currently deficient.

Distress: Inadequate

Notes: Site is missing required storm sewage system at building perimeter. Water floods through doorways during rain events.

Recomm.: The system should be replaced.
