## SELECTION OF THE MOST APPROPRIATE TECHNOLOGY OF REPARATORY HARDFACING OF WORKING PARTS ON UNIVERSAL CONSTRUCTION MACHINERY

**Abstract:** The aim of this work is to analyse the possibility to increase the service life of working parts on construction machinery exposed to intensive wear, such as steel blades of the rotary device for roadside vegetation maintenance and grass cutting. A special attention is paid to characteristic working conditions and complex wear mechanisms. In order to select the most appropriate repair technology, both model and real investigations were conducted. The aim of the model investigations was to select the most appropriate procedure, filler materials and hardfacing technology. Worn cutting edges of the blades were hardfaced and sharpened by grinding to the shape and dimensions of new blades. Then, both new and repaired blades were alternately mounted on the rotor of the machine. Their wear was monitored under the same working and weather conditions. The repaired blades have proven more resistant to wear than the new ones, which is due to better properties of the hardfaced layers.

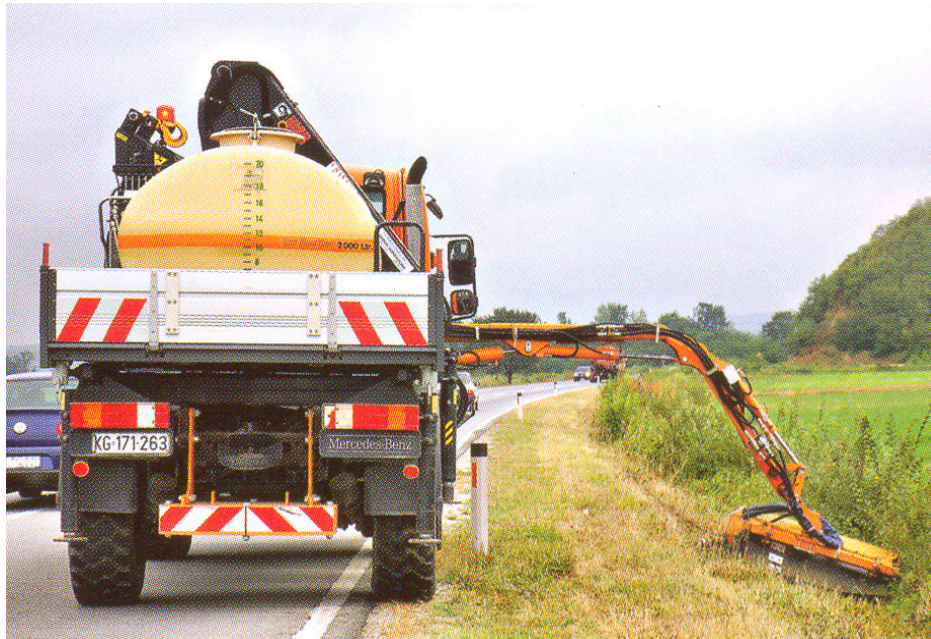
**Figure 1.** Machine and device for vegetation maintenance and grass cutting

The device for cutting grass and other vegetation is mounted on a universal machine Unimag (Fig. 1). This is a multipurpose vehicle on which thirty-two different devices can be mounted and operated. In addition to grass and vegetation cutting, it can be applied for snow clearing, aggregates spreading, land clearing and levelling, preparing soil or aggregate substrate for concrete or asphalt laying, digging holes in the ground, cutting and removal of trees, load lifting, trench digging for utility installation, etc.

The device for vegetation maintenance is powered by the vehicle. The torque is transferred through the output spline shaft connected to the hydraulic pump and hydro motor, and the device is controlled by hydraulic system. V-belt transmission protects the device allowing some slippage in order to prevent overloading and damages. The number of rotations of the output shafts is in the range from 540 to 1000  $\text{min}^{-1}$ .

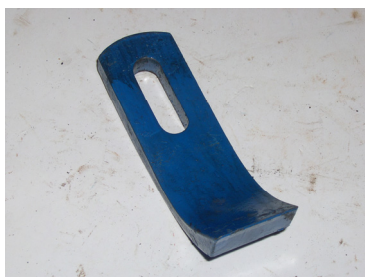
**Figure 2.** A new blade for vegetation and grass cutting

Forty blades (Fig. 2) are mounted in four rows on the holder of the output spline shaft. The blade mass is 0.30 kg, and all the blades are made of quenched and tempered (Q+T) steel Č4732 (JUS) – 42 CrMo4 (DIN). The connection between the rotary device and blades is mechanical, and blades are mounted on a special holder via screws. Whilst in operation the blades come into contact not only with grass, vegetation and soil, but also with rocks. In order to protect the blades, a protective roller is mounted. It rolls on the ground in front of the working part keeping the device at the same distance from the ground. Behind the working part, there is a curtain that prevents grass, vegetation and aggregates from sticking to the blades, which ensures safety of the vehicle operator and other participants in the traffic.

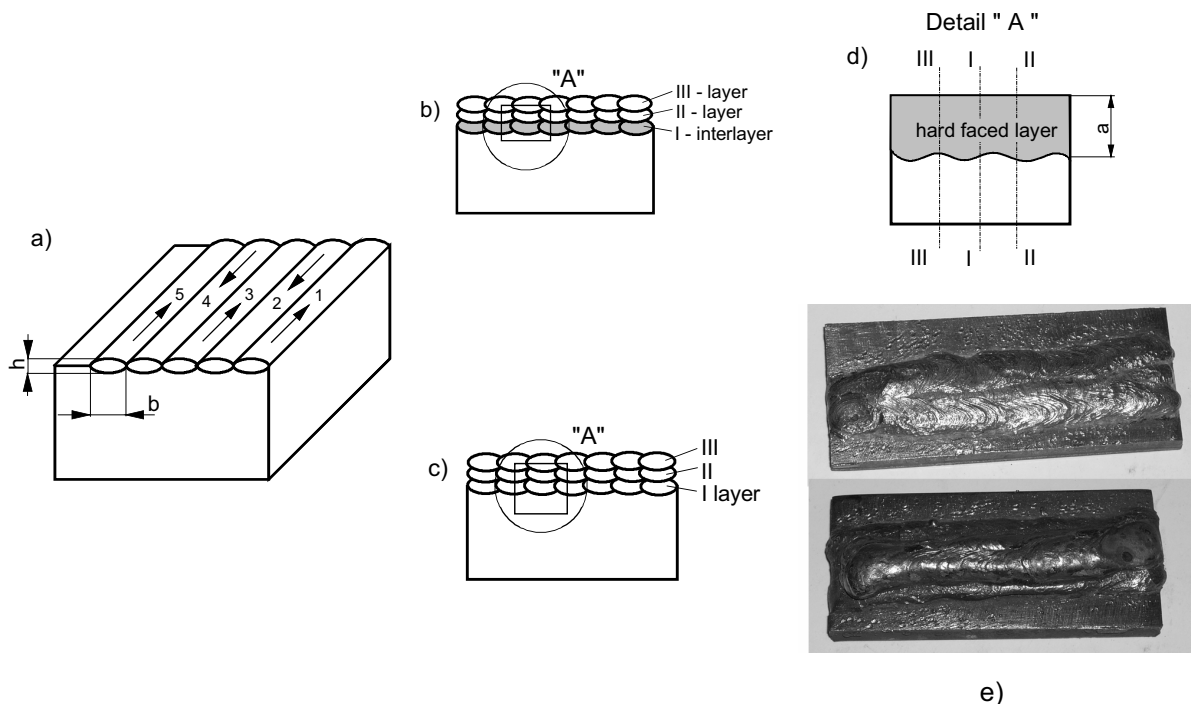
**Figure 3.** Order of hardfaced layers deposition: a - 1<sup>st</sup> layer, b - 2<sup>nd</sup> layer, c - 3<sup>rd</sup> layer, d-metallographic block and e – hardfaced sample models (model photos)

The width of one-pass hardfaced layer was 6.0-10 mm, and its height ranged from 3.0 to 3.2 mm. The way of deposition, the order and number of the deposited layers and the model itself are shown in Figure 3. Prior to each pass, slag was removed with steel brush. The other layers were also deposited in this way (the second - Fig. 3b and the third - Fig. 3c). Figure 3d shows a sample for metallographic and tribological investigations, and Figure 3e shows hardfaced sample models.

Hardness measurements (in direction I-I, Fig. 3d) and analysis of the newly formed structures in the characteristic hardfaced layer zones were performed on metallographic samples shown in

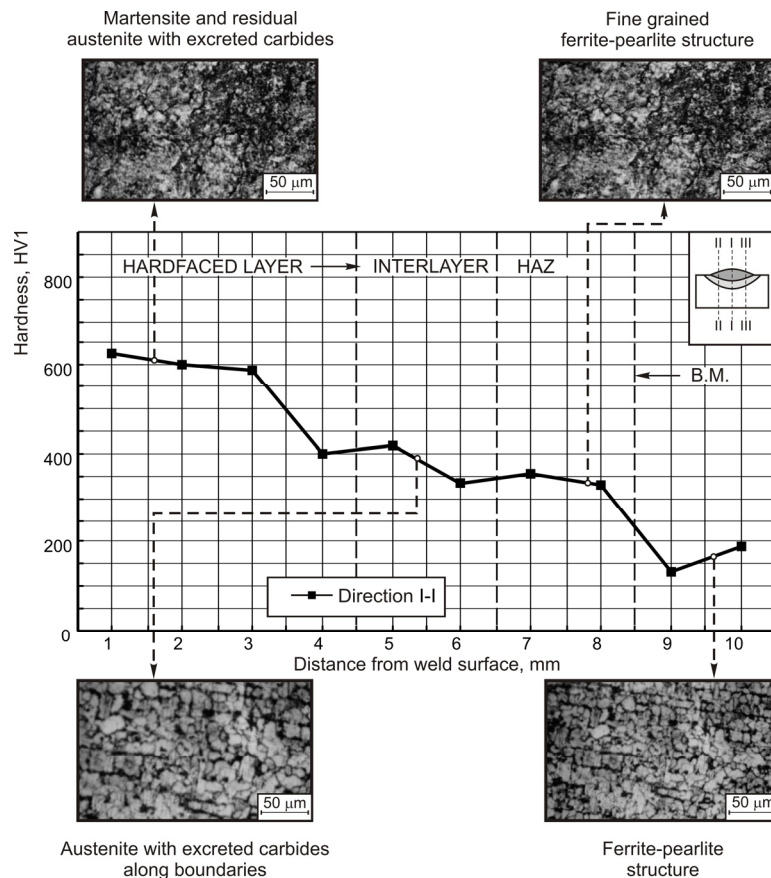
**Figure 4.** Microstructure of the hardfaced metal zones: B.M. - Č0361, interlayer - INOX B 18/8/6 and hardfaced layer - E DUR 600

Figure 3. The most important results of hardness and microstructure distribution are given in Figures 4, 5, 6 and 7 [1-9].

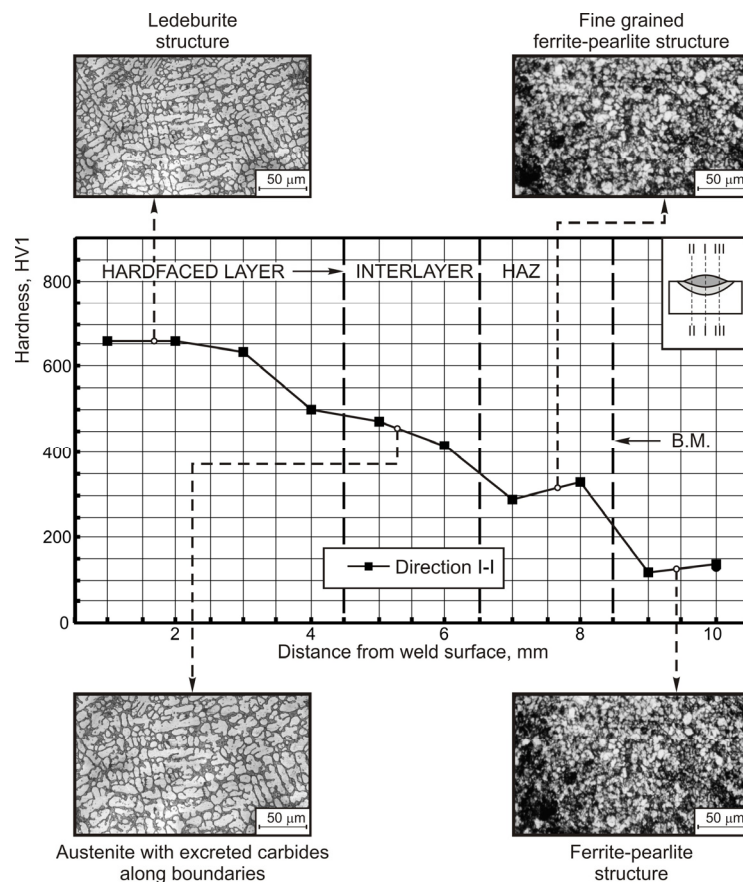
**Figure 5.** Microstructure of hardfaced layer zones: B. M. - Č0361, interlayer - INOX B 18/8/6 and hardfaced layer - CrWC 600

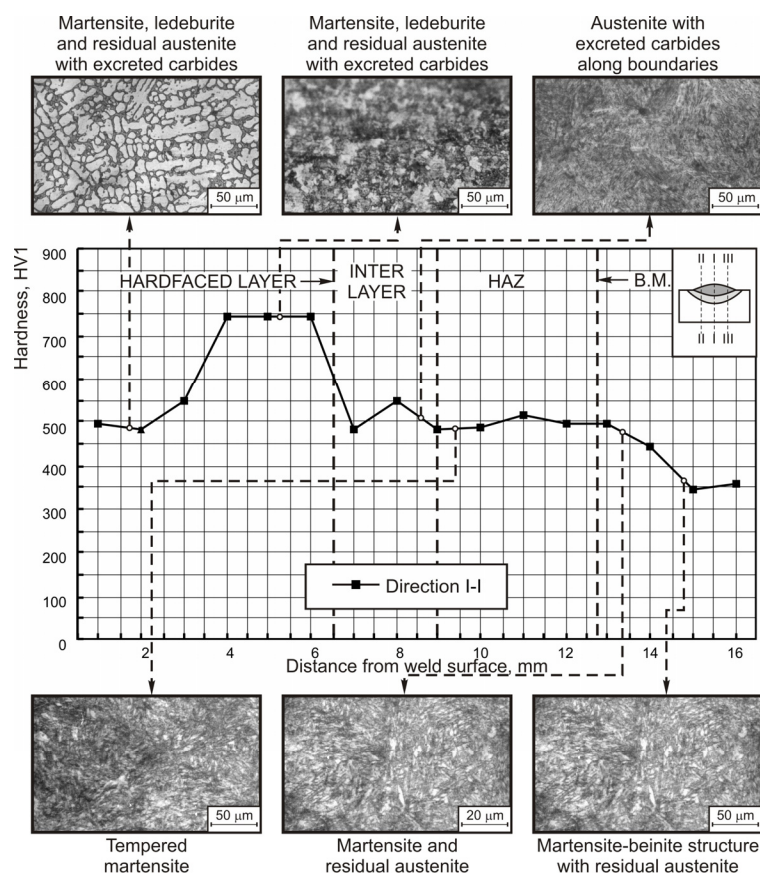
**Figure 6.** Microstructure of hardfaced layer zones: B. M. - Č0361, interlayer - INOX B 18/8/6 and layer - ABRADUR 58

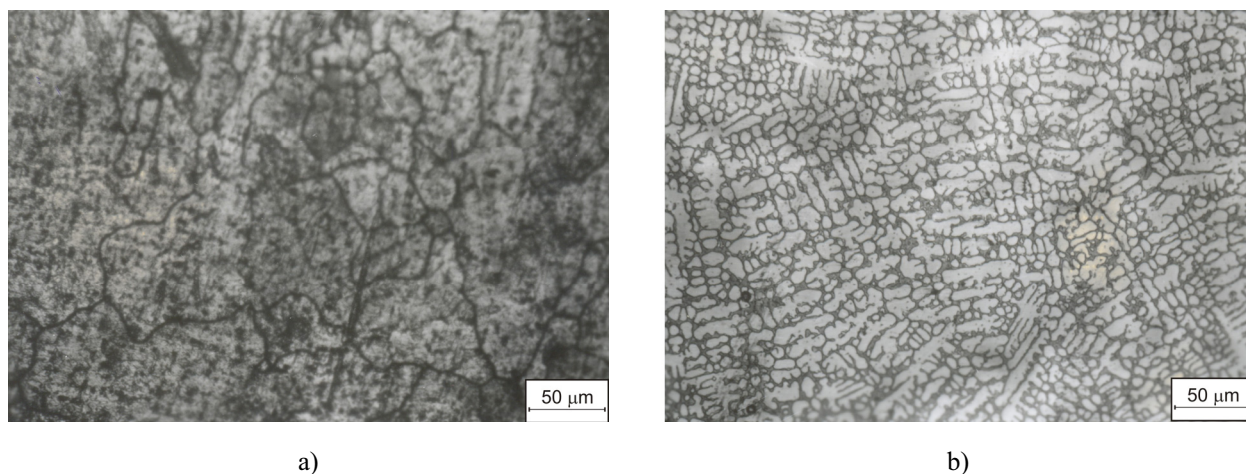
**Figure 7.** Microstructure of the hardfaced layer: (a) E Mn17Cr13 (200×) and (b) INOX B 18/8/6 (200×)

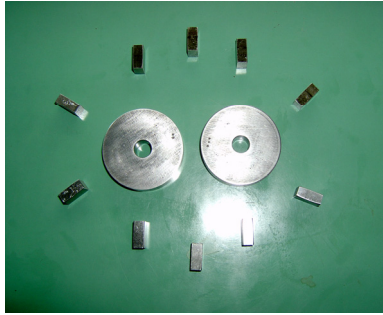
**Table 5.** Technology of the sample preparation for tribological investigations (blocks and disks) [2]

Sample number	Substrate material	Hardfaced layer material	Number of the hardfaced layers	Height of the hardfaced layer, mm	Blocks and discs
1.	Č0361	Interlayer-INOX B 18/8/6 Hardfaced layer -E DUR 600	3*	4.2-5.6

2.	Č0361	Interlayer -INOX B 18/8/6 Hardfaced layer -CrWC 600	3*	4.5-6.0	
3.	Č0361	Interlayer -INOX B 18/8/6 Hardfaced layer -ABRADUR 58	3*	3.0-3.5	
4.	Č0361	Hardfaced layer -E Mn17Cr13	3	6.2-8.0	
5.	Č4732	-	-	-

\*) The first layer is a plastic interlayer of F. M. - INOX B 18/8/6, while the second and the third layers are made of F. M.–ABRADUR 58, E DUR 600 and CrWC 600.

Prior to each investigation, the contact surfaces of the discs were grinded to remove the wear traces so that their roughness could be measured and compared to the contact surface roughness of the tested blocks. Table 5 shows the technology of the sample preparation for tribological investigations of the hardfaced layers and base materials. The coupled pairs "disc- block" were lubricated with the motor oil GLX 2 SAE 15 W-40.

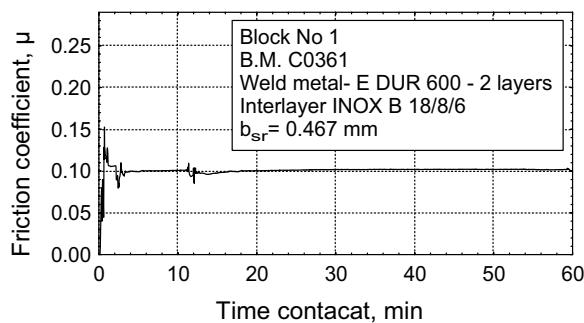
**Figure 8.** Change of the friction coefficient during the contact of 60 min

Prior to investigations, topography of the disc and block surfaces was measured on the computer measuring system Talysurf 6. Then, the contact was realized. The normal force of  $F_N = 300$  N and the sliding speed of  $v_{kl} = 1$  m/s were adopted. During the contact of  $\approx 60$  min, a change of the friction coefficient was registered (Fig. 8, 9, 10, 11 and 12). When the contact was terminated the topography of the disc and block surfaces was studied i.e., the wear scare area of the block was measured (Fig. 13). In this way, tribological characteristics were determined. The wear scare width was measured using a universal microscope UIM-21, with magnification of 50 times.

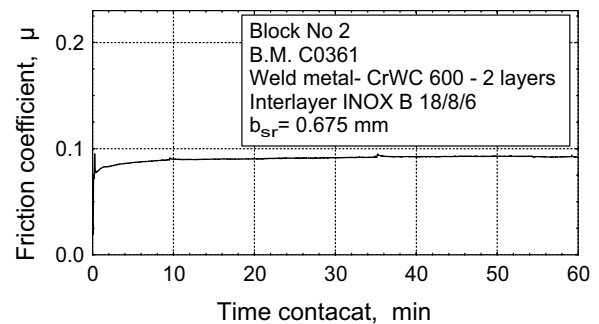
**Figure 9.** Change of the friction coefficient during the contact of 60 min

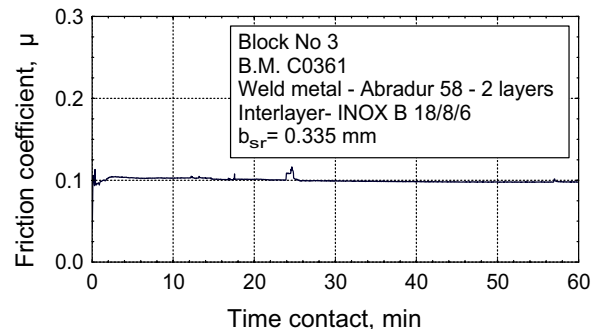
**Figure 10.** Change of the friction coefficient during the contact of 60 min

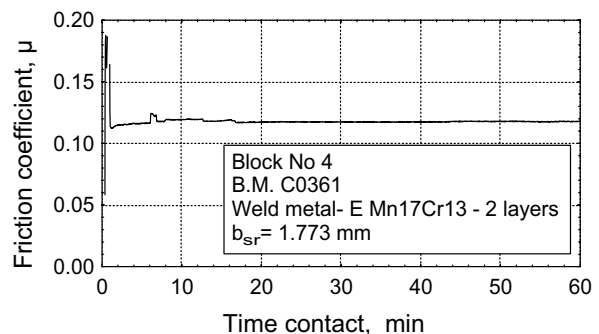
**Figure 11.** Change of the friction coefficient during the contact of 60 min

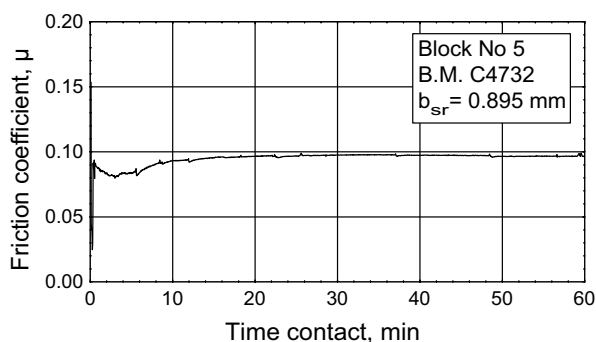
**Figure 12.** Change of the friction coefficient during the contact of 60 min

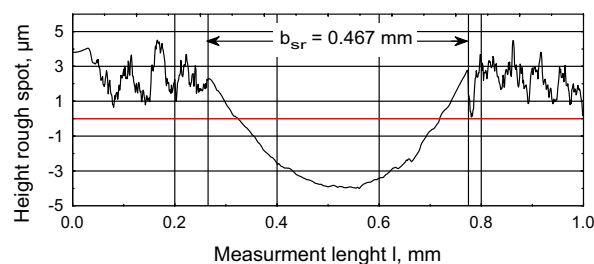
**Figure 13.** Layout of the wear scar - block No 1 (after the contact of 60 min)

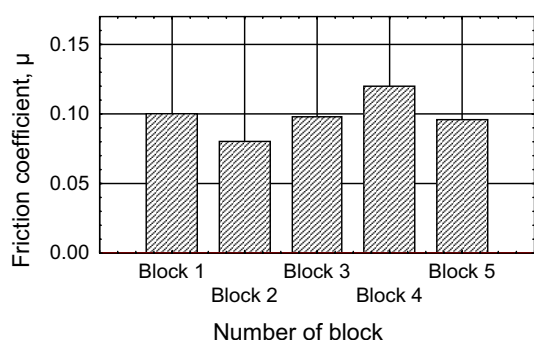
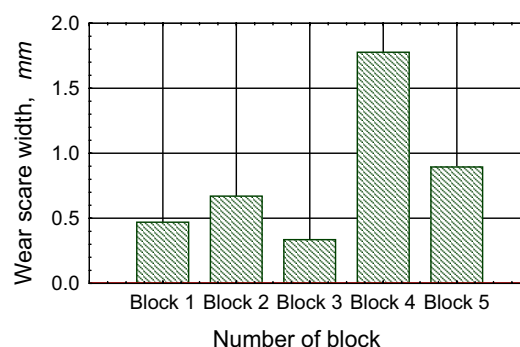
Block 1-E DUR 600, Block 2-CrWC 600, Block 3-ABRADUR 58, Block 4- E Mn17Cr13, Block 5-Č4732

**Figure 14.** Histograms of the mean values of friction coefficients (a), and wear scar widths (b) after the contact of 60 min

Figure 14a gives a graphical presentation of mean values of the friction coefficient, and Figure 14b shows mean wear scar area widths of the investigated blocks.

Measurements of the wear scar width have revealed that the hardfaced layers have a significantly higher resistance to wear compared to base material of the blades. This particularly applies to the hard-faced layers obtained using the electrode ABRADUR 58, with application of the interlayer electrode and without preheating. It illustrates how complicated it is to select hardfacing technology and filler materials for real technological working conditions of the construction machinery.

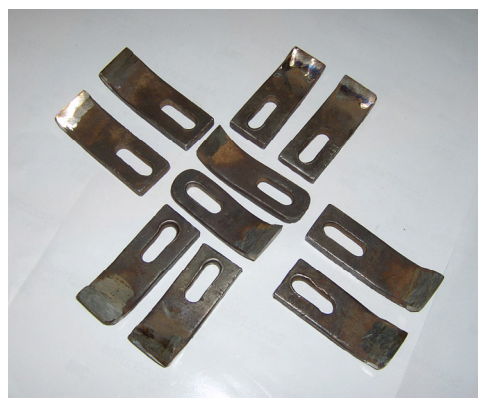
**Figure 15.** Blades repaired with different filler materials

The technology selected on model investigations was applied to the real parts. For investigations under real conditions, 10 blades were hardfaced. Two blades were hard-faced with electrodes E DUR 600 and E Mn17Cr13, and three blades were hardfaced using the electrodes ABRADUR 58 and CrWC 600. Cutting blade edges were hardfaced along the back and front angle sides of the blade, lengthwise. The width of the hardfaced layer was about 25 mm. The hardfaced blades (Fig. 15) were sharpened by grinding and then they

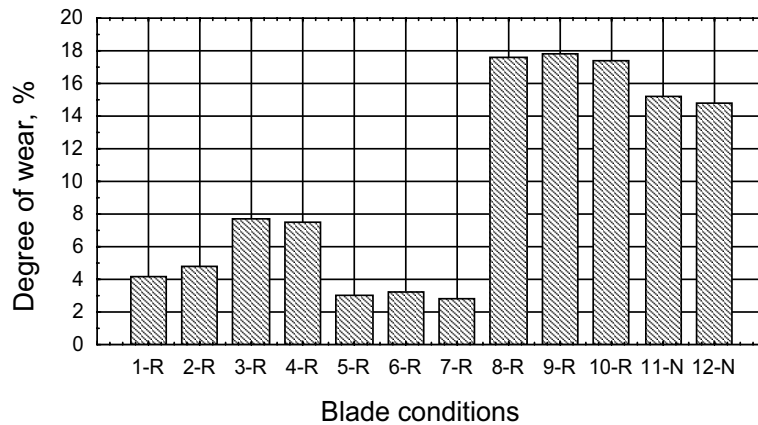
1-R and 2-R – **ABRADUR 58**; 3-R and 4-R – **CrWC 600**; 5-R, 6-R and 7-R – **E DUR 600**; 8-R, 9-R and 10-R – **E Mn17Cr13**; 11-N and 12-N – **NEW BLADES (B. M.)**

**Figure 16.** Graphical presentation of the degree of wear of the blades after 120 hours of effective work

Thus repaired and sharpened blades were mounted together with new blades on the device and their performance was monitored under real working conditions. The mass of the blades before mounting was 0.30 kg. The wear process was monitored during 120 hours of effective work. Then the devices were cleaned and washed and all the blades were dismounted. Figure 16 shows the mass losses of new and hardfaced blades.

Based on the material mass losses of the studied samples, it can be concluded that, under the same working conditions, the hardfaced blades have in general shown better resistance to wear compared to new, not hardfaced blades. The same conclusion can be drawn for the blades hardfaced with ABRADUR 58, CrWC 600 and in particular with E DUR 600, while the blades hardfaced with E Mn17Cr13 exhibited significantly less resistance to wear, even compared to new blades. This is the result of the working conditions and impossibility of austenite to transform into martensite in shallow surface layers of the hard-faced metal. Therefore, it can be concluded that manganese austenite steel or Hadfield steel is not suitable for the given working conditions [2, 6, 9].
