Applies To: **2001–02 Accord** – Check the iN VIN status for eligibility
2001–03 Civic – Check the iN VIN status for eligibility
2003 Civic Hybrid – Check the iN VIN status for eligibility
2002–04 CR-V – Check the iN VIN status for eligibility
2002 Odyssey – Check the iN VIN status for eligibility

Safety Recall: Replacement Driver's Airbag Inflator Can Be Over-Pressurized

(Supersedes 10-039, dated December 21, 2011, to revise the information marked by the black bars)

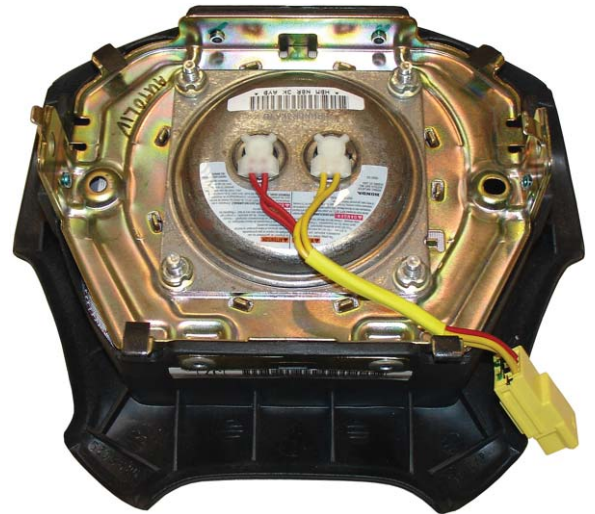
AUTOLIV (not affected)

3. Determine if the airbag is made by Autoliv or Takata by comparing inflators to those in the images below.

NOTE: The Autoliv serial number label is different from the Takata label.

- If the airbag is made by Autoliv, the airbag is OK. Go to REPAIR PROCEDURE A.
- If the airbag is made by Takata, go to step 3.

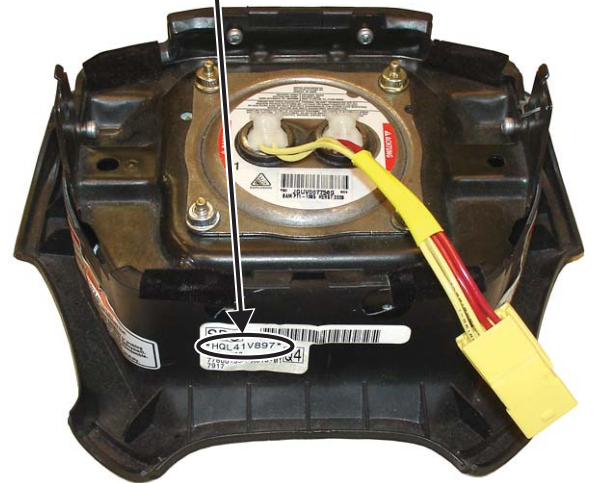
TAKATA

Locate serial number here.
