Verado L6 Integrated Oil Module Inspection and Repair

Models Covered	Serial Number
225/250/300/350 Verado L6	USA - 1B829209–1B889461
225/250/300/350 Verado L6	Belgium - 0P568238–0P575810

Mercury Marine has received isolated complaints of engine oil leaks on outboards listed above due to movement of the rubber end sheet inside the integrated oil module. Mercury Marine has improved the retention method for the rubber end sheet. Engines without this improved rubber end sheet retention method may exhibit an engine oil leak.

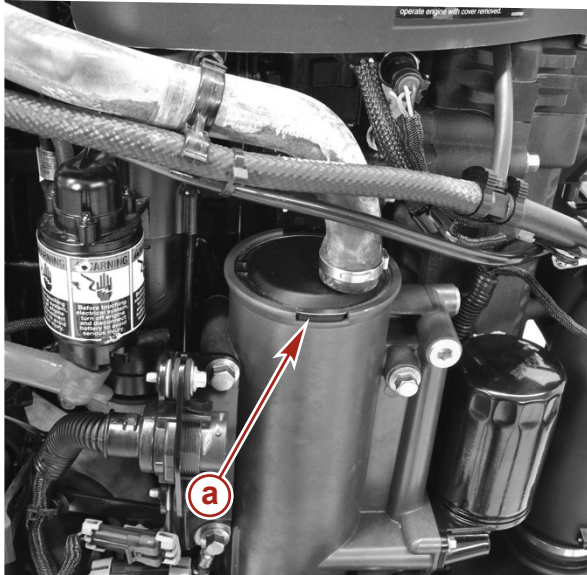
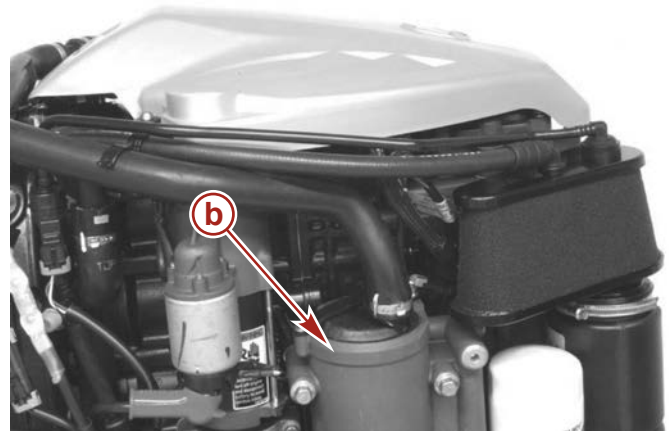
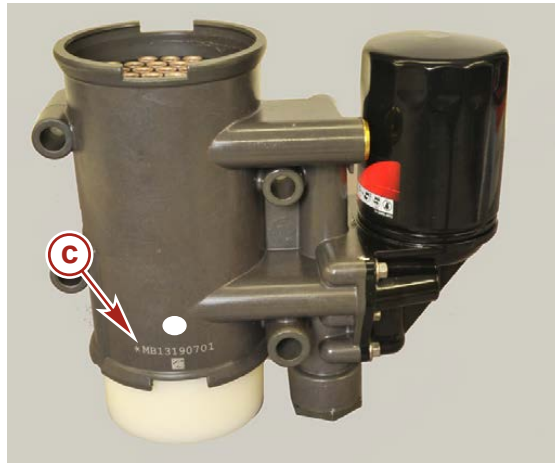
50466

1. Inspect the housing for a machining slot. If the integrated oil module (IOM) does not have a machining slot as indicated in the right-hand picture below, no further action is required. If the IOM does have a machining slot as indicated in the left-hand picture below, and has a serial number below MC13151702, continue to the correction procedure outlined following. If the IOM serial number is MC13151702 or above no further action is required.

- a** - Machining slot
- b** - No machining slot
- c** - IOM serial number (MC_ _ _ _ _)

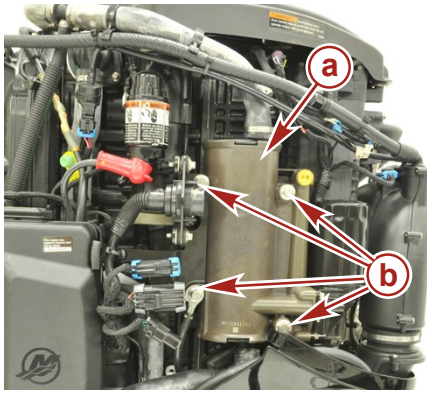
50283

- a - IOM
- b - IOM mounting bolts

2. Following the service manual procedure, remove the IOM from the engine.

NOTE: If the engine was recently run, allow the engine to sit for one hour so the engine oil drains back to the sump.

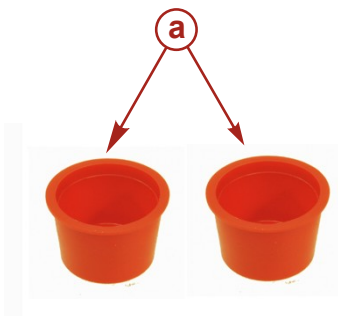
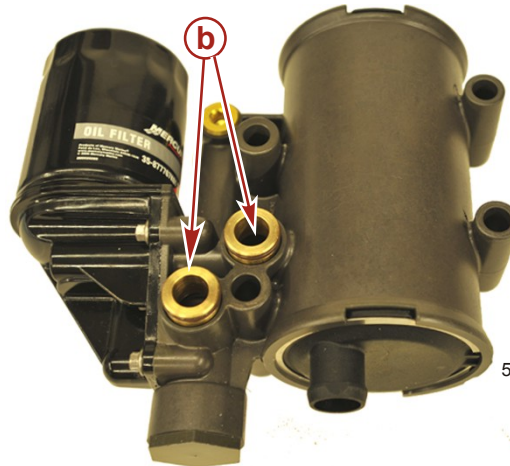
50293

- a - Adapter tube cap
- b - Adapter tube

3. Temporarily install the red caps provided in the IOM coining tool kit over the adapter tubes to keep debris out, and to capture any residual engine oil inside of the IOM.

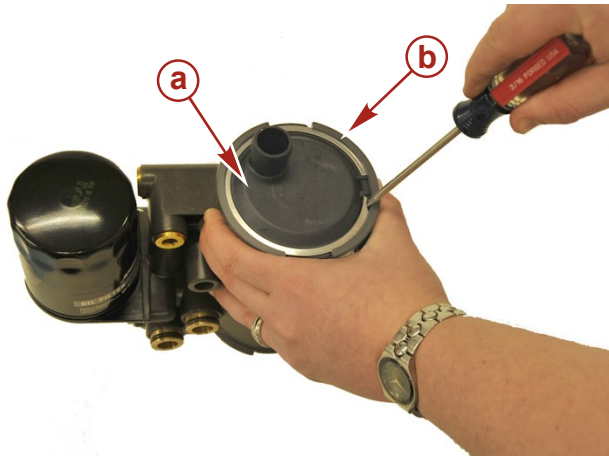
50284

- a - IOM end cap
- b - Retaining ring

4. Remove the retaining rings that hold the IOM end caps in place. Remove the IOM end caps.

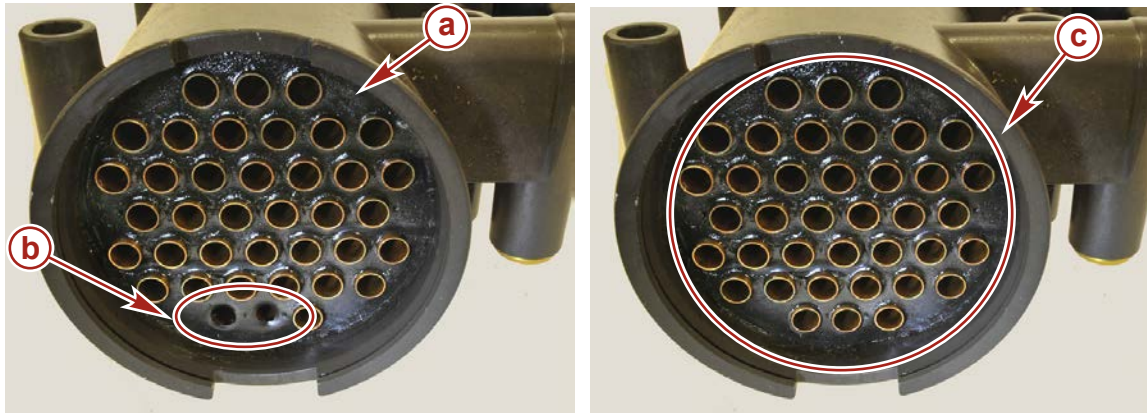
50294

5. Inspect the rubber end sheet for signs of movement. If the rubber end sheet has not moved above the cooling stack tubes, proceed to the **Correction** section. If the rubber end sheet has moved above the cooling stack tubes, contact Mercury Technical Service at 920-929-5884 for further instruction. If the IOM is replaced, record the IOM serial number in the warranty claim text.

- a - Rubber end sheet
- b - Cooling stack tubes below rubber end sheet
- c - Cooling stack tubes above rubber end sheet

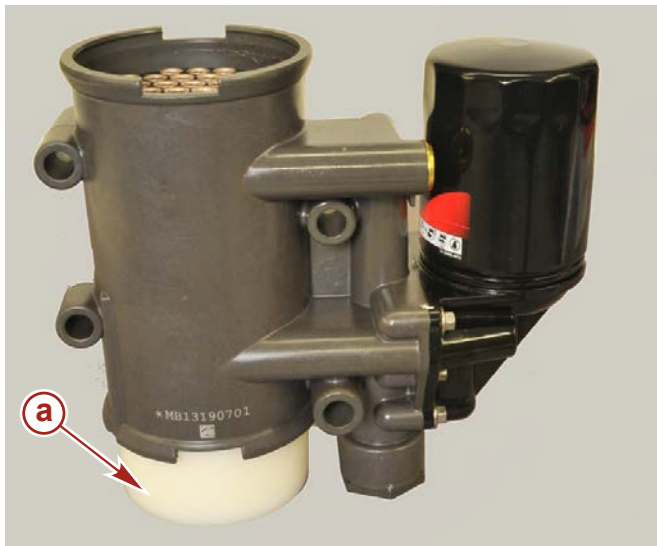
50288

- a - IOM coining support spacer

1. Place the IOM coining support spacer under one end of the IOM.

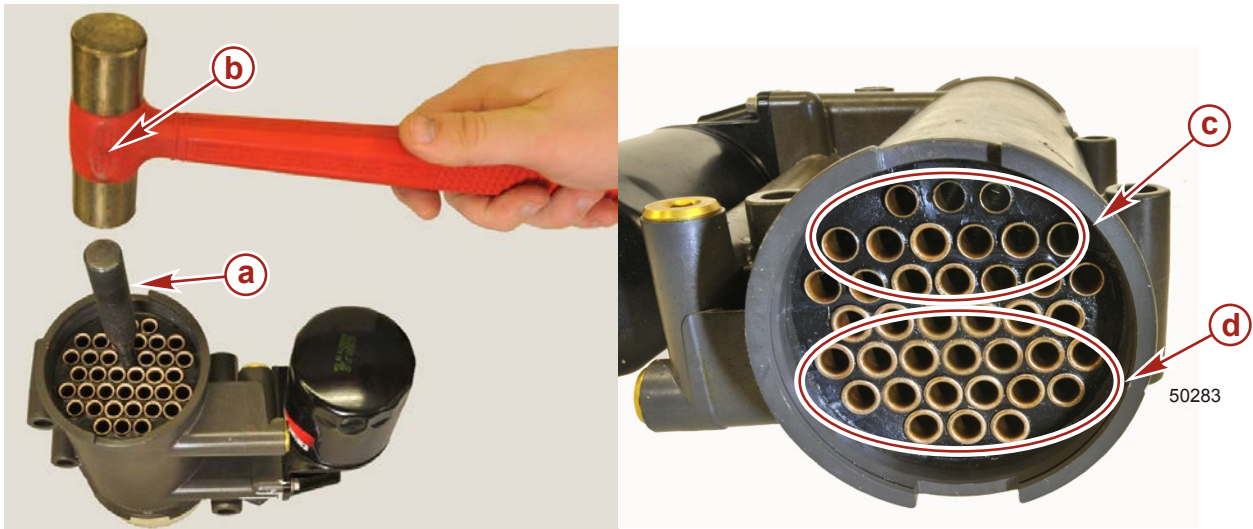
- a** - Coining tool
- b** - Brass hammer
- c** - Improperly coined tubes
- d** - Properly coined tubes

2. Using the IOM coining tool, coin all of the cooling stack tubes on both ends of the IOM. Take special care to ensure that all tubes are properly coined.

NOTE: Some debris will be created as part of the coining process.

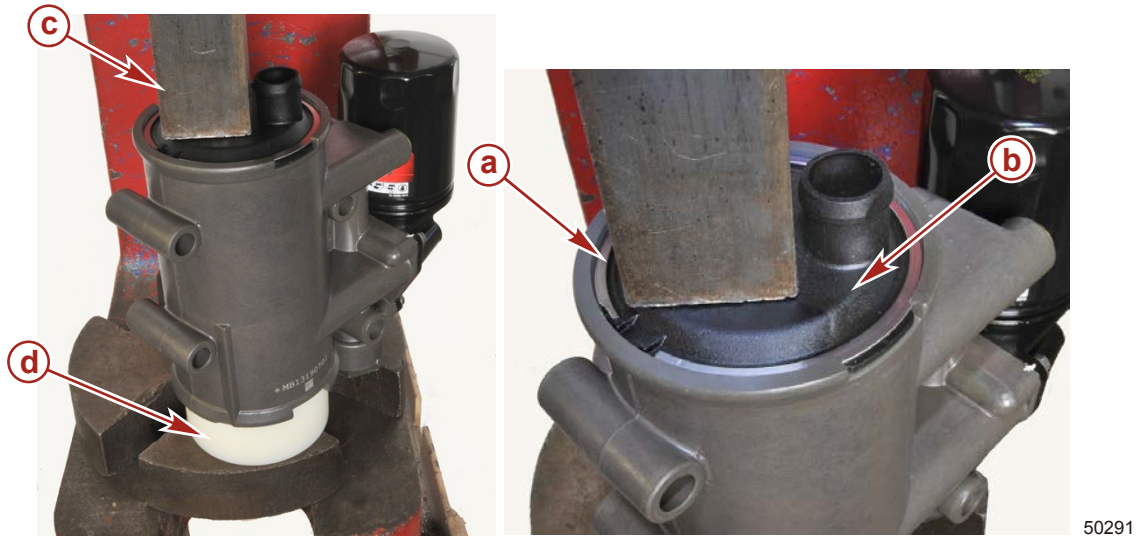
- a** - Retaining ring
- b** - IOM end cap
- c** - Arbor press
- d** - IOM coining support spacer

3. Using tap water, flush all debris out of the IOM that was created during the coining process.
4. Using an arbor press or a hand clamp, install the new IOM end caps and reuse the retaining rings. Pay special attention to the retaining ring and IOM end cap orientation.

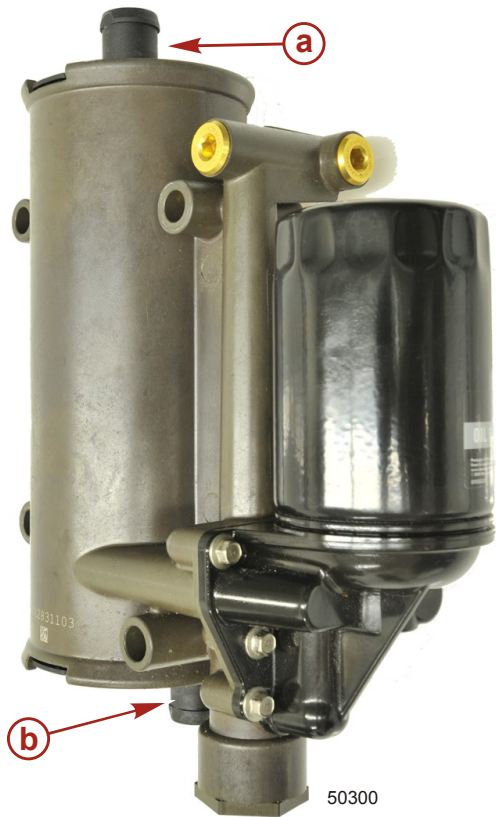
- a - Upper end cap cooling water hose barb orientated towards the front
- b - Lower end cap cooling water hose barb orientated towards the rear

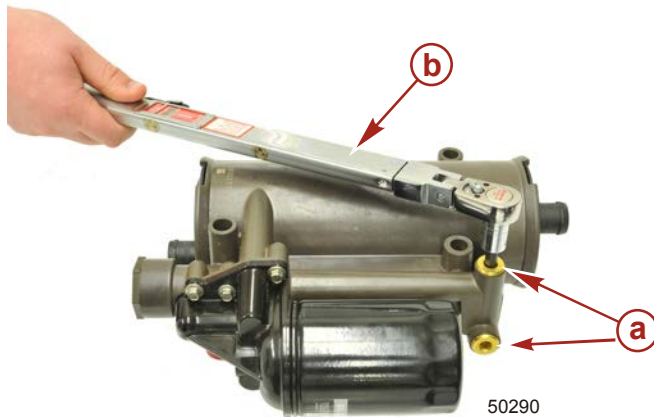
- a - Zero-Leak® plug
- b - Torque wrench

5. Loosen the Zero-Leak® plugs one full turn, then tighten the plug to the specified torque.

Description	Nm	lb-in.	lb-ft
Zero-Leak® plug	10	89	7.4

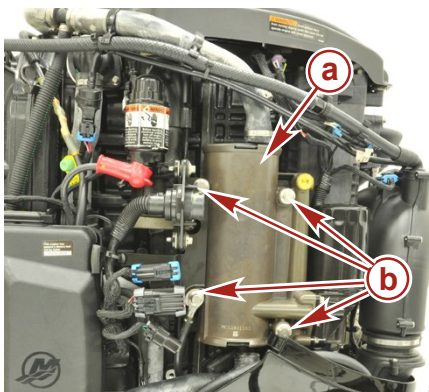
50283

- a - IOM
- b - IOM mounting bolts

- After removing the adapter tube caps, follow the service manual procedure to install the IOM.

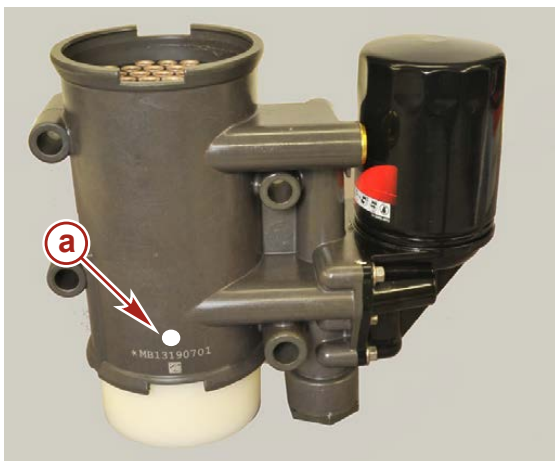
50295

- a - Identifying mark

- Check engine oil level. If engine oil is low, fill as required.
- Using an engine flushing attachment, start the engine and check for engine oil and/or cooling water leaks. If leaks are found, repair as required.
- After a successful test run, degrease the IOM body and place a white paint dot on the side of the IOM above the IOM serial number indicating that the IOM has been inspected and reworked.

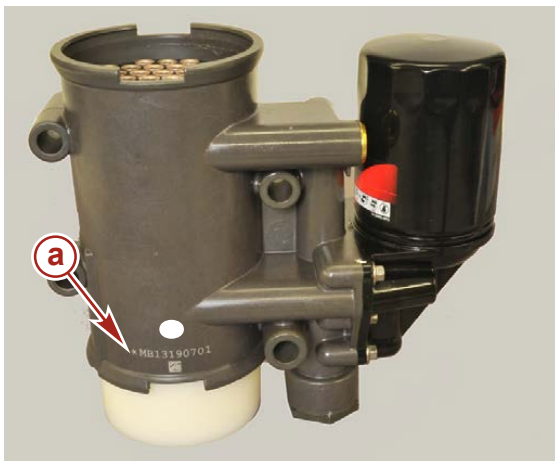
50296

- a - IOM serial number (MC_ _ _ _ _)

- Record the IOM serial number. When completing the warranty claim, place this serial number in the claim text box.

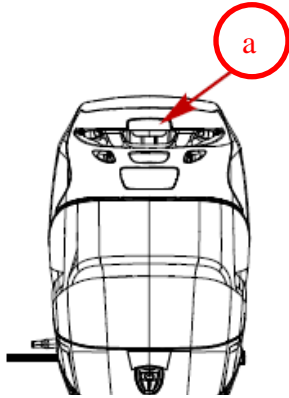
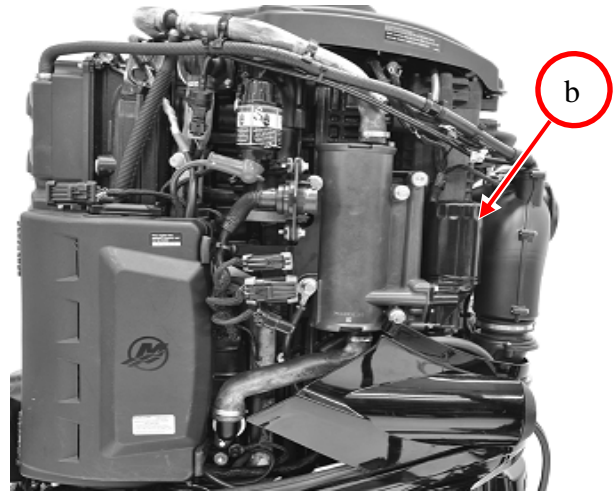
50298

Trim the engine to the vertical position and remove the top cowl. The integrated oil module is located on the starboard side of the engine.

a.) Top cowl latch lock

b.) Integrated oil module

- 1.) Pull up on the top cowl latch lock.
- 2.) Pull top cowl forward and lift off.

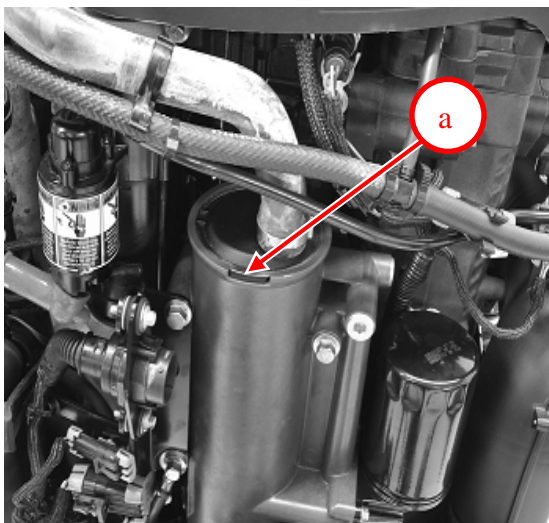
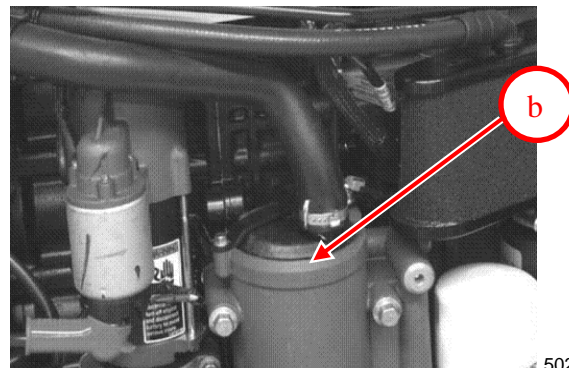
50282

3.) If your integrated oil module has a machining slot in the rim as shown in the photo on the lower left, please contact your Mercury dealer to schedule an appointment for repair of the integrated oil module.

If your integrated oil module looks like the unit pictured on the lower right with no machining slot, there is no need for any further inspection or rework.

a.) Machining slot

b.) No machining slot
