Some ATF Leaks Check Out “NTF”

**HONDA** ServiceNews

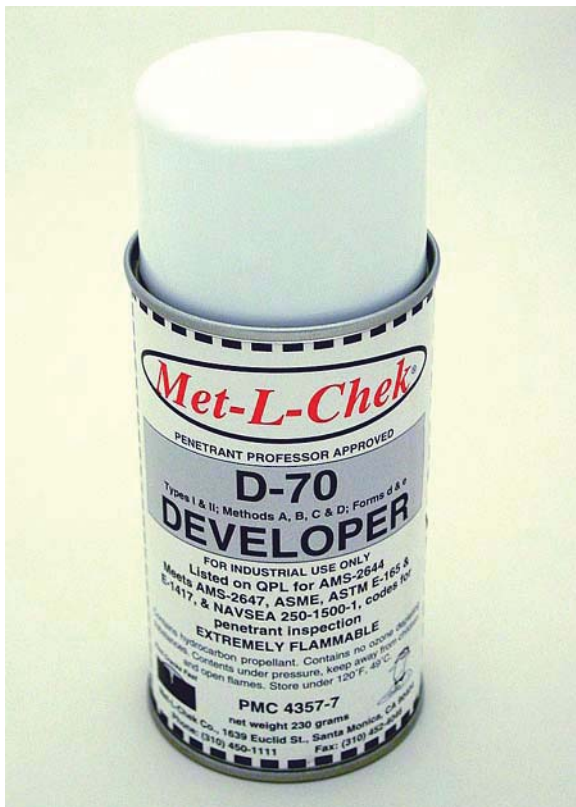
To make sure you've got a real ATF leak, first use a pressure washer to thoroughly clean the A/T, then use Met-L-Chek D-70 Developer to check for leaks. This product is a highly absorbent, powder-like coating that pinpoints leaks by changing color when it soaks up any liquid.

To apply D-70, clean the affected area with contact cleaner, then dry it completely. Apply a thin, even film of D-70, then apply pressure to the system, and wait for the leak to appear. If you still spot ATF leakage, then order a reman A/T.

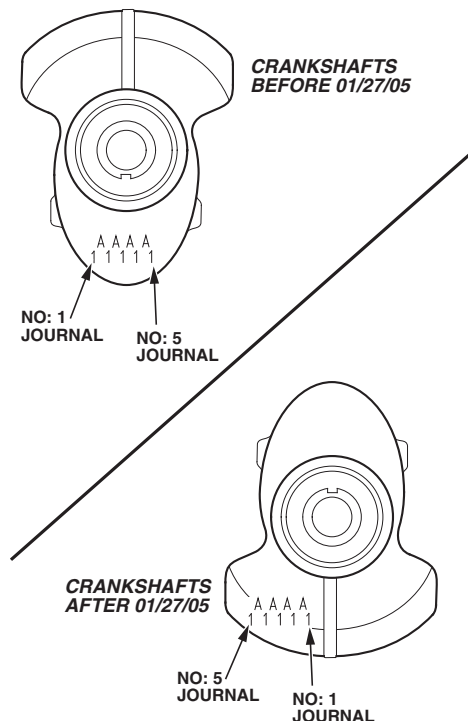
Starting in January 2005, the location of the crankshaft main journal code was changed on some Ohio-built L4 engines. Crankshafts made through January 27, 2005, have the main journal code stamped on the face of the #1 cylinder counterweight.

The top row has four letters representing the rod journal sizes. The bottom row has five numbers representing the main journal sizes. Both rows from left to right specify the journals from the pulley end to the flywheel end.

Crankshafts made since January 27, 2005, have the same two rows of journal info, but they're now on the rod throw end of the crankshaft and are read from right to left.

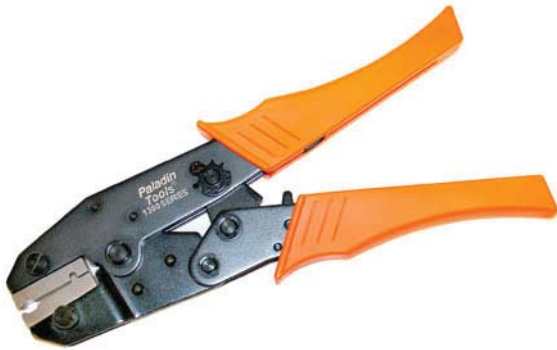
Need to repair loose terminals on an igniter (also known as the ignition control module) for a '96–00 Civic? The Igniter Terminal Crimping Tool (T/N 07AAE-S04A120) makes short work of it. This required special tool is being sent to all Honda dealerships, and it's designed to crimp the terminals that connect to an igniter with P/N 30130-P06-006, H/C 4317988.

Just center the terminal in the opening of the tool, and give the handle a firm squeeze. You've got a perfect crimp that provides a good, solid connection. When installing a terminal on the igniter, always slide it on straight. Never slide the terminal at an angle or wiggle it from side to side. If you do this, you could cause the terminal to spread and make poor contact. Order additional crimping tools through normal parts ordering channels.

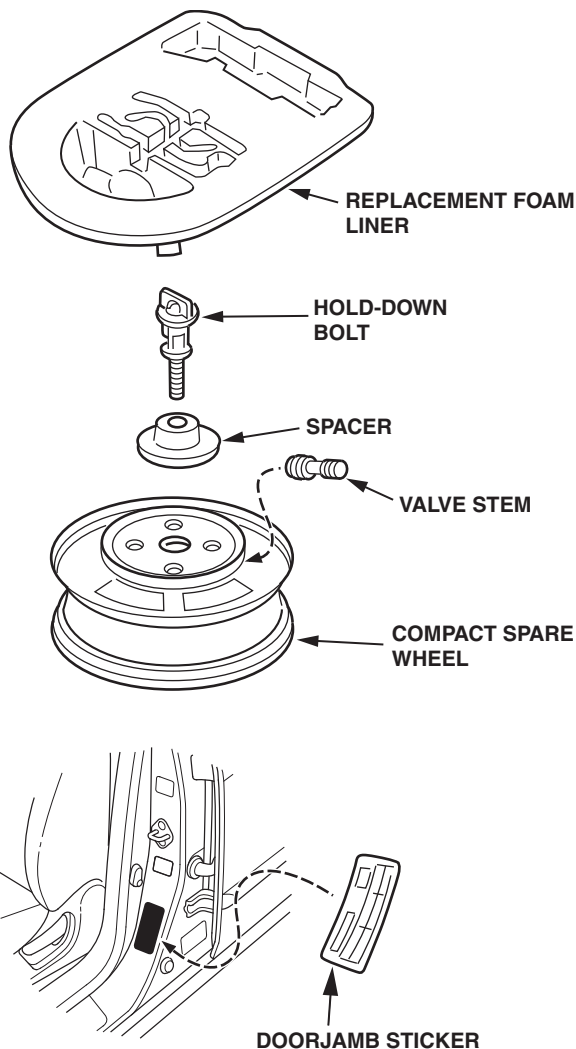
If an '05 Accord Hybrid owner would rather have a real spare tire in the trunk instead of a "spare tire in a can," we've got some good news for you. Honda parts stock now carries an accessory compact spare tire kit. Here's what you get in this kit:

- Replacement foam liner
- Hold-down bolt
- Spacer
- Valve stem
- Compact spare wheel
- Doorjamb sticker with recommended cold inflation pressure

The compact spare tire (it's a T135/90D15) doesn't come with this kit, so you need to order it separately. Here's the ordering info for the kit and the tire:

- **Accessory Compact Spare Tire Kit:**
P/N 06421-SDR-A00, H/C 7955347
- **Compact Spare Tire:**
P/N 42751-GYR-035, H/C 7992845
